Vanderbilt Mansion National Historic Site  
Hyde Park, New York

# Vanderbilt Mansion National Historic Site Historic Furnishings Report

Volume III: Implementation Plan  
September 2015

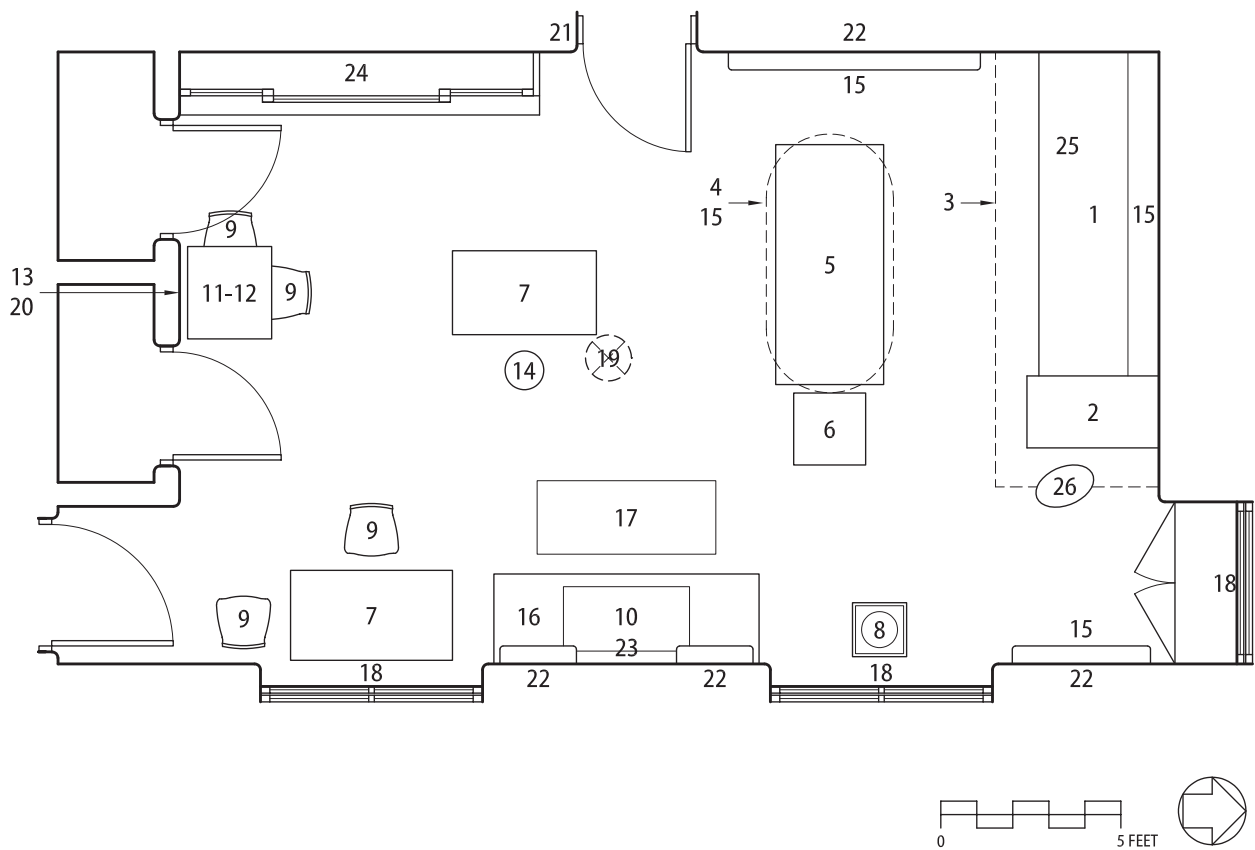
Figure 6. Kitchen (B01) furnishings location plan.

The room includes a mix of site-associated furnishings, period replacements, and reproductions. The most important original feature, the range, remains *in situ* while the adjacent roasting oven is a later National Park Service installation. This oven fits within the marks on the floor for an early appliance, and matches the Duparquet catalog's illustrations of roasting ovens that were traditionally at the ends of period ranges. It should remain unless further evidence reveals that a different apparatus was positioned in this location.

The Monel metal sink, though not the earliest sink, is likely a Vanderbilt modernization and should remain. The pot rack is an accurate NPS reproduction or period replacement and should remain. A reproduction shelf should be installed on the west wall, using the detailing of the existing wood shelves as models.

| <b>KITCHEN (B01)</b> | | | | | |
|---|---|---|---|---|--|
| 22<br>East and west walls | NC and N/A | <b>Wood shelves on iron brackets (4).</b><br>Three shelves on east wall. Similar shelf on west wall missing. | East shelves extant.<br>Marks on west wall. | Retain east shelves. Acquire west shelf. | |

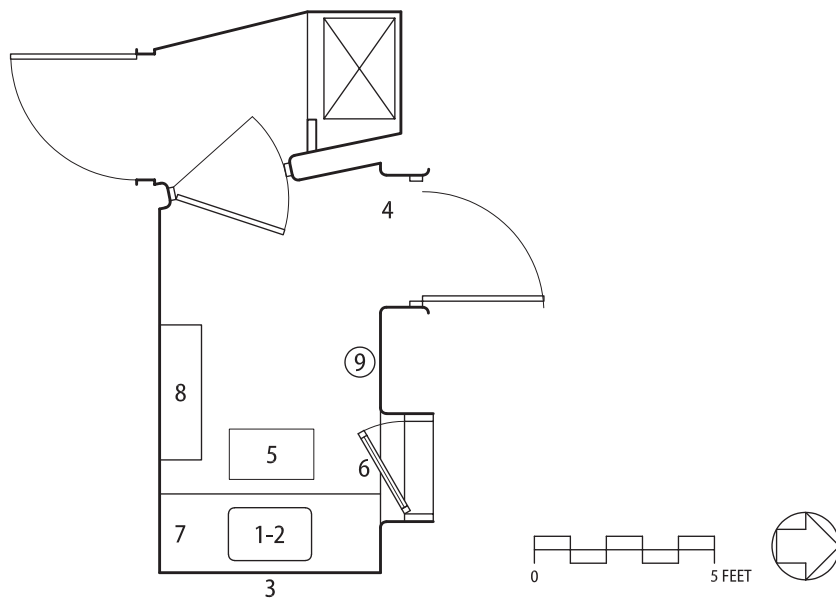
Figure 7. Scullery (B02) furnishings location plan.

There is physical evidence for a few possible additional furnishings. A shelf unit or cabinet (8) should be placed next to the south wall. Shelves would be handy for the temporary placement of the pots and pans and other objects after they were washed, and a worn area of the flooring indicates that a 1'-2" x 3'-9" piece of furniture sat near the south wall.

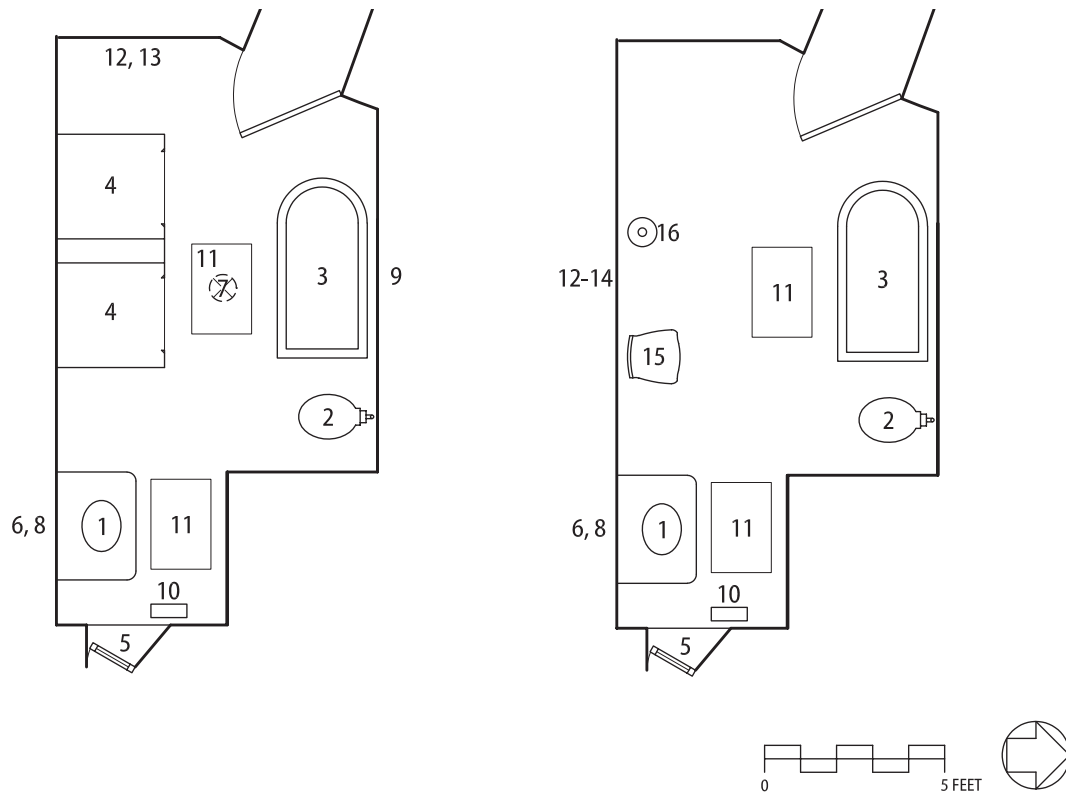
Figure 11. Men’s Bathroom furnishings location plan, Option 1 (left) and Option 2 (right).

This is the only servants’ bathroom that retains its bathtub, and so it could be fully restored to its Vanderbilt era appearance. The following chart and plan include the textiles and window treatments appropriate for that era. Fully restoring the room requires removing evidence of the World War II era: the light fixtures, wire mold and electrical fittings, mirror, shower head, and shower stalls. A new electric wall bracket and a mirror above the lavatory, along with a white-painted costumer and chair, would complete the restoration.

| MEN'S BATHROOM | | | | | |
|---|---|---|---|---|--|
| 6<br>Option 1: south wall | NC | <b>Electric wall fixture.</b><br>WWII era. | Extant. | Option 1: Retain.<br>Option 2: Replace with wall bracket based on typical brackets in basement rooms. | |
| 8<br>South wall | COLL | <b>Mirror.</b><br>Extant mirror is WWII era. | Extant. | Option 1: Retain.<br>Option 2: Replace with mirror similar to mirror in North Lavatory. | |

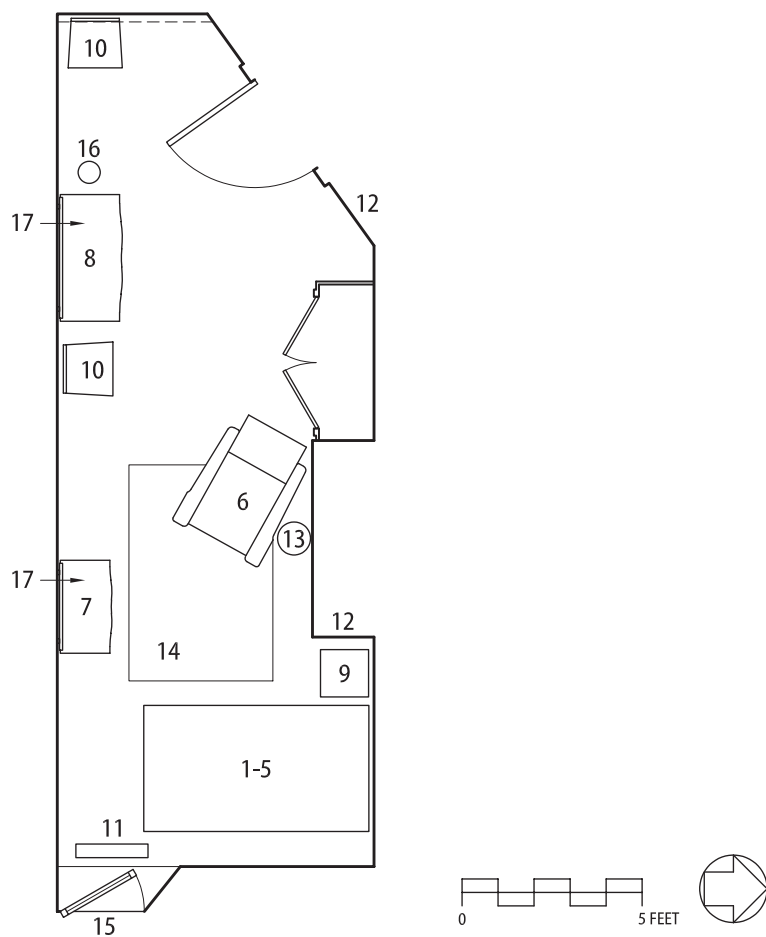
Figure 12. Boot Room/Servant's Room (B05) furnishings location plan.

According to the 1938 Curry inventory, this room was furnished with the typical oak furniture found in the servants' rooms, with the extra amenity of an oak Morris chair. According to a key in the housekeeper's key cabinet, at an earlier date this space functioned as the boot room. To fulfill this plan, the Vanderbilt-era closet needs to be restored to its position on the north wall and a linen roller shade (dark green) should be installed in the window.

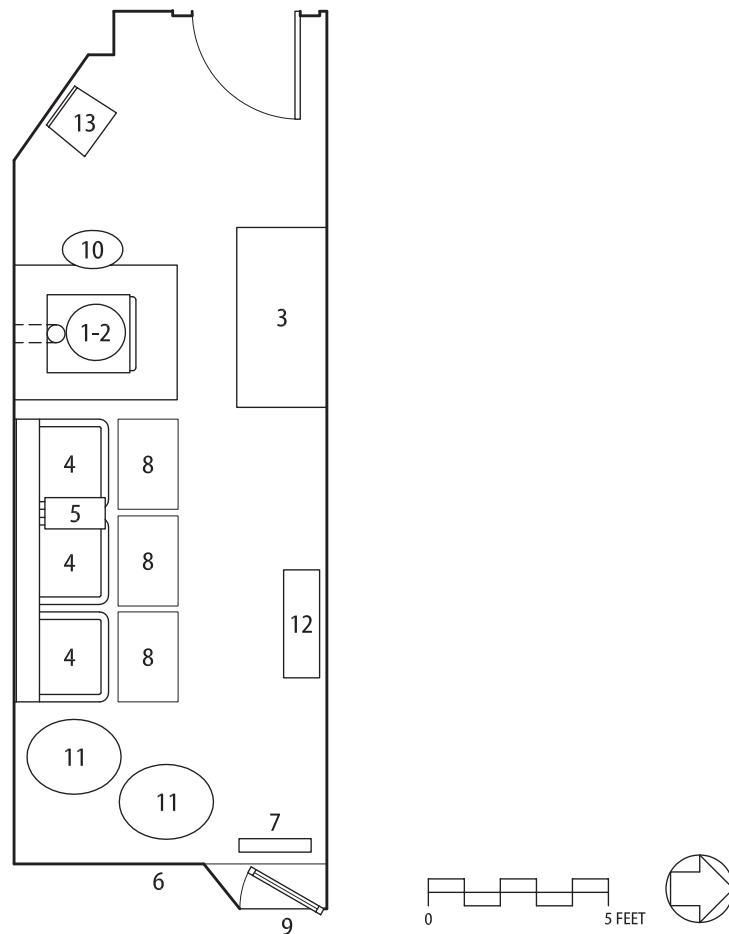
Figure 13. Service Laundry (B06) furnishings location plan.

This room has all of the features of the adjacent larger laundry except for the drying racks. The servants' laundry was probably placed on the drying racks in the adjacent room. The stove (James & Kirtland) and its set-up details should duplicate conditions in the main laundry. A linen roller shade (dark green) should be placed at the window, and the glass panel restored to the door.

The room is currently used as an NPS staff break room. It houses a water heater and a washer and dryer. If possible, the water heater should move to the sub-basement or an on-demand water heater should be installed. The washer and dryer can be removed, since they are no longer used for laundry.

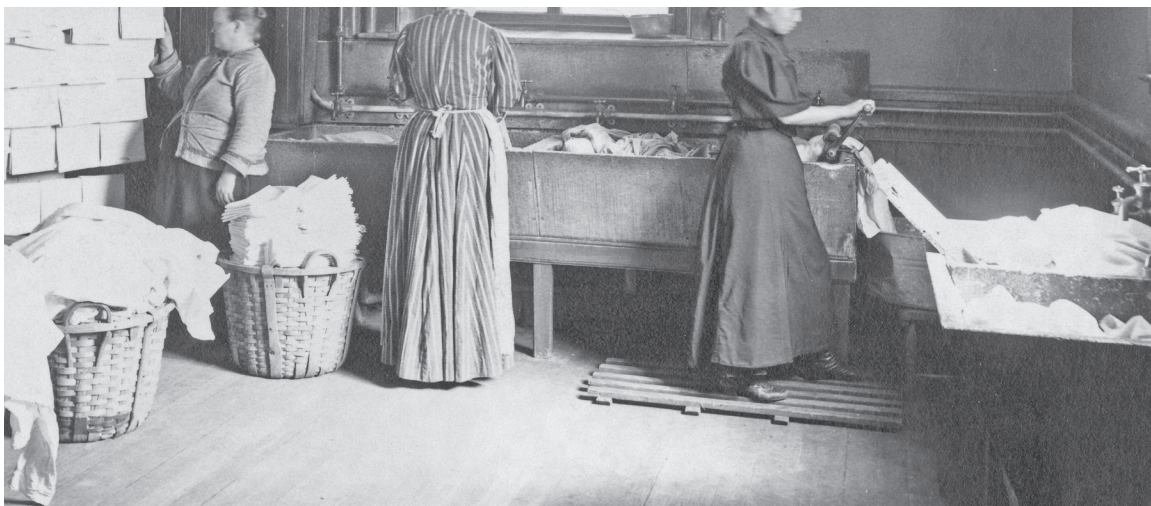
Figure 15. (Below) Detail from circa 1905 photograph of a laundry, showing a mangle, laundry baskets, and a wood platform/mat. Prints and Photographs Division, LC-H25- 3880-HO.

The laundry stove remains *in situ* but a necessary component is missing. The cast-iron superstructure, that held the irons for warming, needs to be restored. Irons should be placed on the restored stove rack. Other important furnishings necessary for a functioning laundry include a coal bucket (hob), laundry baskets, a clothes wringer, and floor mats in front of the laundry tubs. Laundry supplies were kept in the closet and cabinet at the south end of the room. One or two of the drying racks should be extended to display a sampling of the laundry, such as sheets, pillowcases, towels, etc. The windows should include linen roller shades (dark green), and the door to the hall should have the glass panel restored.

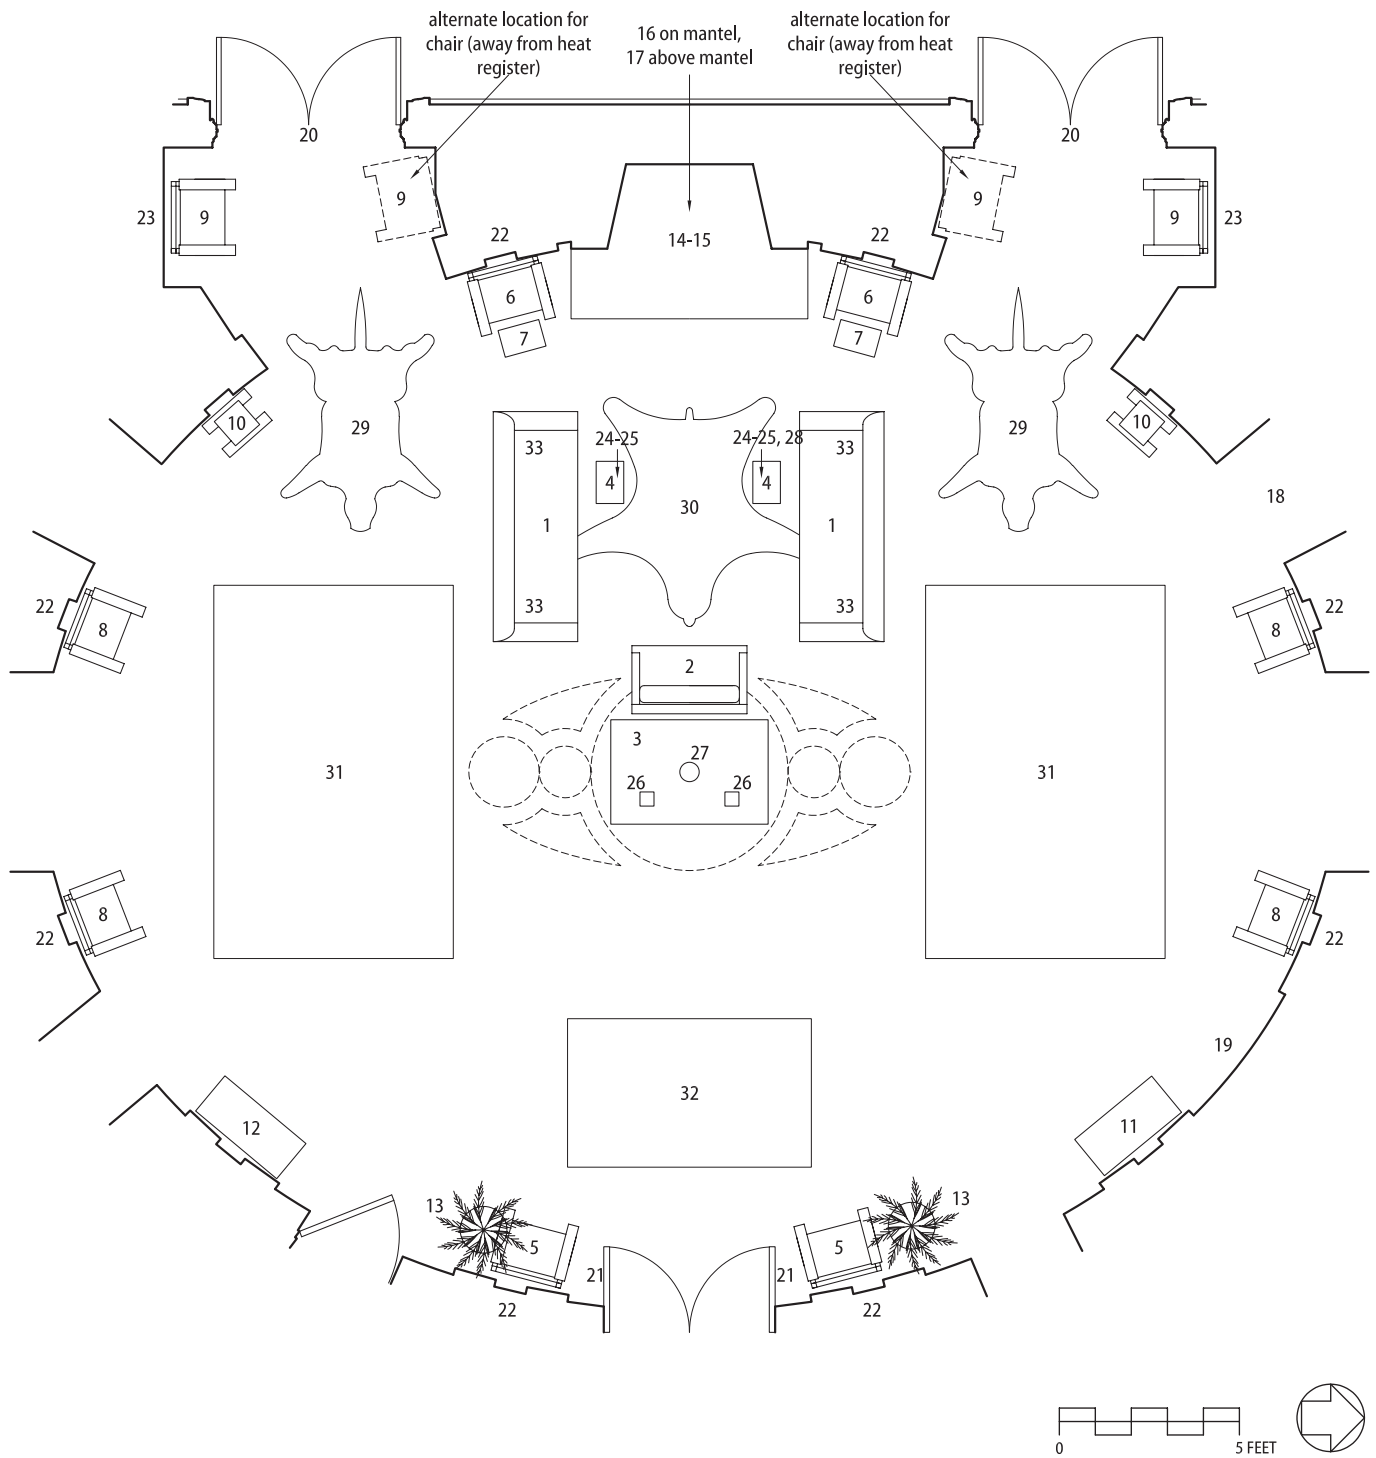
Figure 28. Hall (101) furnishings location plan.

The primary additions to the Hall after 1906 are the two large sofas (VAMA 214 and 215) initially supplied by Stanford White for the Living Room and placed facing each other in front of the fireplace forming an intimate area for relaxation. The two small oak smoker's stands (VAMA 758 and 922) should be placed in front of the sofas for easy use and each should include ashtrays. By 1938 the floor was covered in a variety of rug types including two large "old Rahver Garden" rugs. Reproductions of this rug type should be placed at the north and south ends of the Hall as shown in the 1938 photographs. Three floor coverings, two tiger

Objects that may have been placed here seasonally include large potted plants, such as ferns or possibly the topiary trees seen in early exterior photographs of the south and east porches. To represent this tradition, the two large Chinese pots on stands (VAMA 750 and 752) should be “planted” with large artificial ferns and placed here. Possible locations include flanking the east entrance door or flanking the center table. Their placement and number probably varied over time. Additional objects to be acquired for the Hall include a pair of silver card trays to be placed on the center table as well as seasonal flower arrangements placed on that surface. The important French clock (VAMA 751) introduced to the Hall by Mrs. Van Alen sometime after the death of Frederick Vanderbilt could be moved to the French table in the second floor north foyer. The 1938 Curry inventory indicates that a clock (now missing) was located there.

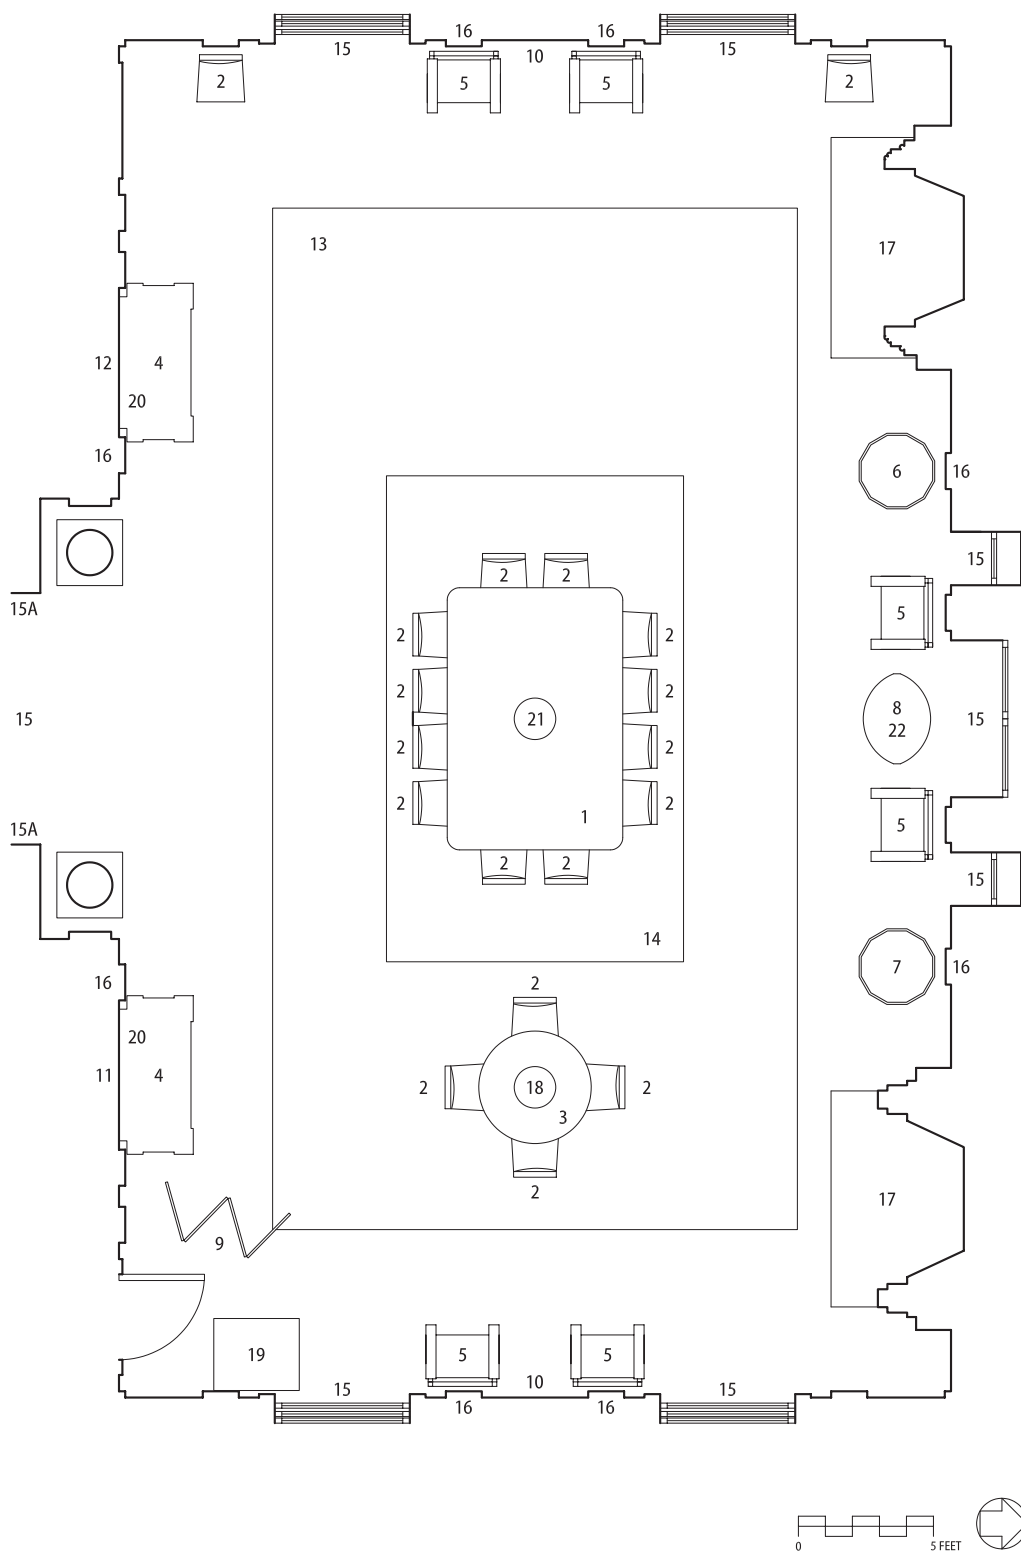
Figure 40. Dining Room (106) furnishings location plan.

The two console tables should display arrangements of silver, including large trays set against the paneled wall (where there are still marks from the original trays), trophies, and other large pieces.

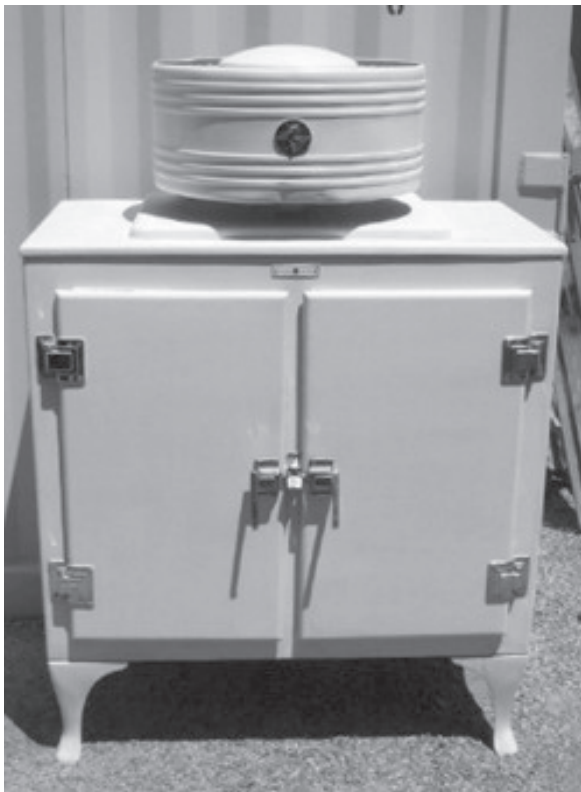
Figure 41. A 1930s General Electric monitor-top refrigerator. [www.antiquevintageappliances.com](http://www.antiquevintageappliances.com).

Other significant missing furnishings include the pendant lamp, which was probably similar to the extant lamps in the Laundry, and the refrigerator that was located next to the west wall below the cabinets. A possible choice for the refrigerator would be a white enameled two-door monitor top General Electric model from the early 1930s. Linen roller shades (ivory) should be placed at each window.

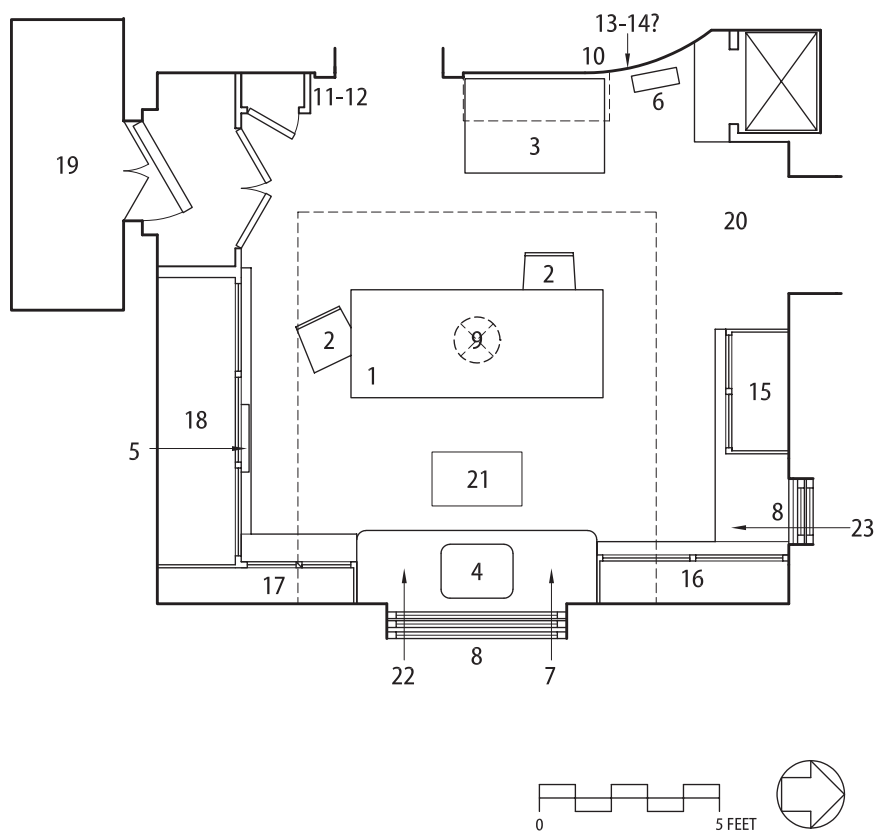
Figure 42. Butler's Pantry (107) furnishings location plan.

If feasible, the park should relocate the maintenance storage currently in the silver vault, and then increase access into the Pantry so that visitors can see a display of appropriate reproduction silver through the open vault door.

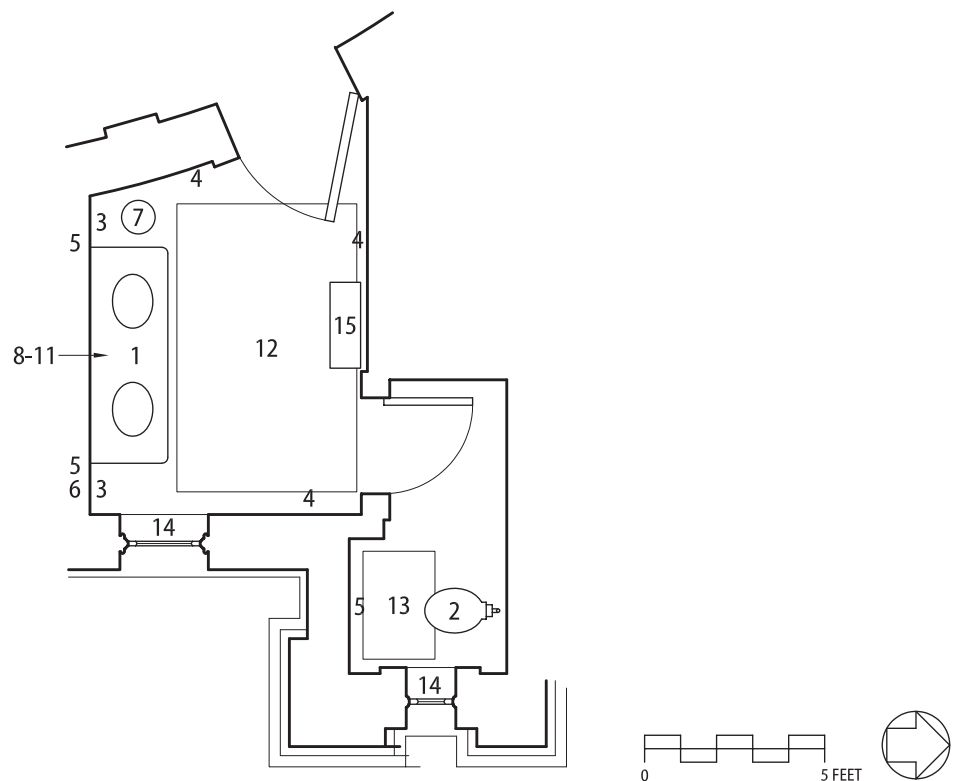
Figure 43. Lavatory/Coats Room (108) furnishings location plan.

The size and plan of this room allow placement of only a few furnishings: a rug for the floor and a small bench (VAMA 777) placed next to the north wall. This room provides the opportunity to display a bench not otherwise on exhibit. Although not documented in this space, a place for short-term sitting would be a welcome amenity in a ladies' powder room. A linen roller shade (ivory) should be placed at the window here and in the toilet room.

One of the hooks might hold a lady's cloak, and an umbrella would be appropriate for the ceramic jar in the southwest corner. The addition of hand towels and items on the marble counter—toilet water, soap and a soap dish, pincushions, and a hair pin box (some of which were on the lavatory in 1940)—would make this lavatory space complete.

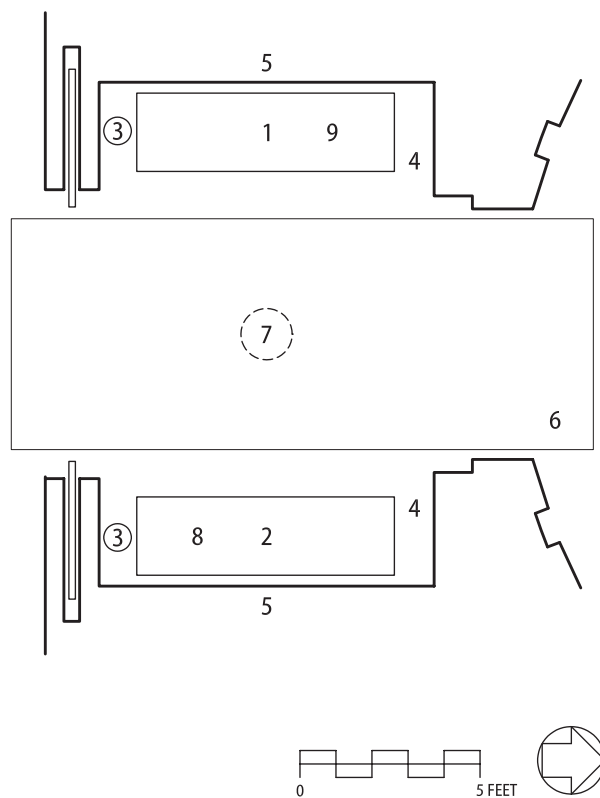
Figure 44. South Foyer (109) furnishings location plan.

This passage to the Living Room retains the furnishings noted in the 1938 Curry inventory with the exception of the rug, which may not be practical for visitors. The two bronzes (VAMA 878 and 1002) can be placed here if they are not installed in the Living Room.

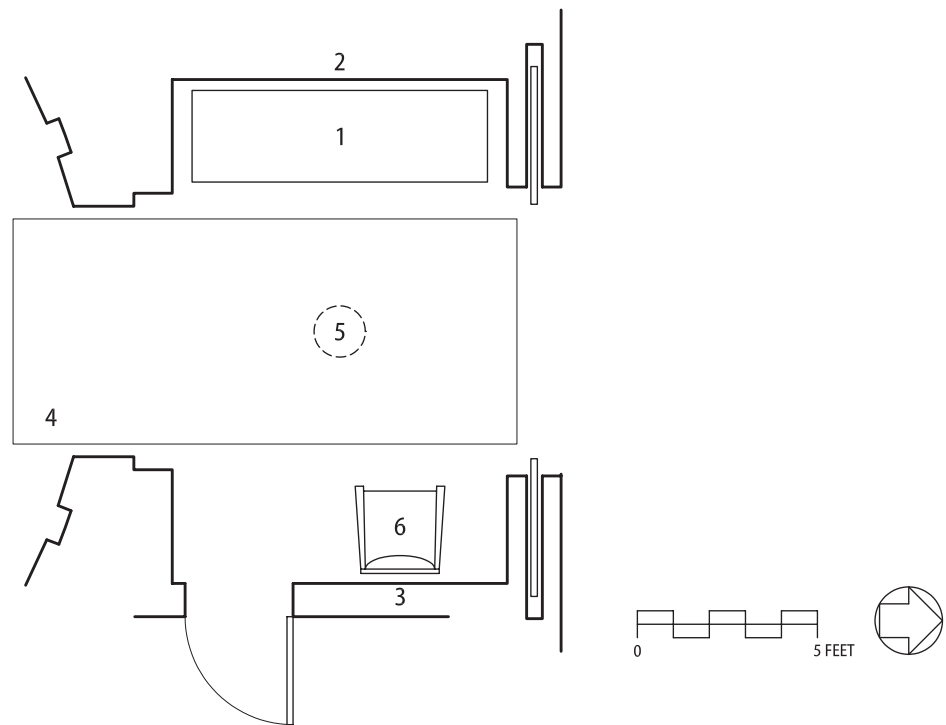
Figure 45. North Foyer (110) furnishings location plan.

This passage leading to the Dining Room was sparsely furnished in 1938. The only objects noted in that inventory that are now missing are the tapestry on the east wall, the rug and one of the Chinese ceramic jars. The jar was probably placed here temporarily when not in use in the adjacent Hall. The tapestry should be restored to the east wall. The placement of a rug is optional.

The east side of the space would be an appropriate place to display high-style items from the collection. The plan shows one of the larger chairs from the collection, one of the pair with the eagle finials (VAMA 381), but it could also be displayed with its partner at the top of the Main Stair.

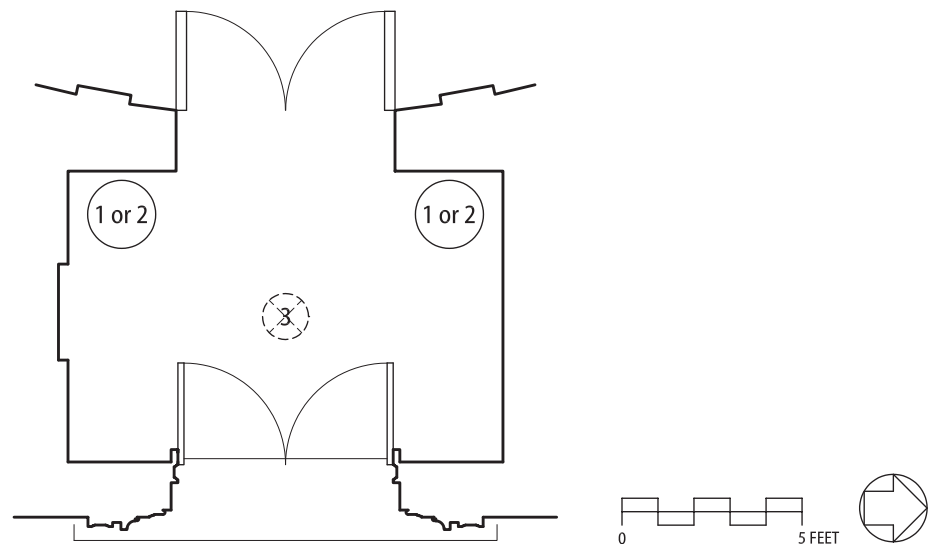
Figure 46. Vestibule (111) furnishings location plan.

The Vestibule is furnished simply, based on the 1938 Curry inventory. Period photographs of similar vestibules reveal that they rarely included any furniture and relied solely on their architectural detailing and lighting for impact.

The original hanging pierced metal lamp fixture remains *in situ*. The pair of Italian green pottery jars (VAMA 766, 767), probably the ones purchased by Stanford White, should be placed to flank the door into the Hall (101), as they were in 1938. An alternative scheme would place the two large bronze standards (VAMA 6875, 6876), also purchased by Stanford White, in the locations flanking the door to the Hall (101) in place of the Italian jars (if the jars are deemed too fragile to place that close to visitors). This scheme would also provide a more secure location for the two standards, historically located on the west porch.

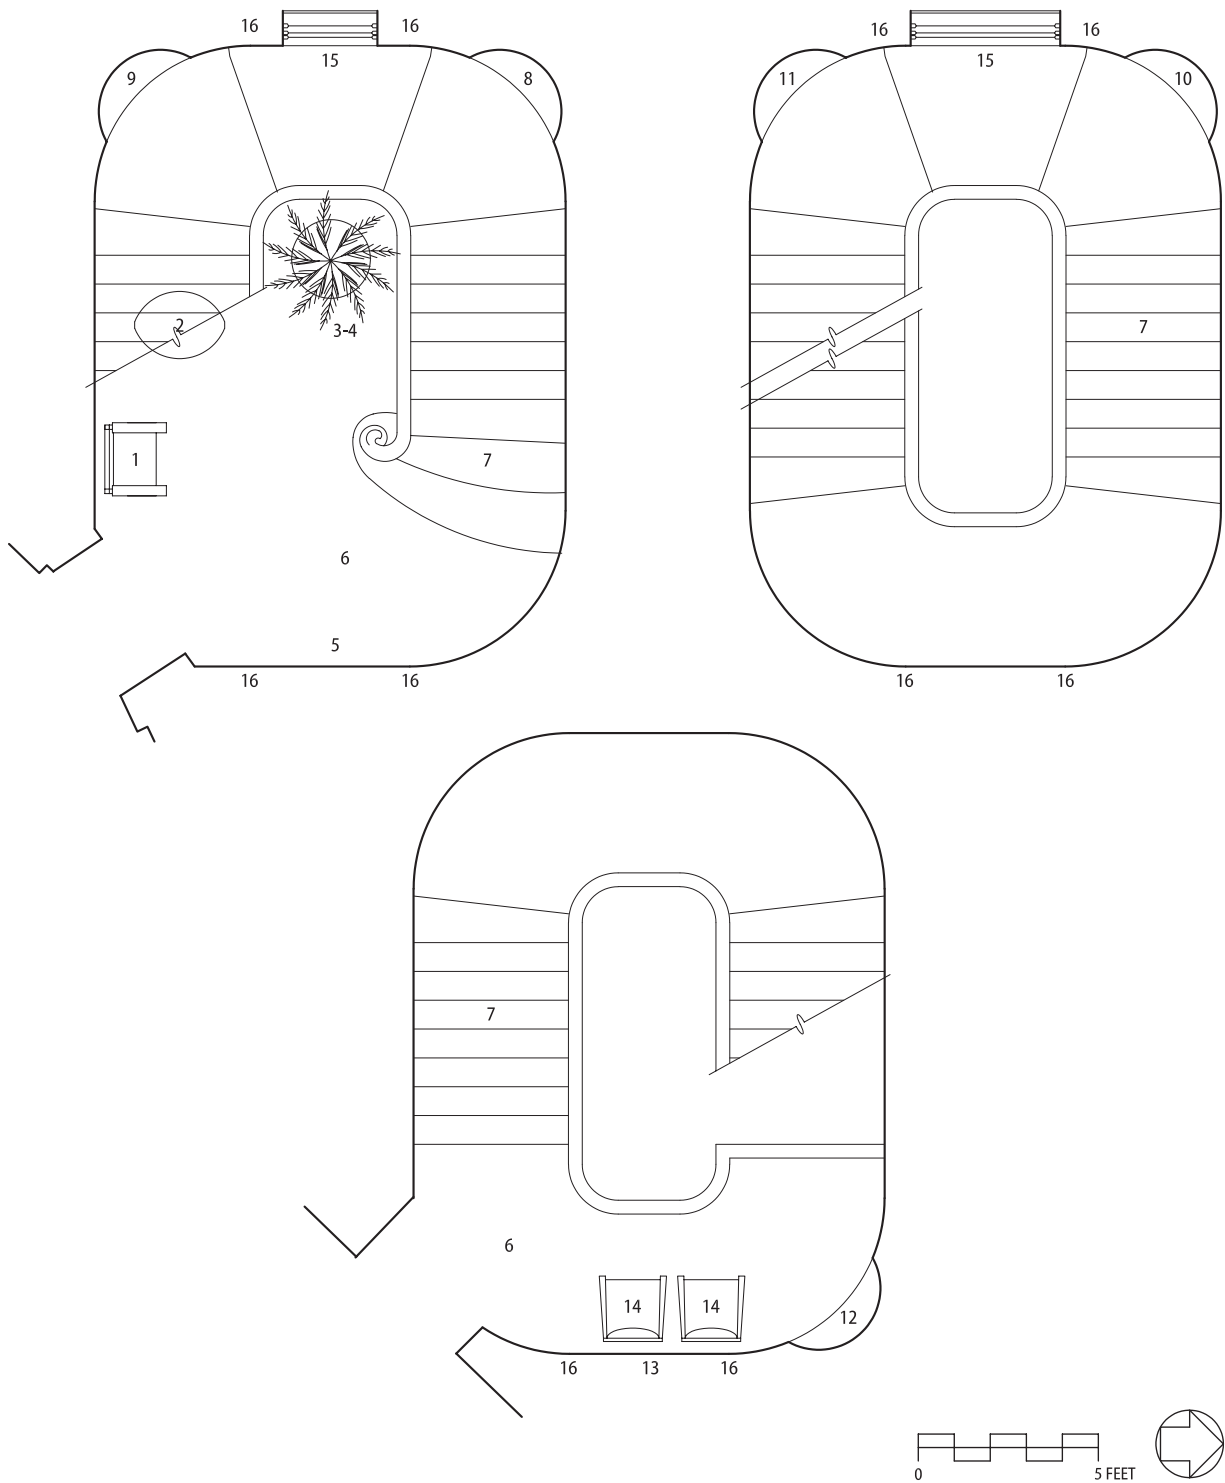
**Figure 47. Main Stair furnishings location plan: first floor (upper left); intermediate landing (upper right); second floor (center).**

The stair hall retains all of its appropriate furnishings as noted in the 1938 Curry inventory. The Chinese jar at the base of the stair should contain a large artificial palm that extends up beyond the first landing (based on an interview with the Vanderbilts' gardener). Ferns and palms are seen in period photographs of similar stair halls, like that at the Ogden and Ruth Livingston Mills home, Staatsburg.

The top landing, along the east wall, is an appropriate place to display chairs from the collection, possibly the pair with eagle finials (VAMA 381-382). The Austrian blinds at the two west windows should be reproduced.

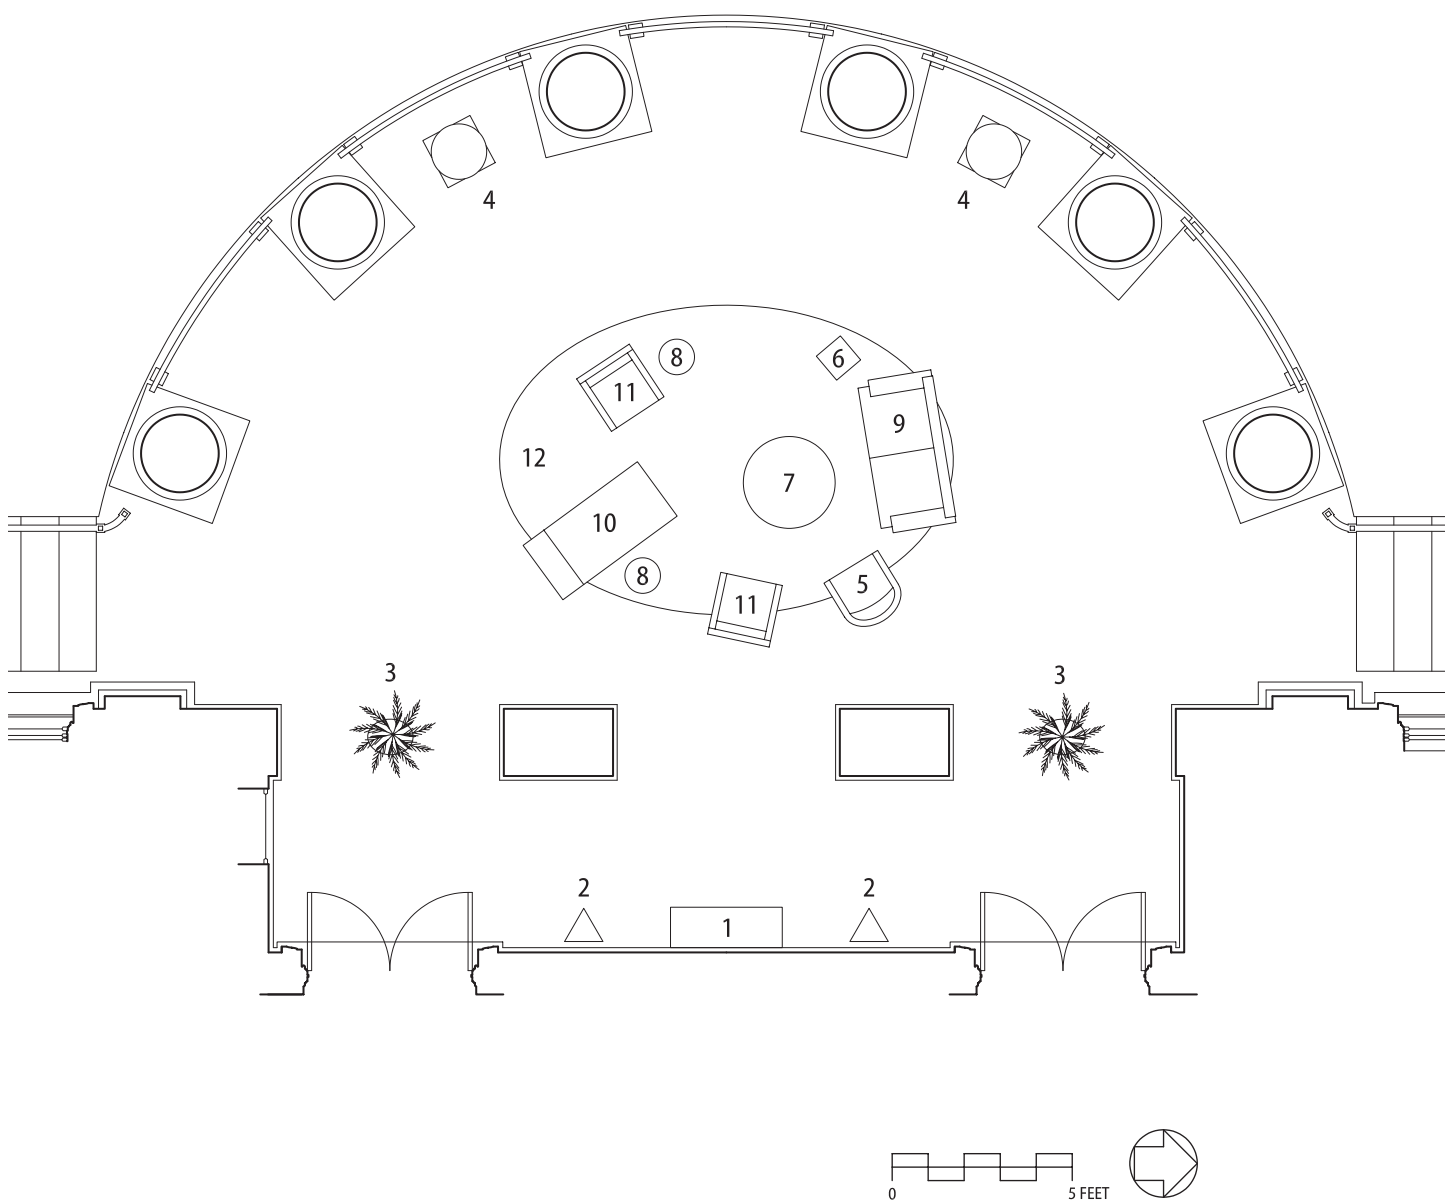
Figure 49. West porch furnishings location plan.

The following charts and plans list all of the furnishings as if the porches were to be fully furnished. The 1938 Curry inventory and the few existing exterior photographs that record the porches reveal at least two types of furniture: a collection of cane and rush pieces and a stick and reed set. The cane and rush set included at least four curved back arm chairs, five fan back chairs, two small hour-glass tables, four tabourets, and a round oak top table. The stick and reed set included a davenport (sofa), a chaise lounge, a flat bench lounge, and two arm chairs. Over time, when in use, the two sets were probably mixed in the various locations. A pair of wood settees seen in photographs on the east porch date to after the Vanderbilt era. Other important, more static, furnishings include the marble urns, the marble fountain, and the pair of iron and sheet brass standards (VAMA 6875, 6876).

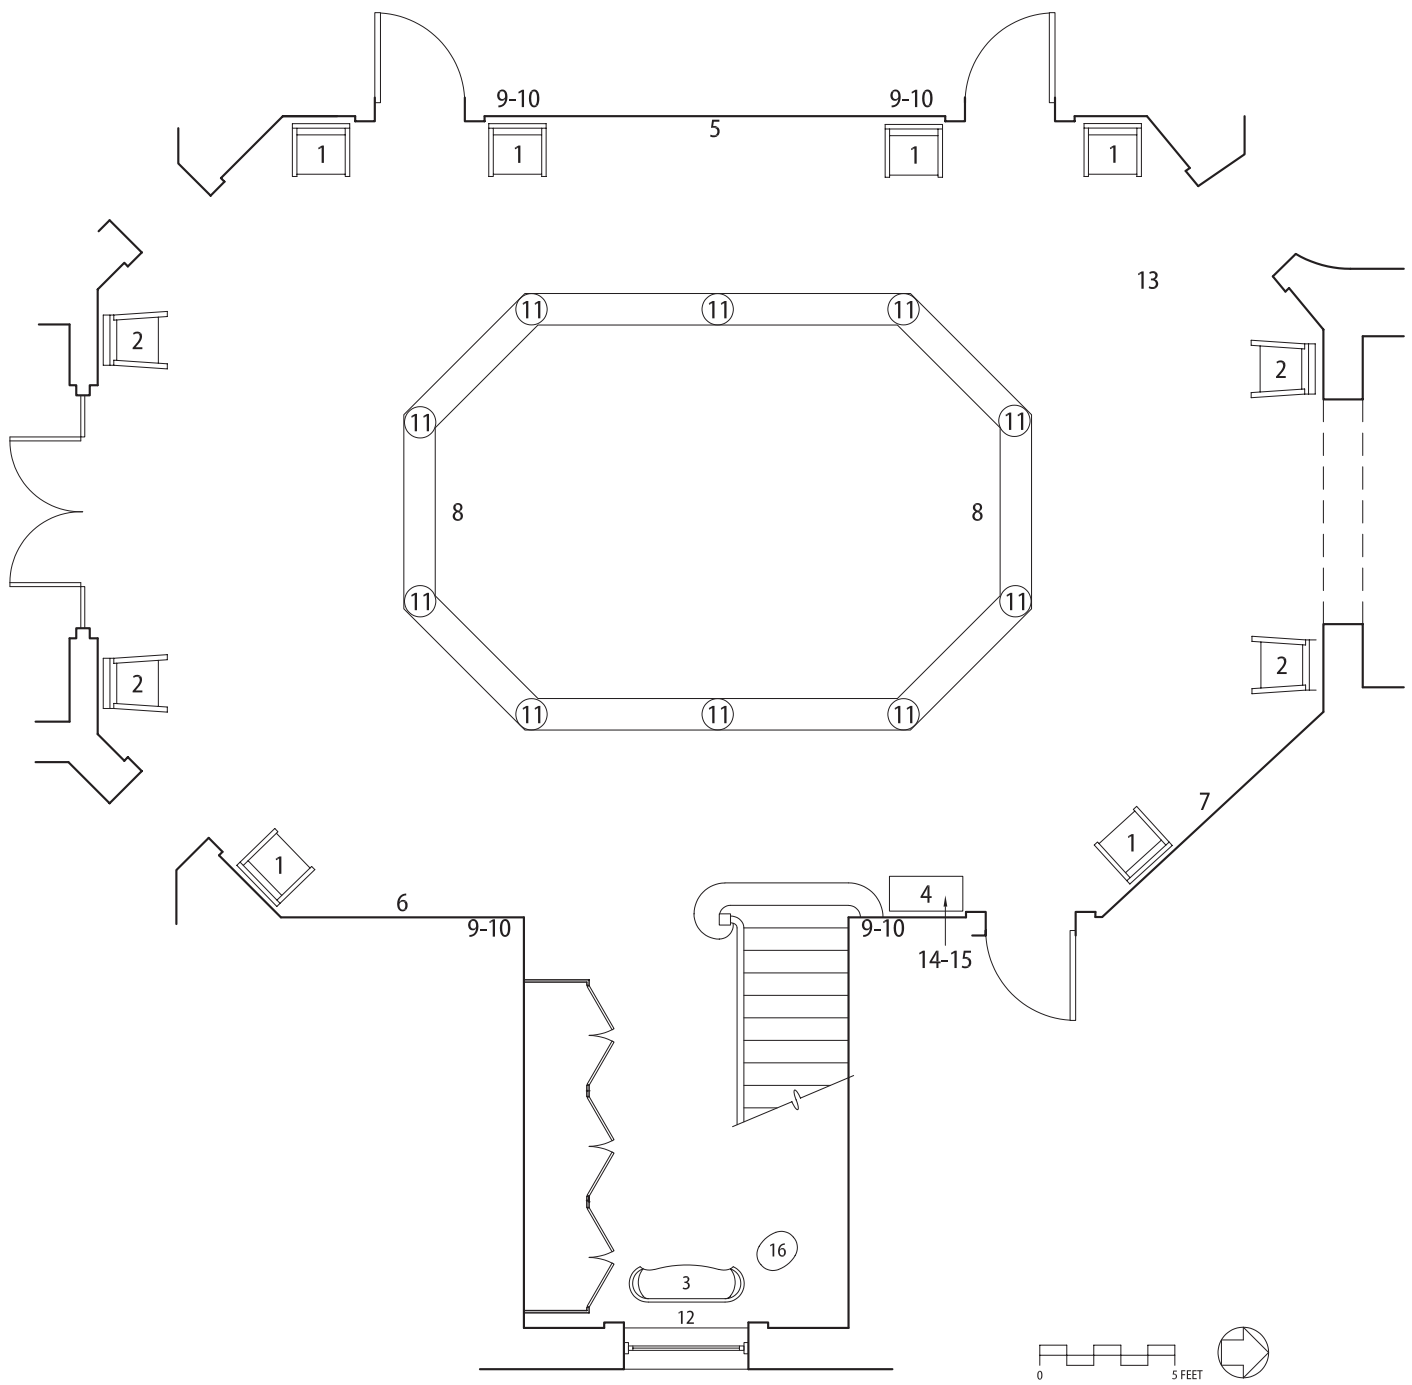
Figure 55. Second floor Hall (201) furnishings location plan.

One issue, still to be resolved, is the installation of the tapestry (VAMA 372, number 7 on the plan) that hangs in front of an air register. When the tapestries are again hung in the Hall, rope stanchions will need to be installed to protect the valuable textiles from visitors.

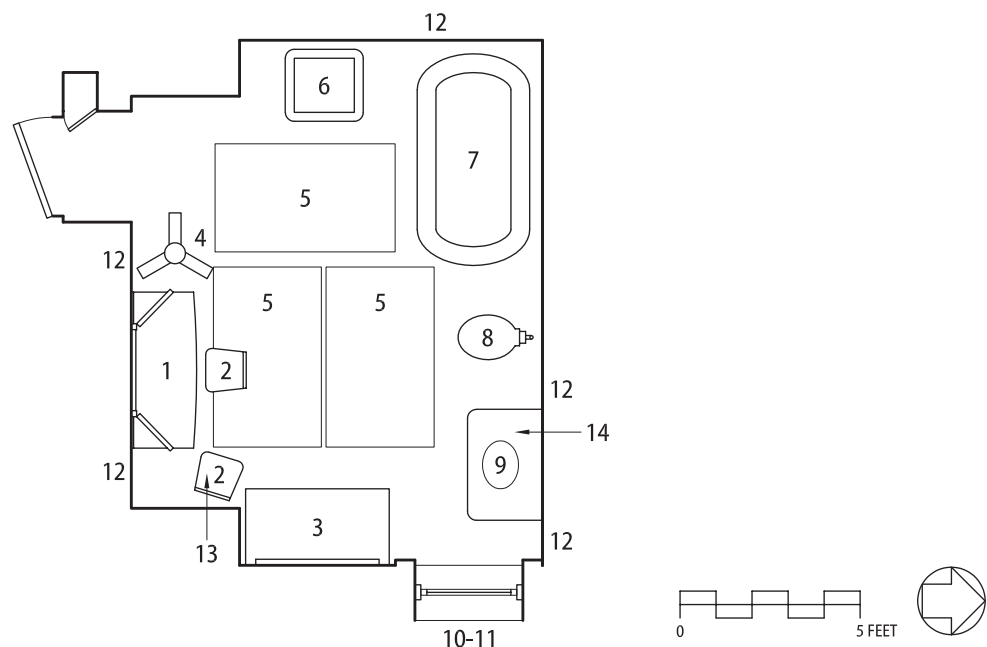
Figure 56. Mrs. Vanderbilt's Bathroom (202) furnishings location plan.

The dressing table forms part of the suite of white enameled furniture placed in the third floor Green Bedroom (306). It may have been removed to this bathroom when a desk was installed in the bedroom. Its placement in this bathroom forms an interesting counterpart to the more formal dressing table in Mrs. Vanderbilt's bedroom.

The window included a linen roller shade (ivory) and some form of curtain but there is no evidence for a treatment that included a colorful valance like the ones in Mr. Vanderbilt's bathroom. The floor was partially covered by three rose-colored mohair rugs that should be installed or reproduced. This is the only bathroom that has no towel bars or toilet paper holder. In this plan, the folded towels are placed on a chair and on the lavatory; it is possible that there was a freestanding towel rack and toilet paper holder in the room when it was in use.

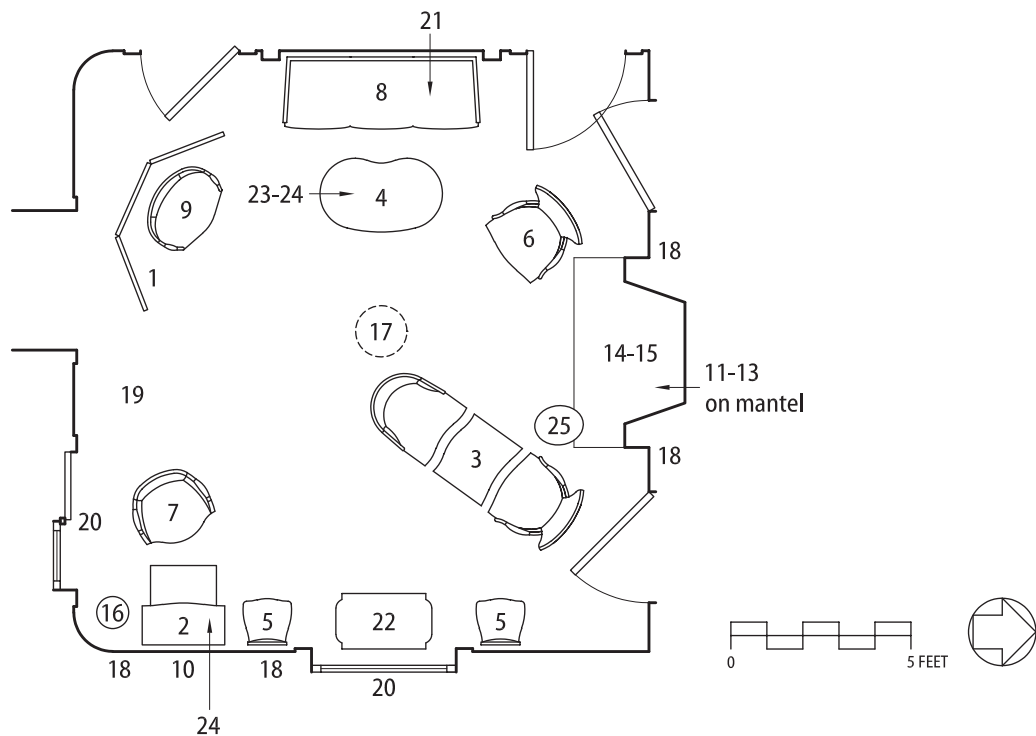
Figure 58. Mrs. Vanderbilt's Boudoir (203) furnishings location plan.

All of the Vanderbilt-era giltwood caned seat furniture remains in the Boudoir, with the exception of the settee, which should be restored to its prominent position below the mirror set into the west wall. The gilt and painted kidney-shaped table is placed in front of the settee to serve as a sofa table. The vitrine table (VAMA 613), in Mrs. Vanderbilt’s Bedroom in 1938, is placed near the east window. A desirable furnishing, not recorded in the room, is a small, possibly gilt, table to place next to the chaise lounge. The three-panel screen was probably placed to provide privacy when the service door in the northwest corner was opened, but installation in that location would block the visitors’ view of the room.

In addition to the extant drapery and curtain treatments, each window should include a linen roller shade (ivory). The original Wilton carpet, or a reproduction of the carpet, should be installed.
