Vanderbilt Mansion National Historic Site  
Hyde Park, New York

# Vanderbilt Mansion National Historic Site Historic Furnishings Report

Volume III: Implementation Plan  
September 2015

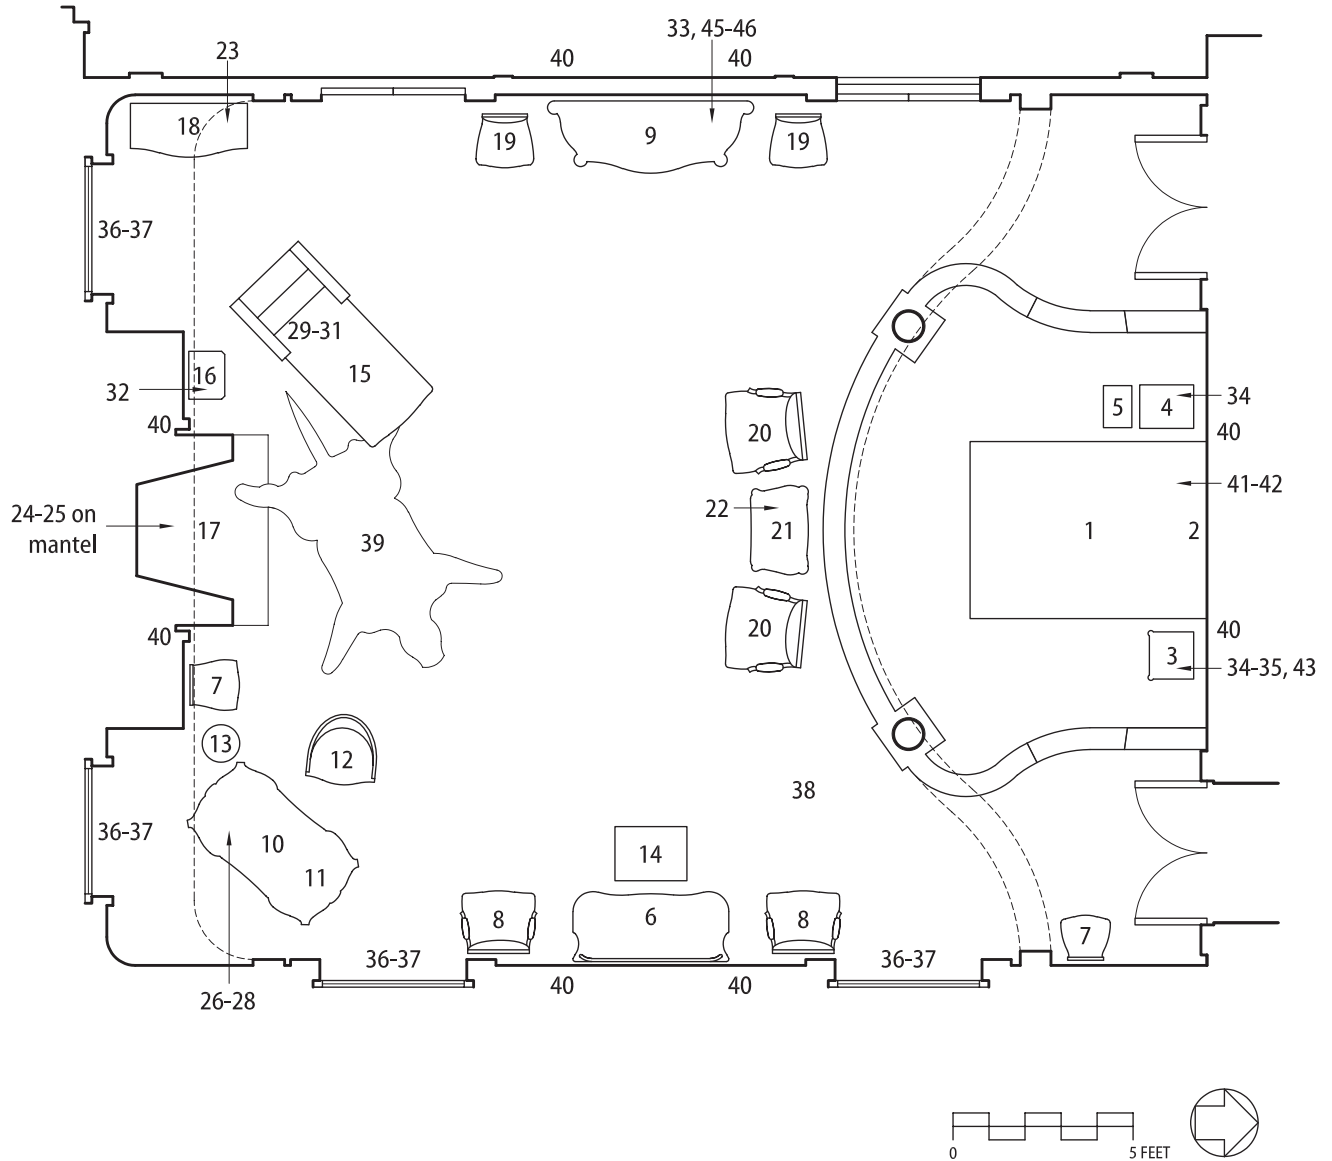
Figure 59. Mrs. Vanderbilt's Bedroom (204) furnishings location plan, Option 1.

A significant furnishing missing from the room and not listed in the 1938 Curry inventory is a dressing table. All of the guest bedrooms include this amenity. A dressing table (VAMA 4555), currently in storage, matches Mrs. Vanderbilt's bed in design and material. In 1938 it was situated in the adjacent Boudoir but it is likely that it was originally installed here to complement the bed.

In both placement options, the folding stool or pliant (VAMA 600) is used with the dressing table. The poor condition of the giltwood frame and the upholstery indicate that this seat received extensive use; it will need restoration and a reproduction cushion.

Each of the window openings, with the elaborate valances, curtains, and lace panels, should include an ivory linen roller shade.

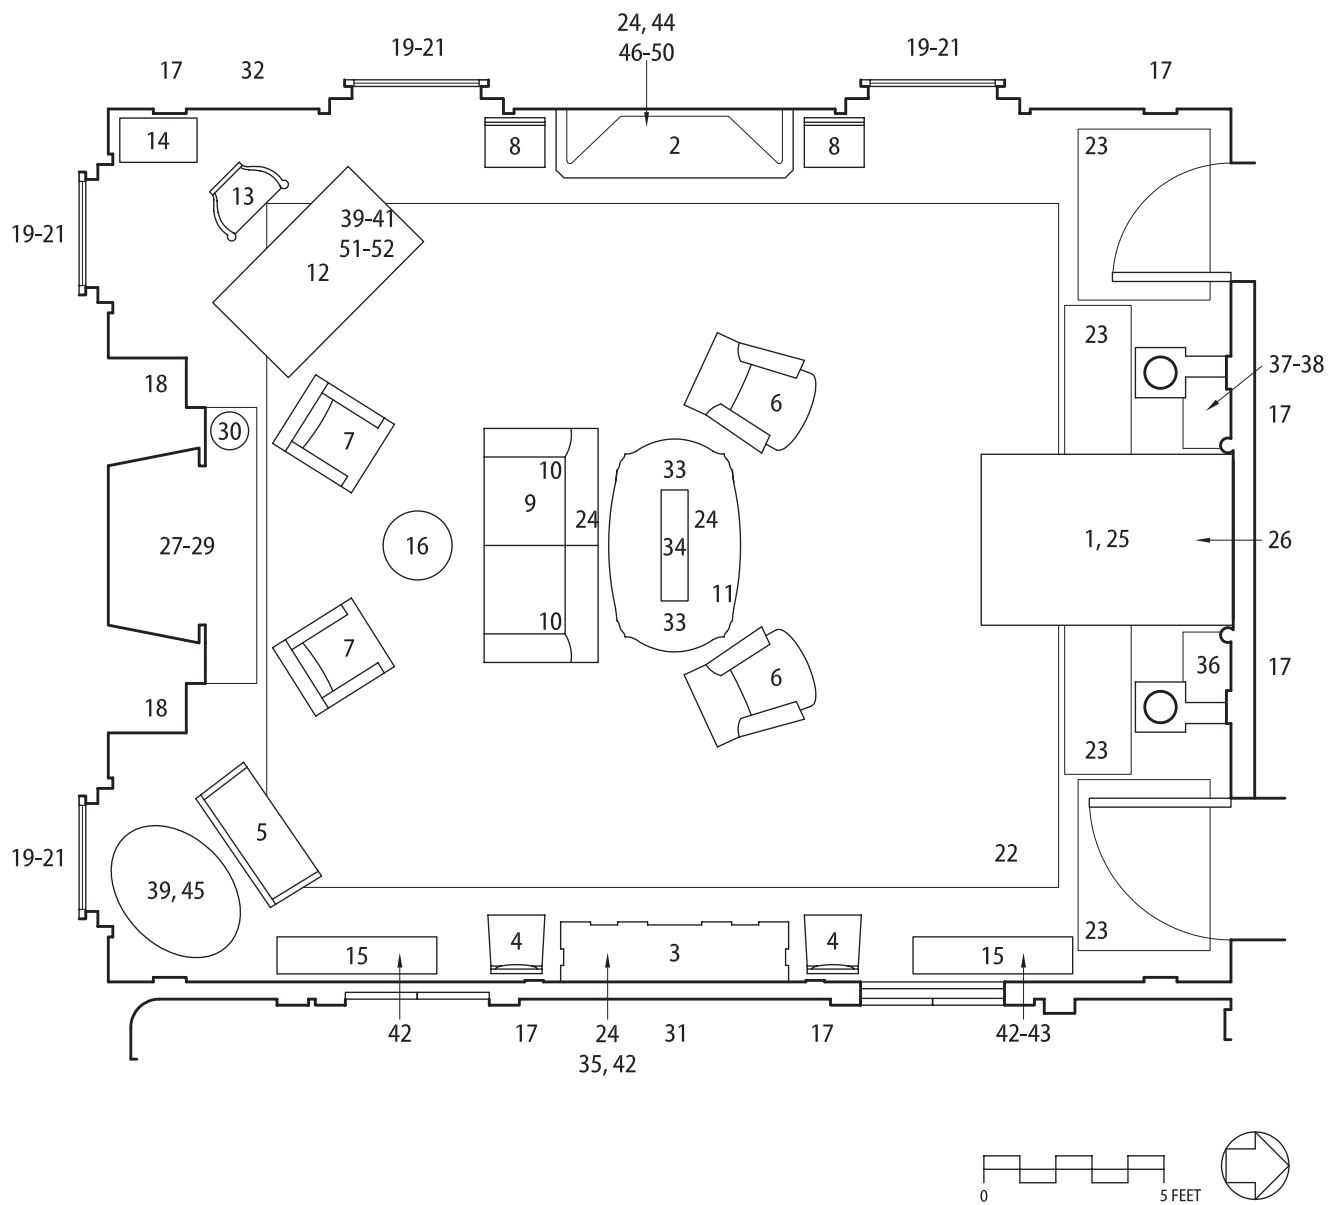
Figure 61. Mr. Vanderbilt's Bedroom (205) furnishings location plan.

The 1938 Curry inventory includes two small bookcases that held approximately 350 books. These books were removed by 1940. This plan places the two ebonized bookcases (from the collection) flanking the east wall cabinet. In 1938 they were listed among the furnishings in the Pavilion but probably had their origin at 459 Fifth Avenue like other pieces in Mr. Vanderbilt's bedroom. A few books should be placed on the bookcases and on the cabinet shelf.

To fully realize this plan, it is necessary to fabricate and install accurate reproductions of the original window valances and curtains, a significant part of the rich ambience of the room. Each opening included an ivory linen roller shade and a brass rod to support a lace curtain panel.

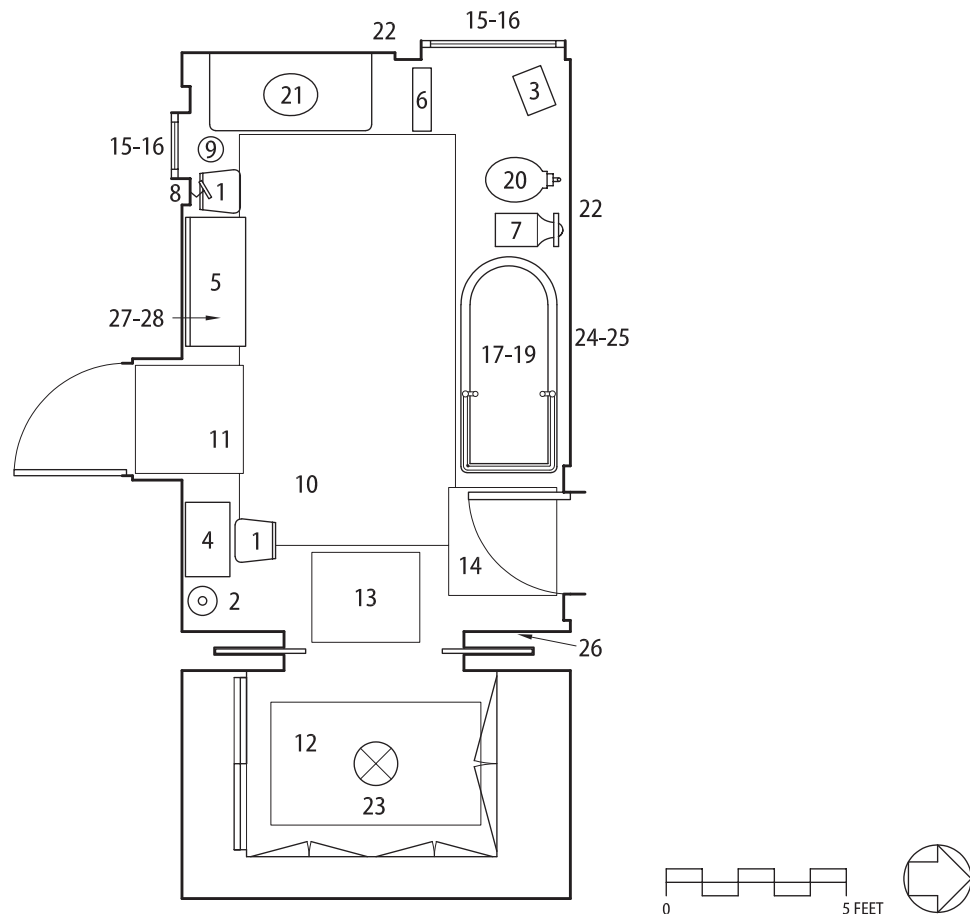
Figure 62. Mr. Vanderbilt's Bathroom (206) furnishings location plan.

This bathroom retains all of the original plumbing fixtures with the exception of the sitz bath that was removed for Mr. Vanderbilt sometime prior to 1938. The mahogany dresser is in the former location of that fixture. All of the other furnishings are finished in the white enamel typical of all of the bathrooms. The placement of the furniture fills every part of the room; even the floor surface is amply covered by various rugs.

The 1940 photograph from the Traudt Family Album records the west half of the room and the handsome window treatments (VAMA 555-556): deep scalloped valances with a printed floral design and vertical checkerboard patterned divisions, above curtain panels with the same motifs seen on the valances. The historic window curtains in the collections should be carefully reproduced and installed here.

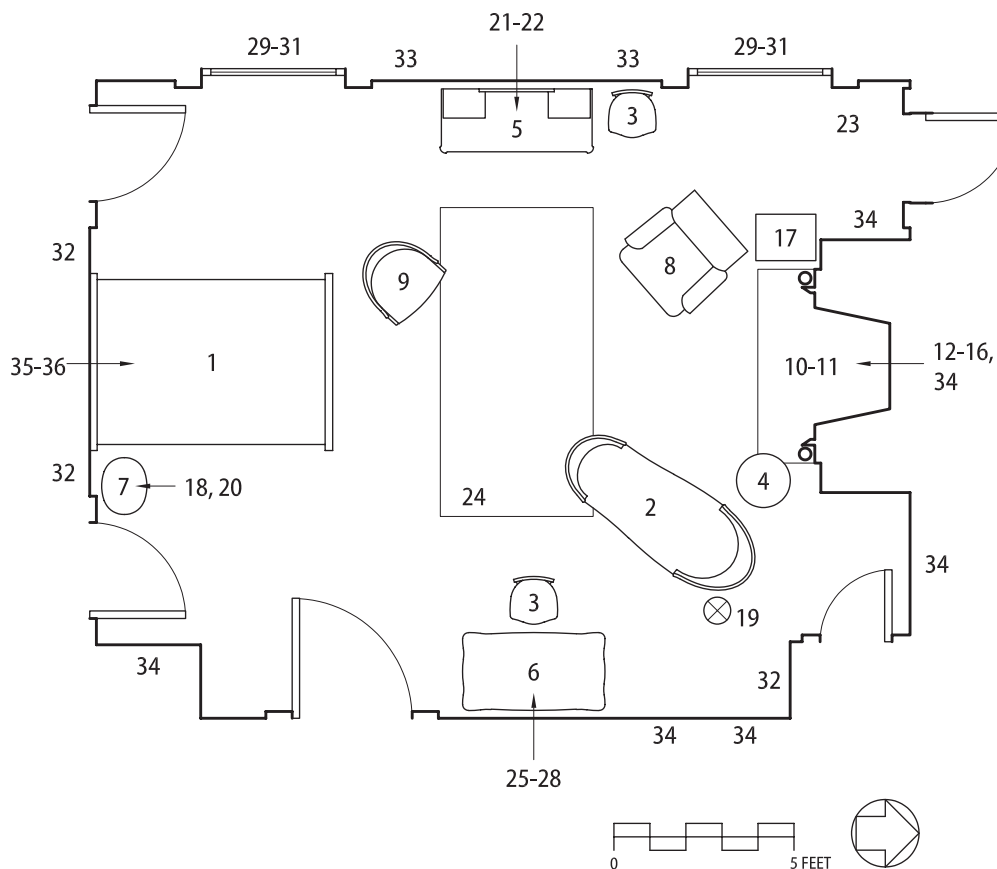
Figure 63. Large Red Bedroom (207) furnishings location plan.

This bedroom retains its suite of grey enameled furniture that includes a bed, dresser, nightstand, gilded cane chaise lounge, arm chair and two side chairs. The same decorative motifs are seen on each piece. Typically, each guest room suite included a writing table or desk, but the desk used here (in place in 1938) is originally from the Second Floor Green Bedroom (213). If this suite included a matching desk, its whereabouts is unknown.

To fully realize this plan, accurate reproductions of the window valances, curtains and bed canopy drapery need to be fabricated and installed. The superb quality of these original textiles was an important aspect of this room and the other guest rooms. Besides the finely detailed valances and curtain panels, each window includes a pull-up curtain (Austrian blind) and an ivory linen roller shade.

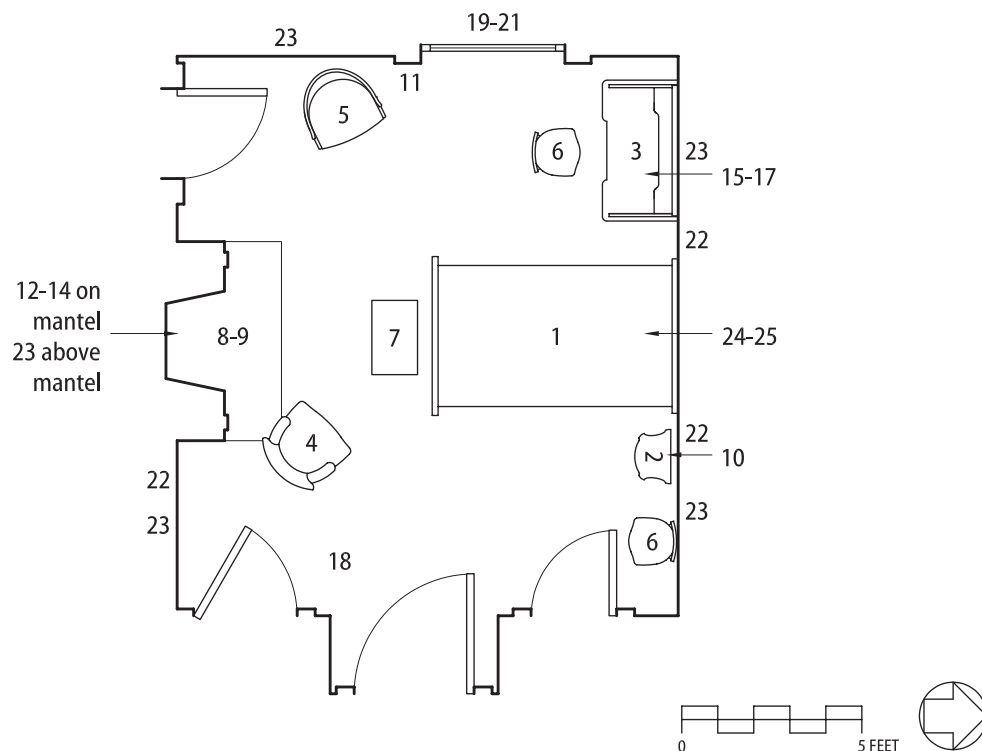
Figure 64. Small Red Bedroom (208) furnishings location plan.

The determination of the original furnishing of this room is problematic. The bed that should match the classical detailing of the canopy frame is missing from the VAMA collections. It was removed sometime before 1938. In that year, one of the single beds, now in its original position in the Blue Bedroom, was used here. For this plan, the bed (VAMA 338) originally used in the Second Floor Green Bedroom (213) is placed here. If that room is to be placed on view, then the bed should be restored to that room and another bed acquired for this location.

The washstand/shaving stand (VAMA 389) is placed here because this guest room does not have direct access to the bathroom (220), and to accompany the shaving mirror on the window trim (at an appropriate height for shaving. Both of these features indicate that a male guest typically occupied this room.

A tall five-drawer chest with cane inset panels (VAMA 390) was located here in 1938 but does not seem to relate in detailing to the other pieces in this room or any of the guest rooms. Its origin is undetermined but it is possible that it formed part of a missing suite of furniture originally used in this room.

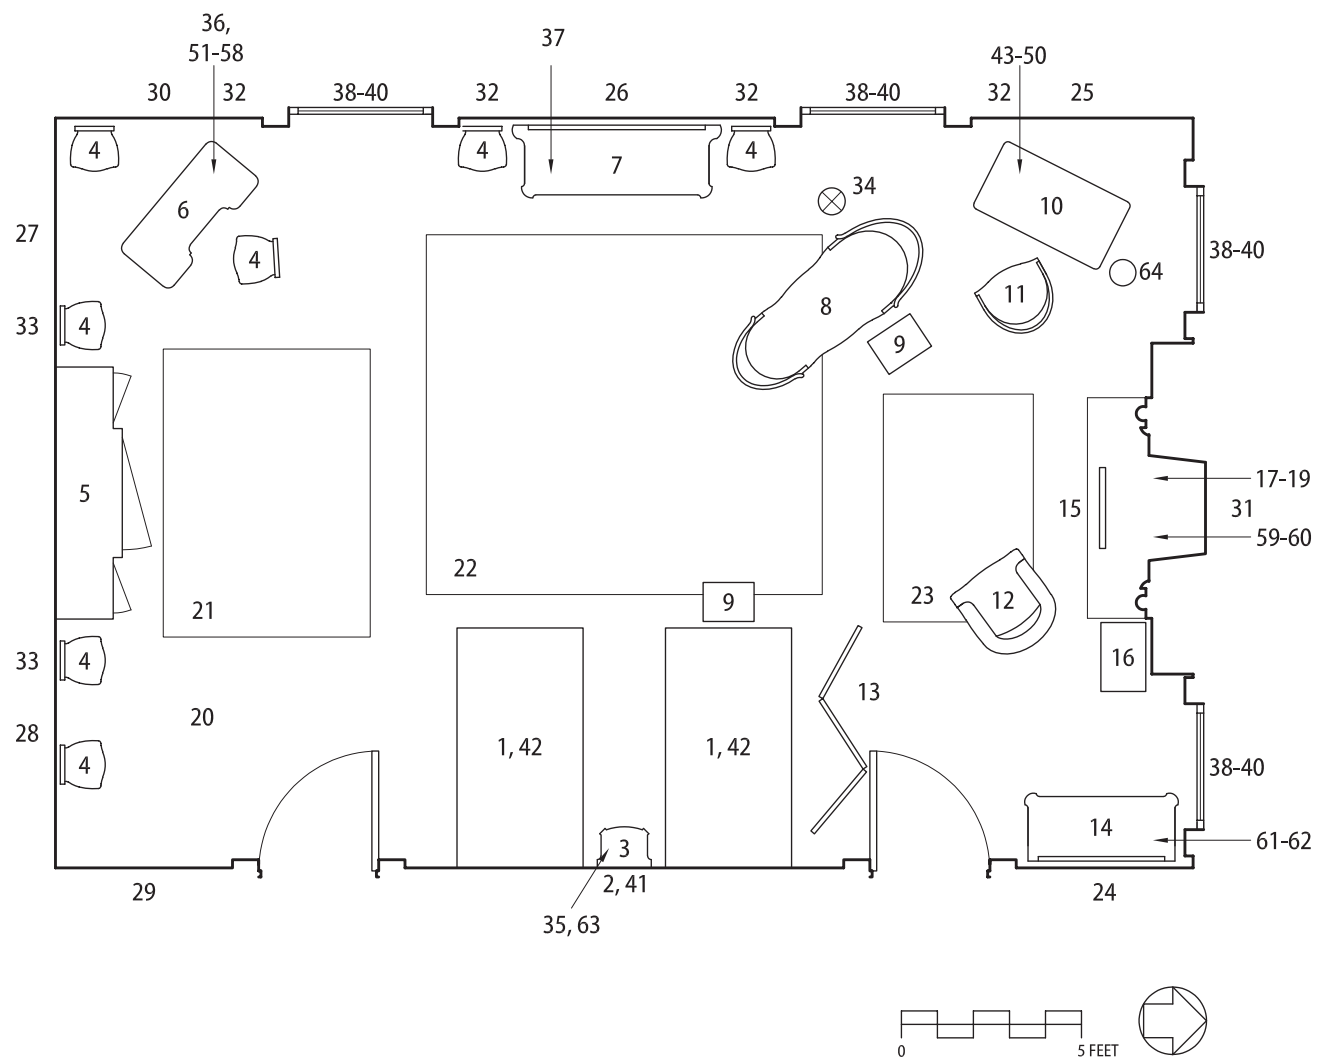
Figure 65. Blue Bedroom (209) furnishings location plan.

For the purposes of this plan, the dressing table (VAMA 301) is placed at the south end of the room (as noted in the 1935-38 notebook), and the writing table (VAMA 256) is placed at the north end. A reversal of the placement of these pieces is also possible, placing the dressing table in a more private location.

The elaborate window treatments also included pull-up curtains (Austrian blinds) and linen roller shades (ivory). The placement of the three rugs in the room will diminish the institutional appearance of the large expanse of the original red wall-to-wall carpet.

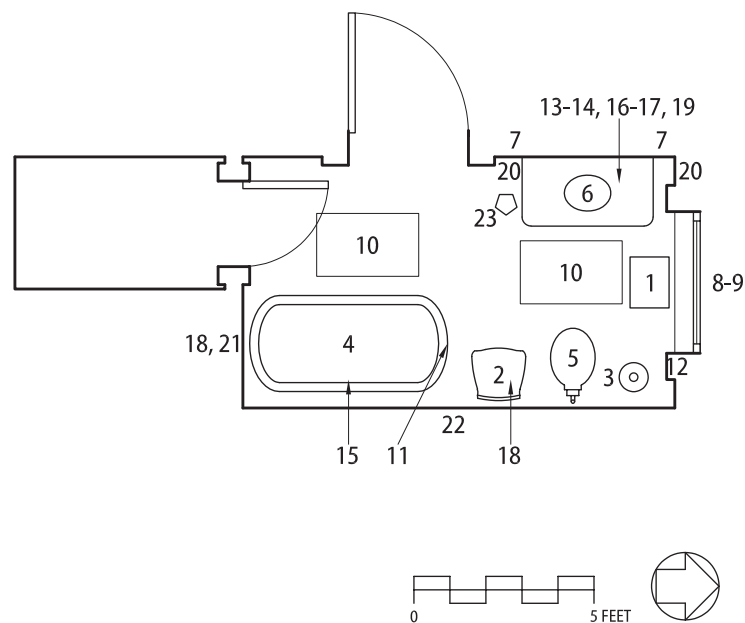
Figure 66. Blue Bedroom Bathroom (210) furnishings location plan.

The plan for this bathroom is based on the 1938 Curry inventory and on the 1938 notes that list instructions to prepare the room for a guest. The pieces are placed as seen in the 1964 Chambers photograph. An option might be a reversal of the placement of the small table and chair. The window should include a pair of curtain panels, either sheers or a linen fabric with a printed border motif, as well as a linen roller shade (ivory).

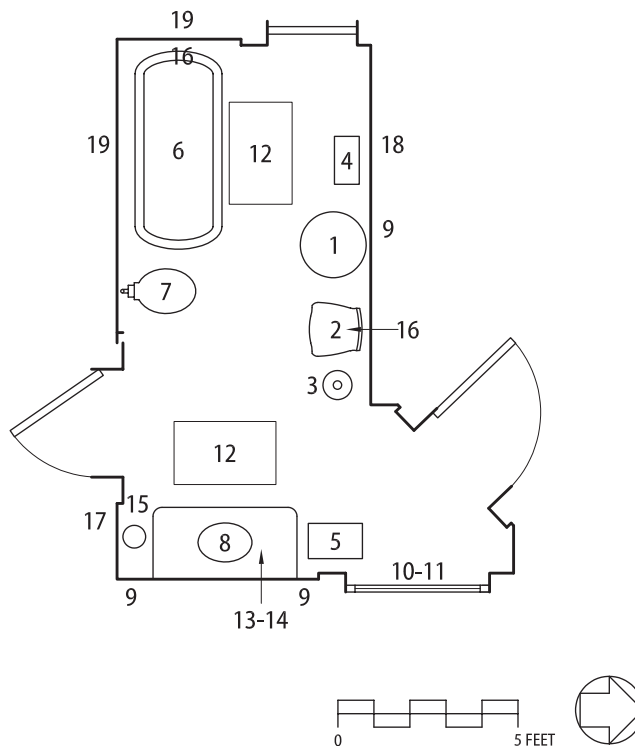
Figure 68. Mauve Room/Green Room Bathroom (212) furnishings location plan.

The furnishings placed here are as noted in the 1938 Curry inventory with the exception of the shaving stand (VAMA 552), which belongs in Mr. Vanderbilt's bathroom and should be placed there if that space is made accessible to visitors. The window should include a pair of curtain panels, either sheers or linen fabric with a printed border motif, as well as a linen roller shade (ivory).

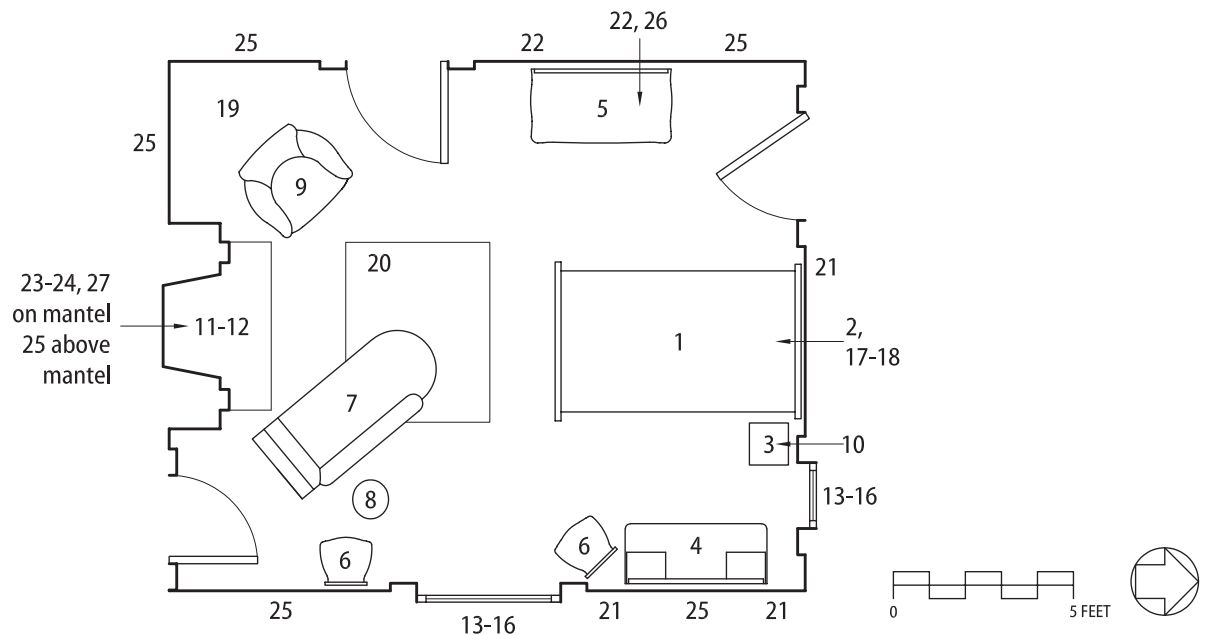
Figure 69. Second floor Green Bedroom (213) furnishings location plan.

A unique feature in this room is the bed canopy frame, which matches the curtain poles and is of a different form than the other guest room bed canopies. The rococo inspired furniture contrasts with the classically inspired canopy frame, which is unique among the guest room suites.

The windows featured exquisitely appliqued and embroidered valances and curtain panels (two panels at the east window and a single panel at the narrow north opening), pull-up curtains (Austrian blinds), and linen roller shades (ivory). The original valances and curtains are in storage; reproductions should be made and installed.

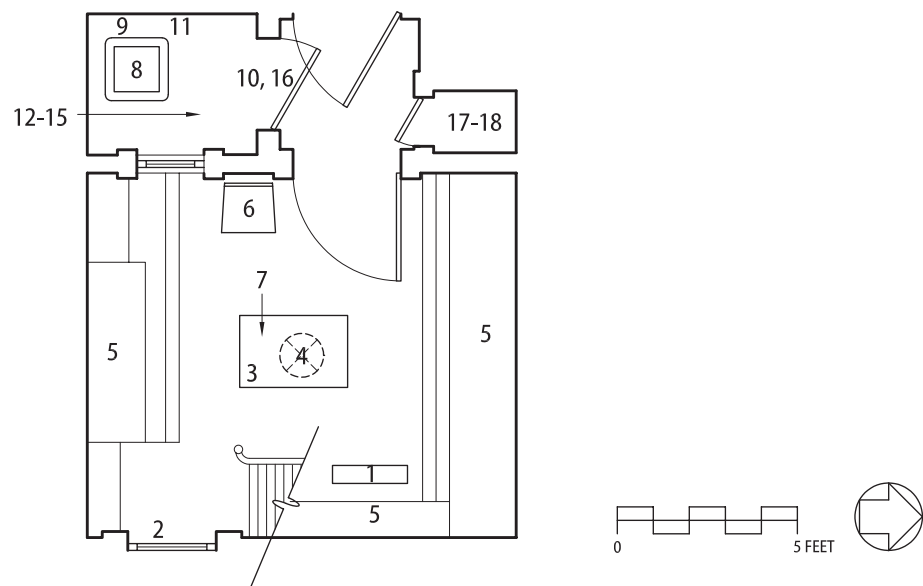
Figure 70. Linen Closet (214) furnishings location plan.

This room is not currently furnished or open to visitors. The furnishings to be placed here are very simple: a side chair, a plain small table and a short ladder or stepstool. Although no furnishings are noted in the 1938 Curry inventory, these pieces would be necessary in the operation of the closet. Mary Elizabeth Carter's *Millionaire Households and their Domestic Economy* notes the importance of a chair, a table for sorting and stacking linens, and a stepladder for accessing the upper shelves. The chair would serve both this room and the Maids' Closet. A period note found in the closet asks that wet bundles of laundry be left on the chair.

Of more interest is the determination of placement and storage methods of the household linens kept on the shelves here. It has yet to be determined what purpose the horizontal wood rods served in some of the shelving recesses.

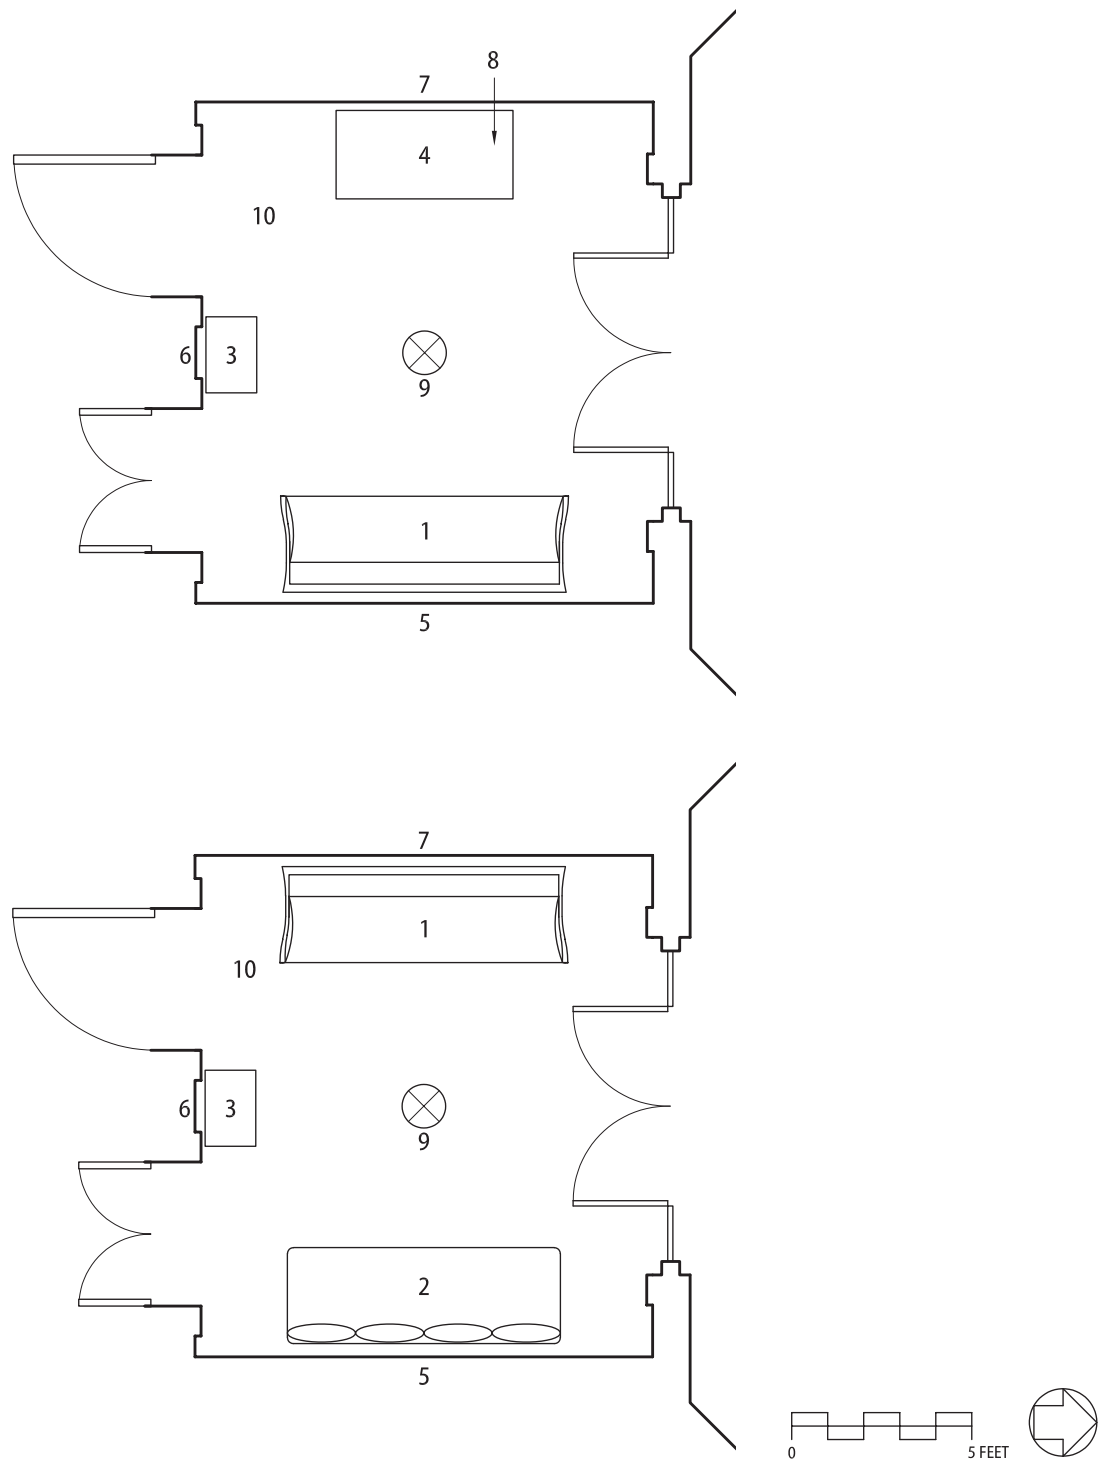
Figure 71. Second floor South Foyer (215) furnishings location plan, Option 1 (upper drawing) and Option 2 (lower drawing).

Since the placement of the portrait postdates the Vanderbilt occupancy, and it is out of character for the Hyde Park mansion, one option would be to remove it from the Foyer (shown in Option 1). If the *Sleighing Party* cannot be located and acquired, the west wall would be an ideal location to display some of the other oil paintings that probably originated from 459 Fifth Avenue. In 1938, several of these paintings were found in the Third Floor Pink Room (326).

In Option 1, the walnut table (VAMA 478) remains next to the west wall with the model of the Warrior displayed on its surface. In Option 2, the table is removed and the sofa is placed against the wall. A reproduction of the extant lounge currently in the North Foyer should be produced and placed next to the east wall. In both options, a small Chinese teakwood stand with inset marble top is shown placed between the south wall doorways, as it was in 1938.

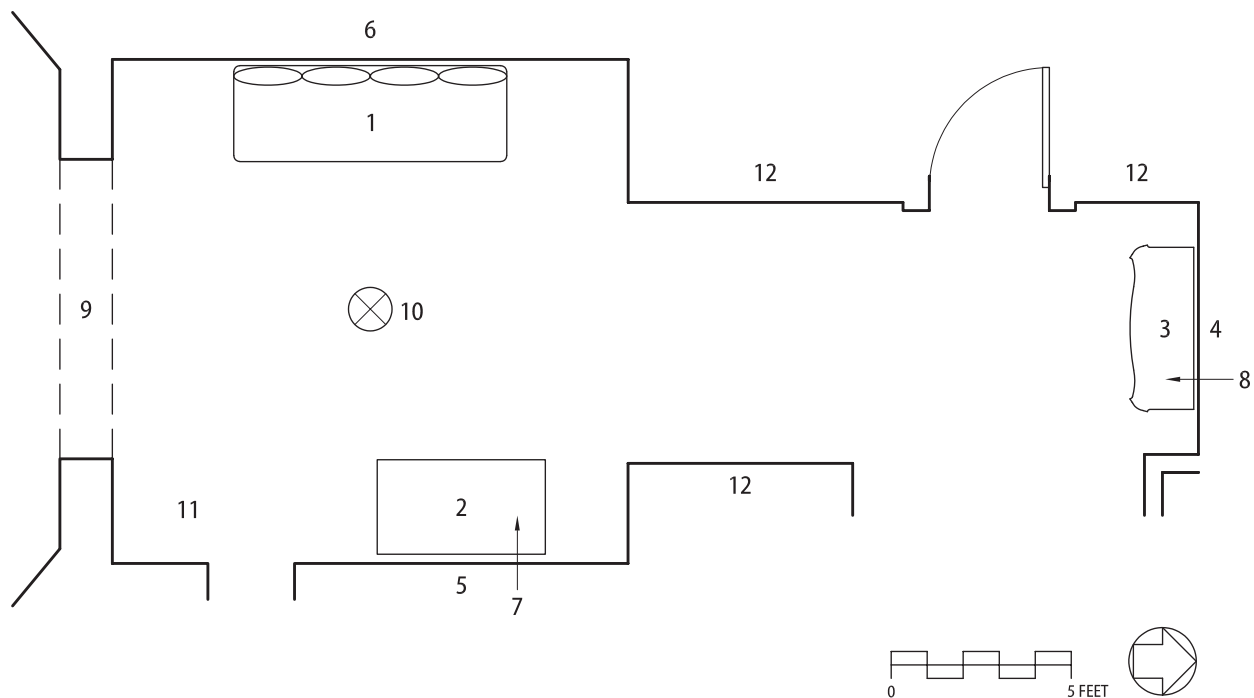
Figure 72. Second floor North Foyer (216) furnishings location plan.

The three paintings also remain in their 1938 locations. The empty wall space, immediately south of the door to the Blue Bedroom, might be an ideal location to display one of the oil paintings currently in storage.

The 1938 Curry inventory indicates that “Italian red velvet” portieres were located in this Foyer, probably in the south opening to the hall. If evidence for the rod that supported these fabric panels can be found, then reproductions should be installed.

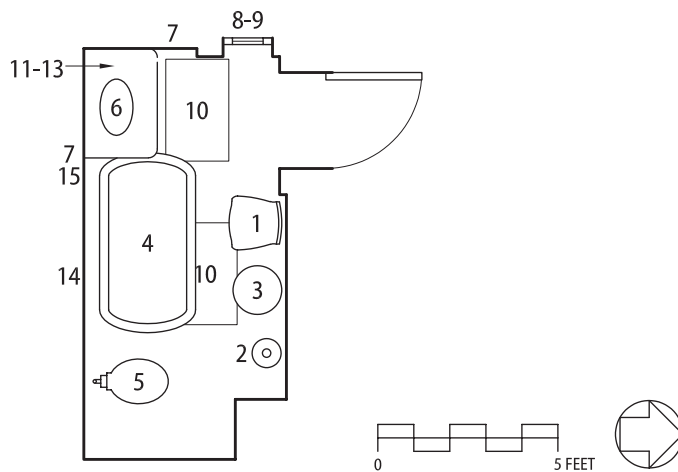
Figure 73. Red Bedrooms' Bathroom (220) furnishings location plan.

The few furnishings located here in 1938 were probably placed along the north wall, the only available space. A linen roller shade (ivory) should be installed in the window opening.

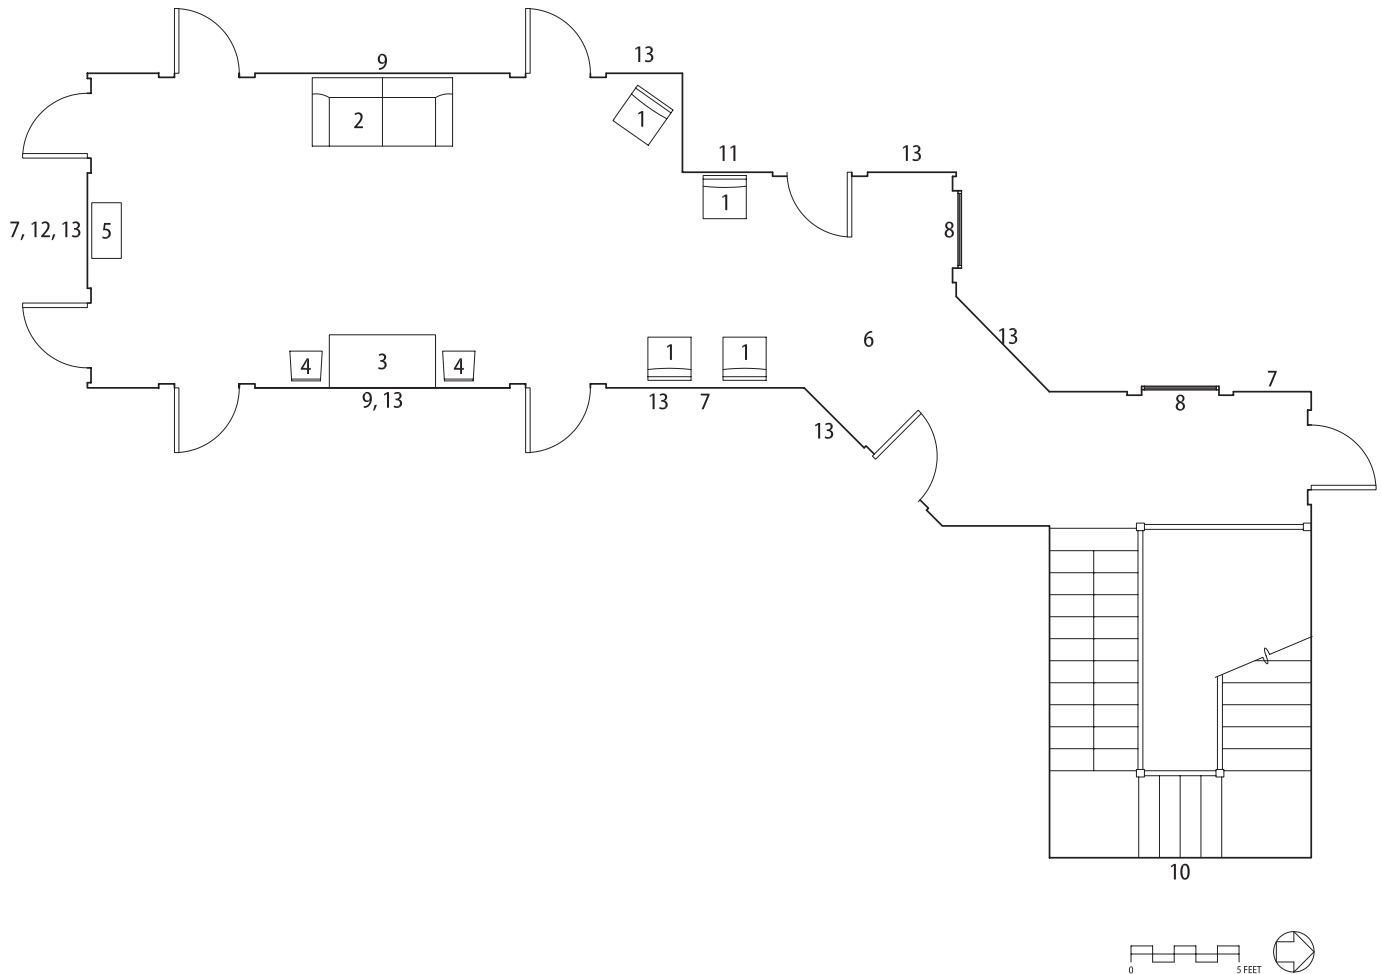
Figure 75. Guest Hall (301) furnishings location plan.

The long, irregularly shaped Guest Hall apparently served as a catch-all for odd furnishings from various locations. The 1938 Curry inventory records an array of mismatched furniture and various works of art, including two tapestries. The proposed plan duplicates this condition and includes several pieces that were in the hall in 1938 as well as the addition of the red upholstered sofa to be placed along the west wall.

An important original feature of this hall is the trellis-patterned wall-to-wall carpet, currently in storage. The carpet should be reproduced and installed. Linen roller shades (ivory) should be installed on the windows that open to the light well.

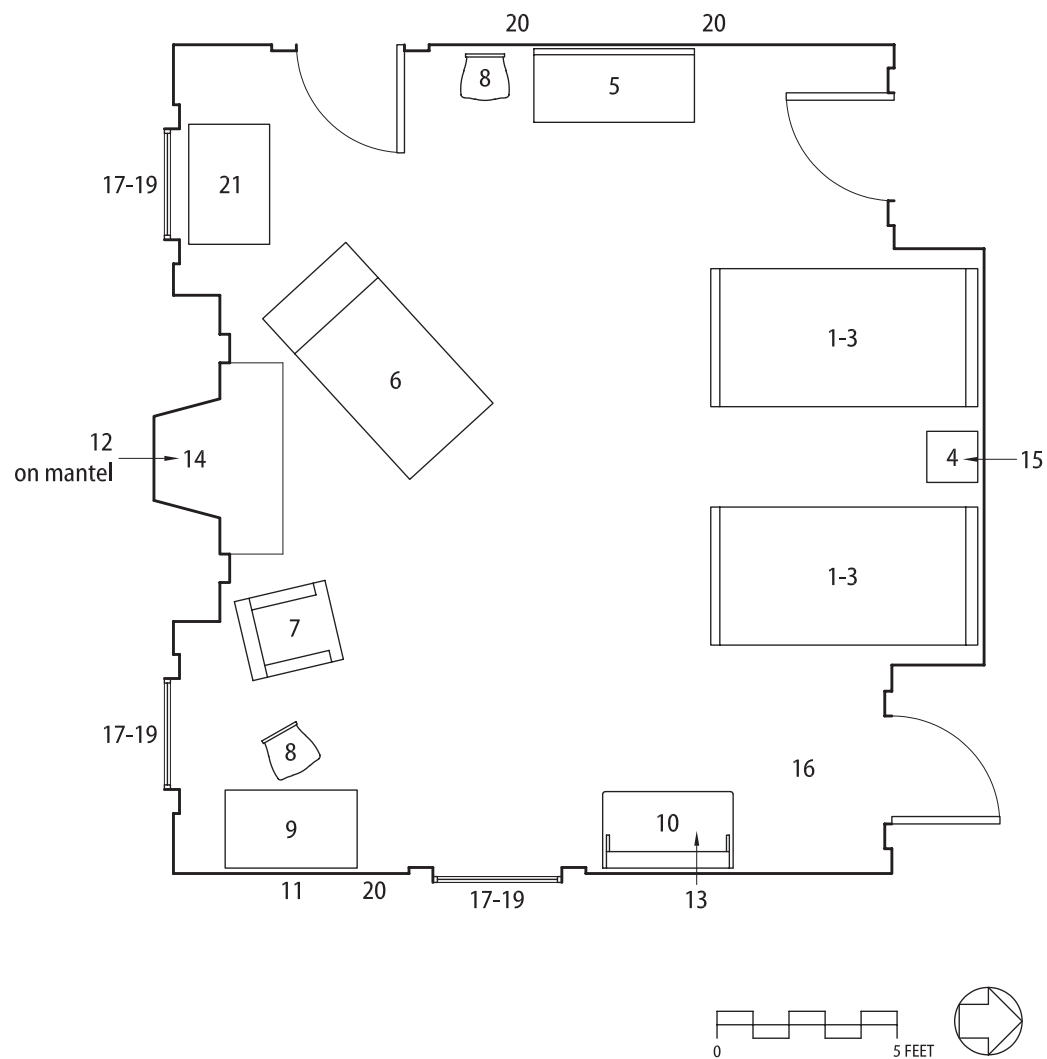
**Figure 76. Lavender Room (303) furnishings location plan.**

All of the furnishings noted in the 1938 Curry inventory remain in the room or in the VAMA collections except for the Sormani roll-top desk, which was removed by Mrs. Van Alen and is currently at Chauteau-sur-Mer in Newport. The desk and a giltwood cane chair (possibly the un-numbered chair currently in Mrs. Vanderbilt's bedroom) were placed here after removal from some other more prominent location in the house, such as the Reception Room.

For this plan, the Herter suite is arranged as shown in the 1964 Chambers photographs. The oak table (VAMA 189), not of the same quality as the Herter suite, was probably placed here at an undetermined date to serve as a writing table, an amenity common to all of the guest rooms.

Unfortunately, there is no photographic evidence for the window treatments. The extant hardware and marks on the window trim match those in the Pink Room, indicating that similar curtain panels with tiebacks, Austrian blinds, and roller shades were used in the opening. It is likely that the fabric matched the *Toile de Jouy* used on the wall and at the dressing table.

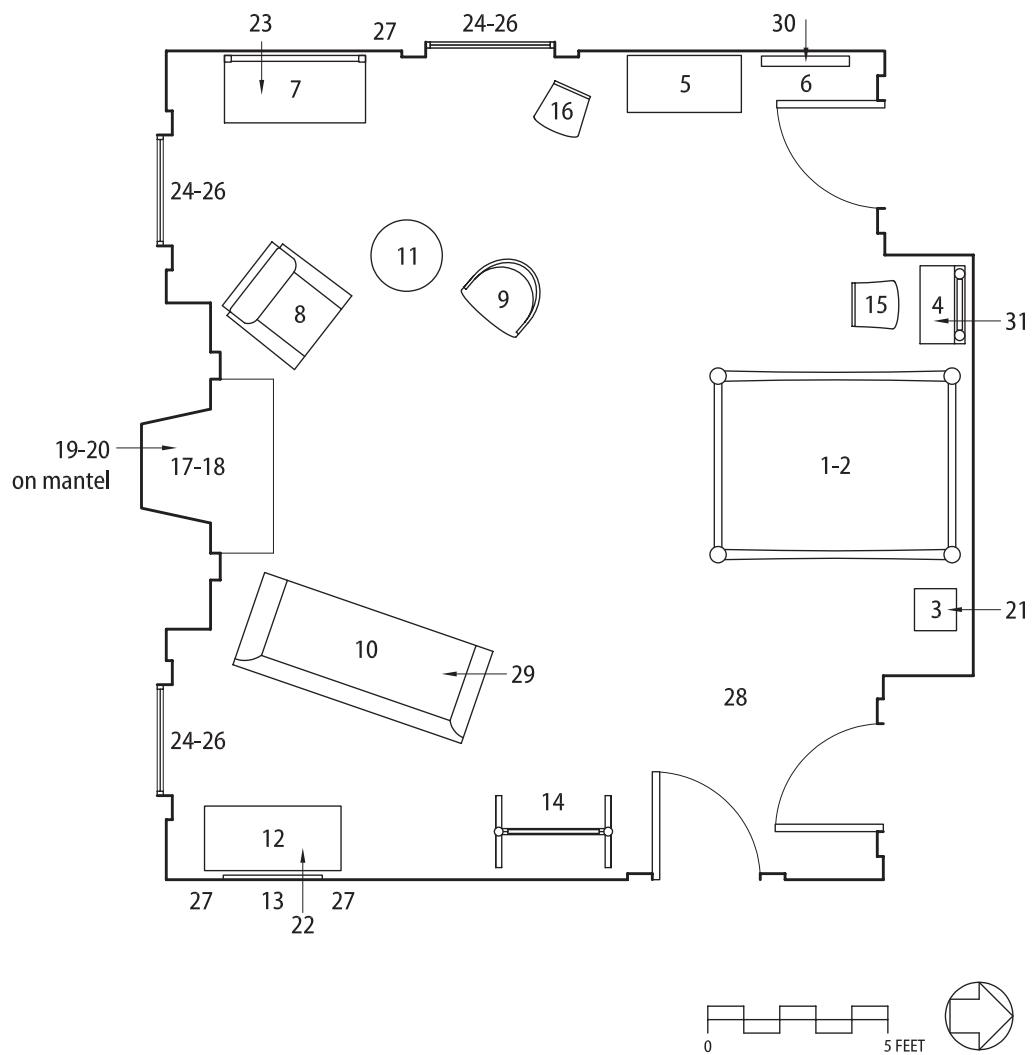
**Figure 77. Empire Room (304) furnishings location plan.**

The small dressing table (VAMA 399, 74) placed next to the bed may have functioned as a desk. This use is confirmed by the items included in the 1938 Curry inventory: a nine-piece brass desk set, French inkwell in bronze and marble, and brass and glass pen tray. One of the side chairs is placed in front of the dressing table/desk.

The original window curtain panels should be removed from storage and installed at the windows. If reproduction curtain panels are produced, then a decision needs to be made concerning whether to match the faded color of the original artifacts or to produce the new fabric to match the original unfaded green color of the silk. Ivory linen roller shades should be installed.

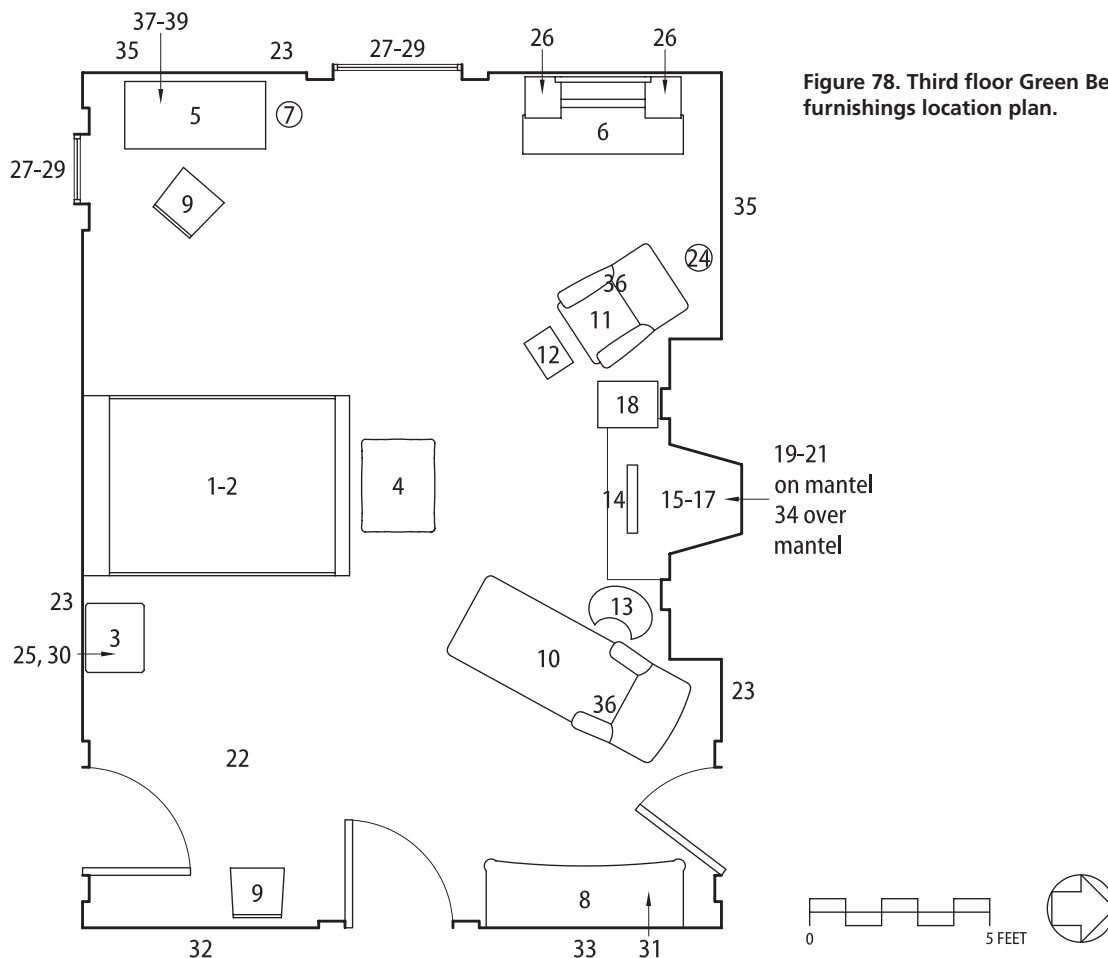
**Figure 78. Third floor Green Bedroom (306) furnishings location plan.**

The plan generally places the furniture as seen in the 1964 Chambers photographs, with the washstand near the bathroom and the desk and dresser near the windows. An additional piece that belongs with this “suite” is the dressing table (VAMA 560) that in 1938 was in Mrs. Vanderbilt’s bathroom. It may have been used here prior to the introduction of the desk, or it was possibly placed on the east wall adjacent to the door to the bathroom (but then the door could not fully open).

Ivory linen roller shades and the original “striped silk damask” curtain panels (or reproductions) should be installed and made operable with the pulley system. The plum wall-to-wall carpet should be reproduced and installed.

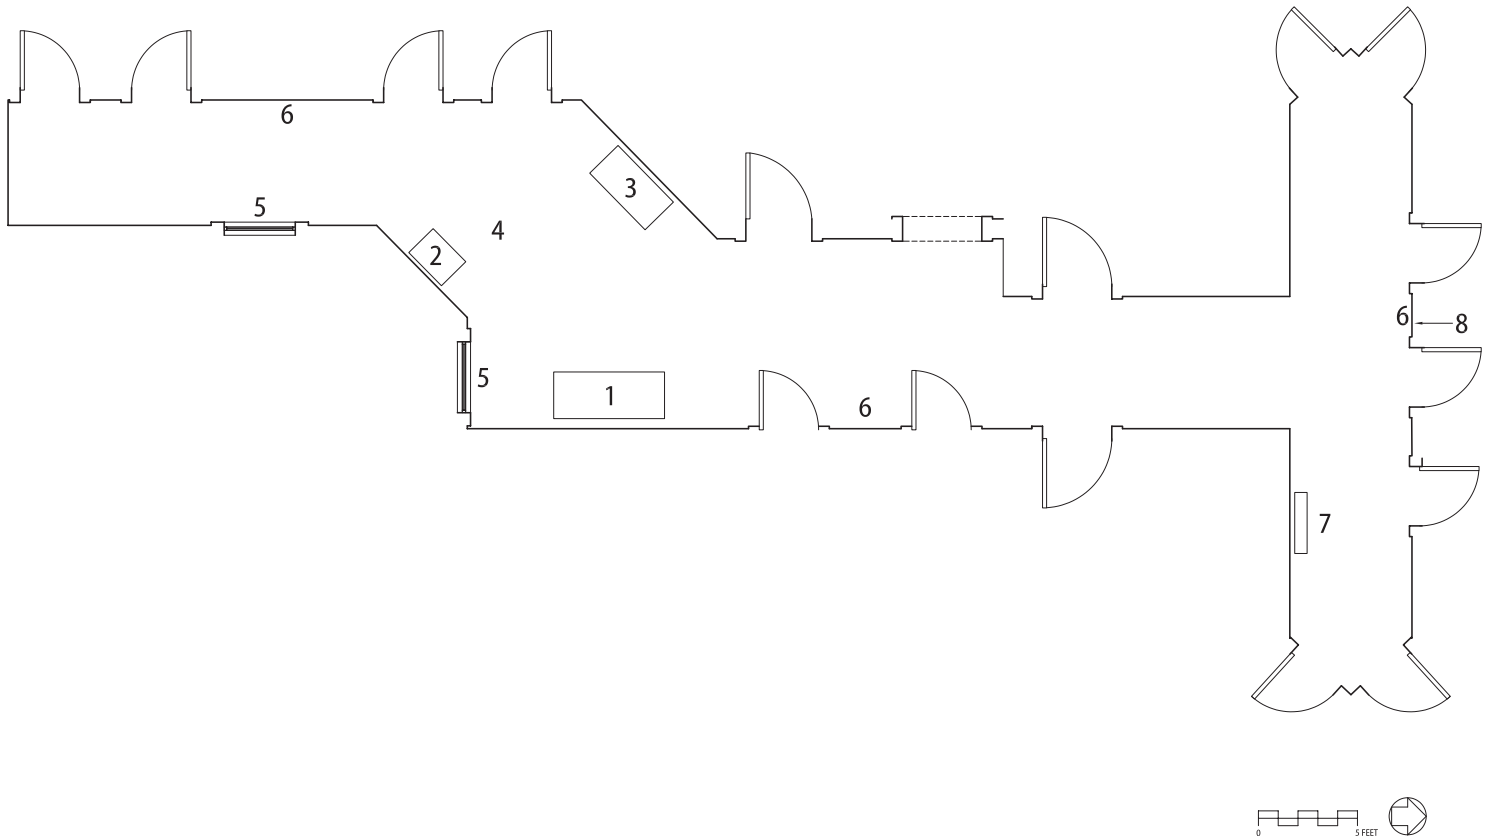
Figure 79. Third floor Service Hall furnishings location plan.

How this extensive area was used remains unknown, beyond its use as a passage. The larger area at the south end, flanking the light well, is ample enough to have functioned as an area for the household staff to relax. The 1938 Curry inventory places a chintz day bed and a single door maple chiffonier somewhere in this hall, as well as a cedar chest containing blankets, indicating that the Hall may have been used as shared living space or storage. The plan places these furnishings in the large area at the north end of the hall. The two windows feature linen roller shades (ivory), and the floor is covered in wall-to-wall carpet.

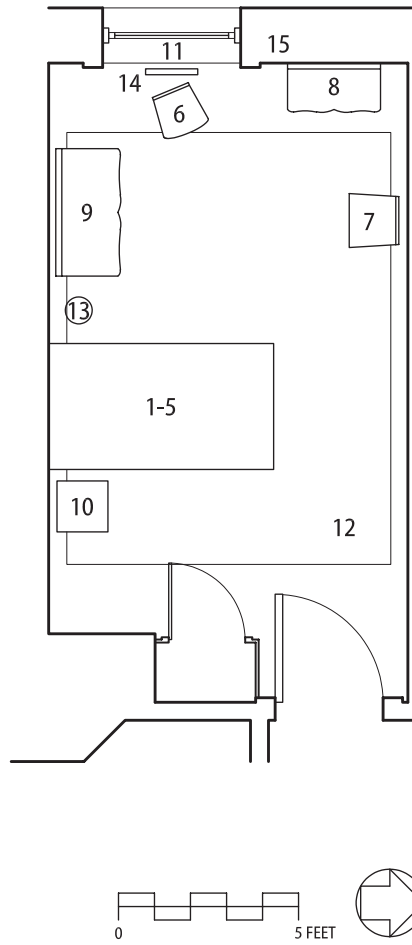
**Figure 80. Maid's Room (307) furnishings location plan.**

These four rooms are furnished in a similar manner, with simple mass produced oak furniture and iron beds. The windows should have ivory linen roller shades.

In 1938, room 308 included two bamboo style chairs painted white. In 1964, one of these chairs was located in the Lavender Bedroom. There was also a white painted rocker in the room, an amenity not found in the adjacent Maid's Rooms. One of the Maids' Rooms should include some personal items belonging to the occupant. Such items might include books; magazines and newspapers; photographs; desk accessories; and items on the dresser and washstand, including towels.
