Vanderbilt Mansion National Historic Site  
Hyde Park, New York

# Vanderbilt Mansion National Historic Site Historic Furnishings Report

Volume III: Implementation Plan  
September 2015

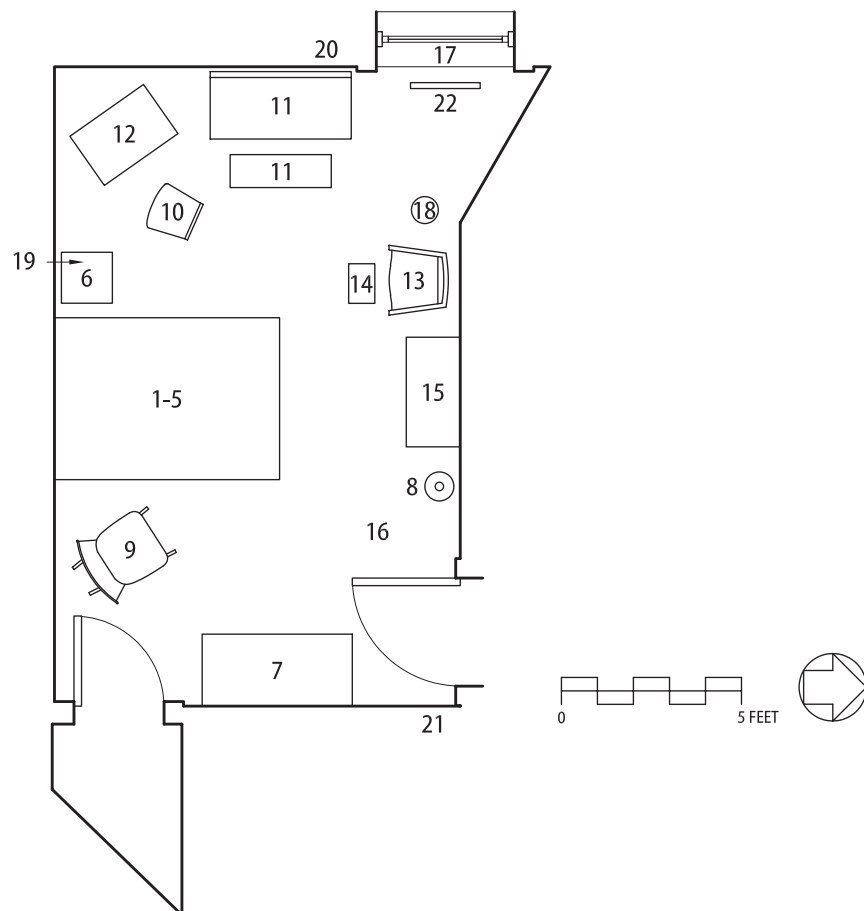
Figure 84. Sewing Room/Lady's Maid's Room (311) furnishings location plan.

The white painted suite in this room is of a better quality than the oak pieces found in the smaller rooms occupied by the maids. The furniture is placed as shown on the 1942 drawing based on the interview with Theresa Farley. The third floor had two sewing rooms by 1927, according to Mrs. Farley. The lady's maid needed her own space for mending Mrs. Vanderbilt's clothes; linens, etc. would have been handled by other servants in another room.

This is the only servant's room that includes wall-to-wall carpeting, an indication of the occupant's status among the staff. A sewing machine is placed here, based on the drawing, and to reference the sometime use of this space as the sewing room; a lady's maid needed easy access to a sewing machine when mending. The window should have an ivory linen roller shade.

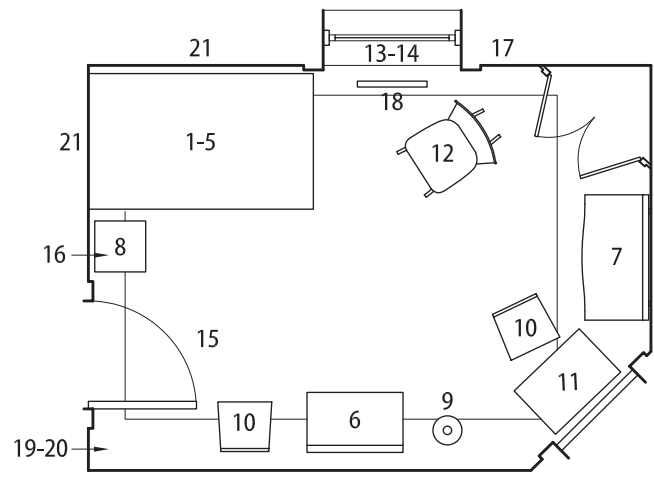
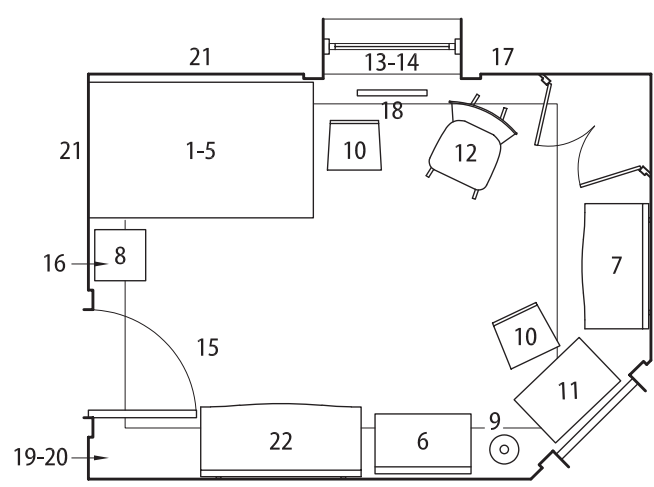
**Figure 85. Maid's Room (314) furnishings location plan: Option 1 (upper drawing) and Option 2 (lower drawing).**

The quality of the furnishings in this room in 1938 was much better than the furniture used in the other rooms occupied by the servants. The mahogany suite is equal to the quality of the painted furniture used in the guest bedrooms.

The proposed plan is based on the 1942 interview with Theresa Farley. That plan includes the chest of drawers (VAMA 1043) not currently in the room but does not include the dresser (VAMA 1059). Option 1 places the chest on the east wall. Option 2 makes use of both case pieces and places the chest and dresser together on that wall. In both options, the bed is placed in the southwest corner, either along the west wall or along the south wall as shown in the Farley plan. The white painted table, not part of the suite, serves as a writing table and is positioned in front of the locked northeast door. This may be one of the three extant white enamel finished breakfast tables. The other two tables are placed in the Mauve Room and the third floor Green Room.

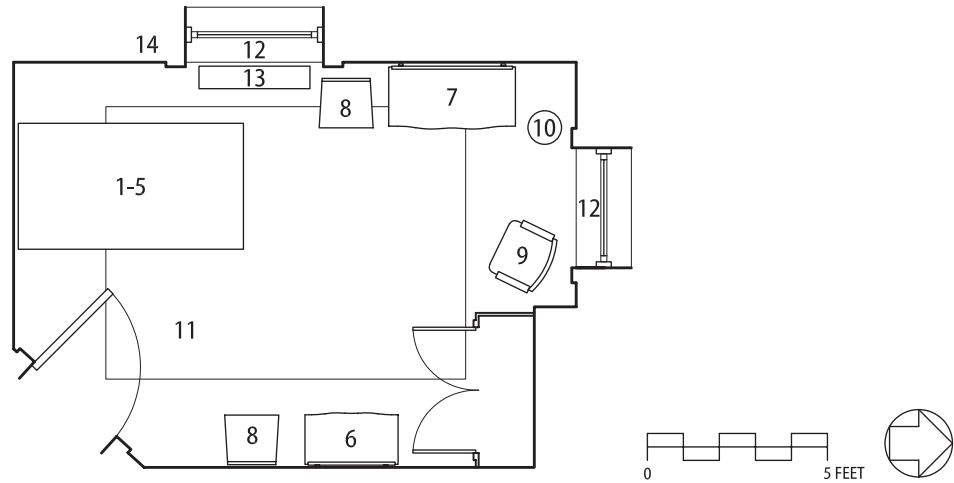
Figure 86. Servant's Room (315) furnishings location plan.

This room is simply furnished with the same oak pieces used in the other servants' rooms. Also included are an oak arm chair and a floor lamp (as listed in the 1938 Curry inventory). The windows include linen roller shades (ivory).

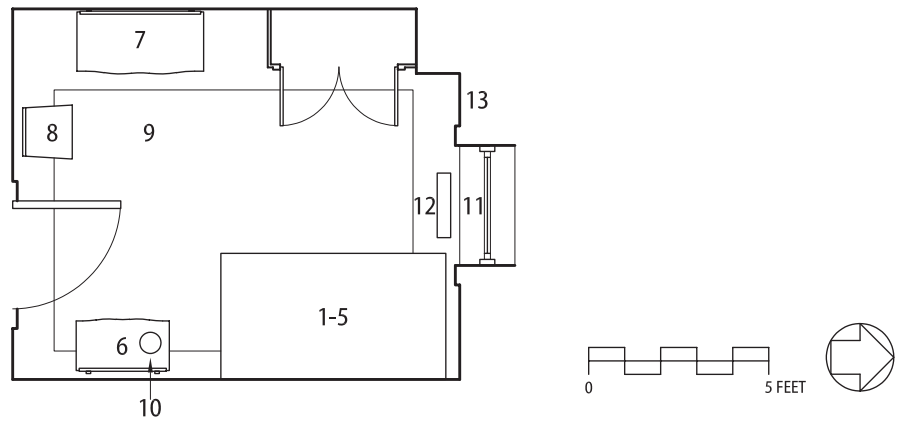
Figure 87. Servant's Room (328) furnishings location plan.

This room is simply furnished with the same oak pieces used in the other servants' rooms. The window includes an ivory linen roller shade.

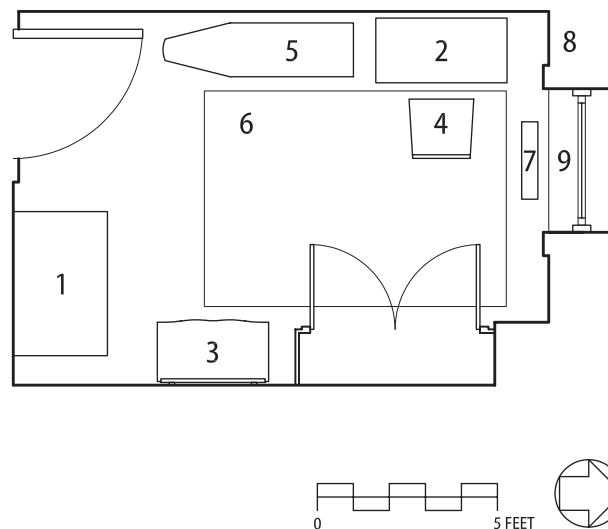
Figure 88. Sewing/Pressing Room (318) furnishings location plan.

Based on the McKim, Mead & White plan, this room was originally intended to function as a servant's bedroom. By 1927, it was used as a sewing and pressing room (according to an interview with Theresa Farley and the 1942 plan based on her memories). It is likely that the change happened when the mansion was fully staffed, while Mrs. Vanderbilt was alive; after her death, the lady's maid's room with its sewing machine was available and there would be no need for a second sewing space. Moreover, the "old" sewing machine in the 1938 Curry inventory implies that it had been in use for some time. Therefore, the plan interprets the room as the sewing/pressing room.

The small room includes a folding ironing board rather than a large pressing table. The washstand remains in the room from the time this was originally a servant's bedroom.

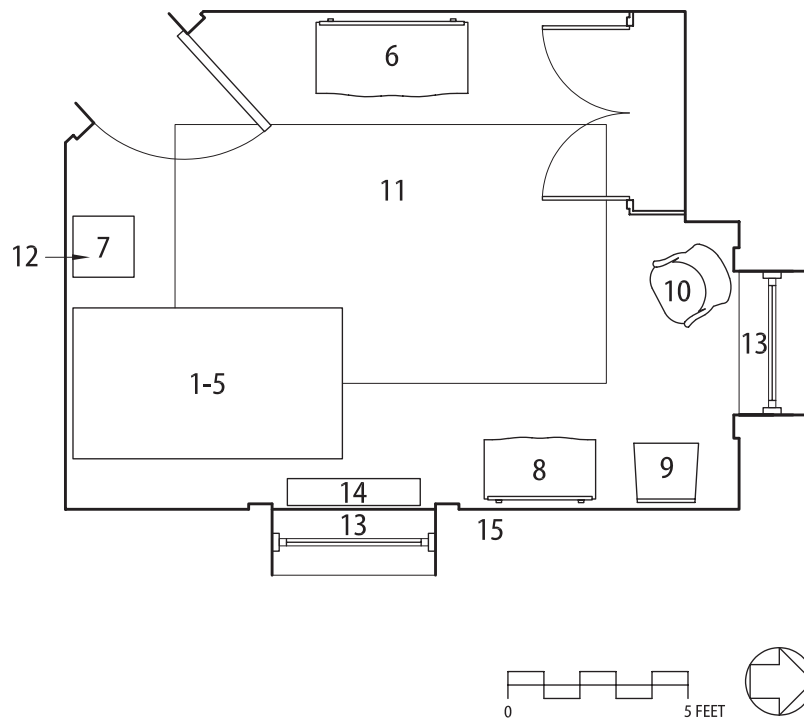
Figure 89. Servant's Room (319) furnishings location plan.

This room is simply furnished with the same oak pieces used in the other servants' rooms. The Windsor arm chair distinguishes this room from the others. An ivory linen roller shade covers the window.

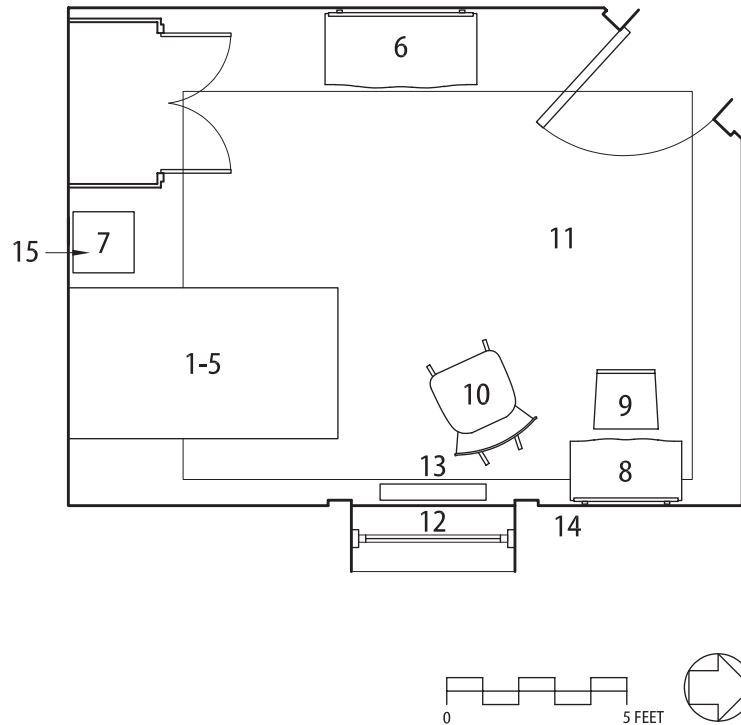
Figure 90. Servant's Room (320) furnishings location plan.

This room is simply furnished with the same oak pieces used in the other servants' rooms, but also includes a rocker. An ivory linen roller shade covers the window.

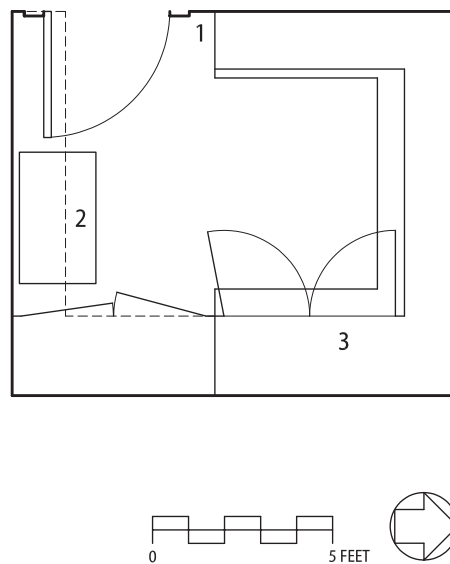
Figure 91. Trunk Room/Storage Room (321) furnishings location plan.

Although designated as the “Trunk Room” on the McKim, Mead & White plan, few trunks would have fit between the original built-in cabinets that line the walls. By 1938, the room stored a large number of linens and decorative objects, hidden in the enclosed cupboards and in the drawers. The plan shows the room with one cupboard door open, to display some of the fine objects in the collection not otherwise exhibited. The original free-standing chest near the south wall remains in place.

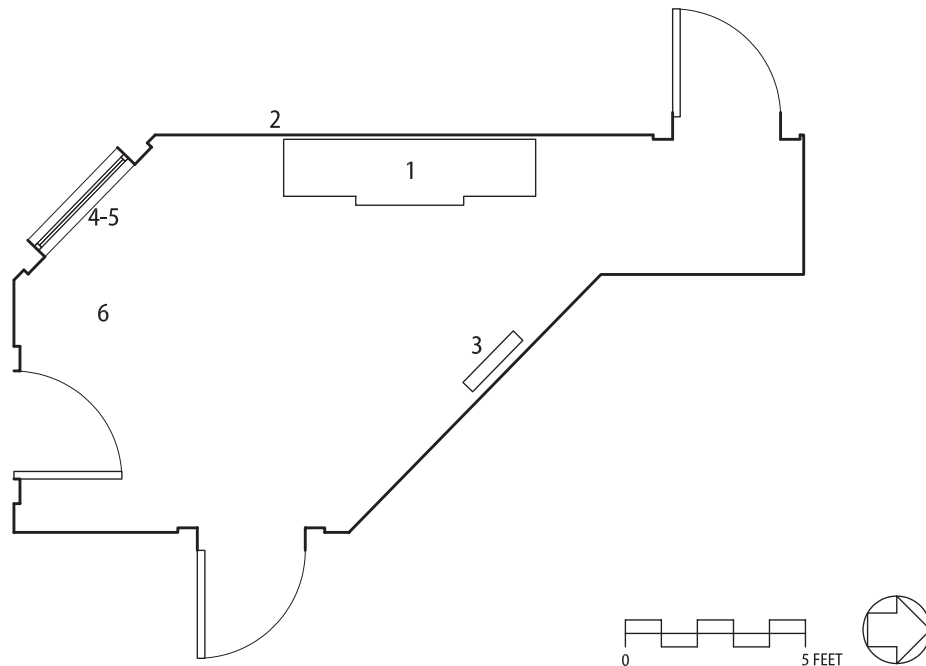
Figure 92. Housekeeper's Hall furnishings location plan.

The plan for this passage reflects its appearance in 1938 (and presumably earlier), with the walnut wardrobe (VAMA 3923) placed next to the west wall. Linen roller shades (ivory) and a simple pair of curtain panels are installed at the single window. Wall-to-wall carpet should cover the floor.

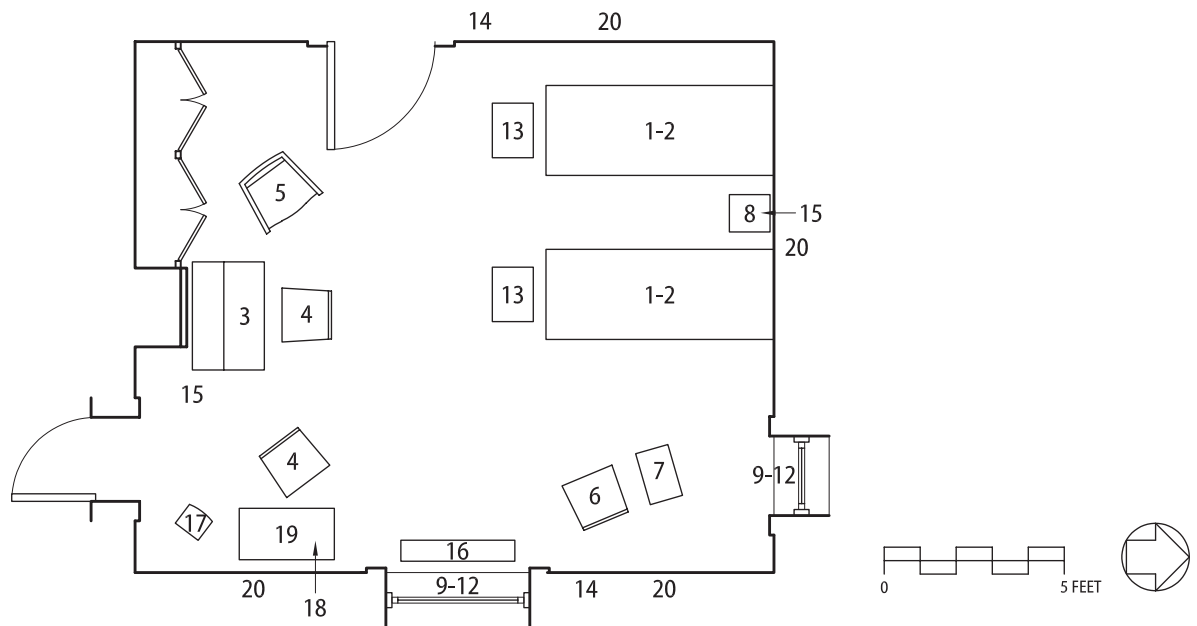
Figure 93. Housekeeper's Sitting Room (322) furnishings location plan.

The proposed plan interprets the room as it may have appeared during the war years (1942-45) when occupied by Franklin Roosevelt's telephone operator. Although the Vanderbilt furnishings were removed from the room and placed in storage at that time, it is possible that some of the less important items remained in the room. This plan includes Vanderbilt furnishings as well as items acquired to serve the room's new war function. The introduced furnishings include two army cots (based on cots in documentary photographs of CCC camps) and a cabinet switchboard placed on the south wall, near the closet housing the telephone cable.

The Vanderbilt curtains were probably replaced by blackout curtains but the linen roller shades would remain in place. The large oriental rug in the room in 1938 was probably removed for the room's war-time function. No traces of wallpaper have been found on the walls, other than the pieces of blue paper found behind the radiator in the 1950s. Therefore, this plan does not recommend papering the room.

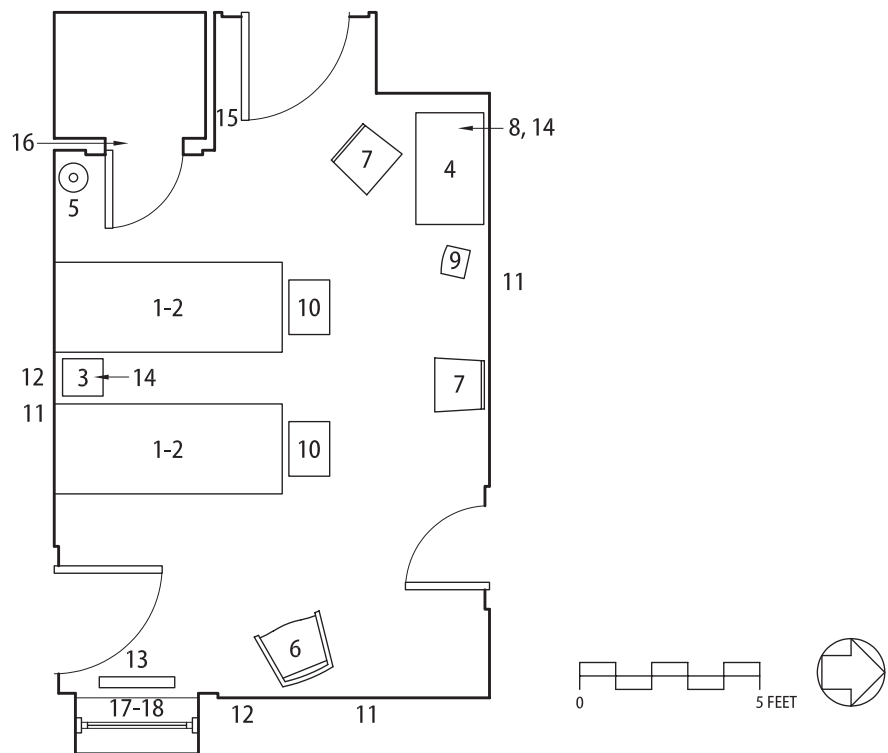
**Figure 97. Housekeeper's Bedroom (323) furnishings location plan.**

The proposed plan interprets the room as it may have appeared during the war years (1942-45) when occupied by Franklin Roosevelt's telegrapher. The room includes some of the Vanderbilt pieces (some items were placed in storage or distributed to other buildings on the estate), as well as new items brought in to serve the room's wartime use. The housekeeper's brass bed is replaced by two army cots. Telegraph equipment is located on a table next to the north wall near where the related wiring enters the room. A small electric space heater is also placed nearby. The typewriter shown on the Sitting Room plan could be displayed in this room instead. The Vanderbilt curtains were probably replaced by blackout curtains, but the linen roller shades remained in place.

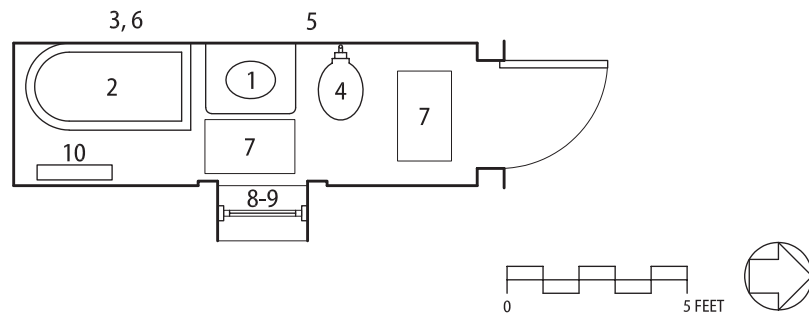
Figure 98. Housekeeper's Bathroom (324) furnishings location plan.

This room retains all of the original plumbing fixtures including the bathtub. The Housekeeper's suite is furnished to interpret the war years (1942-45). The shower head and curtain rod, installed in 1942, should remain in the bathroom. An ivory linen roller shade should be installed at the window along with a black-out curtain.

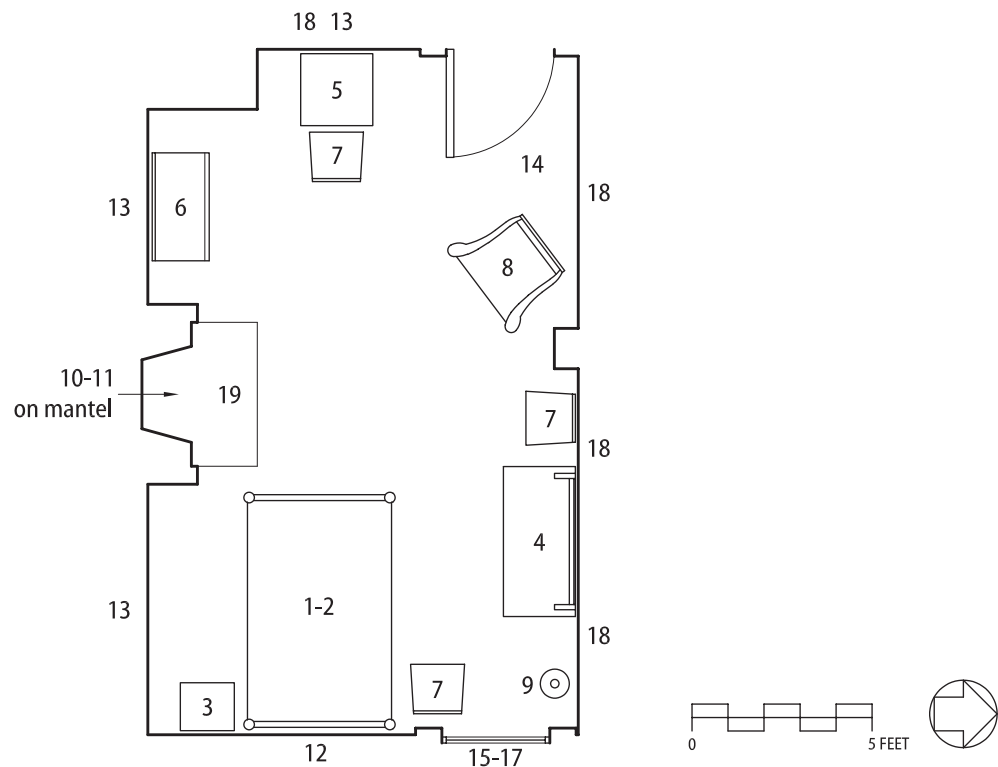
Figure 99. Small Pink Bedroom (325) furnishings location plan.

This room is noteworthy because it is the only guest room to retain its original 1899 wallpaper. The plan includes the furniture noted in the 1938 Curry inventory. The dresser (VAMA 195) and washstand (VAMA 193) form a suite, but the nightstand (VAMA 196) is a lesser quality piece. The surviving chair with a rush seat (VAMA 81) is one of three in the room in 1938. The painted and decorated arm chair with the slat back (VAMA 1074) is part of a suite of painted furniture ornamented with delicately painted floral motifs, and it is possible that the more feminine set was originally used here. It would be complimented by the floral stripe wallpaper and the floral patterned carpet originally in the room. The window treatment includes operable cotton curtain panels, possibly a pull-up curtain (Austrian blind), and a linen roller shade (ivory).

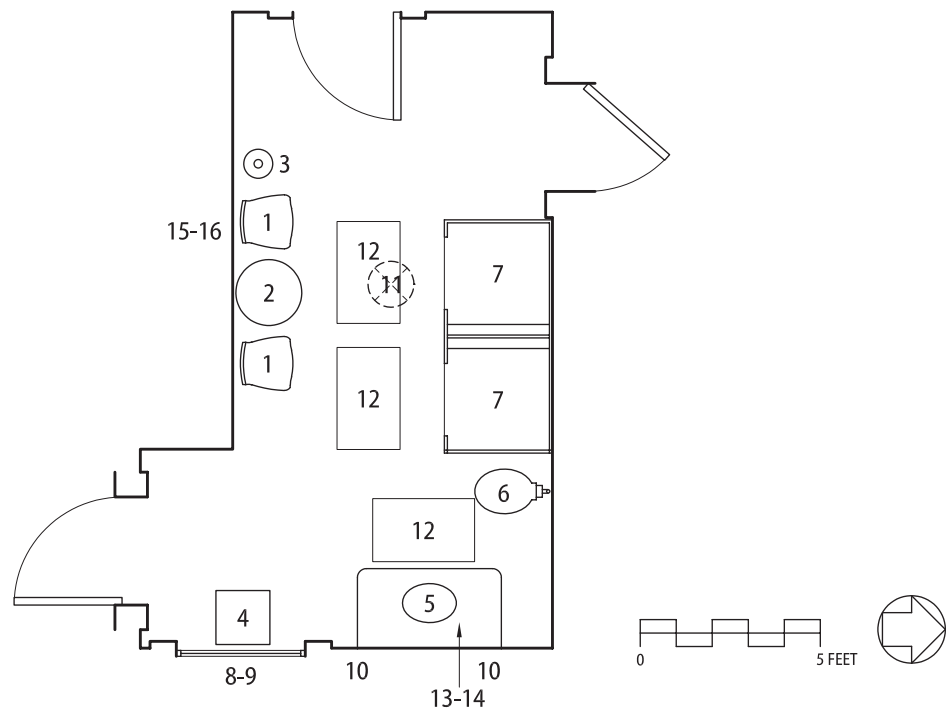
**Figure 101. Pink/Lavender Rooms' Bathroom (302) furnishings location plan.**

The two bathrooms used by Vanderbilt guests (302 and 305) and the two for the servants (312 and 317) were all affected by the 1943 renovations for President Roosevelt's detail. The bathtubs were removed and replaced with shower stalls, and new light fixtures were installed in the servants' bathrooms.

The stalls should remain as testament to that brief (1942-45) but significant phase of the World War II use of the house by President Roosevelt's staff and security detail. This means that the bathrooms cannot be fully restored. The following plans allow for the later changes to remain, but place the painted white furniture, mats, and decorative objects found in the bathrooms in 1938. Recommendations are also included for towels. The bathrooms could also be exhibited empty of furnishings.

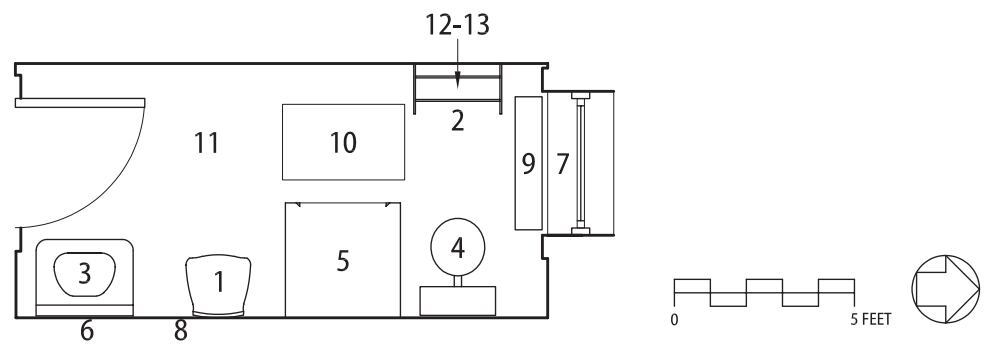
**Figure 104. Bathroom (317) furnishings location plan.**

The north bathroom (317) is very different in character than the other bathrooms. There are no tile finishes, and different plumbing fixtures. The linoleum now in place was installed in 1943; if it is ever removed, the floor can be investigated for earlier finishes.

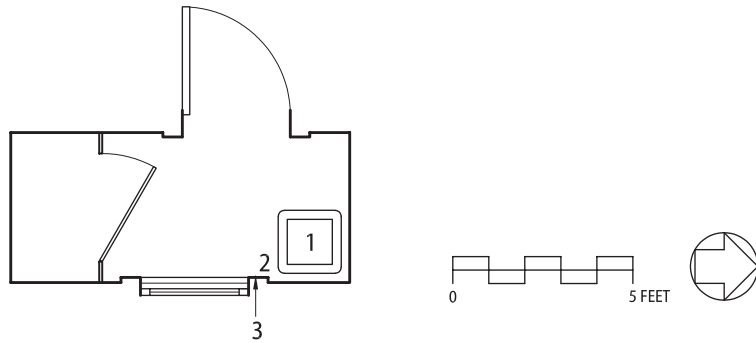
Figure 105. Third floor Maids' Closet furnishings location plan.

This room has remained relatively intact since the Vanderbilt occupancy. The closet can be interpreted as is, but a full restoration would require removing the NPS electrical panel and switches, and restoring the faucet and chain on the slop sink.
