National Park Service  
Cultural Landscapes Inventory  
2010

President's Park South  
The White House (President's Park)

## **Inventory Unit Summary & Site Plan**

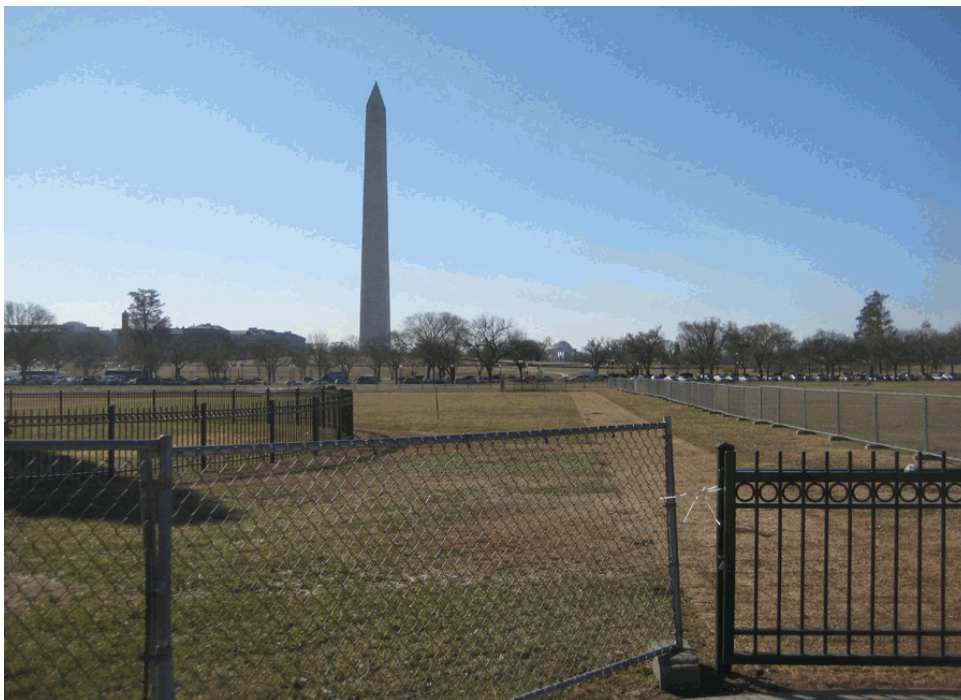
*Figure 8: Primary vista looking south from the north edge of the Ellipse, toward the Washington Monument and Jefferson Memorial (NCR CLP February 4, 2010)*

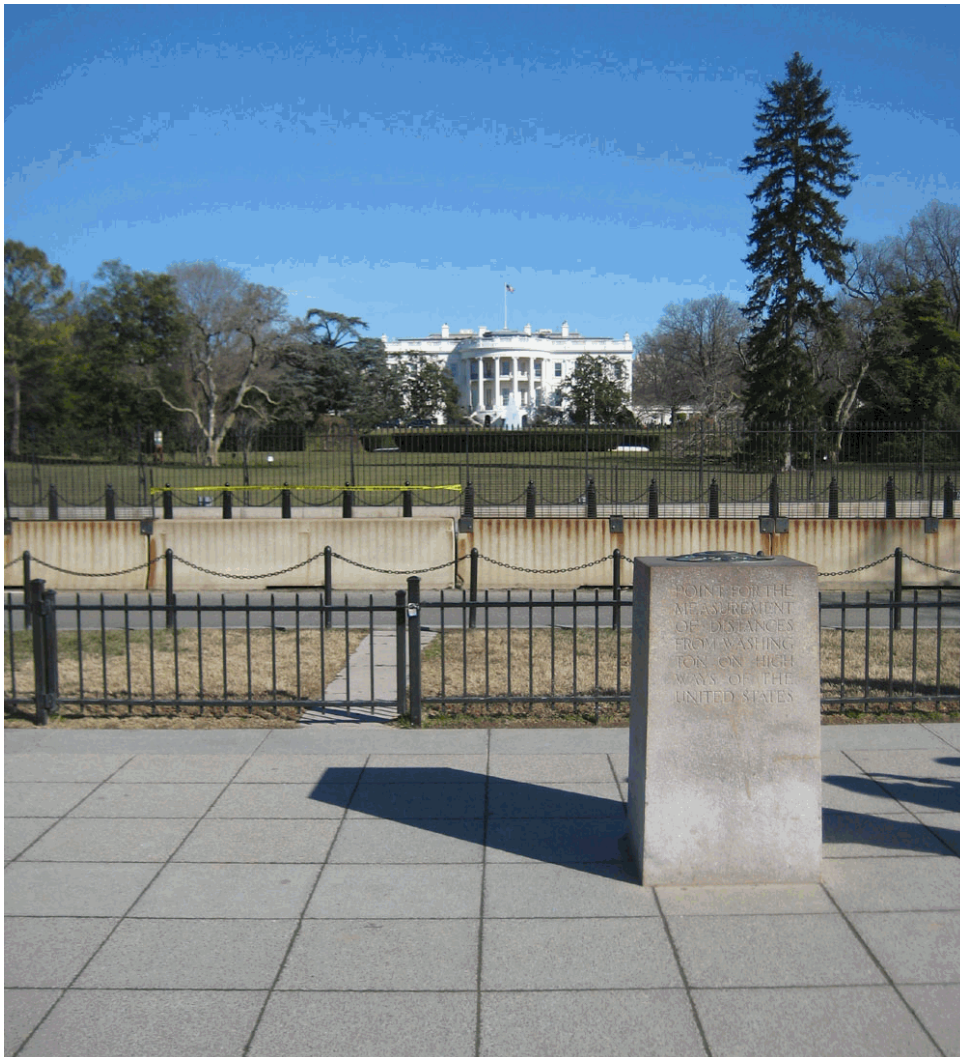
*Figure 10: Primary vista looking north from the Zero Milestone, toward the White House (NCR CLP February 4, 2010)*

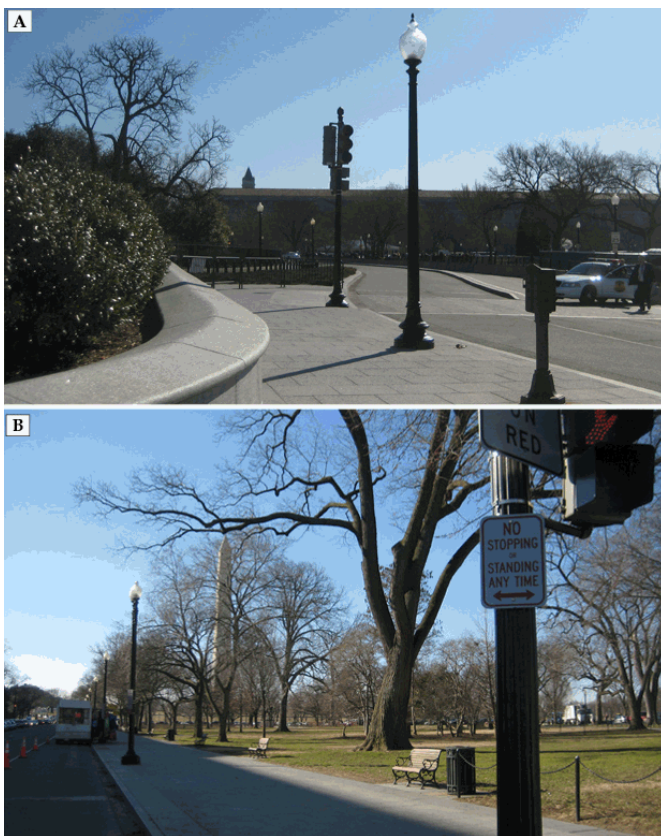
*Figure 22: Views showing small-scale features: A. Looking east across E Street, from south of the First Division Memorial, and B. Looking south along 15th Street (NCR CLP February 4, 2010)*
