National Park Service  
Cultural Landscapes Inventory  
2016

President's Park South  
The White House (President's Park)

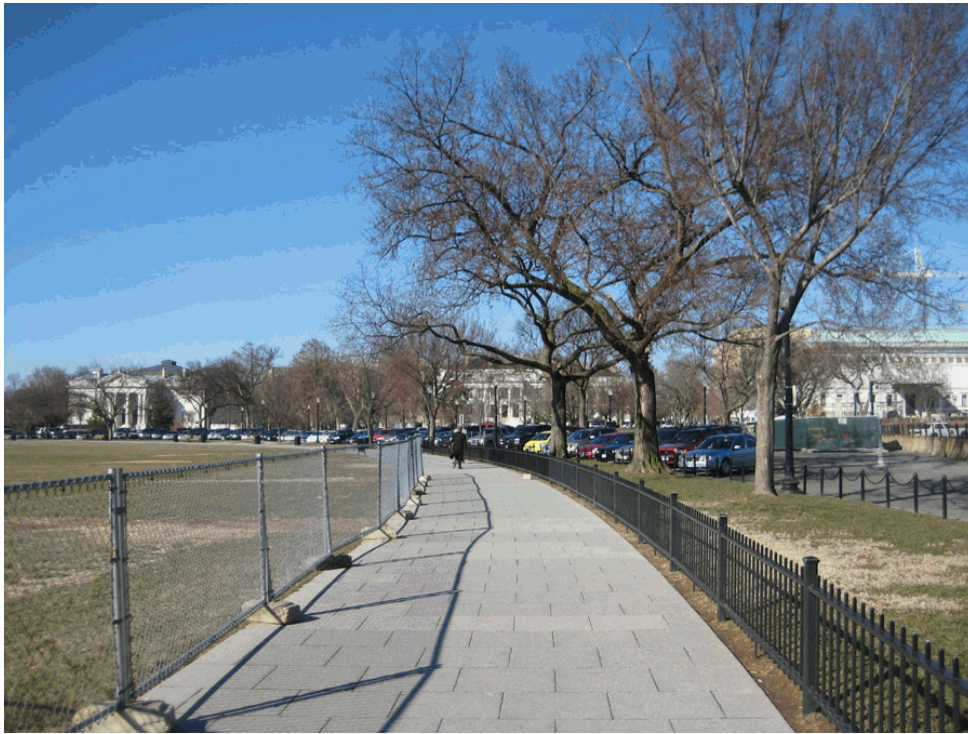
*Figure 3: Looking west across the north edge of the Ellipse toward DAR Continental Memorial Hall (left), the American Red Cross National Headquarters (center), and the Corcoran Gallery of Art (right) (NCR CLP February 4, 2010)*

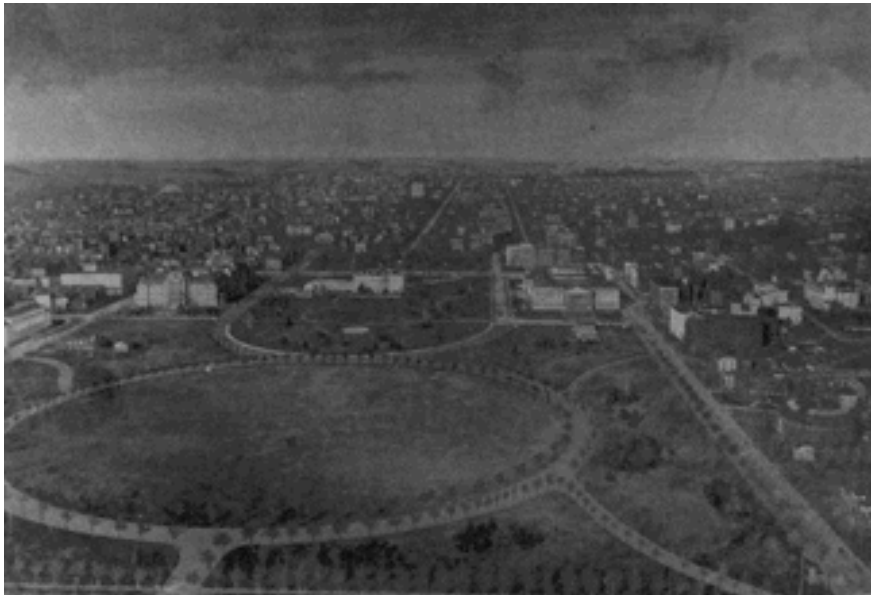
*Figure 7: Circa 1900 aerial view of President's Park South, looking north (Washington, DC, Public Library, Washingtoniana Division)*

established: an Ellipse shape fit into a rectangular space carved by curving roads and walks, with a roughly rectangular shaped quadrant on each side of the White House grounds to the north (see Figure 7).

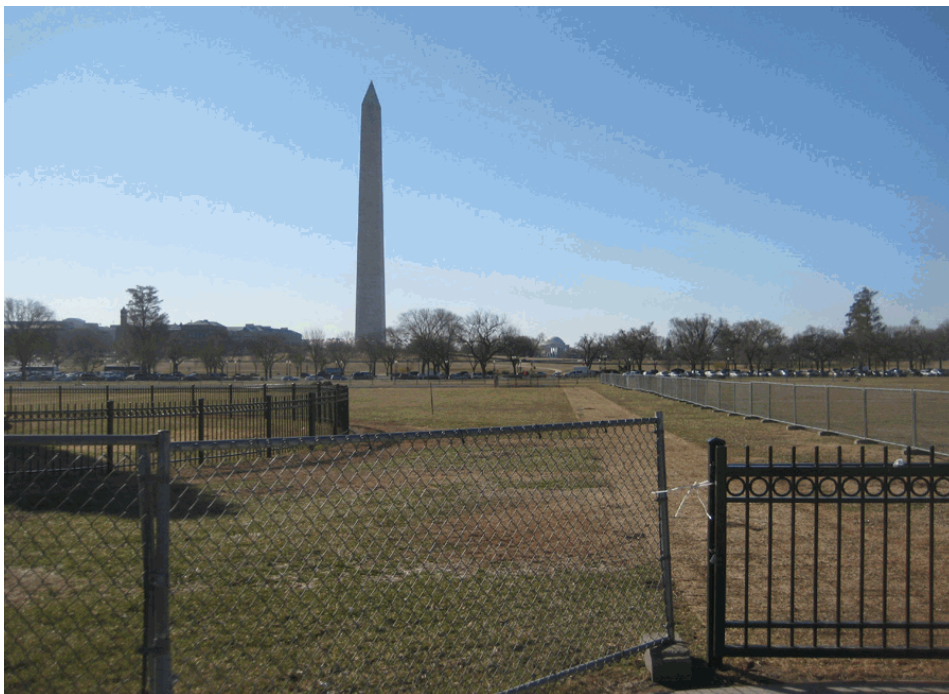
*Figure 8: Primary vista looking south from the north edge of the Ellipse, toward the Washington Monument and Jefferson Memorial (NCR CLP February 4, 2010)*

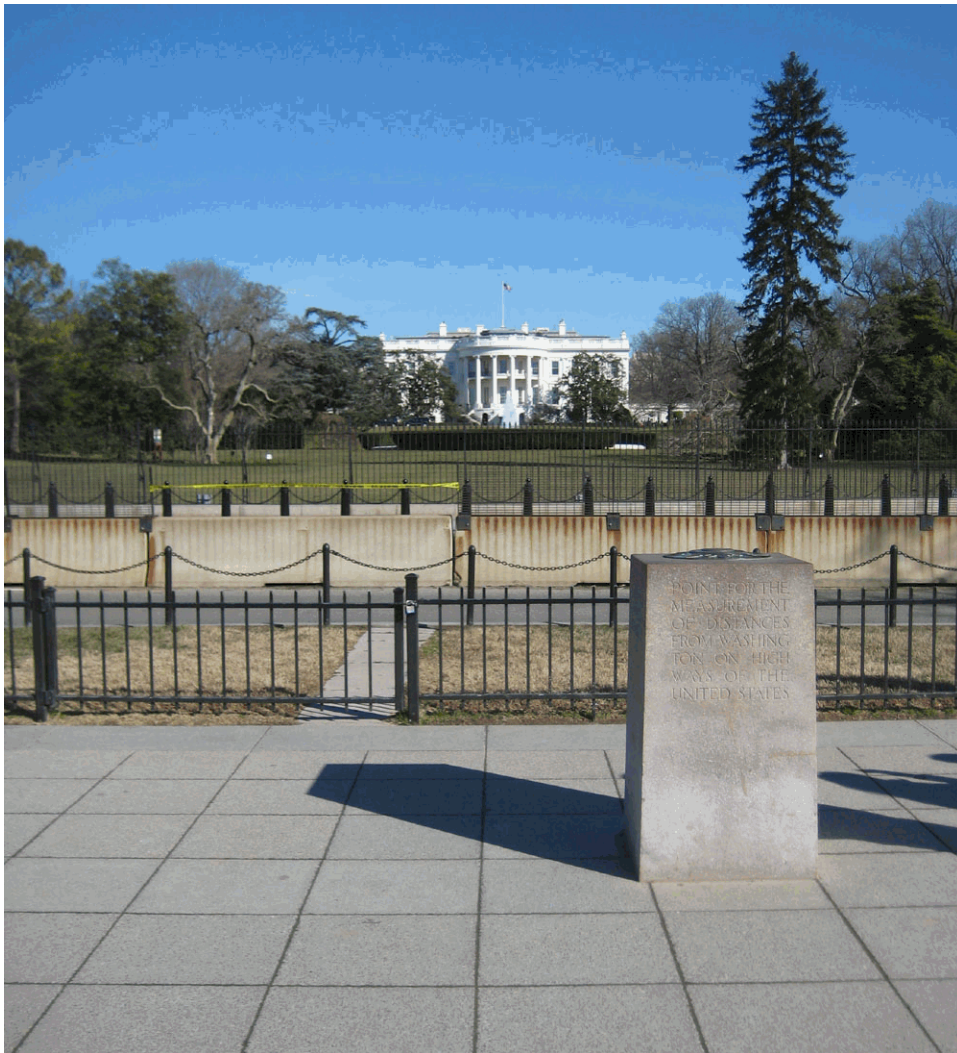
*Figure 10: Primary vista looking north from the Zero Milestone, toward the White House (NCR CLP February 4, 2010)*

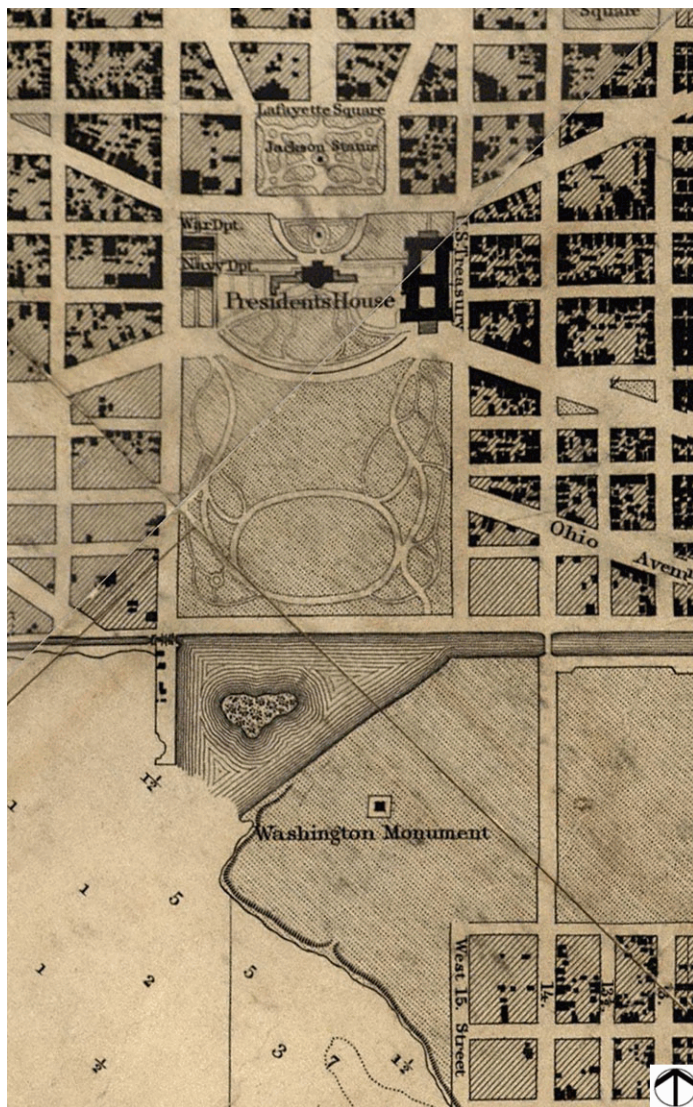
*Figure 12: Detail of Albert Boschke's Map of the District of Columbia, Surveyed in the Years 1856, 1857, 1858 & 1859, showing a planned or proposed arrangement for President's Park South (Library of Congress, Geography and Maps Division)*

President's Park South were first hinted at in the 1830s, when President Andrew Jackson established a "bell shaped" configuration of drives on the south lawn of the White House. (Boyle 2001: 53). Plans for the future layout of the Ellipse area itself followed in 1851, when landscape architect Andrew Jackson Downing developed a plan for the City of Washington's public grounds, including President's Park South. This design was the first plan for a large scale public park in the United States that was at least partially implemented (Horner 2010: 8.57). On the land south of the White House grounds, Downing depicted a circle. Following his sudden death soon afterwards, work on the project lagged, but Downing's original designs were taken up by his assistant, William D. Brackenridge. The earliest stages of implementation began, but were soon interrupted by the Civil War (Boyle 2001: 101, 107). One illustrated version of what was probably emerging in some form during the late 1850s and early 1860s can be seen in Albert Boschke's 1861 map of this area, showing an elliptical shaped road with curving bridle paths on either side (Boschke 1861) (see Figure 12).

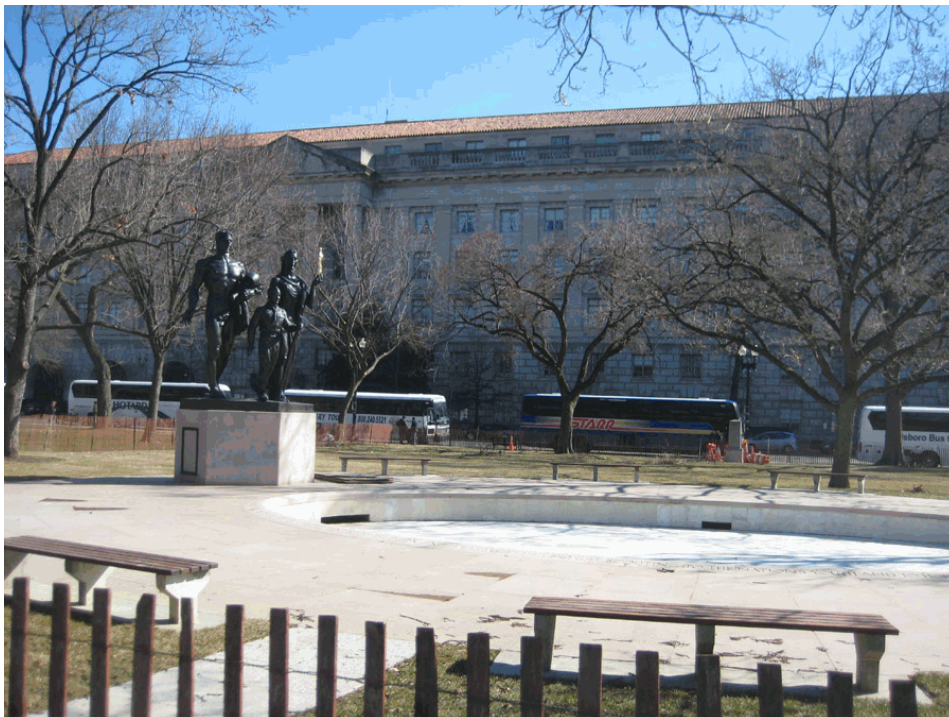
*Figure 14: Looking east toward the Boy Scout Memorial on the Ellipse (NCR CLP February 4, 2010)*

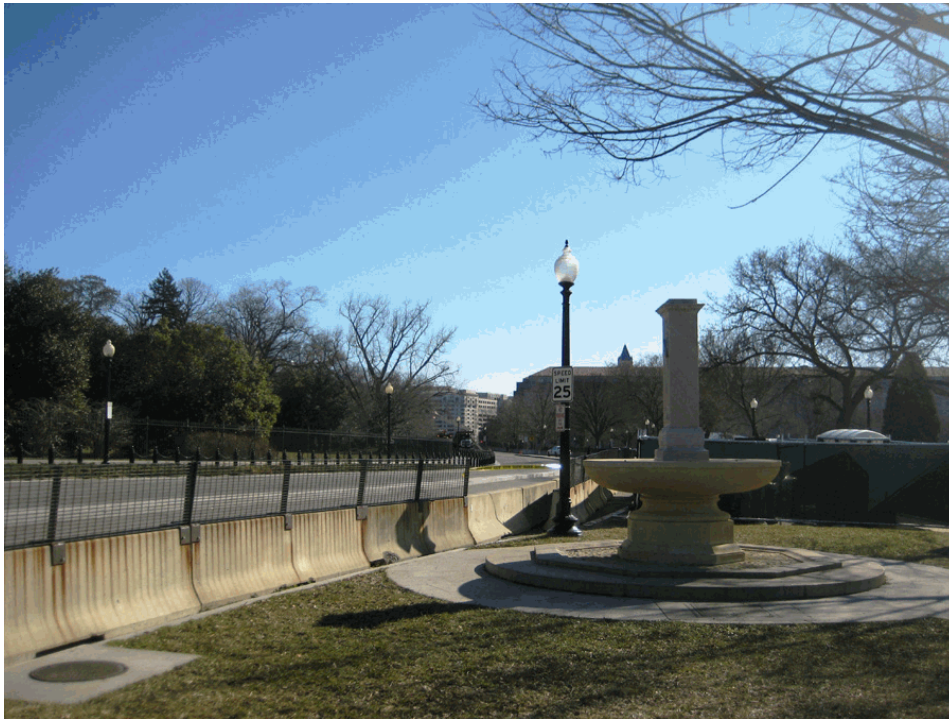
*Figure 15: Looking east from just south of E Street, toward the Butt-Millet Memorial Fountain (NCR CLP February 4, 2010)*

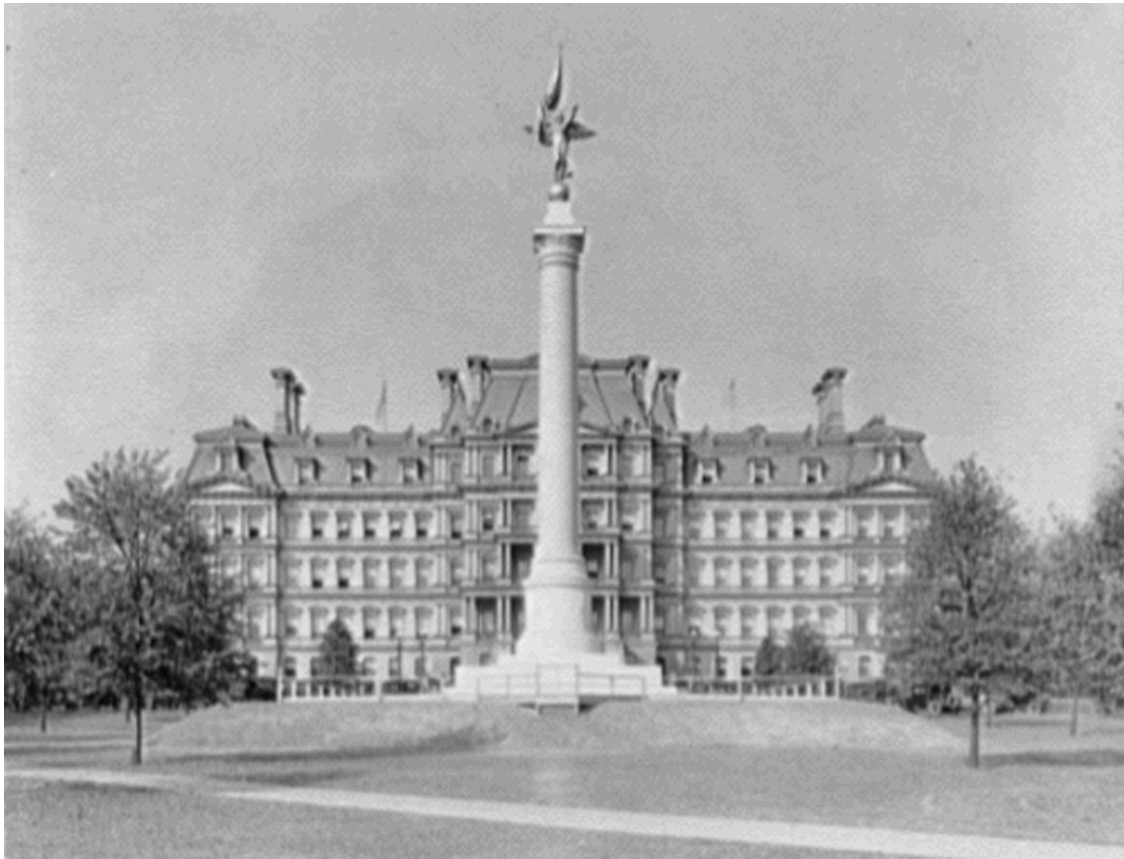
*Figure 16: View looking north toward the First Division Monument ca. 1920s (Library of Congress, Prints and Photographs Division, Theodore Horydczak Collection)*

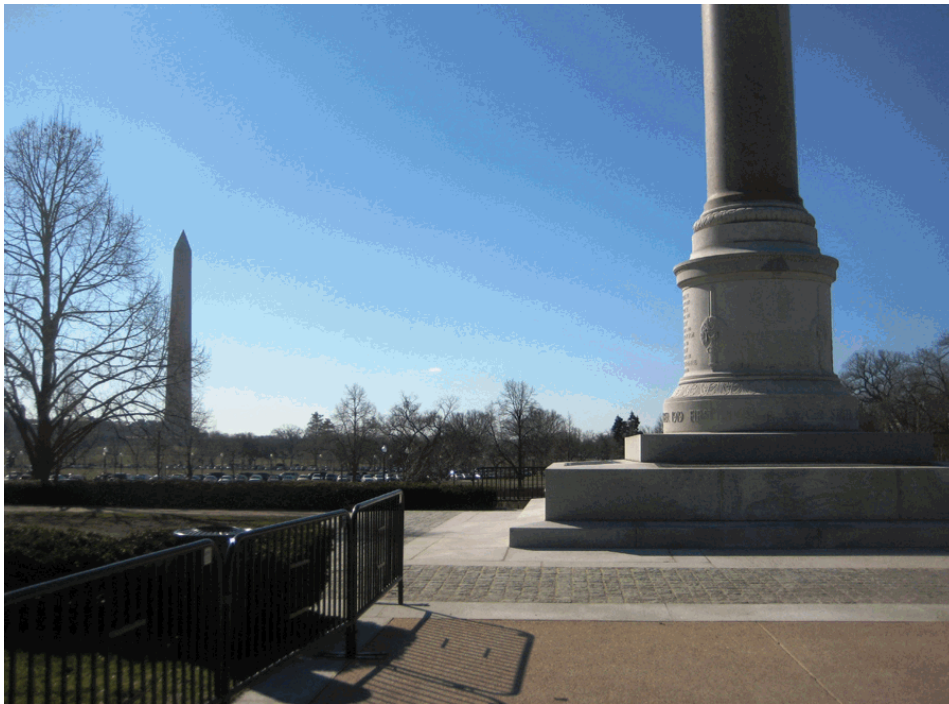
*Figure 17: Looking south from the First Division Monument (NCR CLP February 4, 2010)*

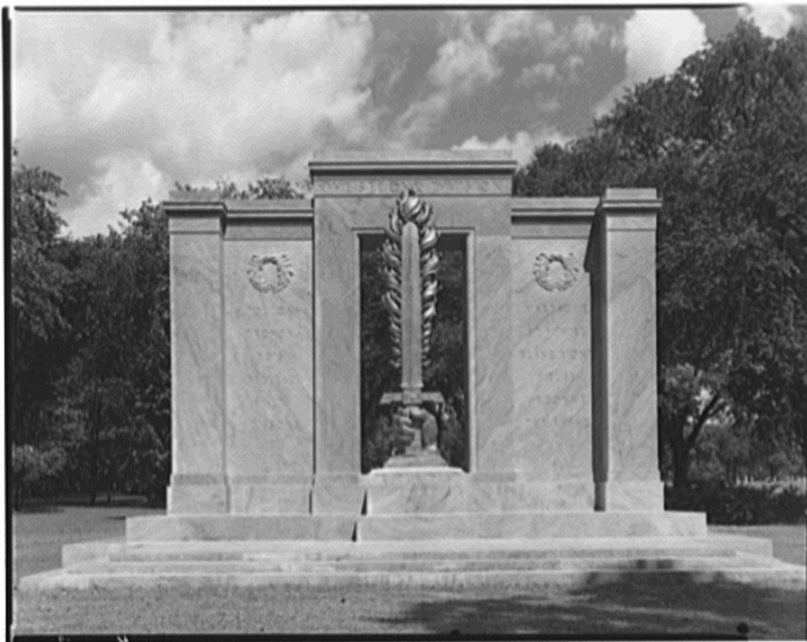
*Figure 18: Circa 1936-50 view of the Second Division Memorial, looking north from Constitution Avenue (Library of Congress, Prints and Photographs Division, Theodore Horydczak Collection)*

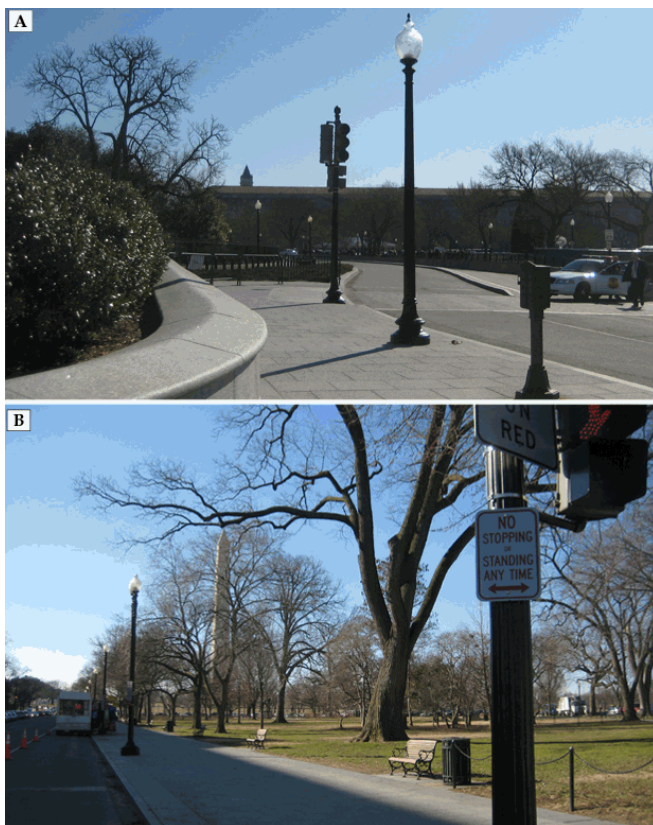
*Figure 22: Views showing small-scale features: A. Looking east across E Street, from south of the First Division Memorial, and B. Looking south along 15th Street (NCR CLP February 4, 2010)*

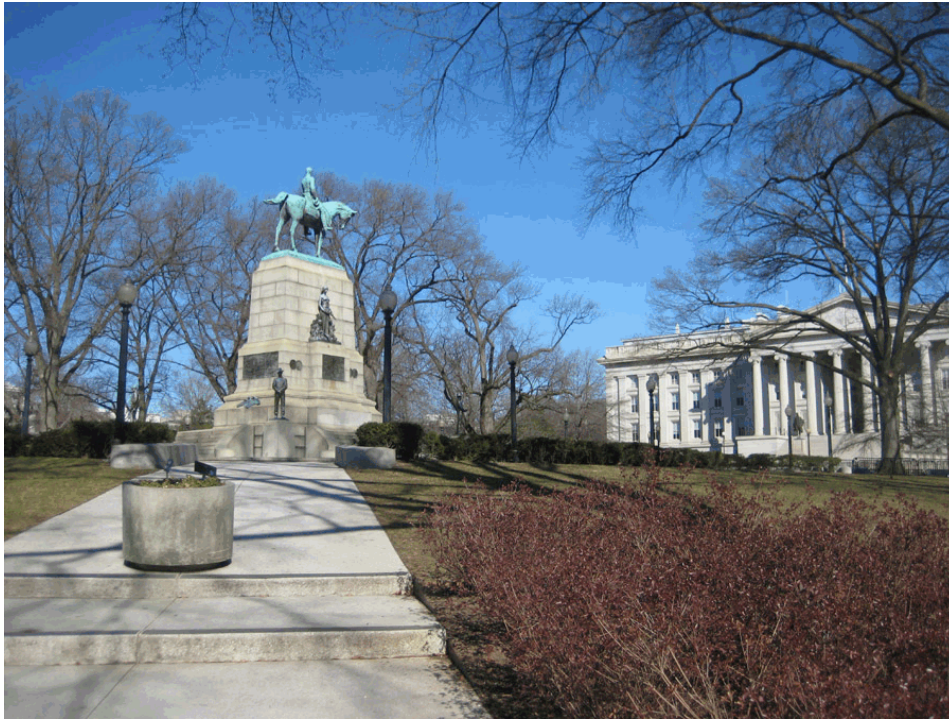
*Figure 23: Looking northwest toward the General Sherman Statue, with the Treasury Building at the right (NCR CLP February 4, 2010)*

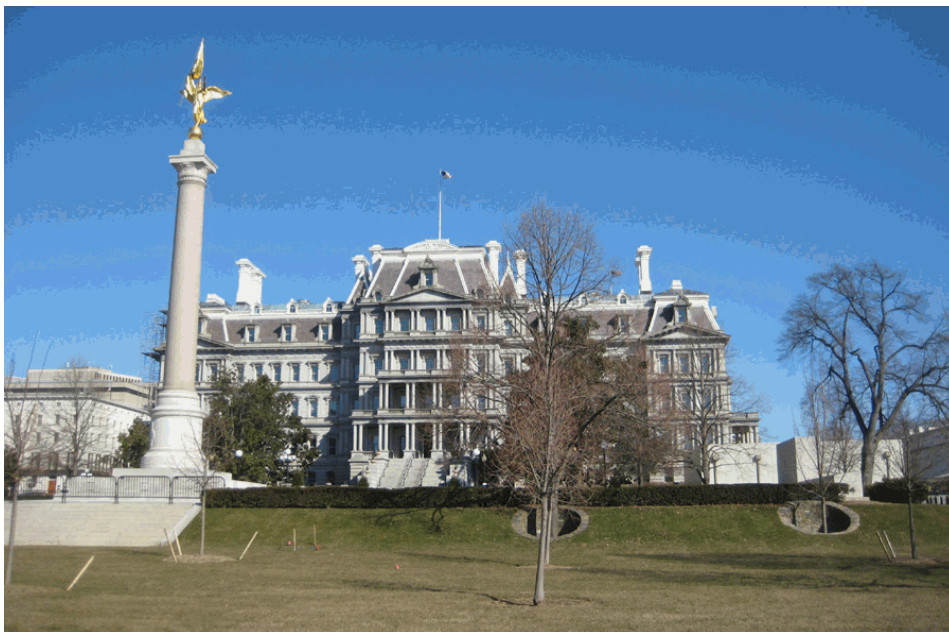
*Figure 24: Looking north toward the First Division Monument, with the Eisenhower Executive Office Building in the background (NCR CLP February 4, 2010)*
