historic structure report
historic data section
january 1982

YELLOWSTONE
OLD FAITHFUL INN

HISTORIC STRUCTURE REPORT
HISTORICAL DATA SECTION
OLD FAITHFUL INN
YELLOWSTONE NATIONAL PARK
WYOMING

by
A. Berie Clemensen

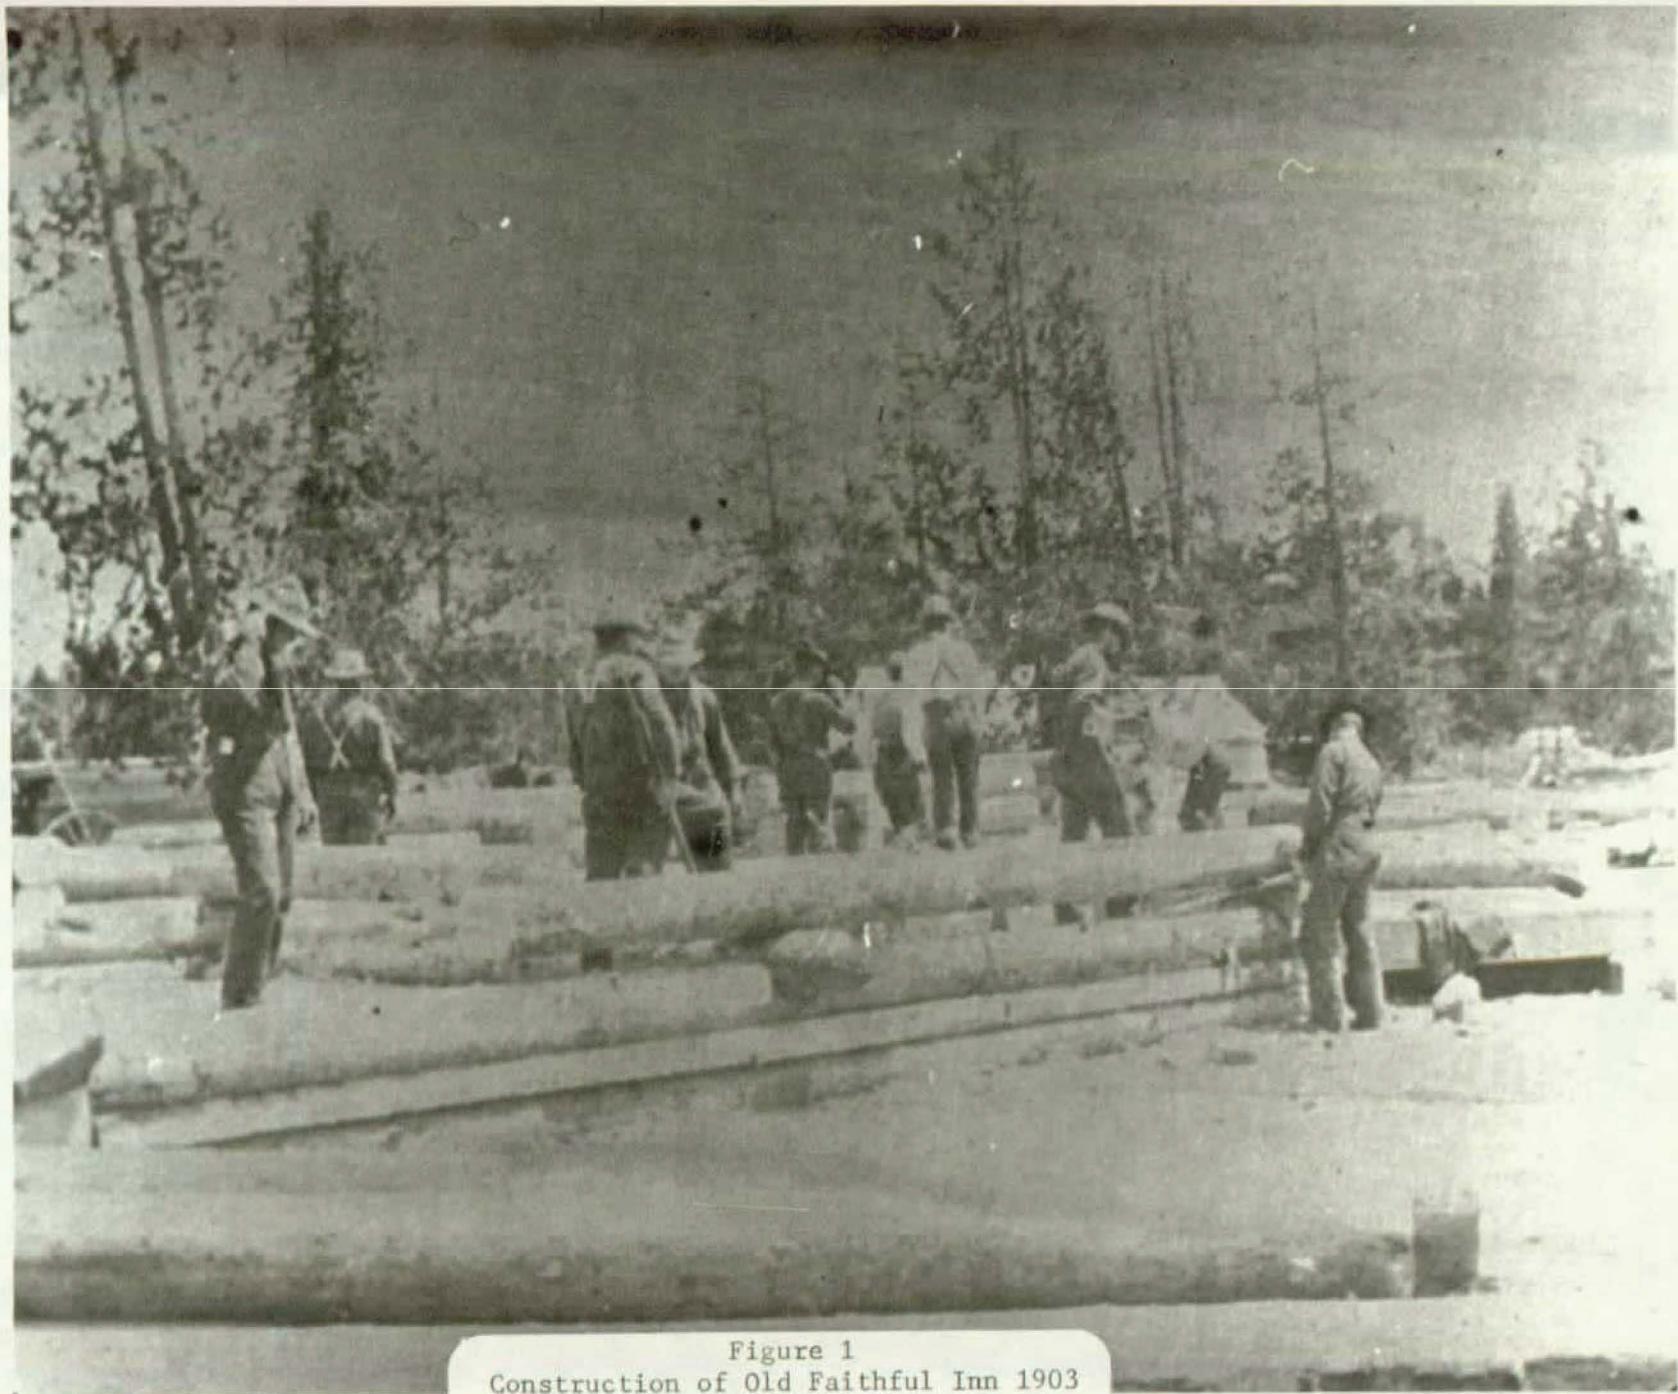
Figure 1
Construction of Old Faithful Inn 1903
Yellowstone National Park Photo

Probably by the end of June enough timbers had been brought to the Inn's site for construction to begin (figure 1). By the end of October the acting park superintendent noted that "A handsome new hotel is being built at the Upper Geyser Basin and will be ready for occupancy next summer."¹⁷ At that time, however, the Inn was only about two-thirds complete. Child had expended his \$100,000 loan plus an additional \$25,000 from the Northern Pacific by the end of October. Of

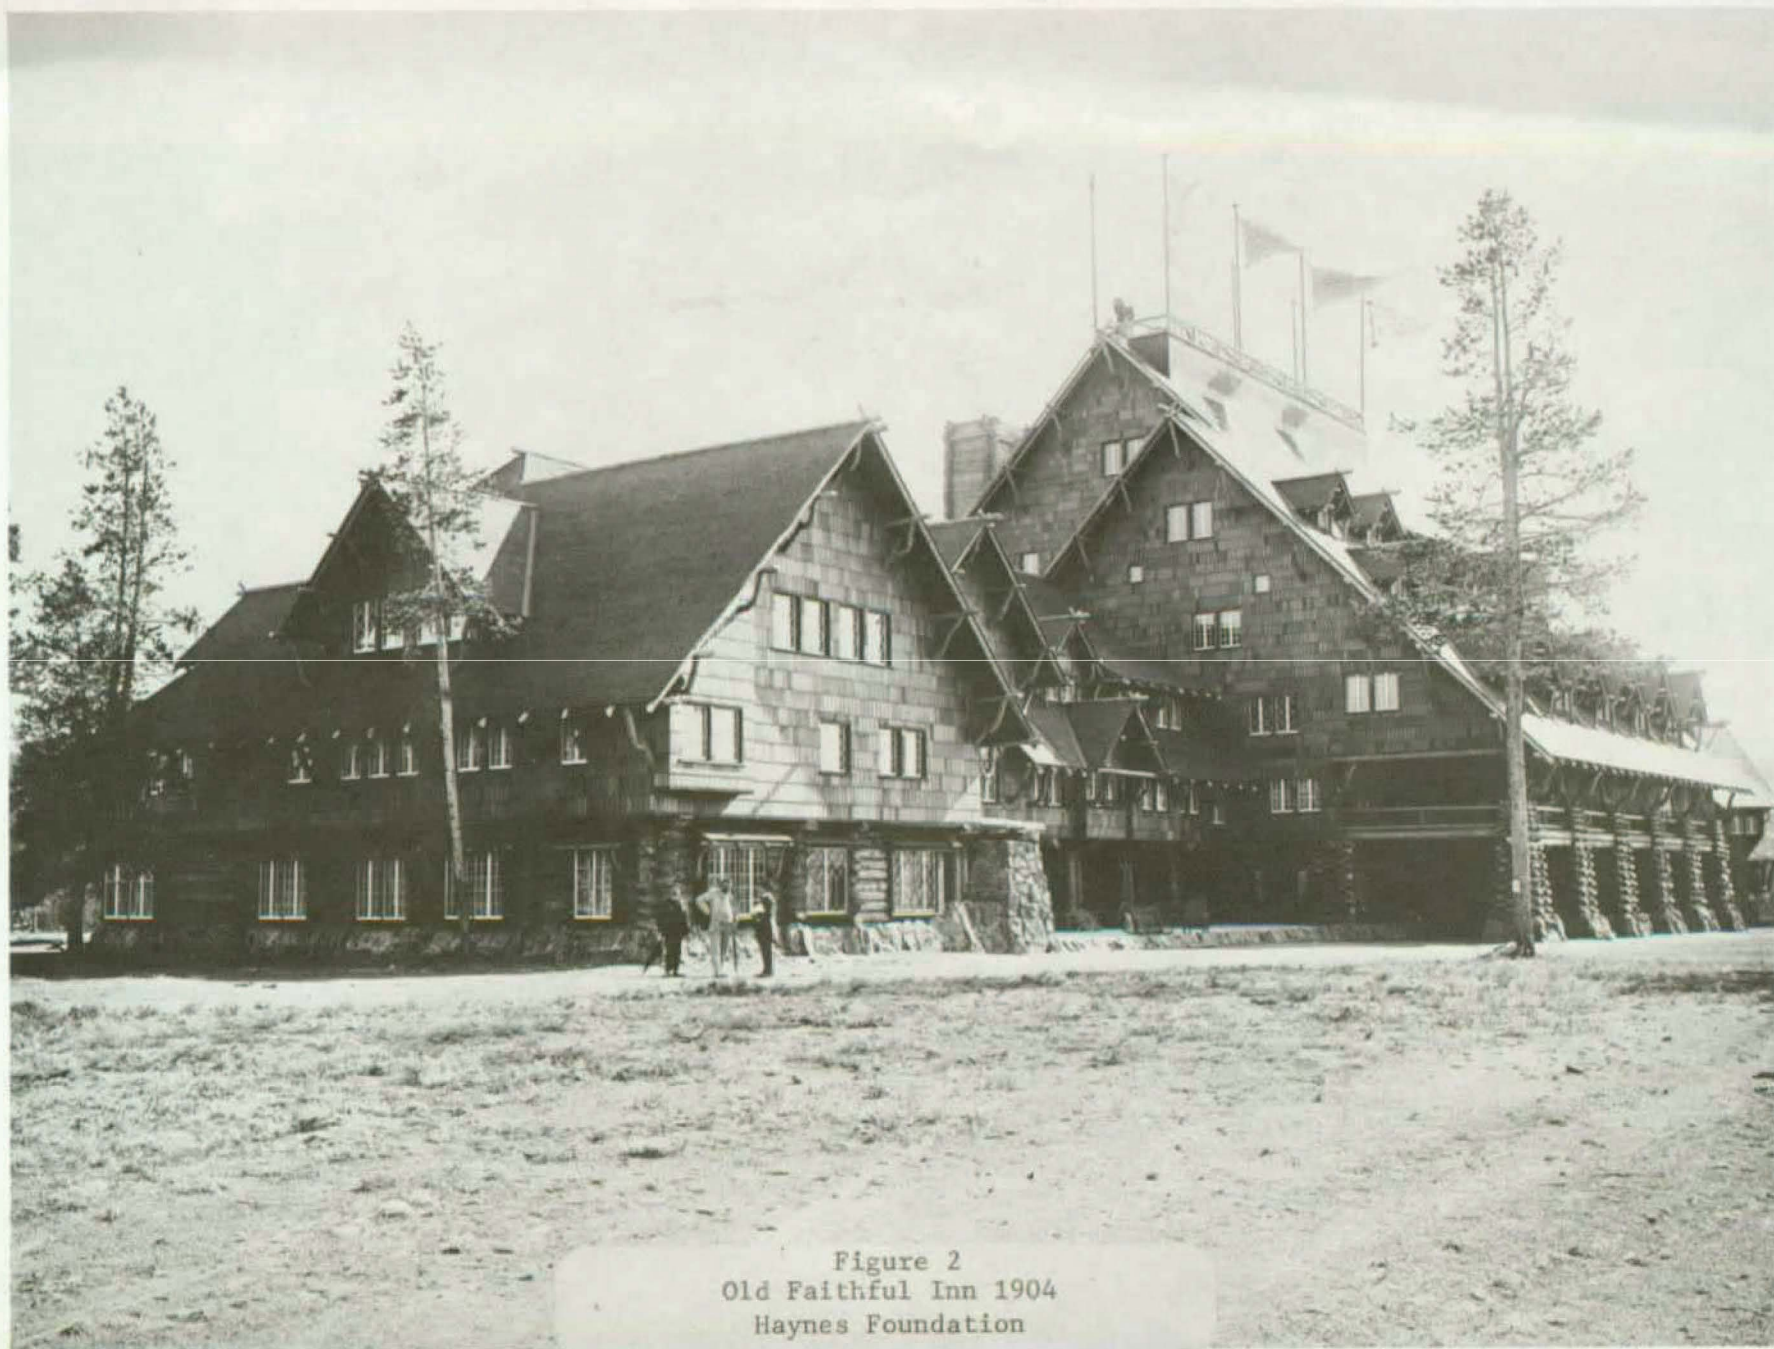
Figure 2
Old Faithful Inn 1904
Haynes Foundation

A photograph of the completed Inn taken from the northeast. It reveals the stonework at the base and one stone pier on the front. The various shapes of window glazing can be seen. Siding shingles, the bottom two courses of which contain a chevron pattern, can easily be seen. The top of the lobby fireplace's cribbed chimney is visible at the rear of the central part of the structure. The widow's walk atop the central portion has eight flag poles and a spot light used for illuminating the Old Faithful geyser at night. The porte-cochere's cribbed supports resting on their rubble bases can be seen beneath the steeply pitched roof of the central part.

On the exterior the first floor walls consisted of unhewn horizontal logs, while the frame upper floors were covered with 36x6-inch cedar shingles. The bottom two courses of shingles contained a saw-tooth or chevron pattern (figures 2-25). The walls rested on a stone masonry foundation. Windows were muntined with either square, round, elliptical, or diamond shaped glazing. The central portion of the building was covered by a steeply pitched gabled roof topped by a widow's walk. Originally, eight flag poles, from which pennants flew, surmounted the widow's walk. By 1927 the number was reduced to six; today only four poles remain. A searchlight was also mounted on the roof, and was used to illuminate Old Faithful Geyser for night viewing. About 1910 a second spotlight was added, but both were removed around 1948. In addition the widow's walk contained a bell which was rung a quarter hour before the dining room opened.

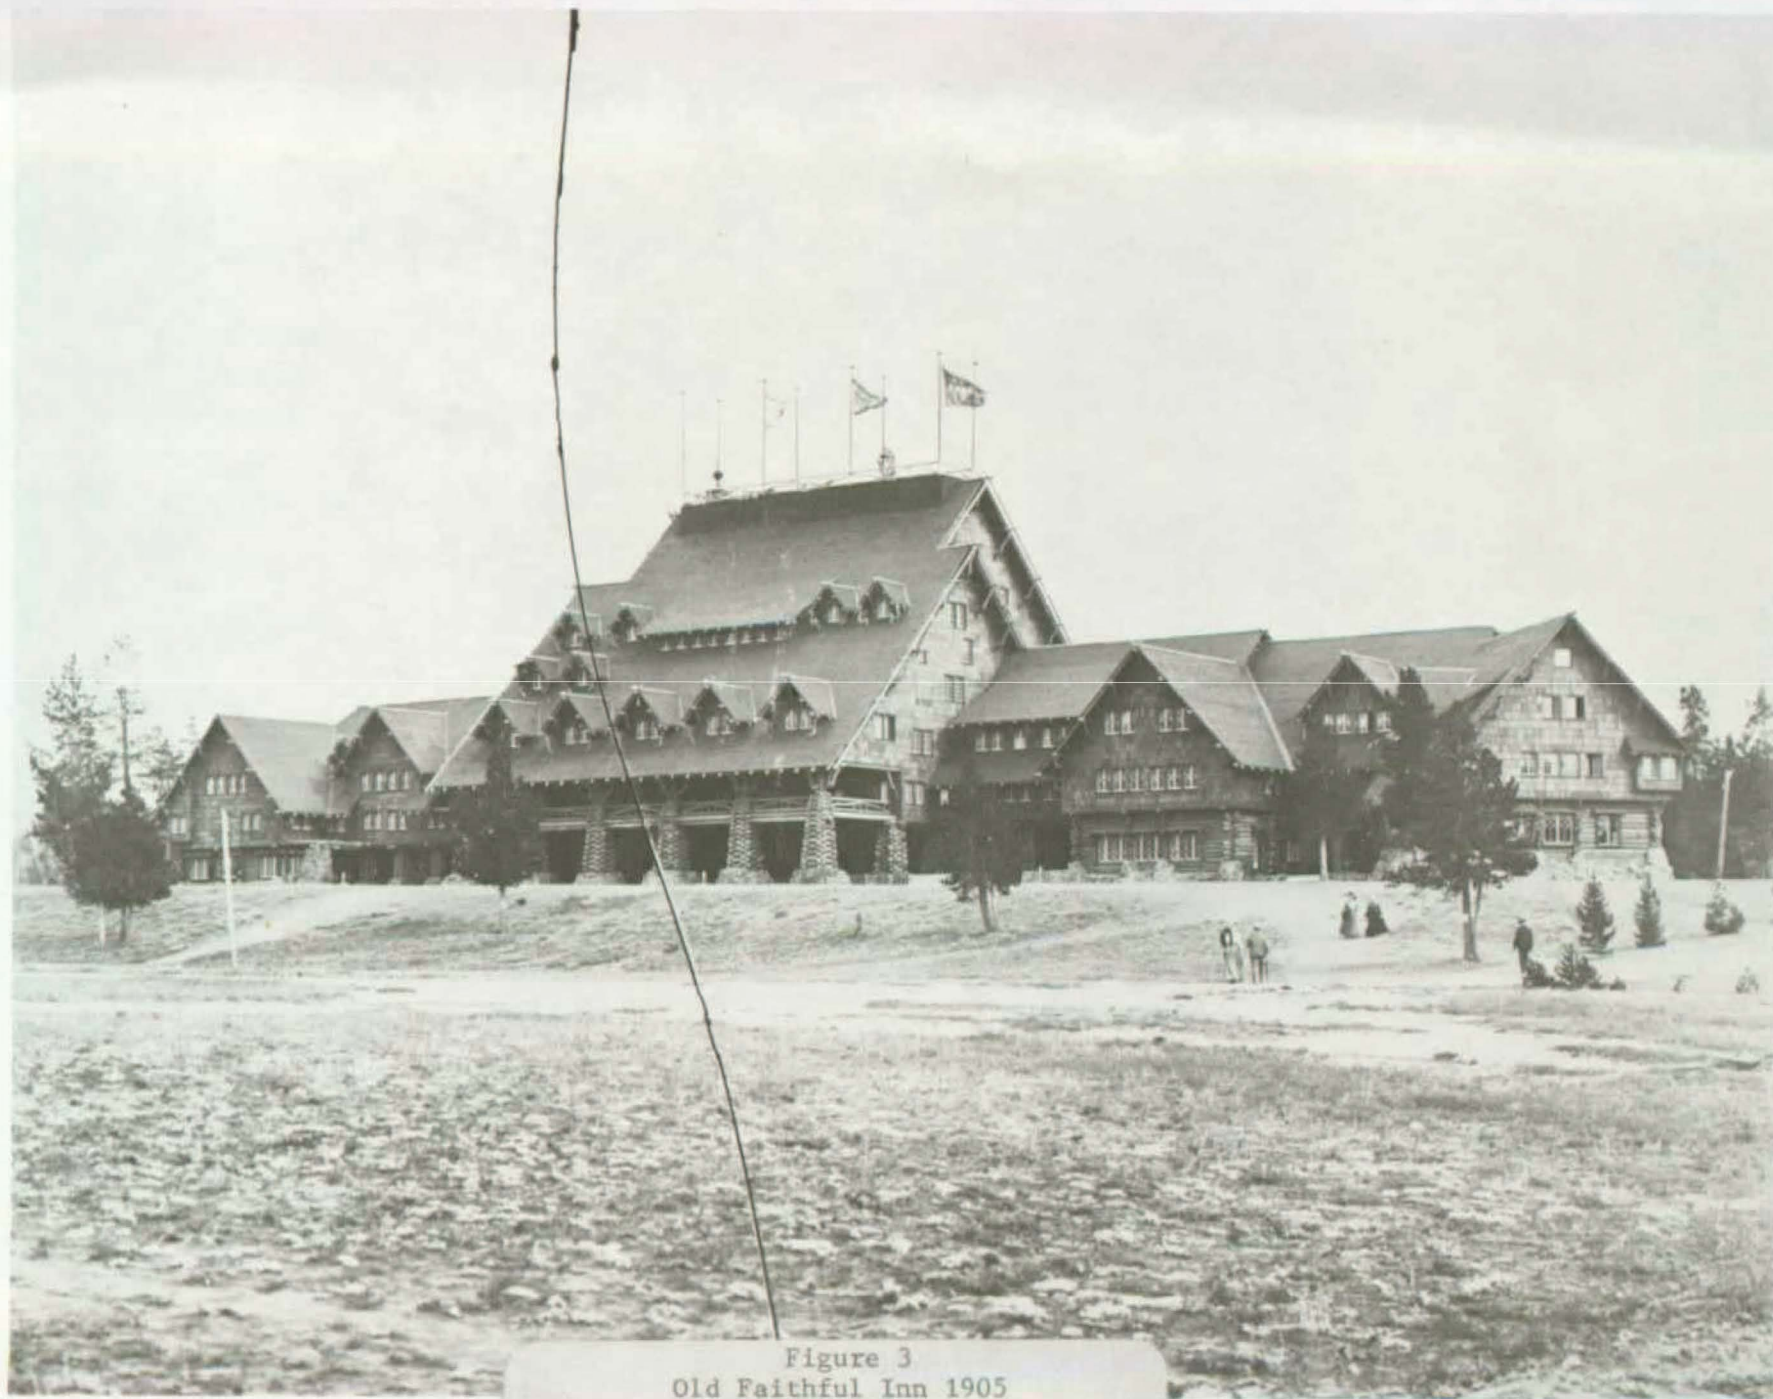
Figure 3
Old Faithful Inn 1905
Colorado Historical Society

A photograph of the Inn taken from the northwest. Here one can see the design of the original west wing.

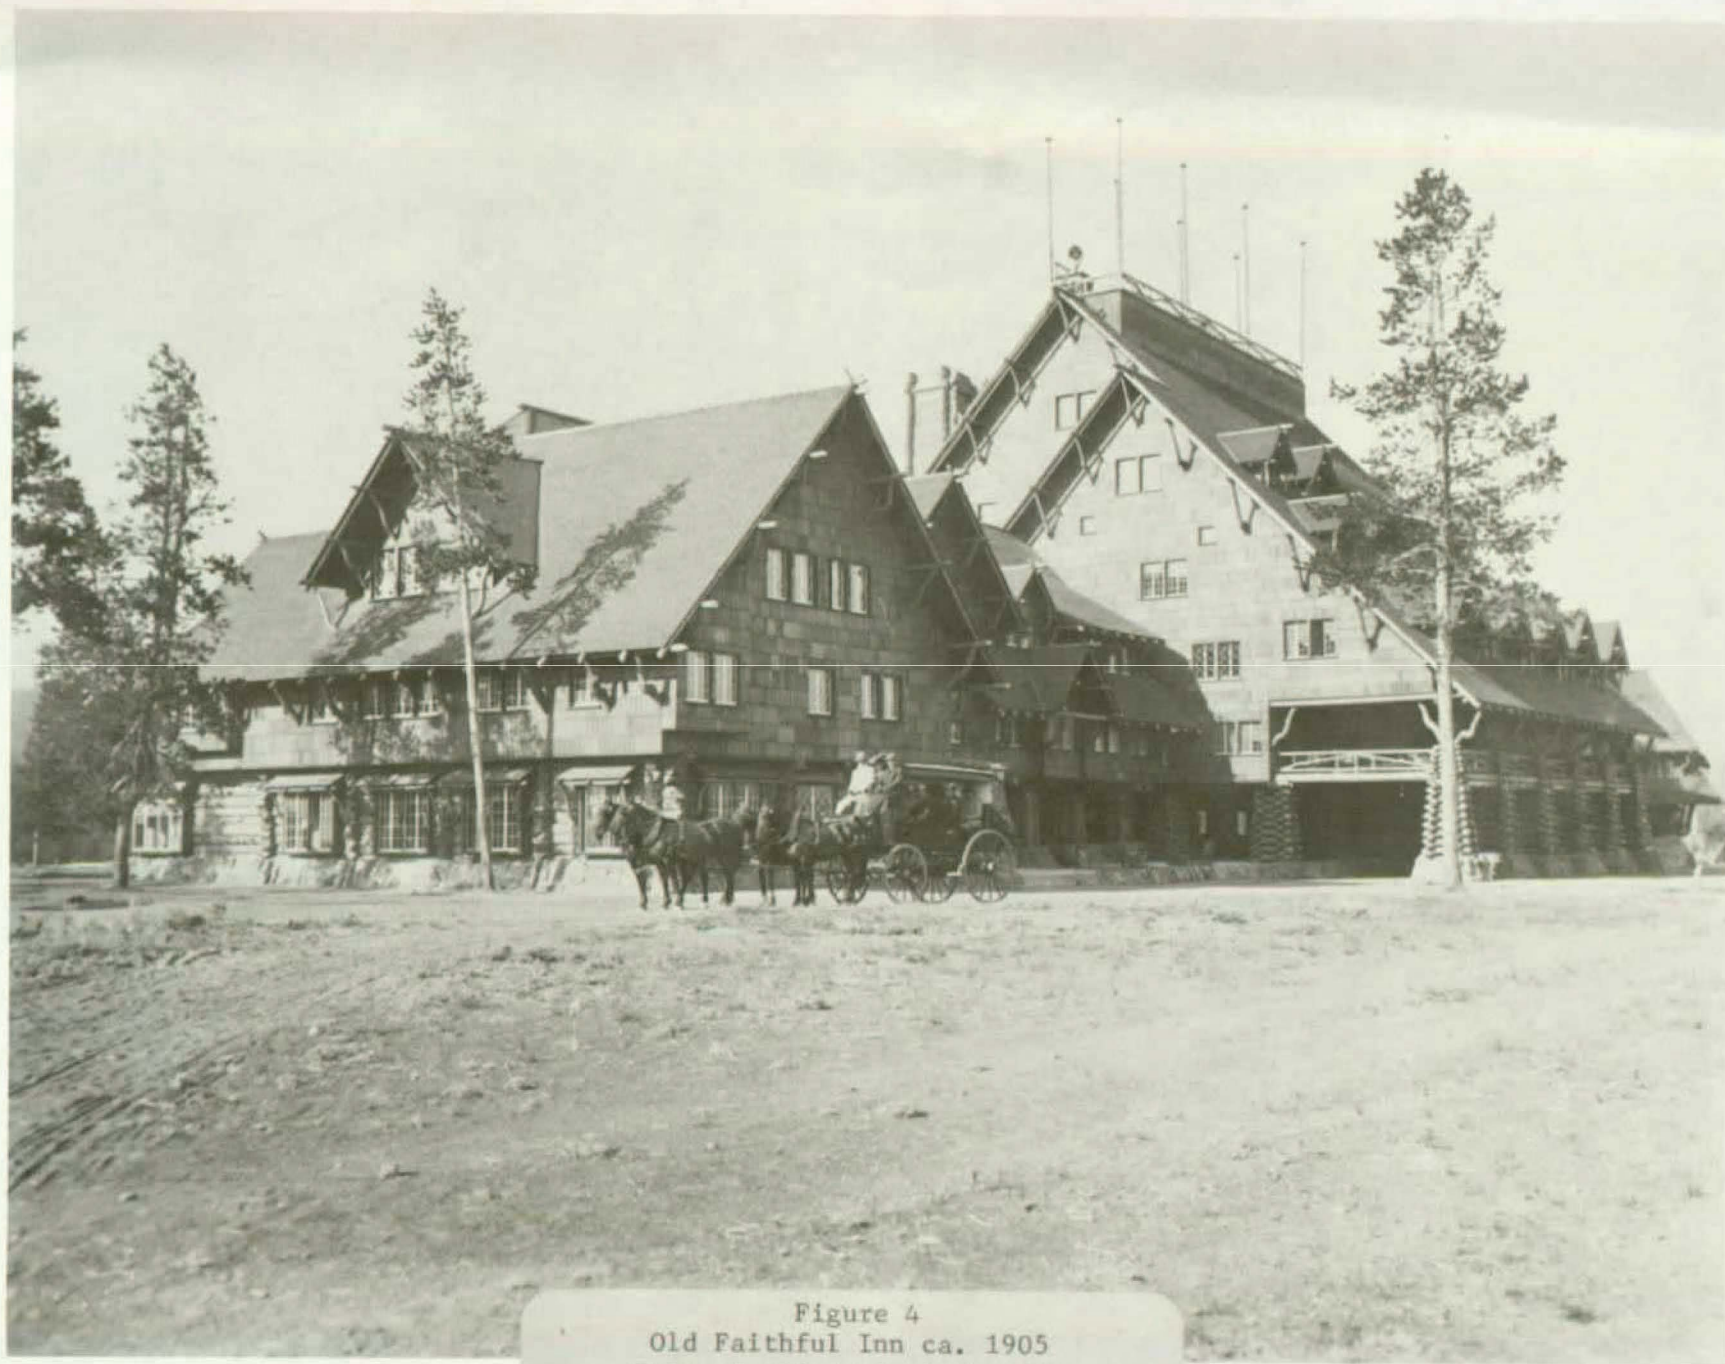
Figure 4
Old Faithful Inn ca. 1905
Colorado Historical Society

A photograph of the Inn taken from the northeast shows the original east wing and a portion of the central part of the old house.

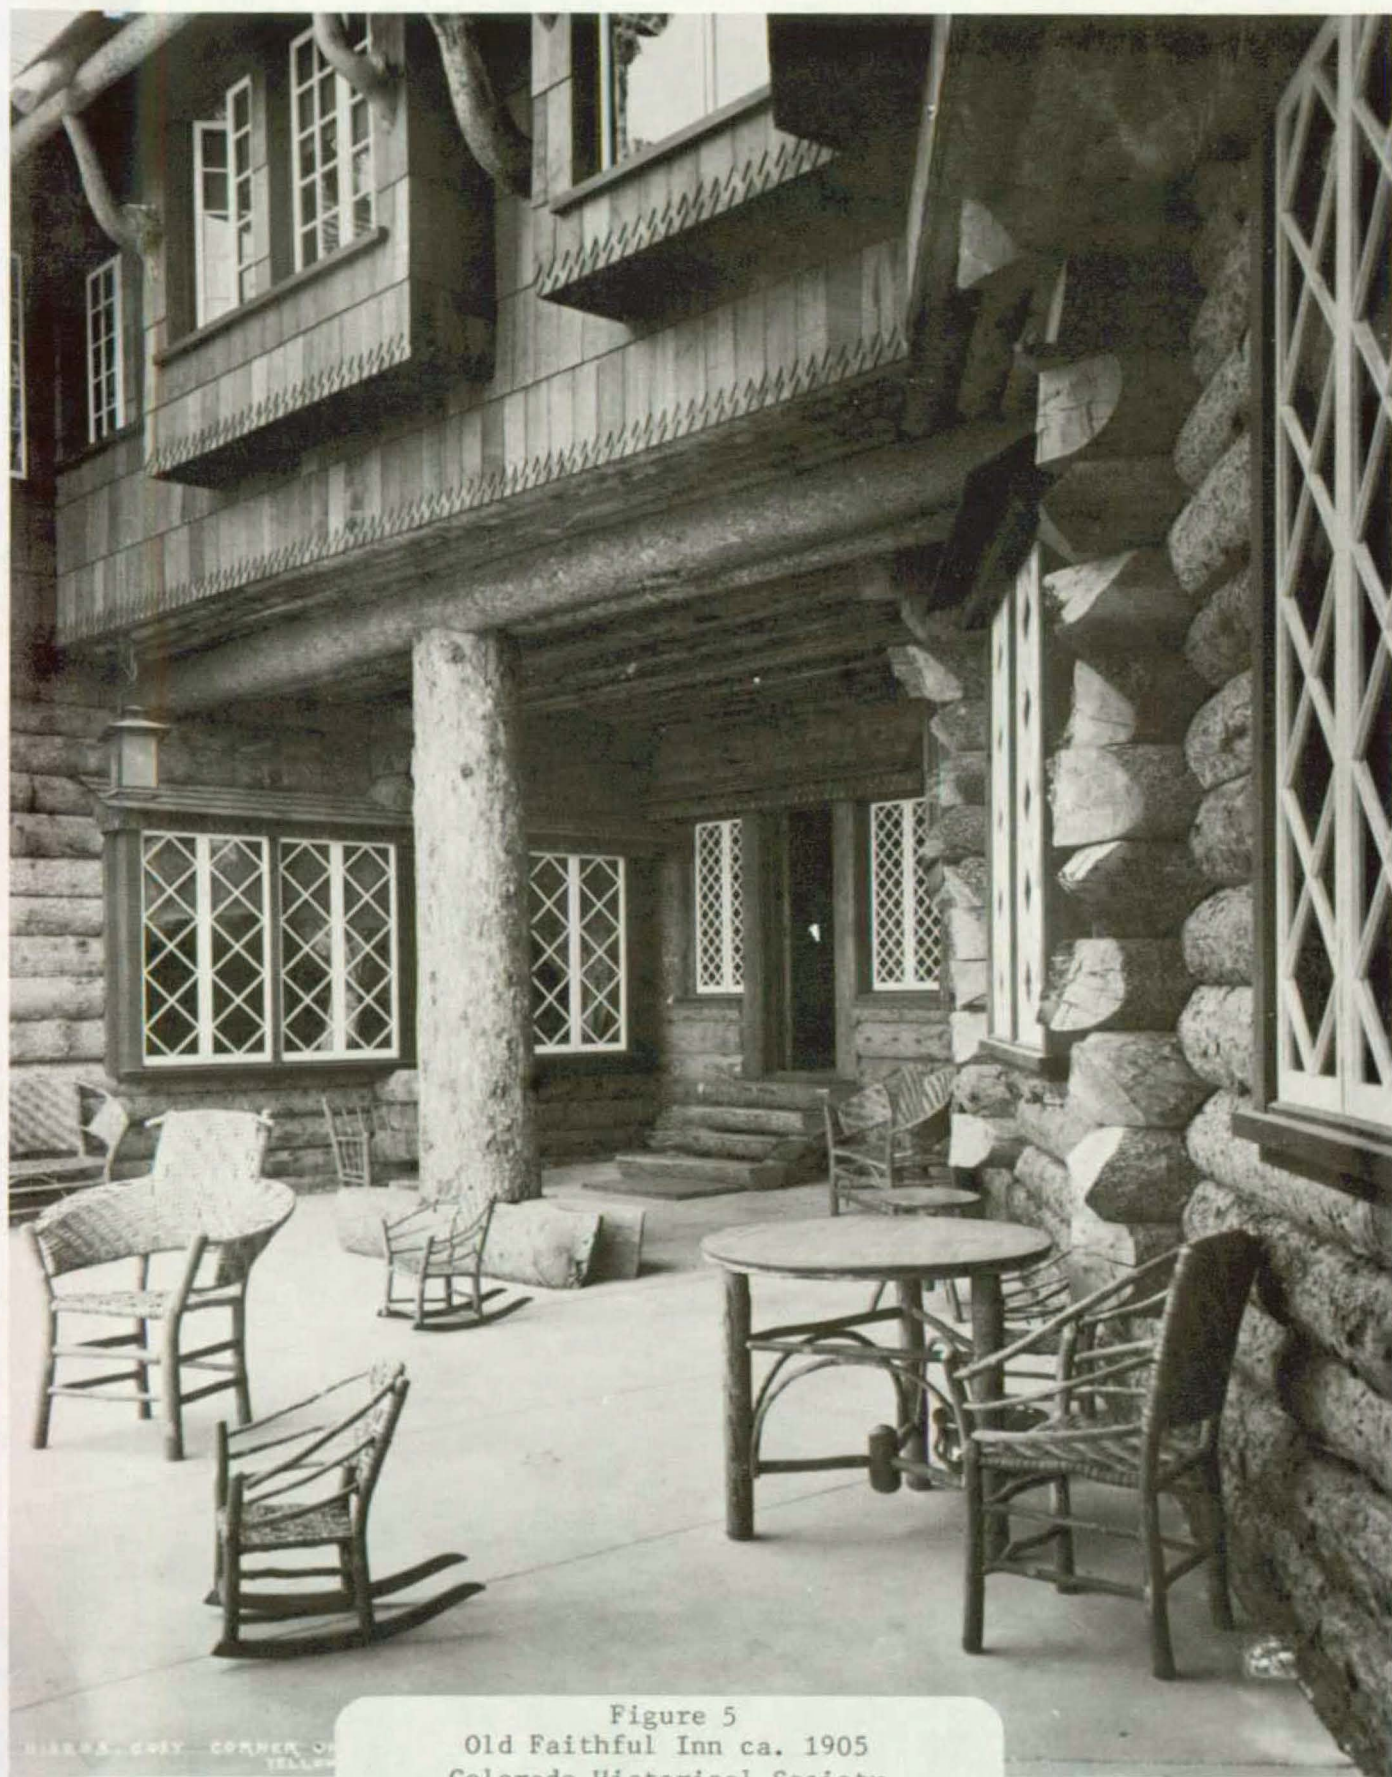
Figure 5
Old Faithful Inn ca. 1905
Colorado Historical Society

A photograph showing an exterior, front recessed area or corner in the original west wing. Diamond shaped window glazing on the ground floor and the bottom two courses of siding shingles with their chevron pattern are shown in excellent detail.

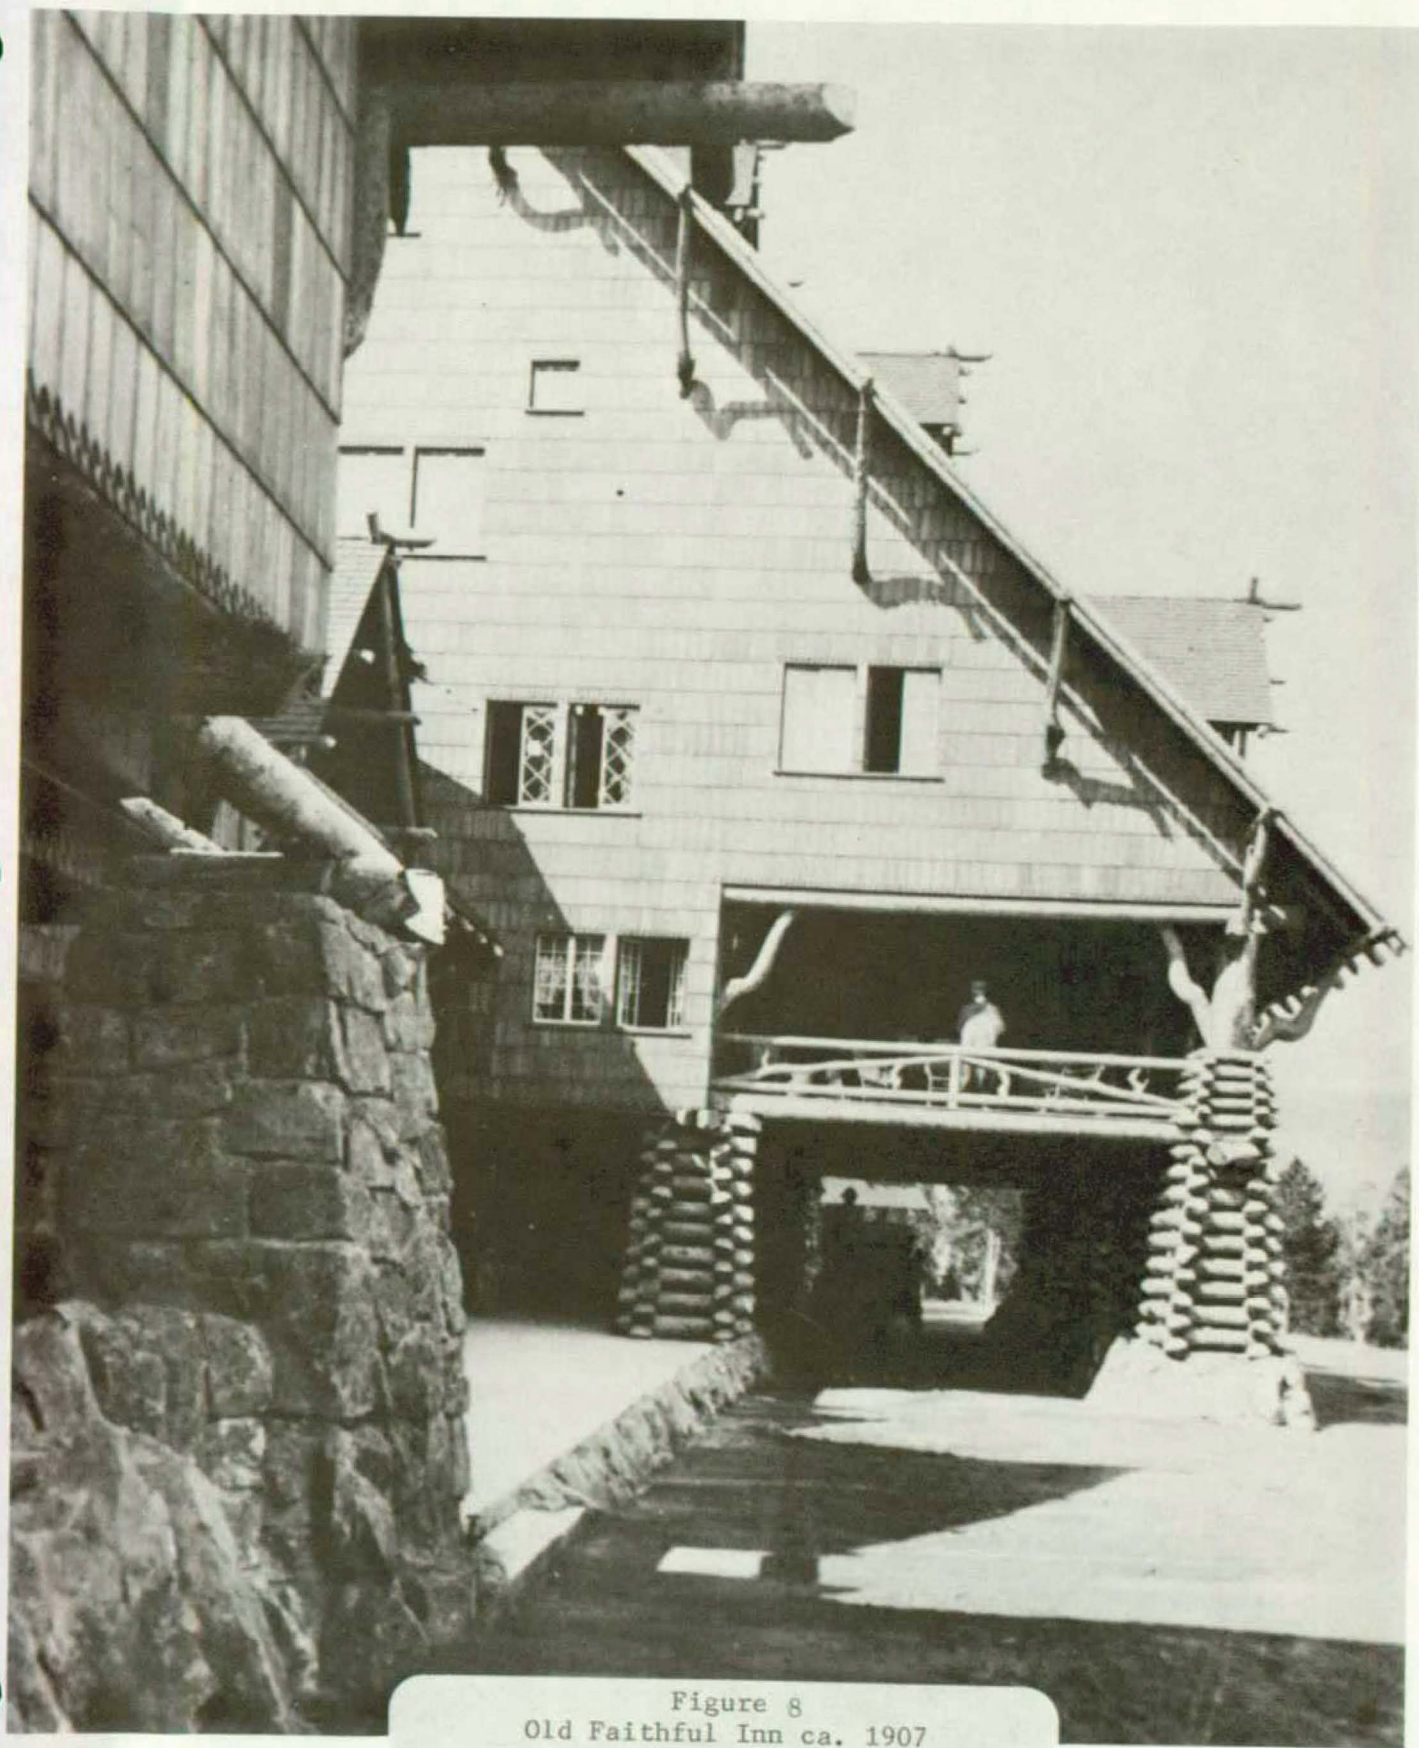
Figure 8
Old Faithful Inn ca. 1907
Minnesota Historical Society

A close view of the east end of the porte-cochere and the railing on the above veranda. Some of the outriggers fixed to the gable wall and edge of the roof can also be seen.

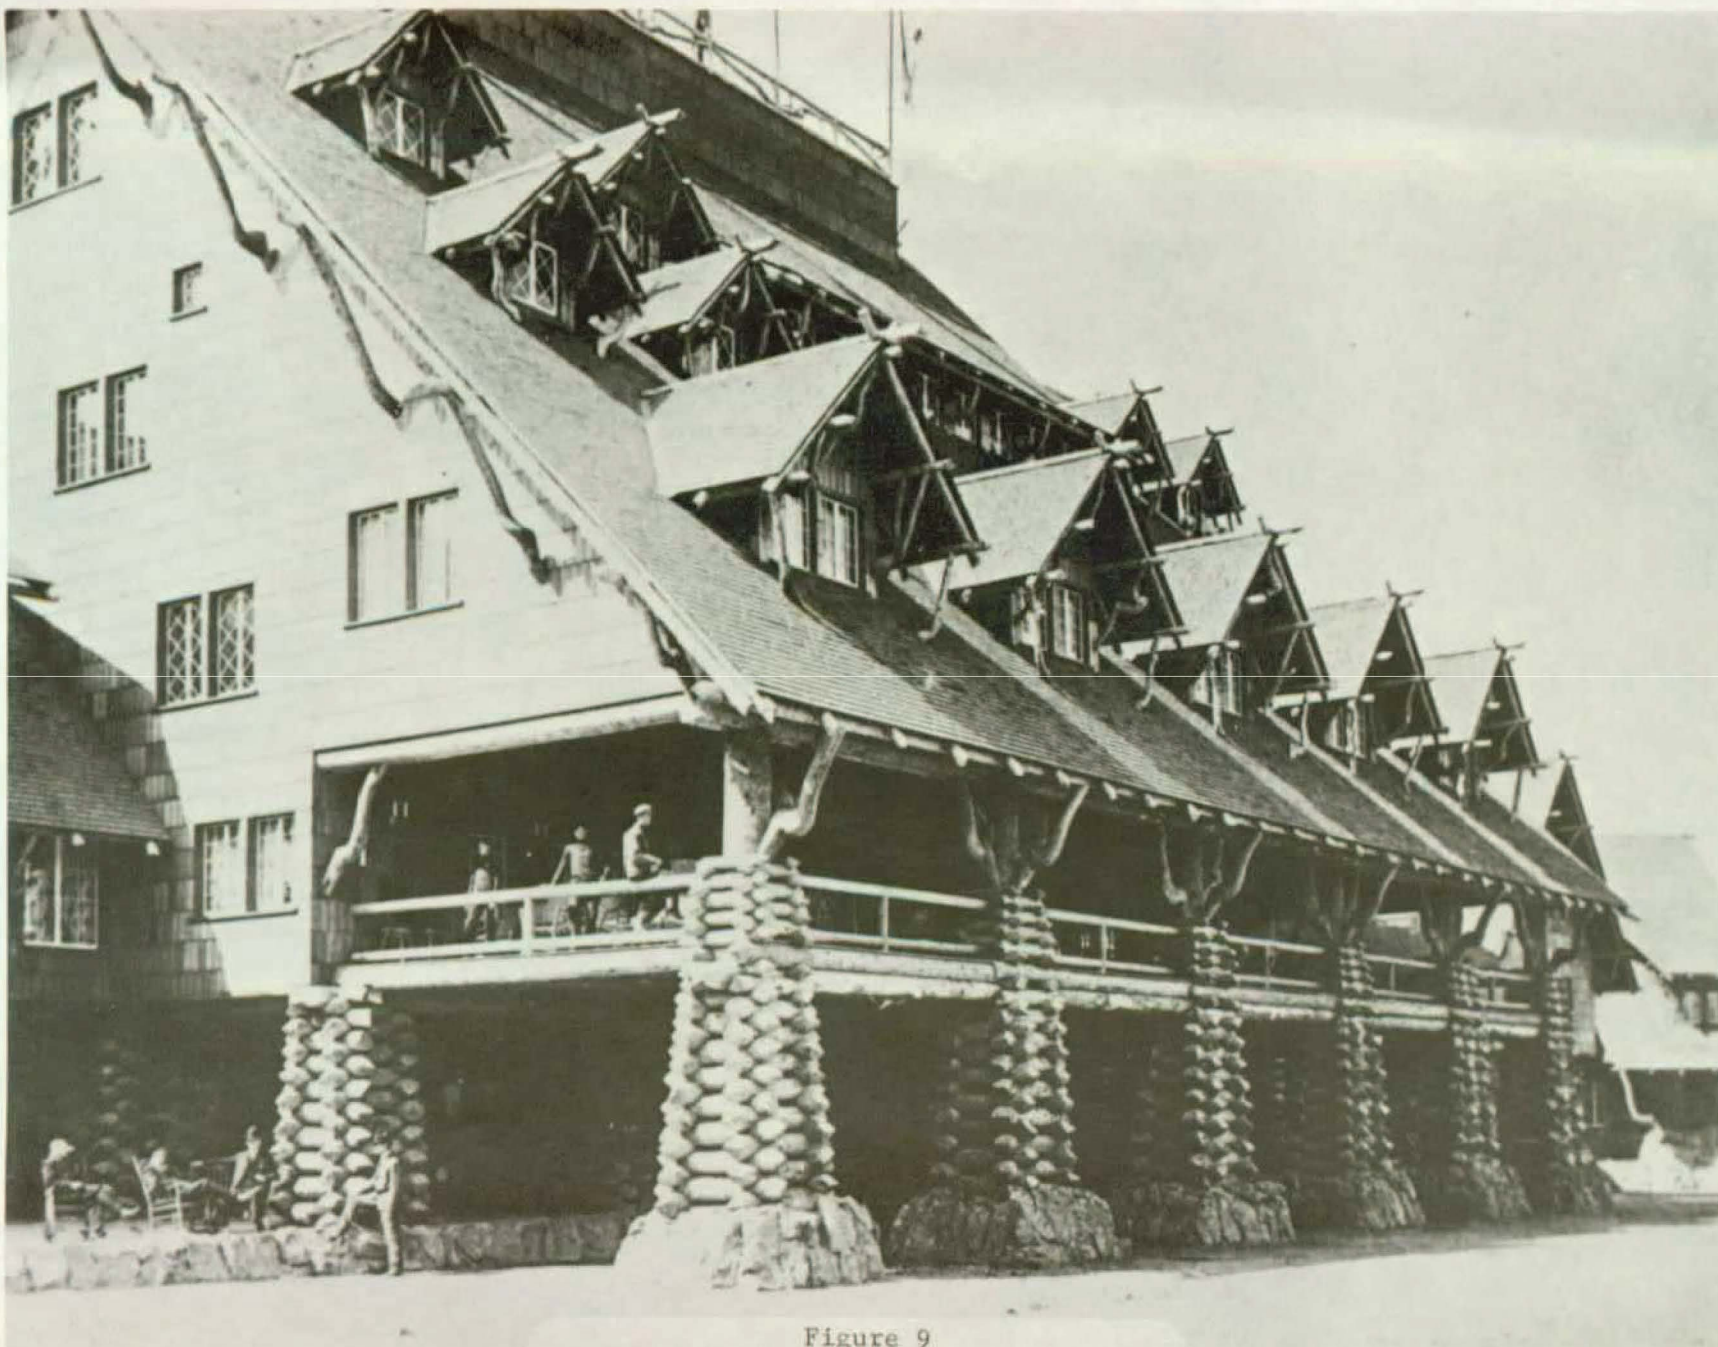
Figure 9
Old Faithful Inn ca. 1907
Minnesota Historical Society

A close up of the porte-cochere detail and the dormers on the roof of the main section.

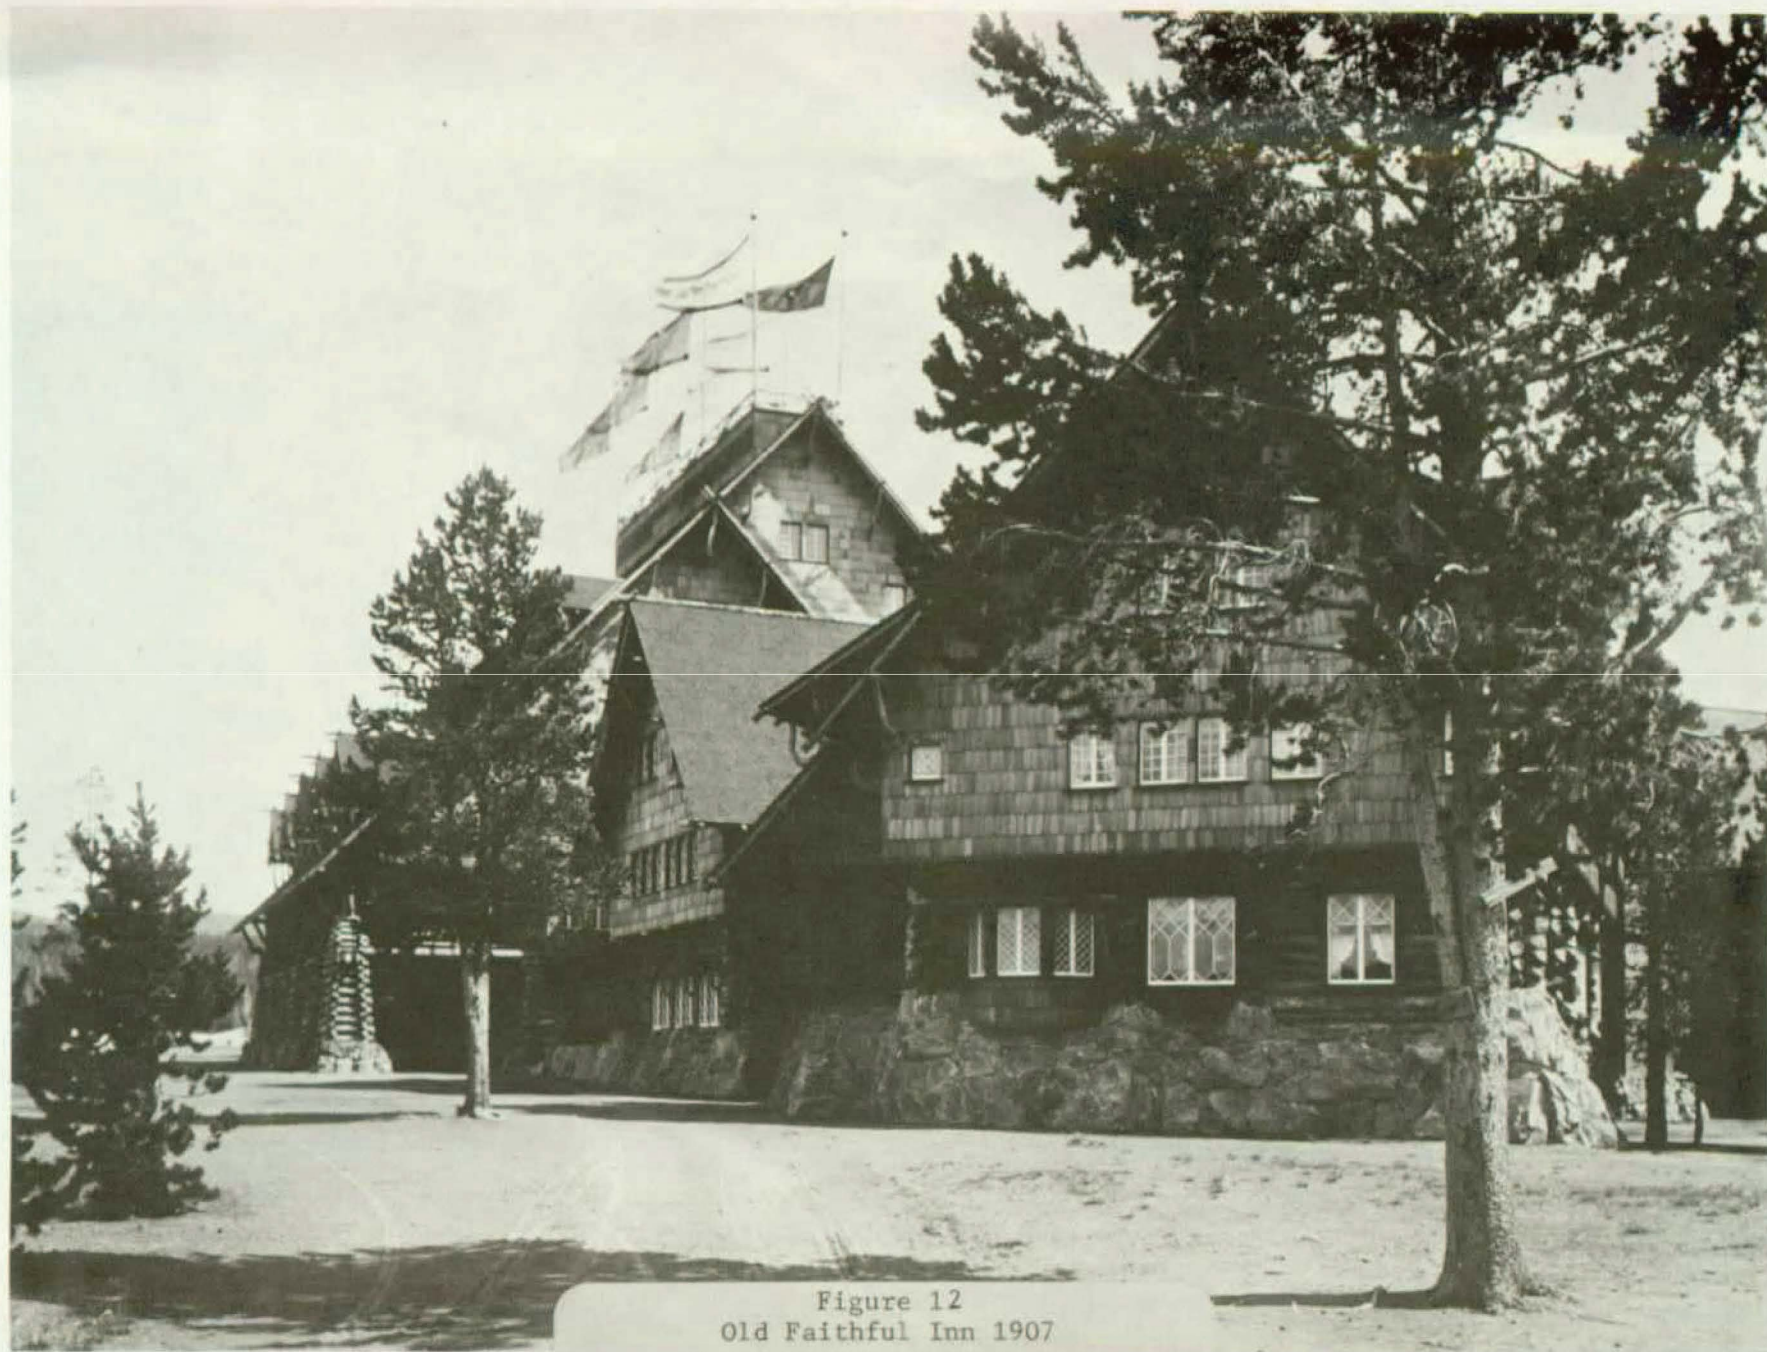
Figure 12
Old Faithful Inn 1907
Wyoming Historical Society

A view of the end of the original west wing. The detail of various window glazing can be observed. In 1927 the new west wing was attached at this point.

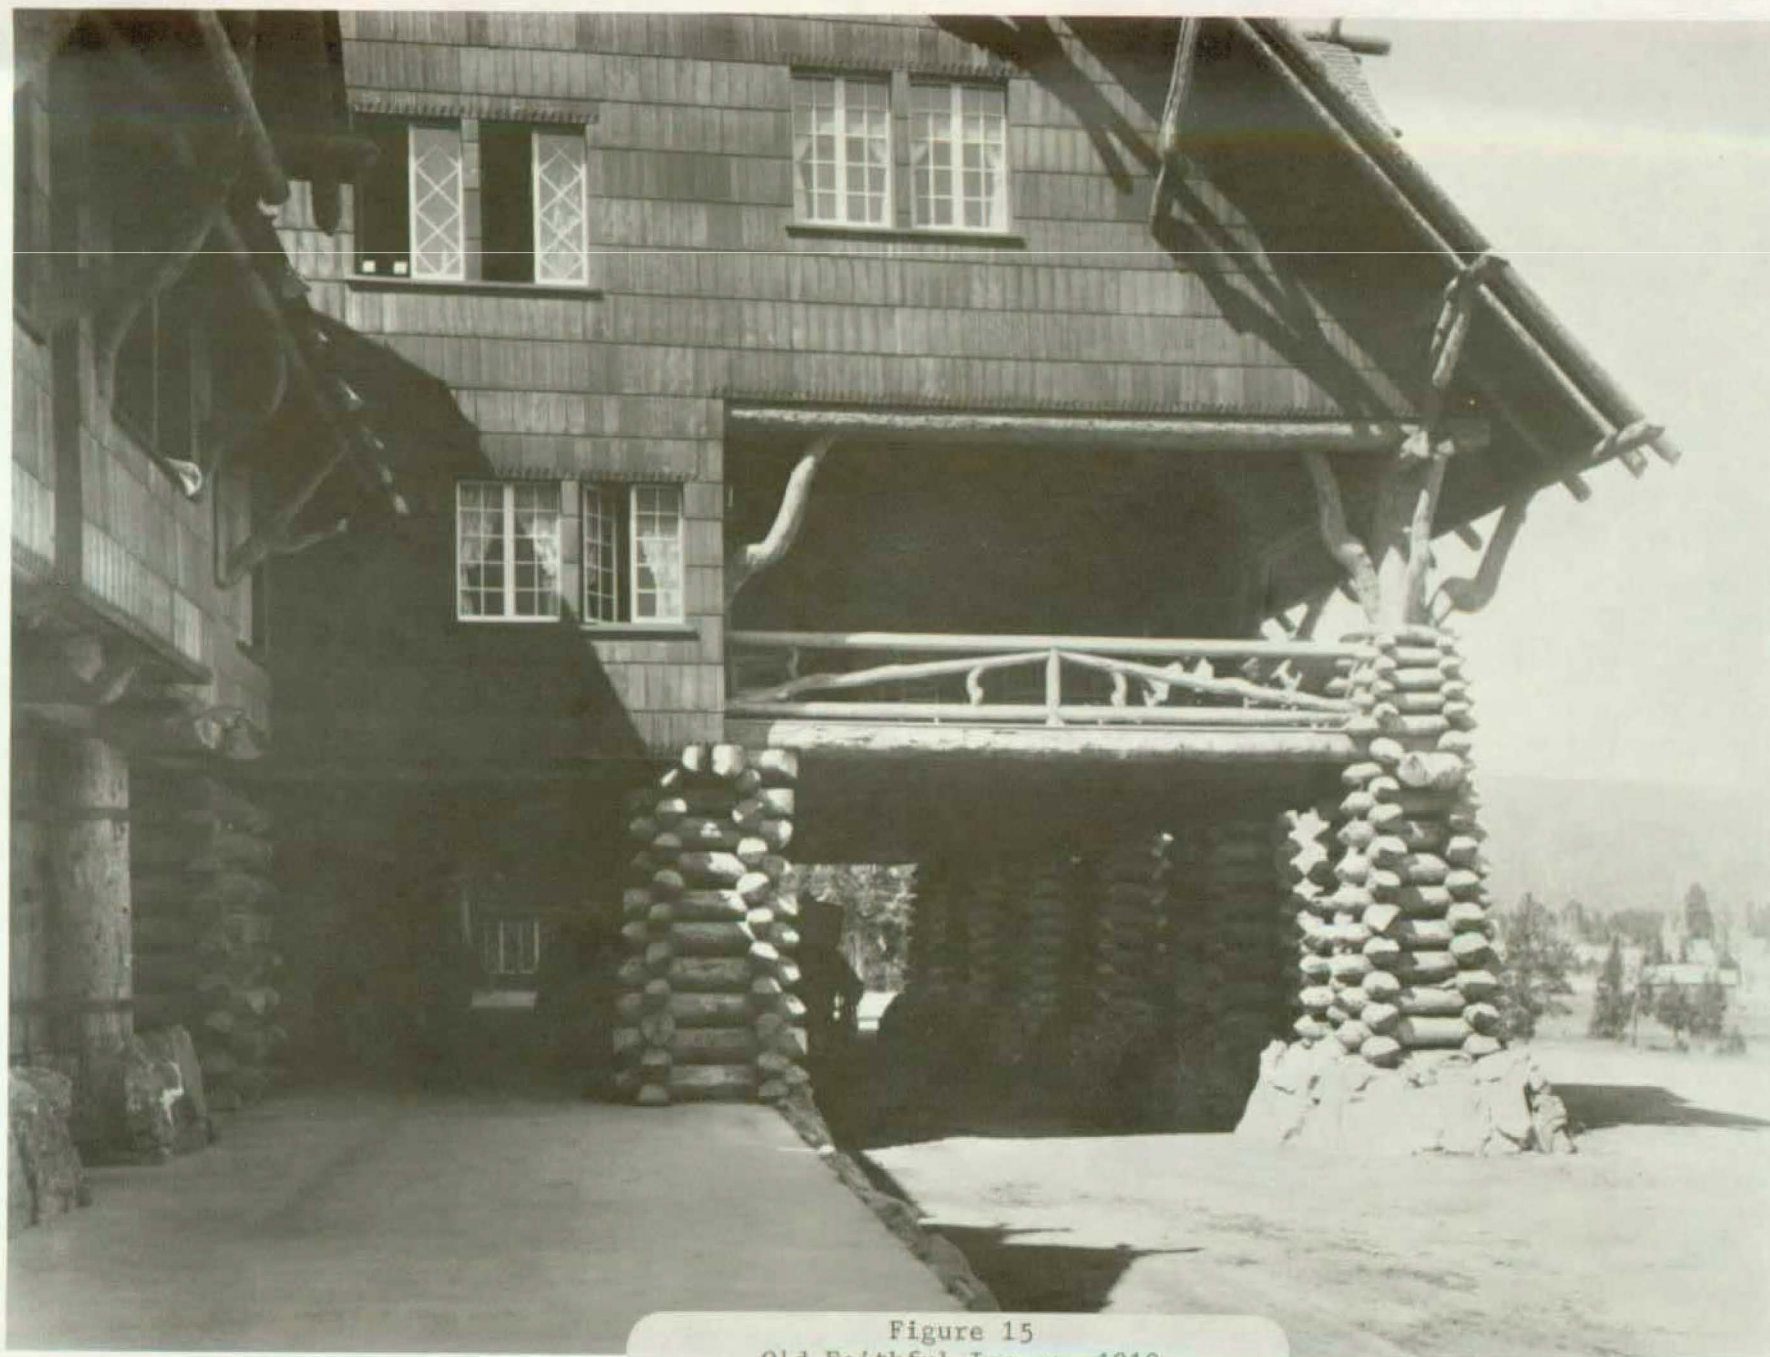
Figure 15
Old Faithful Inn ca. 1910
Henry Ford Museum

A close view of the east side of the porte-cochere and the area immediately above it.
