historic structure report
historic data section
january 1982

YELLOWSTONE
OLD FAITHFUL INN

HISTORIC STRUCTURE REPORT
HISTORICAL DATA SECTION
OLD FAITHFUL INN
YELLOWSTONE NATIONAL PARK
WYOMING

by
A. Berie Clemensen

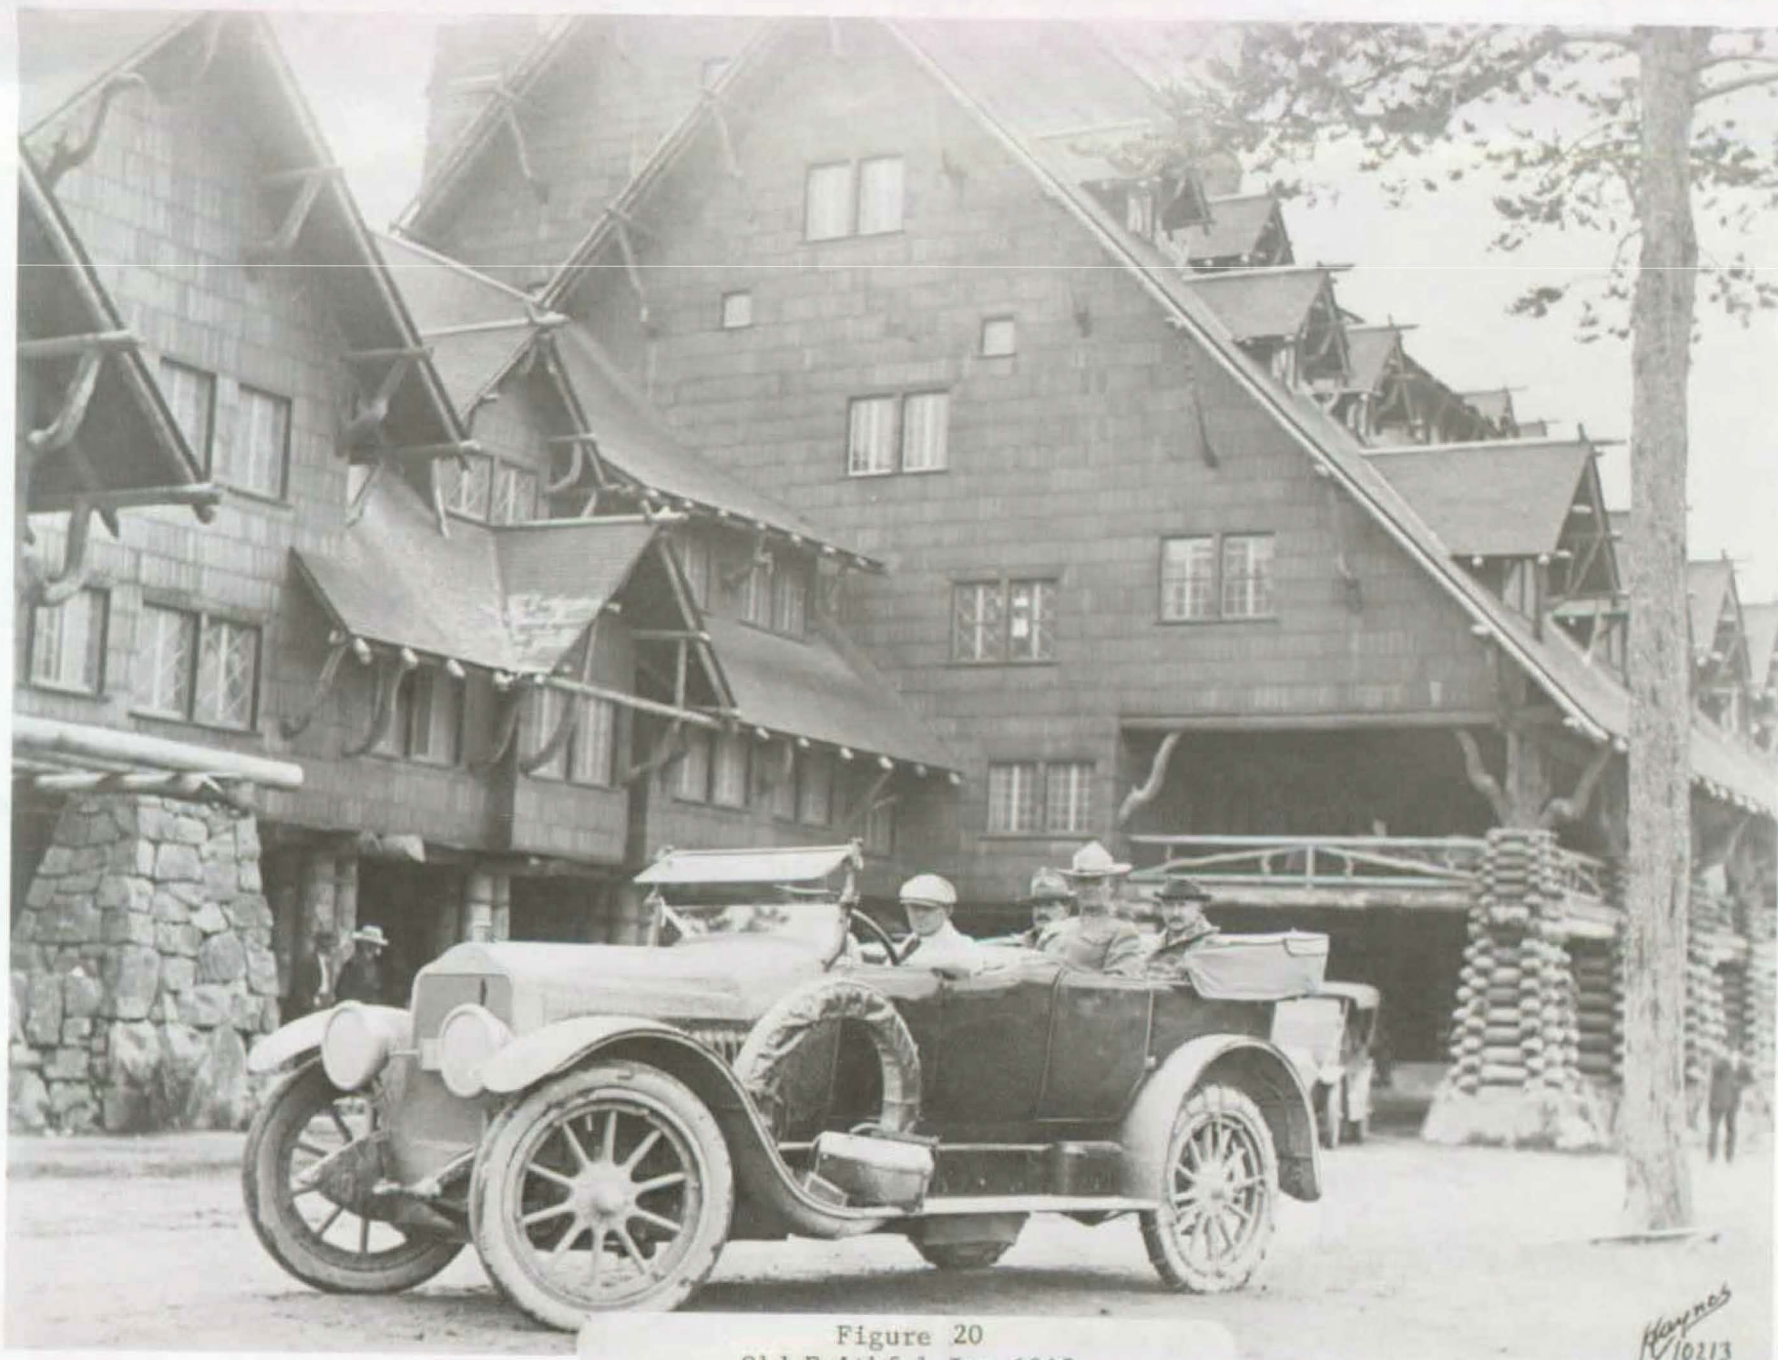
Figure 20
Old Faithful Inn 1915
Yellowstone National Park

A photograph taken from the northeast which shows details on part of the original east wing.

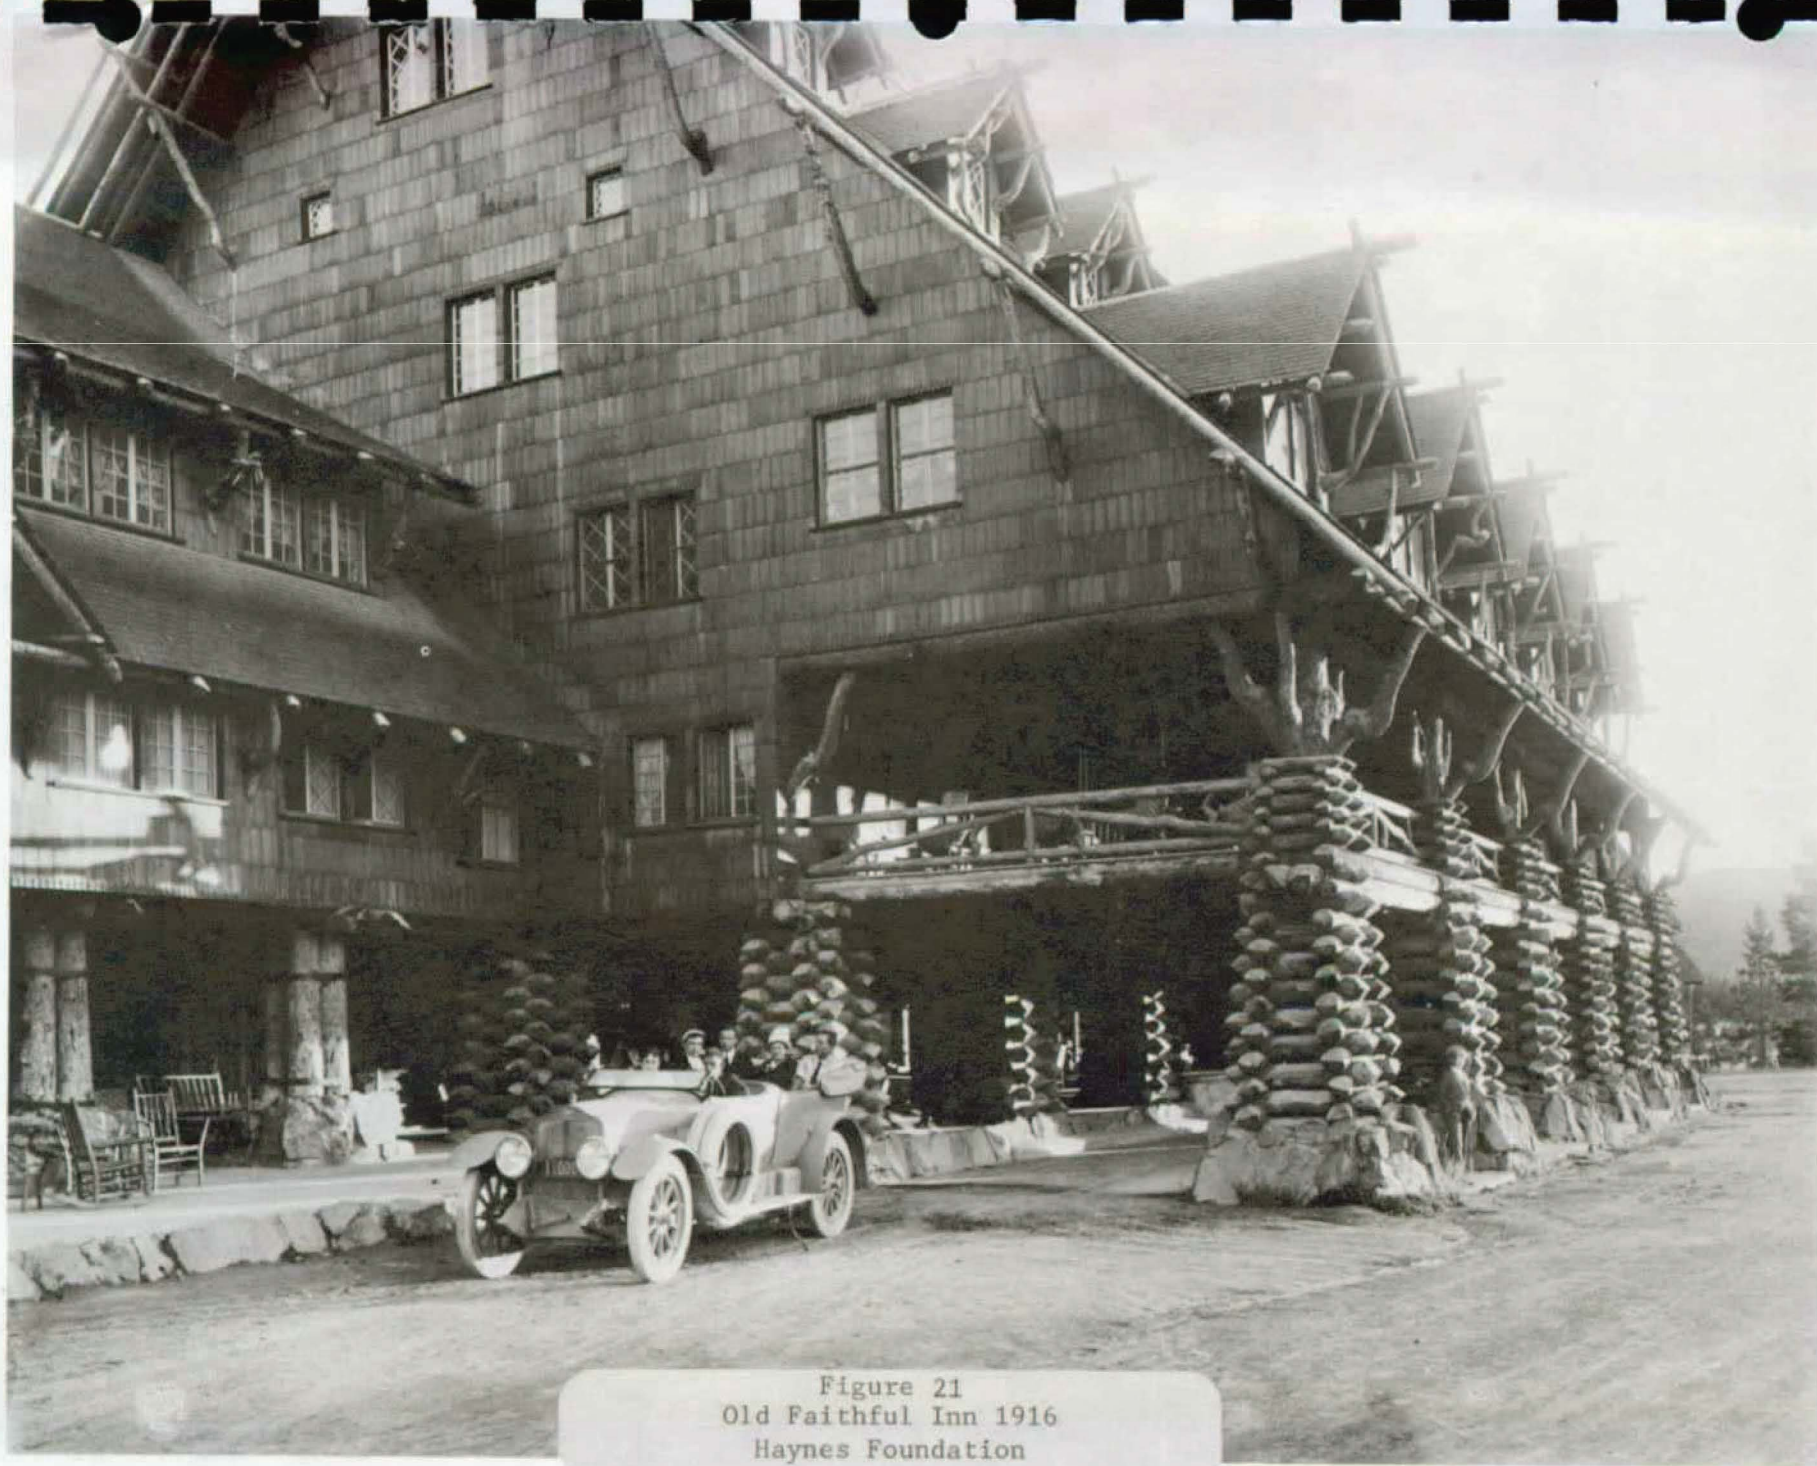
Figure 21
Old Faithful Inn 1916
Haynes Foundation

A close view taken from the northeast which reveals the details of the porte-cochere as well as some dormers and east gable wall of the Inn's central portion.

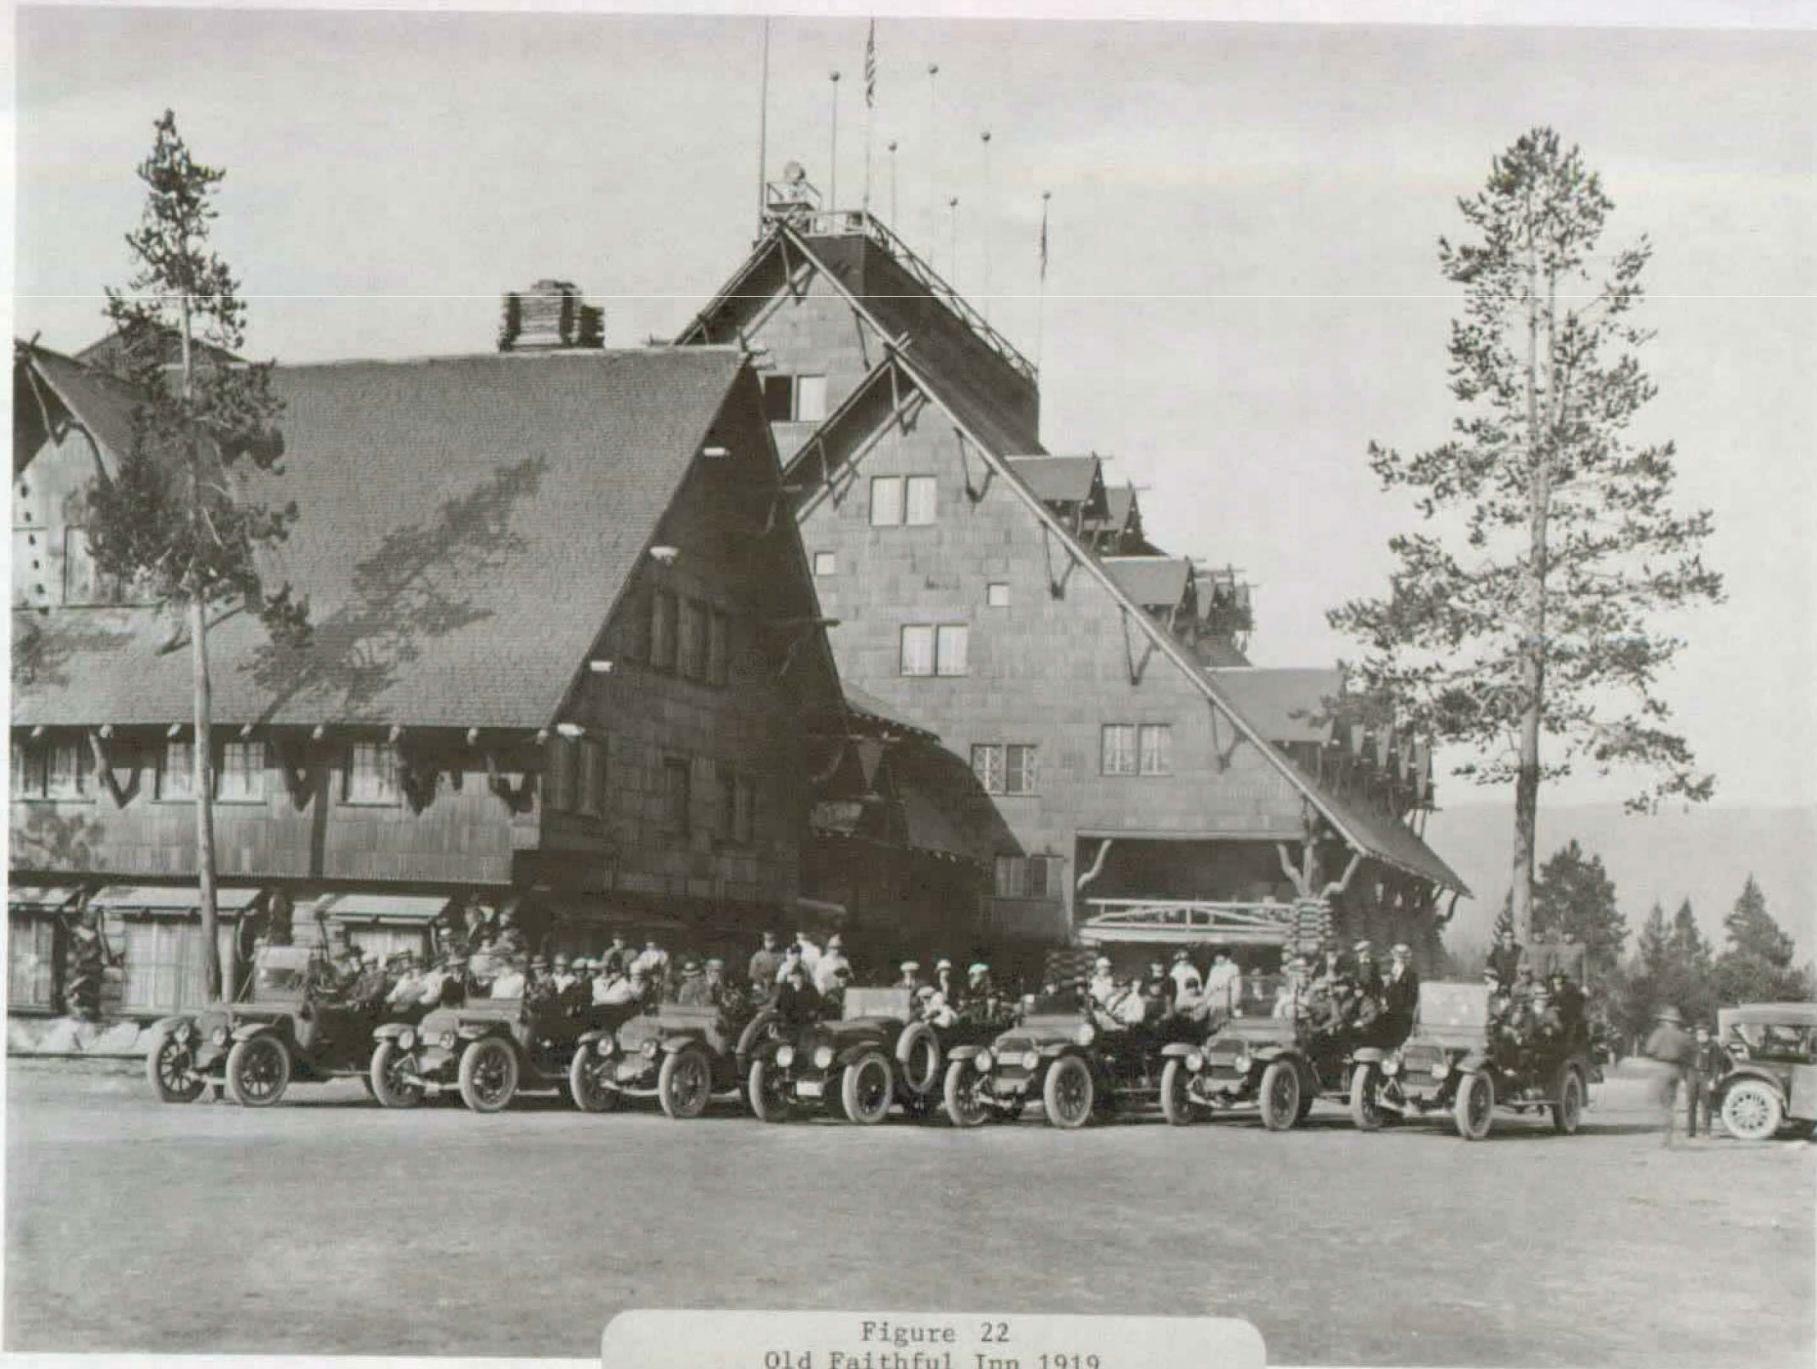
Figure 22
Old Faithful Inn 1919
Haynes Foundation

A view of the Inn from the northeast. Details on the top of the cribbing around the lobby fireplace chimney can be seen as it protrudes above the roof of the original east wing.

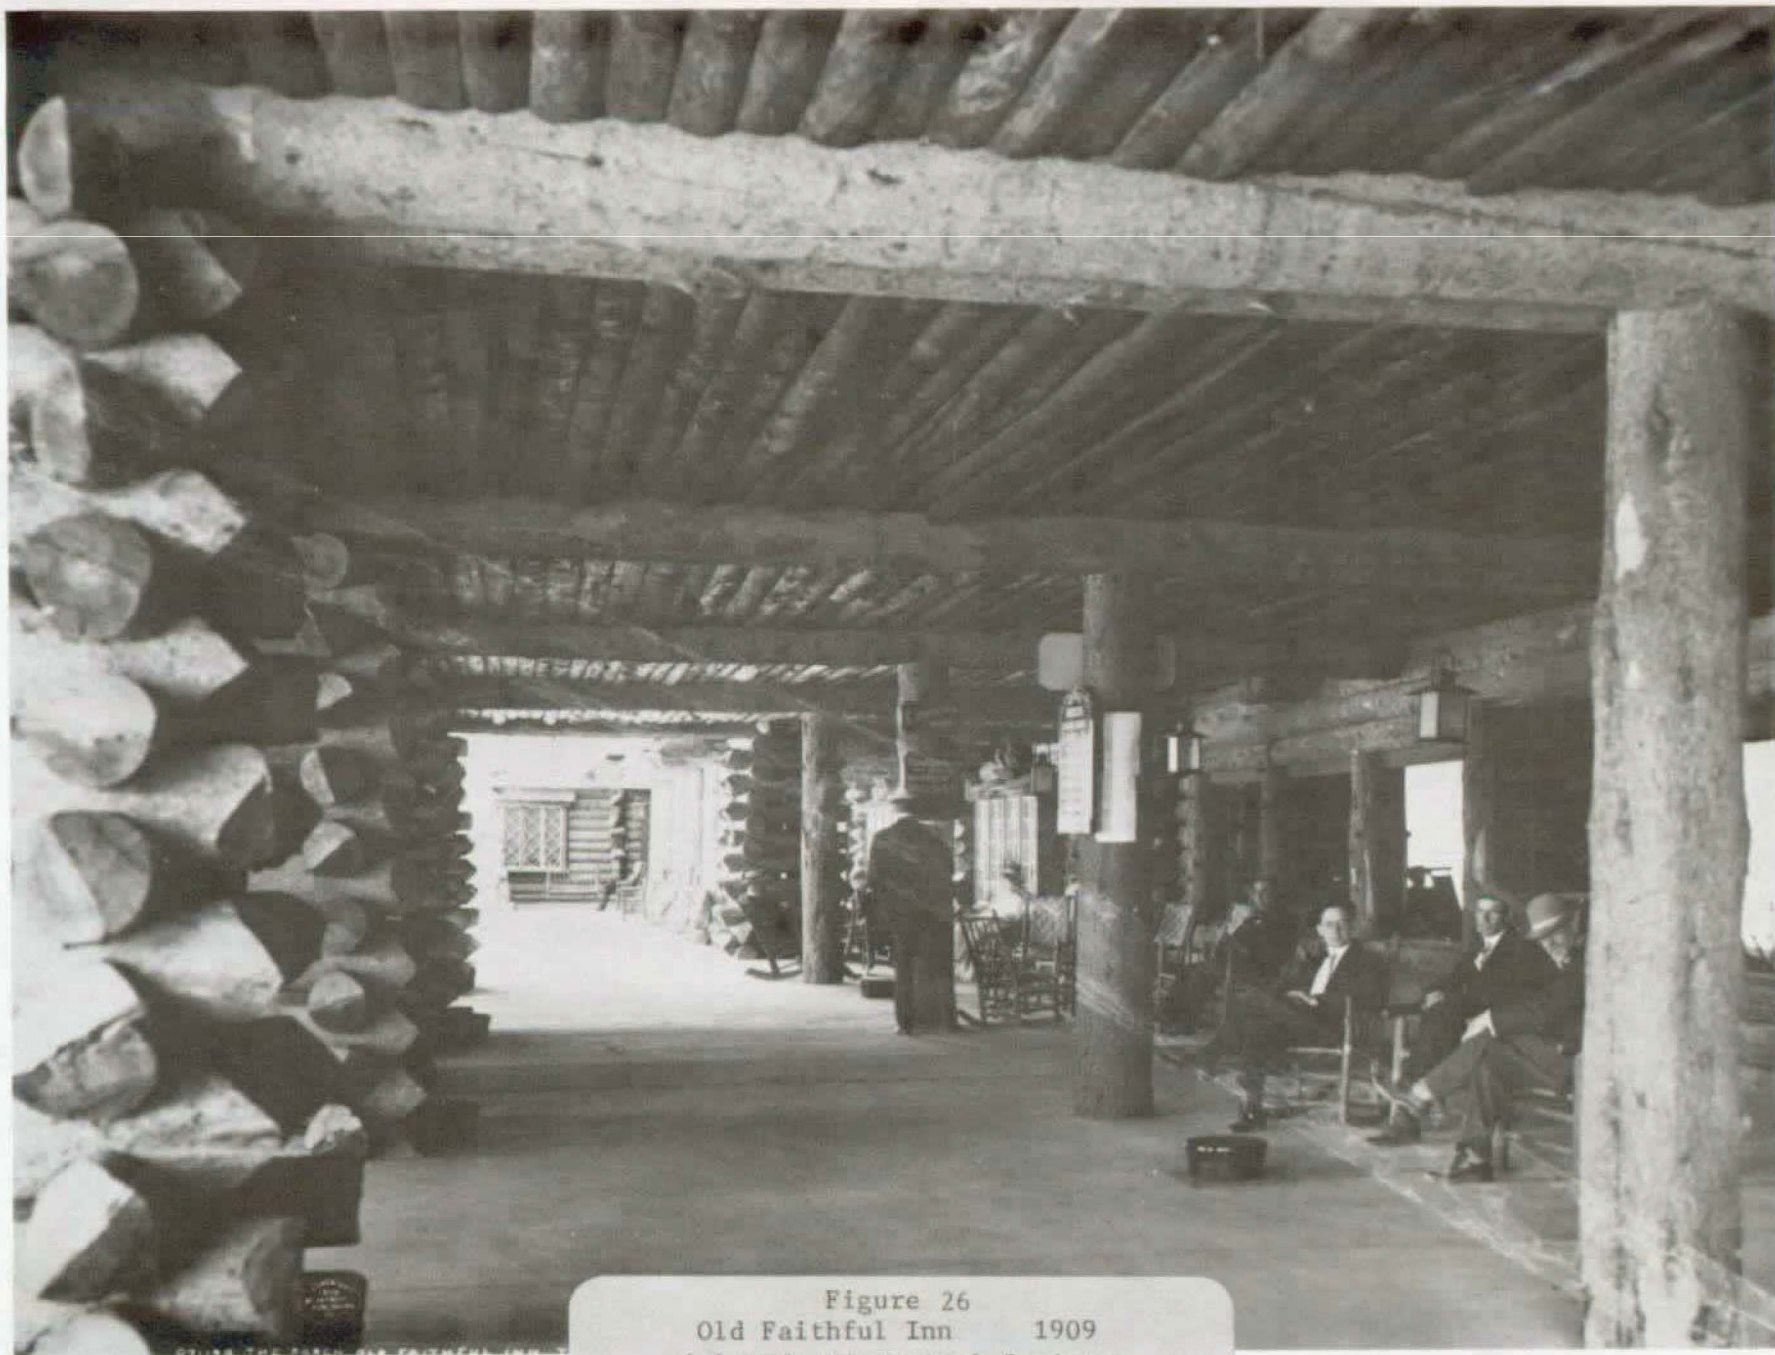
Figure 26
Old Faithful Inn 1909
Colorado Historical Society

A view of the inner part of the porte-cochere showing details of the ceiling and the Inn's front entrance area.

A large porte-cochere, supported by cribbed log piers, was tucked beneath the steep roof of the structure's central section (figure 26). That roof also protected a second floor veranda which was located above the porte-cochere (figure 28). There guests could lounge in rustic hickory rockers and chairs.

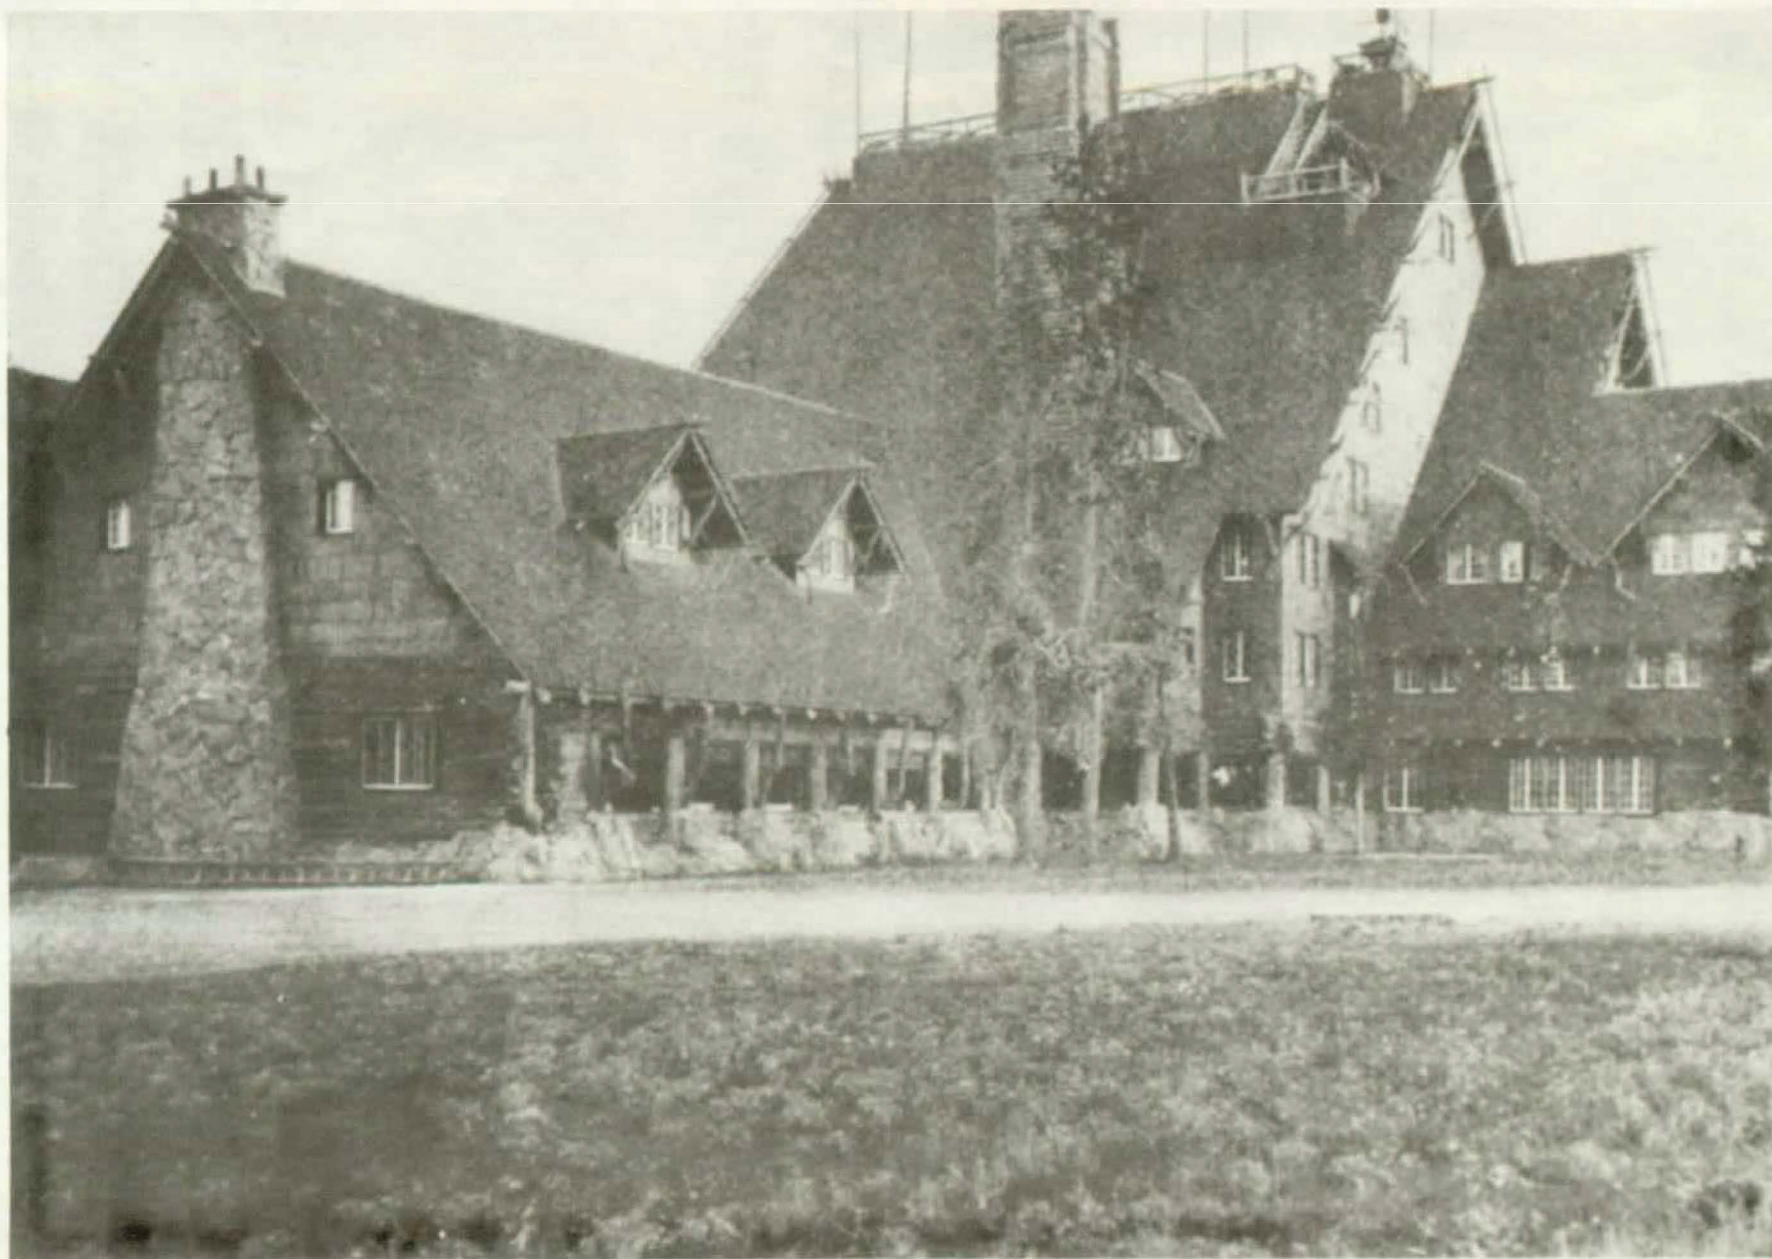
Figure 29
Rear of Old Faithful Inn ca. 1907

A view which reveals the rarely photographed original rear of the Inn without the present day dining room extensions. The lobby fireplace's cribbed chinmey is visible as well as the exterior of the dining room stone fireplace stack. Both fireplace chimneys were severely damaged in the 1959 earthquake. As a result neither bears any resemblance to the ones shown in this picture.

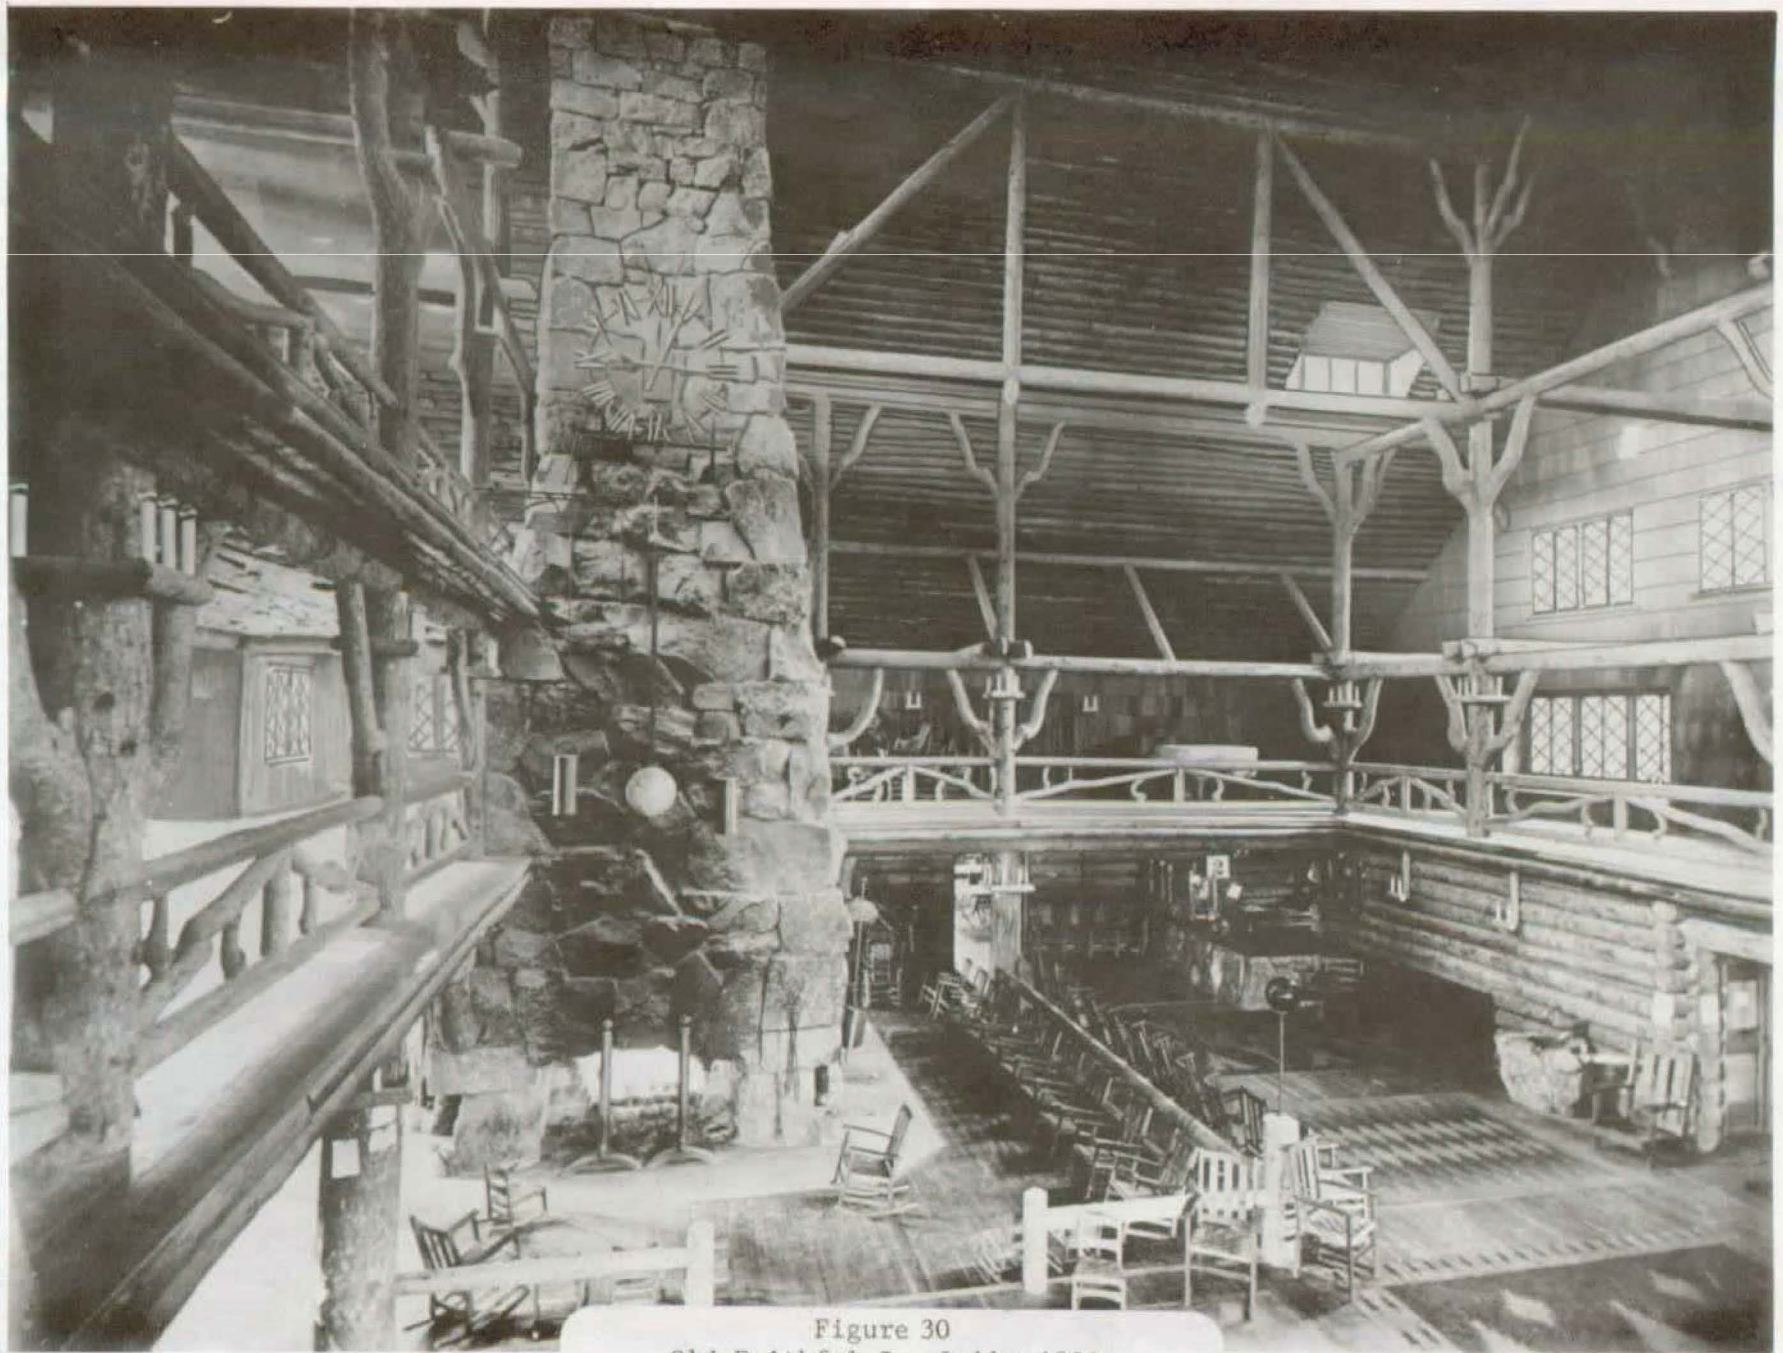
Figure 30
Old Faithful Inn Lobby 1904
Haynes Foundation

The earliest known photograph of the lobby. Some of the details have been drawn by hand on the original glass plate.

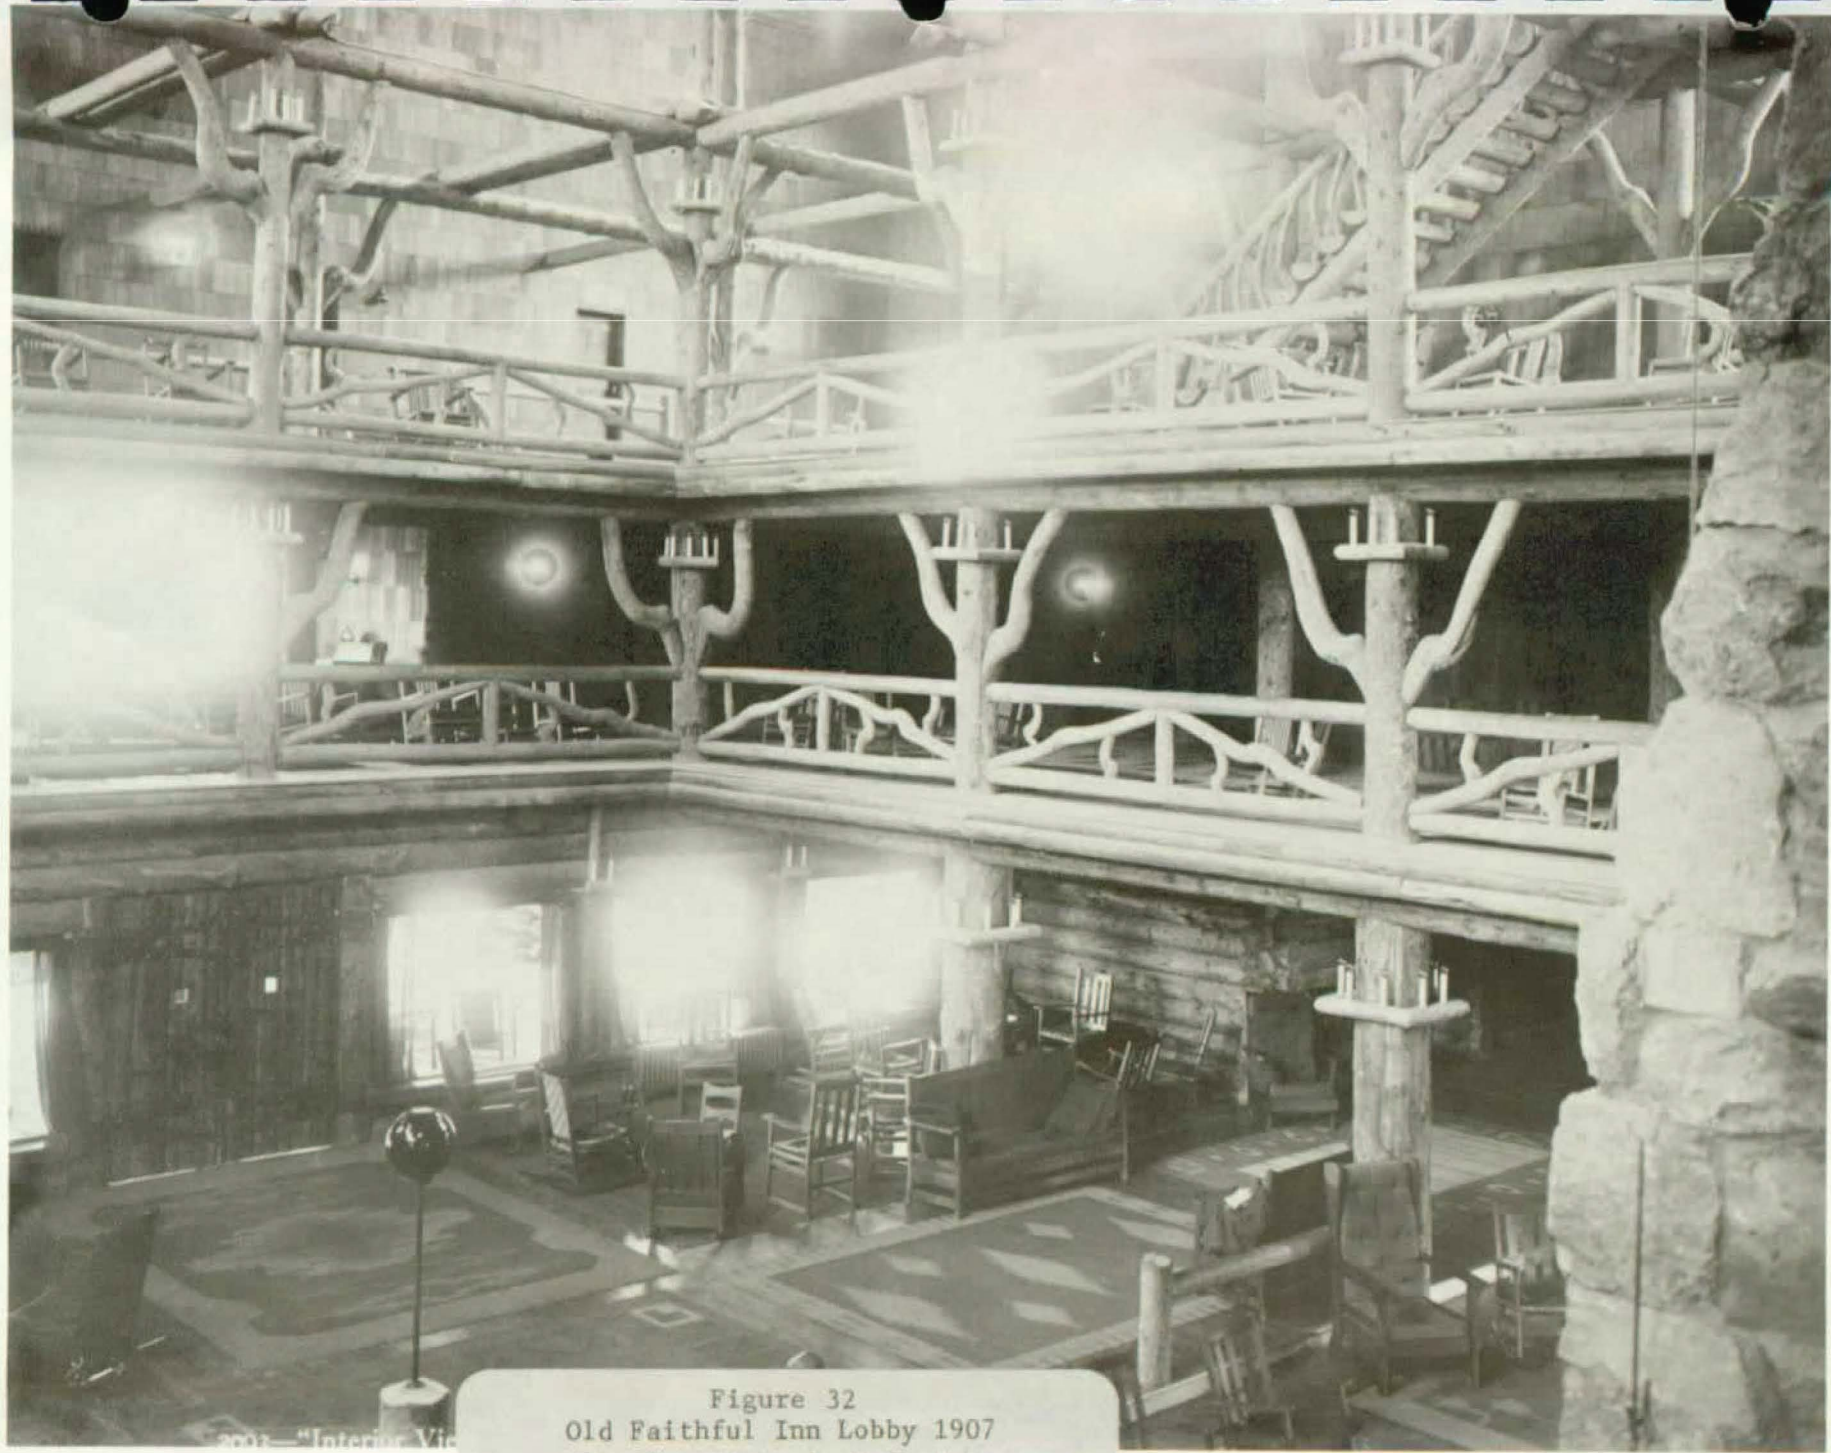
Figure 32
Old Faithful Inn Lobby 1907
Wyoming Historical Society

A photograph of the northeast interior lobby corner. The large iron hinges on the front door are visible.

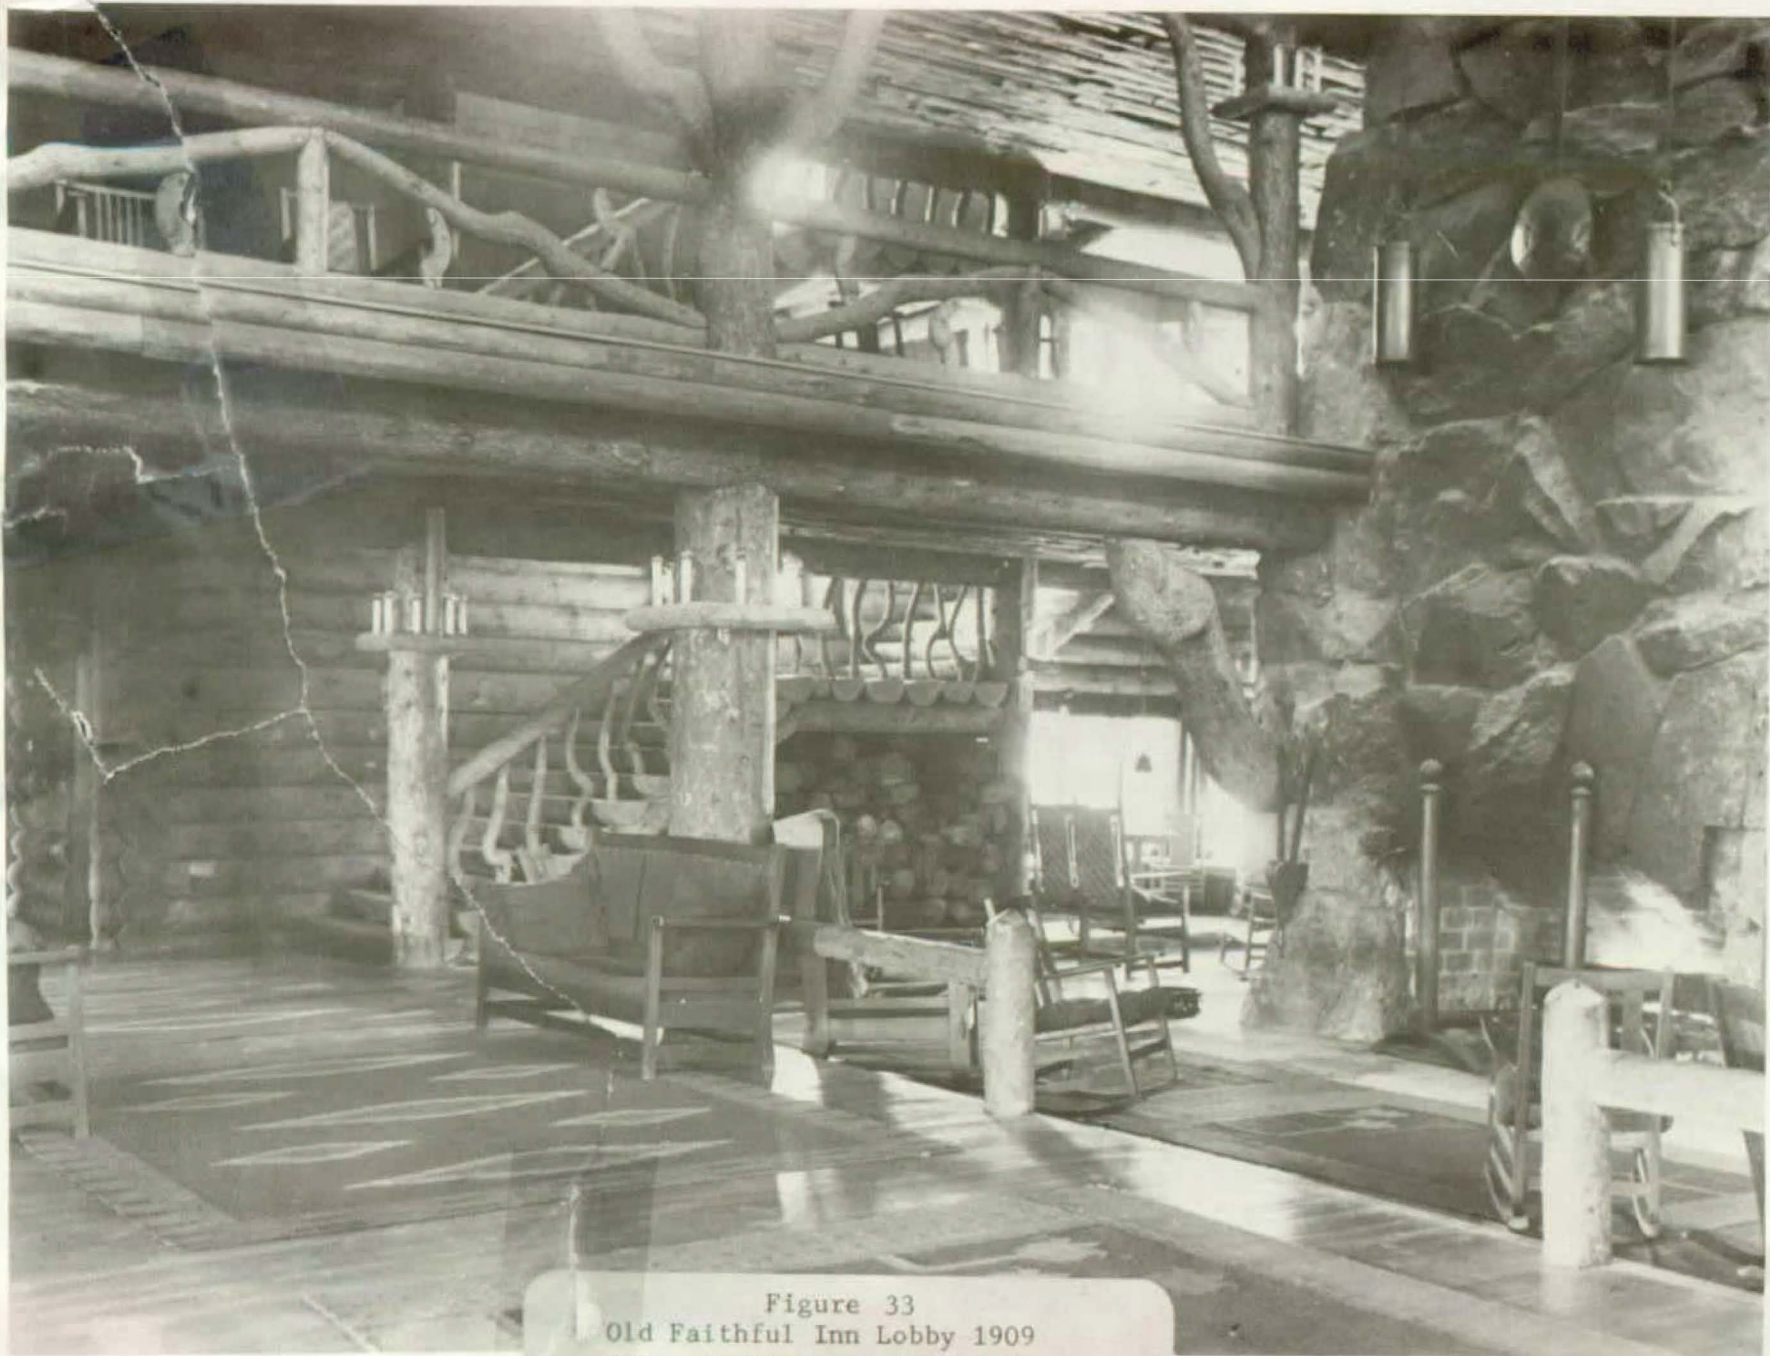
Figure 33
Old Faithful Inn Lobby 1909
Colorado Historical Society

An interior view of the east side of the lobby near the fireplace. It shows the stairway to the second floor balcony. The wall against which the stairs abuts was removed in 1927 and the space behind it used for a porters' desk area.

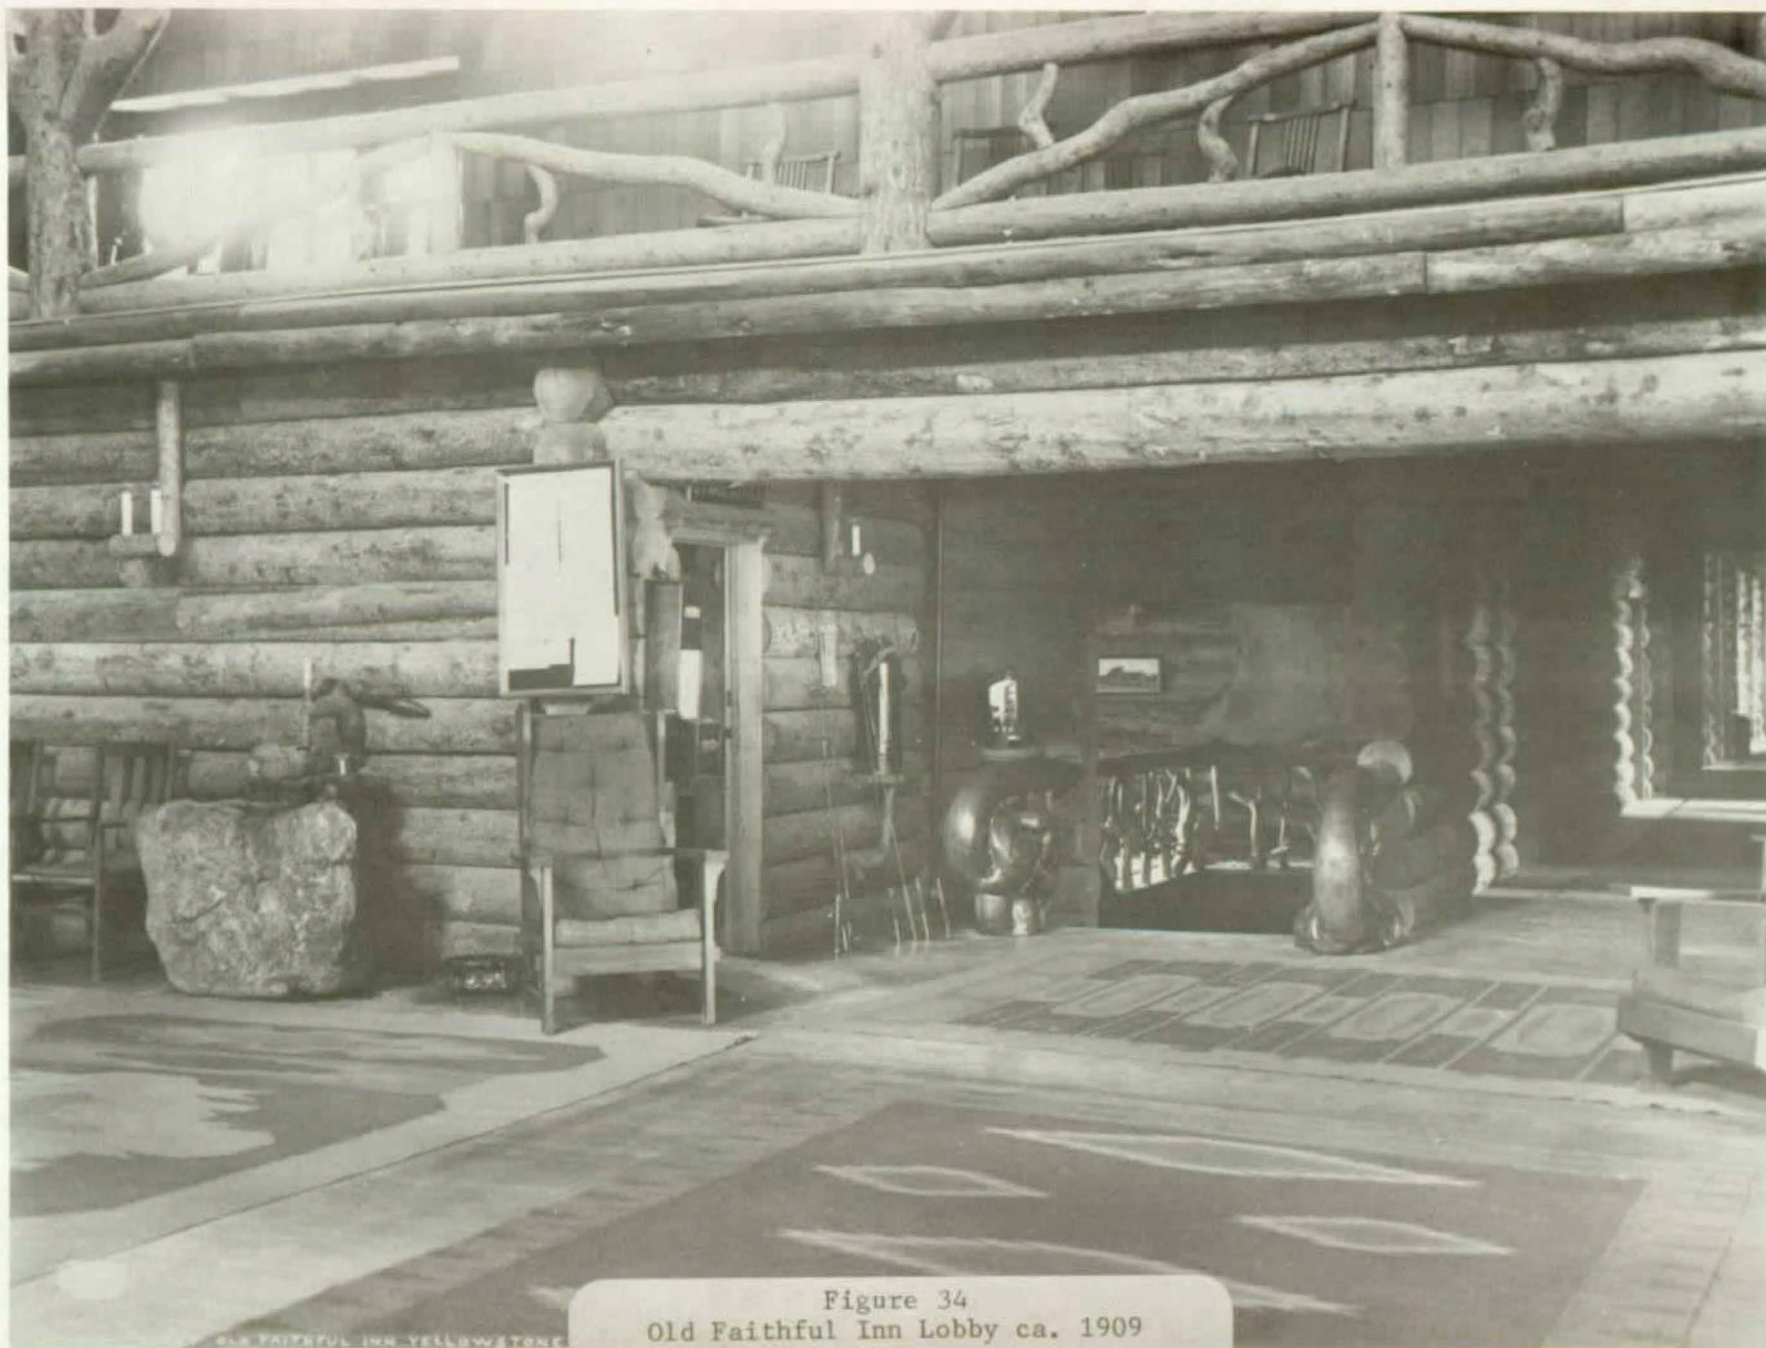
Figure 34
Old Faithful Inn Lobby ca. 1909
Colorado Historical Society

A view of the west interior side of the lobby and hallway leading to guest rooms. The stone drinking fountain can be seen. The stairway leads to the basement where the original bar was located. The walls to the left of the stairs and behind the drinking fountain were removed in 1927. Support timbers in line with the outer edge of the balcony replaced the walls.
