historic structure report
historic data section
january 1982

YELLOWSTONE
OLD FAITHFUL INN

HISTORIC STRUCTURE REPORT
HISTORICAL DATA SECTION
OLD FAITHFUL INN
YELLOWSTONE NATIONAL PARK
WYOMING

by
A. Berie Clemensen

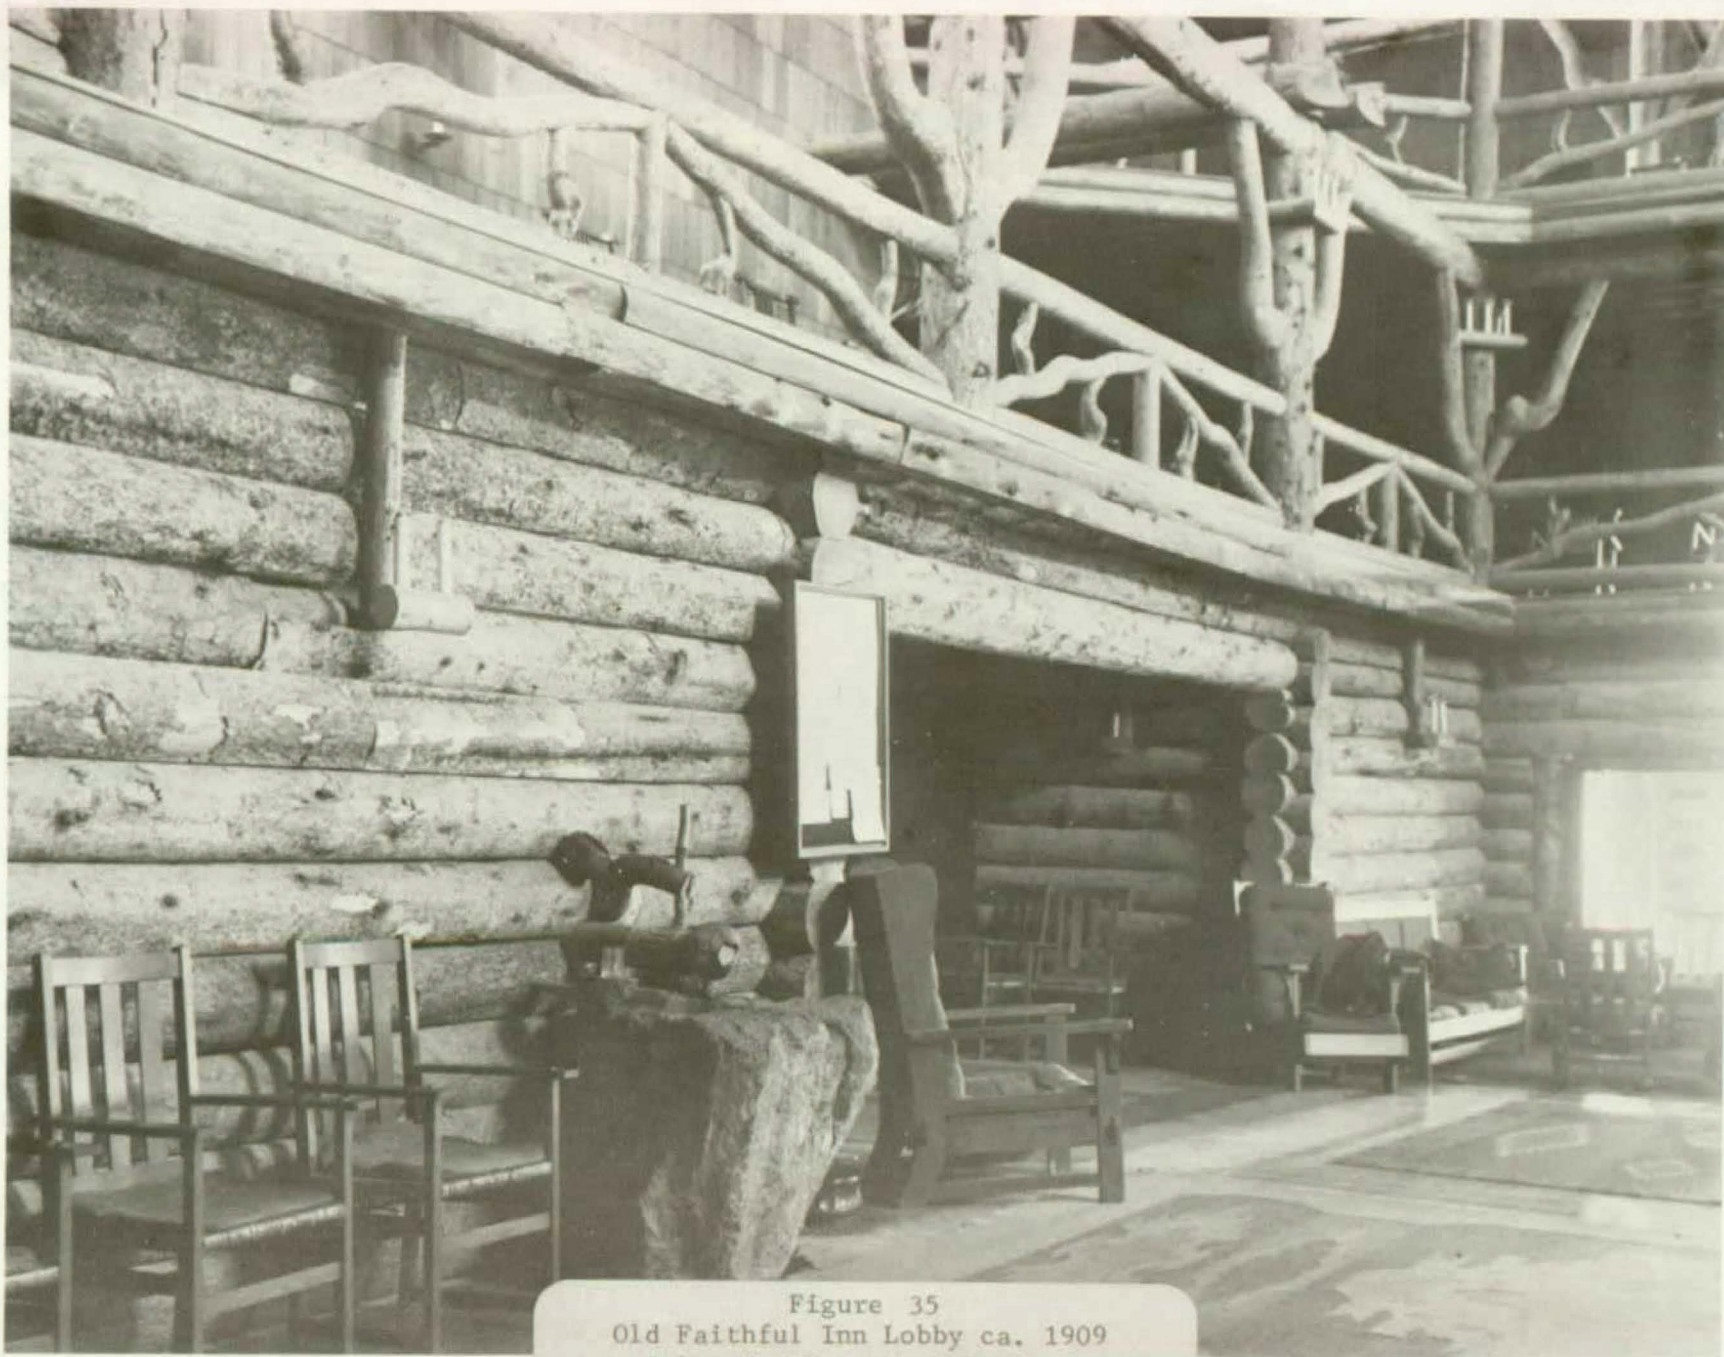
Figure 35
Old Faithful Inn Lobby ca. 1909
Colorado Historical Society

A view of the west interior side of the lobby from a slightly different angle than the previous figure. The wall beneath the balcony which abuts the front wall was removed about 1915 to allow a gift shop to be installed in that area.

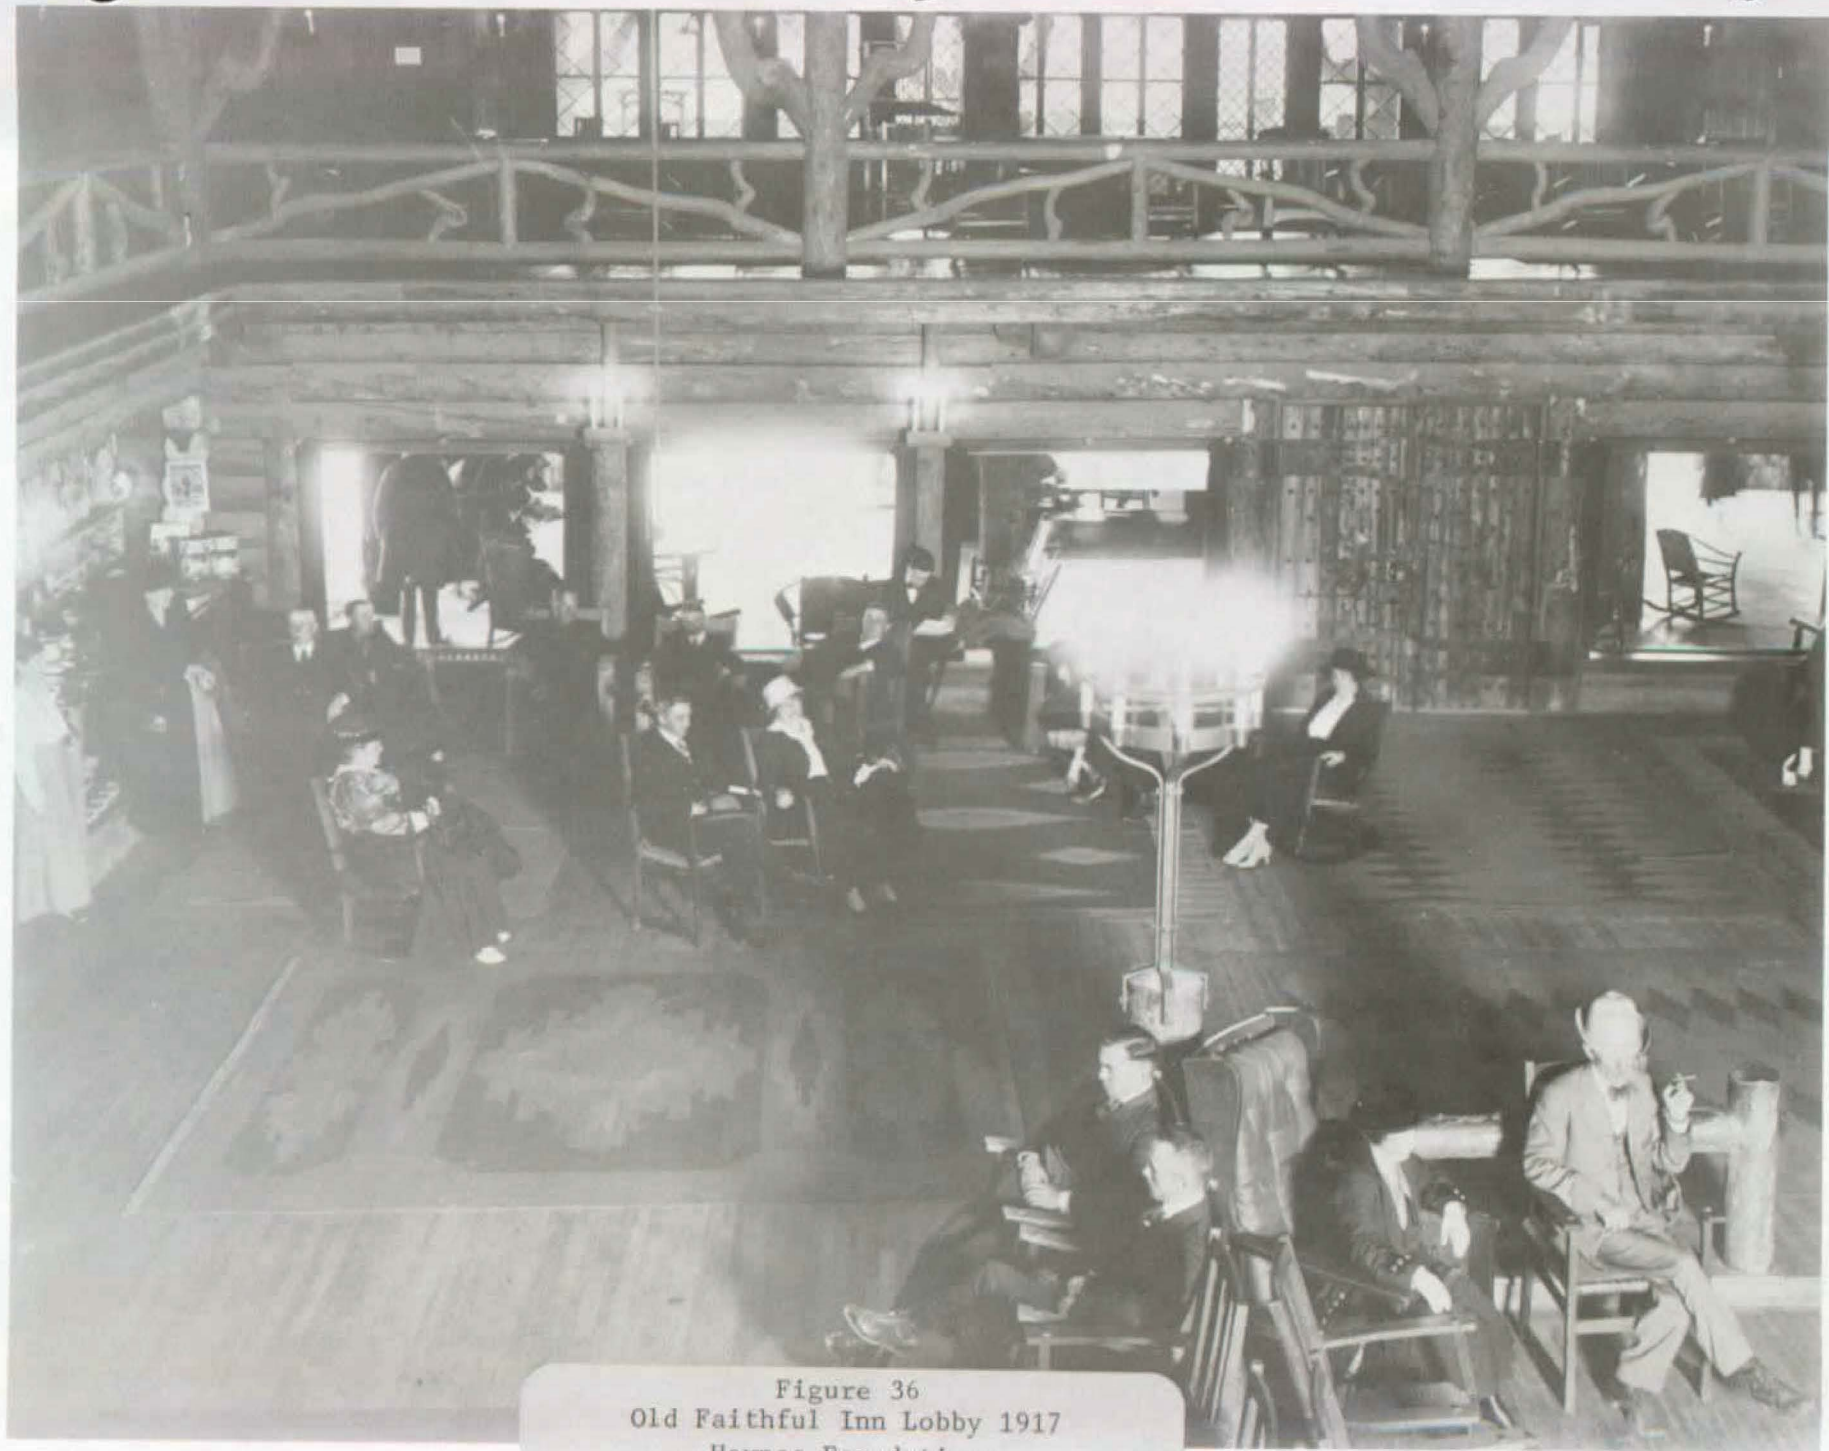
Figure 36
Old Faithful Inn Lobby 1917
Haynes Foundation

A photograph of the interior front of the lobby. Details on the front door can be seen as well as the entrance to the newly installed gift shop mentioned in the previous figure.

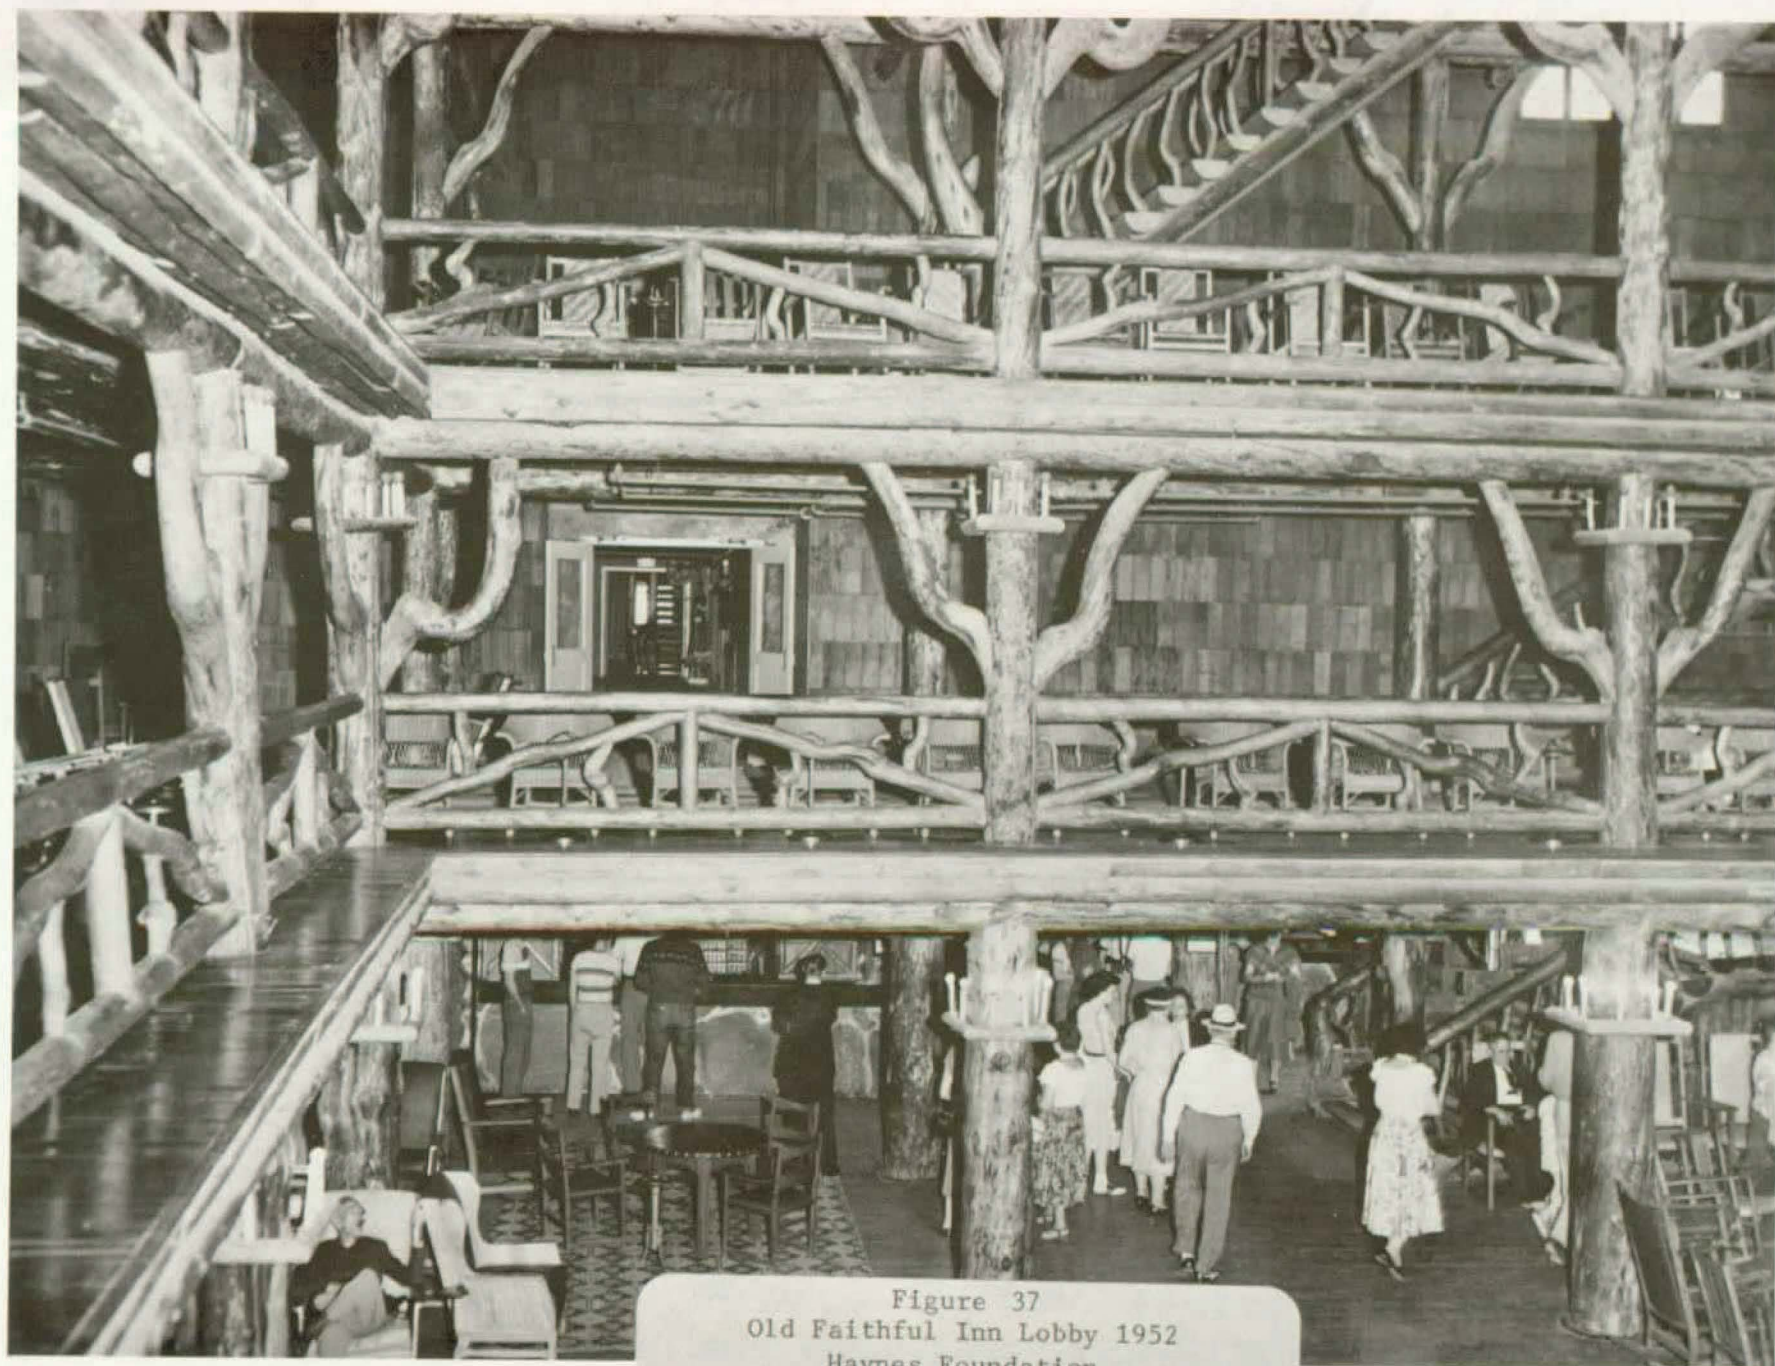
Figure 37
Old Faithful Inn Lobby 1952
Haynes Foundation

A view of the interior northeast corner of the lobby. The support timber columns with their bracing and brackets of gnarled branches are visible on several floors.

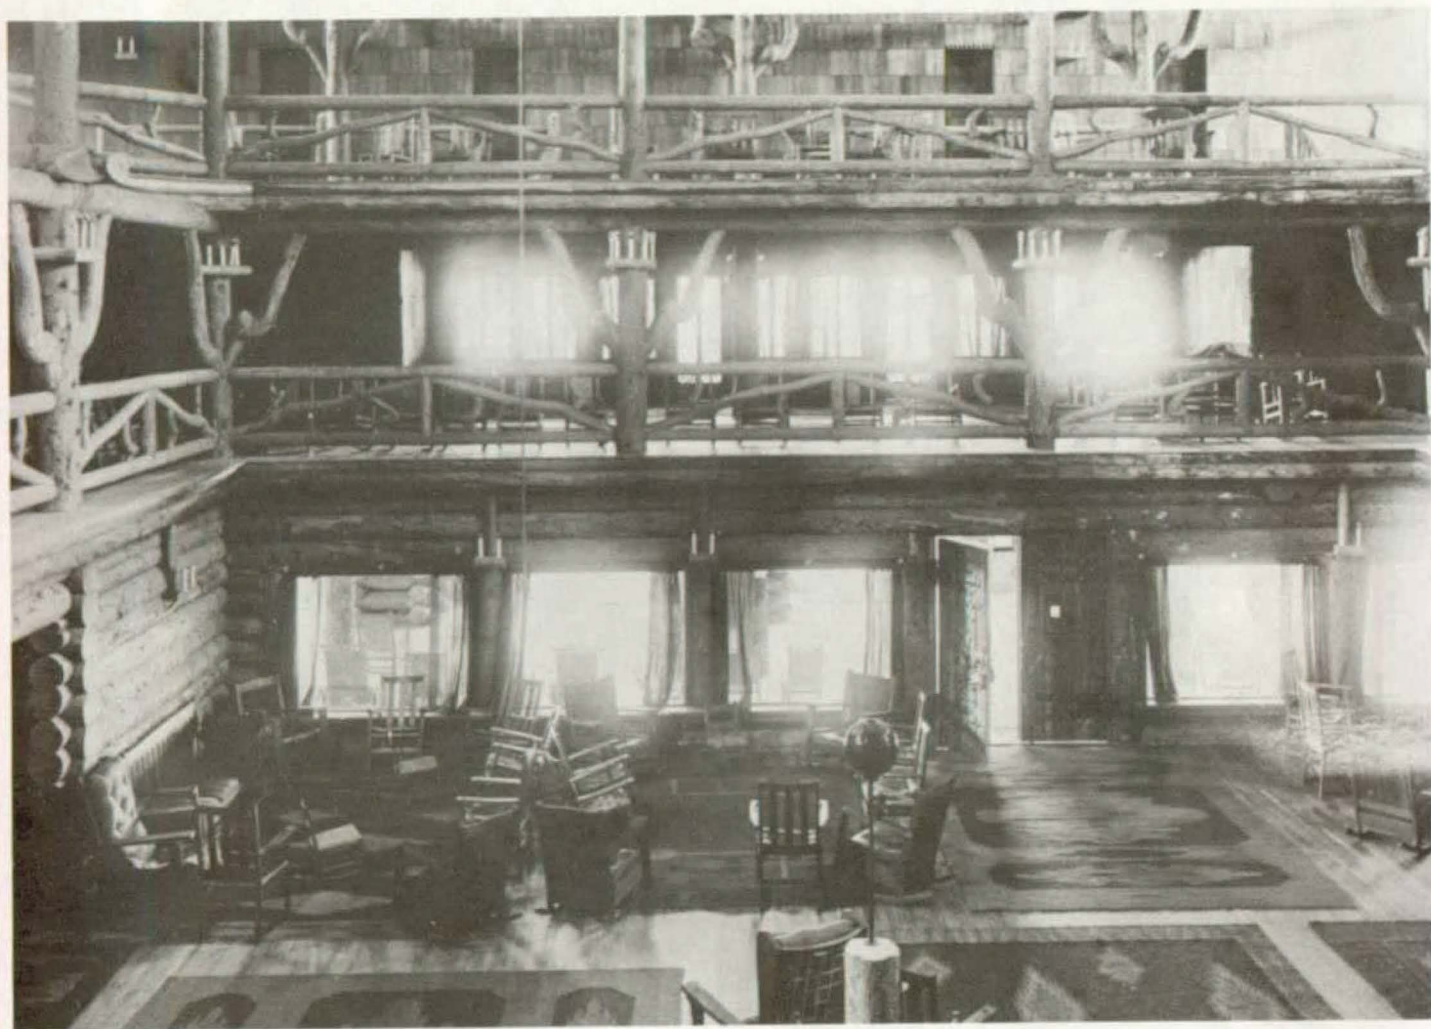
Figure 38
Old Faithful Inn Lobby 1905
Haynes Foundation

A view of the original front of the lobby's interior. In 1927 the ground floor front wall was moved forward beneath the porte-cochere.

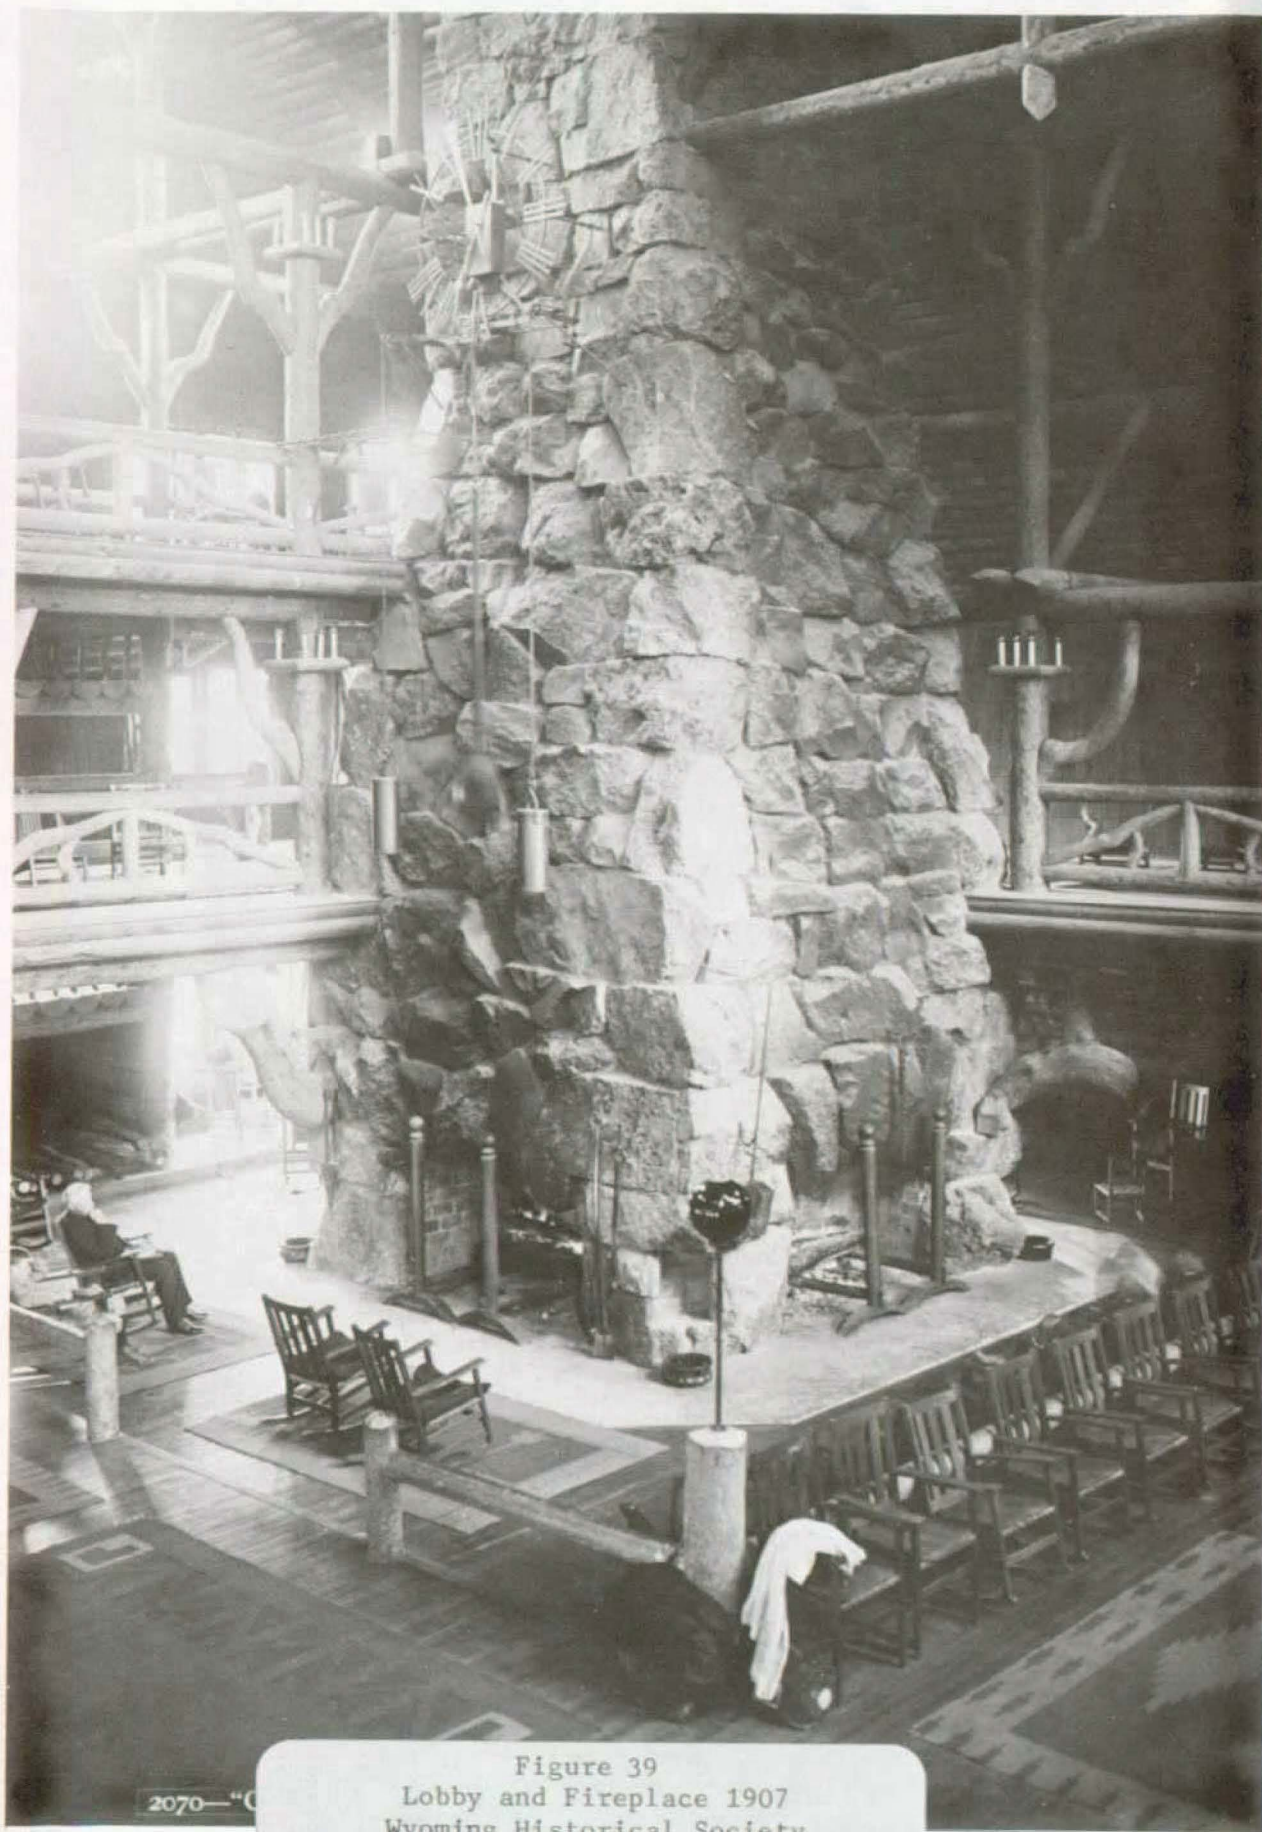
Figure 39
Lobby and Fireplace 1907
Wyoming Historical Society

A photograph of the massive stone fireplace with its large iron clock designed by Robert Reamer.

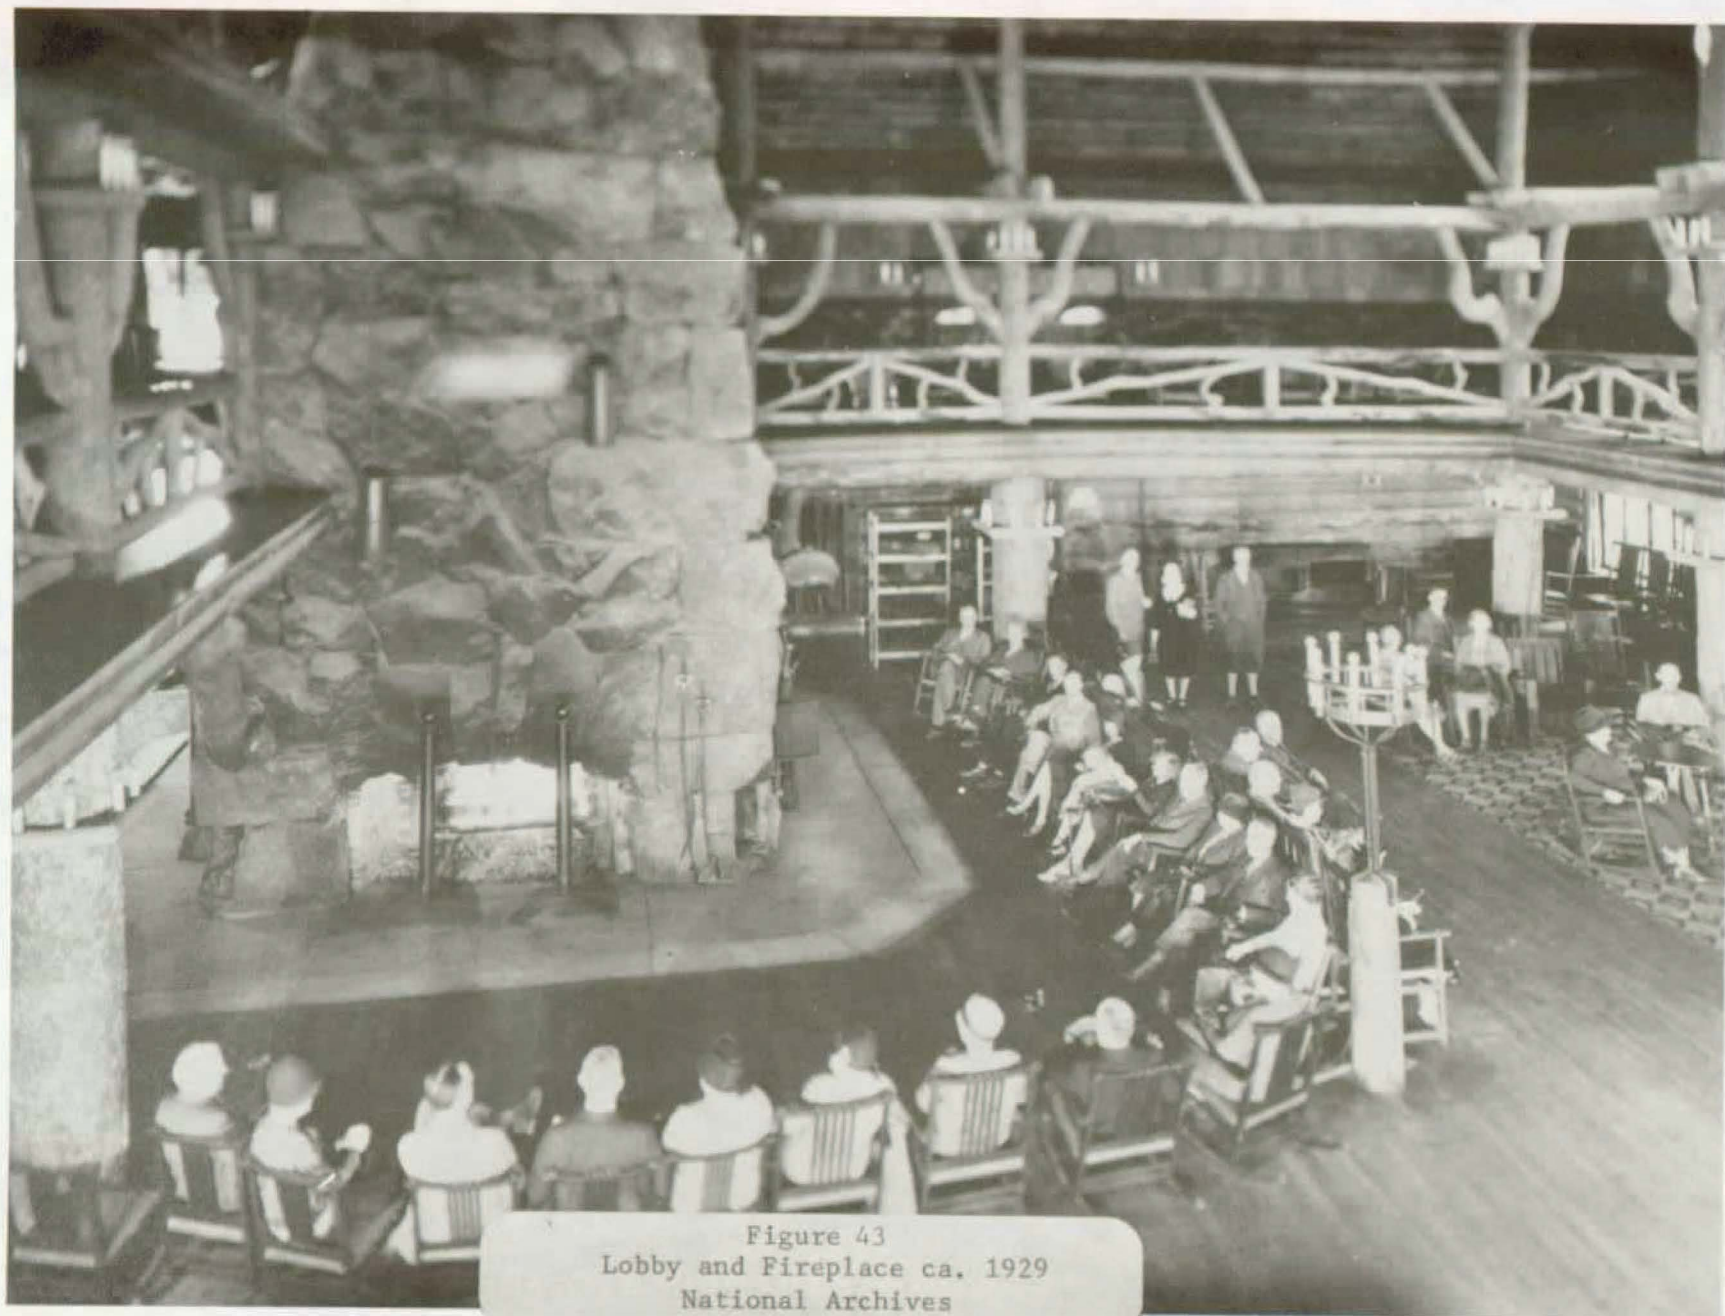
Figure 43
Lobby and Fireplace ca. 1929
National Archives

A photograph of the fireplace which reveals that the concrete area around the base has been replaced and extended slightly. That task was accomplished in 1926.

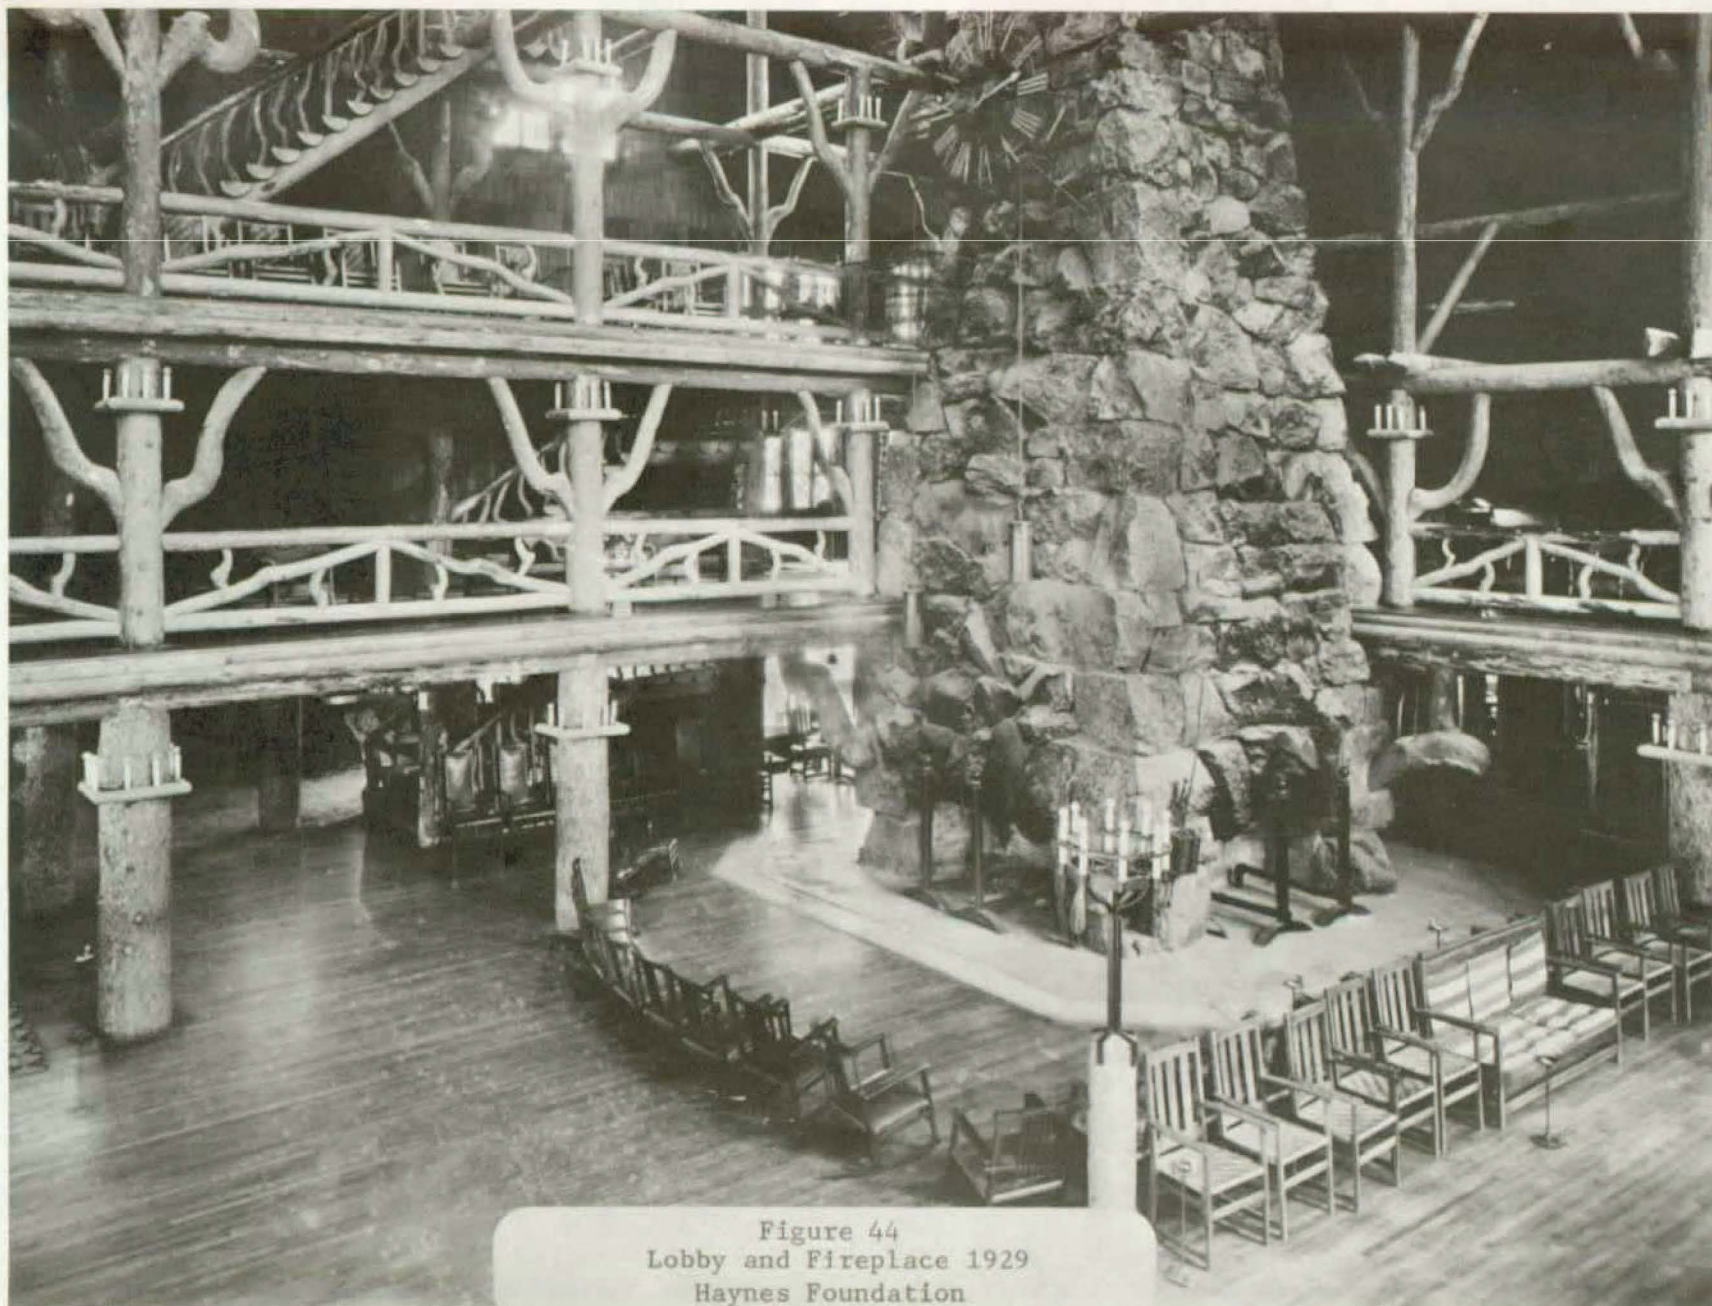
Figure 44
Lobby and Fireplace 1929
Haynes Foundation

A view of the fireplace corner of the lobby. One can now observe that the wall which abutted the ground floor stairway has been removed. A support timber was used to bear the weight once held by the wall.

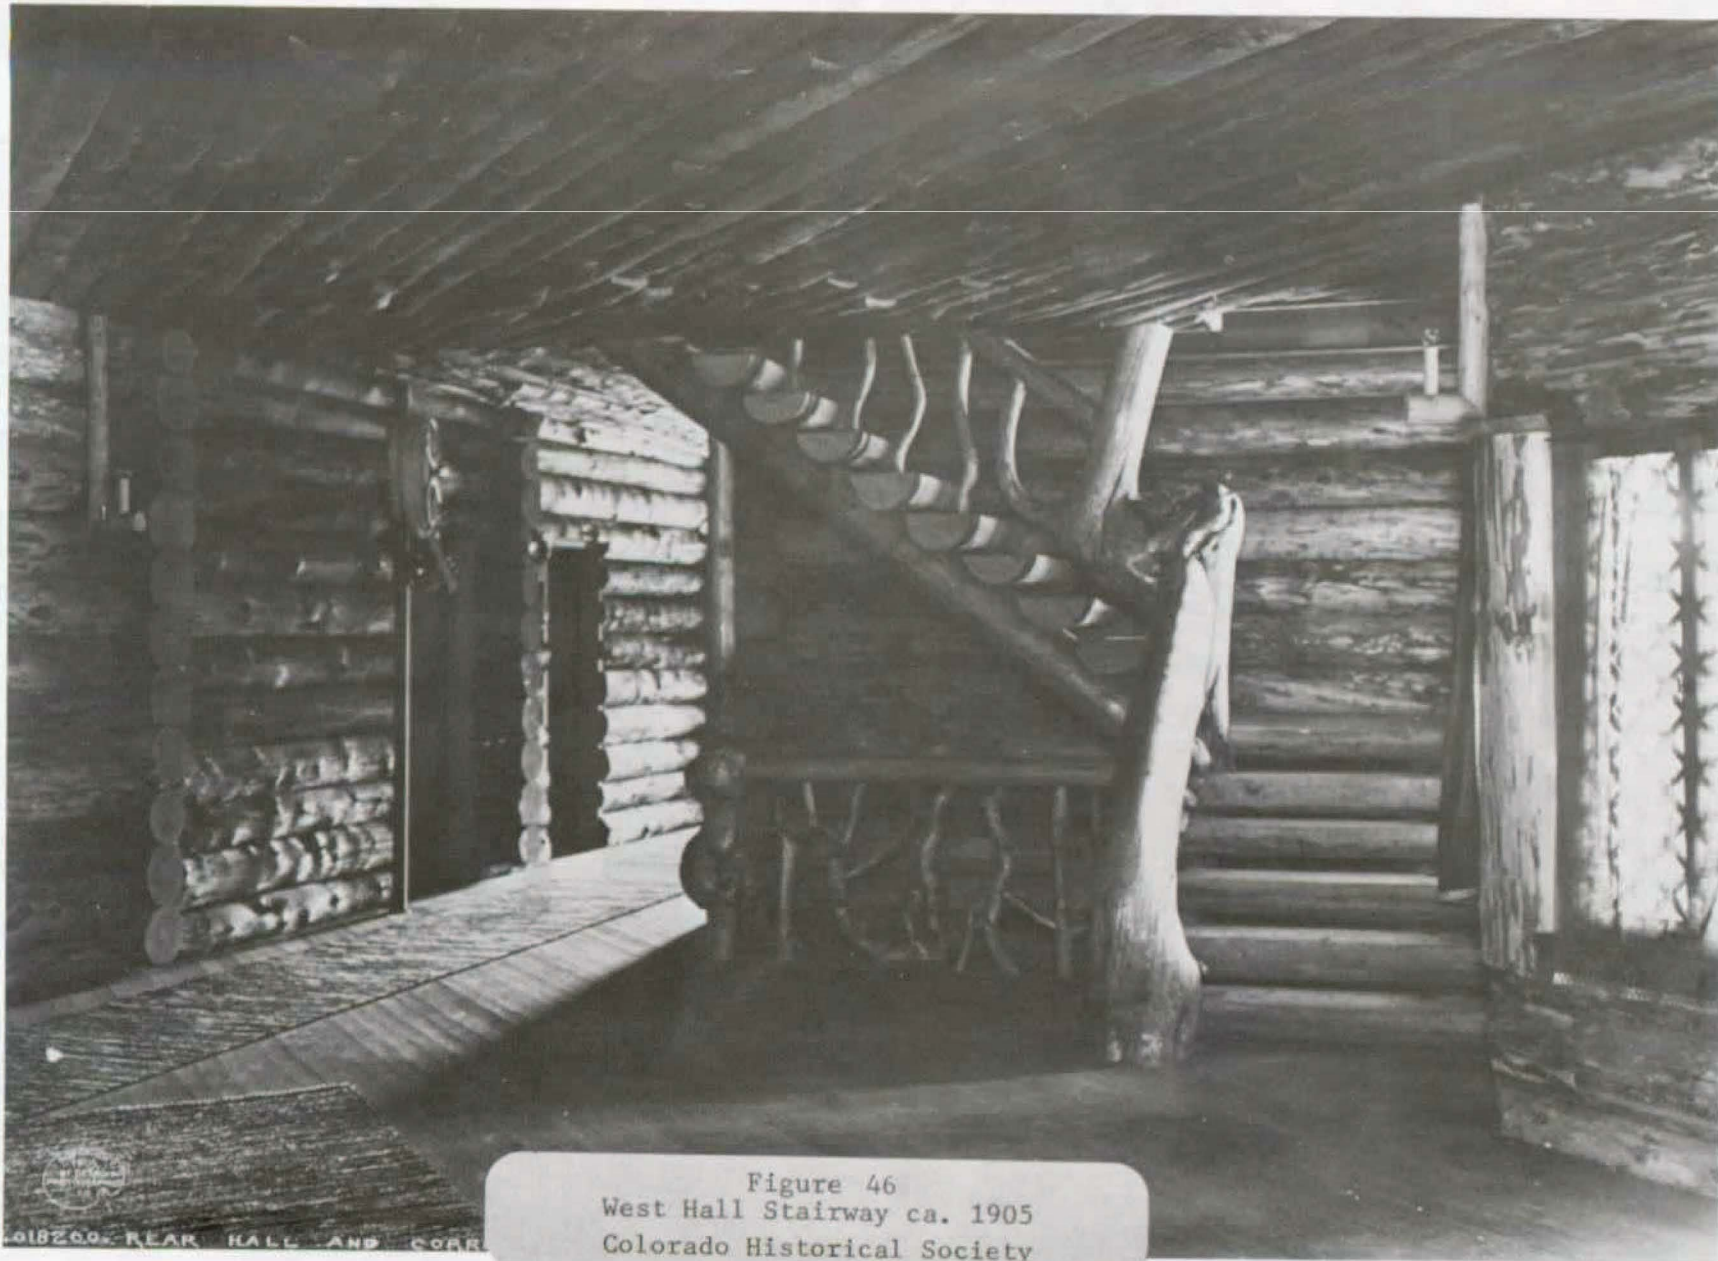
Figure 46
West Hall Stairway ca. 1905
Colorado Historical Society

A photograph of the hall stairway in the original west wing shows its large newel post.

Hallways off the east and west sides of the lobby led to the guest accommodations. Part way along the west hall a stairway with a large newel post led to the second floor (figure 46). Halls on the second and third floors, leading from the balconies, paralleled the ones on the ground floor. The original part of the Inn had 120 rooms, fifty of which were used to house female employees until the girls' dormitory was constructed in 1922. Rooms on the ground floor (figures 47-49) differed from those on the upper levels. The first floor rooms had a rustic log decor while the ones on the above floors were finished with rough, unpainted pine boards (figure 50). Room numbers were made of metal and produced on the site (figure 48).

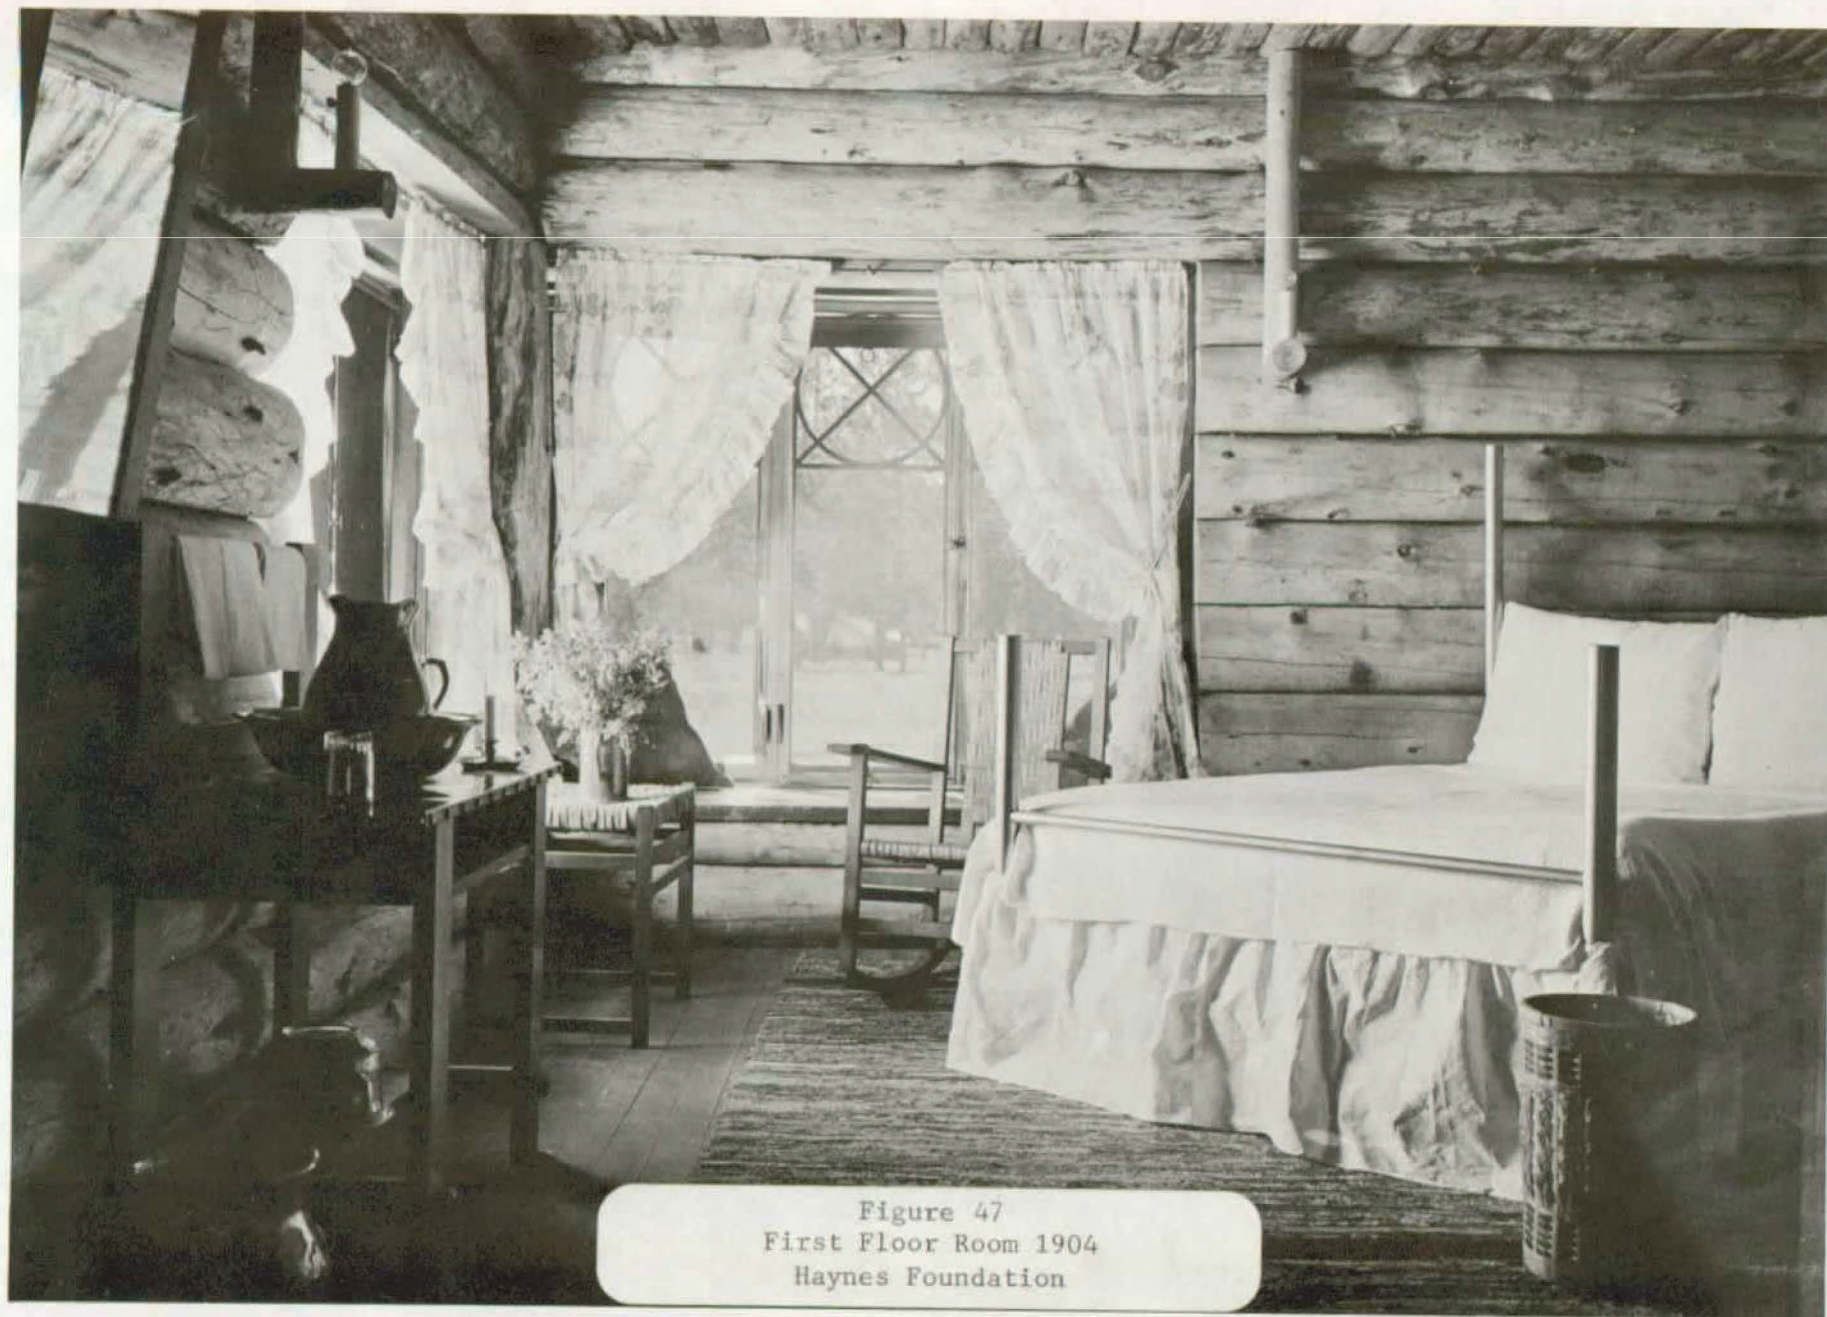
Figure 47
First Floor Room 1904
Haynes Foundation

A view of a first floor room in the original east wing with its rustic decor. Presently numbered room 46, it retains its original appearance down to even the window latches.

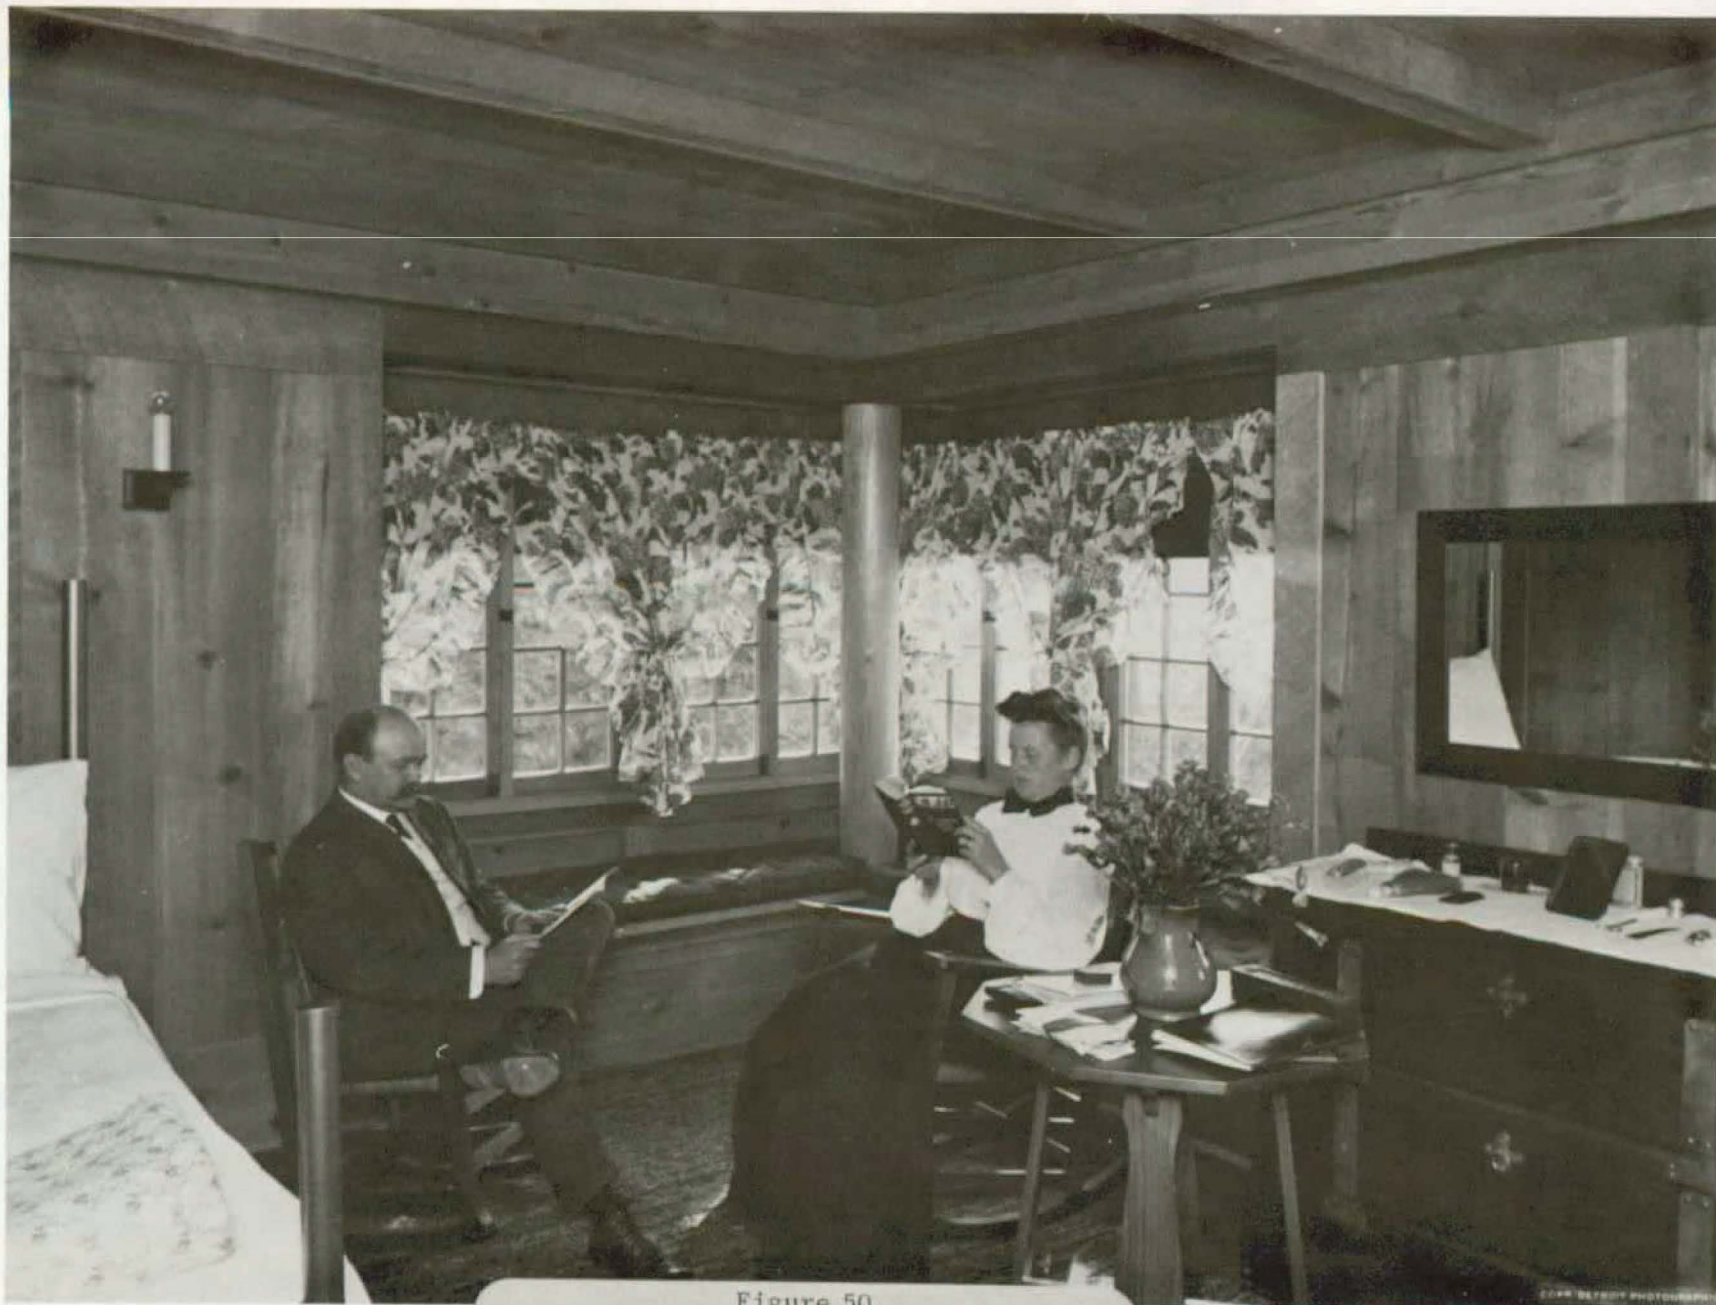
Figure 50
Upper Floor Room ca. 1905
Colorado Historical Society

A photograph of a second floor room in the original west wing showing the rough, unpainted pine boards used on the walls and ceiling. The window on the right was removed in 1927 when the new west wing was added.
