historic structure report
historic data section
january 1982

YELLOWSTONE
OLD FAITHFUL INN

HISTORIC STRUCTURE REPORT
HISTORICAL DATA SECTION
OLD FAITHFUL INN
YELLOWSTONE NATIONAL PARK
WYOMING

by
A. Berie Clemensen

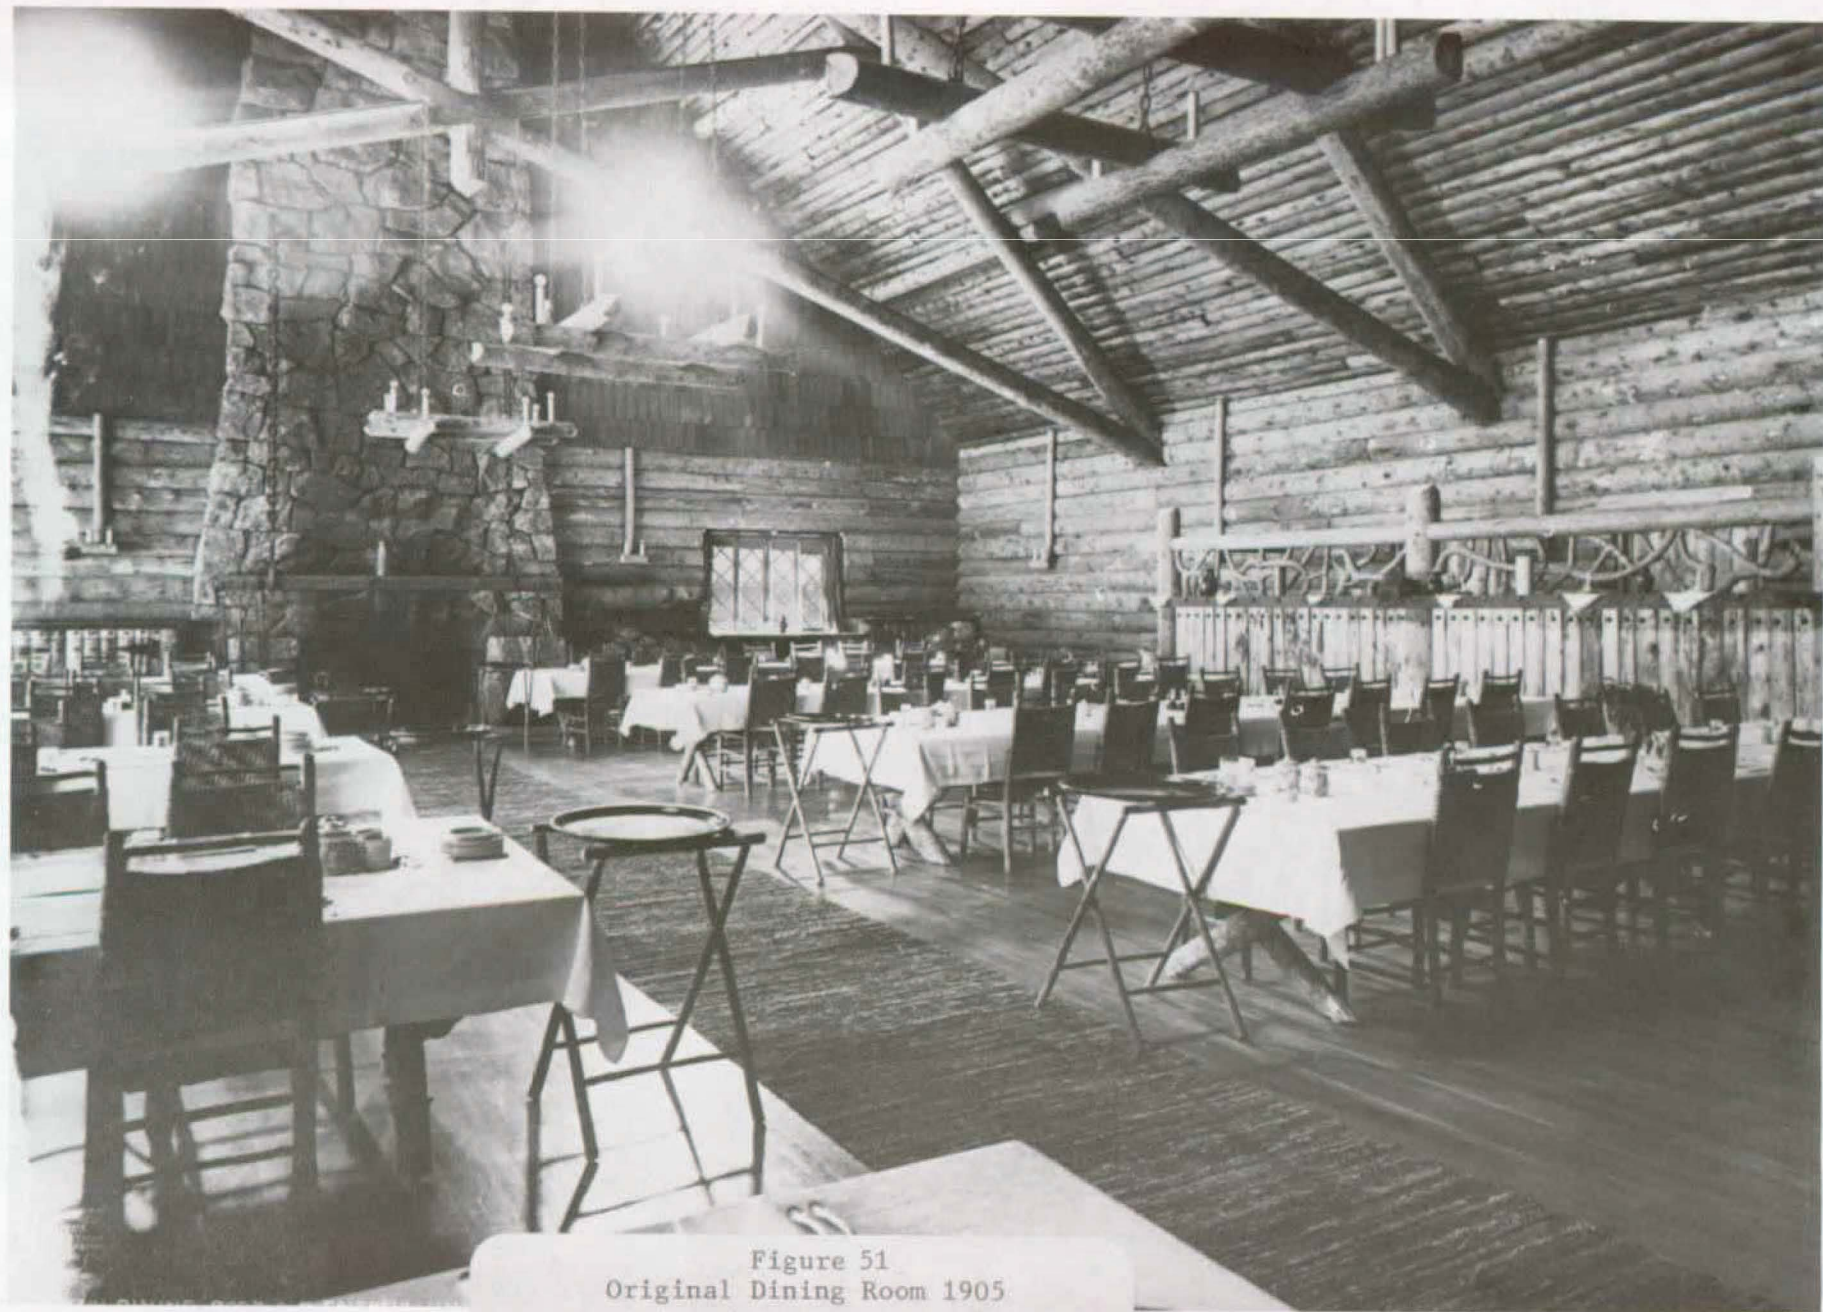
Figure 51
Original Dining Room 1905
Colorado Historical Society

A photograph of the original dining room. It reveals a different roof support system from the lobby, for here Reamer used a series of scissor trusses reinforced with turnbuckled iron rods and gusset plates. The stone fireplace was severely damaged in the 1959 earthquake necessitating its removal to the hearth.

The dining area was located behind the lobby (figures 51-56). Its entrance contained smaller double doors similar to the ones found at the main entrance. These doors also had iron hinges forged on site. Inside, this log room was open to the roof, which, like the underside of the lobby roof, was veneered with split logs. However, unlike the upper reaches of the lobby, the dining room roof was supported by a series of scissor trusses reinforced with turnbuckled iron rods and gusset plates. A stone masonry fireplace was located against the south wall. As opposed to the lobby fireplace, the stone continued above the roof line and had no log cribbing at that point. The firebox contained a spit and oven.²⁴ A decorative partition on the west concealed the kitchen entrance.

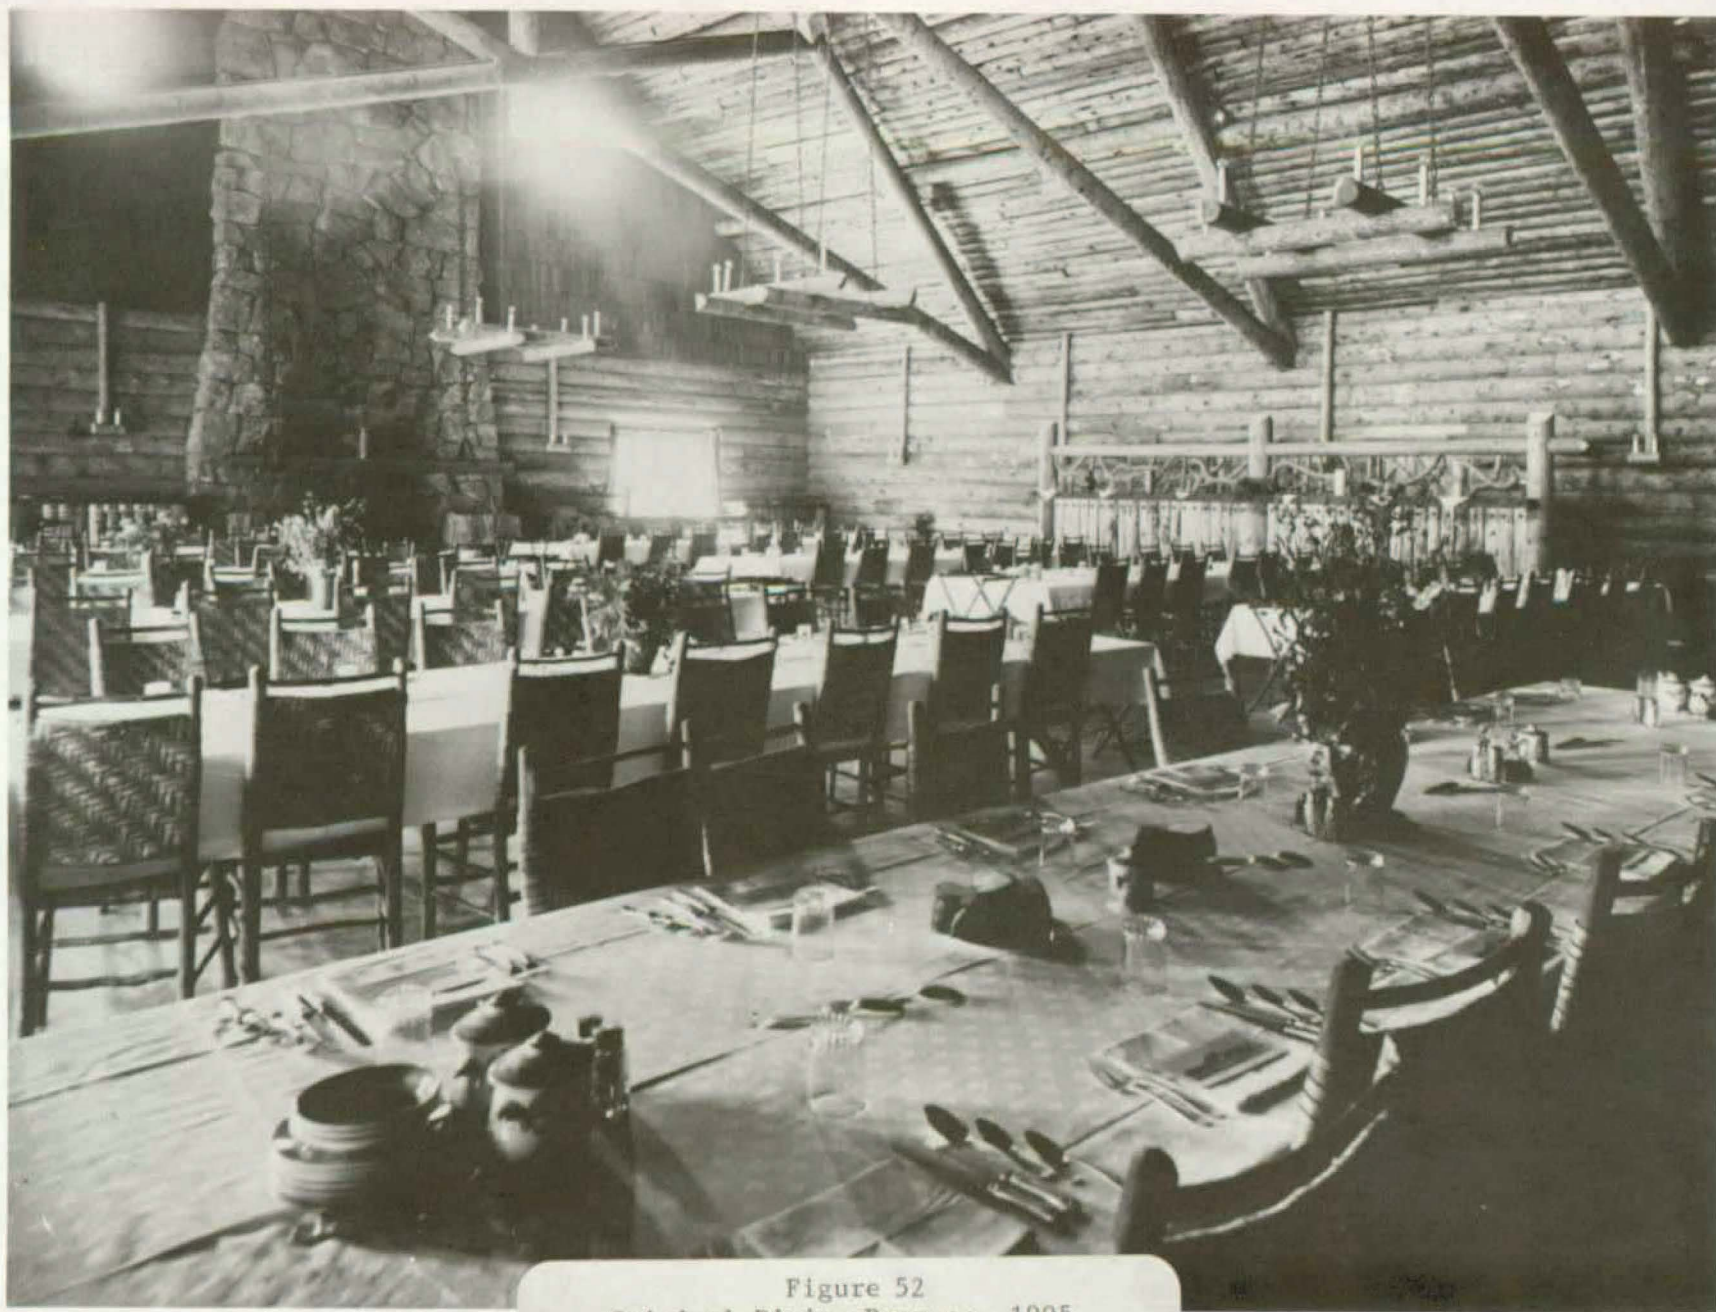
Figure 52
Original Dining Room ca. 1905
Henry Ford Museum

Another view of the original dining room showing the family style dining as well as the place setting detail.

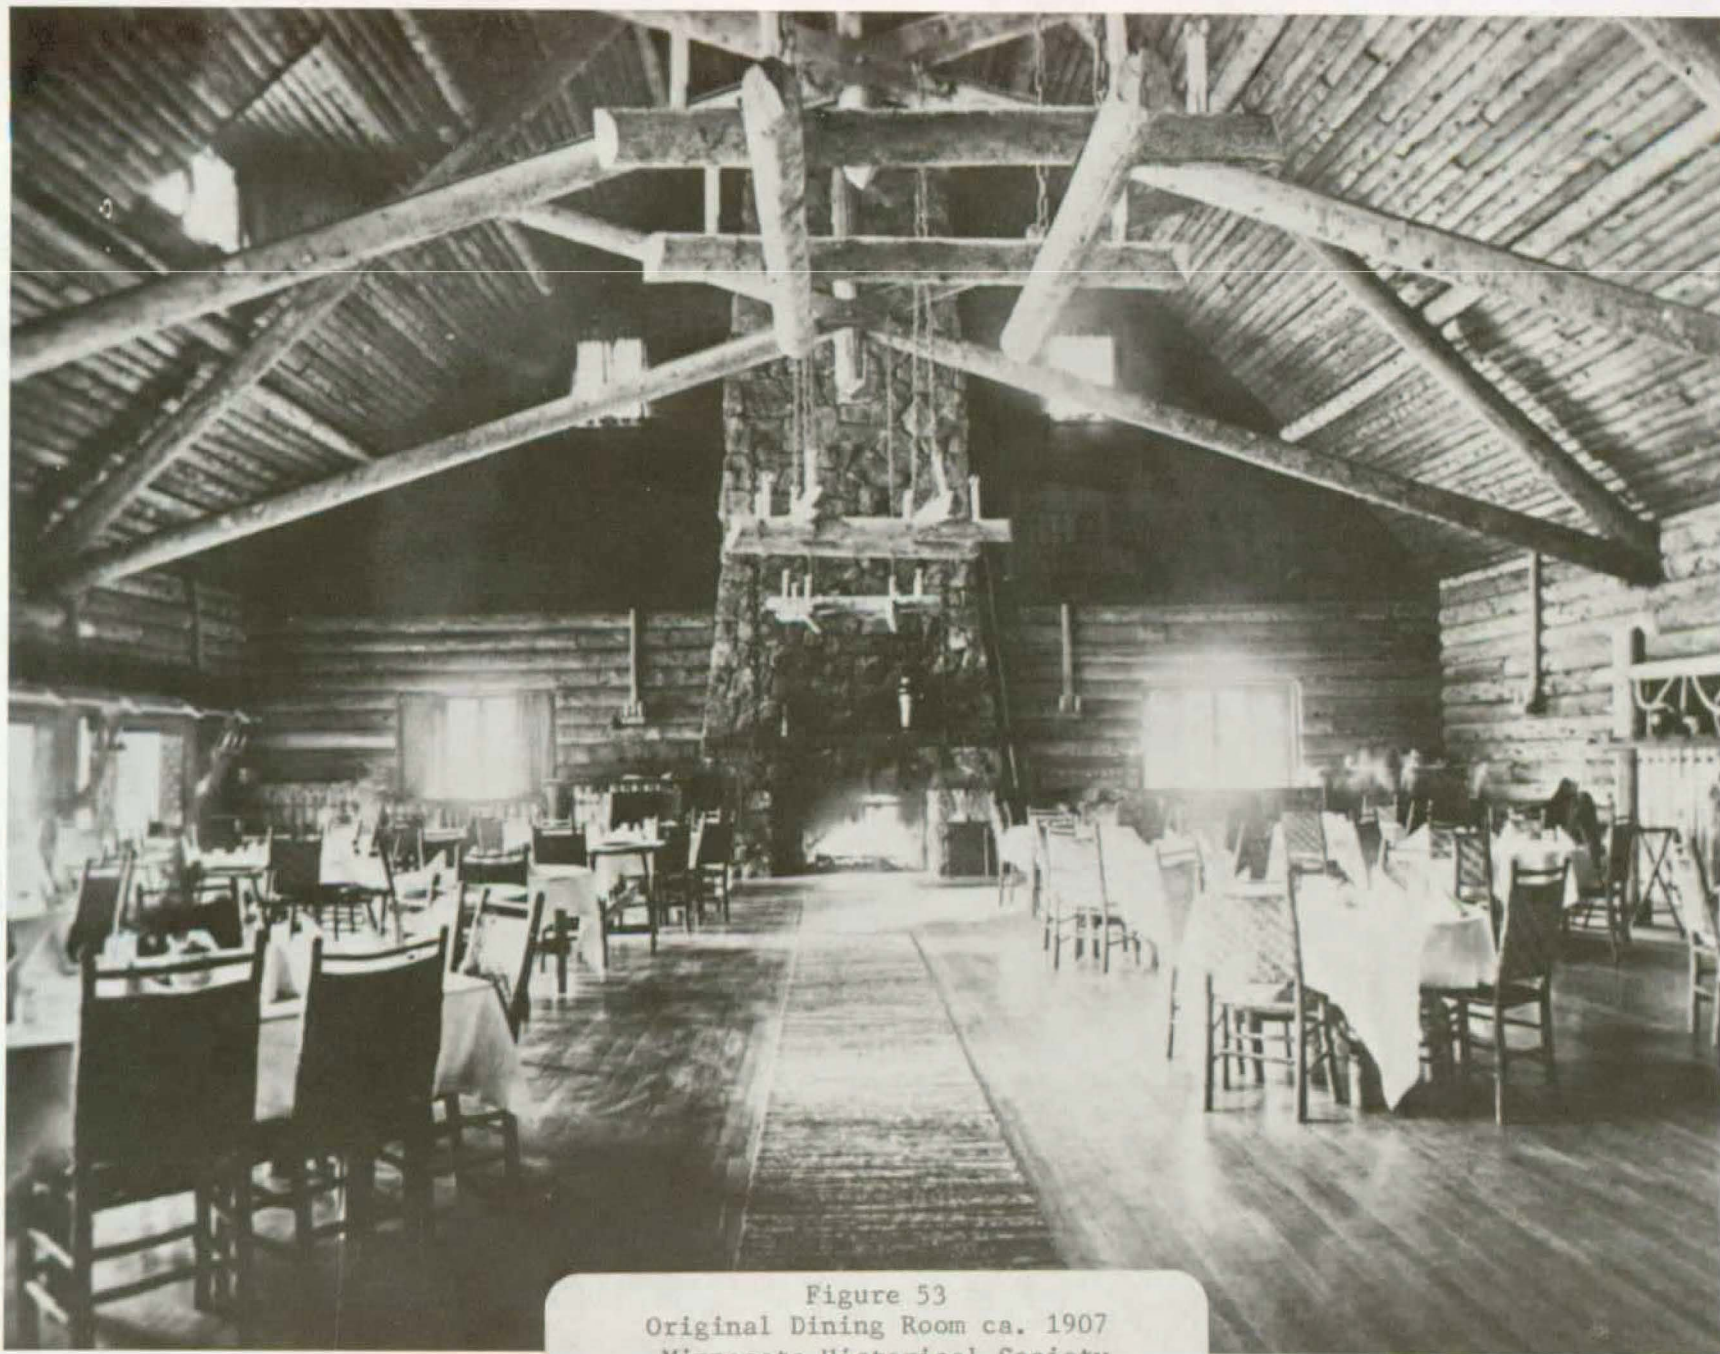
Figure 53
Original Dining Room ca. 1907
Minnesota Historical Society

A photograph of the original dining room. The windows in the upper portion of the far gable wall were removed in 1968.

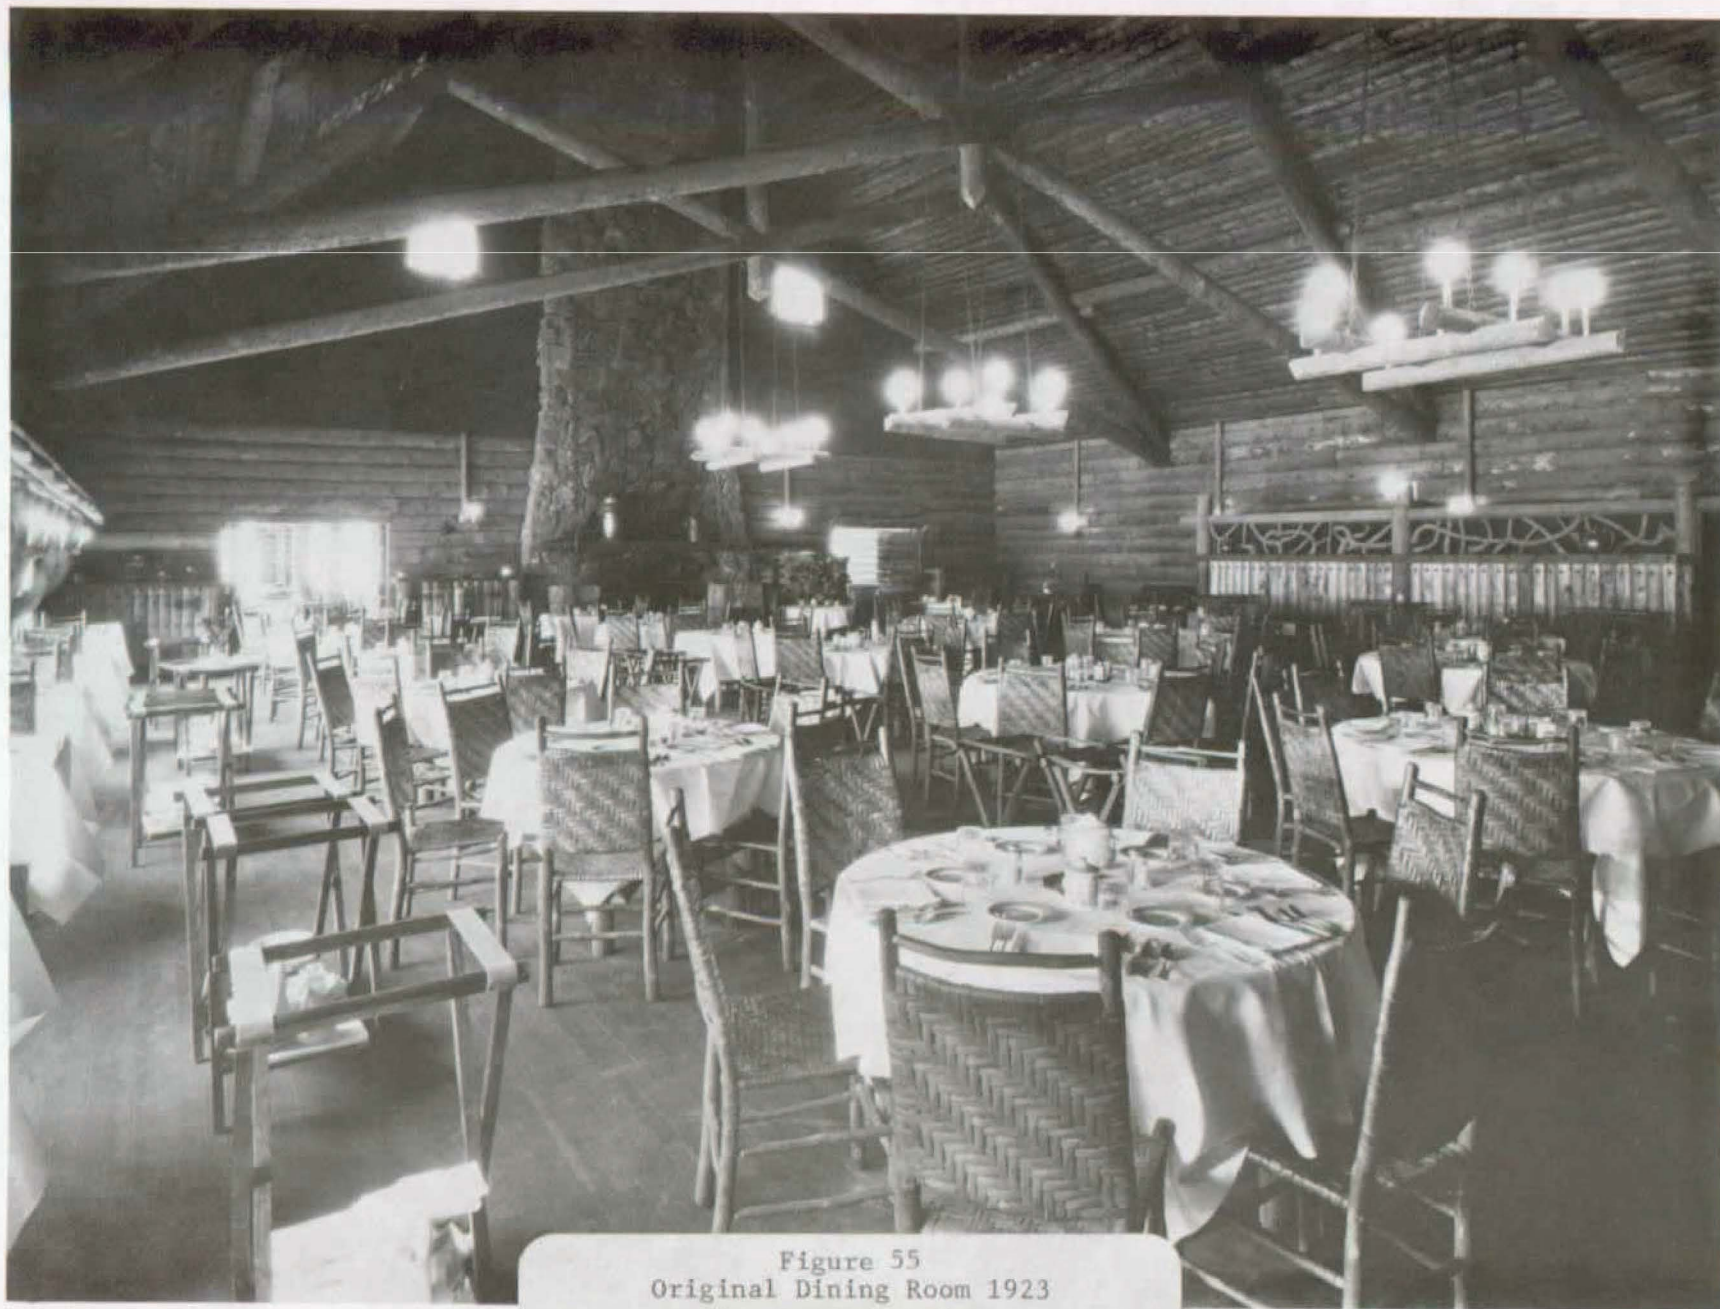
Figure 55
Original Dining Room 1923
Haynes Foundation

A view of the original dining room. It reveals that the two lower windows on either side of the fireplace have been converted to doorways to the 1921-22 south dining area extension.

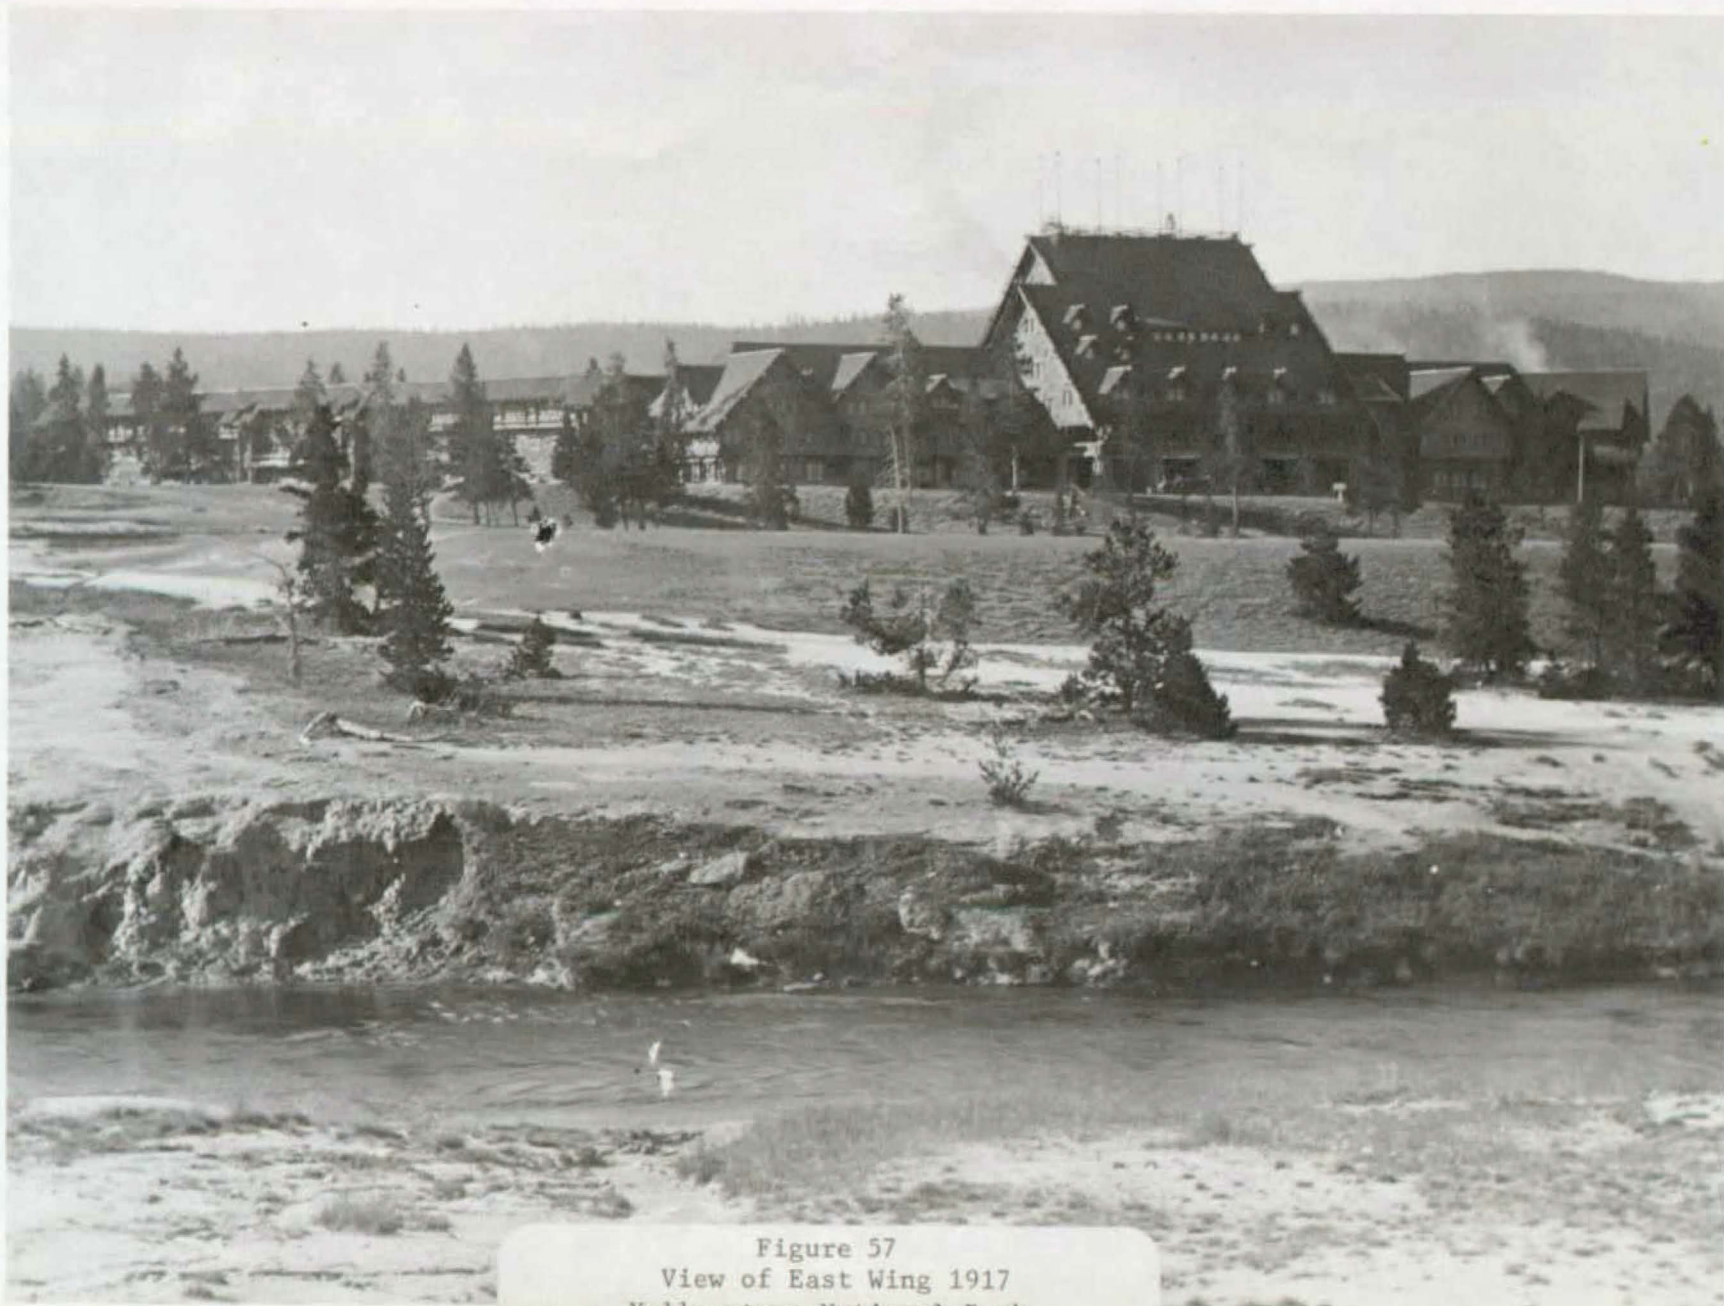
Figure 57
View of East Wing 1917
Yellowstone National Park

A view of the 1913 east wing with its flat roof which had a slight mansard overhang.

Reamer designed the east wing with some log features, but it had a flat tar and gravel roof with a slight mansard overhang. Cedar shingle siding covered the exterior walls. A passageway connected the east wing to the old house. One guest room in the original structure was converted into a hall for access to the passageway. The guest room interiors were plastered (figure 58). Except for minor repairs, interior painting, and a new tar and gravel roof in 1966, the east wing has not changed.

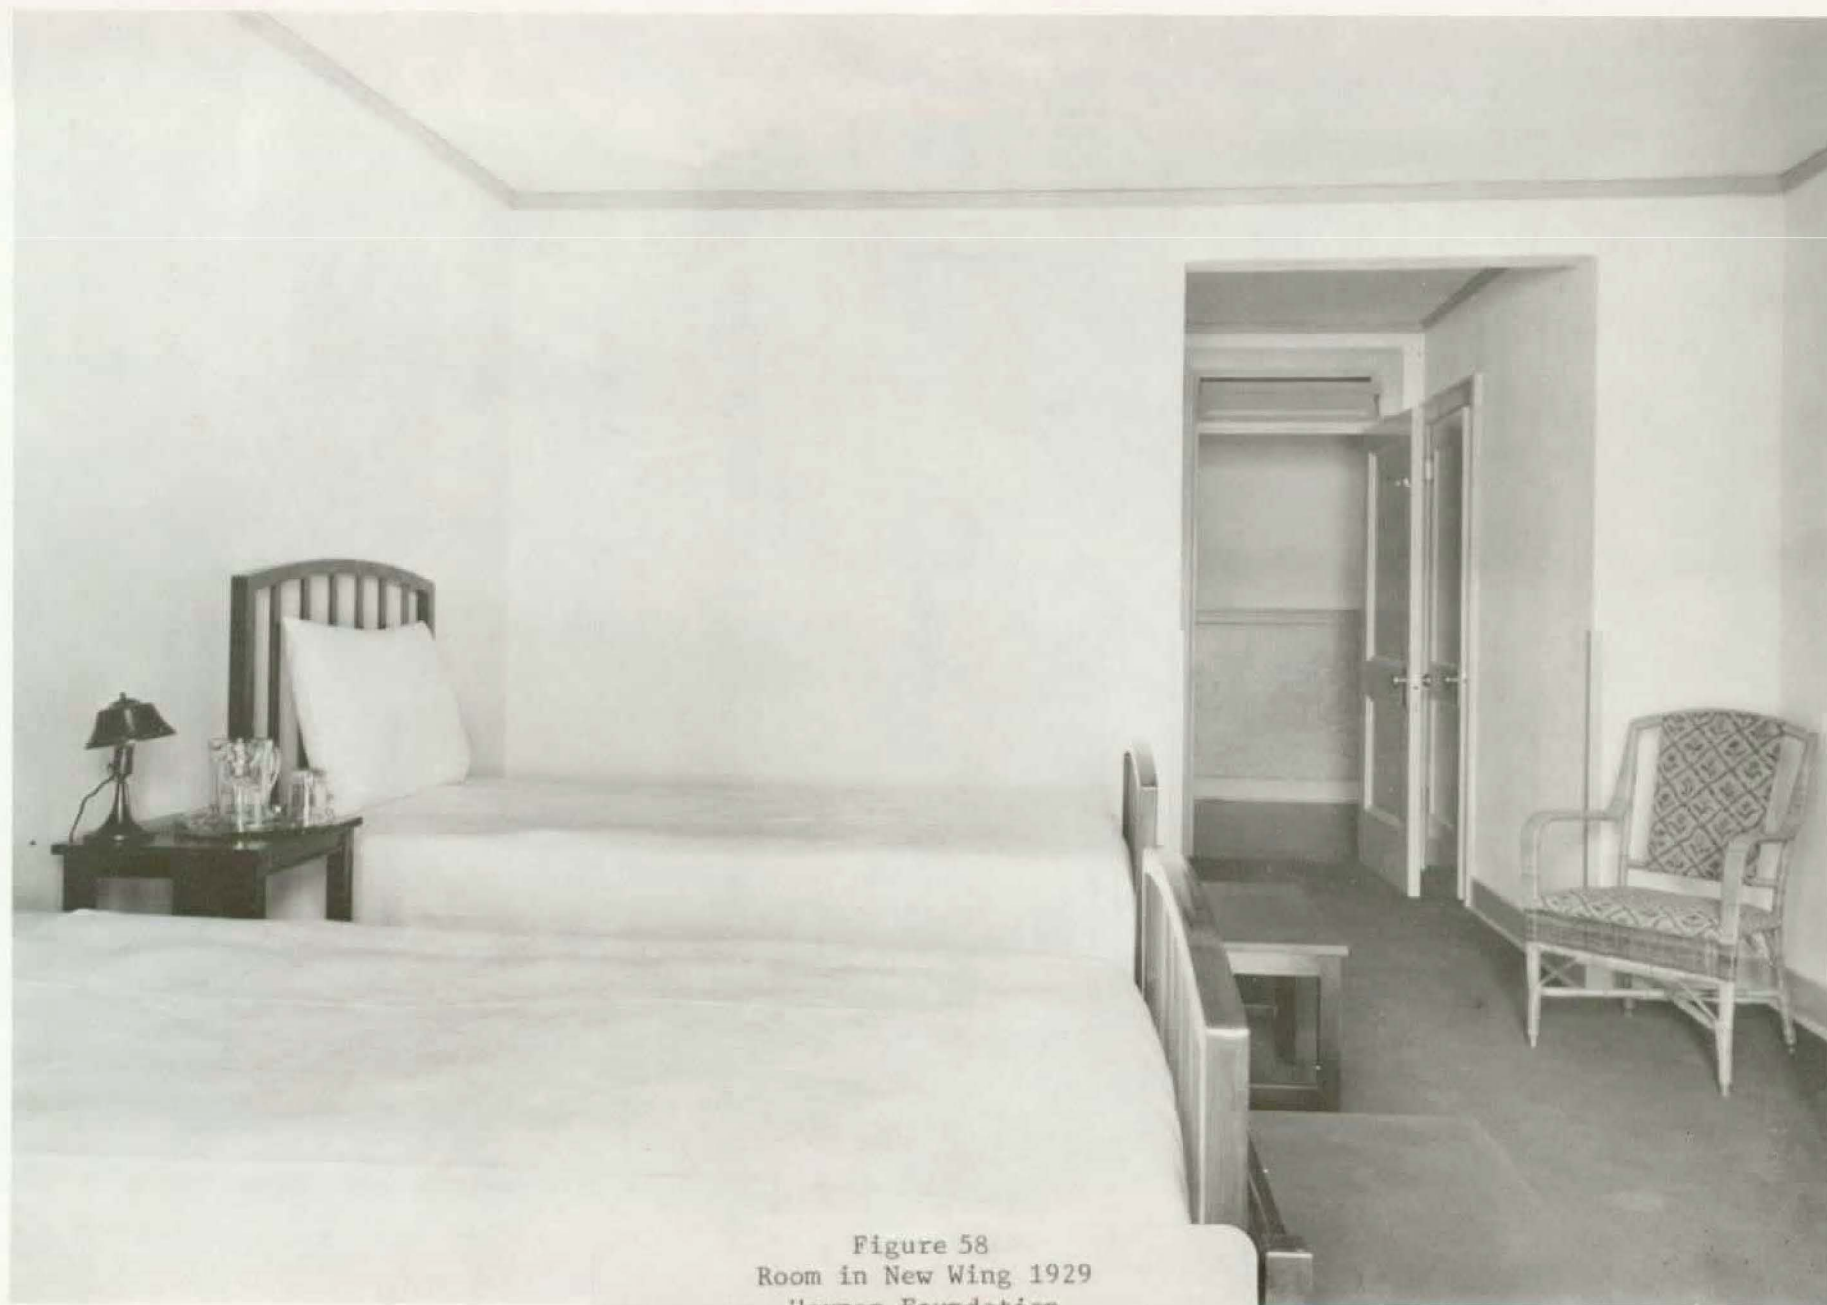
Figure 58
Room in New Wing 1929
Haynes Foundation

A guest room in the new wing reveals plaster walls instead of a rustic design.

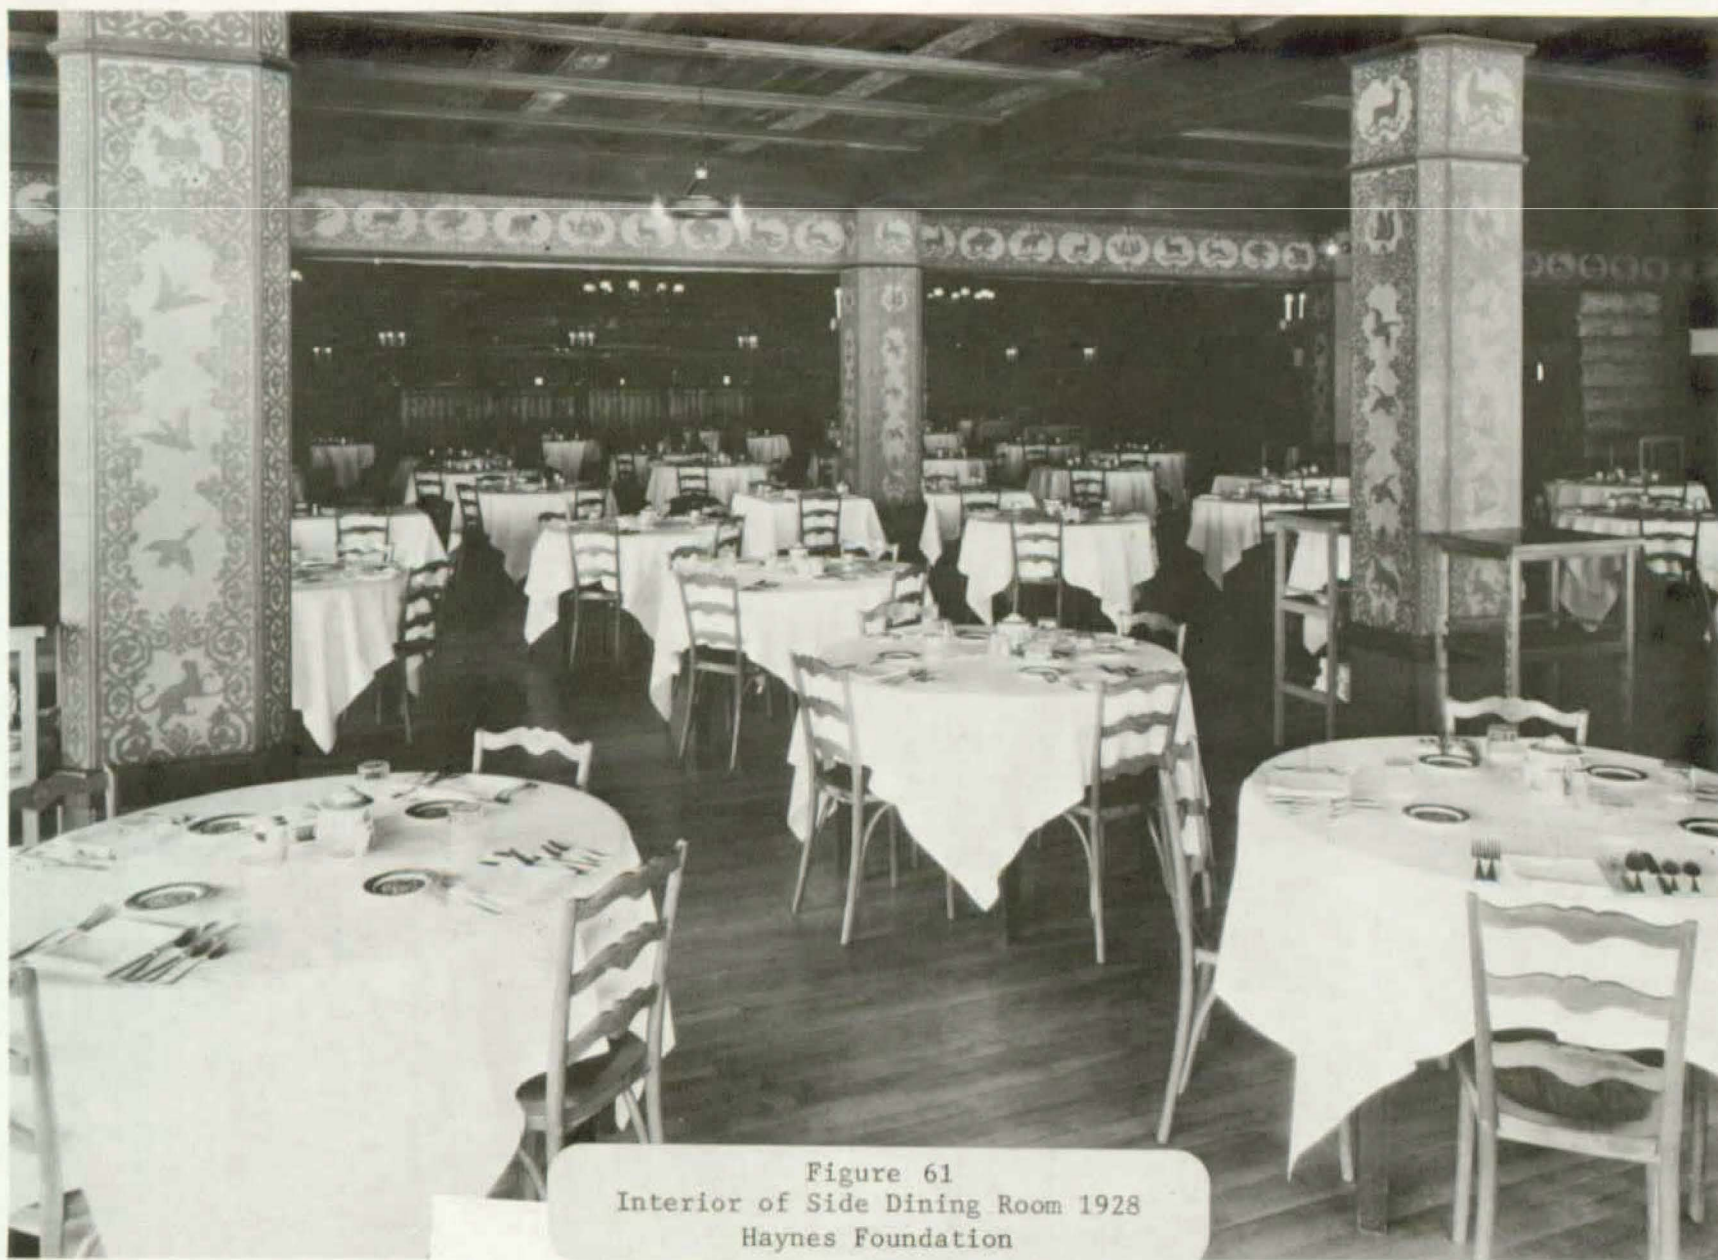
Figure 61
Interior of Side Dining Room 1928
Haynes Foundation

A view of the interior of the side dining room which was constructed in 1927. It reveals the etched design on the columns, beams spanning between them, and some ceiling boards. In 1962 this room was converted into the Bear Pit.

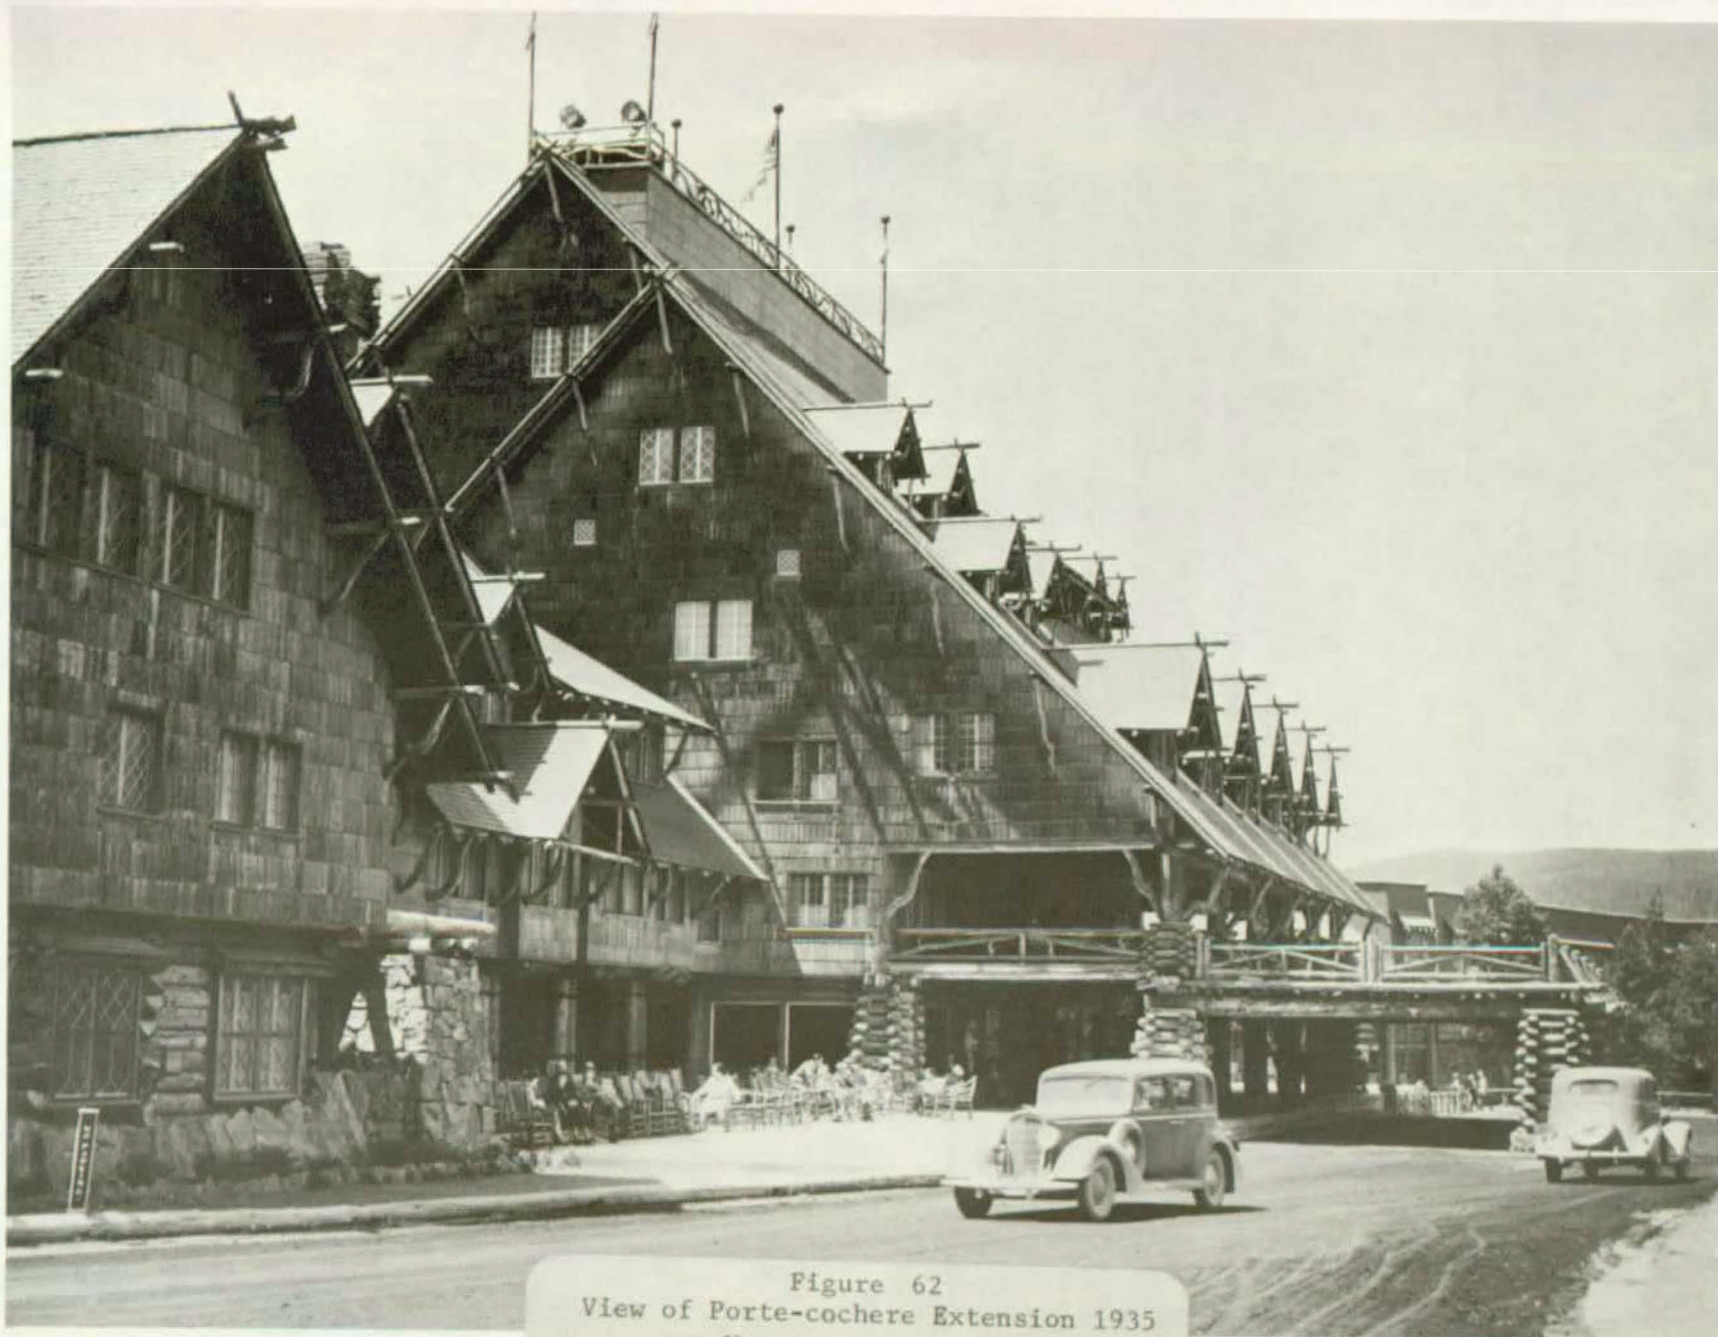
Figure 62
View of Porte-cochere Extension 1935
Haynes Foundation

A photograph of the 1927 porte-cochere extension, the top of which serves as an addition to the veranda.

the old first row of supports was changed to accommodate the log beams on which the floor of the veranda extension rested. All six of those old cribbed supports were removed as well as their stone bases. Only the two side cribs were replaced in a modified form. Those now truncated columns were set on the concrete which filled the old driveway. The inner four cribbed supports were exchanged for large timbers. A rustic railing enclosed the new uncovered veranda extension. That porch was slightly lower than the original veranda. By 1956 the porte-cochere's cribbed supports had weakened, probably through deterioration. They were removed in that year and reconstructed around steel beams which now bore the veranda weight. The cost of that operation was \$2,261.64.³²

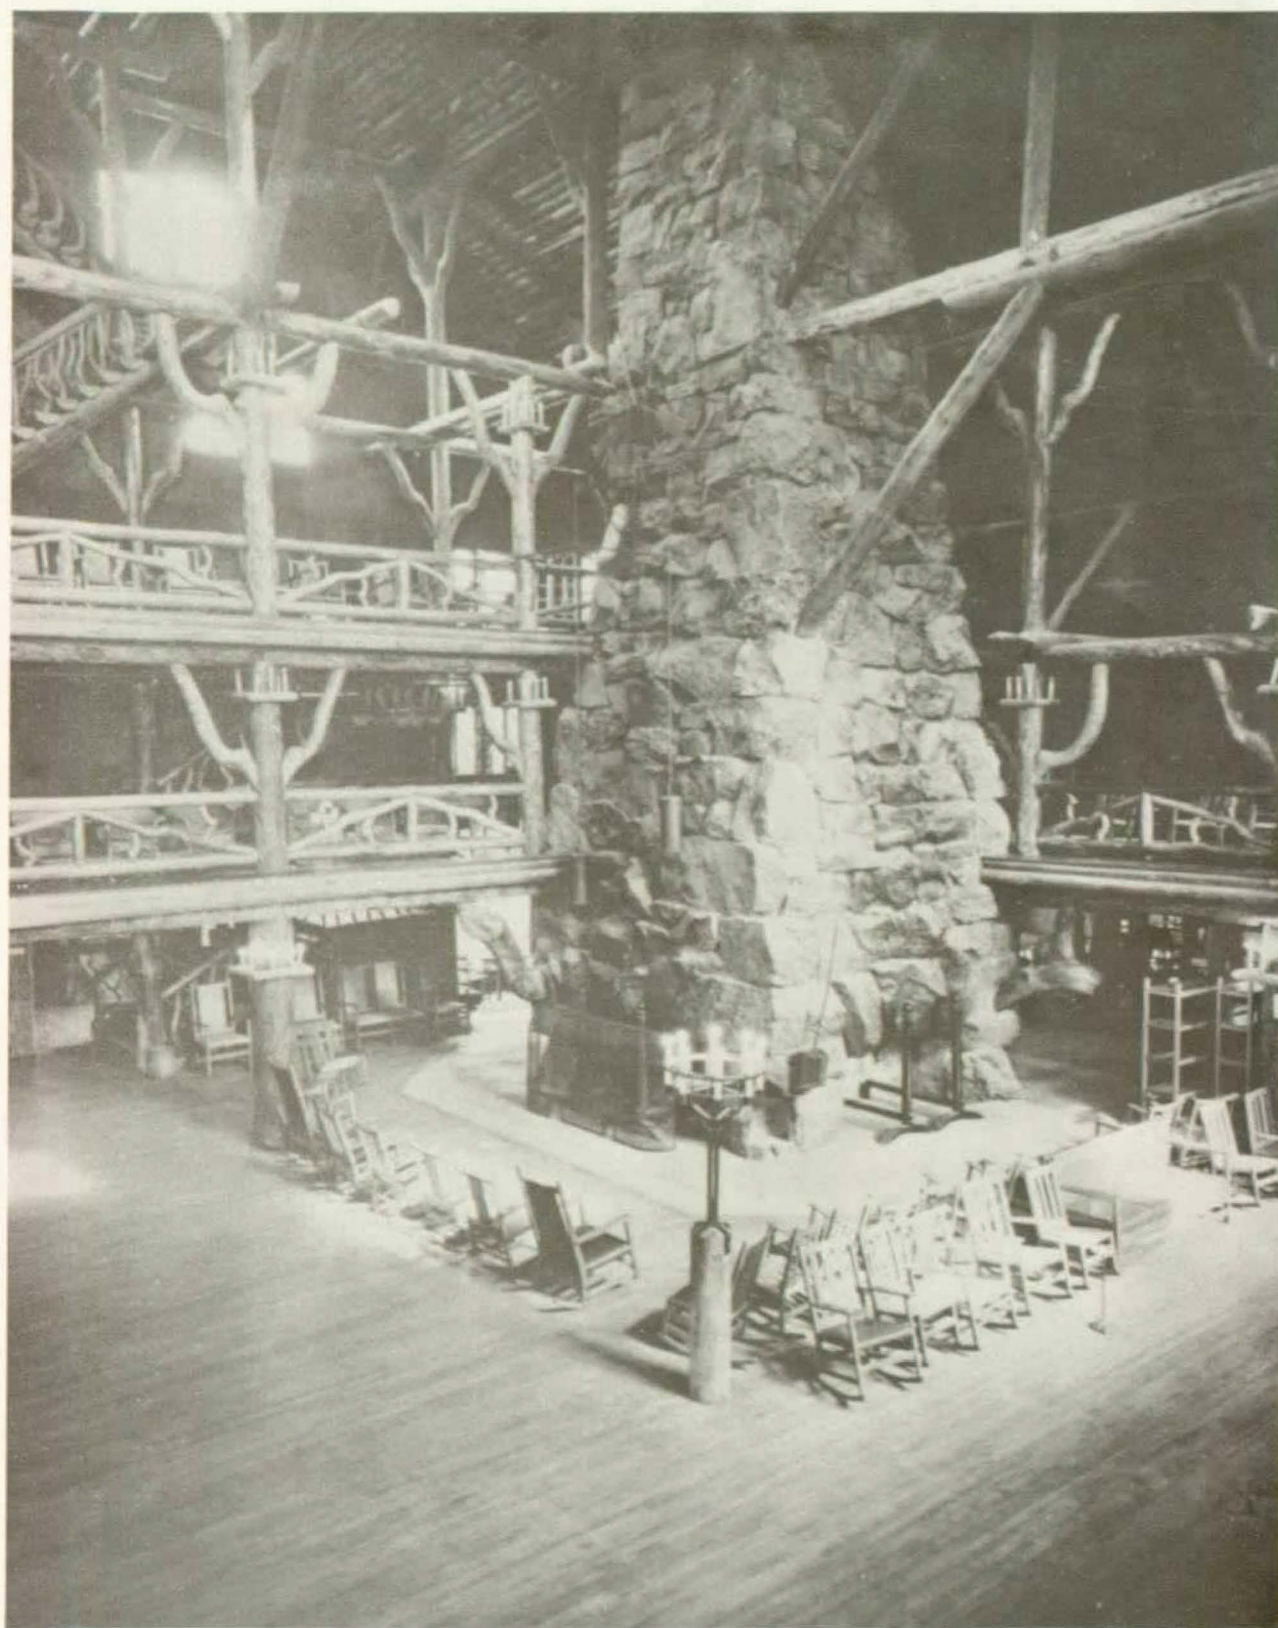
Figure 63
Double Purlin and Diagonal Brace 1952
Haynes Foundation

A photograph which shows one of the double purlins and its diagonal brace propped against the fireplace. The reinforcing of the upper truss system occurred about 1943.
