## National Register of Historic Places Registration Form

historic name El Portal Old Schoolhouse

other names/site number El Portal Chapel, NPS Building No.8847

## Continuation Sheet – Narrative Description

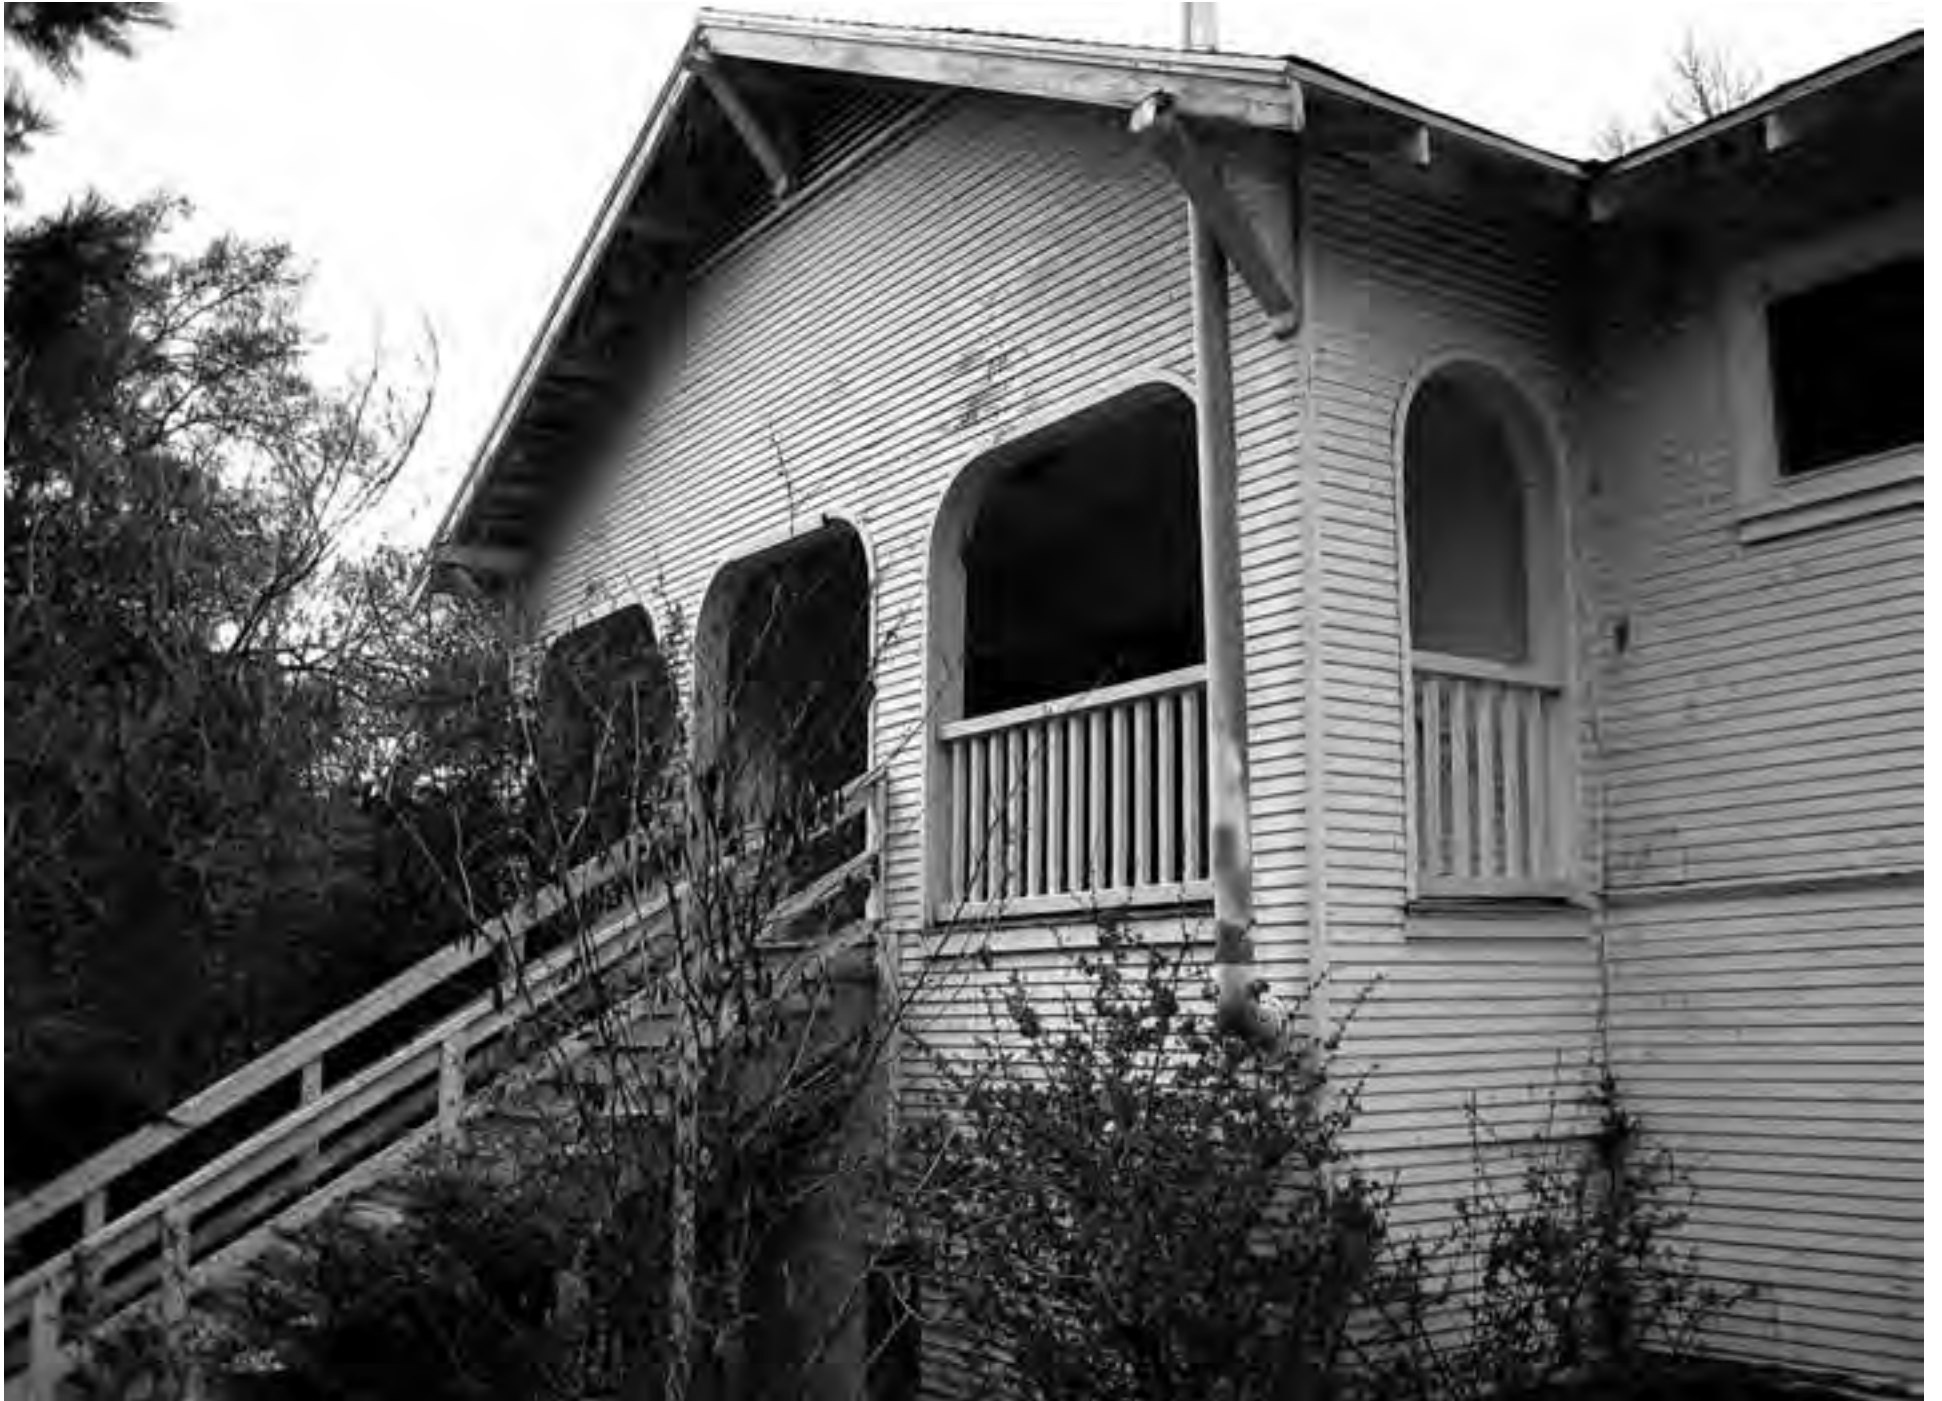
CA\_Mariposa County\_El Portal Old Schoolhouse\_0006

The south elevation (Photo 5) is punctuated with two porches, one being the elevated main entrance to the building and the other smaller porch on the east addition serves as a secondary entrance. The main porch has a front-facing gable roof, which is centrally located on the original portion of the building. (Photo 6) The plan of the porch is T-shape and both projects from and recesses back into the main volume of the building. There are four entrance doors leading from the porch into the building: two panel doors with top-lights along the north wall leading directly into the classrooms and two solid five panel doors leading to the central and west cloakrooms. (Photo 7) The main porch is finished with painted tongue and groove flooring running north to south and wide wood trim around the openings. Porch fixtures include two wall-mounted “bubbler” water fountains and a pendant light with frosted glass shade mounted to the beadboard ceiling. The secondary inset porch on the east addition of the building is smaller in size but still retains the character of the main porch by use of a three-bay front façade and similar materials. (Photo 8) This complement effectively connects the two portions of the building together. The inset porch is rectangular in plan and is nearly symmetrical. It has two entrances leading into the building: a single panel door with a top light along the north wall leading to the east classroom and a solid five panel door on the east wall leading to the east cloakroom. The porches divide the south elevation into three wall segments, each with a set of three hopper windows and accompanying window screens mounted to the exterior trim. The only other window found along the south elevation is a large four light window near the southwest corner at basement level, in which the glass panes have been painted.

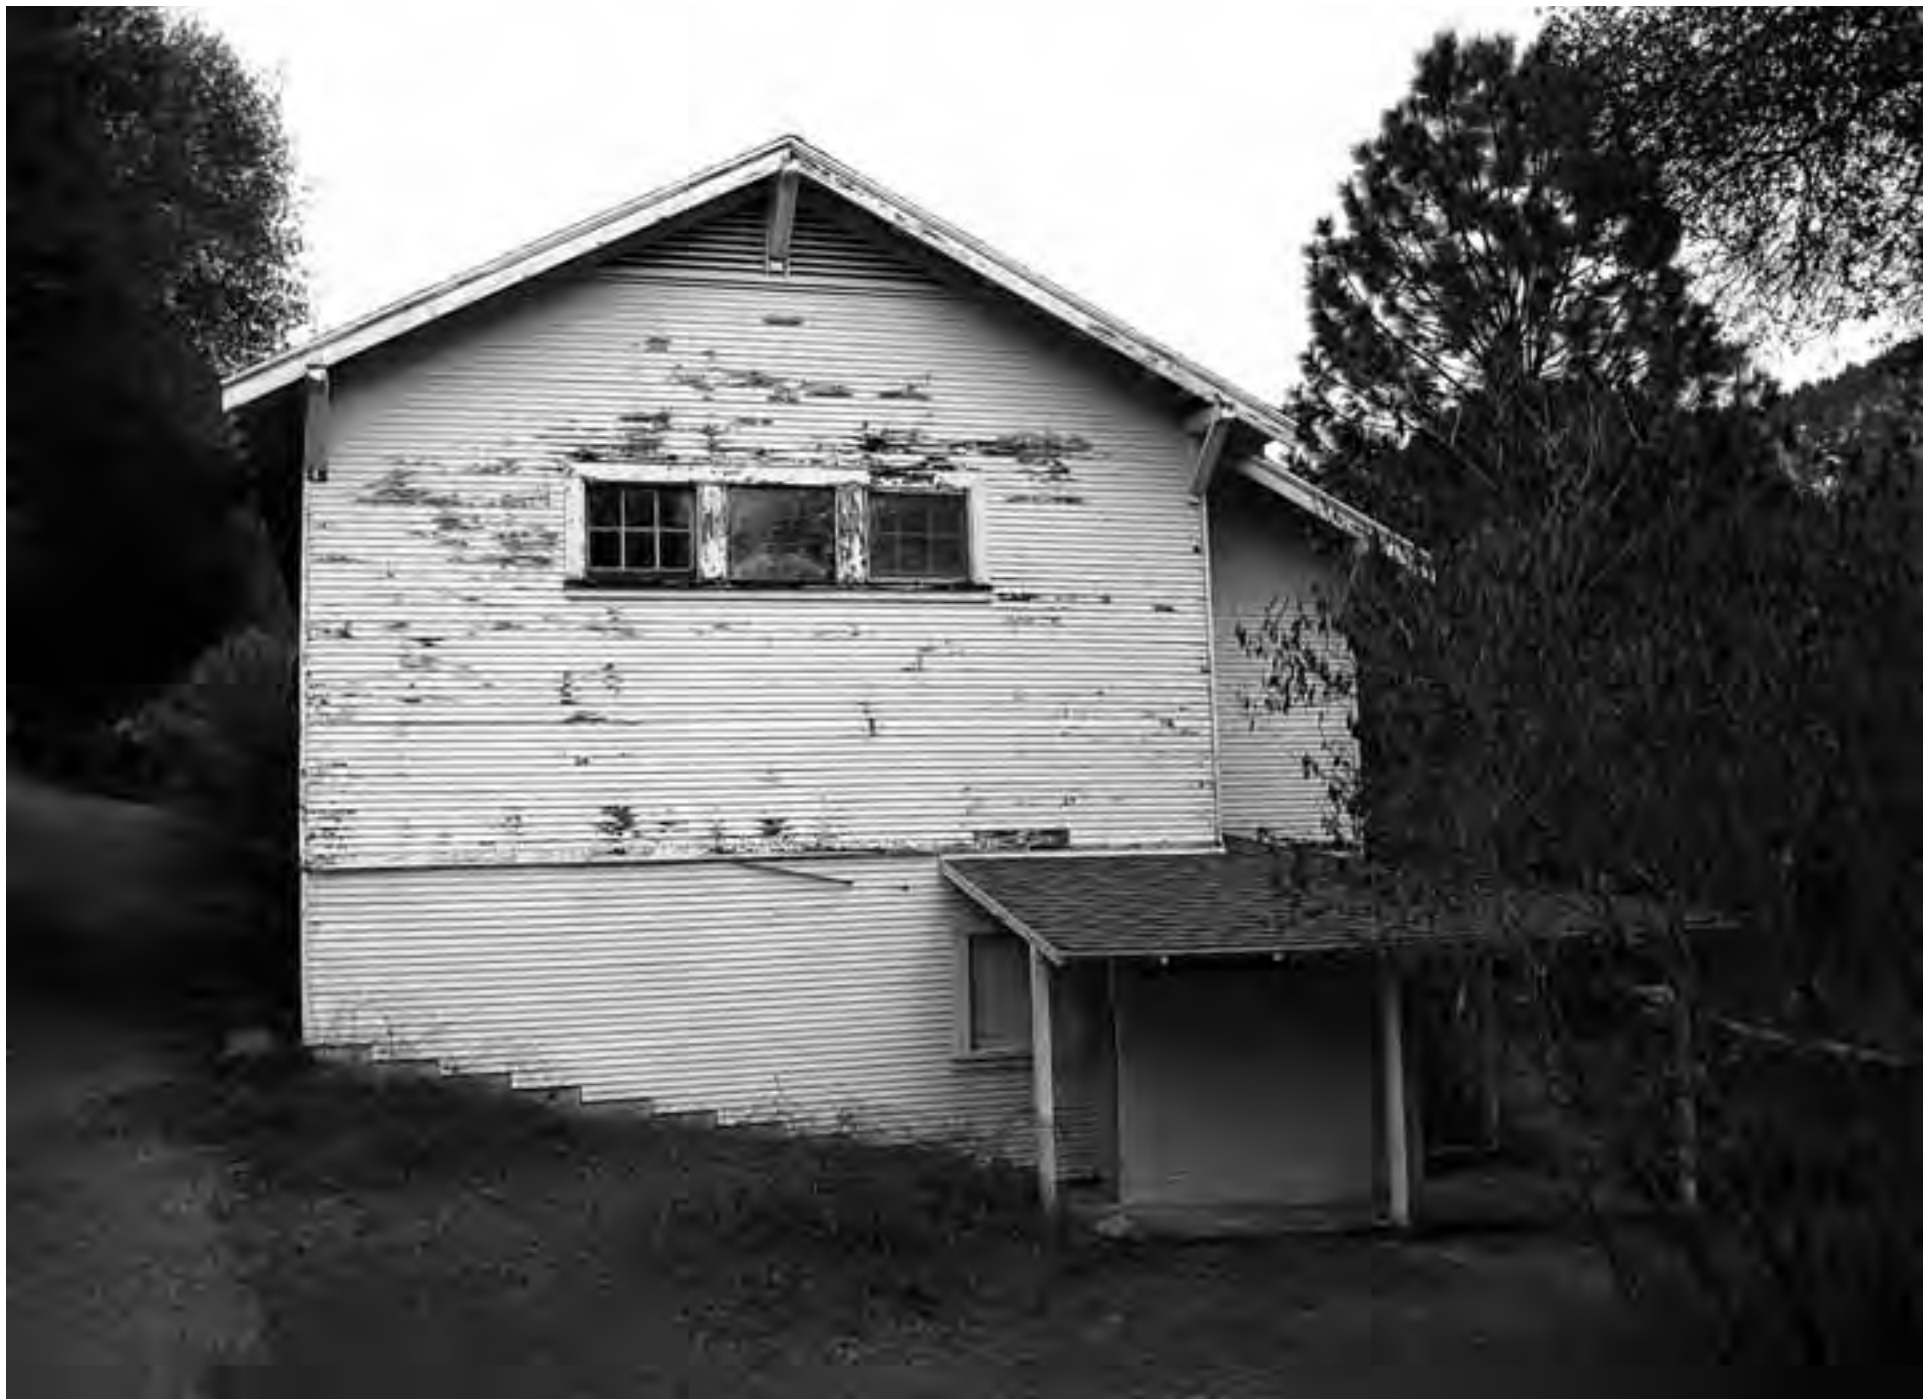
CA\_Mariposa County\_El Portal Old Schoolhouse\_0009

The west elevation is located on one of the gable ends of the building. (Photo 9) The slope of the site affords ample space for two restrooms to be located at the southwest corner of the building. The restrooms are only accessible through the outside of the building and partition walls have been installed atop a concrete slab-on-grade platform to serve as a privacy screen for each of the entry doors. (Photo 10) A quarter-hip roof, with open supports, was added sometime between 1938 and 1960 to provide shelter for the restroom entrances. A window opening within the exterior restroom wall is present but the panes have been removed and the opening boarded-up. A group of three windows is centered on the upper portion of the façade; the middle window has been replaced with stained glass and is flanked on either side by hopper windows.

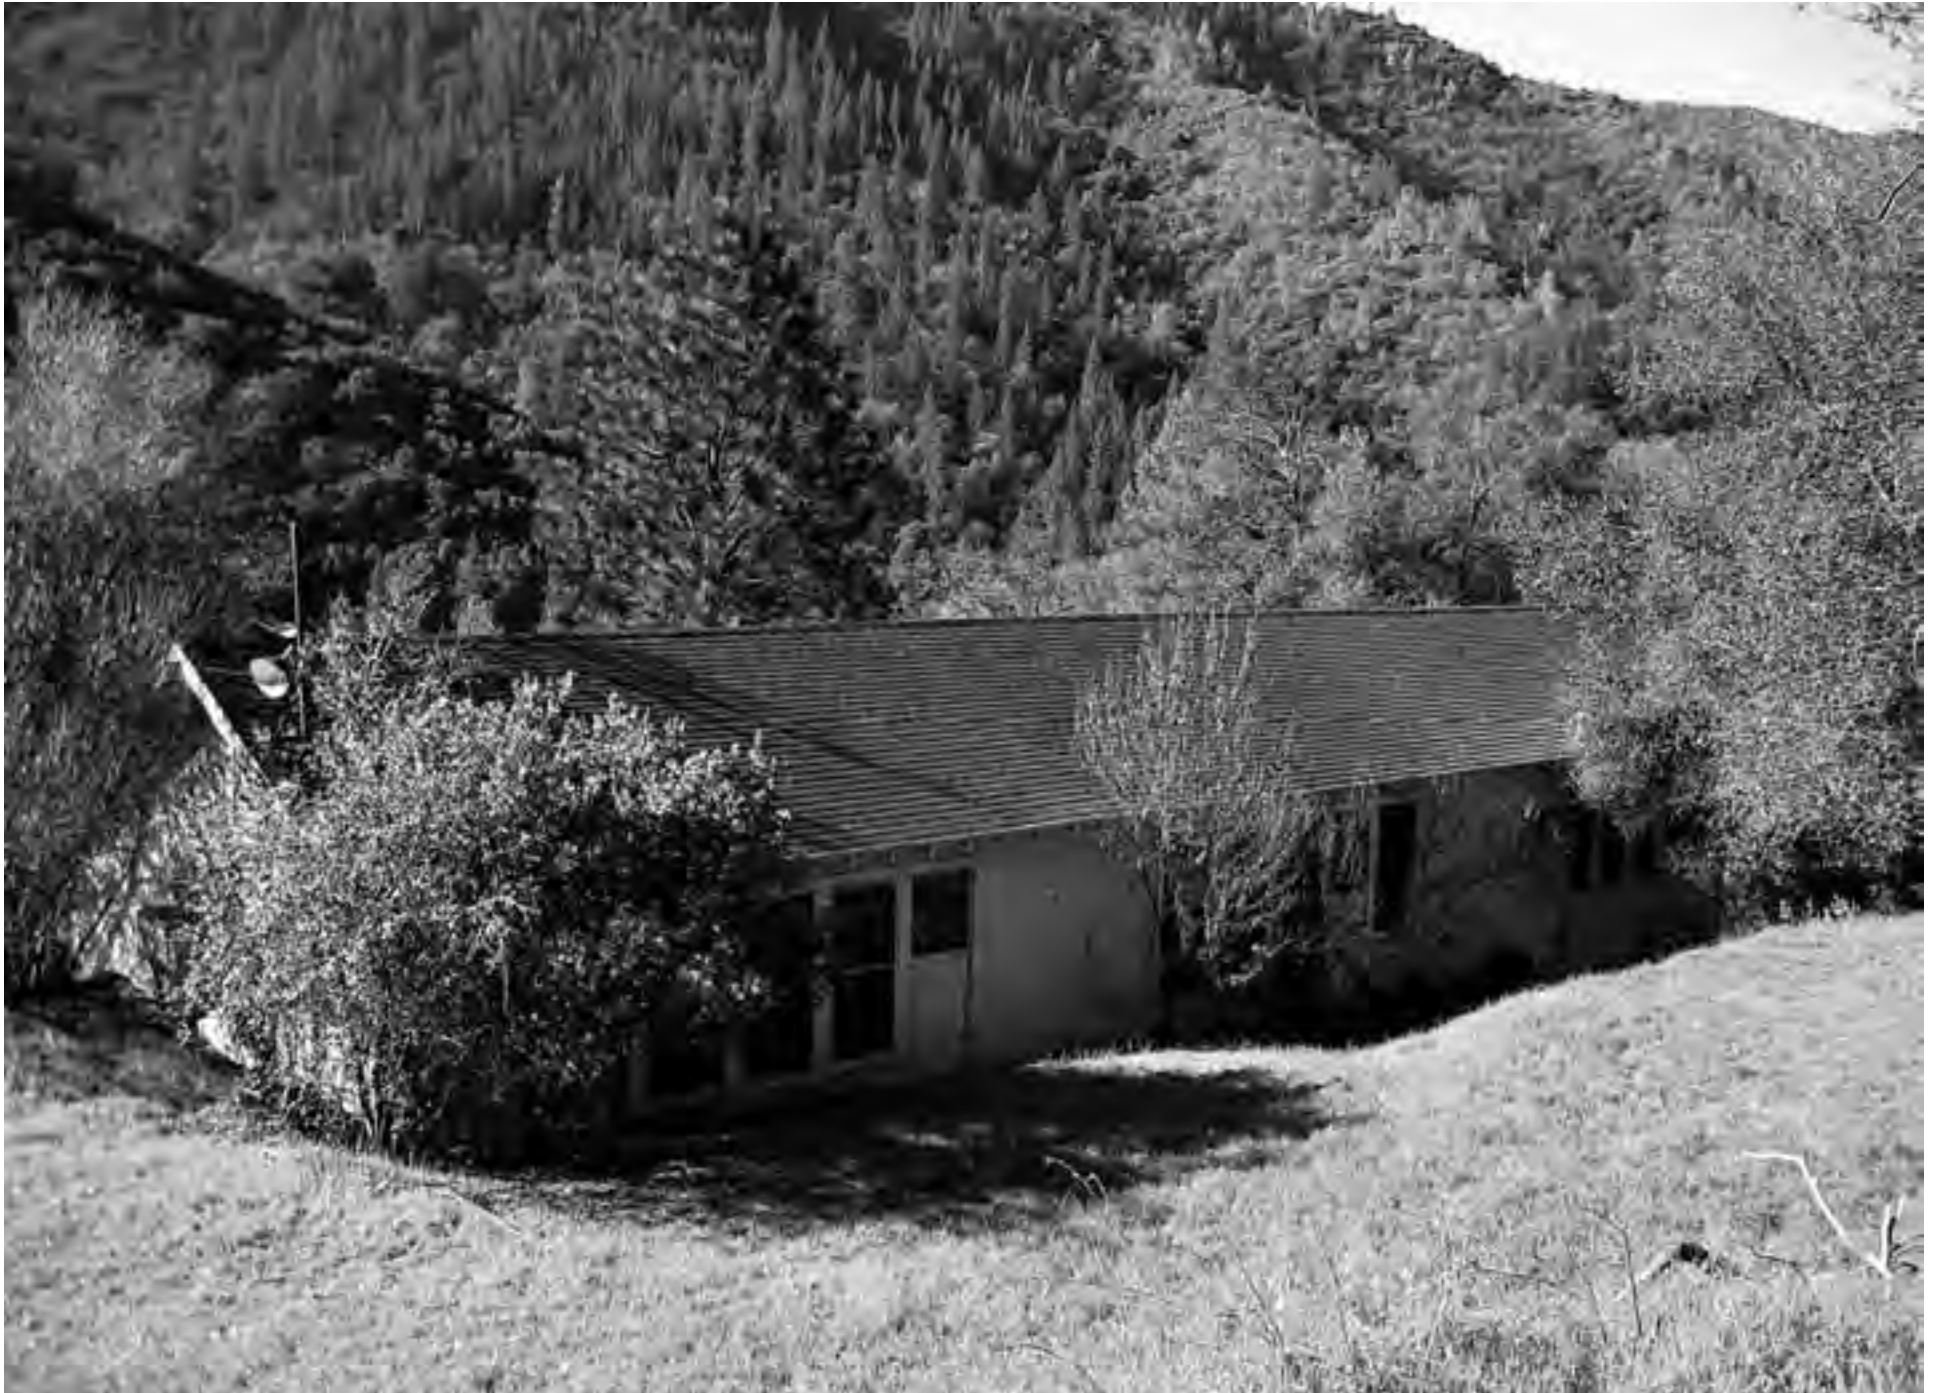
CA\_Mariposa County\_El Portal Old Schoolhouse\_0011

The unbroken north elevation is dominated by evenly spaced groups of five one-over-one double hung windows. (Photo 11) These groupings provide visual reference to the location of the classrooms within the building. The windows have the same consistent wide trim as the smaller hopper windows on the rest of the building. Window

screens were mounted onto the exterior trim for all of the double hung windows at one point in time; however, a number of screens are now missing and several are detached and resting on the ground. In two of the window groupings, a window has been altered to accommodate a short, but wide, emergency door while leaving the top window pane in-tact. (Photo 12) One window within the far west group of windows is boarded entirely to accommodate an air conditioning unit. A vertical seam in the siding presents a visual delineation of where the original building and the addition meet.

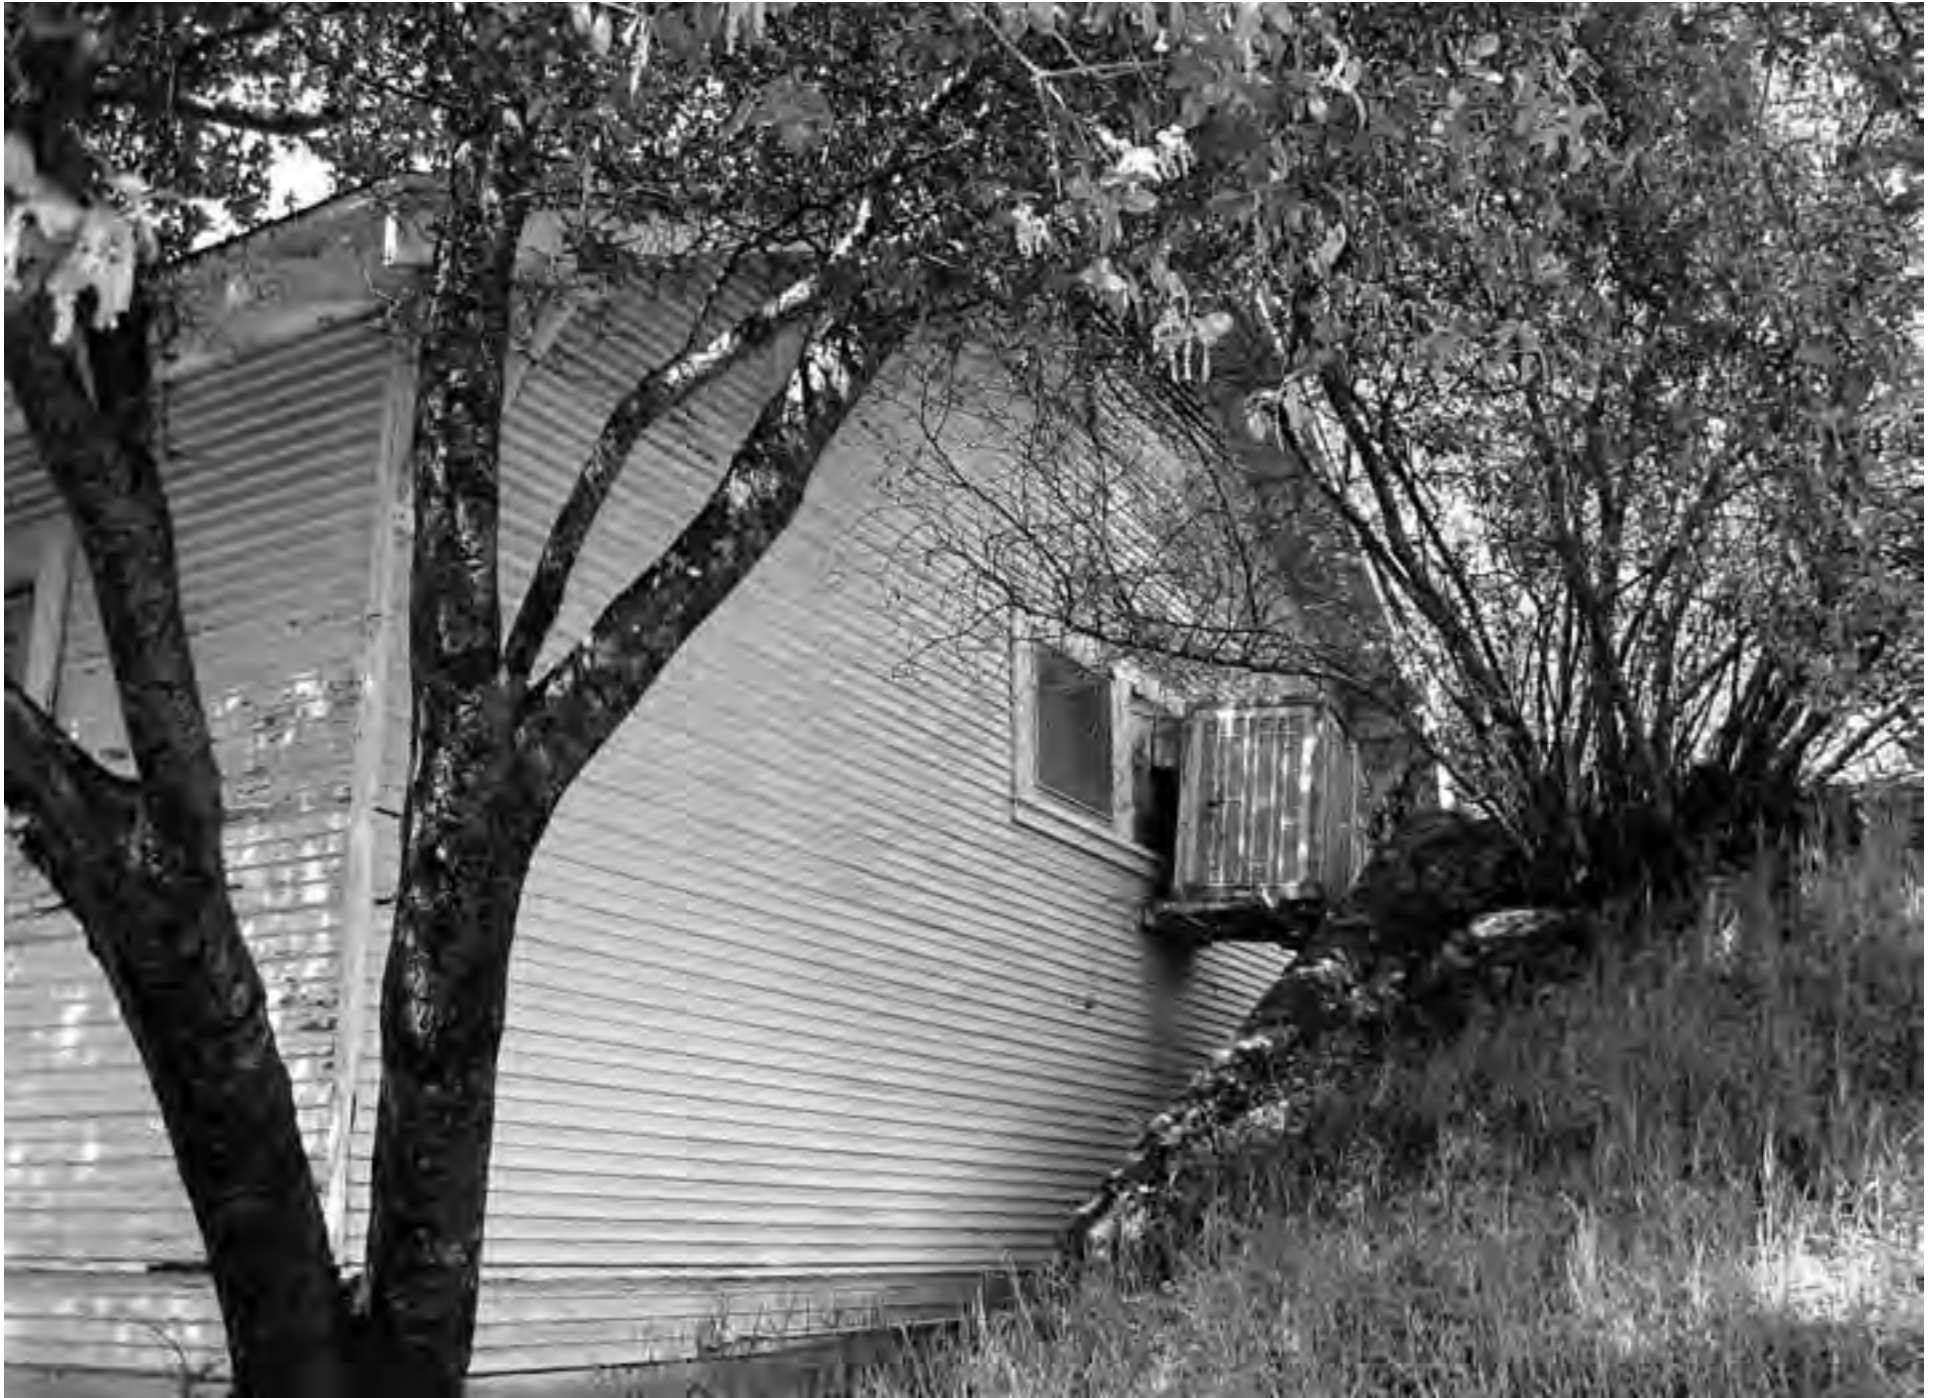
CA\_Mariposa County\_El Portal Old Schoolhouse\_0013

The east elevation of the building is the gable end of the later addition. (Photo 13) A group of hopper windows is centrally located along the façade. The center window has been removed to accommodate an air conditioner, which sits on a metal shelf attached to the façade with brackets and cables. The two flanking windows are intact; however, they have been covered with wire mesh screen.
