**NATIONAL REGISTER OF HISTORIC PLACES
REGISTRATION FORM**

historic name: Wawona Covered Bridge

Description of the Wawona Covered Bridge

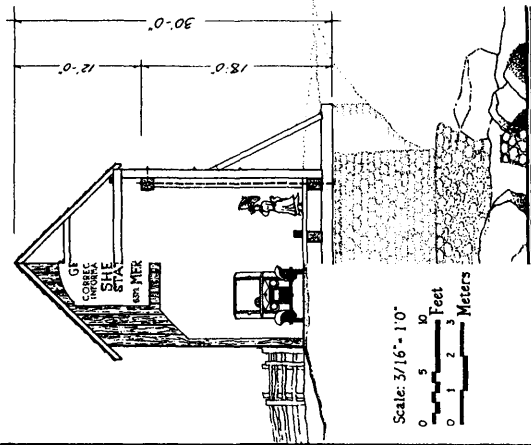
The main truss timbers of the bridge are hand-hewn ponderosa pine. When reconstructed in 1956, historic techniques and tools were employed.

The principal truss members are made of hand-hewn Ponderosa Pine; the vertical and diagonal elements of the truss are made of plain-sawn Douglas fir. The internal frame covering structure is made of plain-sawn Douglas fir with a roof consisting of hand-split sugar pine shakes. The piers and abutments are composed of concrete with stone facing. The property was meticulously rehabilitated in 1956, reusing all salvageable materials and replacing deteriorated materials in-kind, regarding species, dimension, and hand-hewn method of preparation. The bridge remains at its original location in the Wawona region. Because of this accurate approach to the bridge retains integrity of design, location, workmanship, rehabilitation, feeling, and association. The interior structure is currently in good condition. The covering structure is in good condition, with many original siding boards extant.

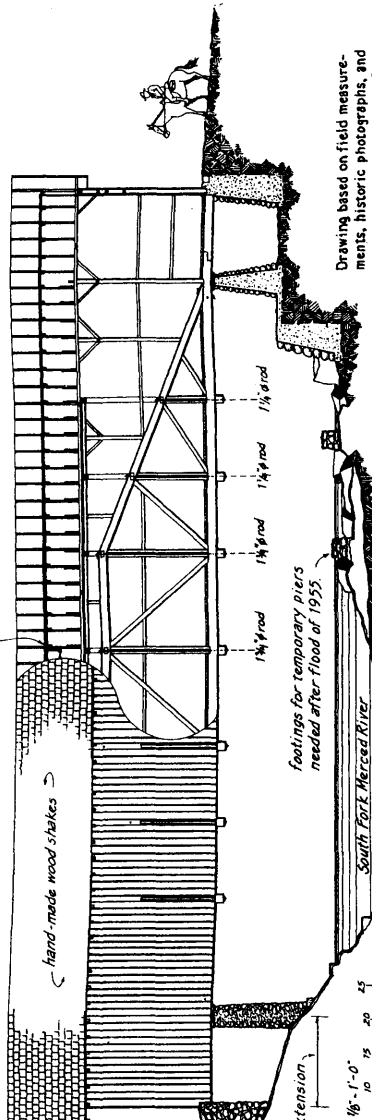
ELEVATION / SECTION

hand-made wood shakes

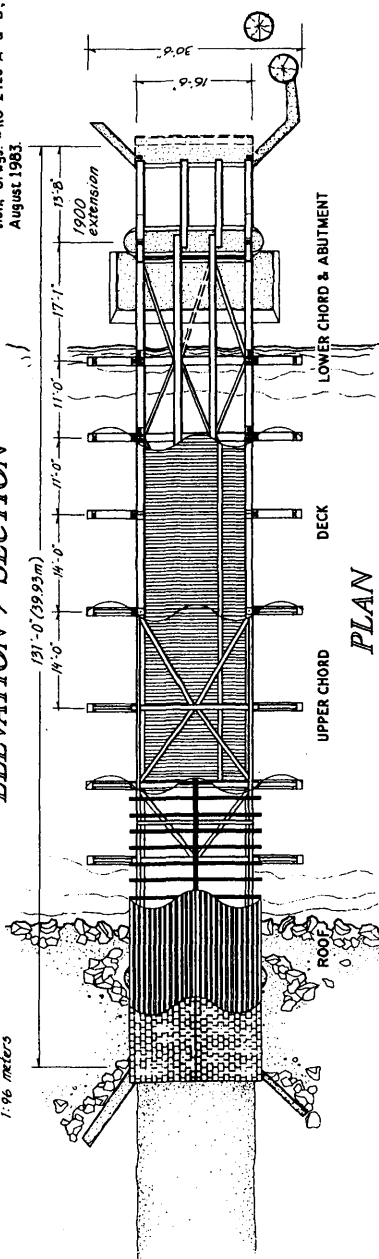
ELEVATION / SECTION

Drawing based on field measurements, historic photographs, and original design documents from the Federal Highway Administration, Drawings # RG 2420-A & B, August 1983.

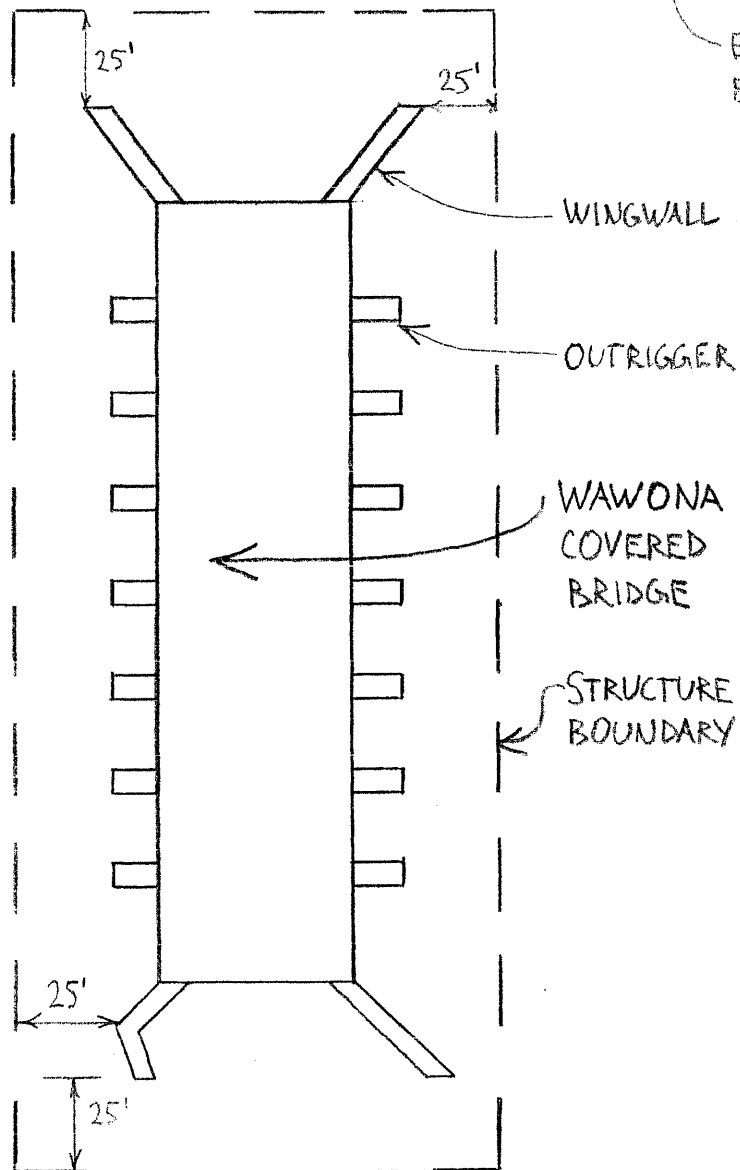
WINGWALL

OUTRIGGER

The 25-foot buffer around the footprint of the bridge was chosen to include projections of the bridge beyond the deck and covering structure, such as the abutments, wingwalls, and outriggers.

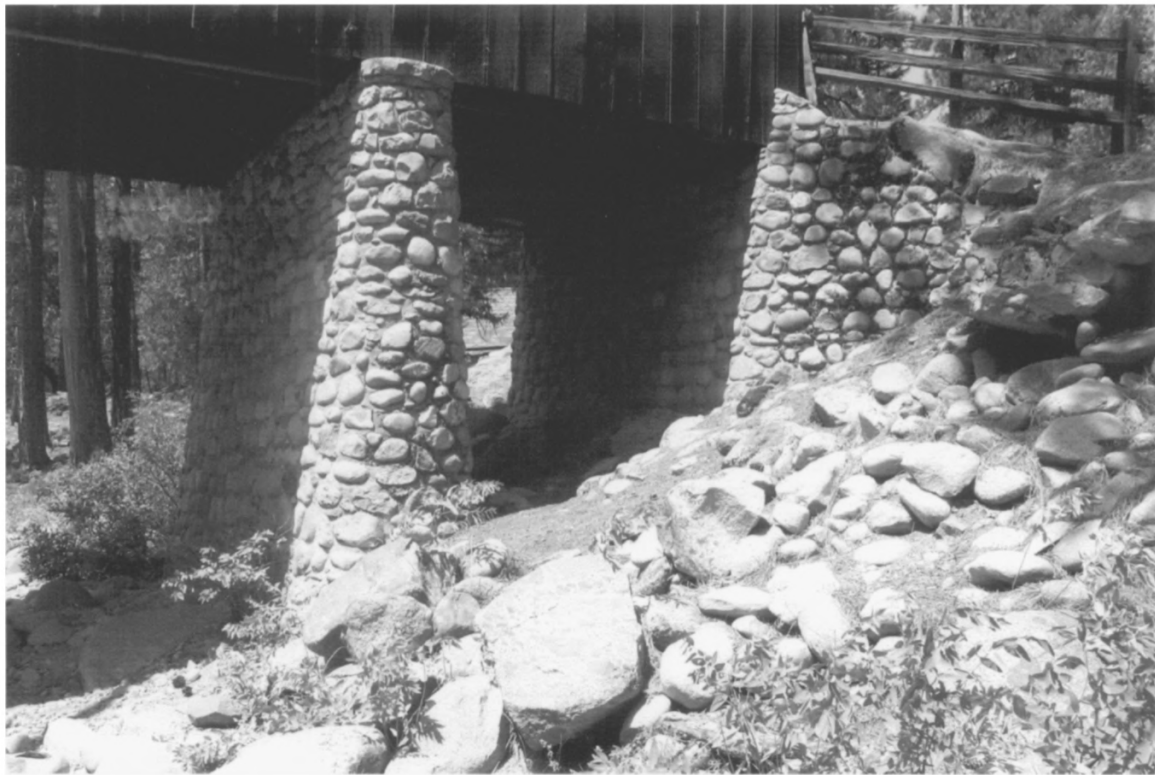
Photo 6

Detail of North Pier & Abutment

Several alteration campaigns have compromised the original appearance of the bridge. The 1956 rehabilitation changed the appearance of the abutments, which are presently composed of concrete faced with stone. The stringers replaced in 1983 duplicated the original dimensions accurately, but used a faux method of wood preparation, in which the timbers were sawn first and then dressed on the surface to give an appearance of hand hewing. The 1983 structural strengthening campaign is the only work documented by existing construction drawings. These drawings indicate that the grade of steel used in the existing tensioning rods could not be verified, thus the steel reinforcing rods were replaced with sizes from 1 1/4" to 1 3/4" in diameter, tied to the wood structural elements using 1" bearing plates and hex nuts. It is not clear from historic photographs of the first bridge if the reinforcing rods used a similar system of attachment to the wood structure.

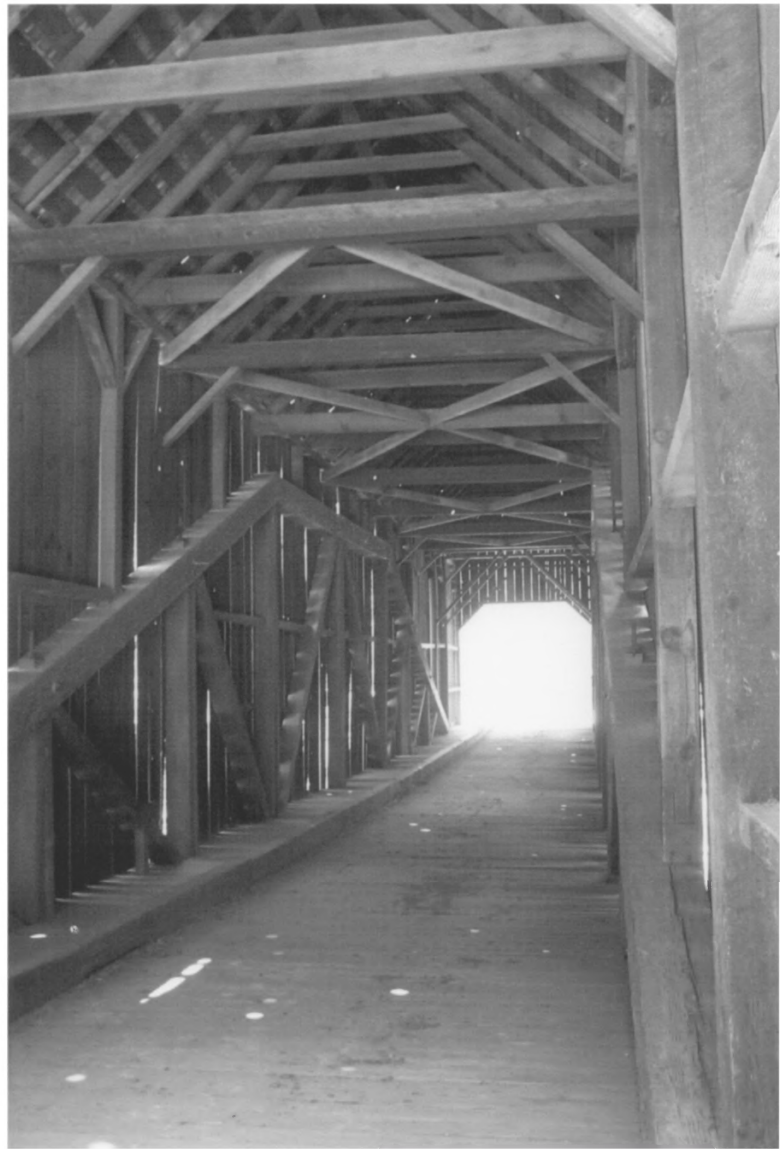
Wawona Covered Bridge
Mariposa County, CA
Yosemite National Park
Seth Bergstein
August 2002
Looking North
Interior Detail
Photo 7
