PERRY'S VICTORY AND INTERNATIONAL PEACE MEMORIAL, THE 1993 PARK-WIDE ARCHEOLOGICAL SURVEY OF SOUTH BASS ISLAND, OTTAWA COUNTY, OHIO

Archeological Report 8

NATIONAL PARK SERVICE
Midwest Archeological Center

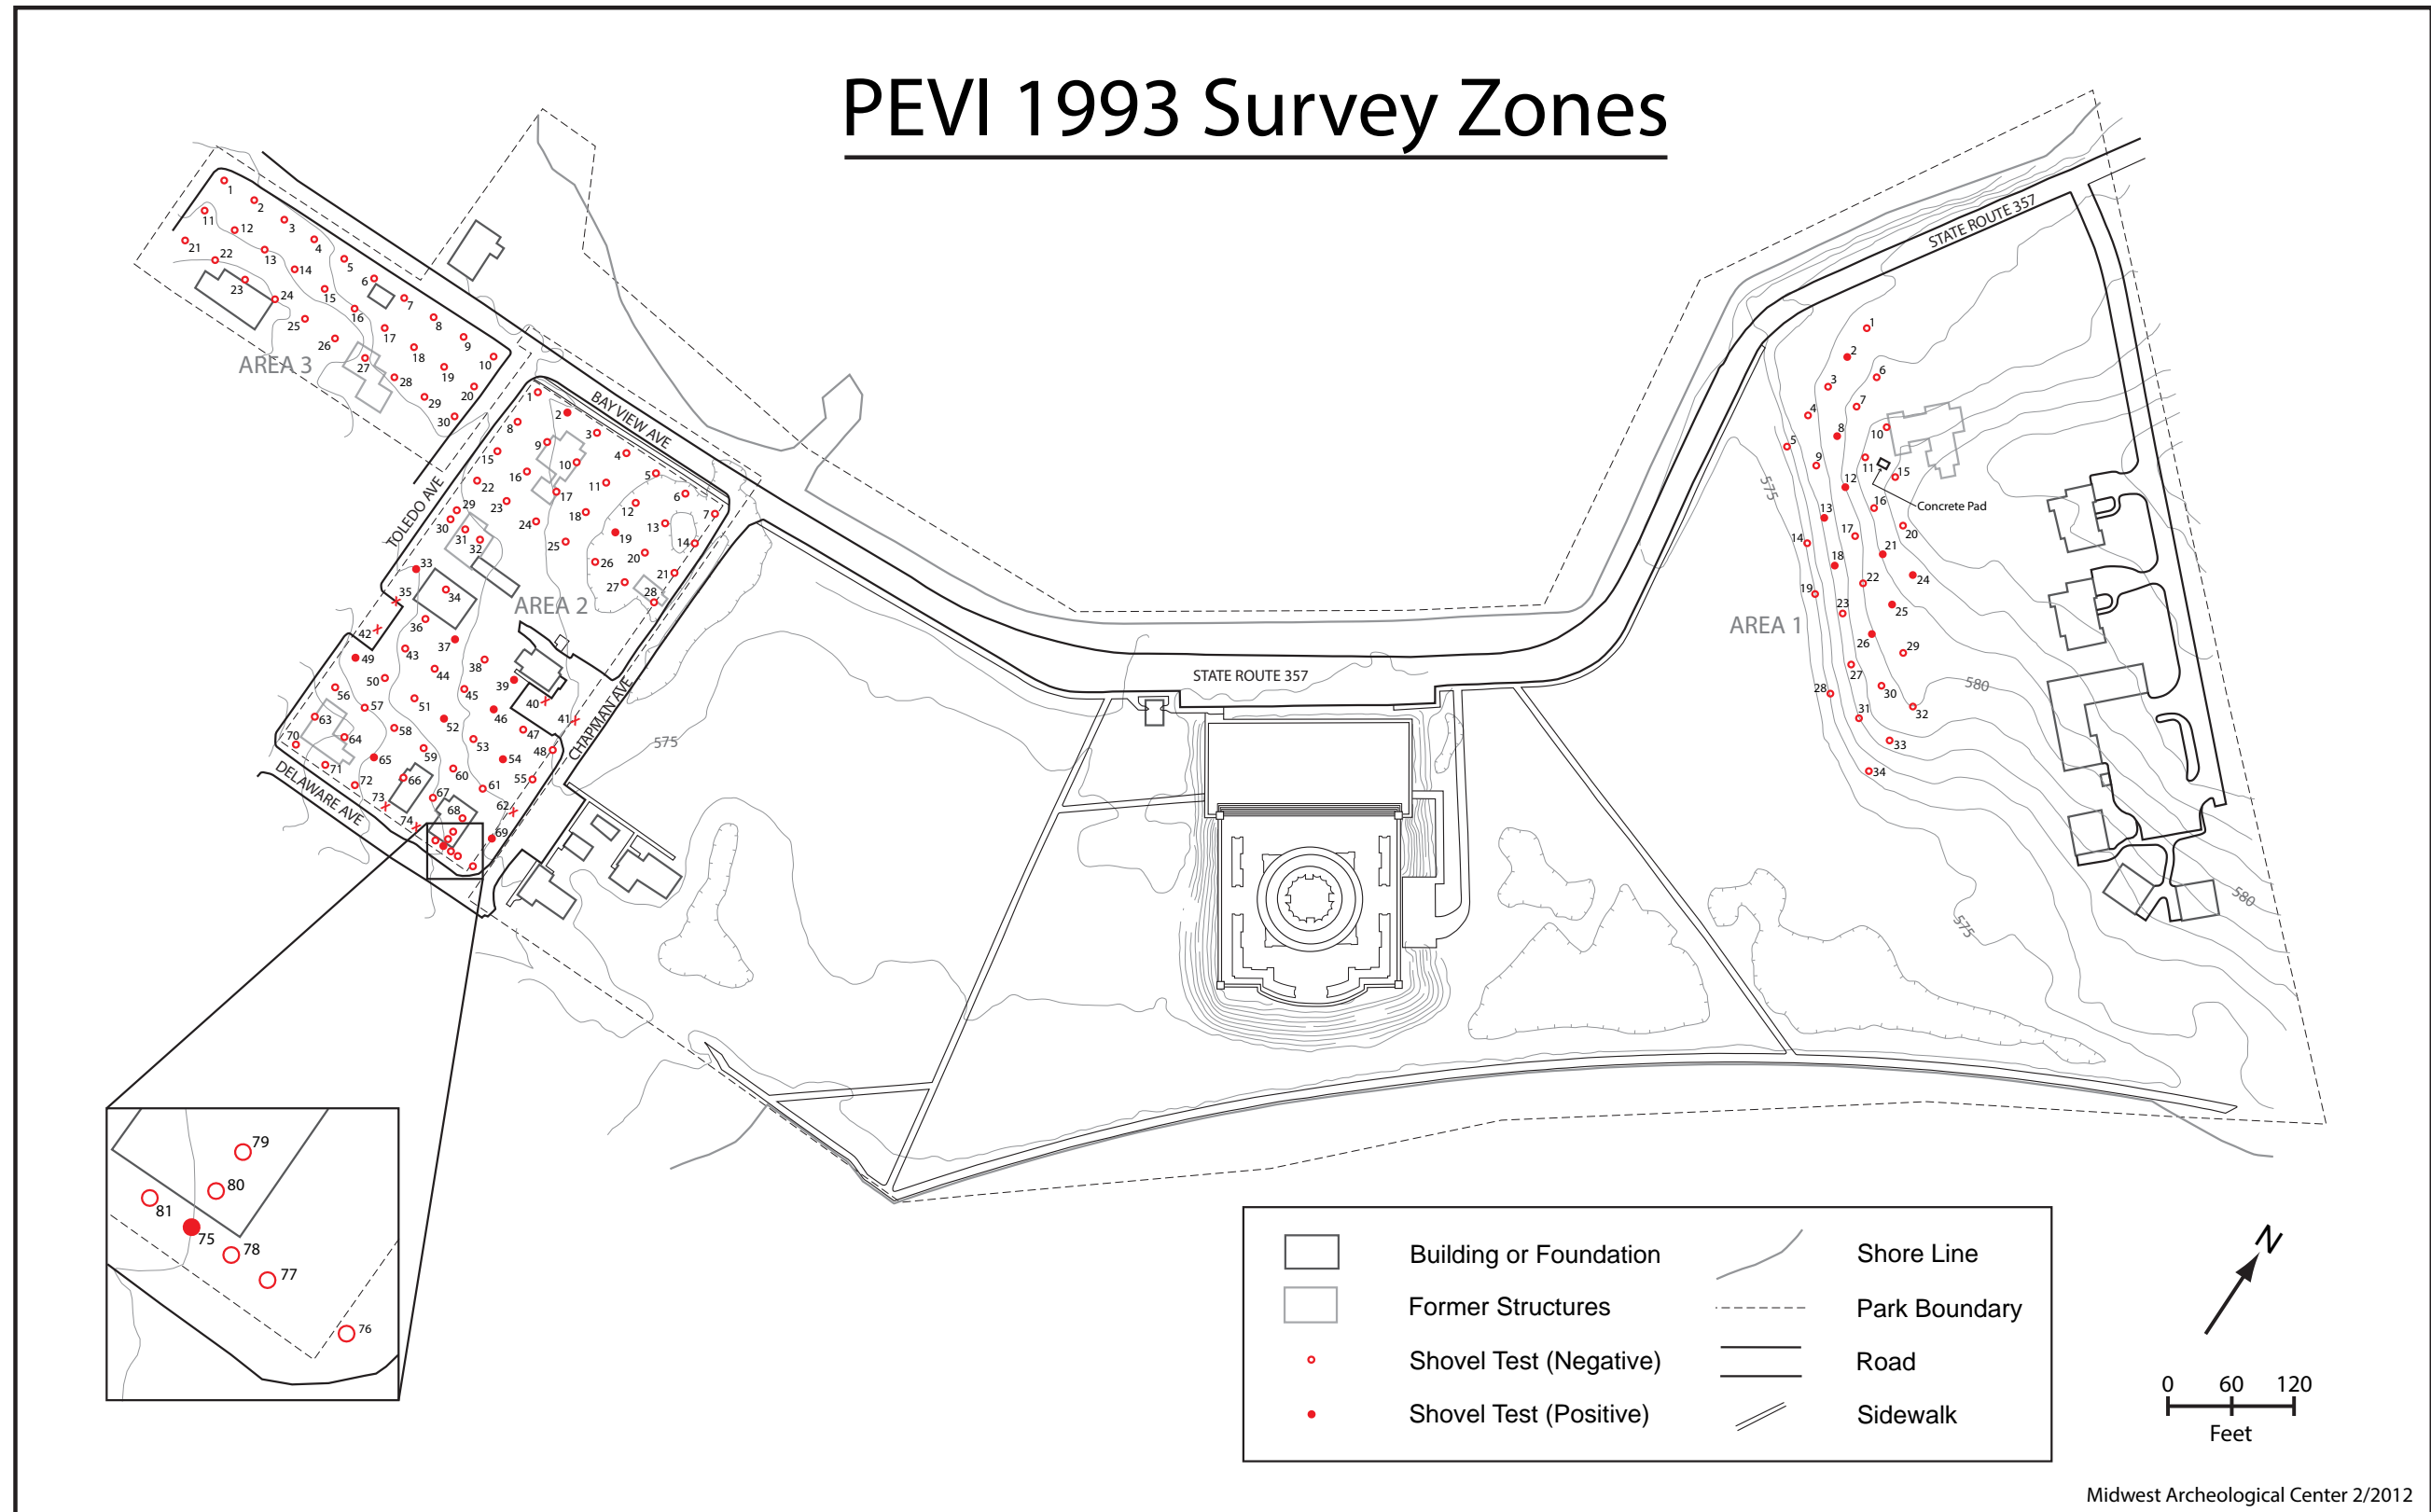
Figure 4. The 1993 Survey Zone Showing Extant and Former Structures; Areas 1, 2, and 3; and the Shovel Test Grids

PEVI 1993 Survey Zones

The inventory survey methods were consistent for all three areas. Shovel tests were aligned along parallel transects. Shovel tests and transects maintained a 10-m interval. Shovel tests measured an average of 30 cm in diameter and were dug until sterile subsoil clay or bedrock was encountered. The contents of each shovel test were screened through one-quarter-inch hardware mesh. All recovered cultural materials, with the exception of recent cultural debris such as plastic, were retained and marked according to provenience. Coal, when observed, was noted then discarded. The location of each shovel test was plotted on project drawings (Figure 4).

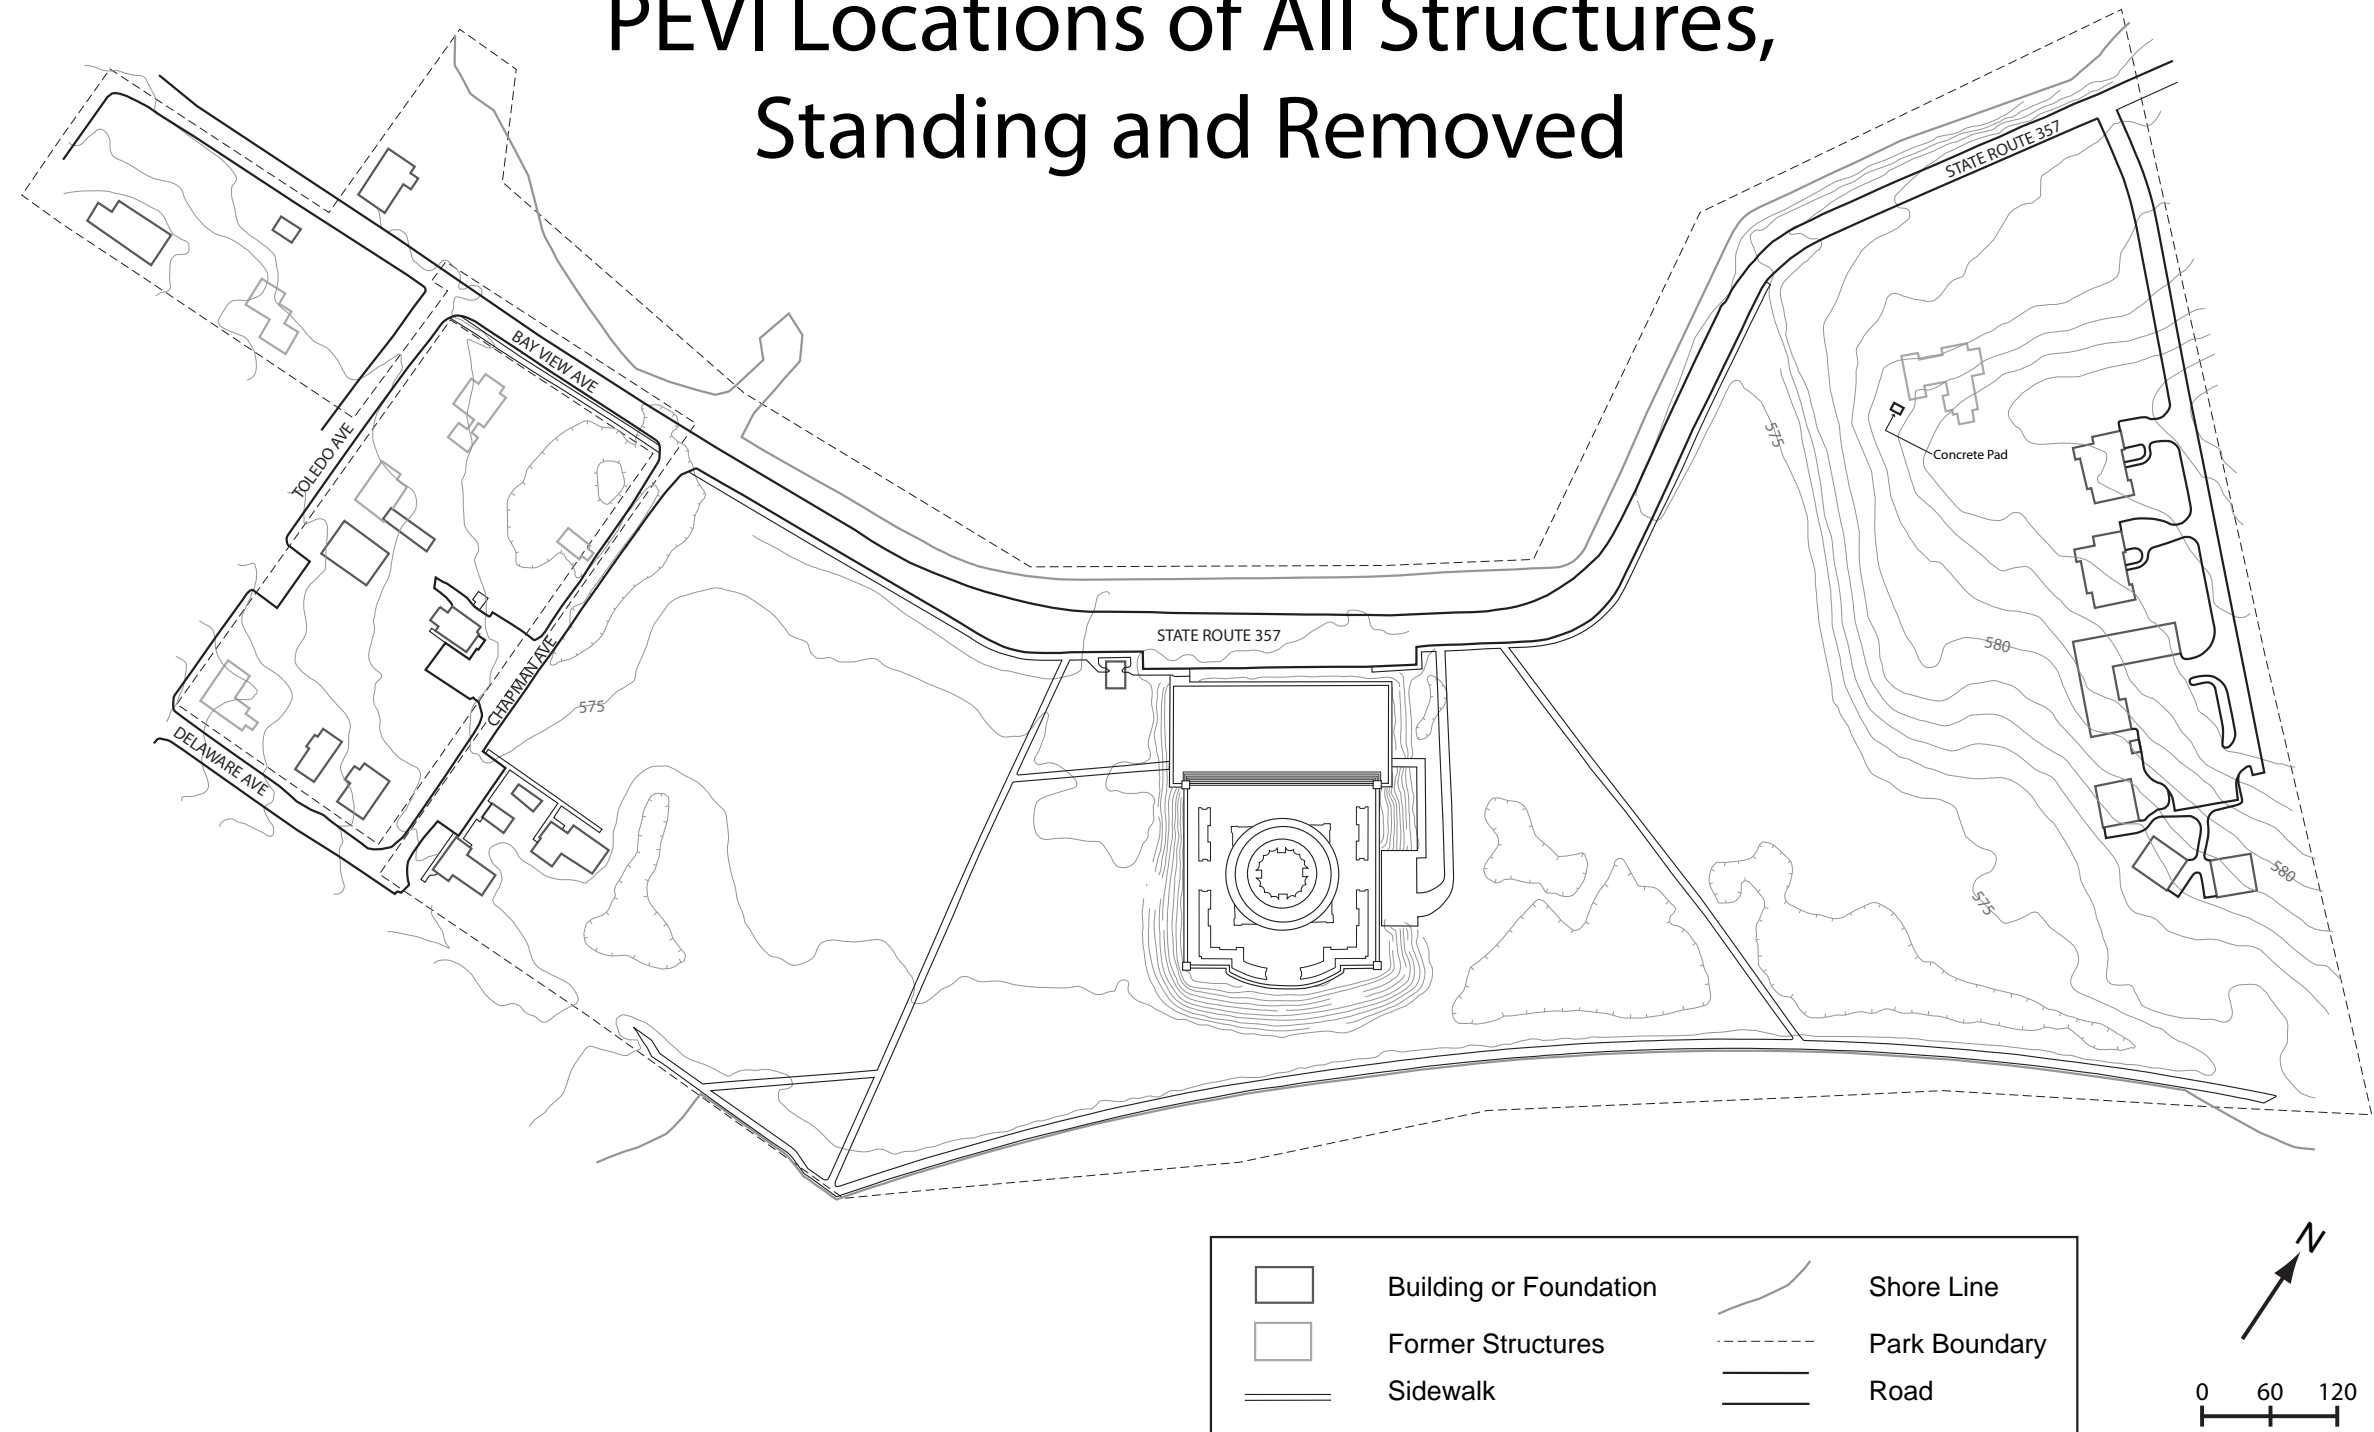
Figure 5. The locations of all structures, standing and removed.

PEVI Locations of All Structures, Standing and Removed

- Structures recently removed from Area 2 include:
- the Barnhill House, formerly fronting Toledo Avenue, was relocated,
- the Bergstrom House, formerly fronting Toledo Avenue, was demolished,
- the Mitchell House, at the corner of Toledo and Bay View Avenues, was burned,
- the Hemphill House, at the corner of Bay View and Chapman Avenues, was relocated,
- the Sutphin House, formerly fronting Chapman Avenue, was relocated,
- the Prendergast House, at the northwest corner of Chapman and Delaware Avenues, was relocated just across the street at the southwest corner of Chapman and Delaware Avenues.

Area 3, which represents the western boundary of the park, was once the location of five structures and two trailers. Three structures were relocated and a fourth, the Log Cabin Restaurant, was demolished, while the two trailers were burned. The nature of the fifth structure, indicated on the map as only a foundation, is unknown. Area 3 now consists of a broad expanse of lawn with sparse cultural plantings.

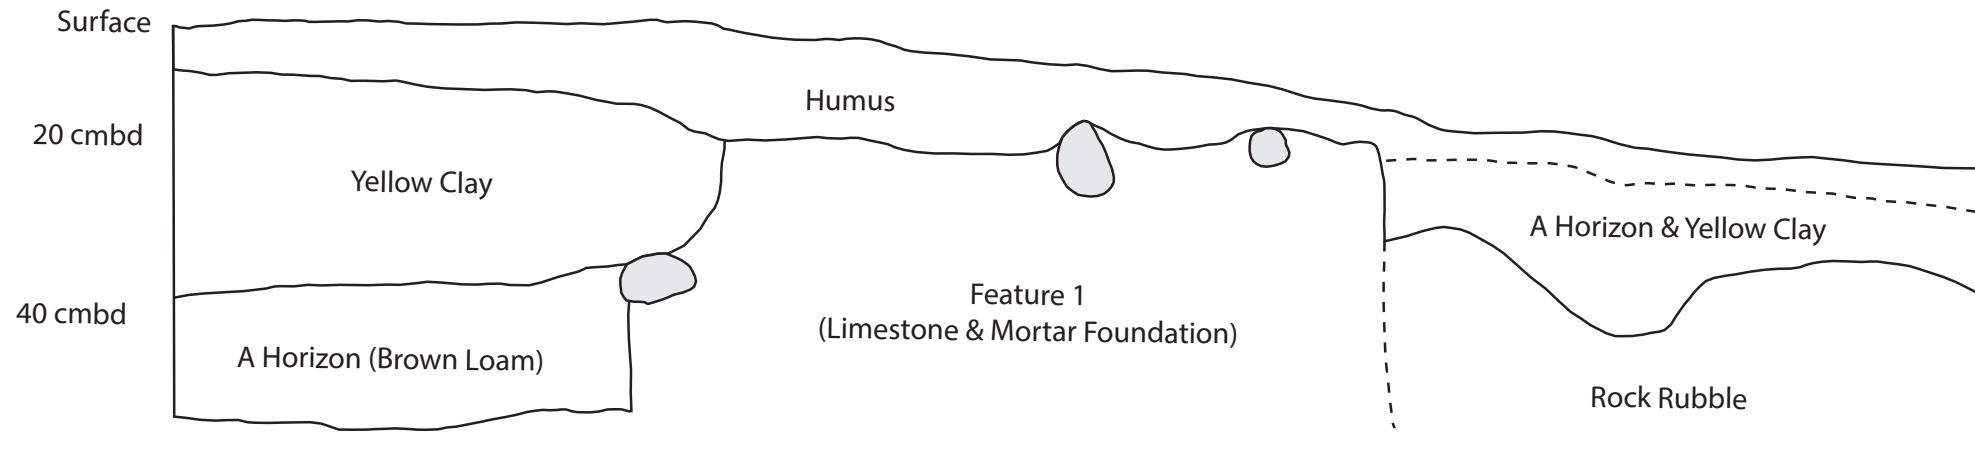
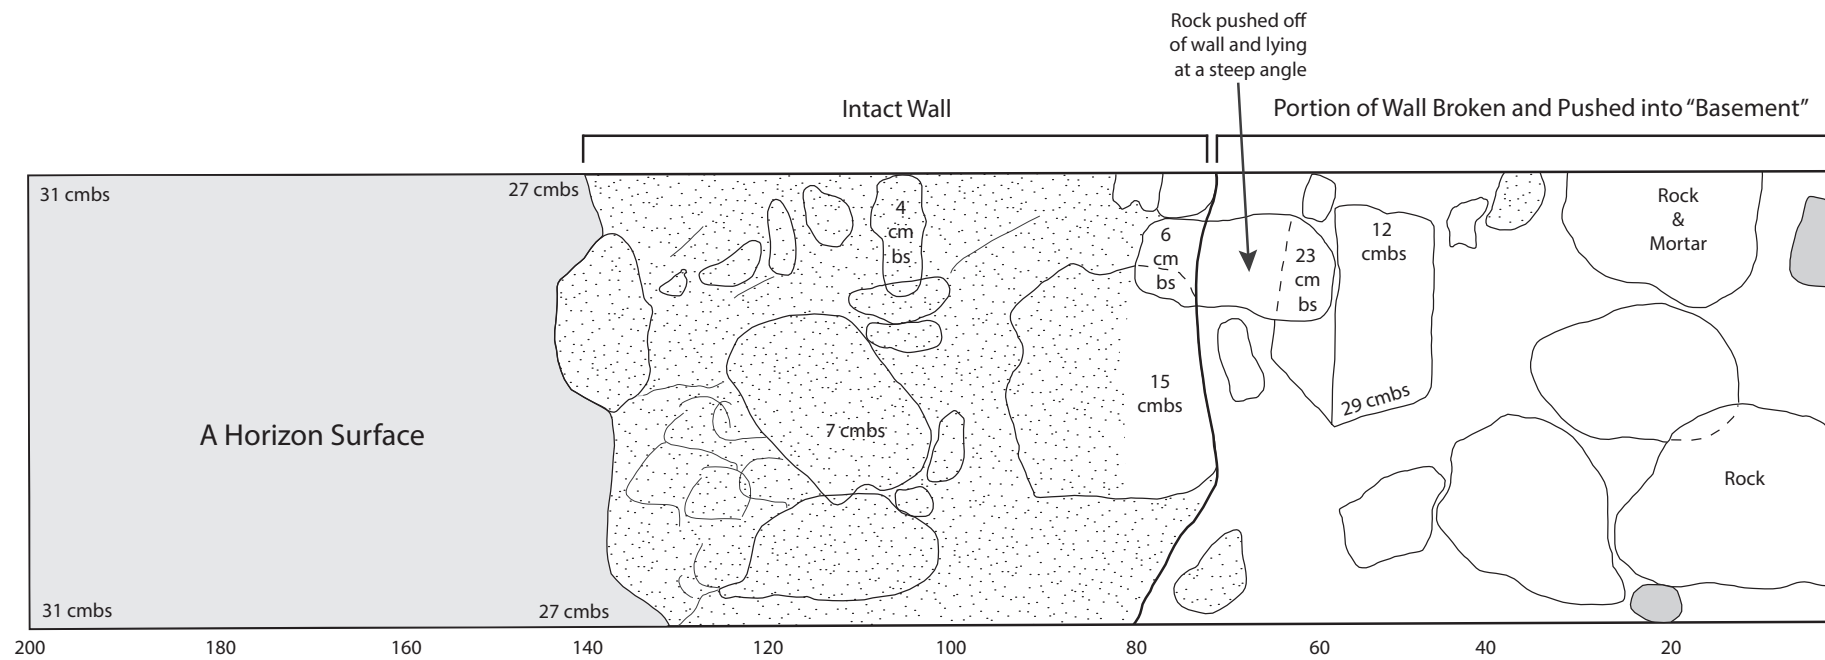
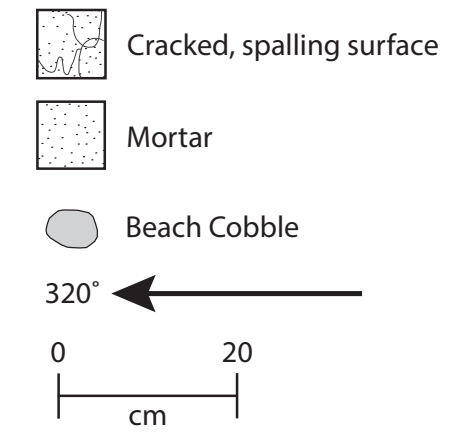
Figure 6. Plan and Profile Views of Feature 1 in Test Unit 1 at Site 1 (33OT244).

PEVI Feature 1993-1

PEVI Site 1993-1
Area 1
Test Unit 1
Feature 1
East Wall Profile
5/5/1993

PEVI Site 1993-1
Area 1
Test Unit 1
Foundation
5/5/1993

A 2 m (grid north-south) by 0.5 m (grid east-west) trench was excavated into the northeast bank of the house depression and was designated Unit 1. Level 1 (0-30 cmbs) consisted of a 5 cm humus layer above a 25 cm layer of yellow clay in the northern third of the unit, a layer of dolomitic limestone rubble and decaying mortar in the center third of the unit, and a mixture of A horizon brown loam and yellow clay in the southern third of the unit. Pea-gravel occurred throughout. Level 1 produced sparse artifacts including a metal object resembling a key plate from a trunk, cut nails (including “floor” or “finishing” nails), wire nails, flat glass, green bottle glass, faunal materials, a small shell, a brick fragment, and sherds from a terra-cotta flower pot (from the southern third

The limestone and mortar rubble was designated Feature 1. The brown loam/yellow clay/decaying mortar fill surrounding the feature was screened but no artifacts were recovered. The highest exposed point of the feature (plan-view) was 4 cmbs; the lowest exposed point of the feature (plan-view) was 15 cmbs. The feature was excavated to a total depth of 50 cmbs. Feature 1, as exposed in Unit 1, is 140 cm long (north-south) and 50 cm wide (east-west). While Feature 1 is likely much larger than its exposed area suggests, time constraints did not allow for further excavation. No builder's trench was evident. It appears that a small foundation was excavated and the limestone blocks were placed directly on it (Figure 6).

The focal point of Area 1 is the house depression (Feature 1) at site 33OT244. This feature represents the remains of a house foundation consisting of an unknown number of courses of local Dolomitic limestone, thickly mortared, which apparently have been pushed into the former basement area. It appears that a small foundation was excavated and that limestone blocks were placed directly on it and then mortared into place. This feature is unusual in that foundations are rare on this part of South Bass Island as flooding is a constant threat. Most houses are built on piers, though excavated foundations are not unknown. Two major questions exist regarding this feature. First, can this feature be associated with a particular structure? Second, what is the purpose of the boulder and concrete pad that currently mark the site?
