VOLUME III OF VI: OUTER ISLAND CLR/HSR

**CULTURAL LANDSCAPE REPORT, HISTORIC STRUCTURE REPORT
AND
ENVIRONMENTAL ASSESSMENT**

LIGHT STATIONS OF MICHIGAN ISLAND, OUTER ISLAND, DEVILS ISLAND,
LONG ISLAND AND SAND ISLAND

prepared by
Anderson Hallas Architects, PC
Golden, Colorado

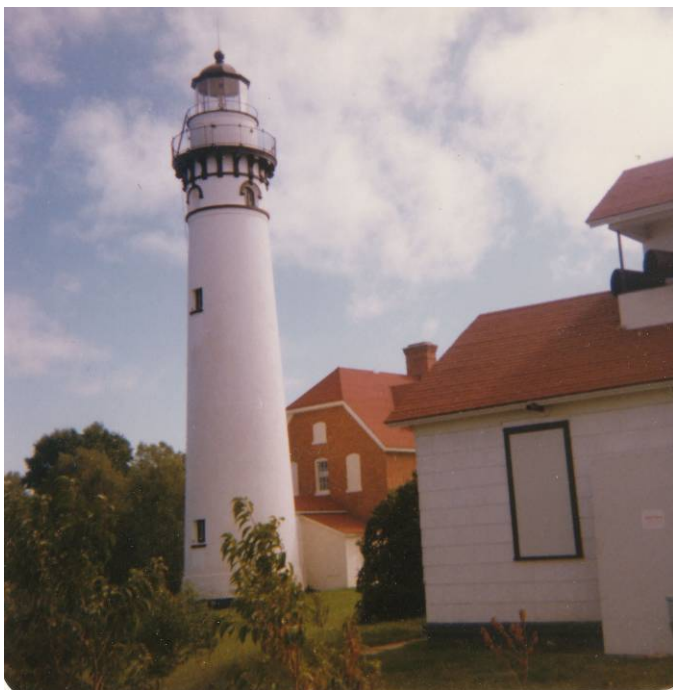
Site Image OI-23: Outer Island Tower, Keepers Quarters, and Fog Signal Building. Note encroaching vegetation in foreground and behind Tower and Keepers Quarters, c. 1977 (Source: NPS APIS Archives)

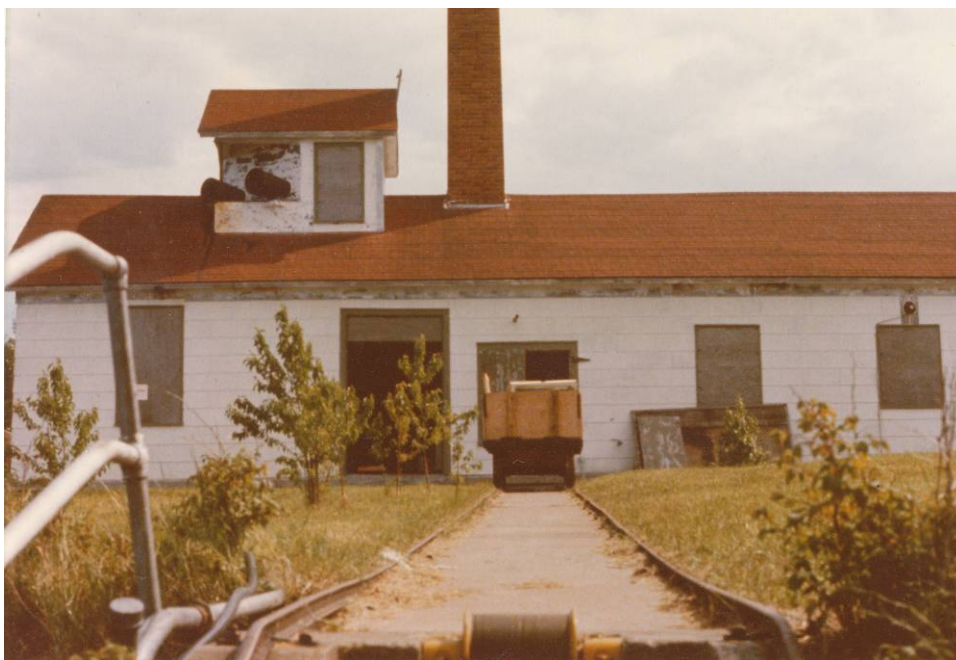
Site Image OI-24: Outer Island Fog Signal Building. Note encroaching vegetation in foreground, c. 1977 (Source: NPS APIS Archives)

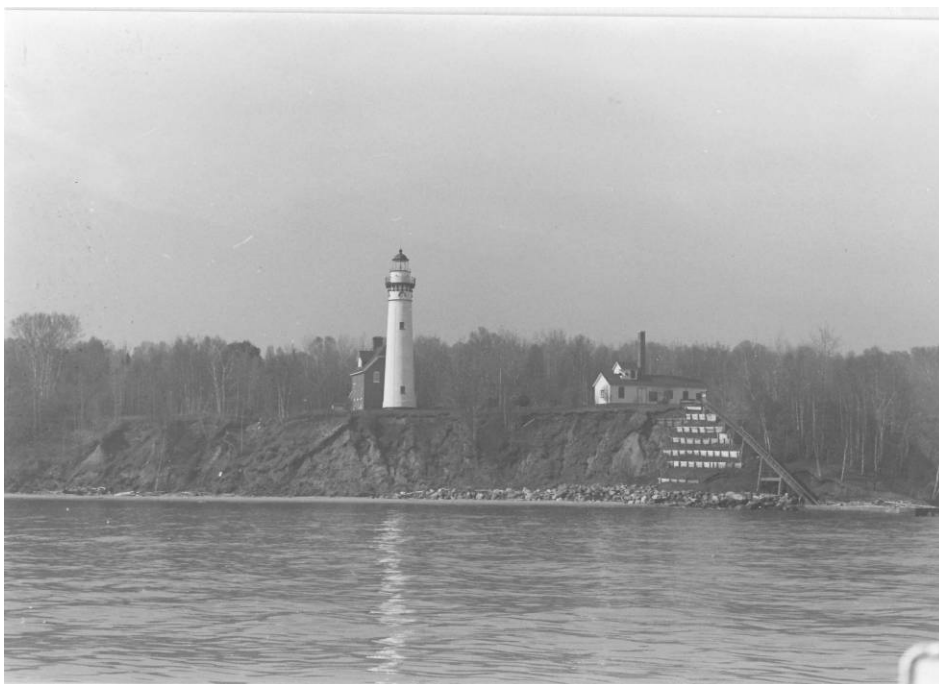
Site Image OI-25: Outer Island Tower, Keepers Quarters, Fog Signal Building. Note bank stabilization work to the left of the tramway, 1981 (Source: NPS APIS Archives)

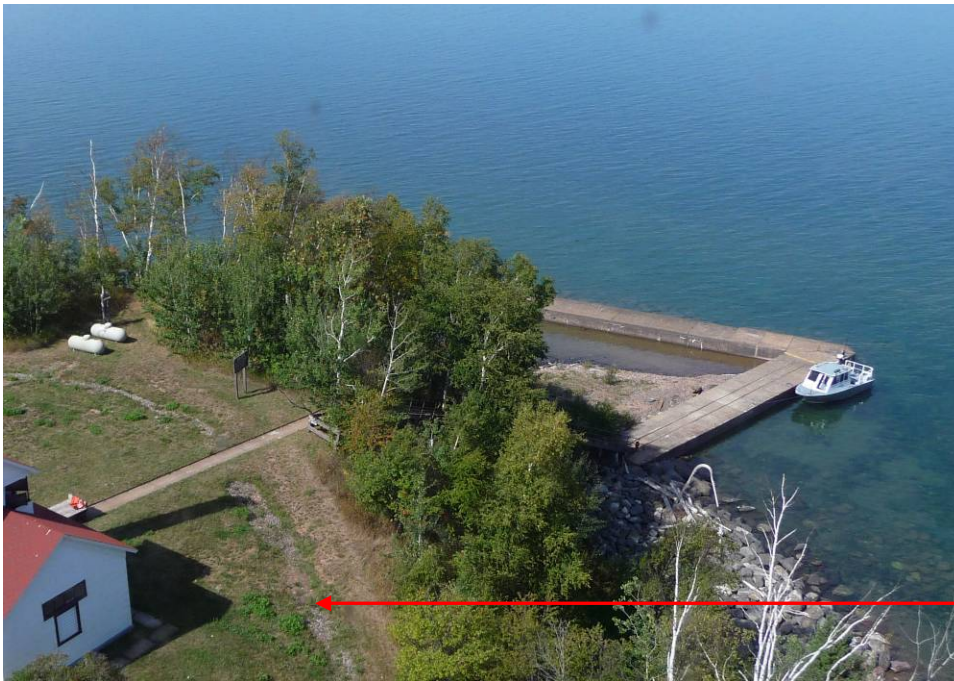
Analysis. The spatial composition of the light station reservation has significantly changed from the island's early history.. While the spatial organization of the light station's buildings, structures, and small scale features remains in place from the period of significance, the surrounding clearing has been greatly reduced due to forest encroachment (Site Image OI-24, OI -25). Automation of the light eliminated the need for a manned presence on the light station. After the USCG removed this presence, the grounds and reservation were not cleared as extensively or as regularly. Spatial composition is an important contributing feature to the cultural landscape, and the encroachment of the forest and reduction in the cleared area has diminished the integrity of this feature and the light station.

Site Image OI-26: View west from Light Tower with boat dock, tram tracks, and concrete walk from Fog Signal Building to the Keepers Quarters: above, after 1934 (Source: NPS APIS Archives); below, 2009 (Source: MBD P1010893.JPG)

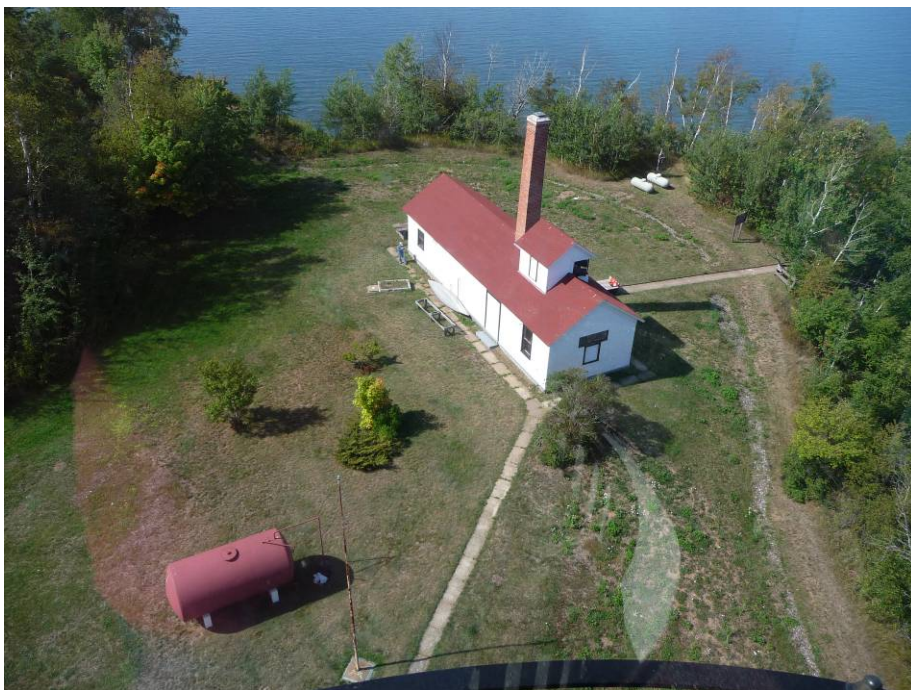
Site Image OI-27: Light station grounds from Light Tower, looking west to Fog Signal Building. Note the vegetation on the embankment, 2009 (Source: MBD P1010887.jpg)

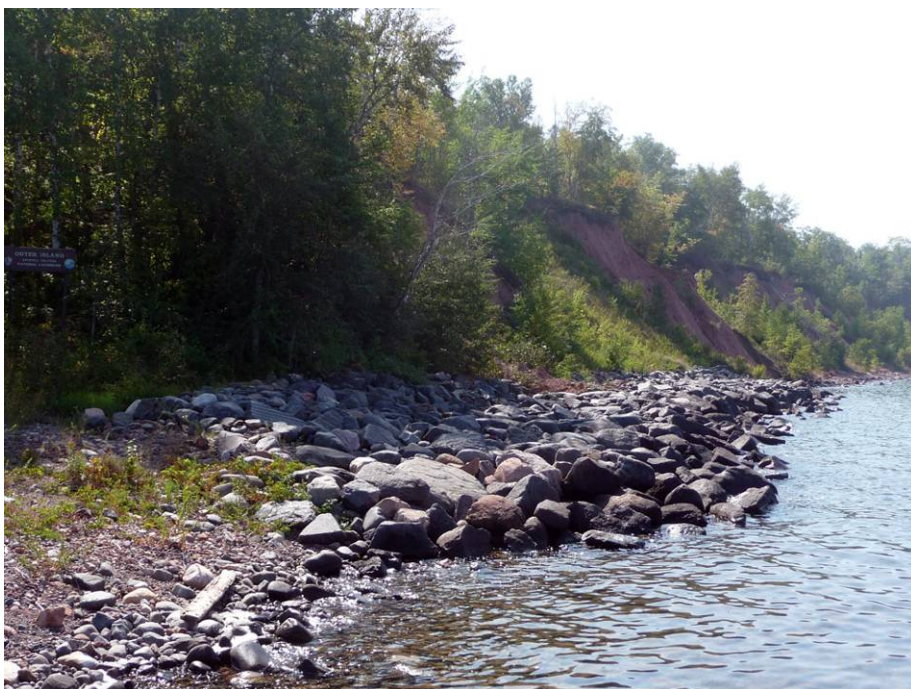
The topography of the light station reservation and light station grounds is a contributing feature. The visual character of the erosion control work has diminished the integrity of the cultural landscape.

Site Image OI-30: Banks and shoreline with erosion control and stone revetment looking west from the dock, 2009 (Source: MBD P1010839.JPG)

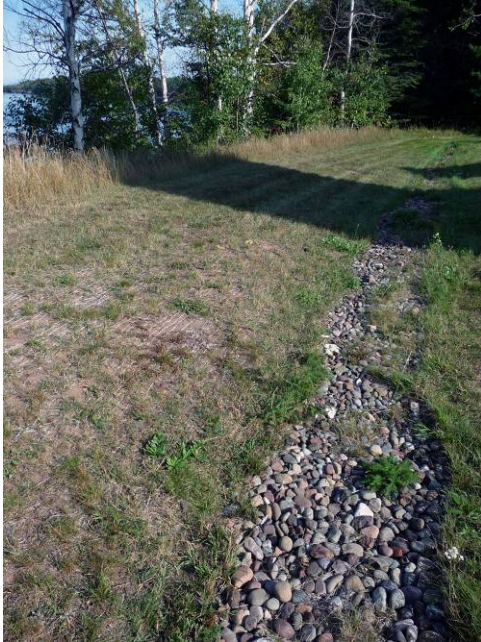
Site Image OI-31: Drainage swale along northern edge of the site, view east from north of the Outer Island Tower, 2009 (Source: MBD P1020009.JPG)

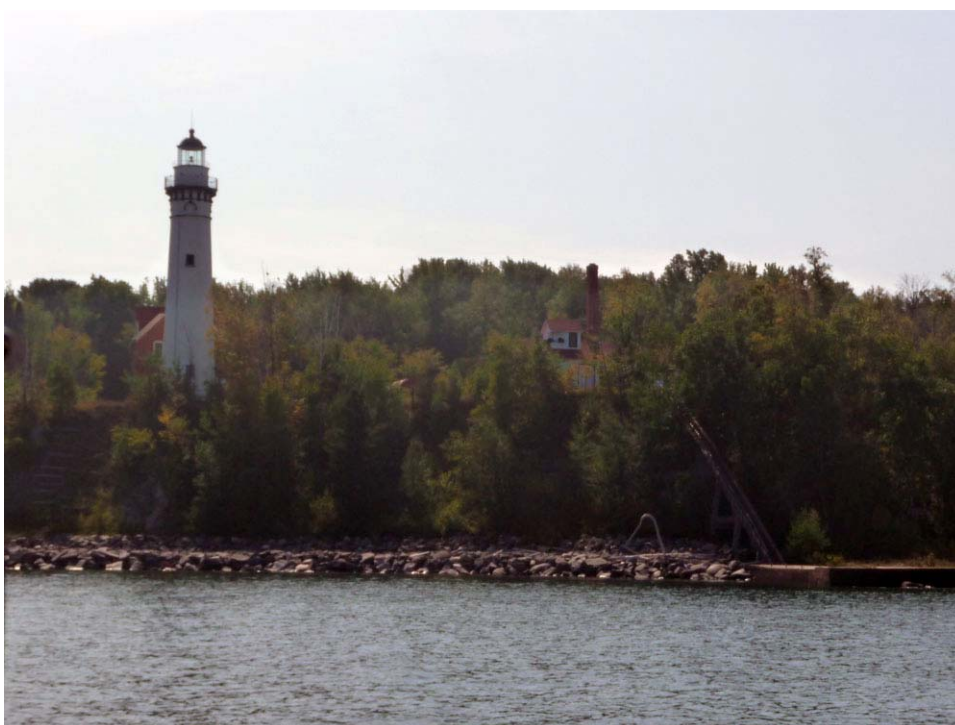
Views and vistas are an important contributing feature to the cultural landscape of the Outer Island Light Station. The loss of these diminishes the integrity of the light station.

Site Image OI-33: View to Tower from Lake Superior; above, 1891 (Source: NPS APIS Archives); below, current view obscured by encroaching vegetation, 2009 (Source: MBD P1010831.JPG)

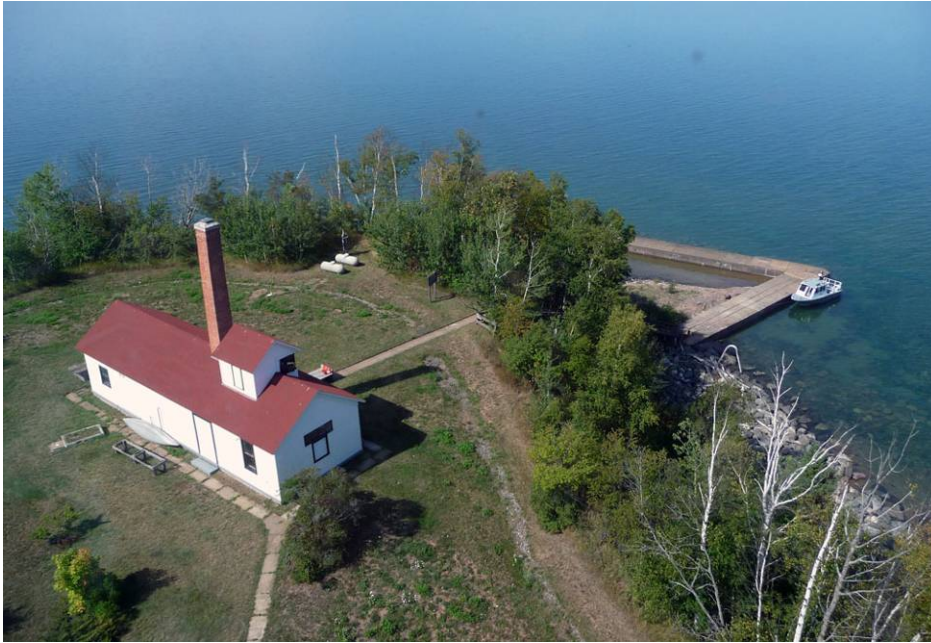
In general, circulation at the light station is in good condition. The condition of individual features is discussed within their respective sections.

Site Image OI-37: View west from Tower with boat dock, tram tracks, and concrete walk from Fog Signal Building to the Keepers Quarters, 2009 (Source: MBD P1010893.JPG)

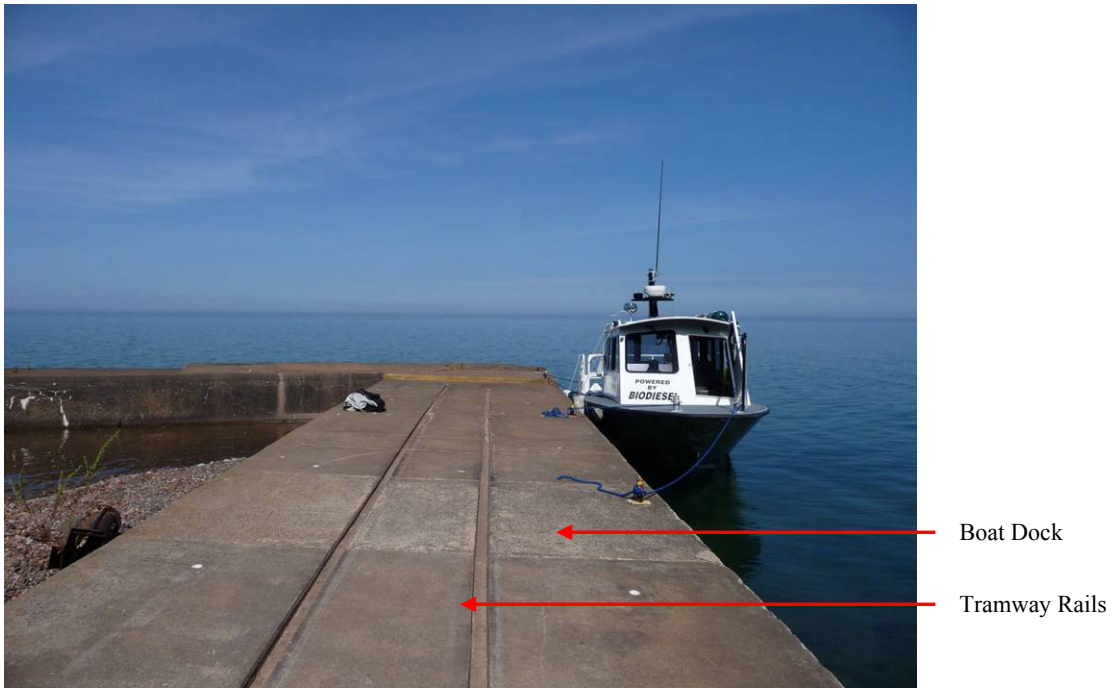
Existing Condition. The concrete boat dock is 14' wide and extends from the shore in an 'L' shape to the north (100') and then jogs west (200'), to form the breakwater. The existing dock was constructed in 1958. It is a steel sheet pile structure in-filled with stone rubble, capped and sided with concrete. The top of the boat dock has approximately 80' of tram rails set into the surface, which are connected to the inclined tramway. The boat dock is in good condition.

Site Image OI-39: Concrete boat dock viewed from the south, tram tracks in center, 2009 (Source: MBD P1010860.JPG)

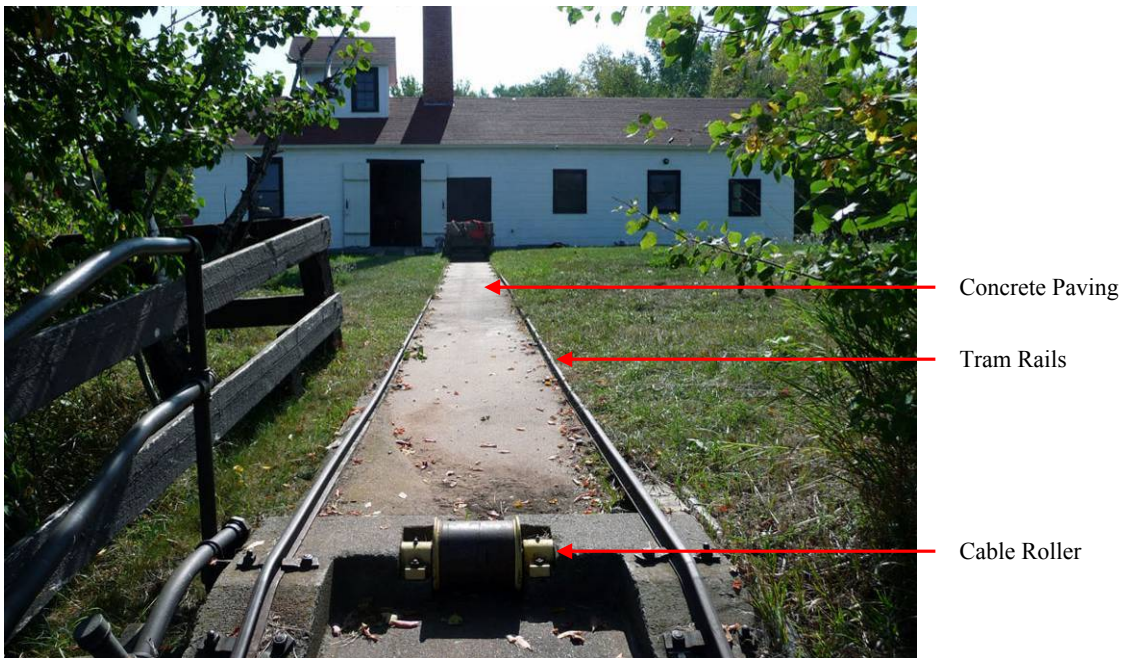
Existing Condition. The tram tracks lead from the top of the tramway to the Fog Signal Building. The tracks are cast iron 25-pound rails, spaced 36" on center matching the tramway and secured to concrete paving. The tracks as a system are intact and remain in place, although vegetation is beginning to encroach on the edges of the concrete paving. Overall the tram tracks are in good condition.

Site Image OI-44: Tram tracks from tramway to Fog Signal Building viewed from the north, 2009 (Source: MBD P1010860.JPG)

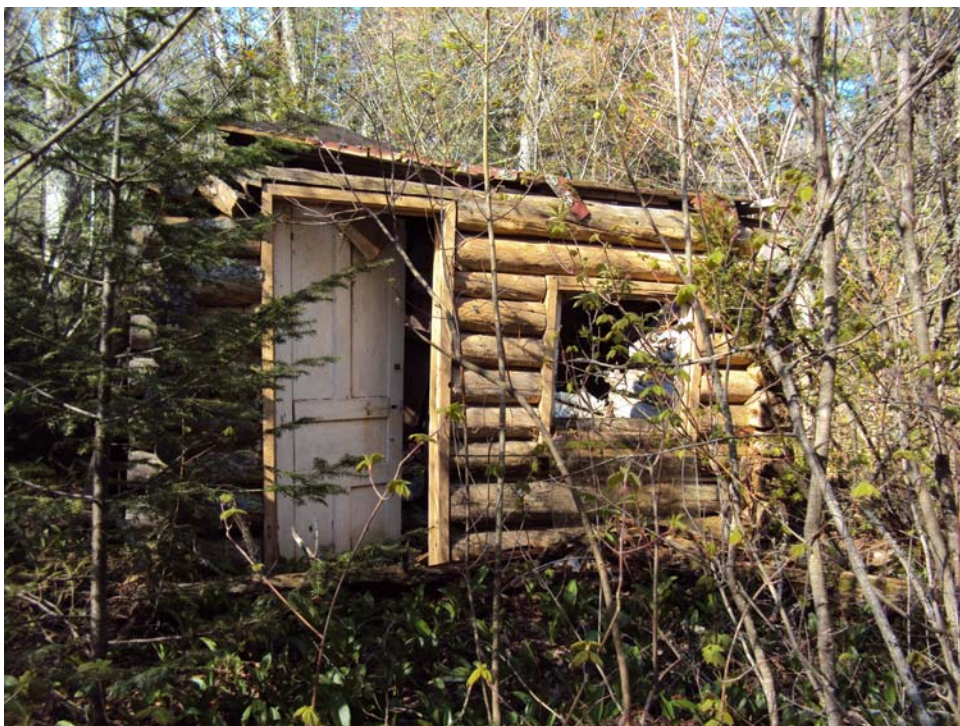
The remnants of a cabin exist in the forest east of the light station grounds. The cabin is approximately 10' x 12', log construction, with a collapsed sheet metal roof, paneled wood door and one window. The cabin is in poor condition.

Site Image OI-45: Remnant cabin east of light station grounds, 2011 (Source: MBD DSC00931.JPG)

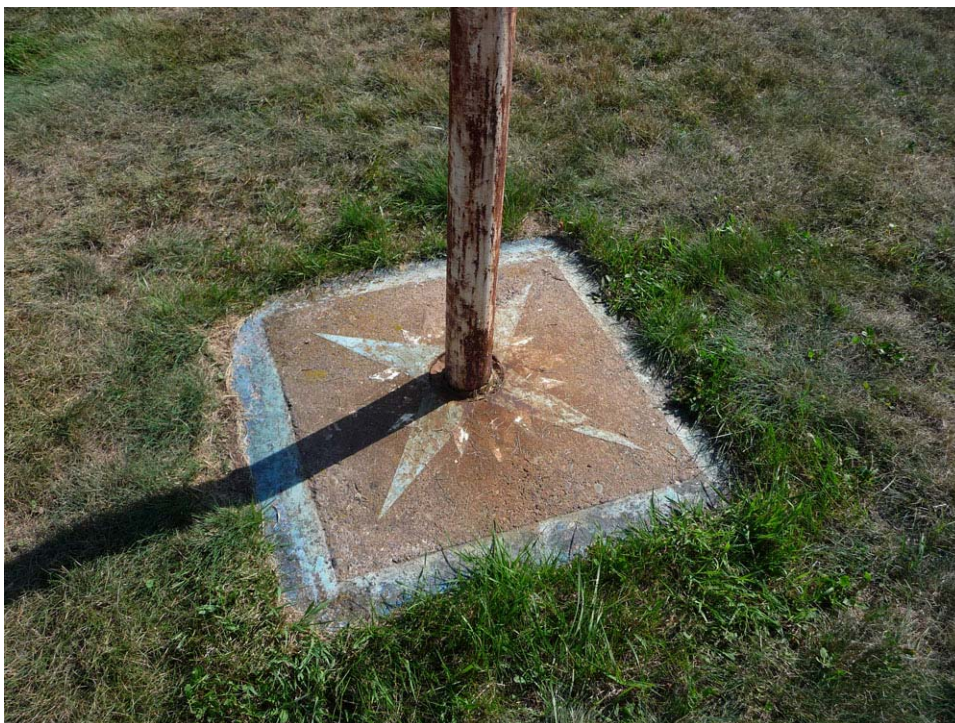
The second flagpole is centrally located between the Fog Signal Building and the Tower and Keepers Quarters along the west side of the concrete walk. The second flagpole dates to the Coast Guard period (1939-1960) and is notable for the compass rose engraved on its square concrete footing which is 3'x3'. The pole is steel and stands approximately 30' high. It appears that it was painted white, but now is heavily rusted. The flagpole is in fair condition.

Site Image OI-48: Second flagpole base and compass rose, 2009 (Source: MBD P1010935.JPG)

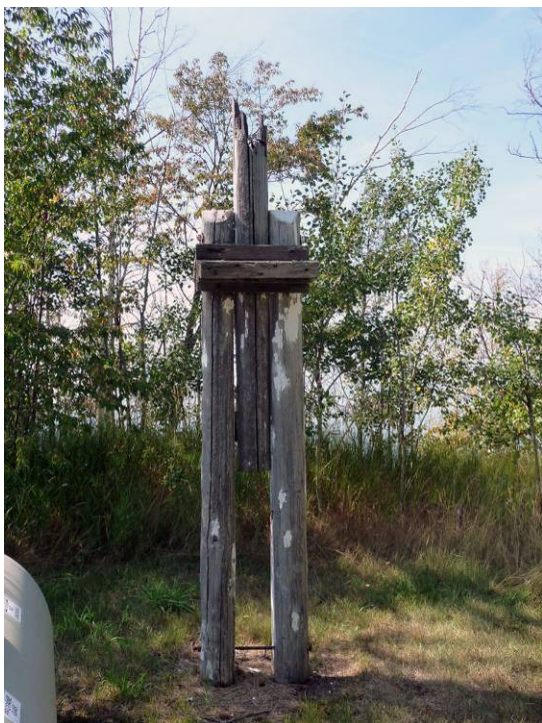
Existing Condition. There are two flagpoles on the light station grounds, the original flagpole and the second flagpole. The original flagpole is near the top of the tramway, approximately 45' west of the light station's main entrance. Historic photographs indicate flagpoles have been located in this area but have been removed or lost due to harsh climatic conditions on the bluff edge. The extant original flagpole remains from the Light Station period (1901-1938) and is constructed of a single wood mast pole, mounted between two shorter wood base columns, with through bolt connections. The center pole is broken, and stands approximately 10' tall. The two columns are approximately 8" in diameter and mounted in a concrete footing. The original flagpole is in poor condition.

Site Image OI-49: Original flagpole, 2009 (Source: MBD P1010916.JPG)

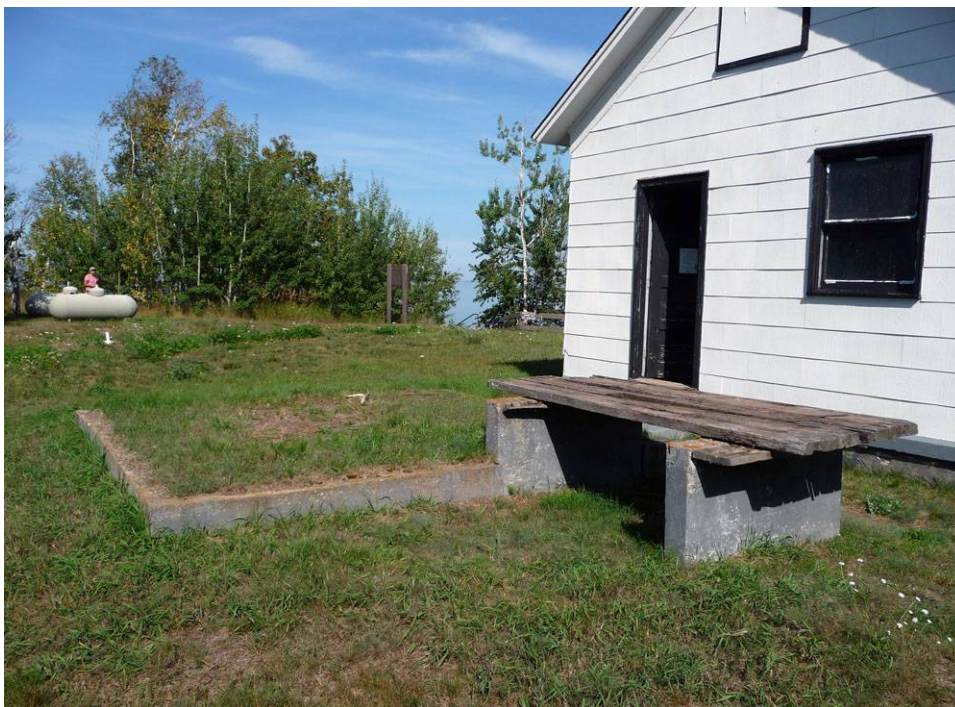
Concrete Foundation and Wall (1901-1938)	OI-58	12' x 12' concrete foundation, 1' tall, 6" wide and (2) 2.5' tall, 6' long, 1' wide walls west of Fog Signal Building. Wood planks sit atop the walls. Historic photographs indicate this area was used for chopped wood and oil storage.	Concrete: Good Wood: Poor	Contributing; Historic photographs indicate this area was present during the Light Station period and modified during the Coast Guard Period
Wood Structure at Fog Signal Building	OI-59	2.5' x 10' Wood Structure at 2' tall south of Fog Signal	Fair	Contributing; from the period of significance

Site Image OI-58: Concrete foundation and wall, 2009 (Source: MBD P1010925.JPG)

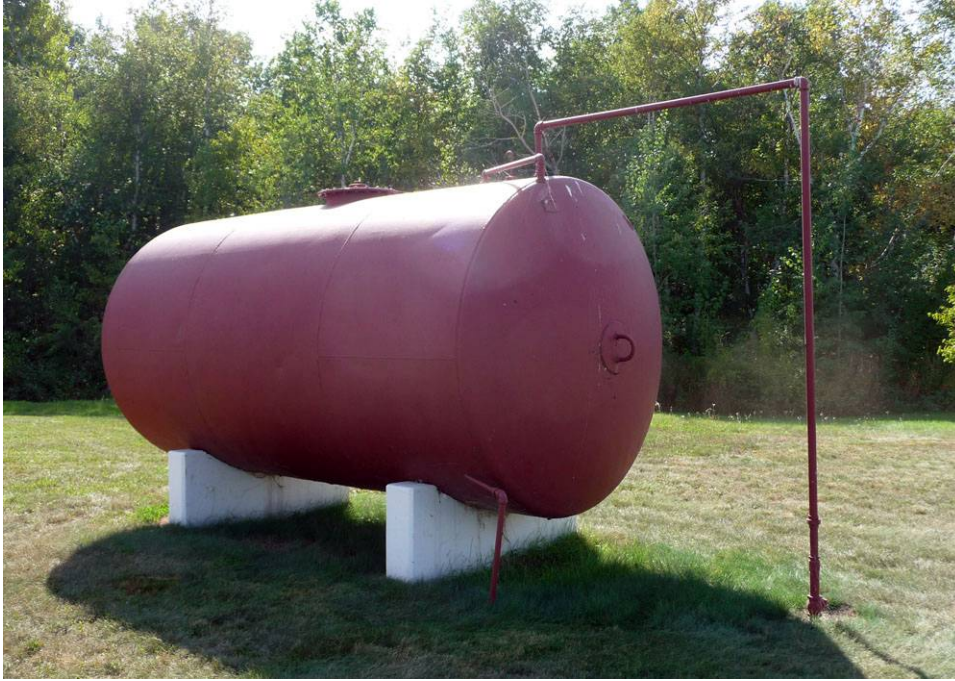
Feature	Site Image #	Description	Condition	Contributing? /Rationale
(1939-1960)		Building		
Fuel Tank (1939-1960)	OI-60	15' x 6' painted metal tank with metal pipe extending north 4' from north end of tank.	Good	Contributing; from the period of significance
Solar Panel (1970 - present)	OI-61, OI-62	Contemporary solar panel, approximately 15' tall located south of Keepers Quarters	Good	Noncontributing-contemporary; Could be Compatible with appropriate siting.
Fiberglass Battery Vault (1970 - present)	OI-61, OI-62	Adjacent to solar panel, 3.5' x 3.5' x 1' tall concrete structure.	Fair	Noncontributing-contemporary; Could be Compatible with appropriate siting.
Wood Planks (2) (1970 - present)	OI-61, OI-63	(2) 3' x 6" wood planks located southeast of solar panel, marking location of the original well	Fair	Noncontributing – contemporary, Compatible
Concrete Footing (date unknown)	OI-61, OI-64	Circular concrete footing with 2' diameter.	Good	Noncontributing, safety hazard

Site Image OI-60: Fuel tank, 2009 (Source: MBD P1010937.JPG)

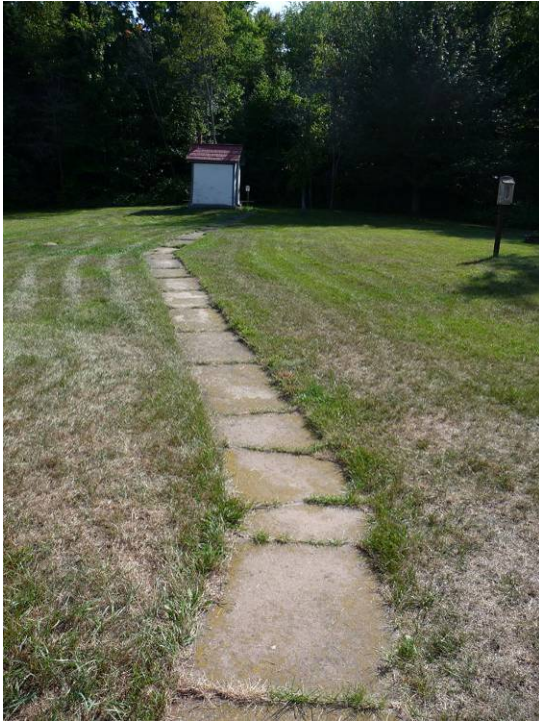
Existing Condition. Vegetation at Outer Island includes natural forested areas, cleared and maintained areas, and domestic plantings. The forest area is a mixed northern hardwood forest and is the predominant landscape of the island. The light station grounds also include historically cleared areas that have been infiltrated by the adjacent forest and are now brush landscape types. The core of the light station is a maintained lawn of mown grasses. Domestic plantings exist near the Fog Signal Building and the Oil Storage, and at the south end of the site, near the Privy. These plantings include: lilac (*Syringa* sp.), serviceberry (*Amelanchier* sp.), juniper (*Juniperus* sp.), maples (*Acer* sp.) and mountain ash (*Sorbus* sp). Trees at the south end of the site, near the Privy include: dogwood (*Cornus* sp.), white birch (*Alnus tenuifolia*), and poplar (*Populus* sp). The condition of the vegetation on the light station grounds varies from good to poor. The cleared area of the light station is in poor condition.

Site Image OI-72: Lawn area, 2009 (Source: MBD P1010952.jpg)

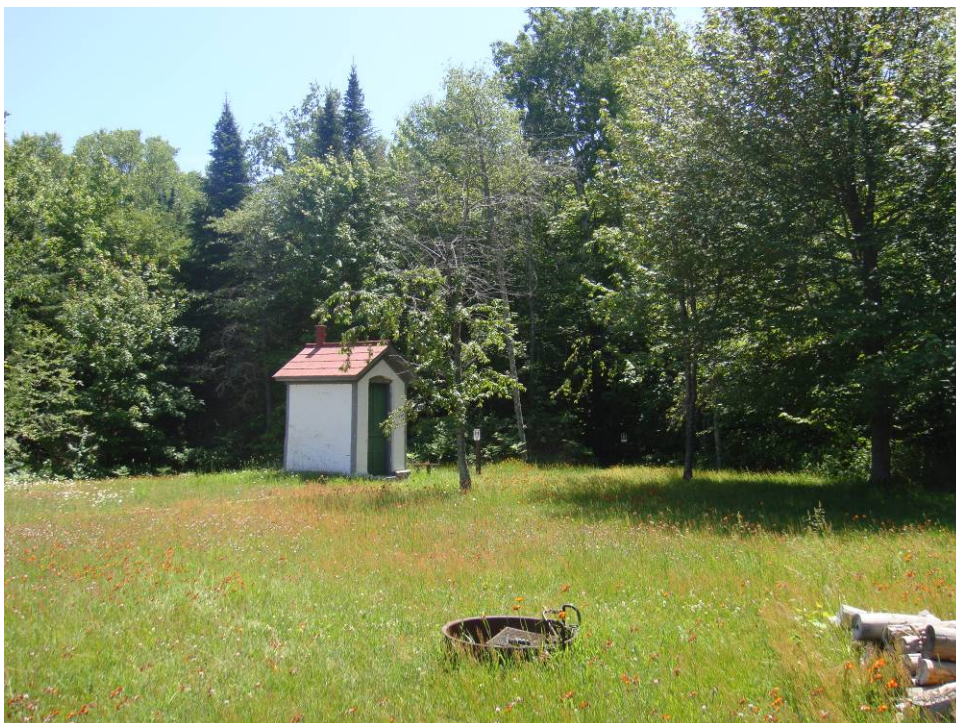
Site Image OI-76: Encroaching forest near Privy, 2009 (Source: MBD DSC00620.JPG)

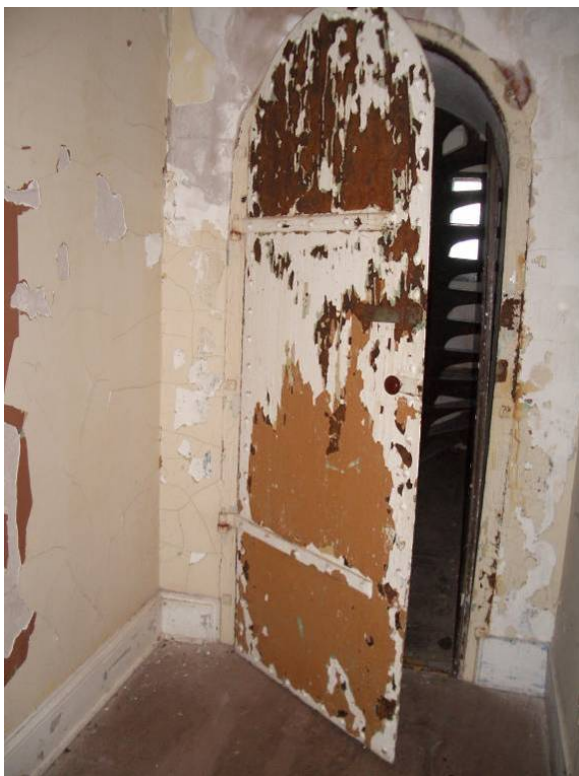
OI-T-02: Door from quarters to Tower (Source: AH IMGP3236)

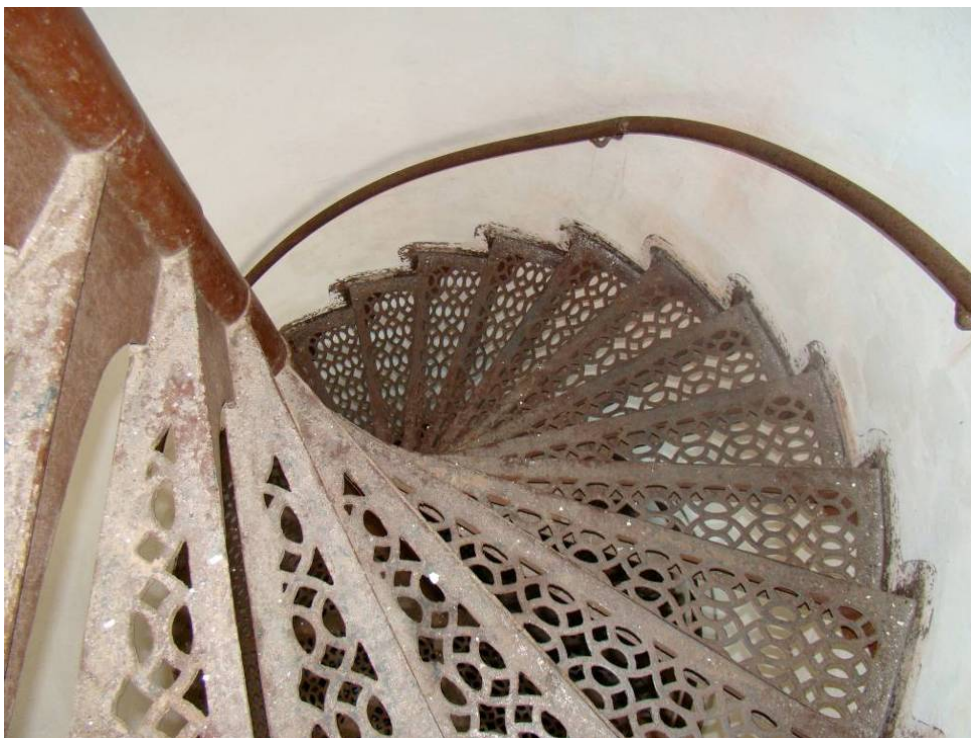
In general the Outer Island Tower is in good condition. The spiral, cast iron staircase is in good condition with some rusting and peeling paint. The brick interior walls are in fair condition with rust stains (from the stairway) and cracked and peeling paint.

OI-T-04: Tower stairs and railing (Source: AH DSC01567)

3. Interior: Add code compliant handrails at landings and near the hatch	The addition of the handrail adds a modern element to the historic fabric.	Design a handrail similar to the existing. Paint to match.	- Improves safety for visitors and staff

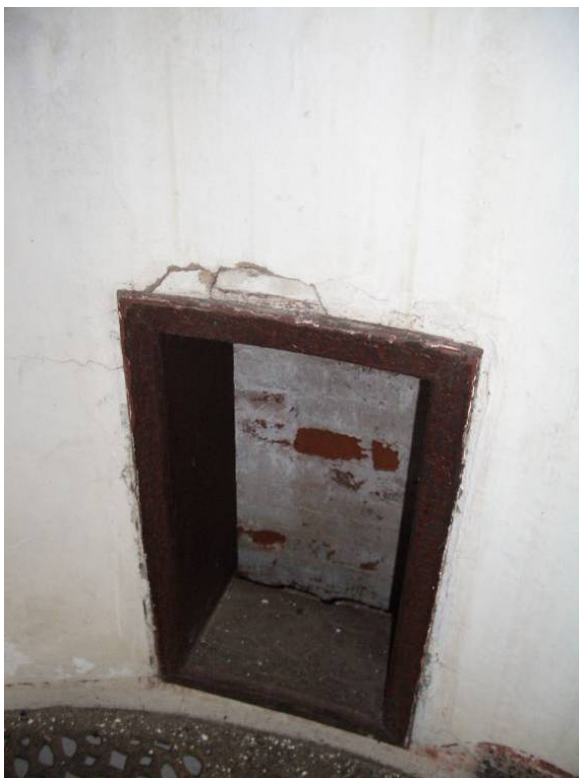
OI-T-05: Tower metal framed access opening (Source: AH IMGP3228)

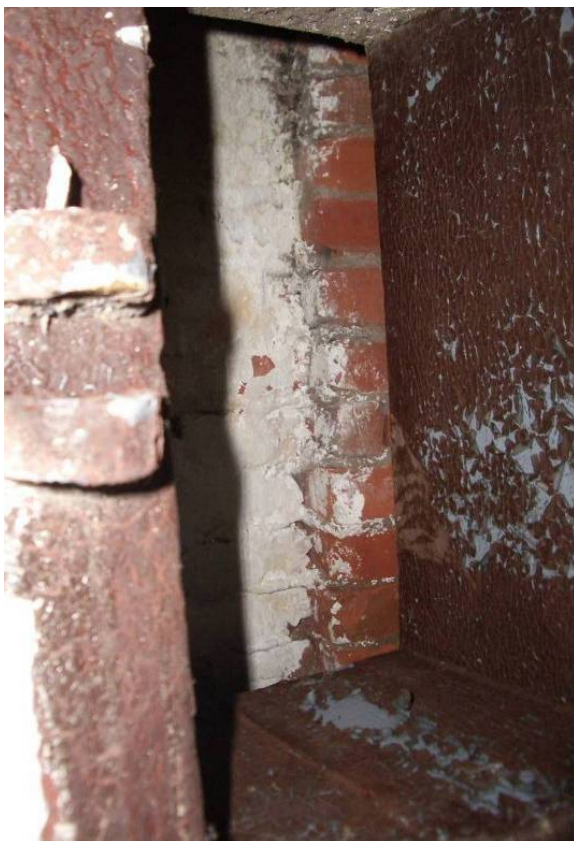
OI-T-06: Tower metal access detail of interior (Source: AH IMGP3229)

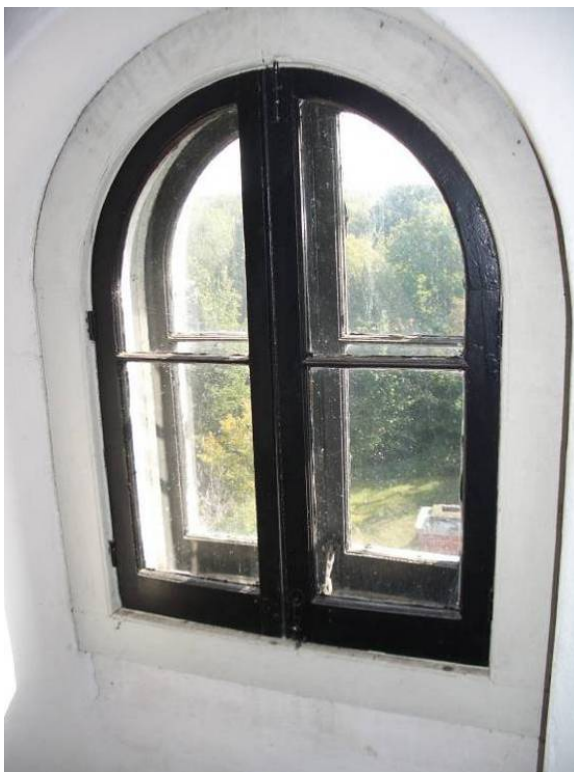
Arched Window. This type of window is in good condition.

OI-T-08: Tower arched window (Source: AH IMGP3227)

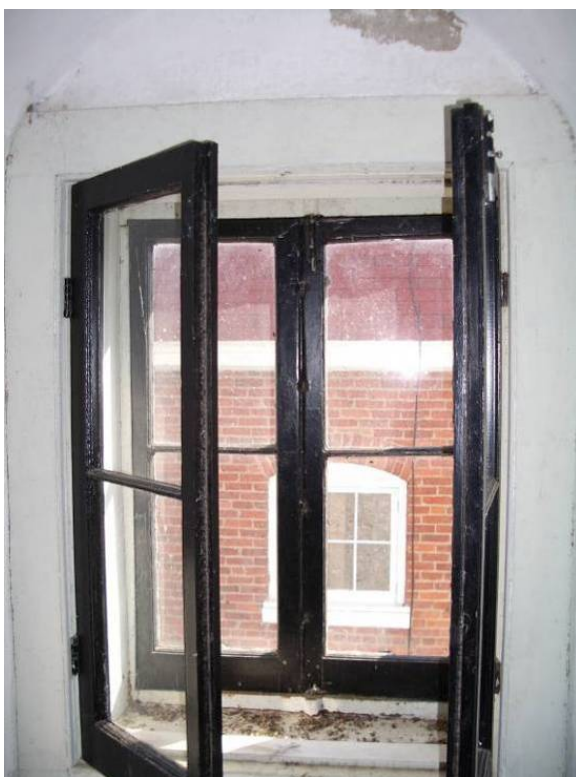
OI-T-09: Tower rectangular window (Source: AH IMGP3232)

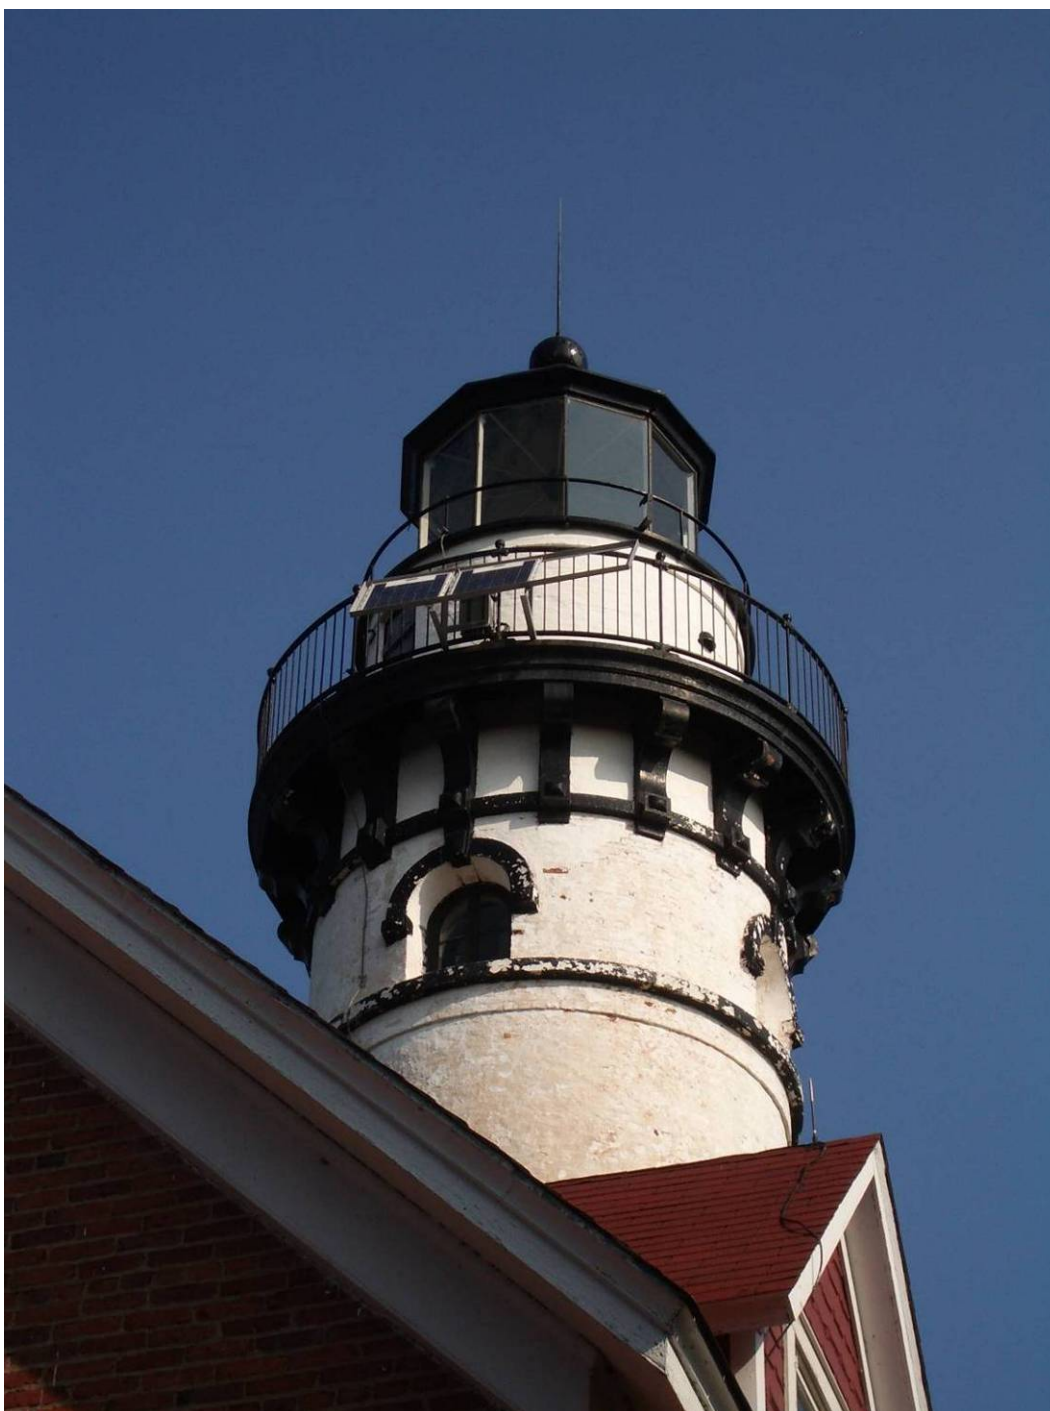
OI-T-10: Lantern south view, 2009 (Source: AH IMGP3101)

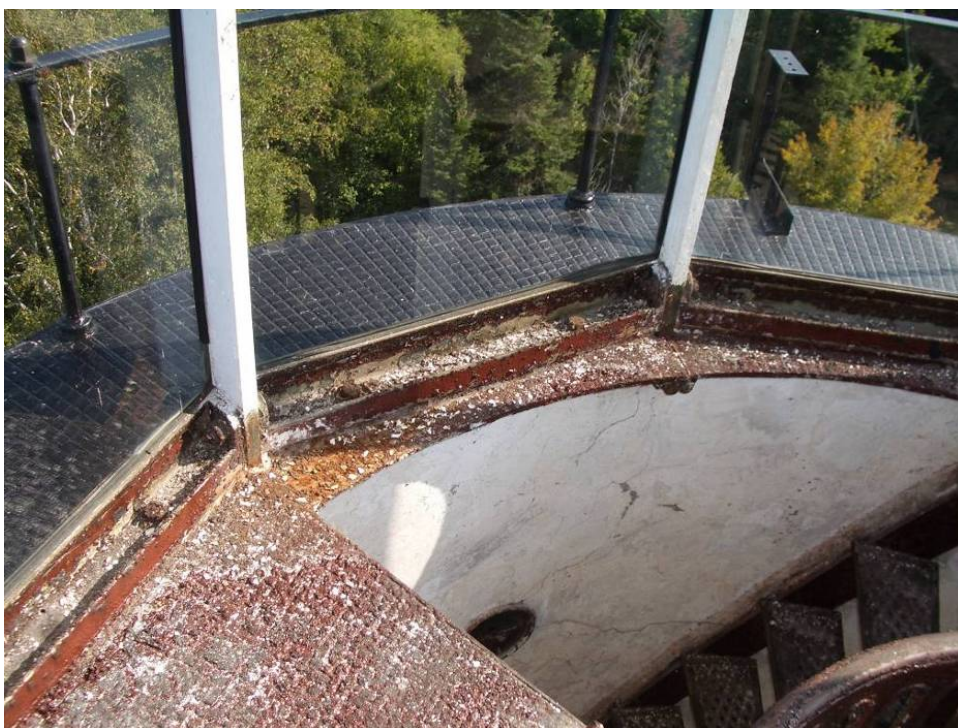
OI-T-12: Lantern floor hatch and ladder (Source: AH IMGP3221)

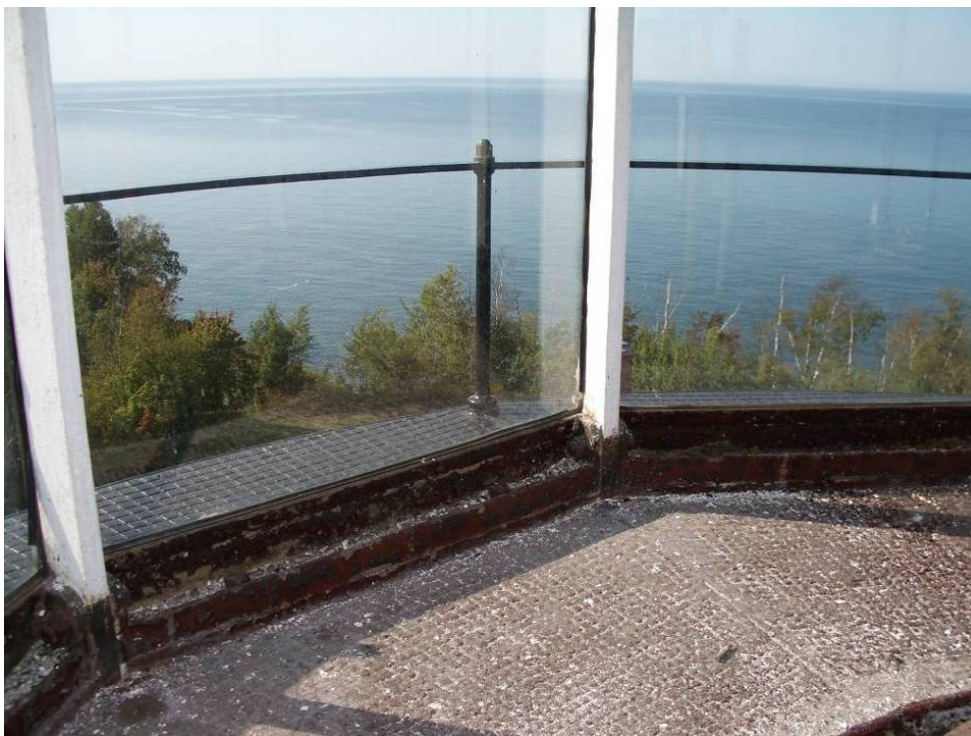
OI-T-13: Lantern glazing and upper interior and exterior walkway and railing (Source: AH IMGP3214)

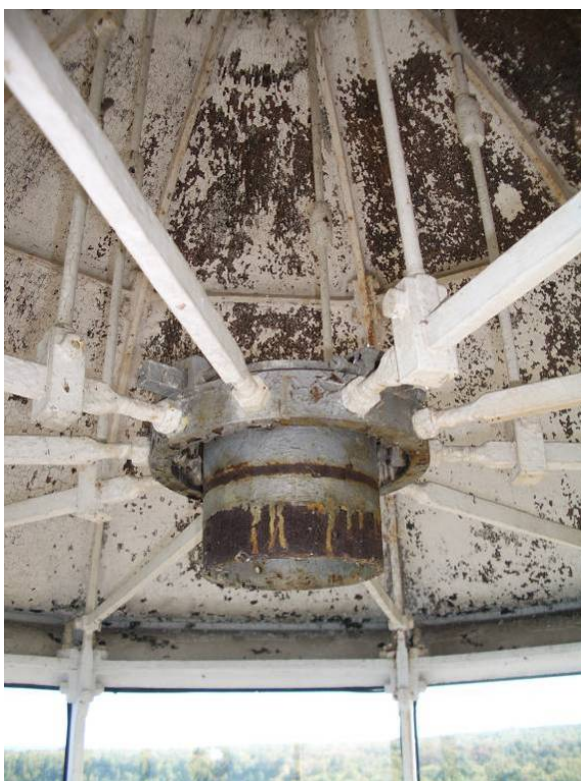
OI-T-14: Lantern ceiling (Source: AH IMGP3220)

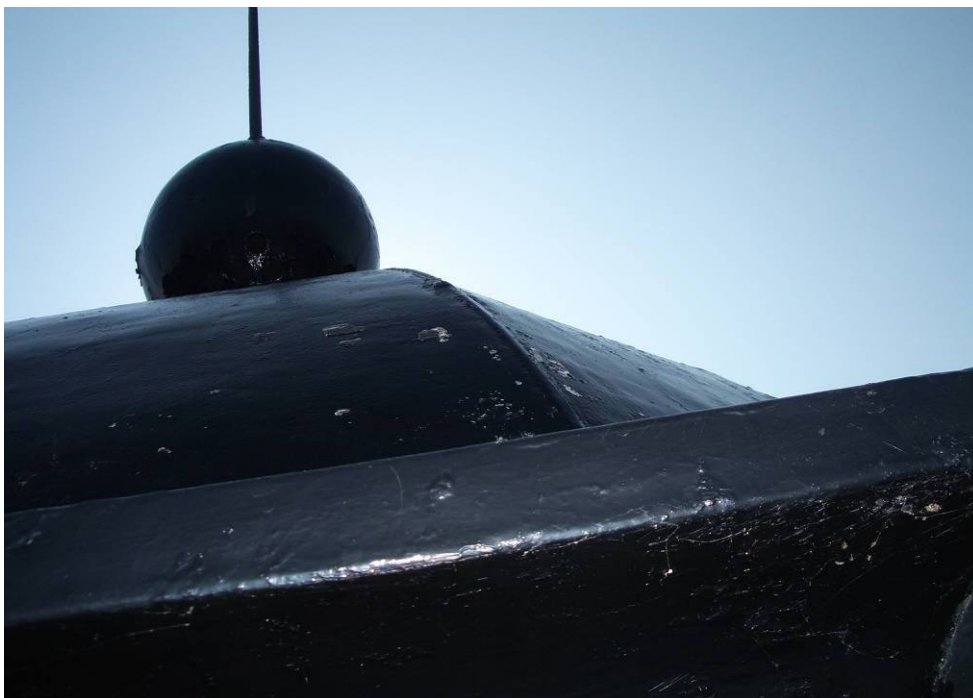
OI-T-15: Lantern roof (Source: AH IMGP3200)

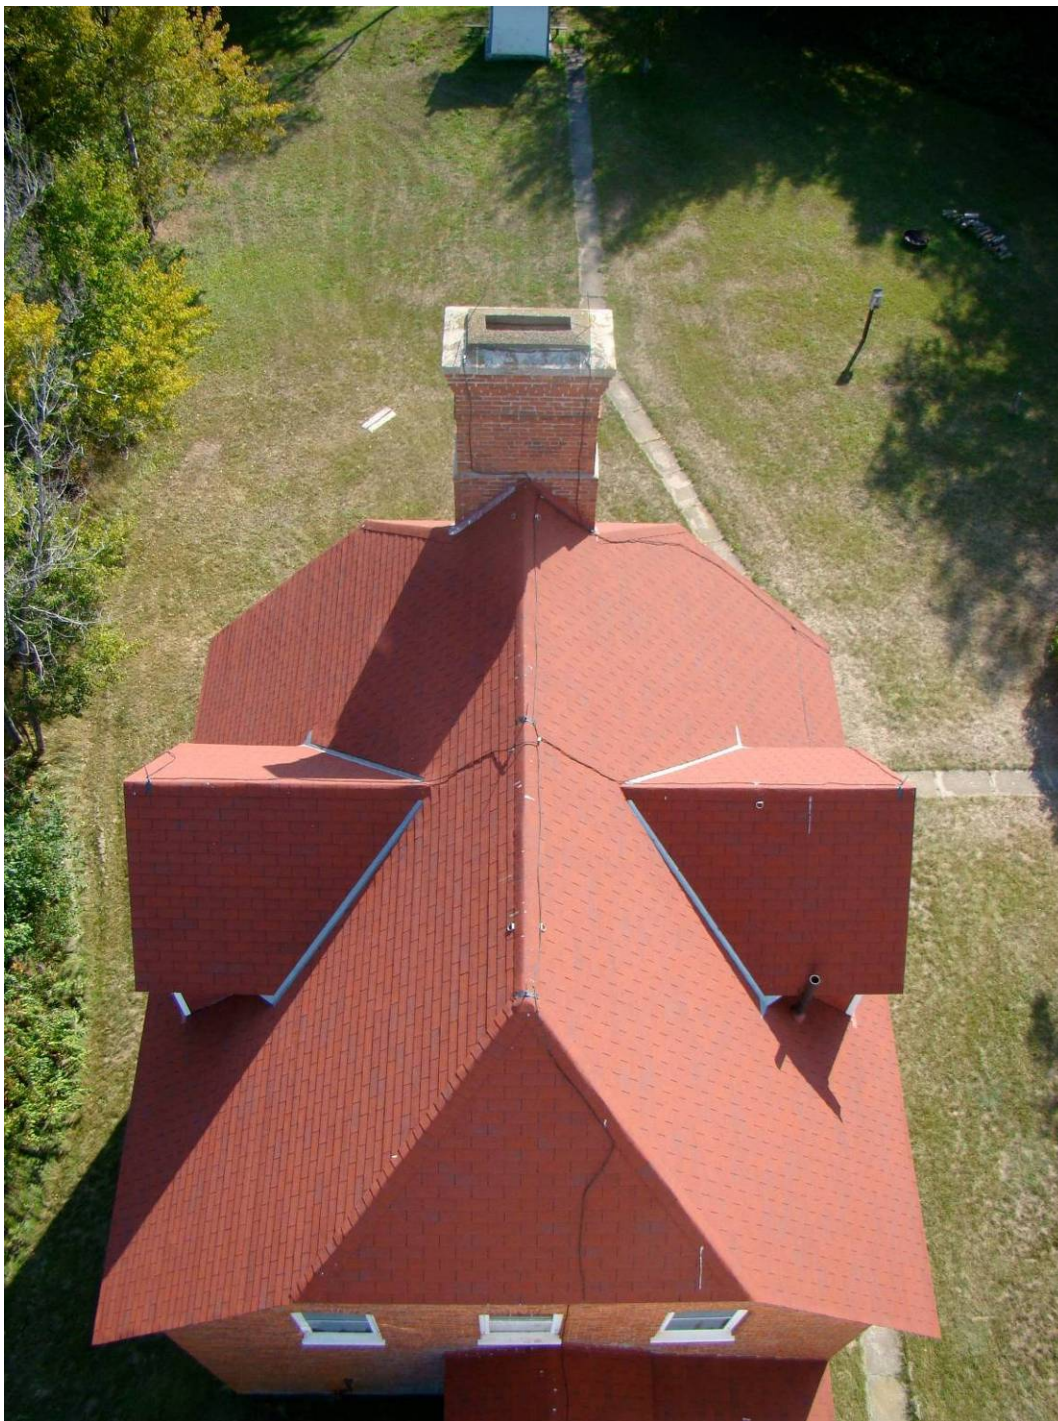
OI-KQ-01: Aerial from Tower, south view, 2009 (Source: AH DSC01514)
