VOLUME III OF VI: OUTER ISLAND CLR/HSR

**CULTURAL LANDSCAPE REPORT, HISTORIC STRUCTURE REPORT
AND
ENVIRONMENTAL ASSESSMENT**

LIGHT STATIONS OF MICHIGAN ISLAND, OUTER ISLAND, DEVILS ISLAND,
LONG ISLAND AND SAND ISLAND

prepared by
Anderson Hallas Architects, PC
Golden, Colorado

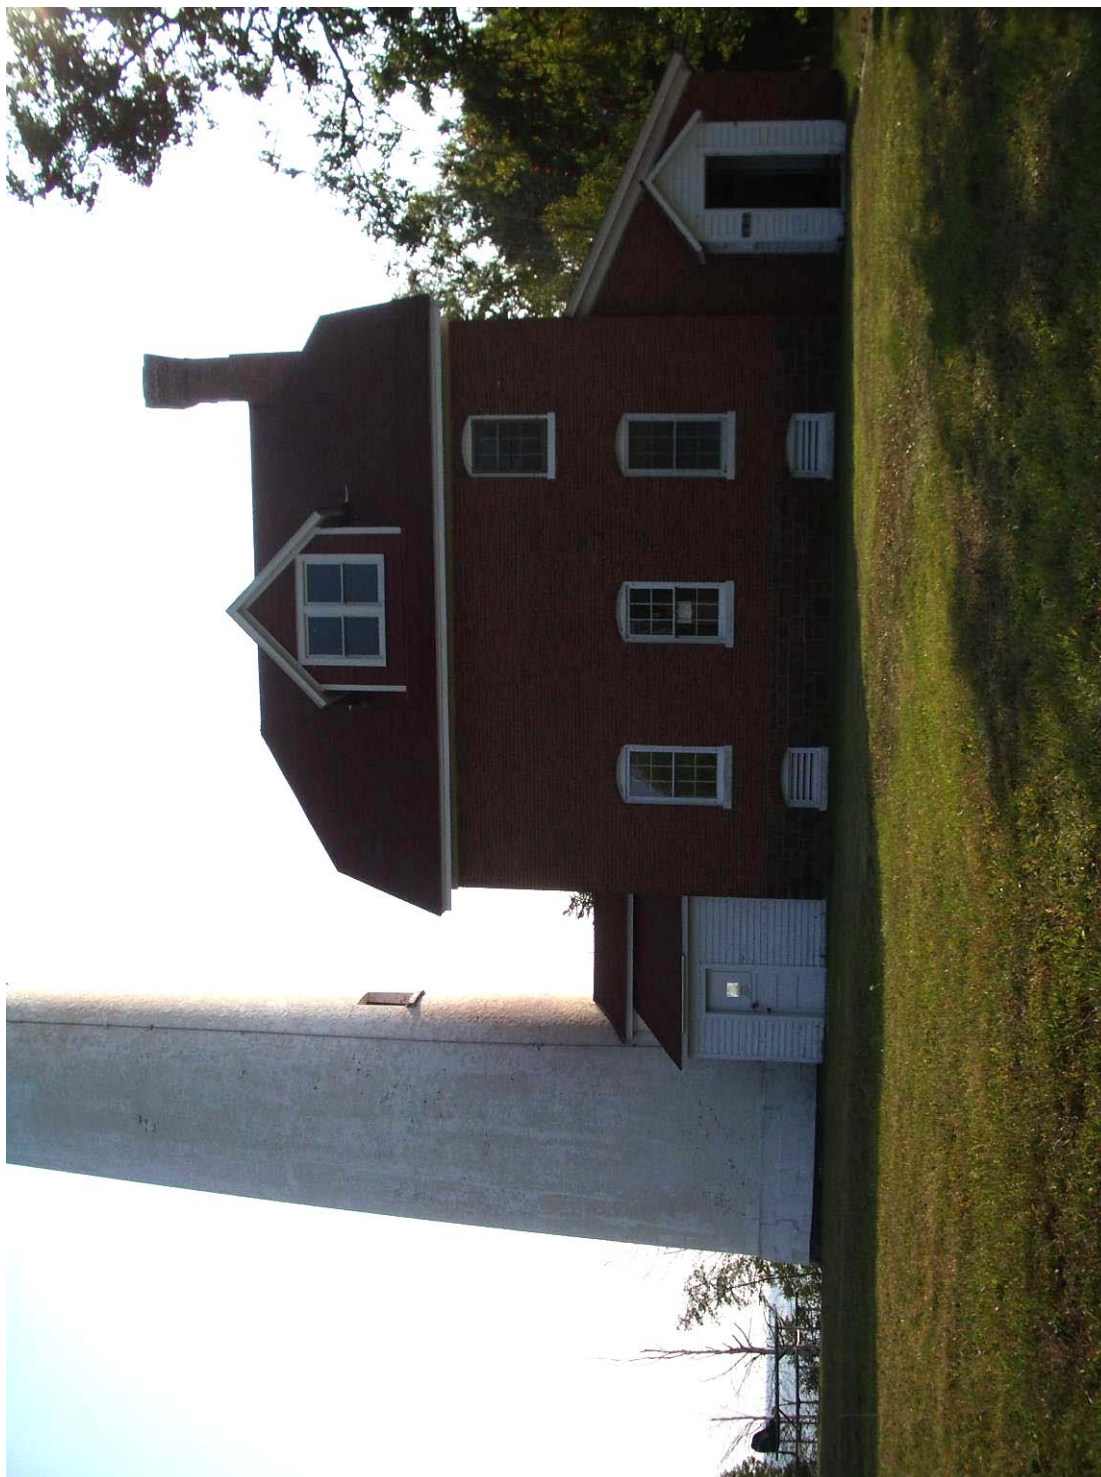
OI-KQ-02: West elevation, 2009 (Source: AH IMG3090)

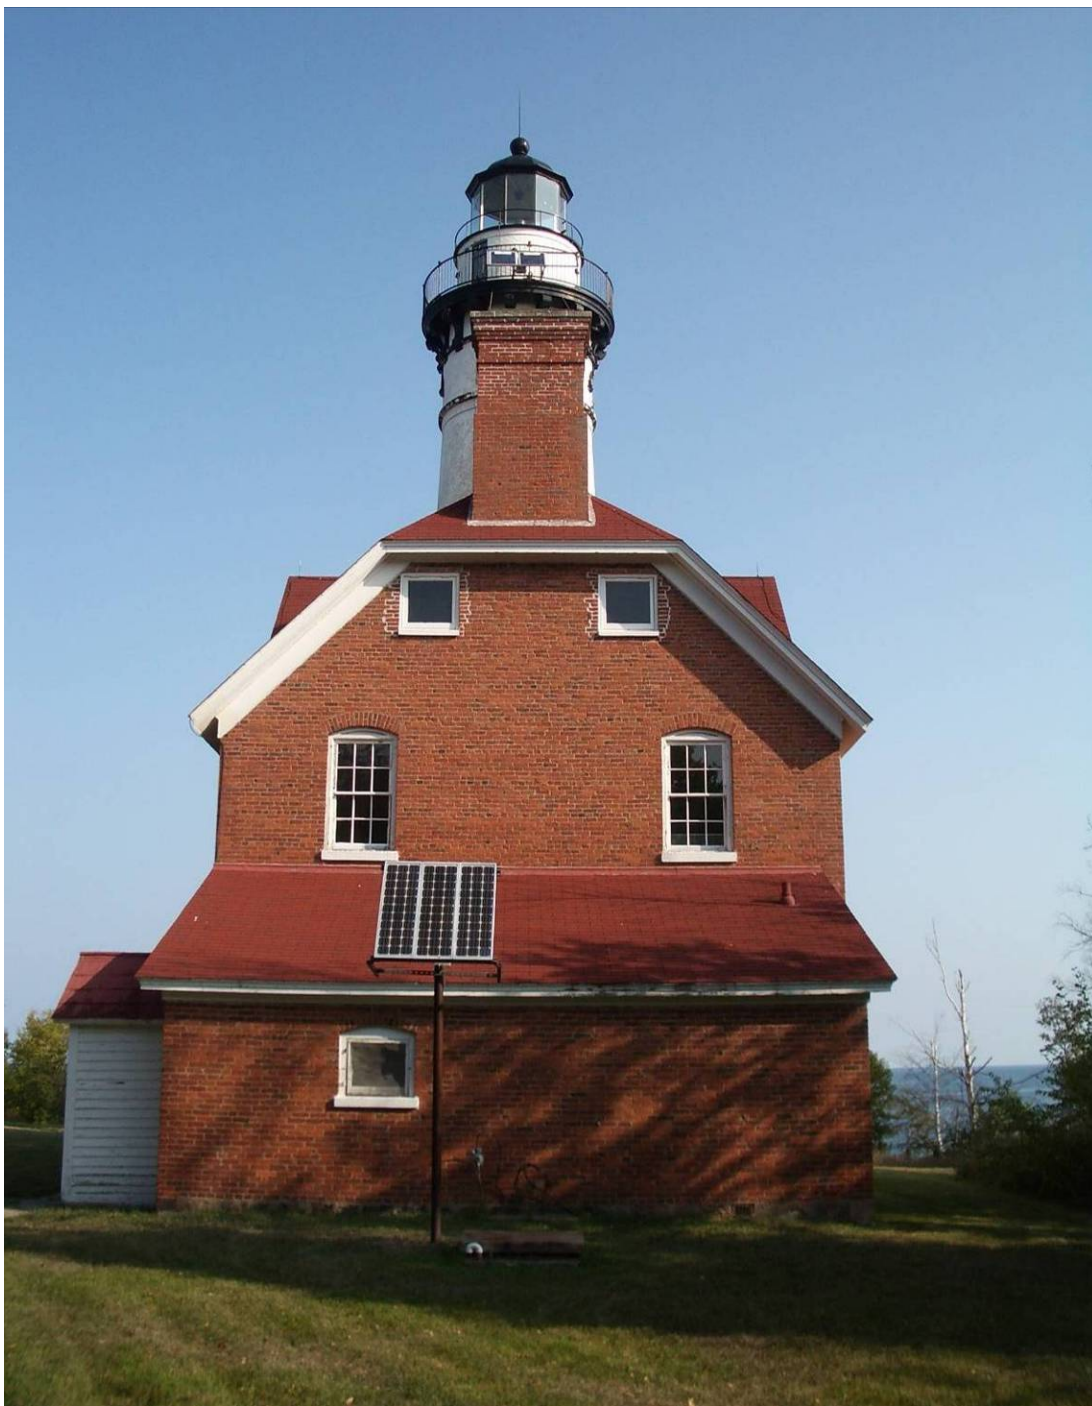
OI-KQ-03: South elevation, 2009 (Source: AH IMGP3091)

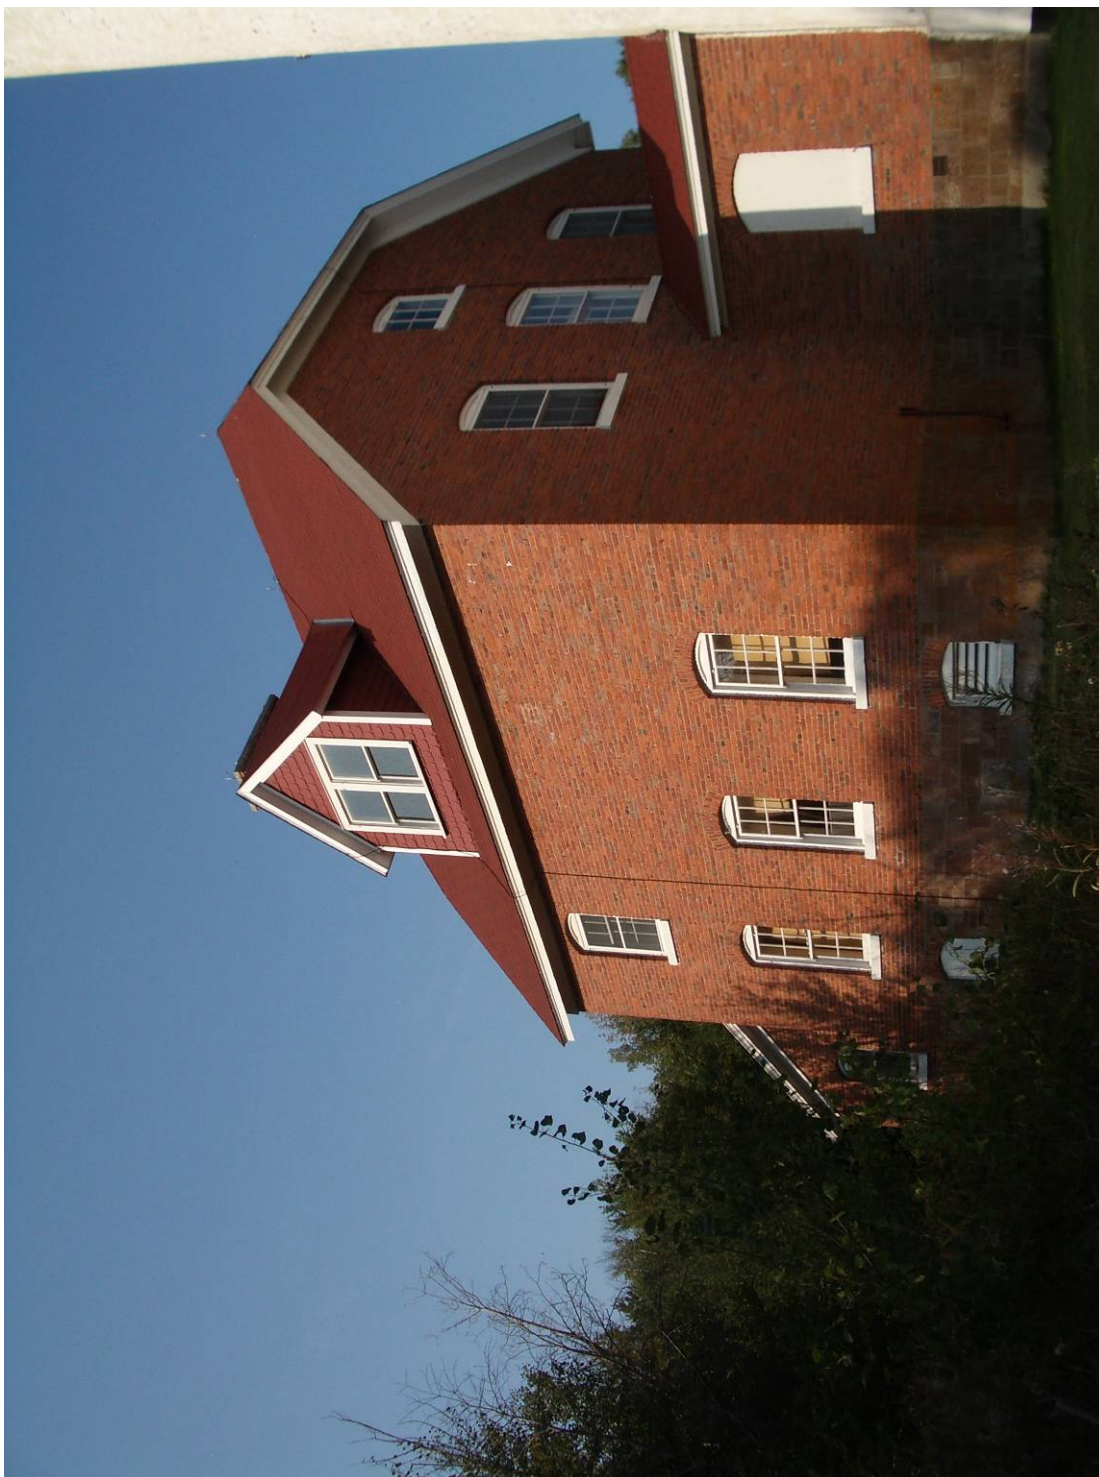
OL-KQ-04: East elevation, 2009 (Source: AH IMG3093)

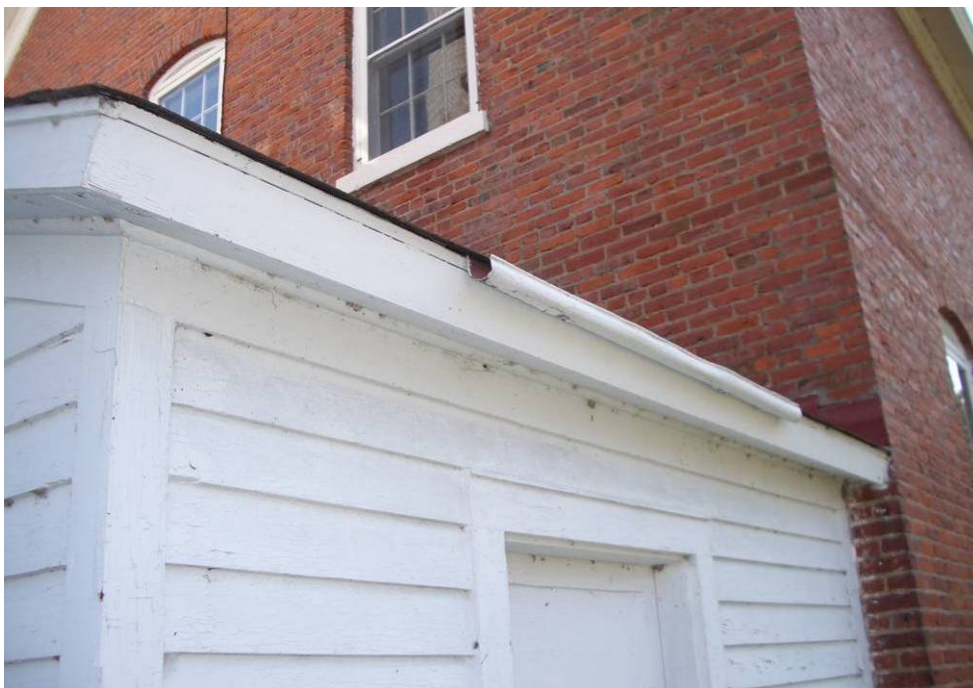
OI-KQ-08: Secondary entrance diverter and trim detail, west elevation (Source: AH IMGP3142)

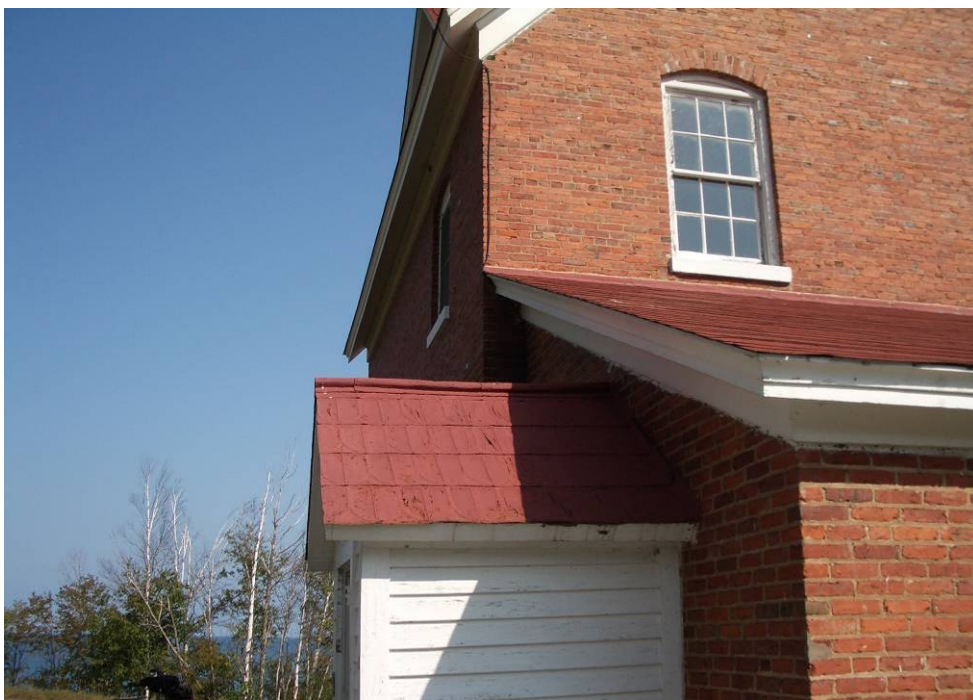
OI-KQ-09: Kitchen vestibule, roof and trim detail, south elevation (Source: AH IMGP3135)

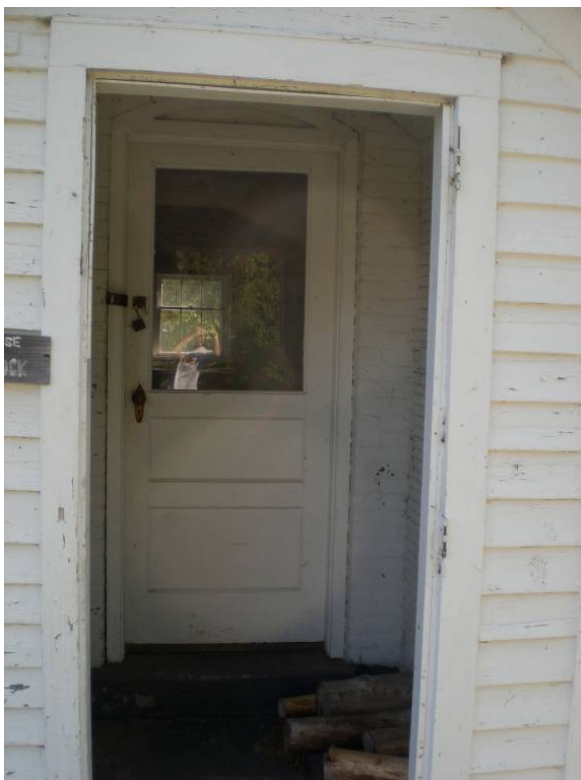
OI-KQ-10: Kitchen vestibule, west elevation (Source: AH CIMG4450)

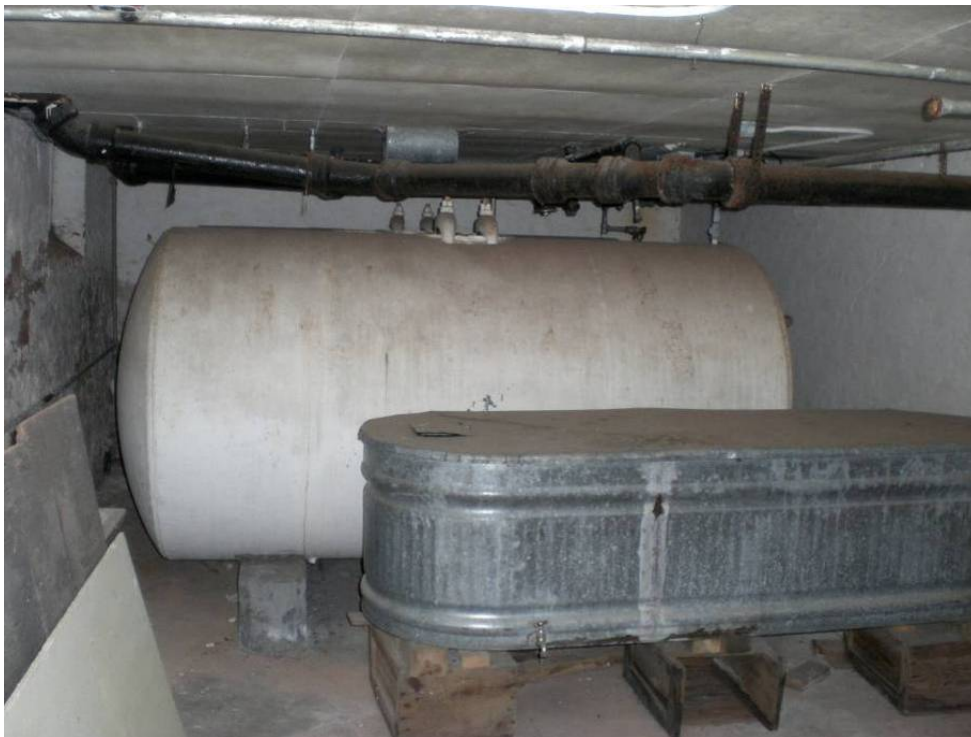
OI-KQ-11: Primary basement room, looking north (Source: AH CIMG4472)

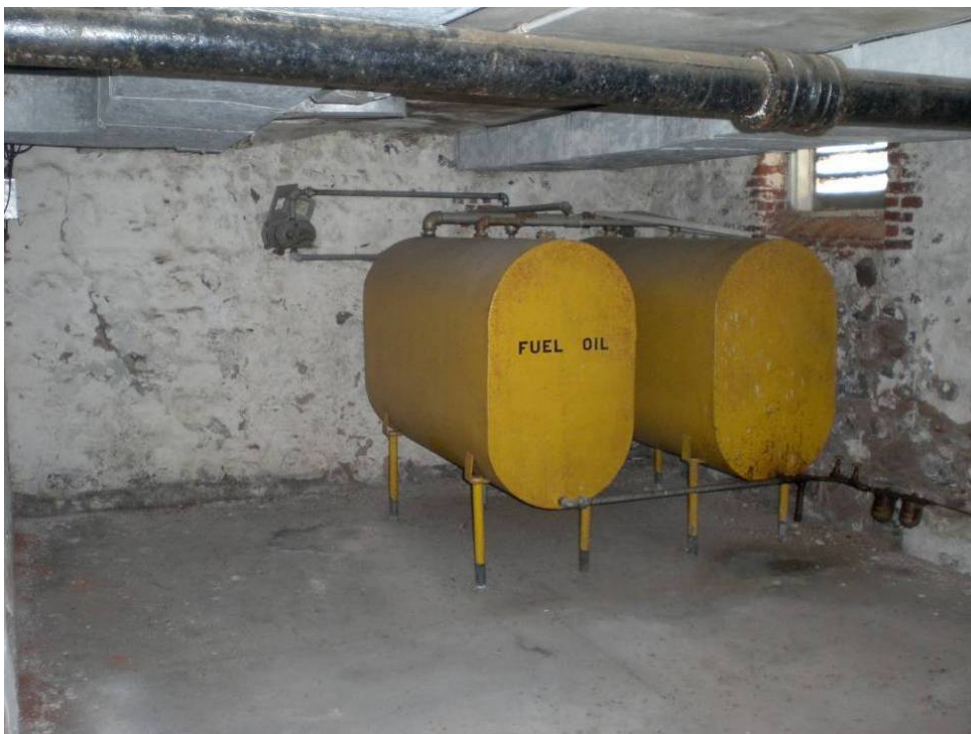
OI-KQ-12: Basement oil storage room, looking northeast (Source: AH CIMG4483)

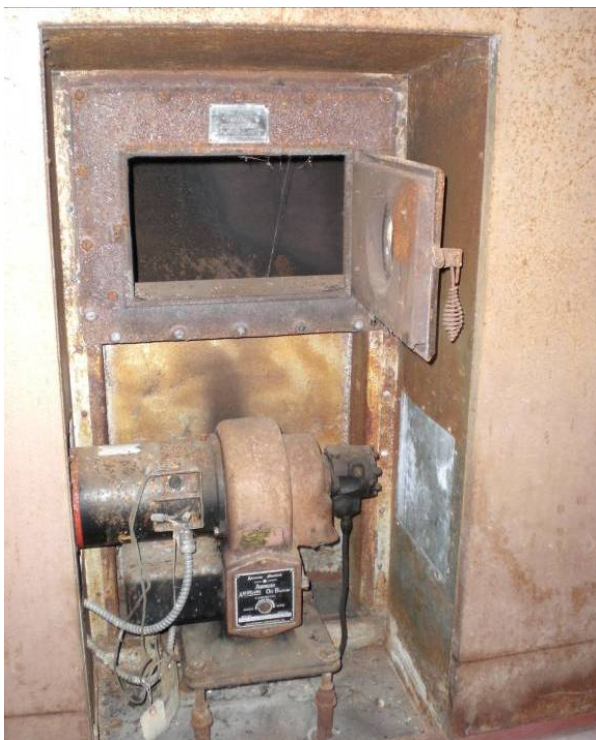
OI-KQ-14: Basement oil storage room furnace detail, south view (Source: AH CIMG4488)

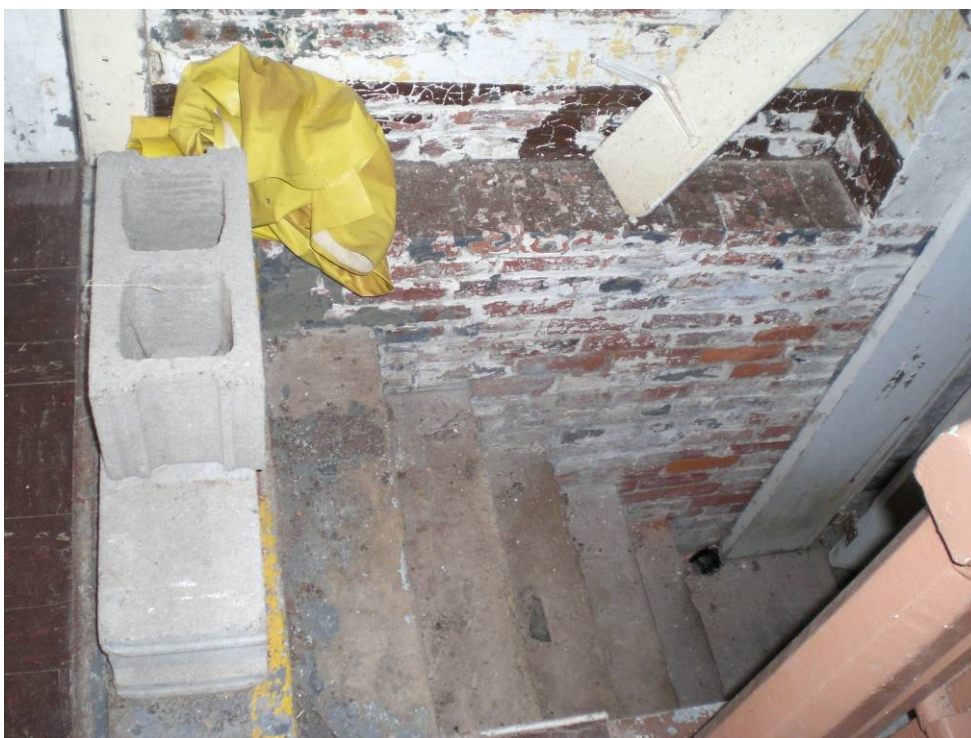
OI-KQ-15: Stair from basement to kitchen, looking west (Source: AH DSC01520)

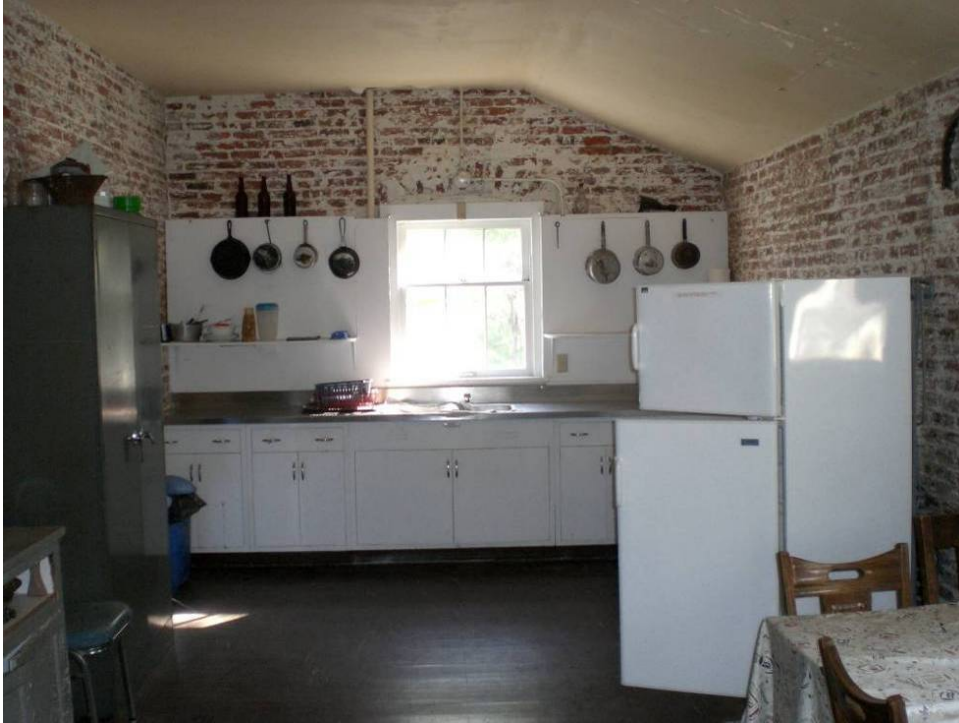
OI-KQ-16: Kitchen, east elevation (Source: AH CIMG4458)

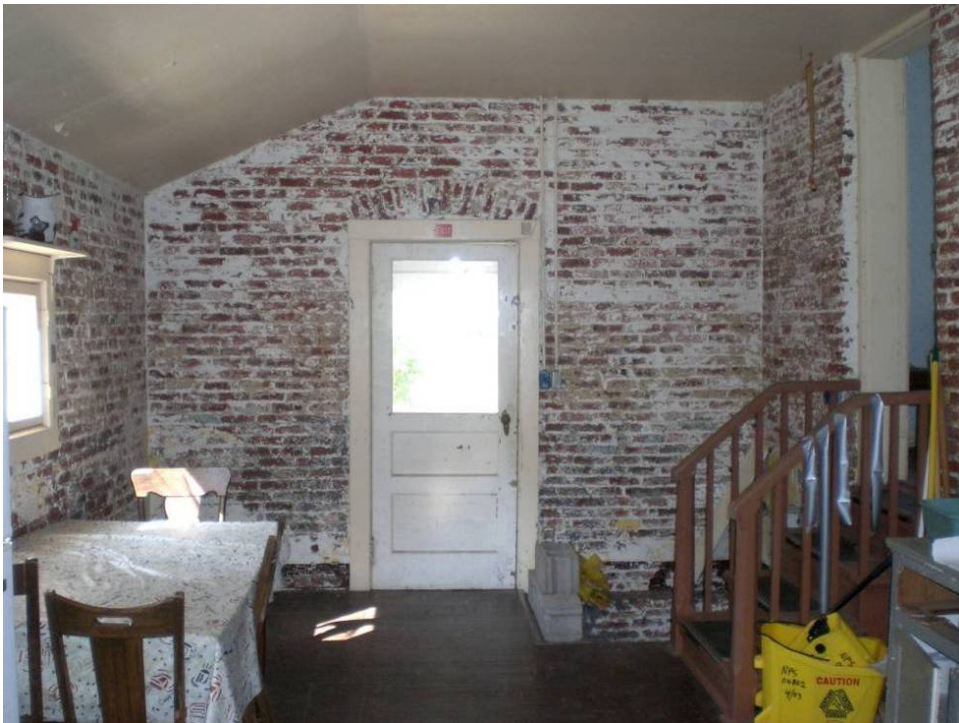
OI-KQ-17: Kitchen and stair to living room, west elevation (Source: AH CIMG4462)

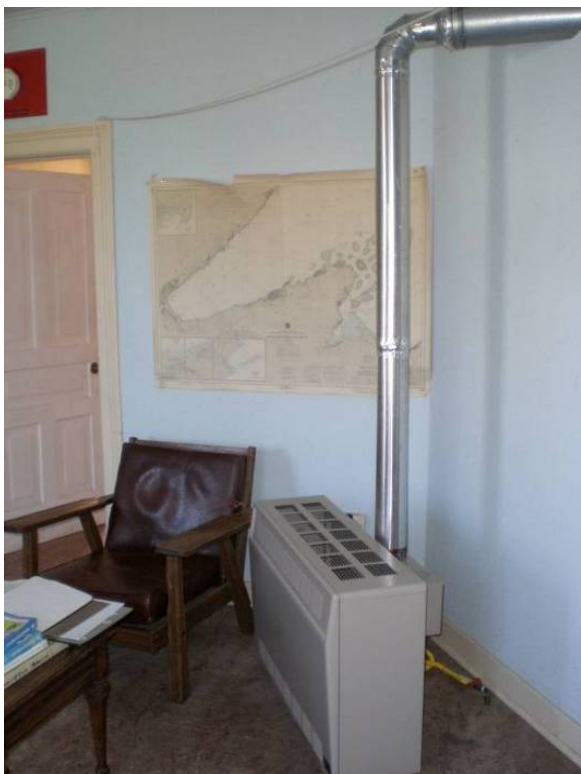
OI-KQ-18: Living room, looking southeast (Source: AH CIMG4499)

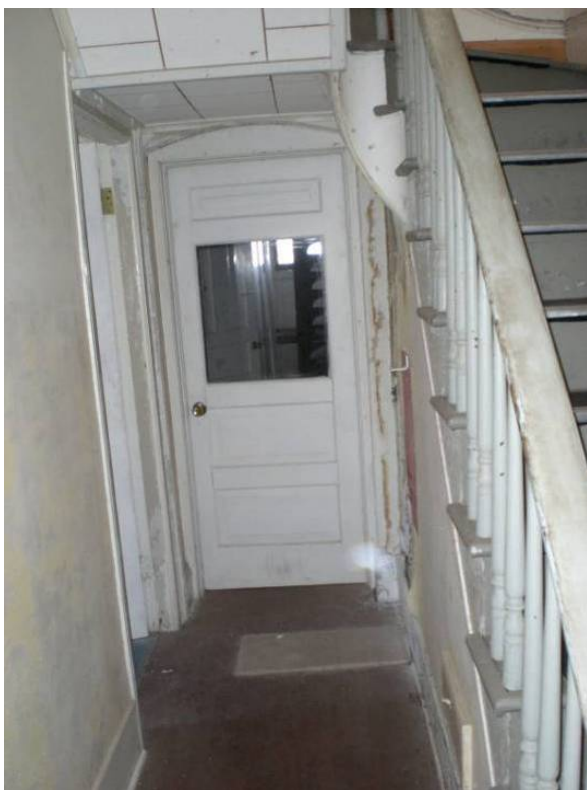
OI-KQ-19: First floor main hall, north elevation (Source: AH CIMG4509)

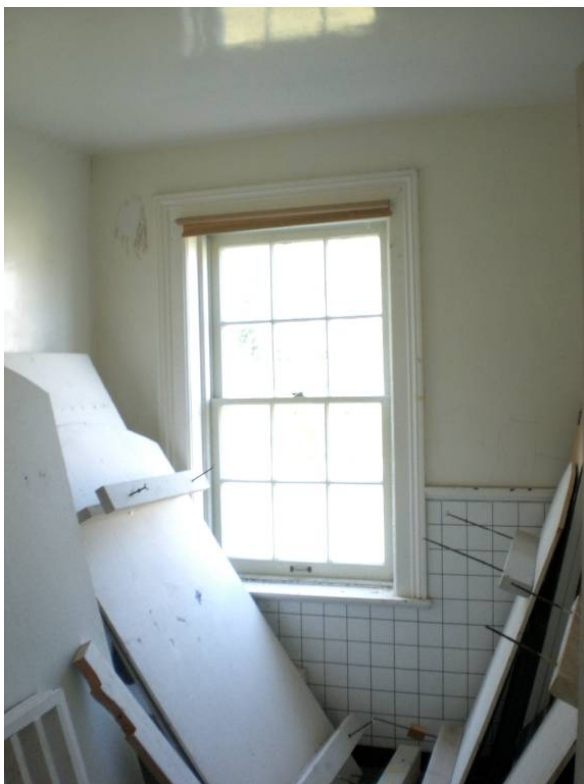
OI-KQ-20: Storage/bath, west elevation (Source: AH CIMG4518)

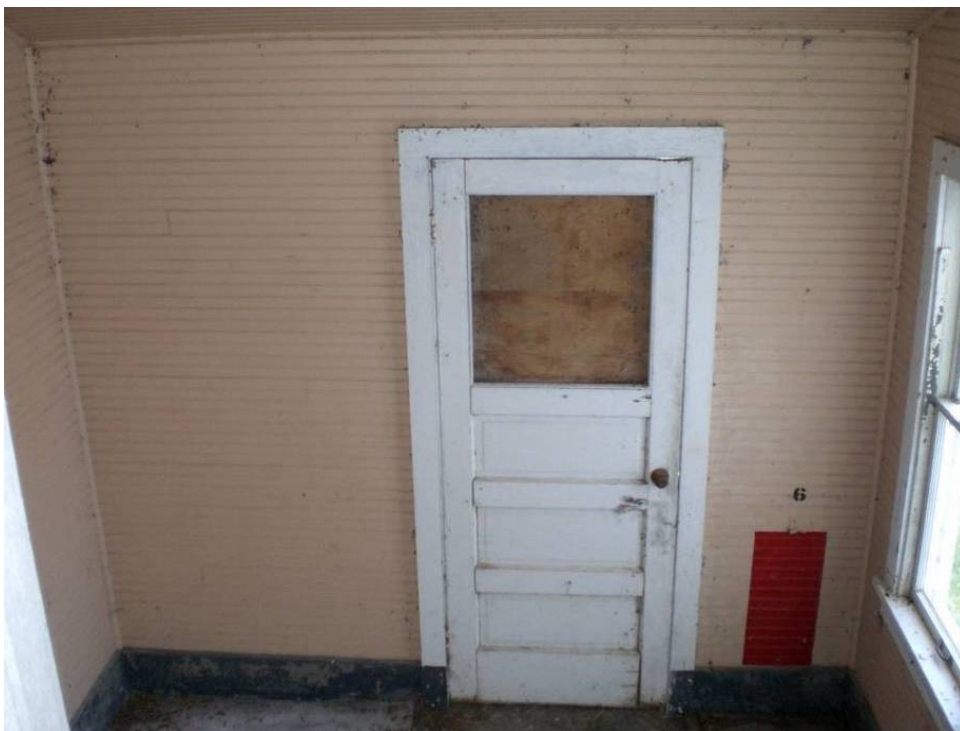
OI-KQ-21: Secondary entrance, west elevation (Source: AH CIMG4530)

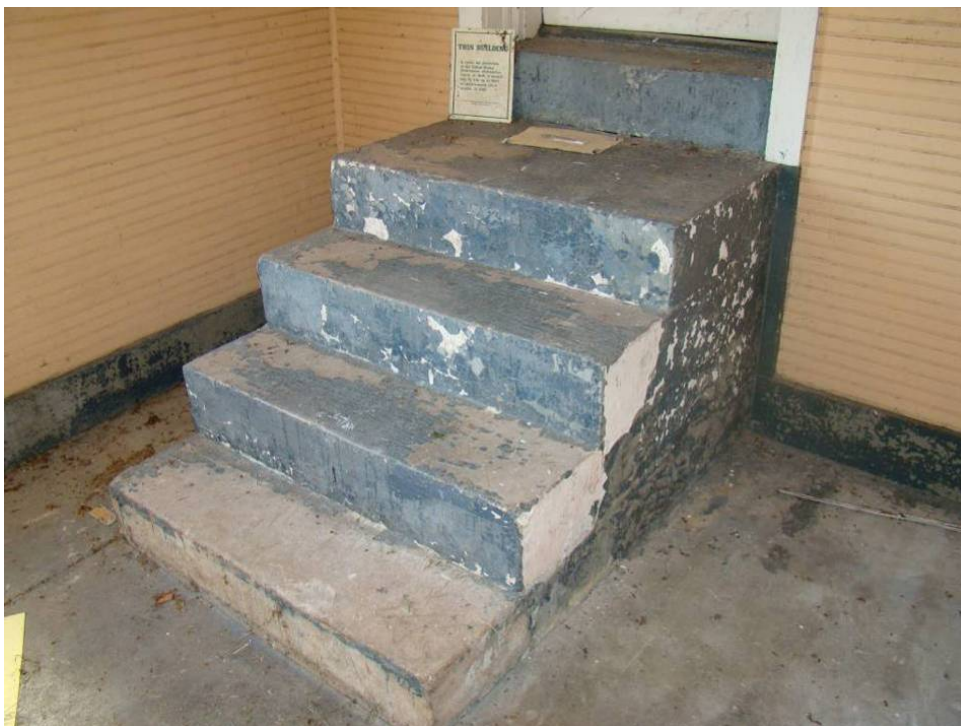
OI-KQ-22: Secondary entrance, looking east (Source: AH CIMG4535)

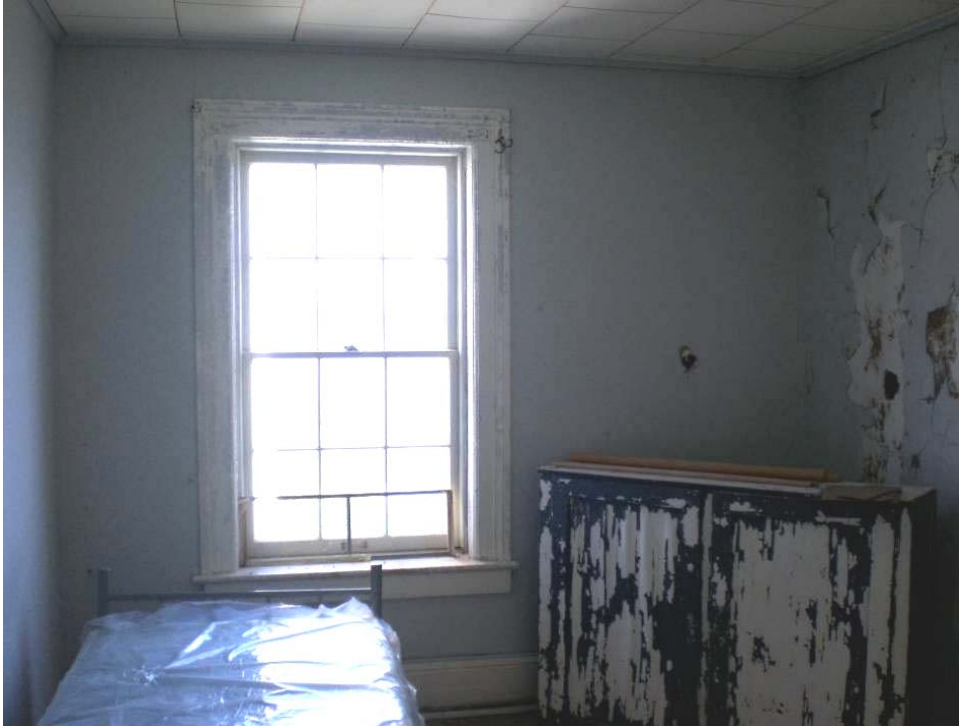
OI-KQ-24: Northeast second floor bedroom (Source: AH CIMG4589)

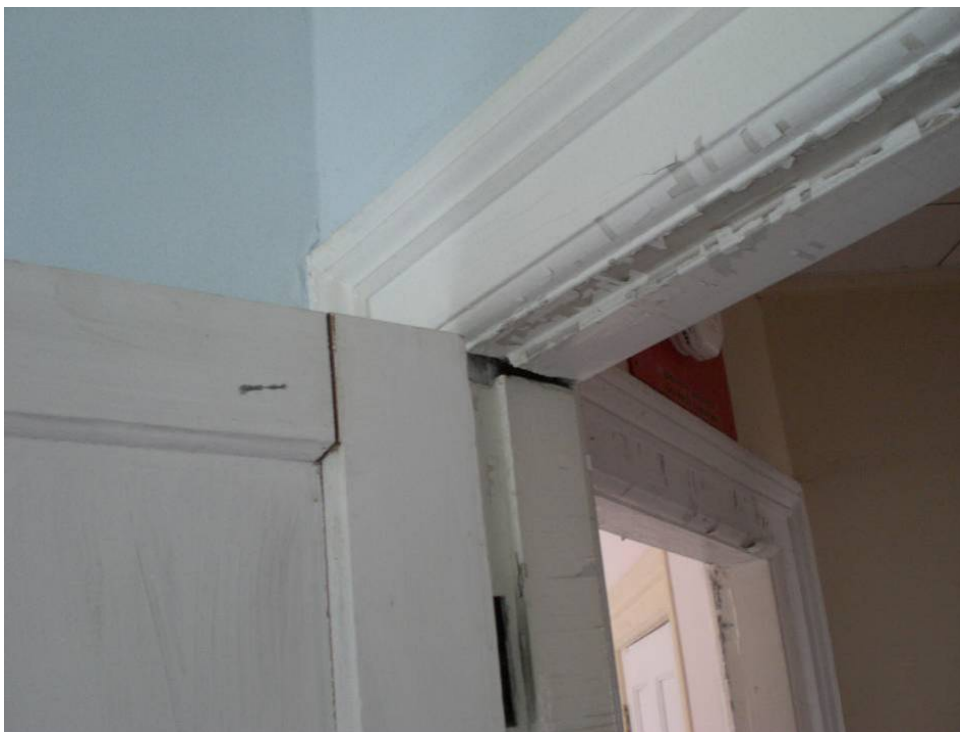
OI-KQ-26: Southeast second floor bedroom door and frame (Source: AH CIMG4617)

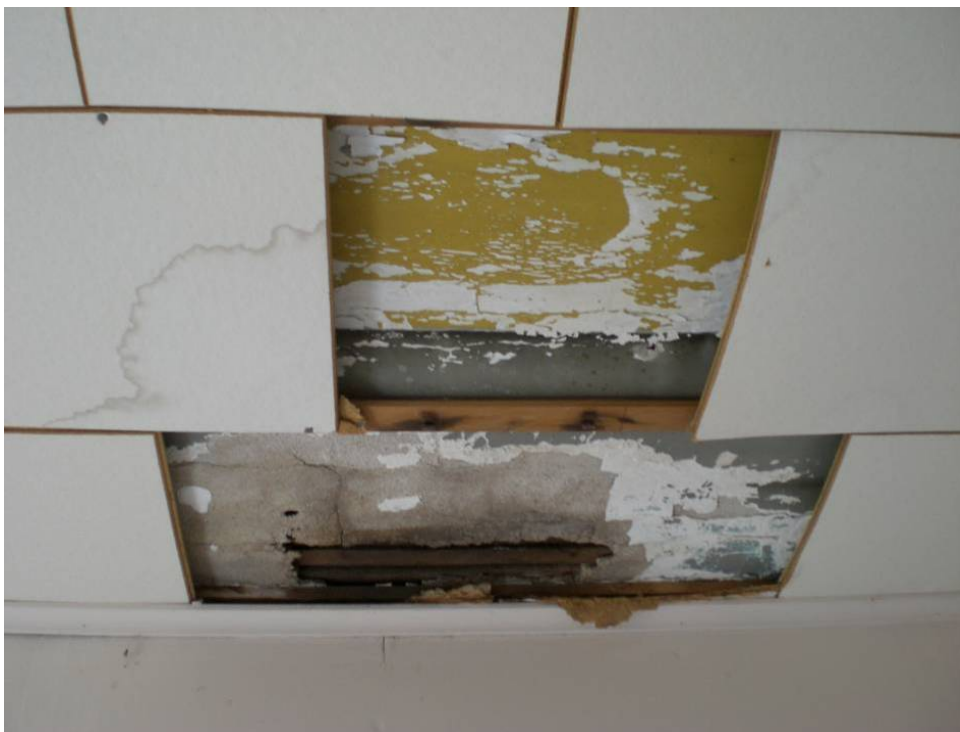
OI-KQ-27: Southwest second floor bedroom ceiling (Source: AH CIMG4630)

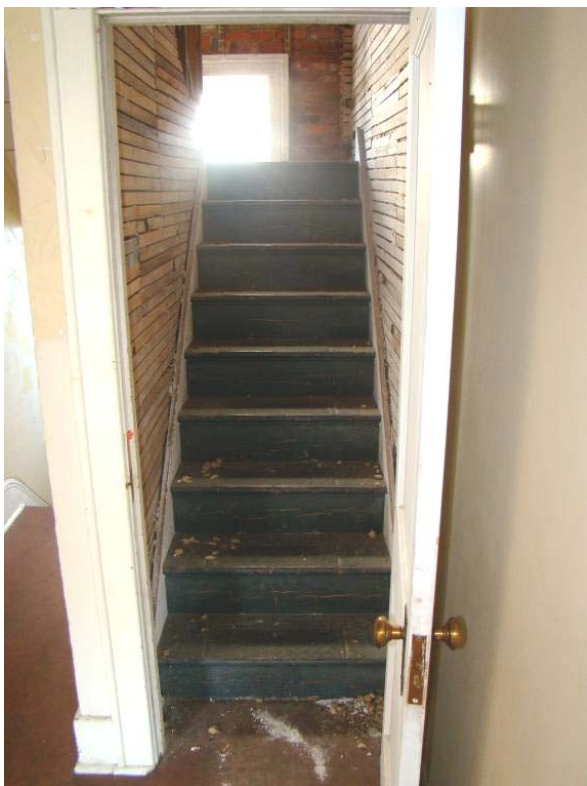
OI-KQ-28: Second floor stair to attic, north elevation (Source: AH DSC01535)

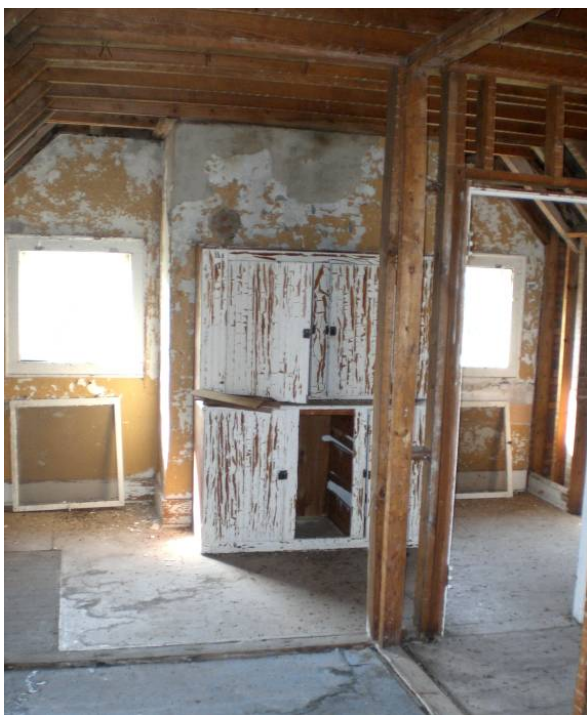
OI-KQ-29: South view of attic space (Source: AH CIMG4661)

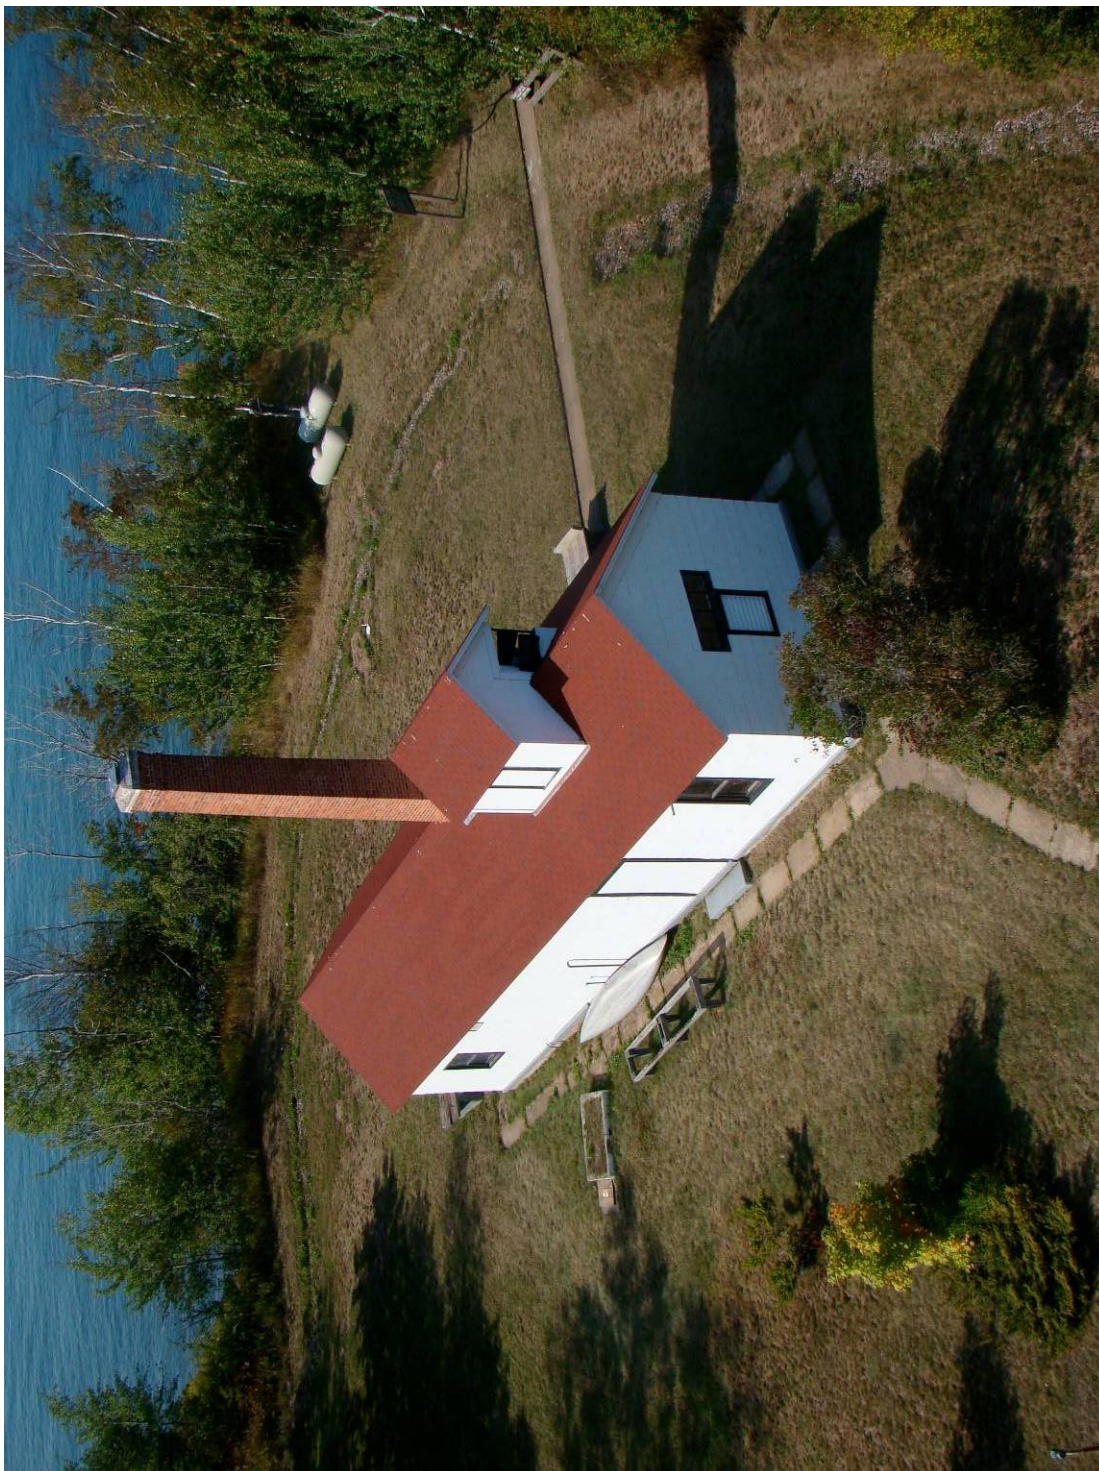
Ol-FSB-01: Aerial, 2009 (Source: AH DSC01512)

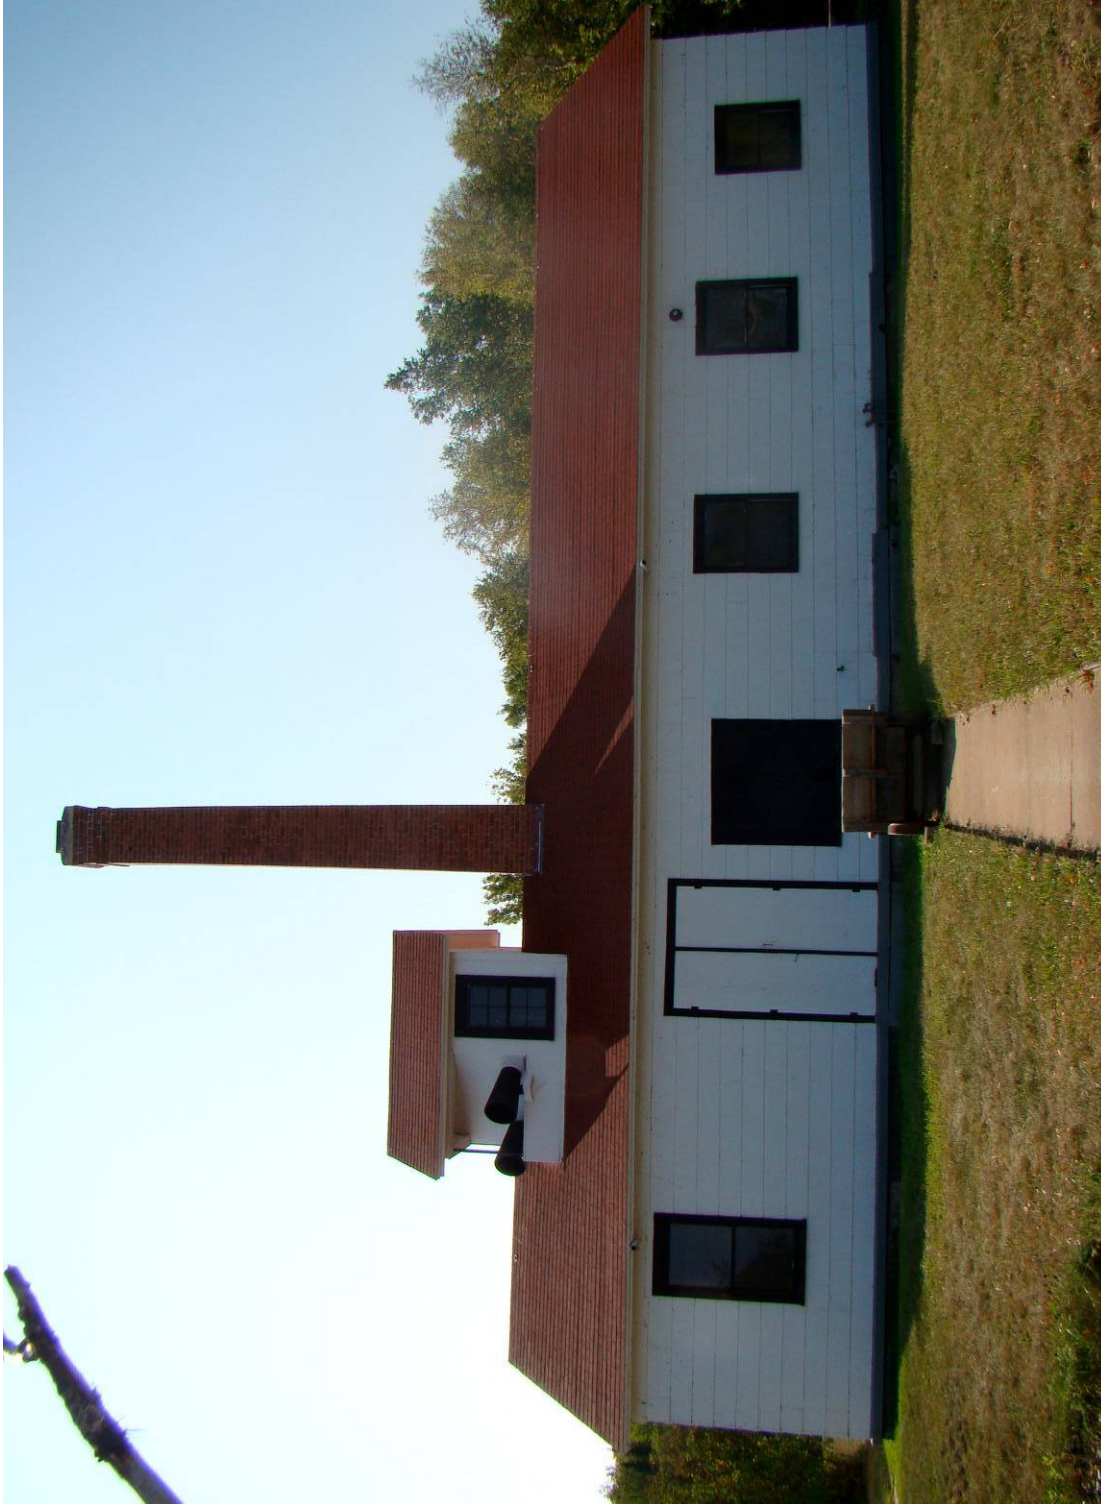
OI-FSB-02: North elevation, 2009 (Source: AH DSC01420)

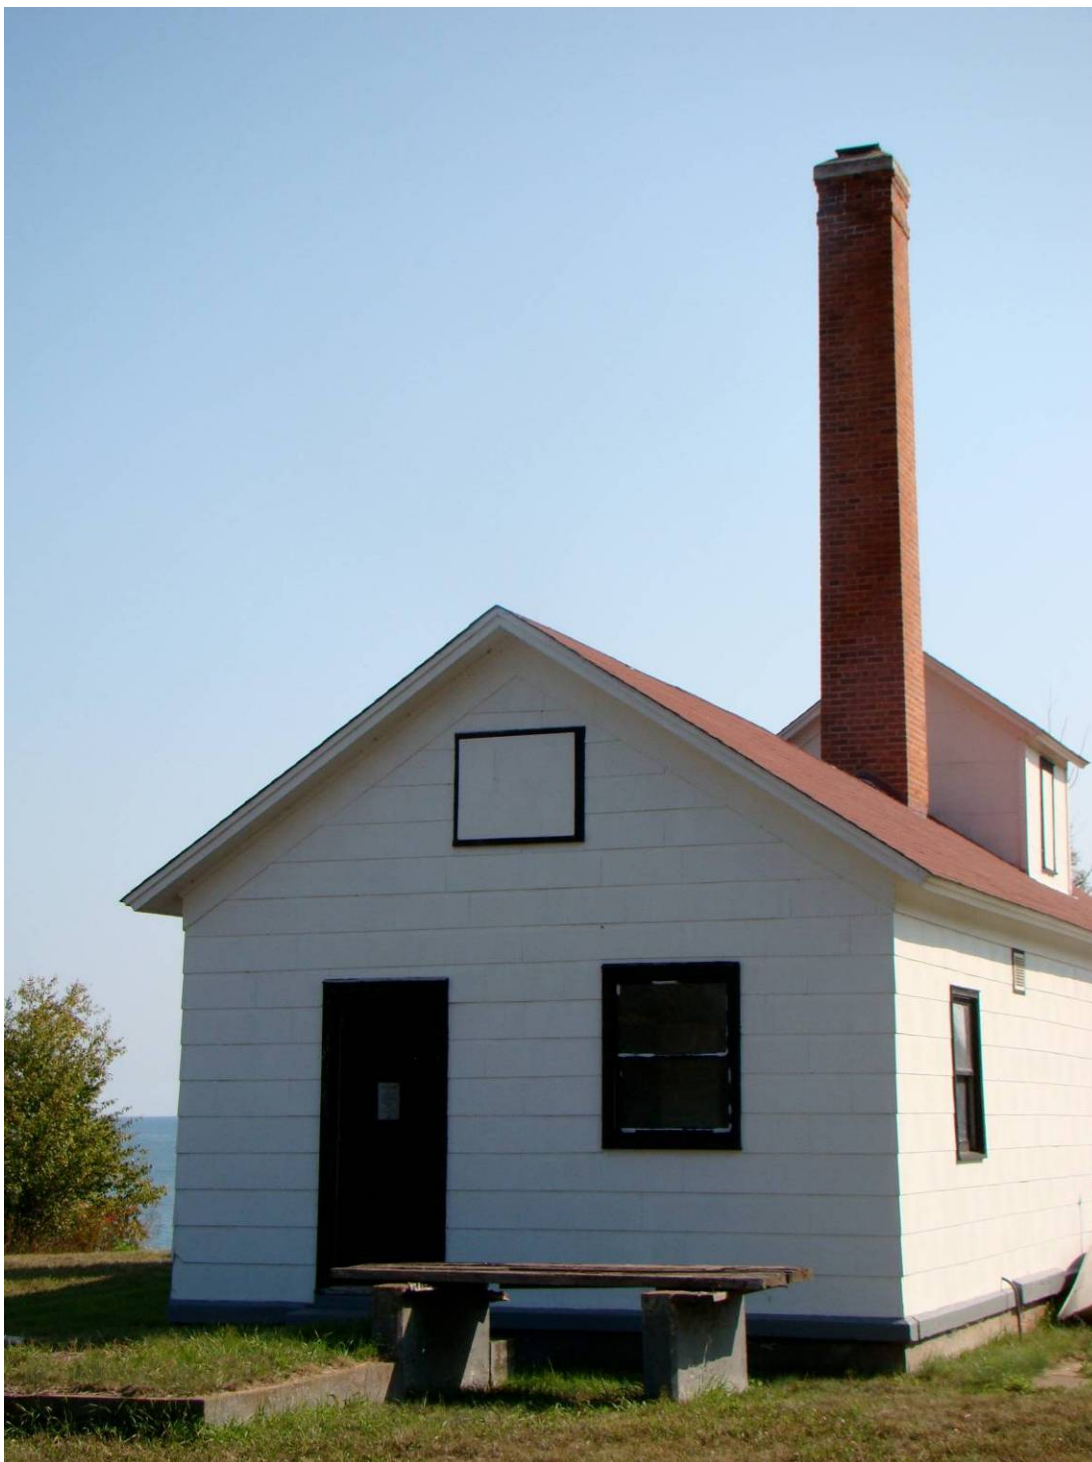
OI-FSB-03: West elevation, 2009 (Source: AH DSC01418)

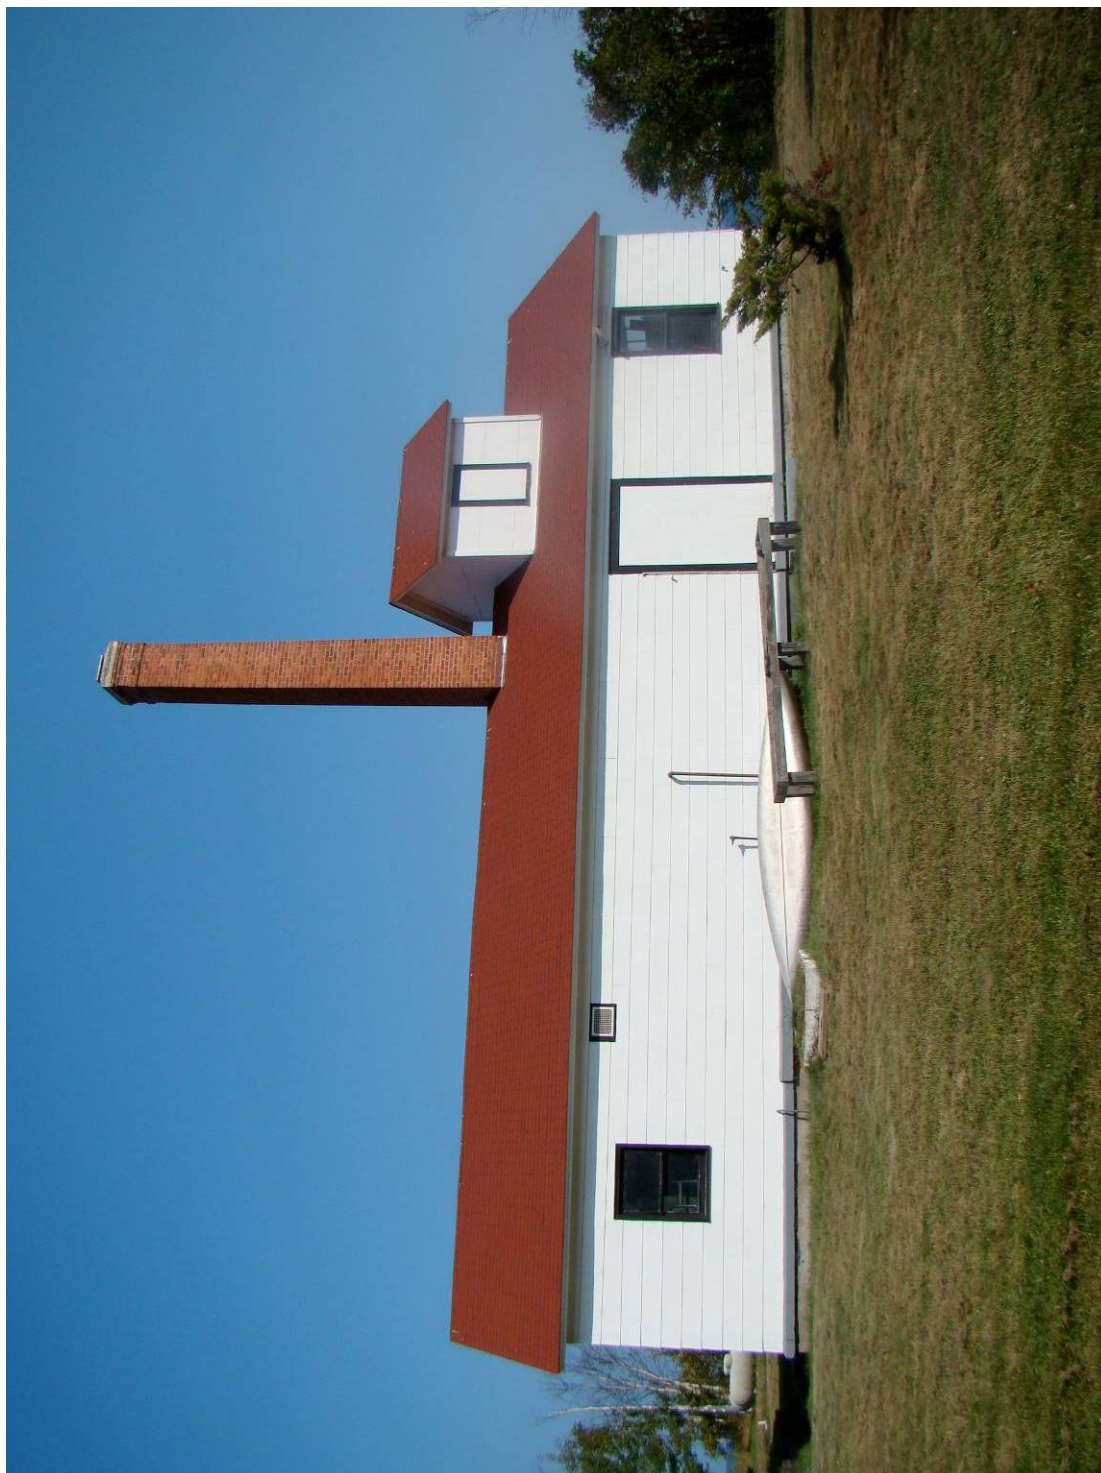
Ol-FSB-04: South elevation, 2009 (Source: AH DSC01417)
