VOLUME III OF VI: OUTER ISLAND CLR/HSR

**CULTURAL LANDSCAPE REPORT, HISTORIC STRUCTURE REPORT
AND
ENVIRONMENTAL ASSESSMENT**

LIGHT STATIONS OF MICHIGAN ISLAND, OUTER ISLAND, DEVILS ISLAND,
LONG ISLAND AND SAND ISLAND

prepared by
Anderson Hallas Architects, PC
Golden, Colorado

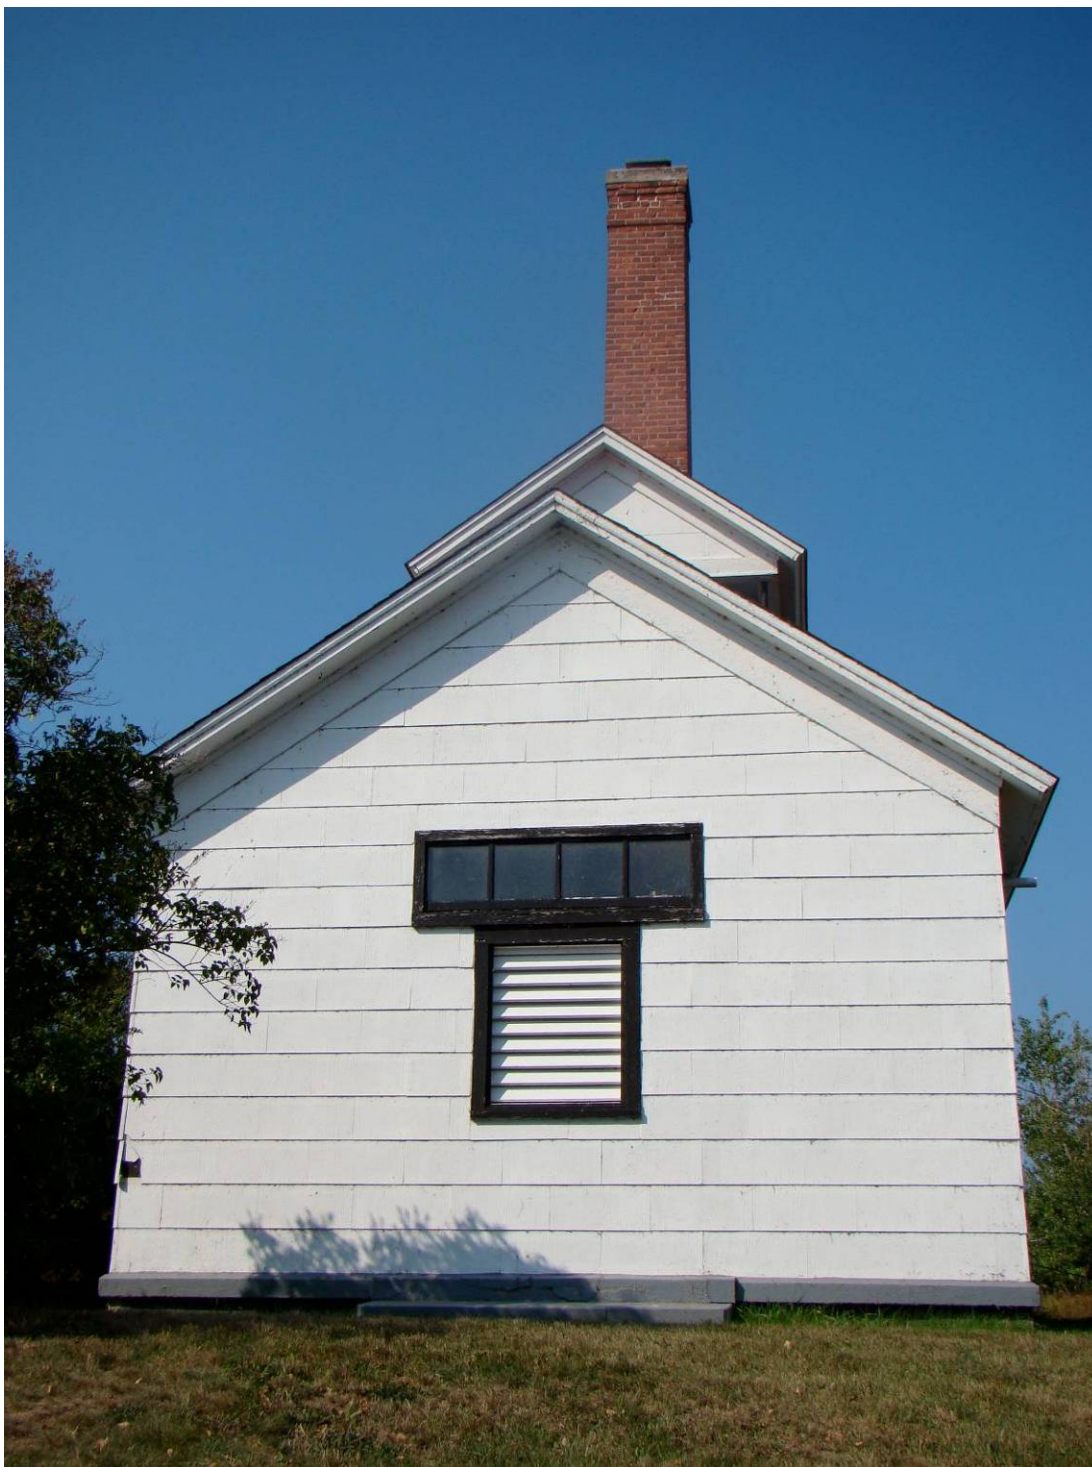
OI-FSB-05: East elevation, 2009 (Source: AH DSC01421)

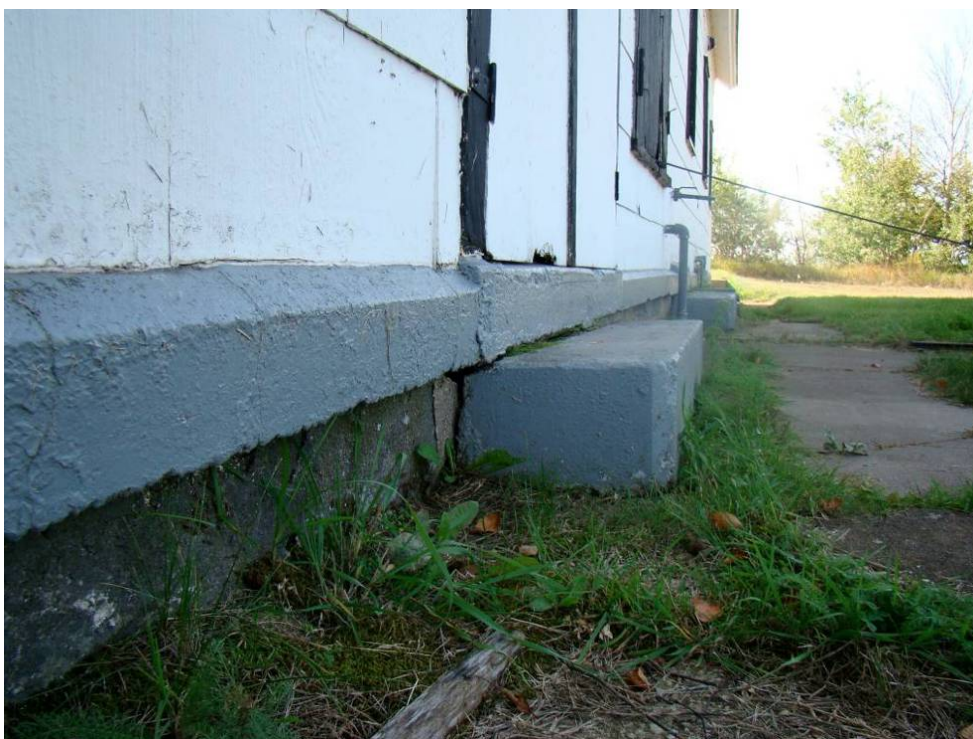
OI-FSB-07: North elevation steps and foundation details (Source: AH DSC01478)

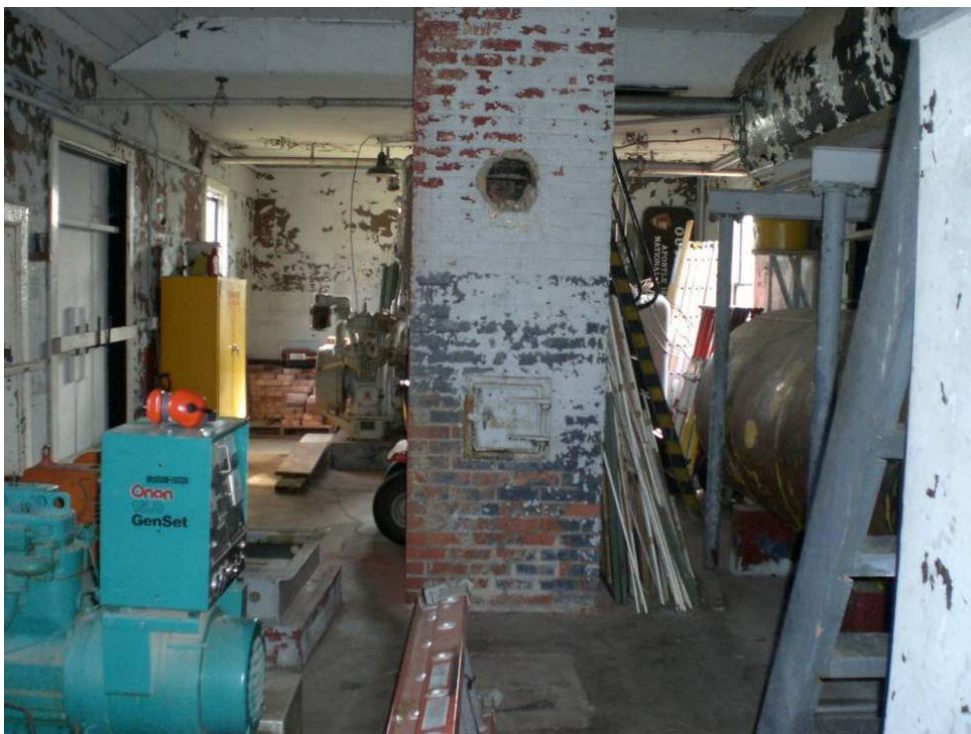
OI-FSB-08: Equipment room, east elevation (Source: AH CIMG4400)

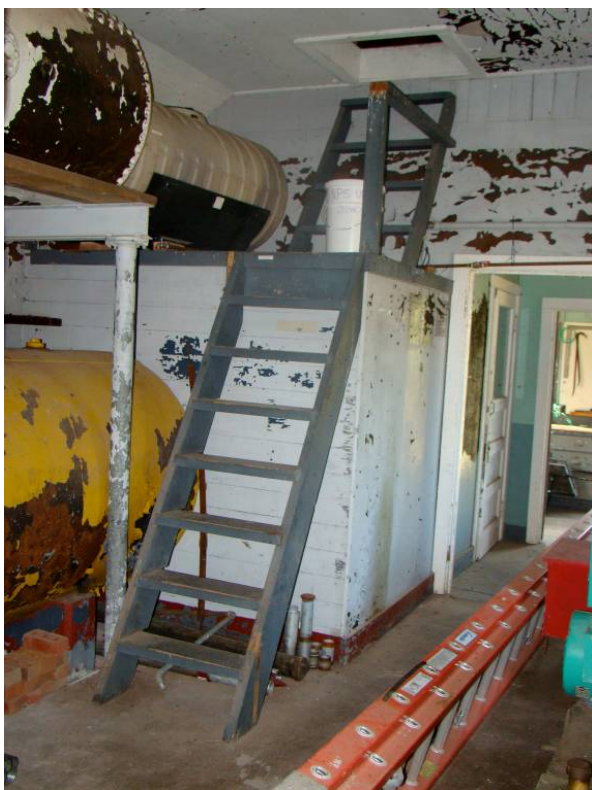
OI-FSB-09: Equipment room and loft, looking west (Source: AH DSC01485)

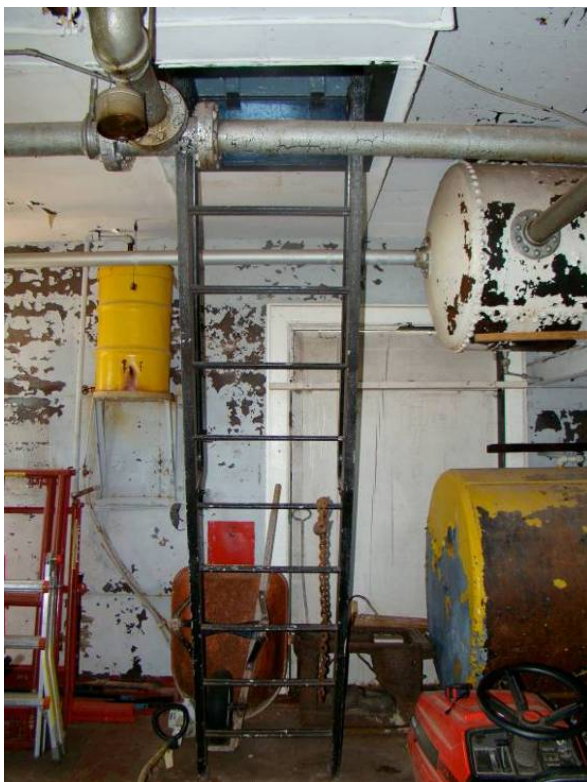
OI-FSB-10: Equipment room ladder to fog signal room, south elevation (Source: AH DSC01490)

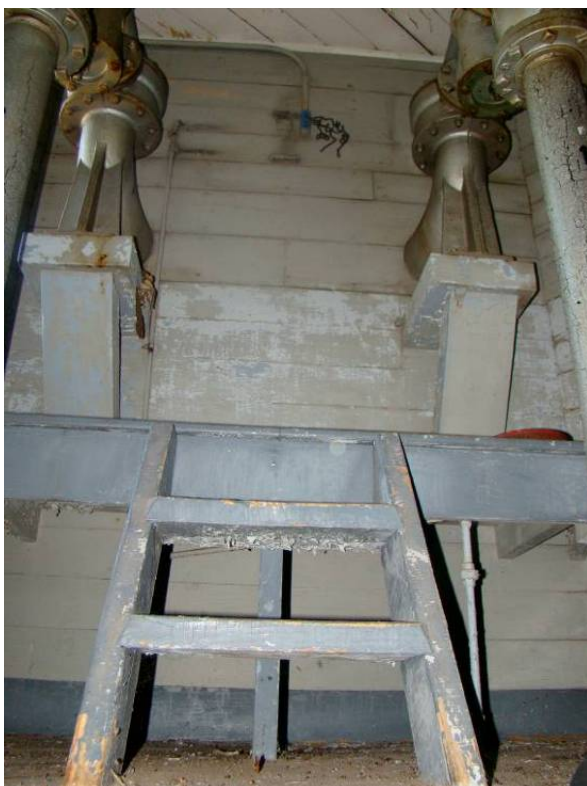
OI-FSB-11: Fog signal room, north elevation (Source: AH DSC01498)

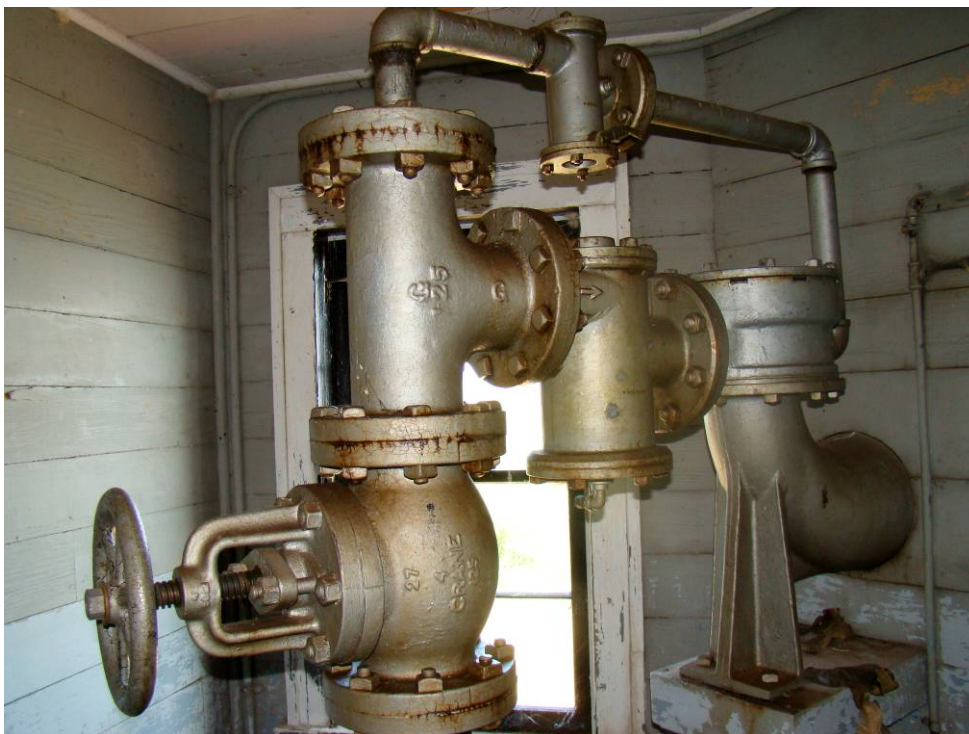
OI-FSB-12: Fog signal room, equipment detail and window, looking northwest (Source: AH DSC01399)

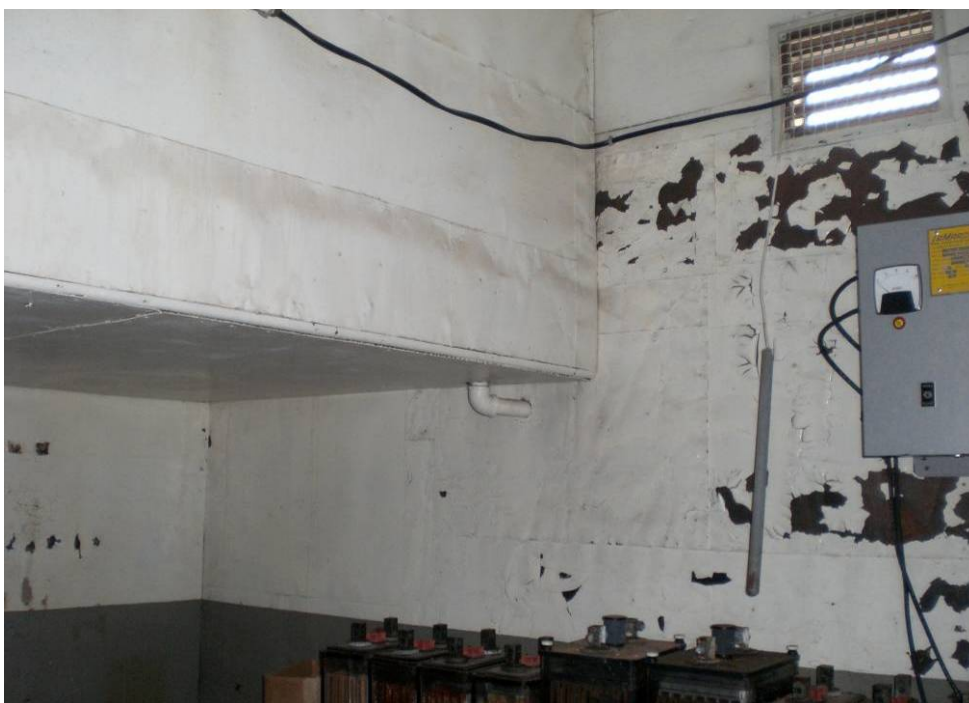
OI-FSB-13: Battery storage room, looking southeast (Source: AH CIMG4414)

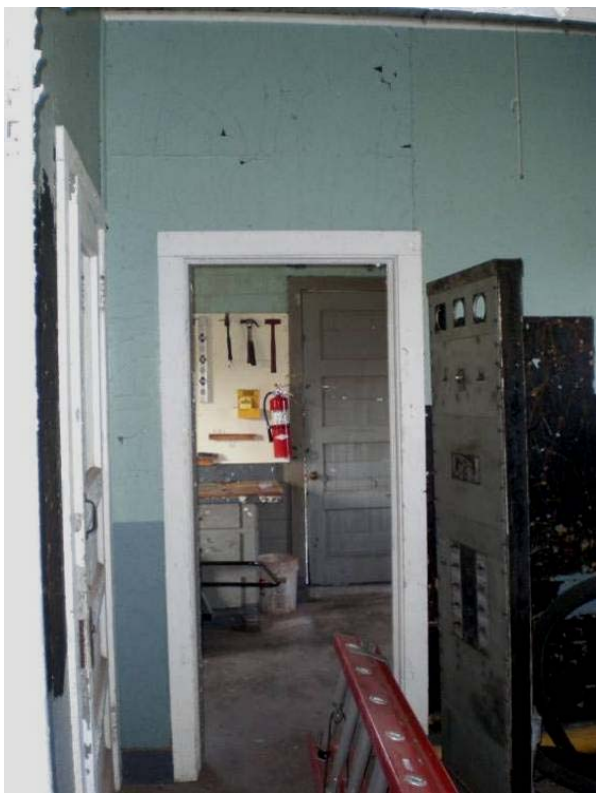
OI-FSB-14: Storage room, west elevation into work room (Source: AH CIMG4438)

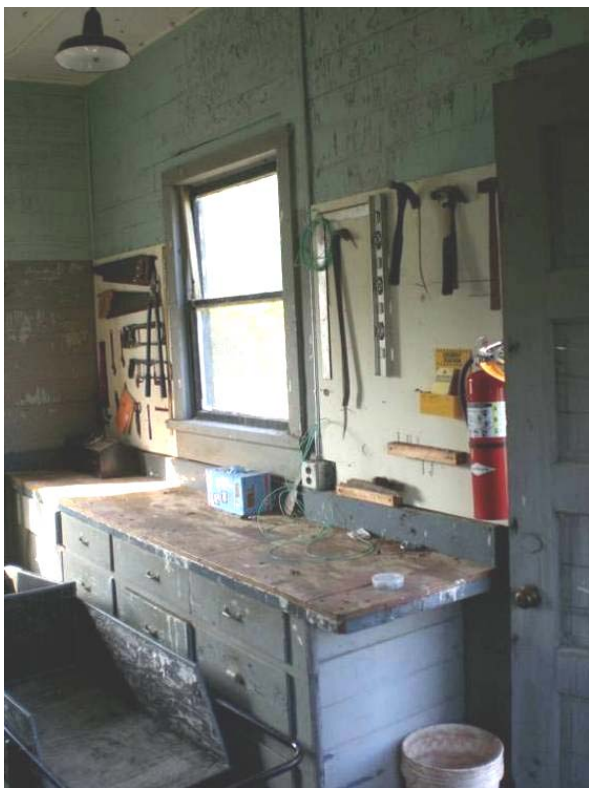
OI-FSB-15: Work room, looking southwest (Source: AH CIMG4425)

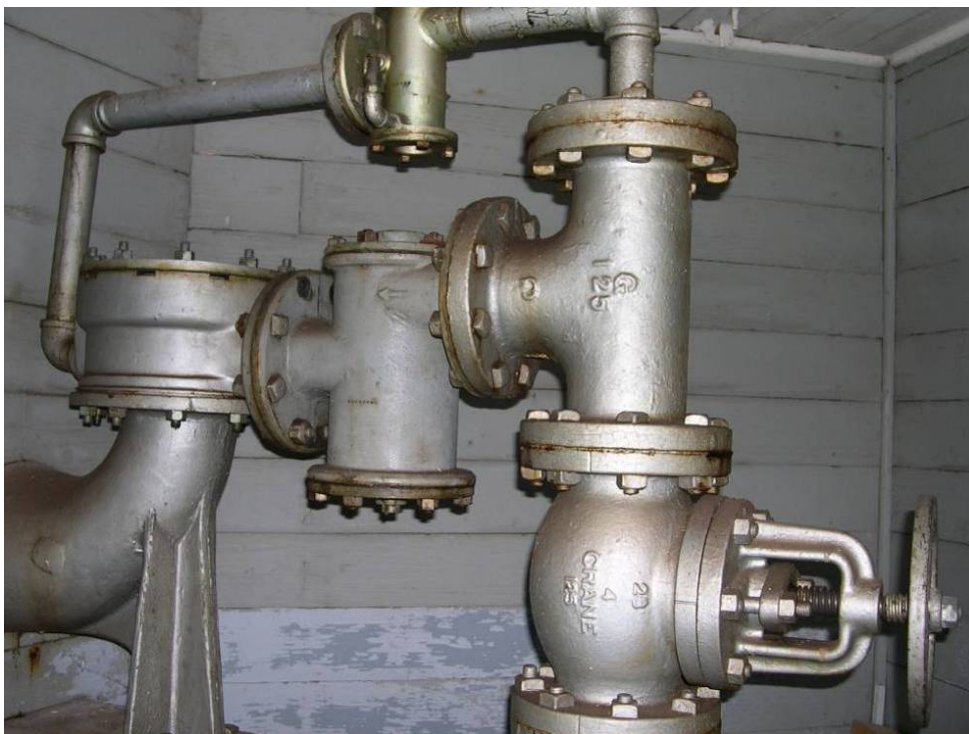
OI-FSB-16: Fog signal valves (Source: RMH)

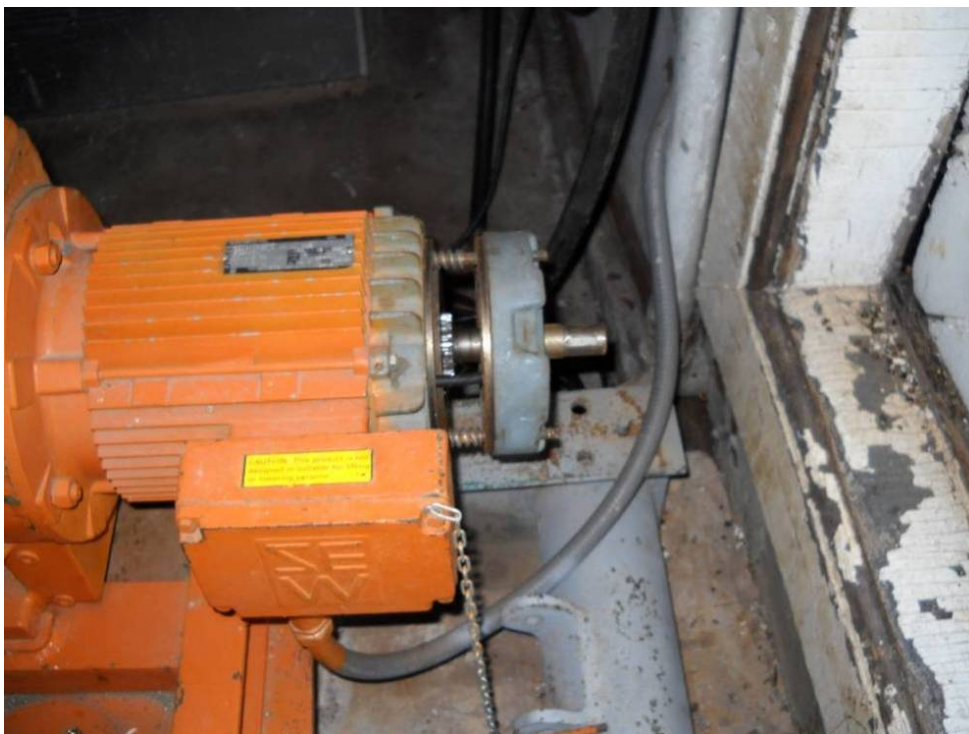
OI-FSB-17: Tram hoist winch, clutch is disassembled and awaiting parts (Source: RMH)

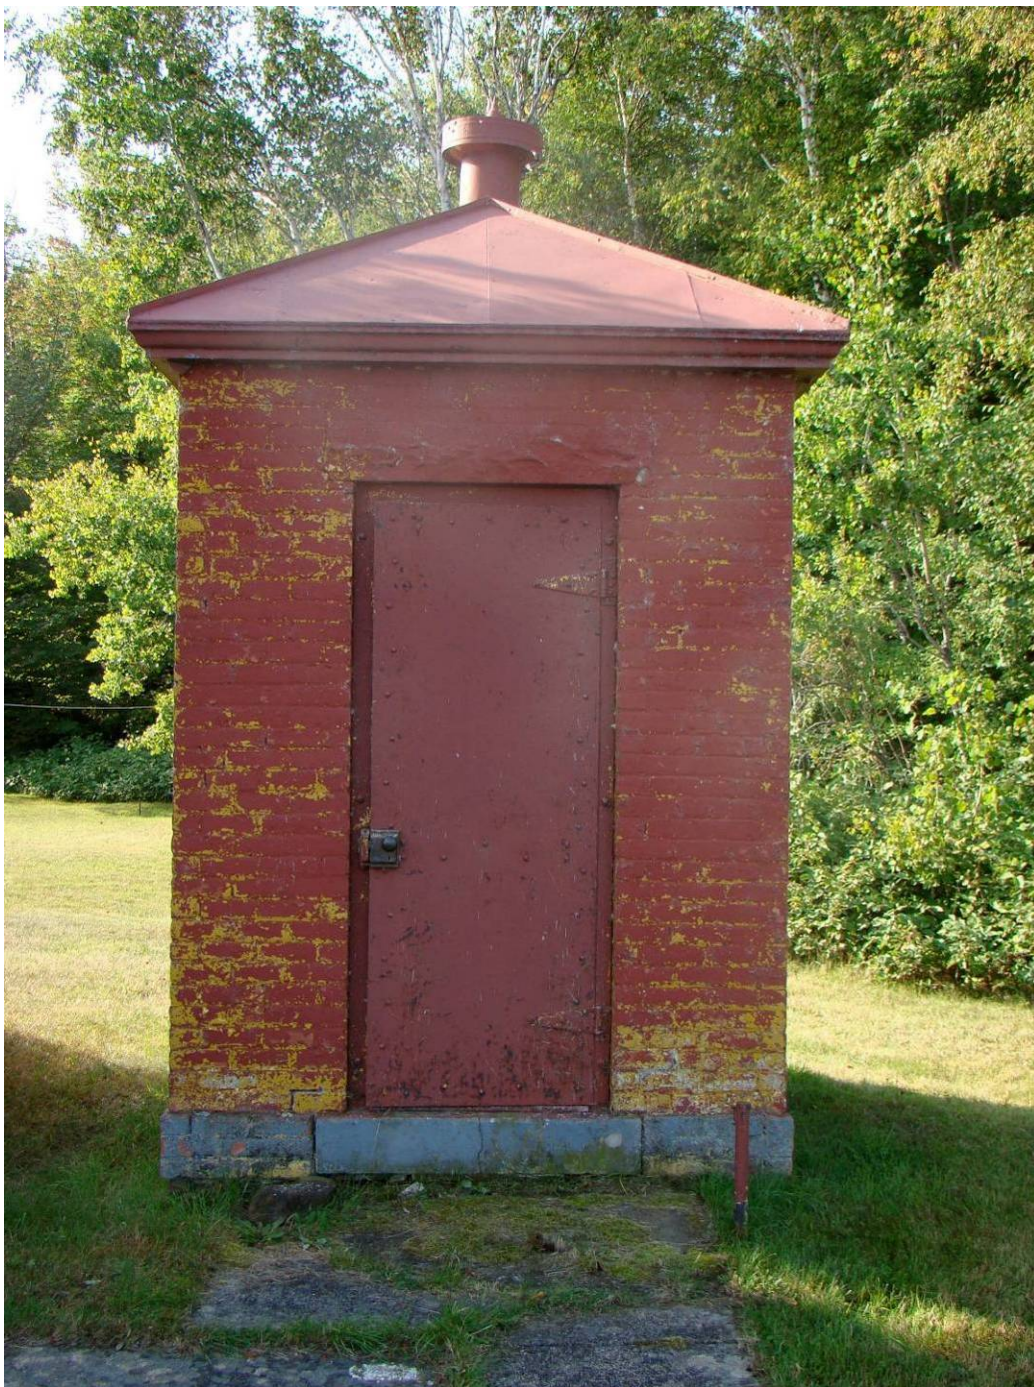
The exterior walls are in fair condition, as the walls need repointing and the brick foundation is exposed and weathering at the southwest corner. The paint is peeling severely.

OI-OS-01: North elevation, 2009 (Source: AH DSC01362)

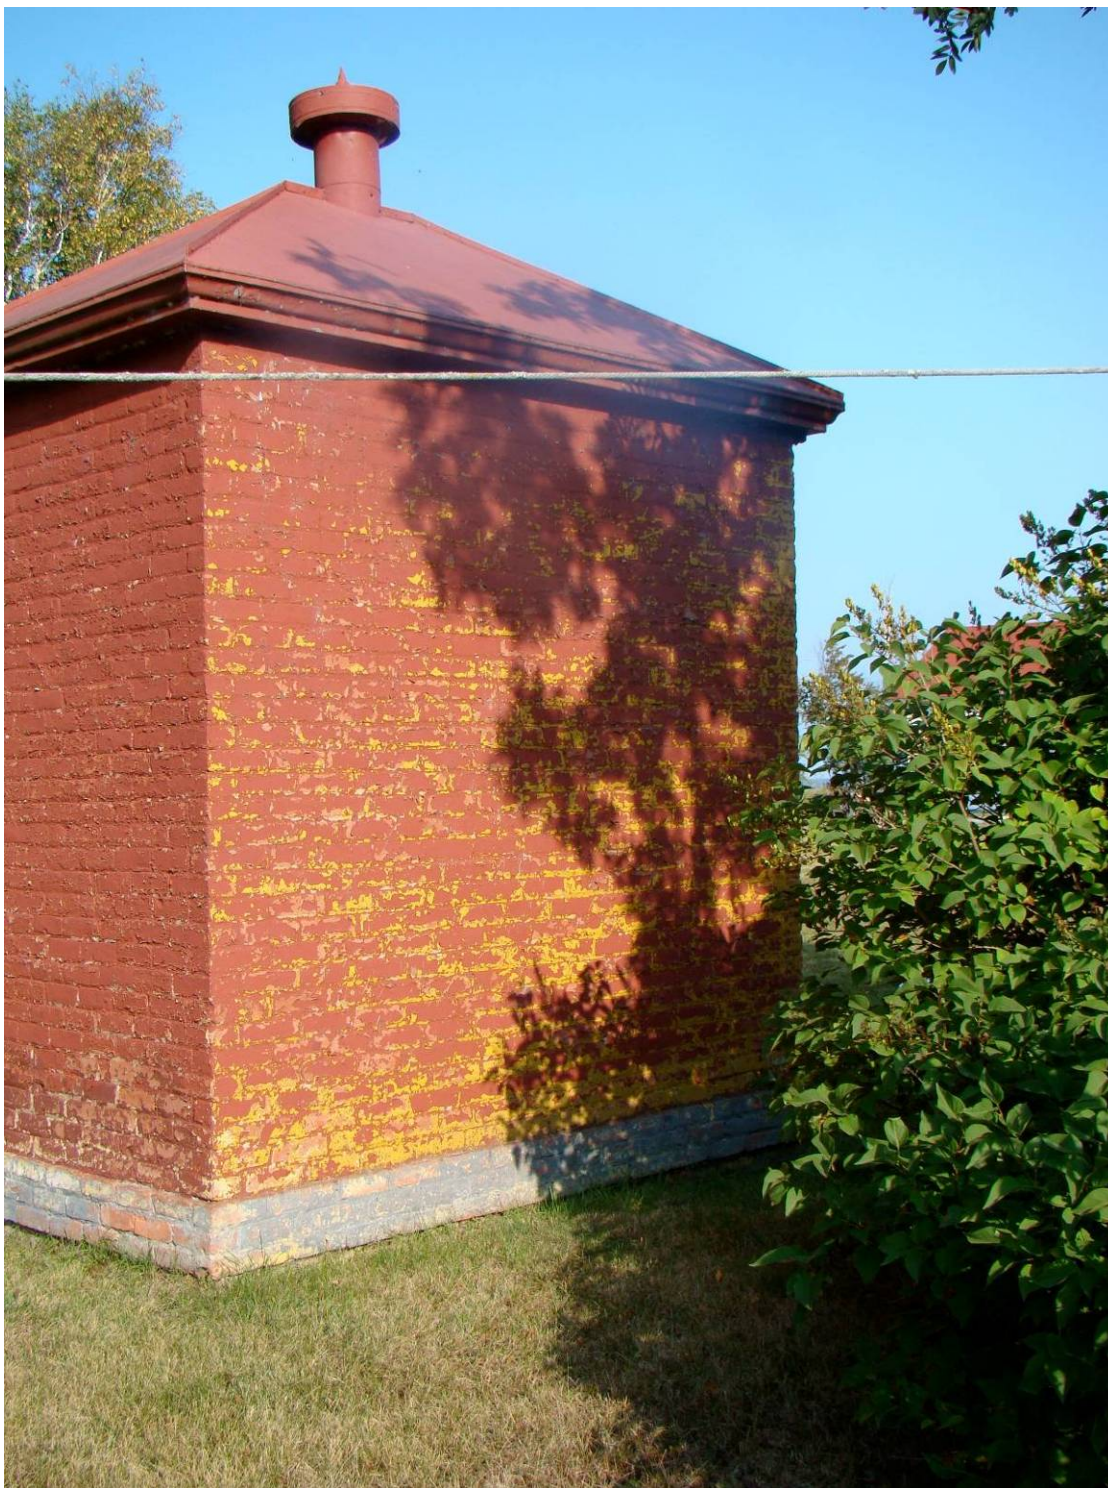
OI-OS-02: East elevation, 2009 (Source: AH DSC01364)

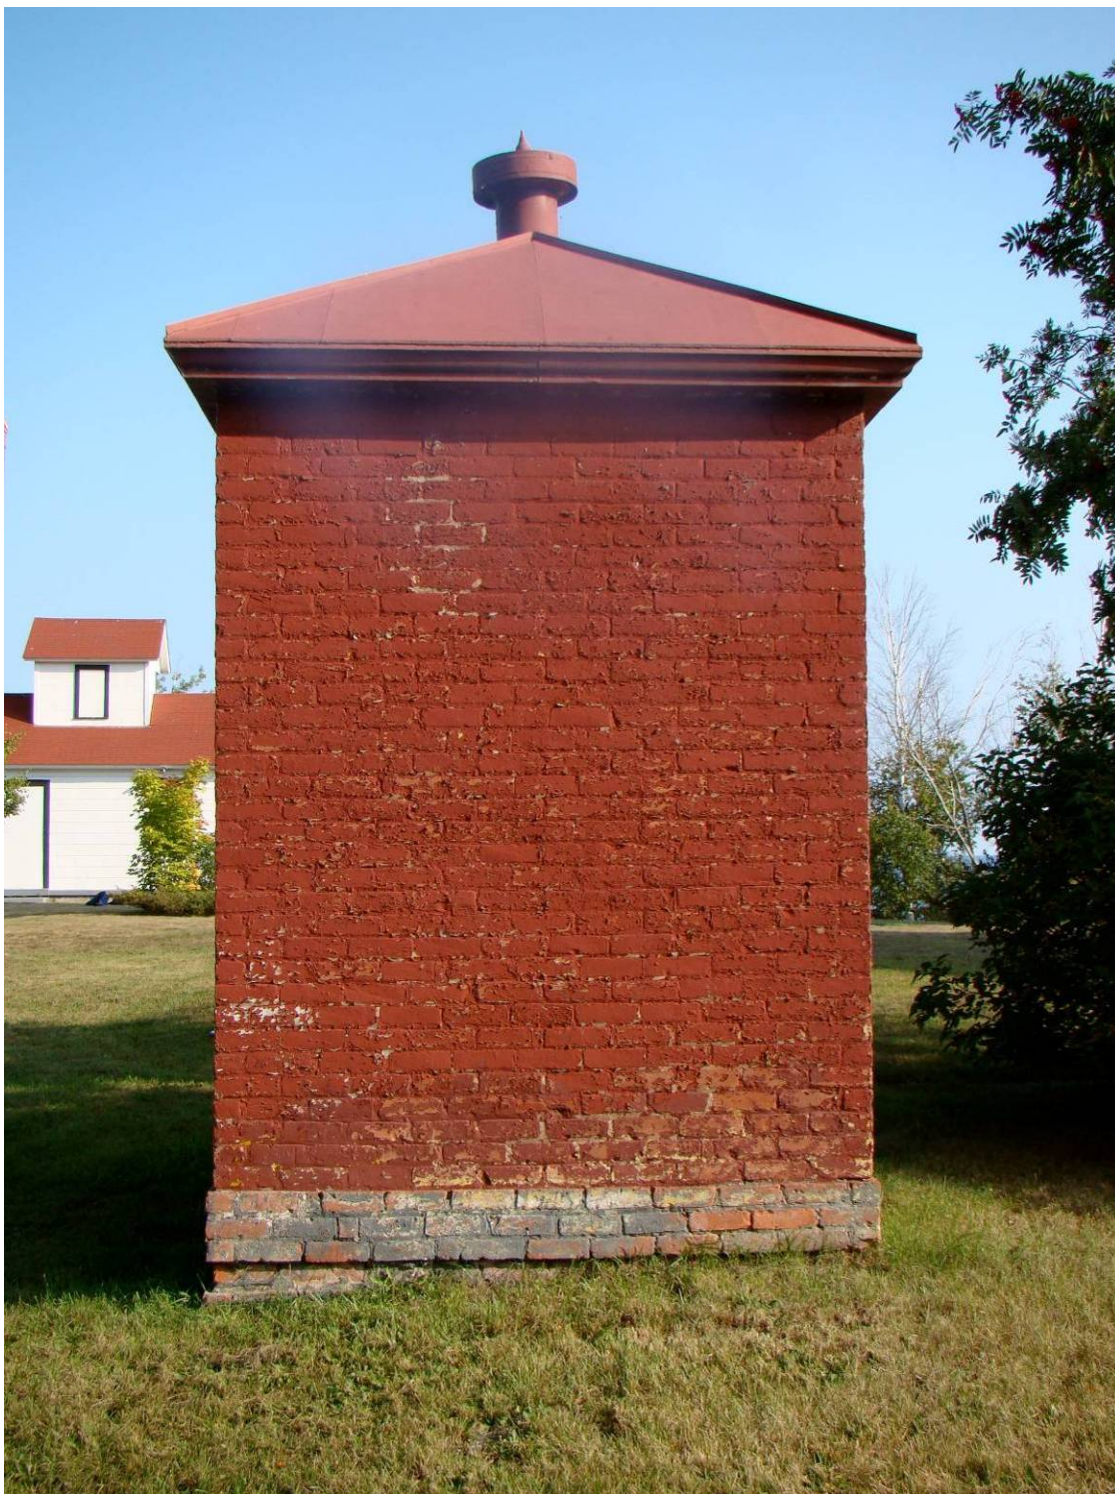
OI-OS-03: South elevation, 2009 (Source: AH DSC01363)

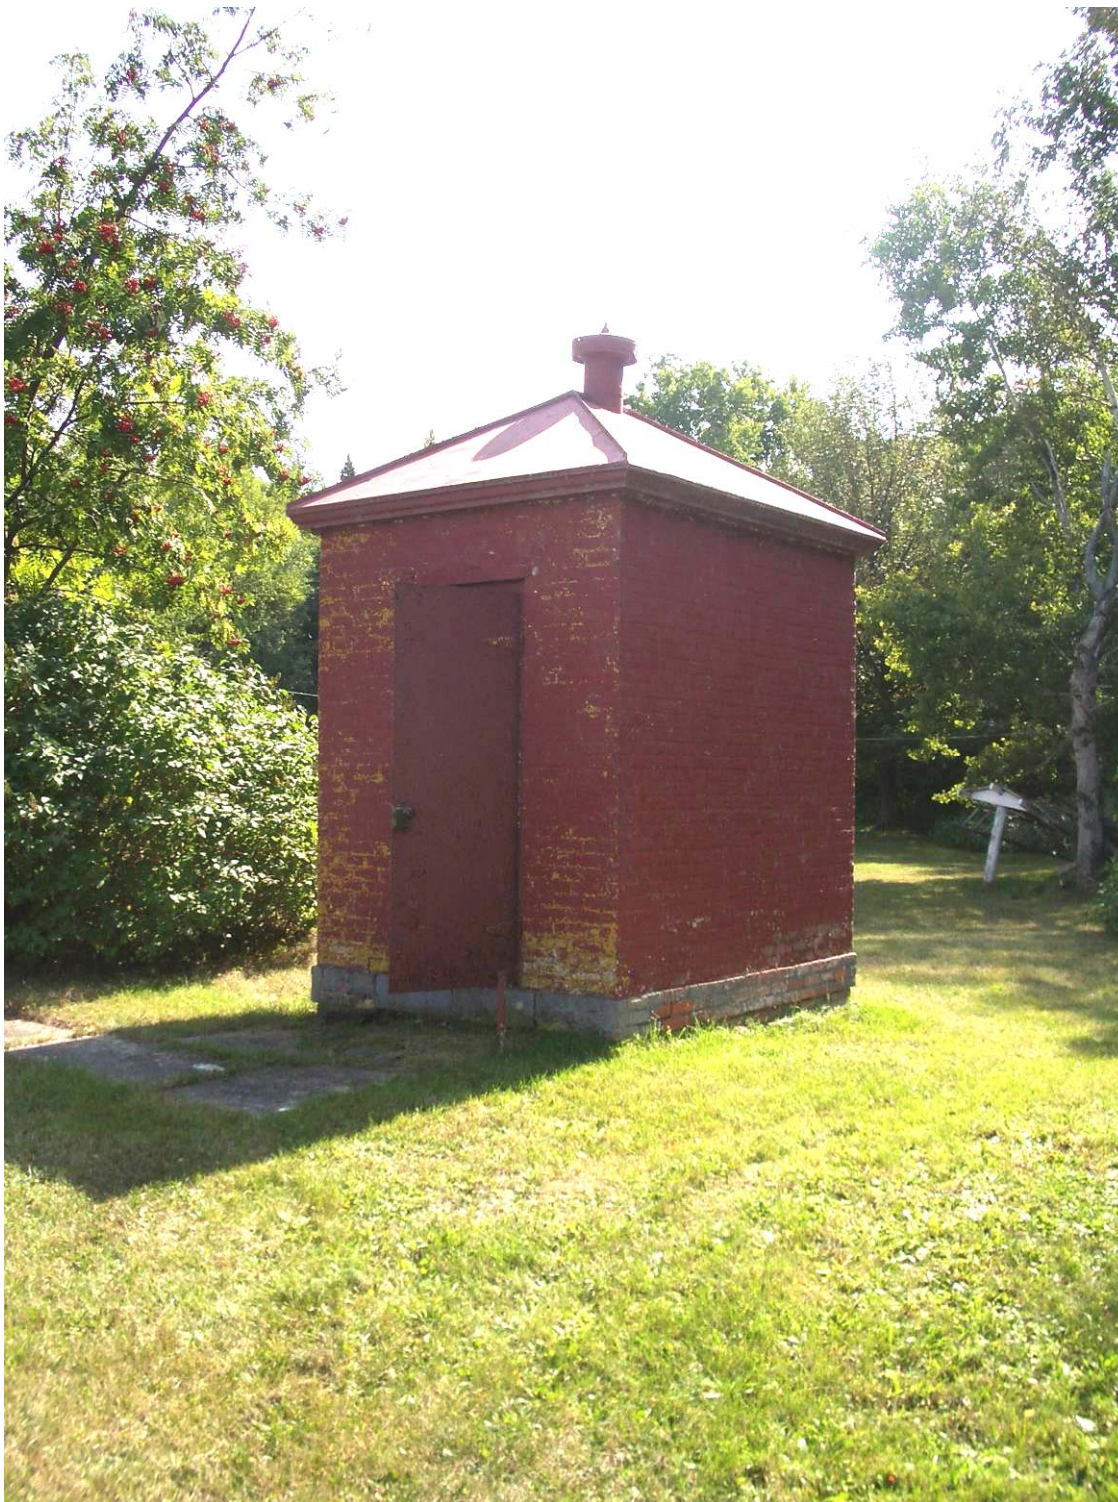
OI-OS-04: North and west elevations, 2009 (Source: AH IMGP3167)

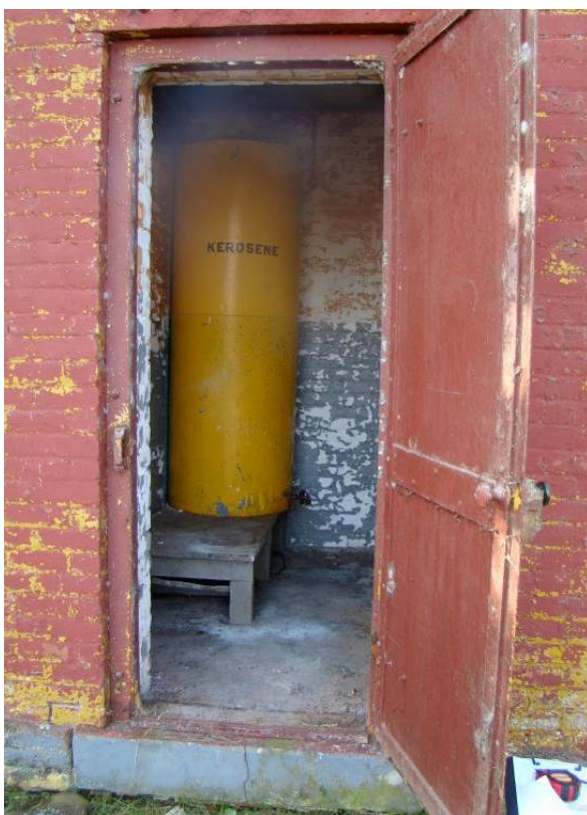
The wall finish for this building is in poor condition. The paint is peeling badly and an older layer of white paint is visible.

The concrete floor is in good condition but the blue-gray paint is deteriorated. The concrete is intact. The front stoop, however, is in fair condition as it is cracked.

OI-OS-06: Interior, looking south (Source: AH DSC01355-A)

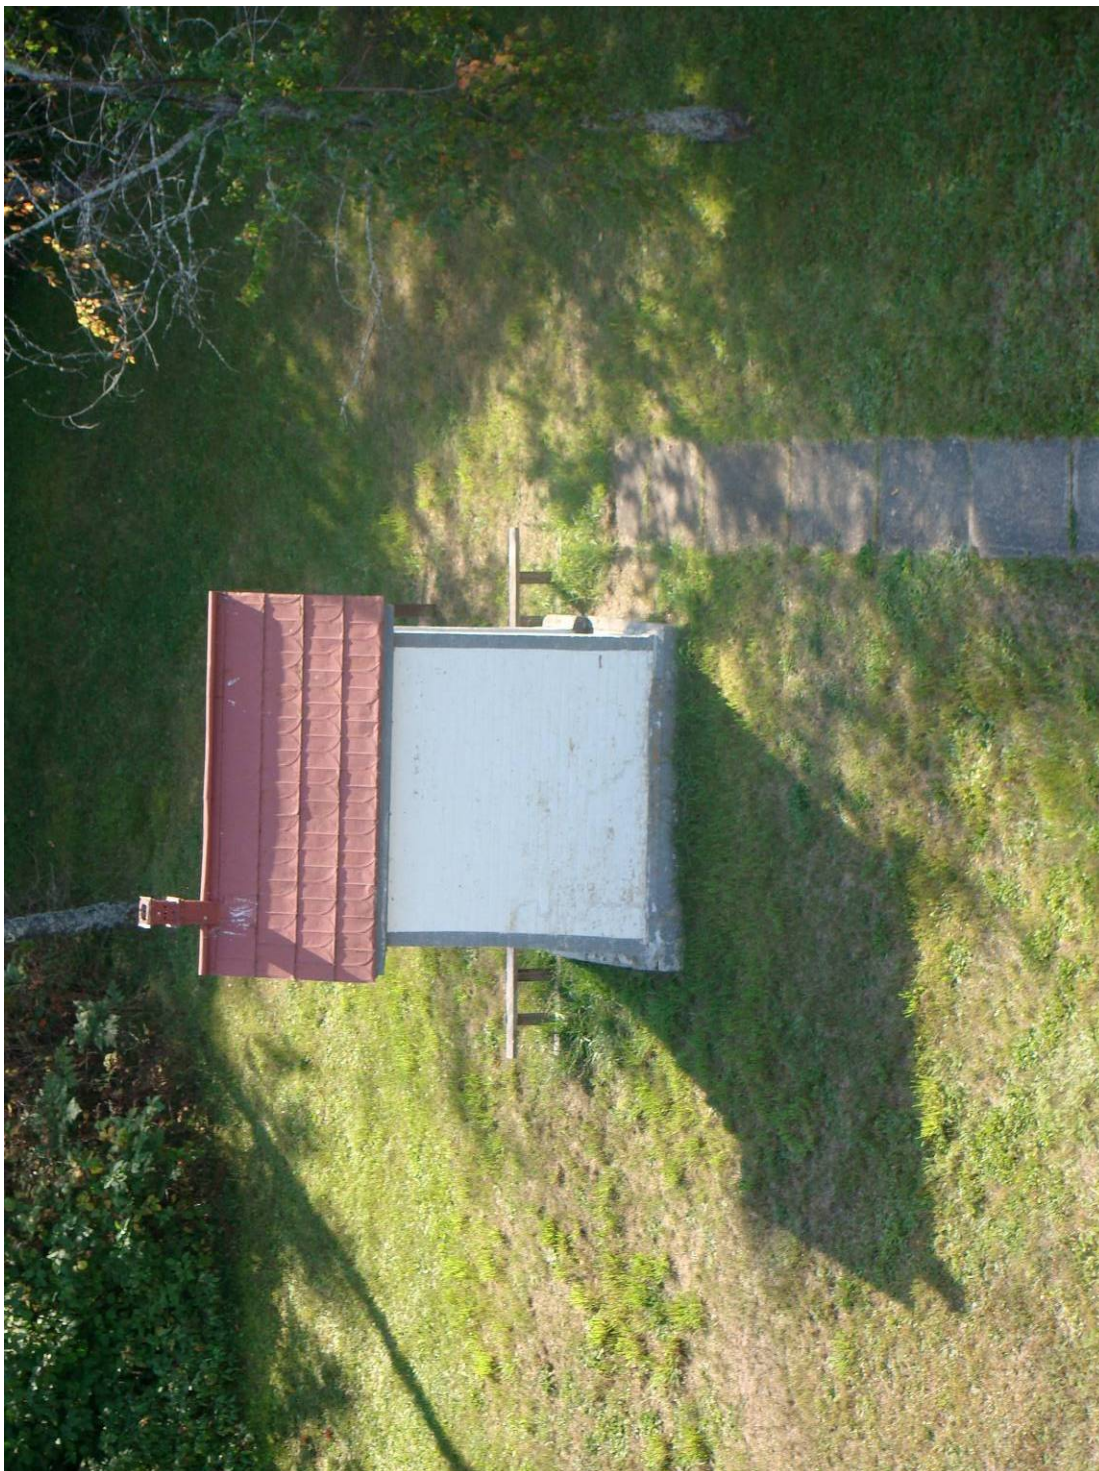
Ol-P-01: Aerial, 2009 (Source: AH DSC01510)

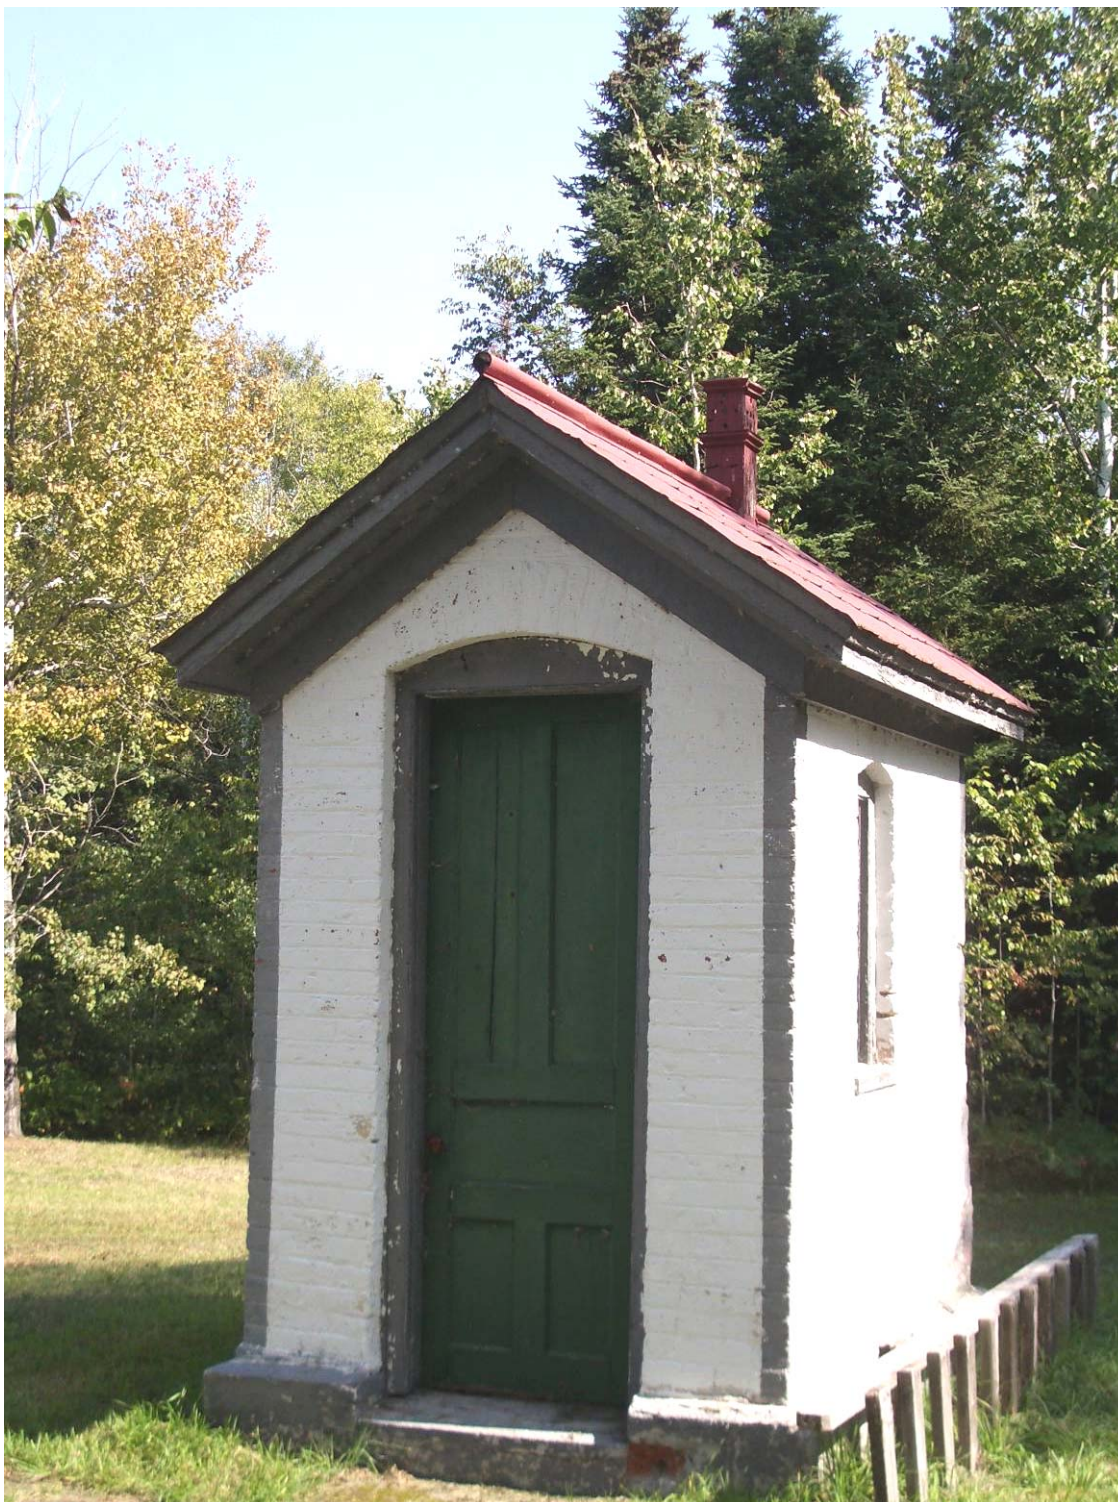
OI-P-02: West elevation, 2009 (Source: AH IMGP3159)

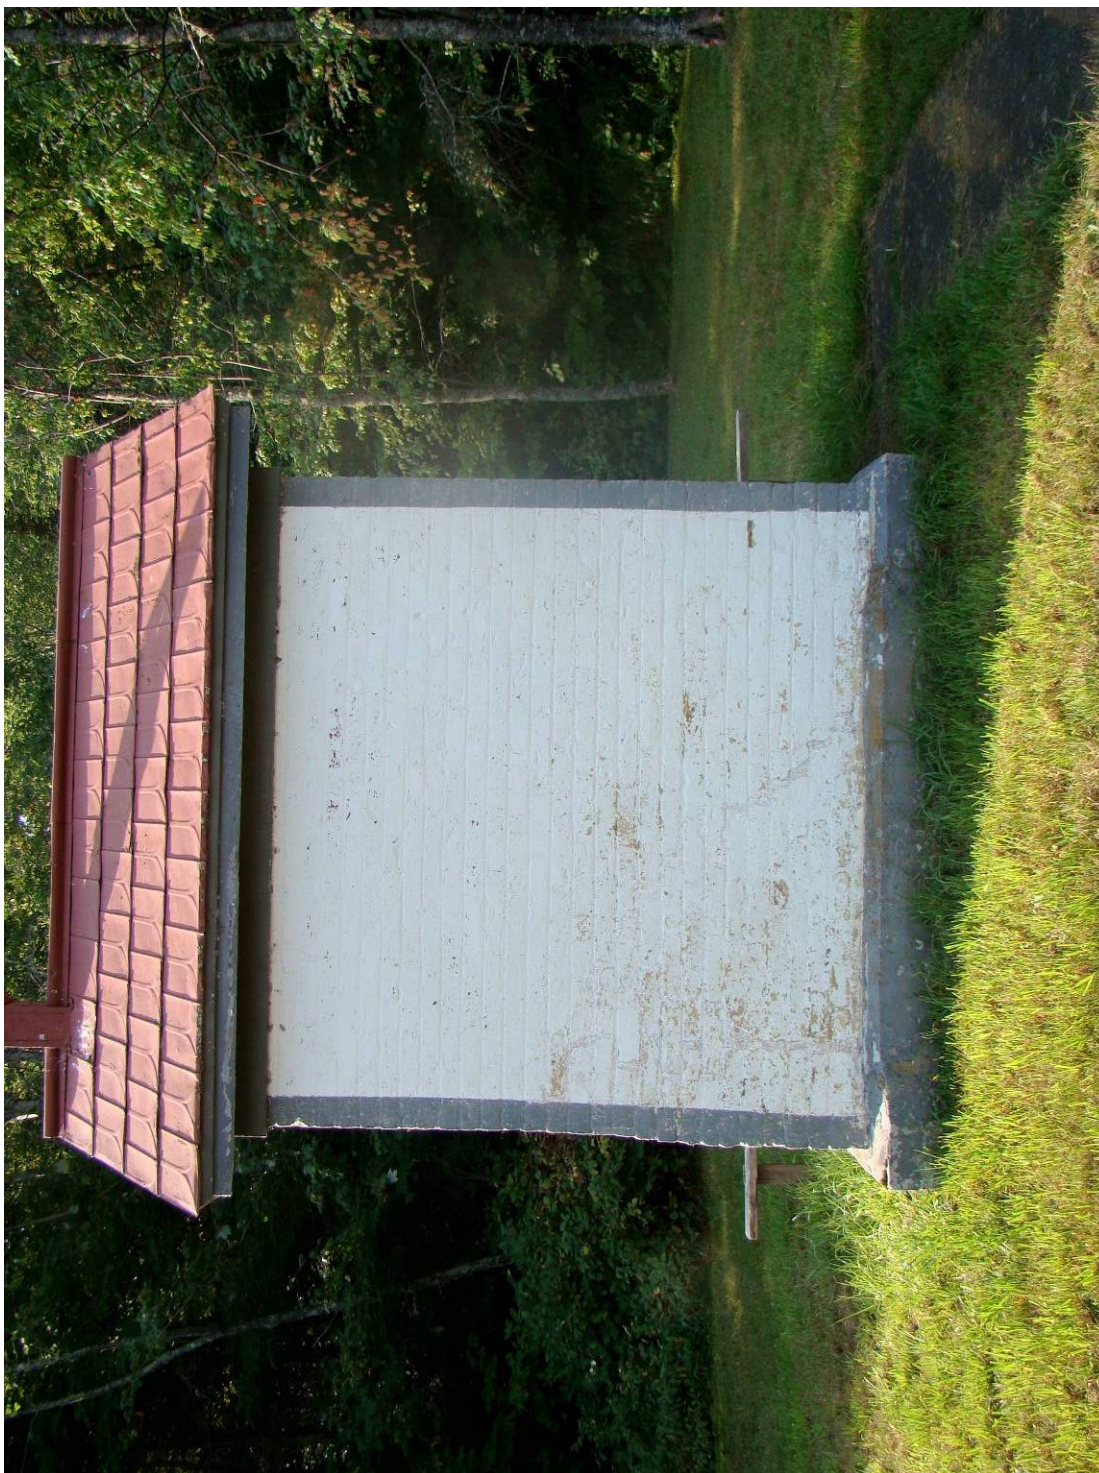
OL-P-03: North elevation, 2009 (Source: AH DSC01374)

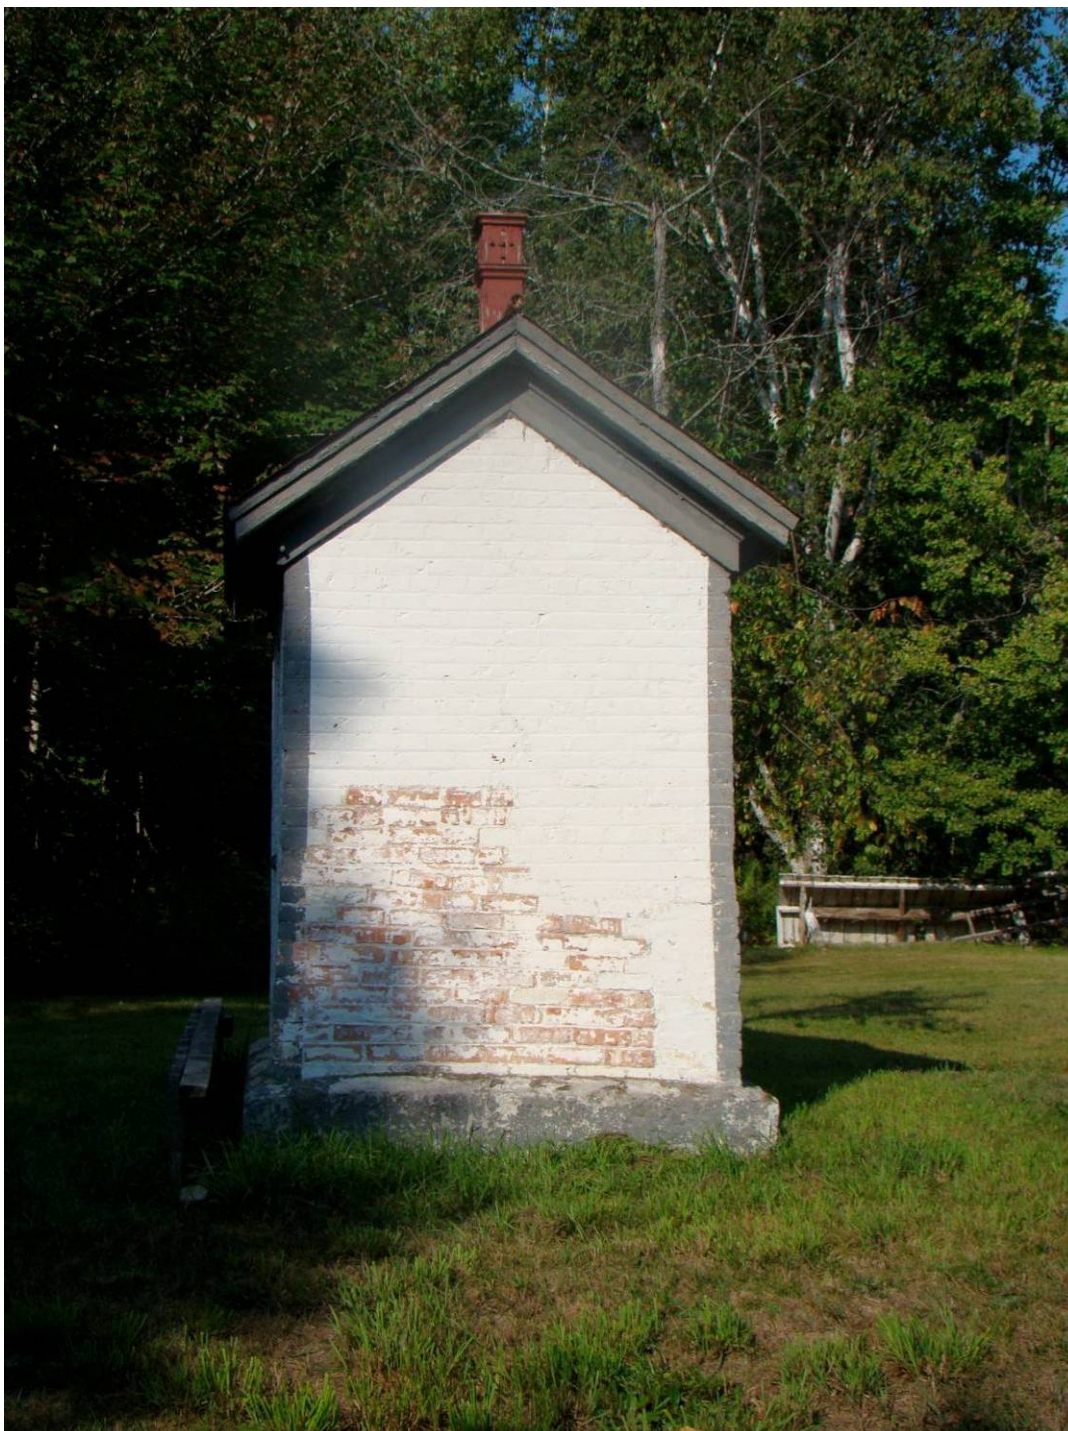
OI-P-04: East elevation, 2009 (Source: AH DSC01377)
