VOLUME III OF VI: OUTER ISLAND CLR/HSR

**CULTURAL LANDSCAPE REPORT, HISTORIC STRUCTURE REPORT
AND
ENVIRONMENTAL ASSESSMENT**

LIGHT STATIONS OF MICHIGAN ISLAND, OUTER ISLAND, DEVILS ISLAND,
LONG ISLAND AND SAND ISLAND

prepared by
Anderson Hallas Architects, PC
Golden, Colorado

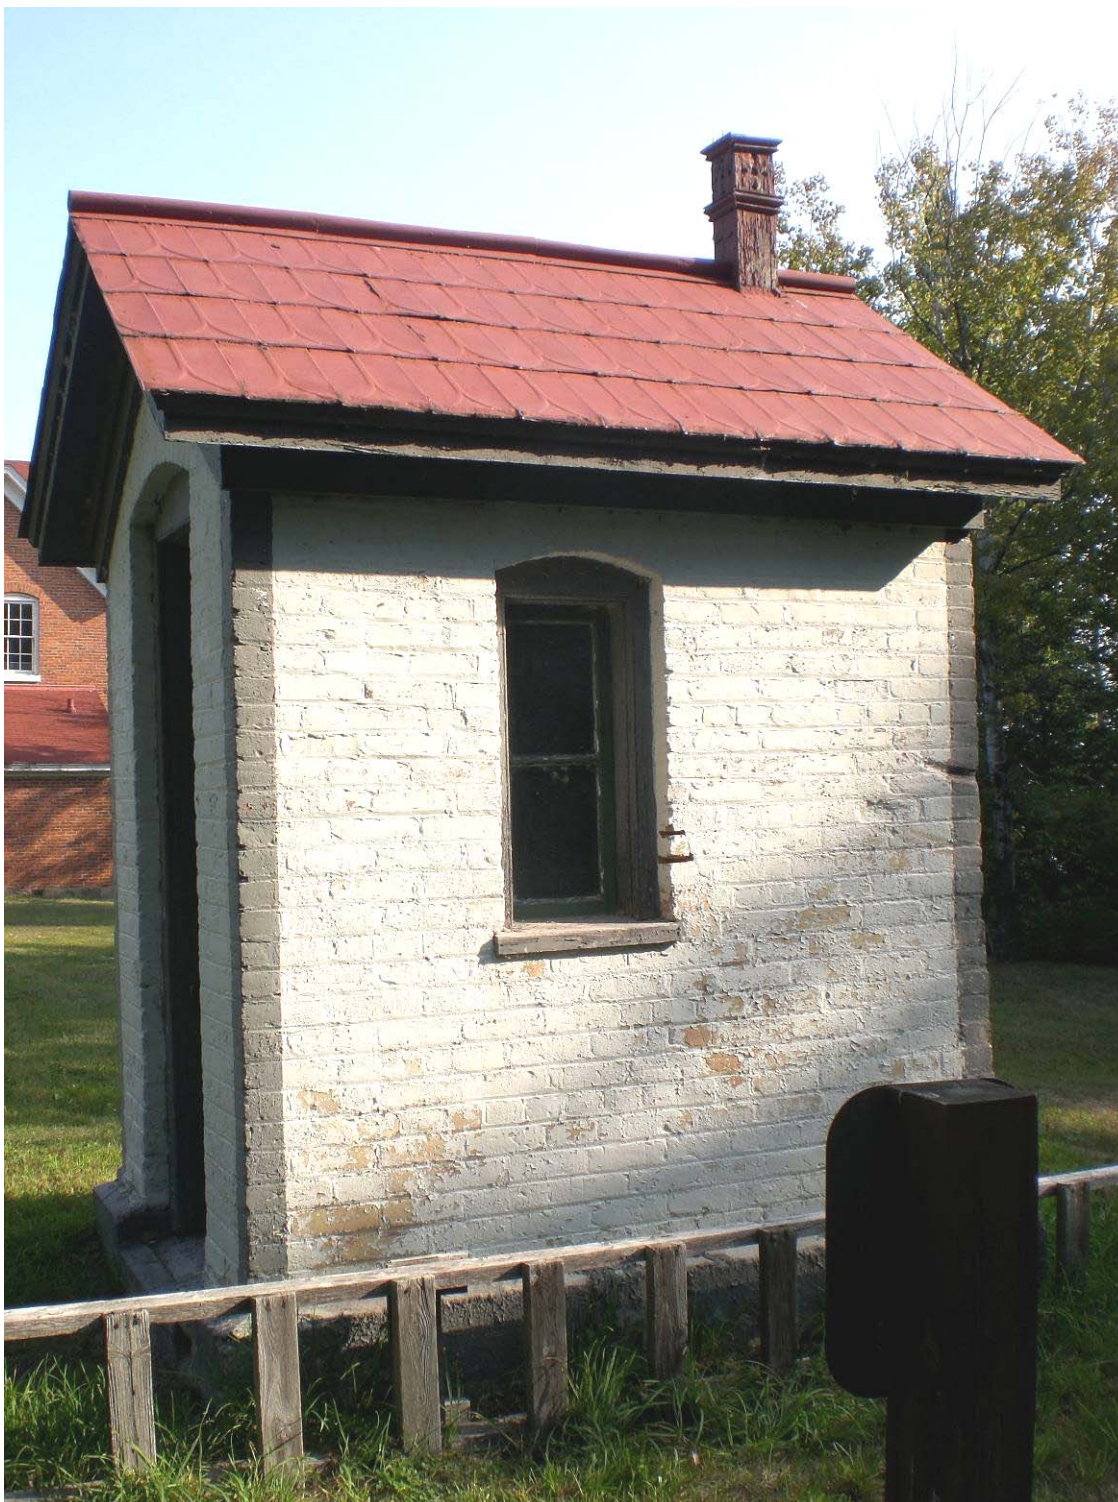
OI-P-05: South elevation, 2009 (Source: AH DSC01376)

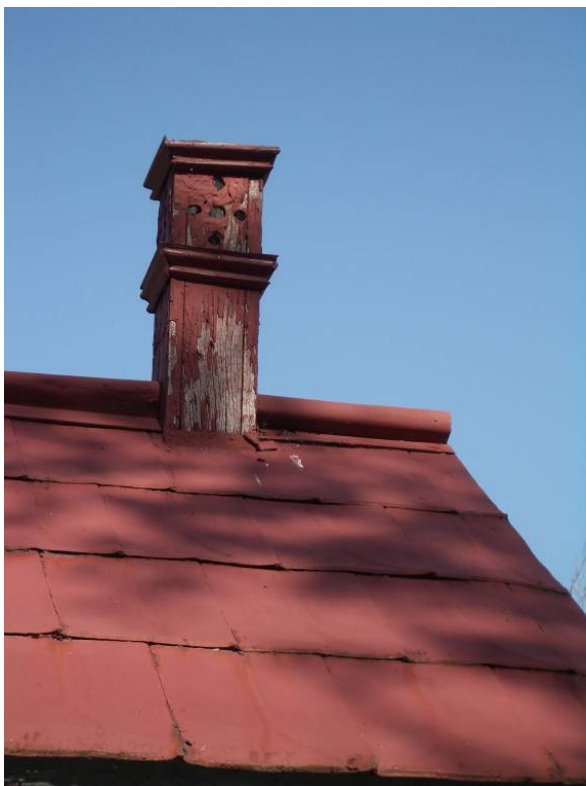
OI-P-06: Roof and vent details, south elevation (Source: AH IMGP3163)

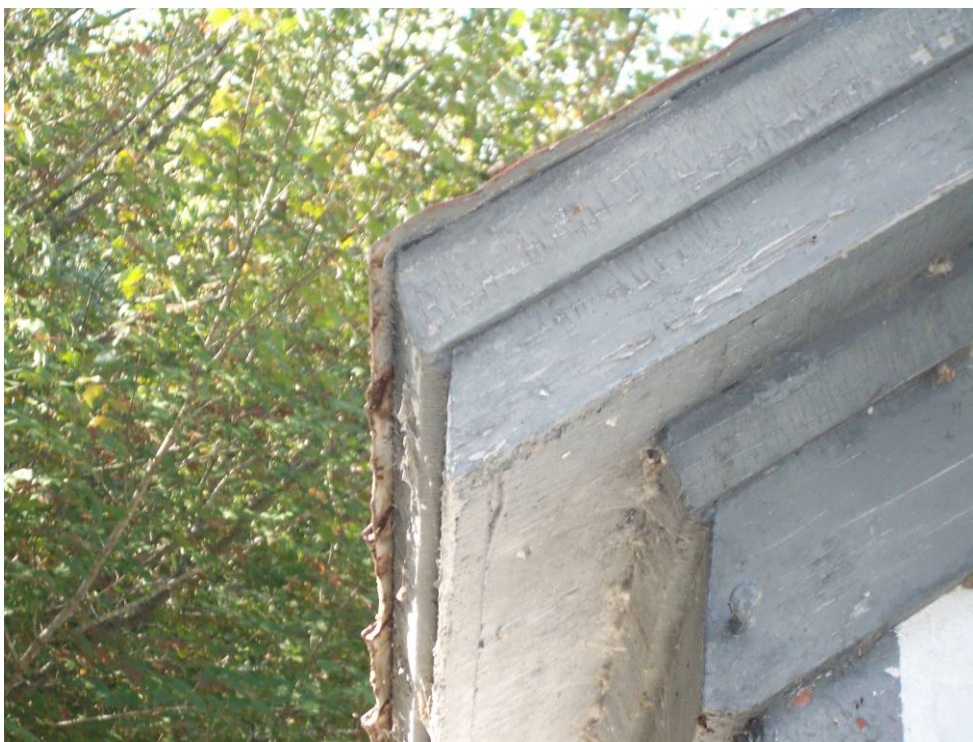
OI-P-07: Trim detail, west elevation (Source: AH IMGP3164)
