CULTURAL LANDSCAPE REPORT • HISTORIC STRUCTURE REPORT

VOLUME IV OF VI: DEVILS ISLAND CLR/HSR

**CULTURAL LANDSCAPE REPORT, HISTORIC STRUCTURE REPORT
AND
ENVIRONMENTAL ASSESSMENT**

prepared by
Anderson Hallas Architects, PC
Golden, Colorado

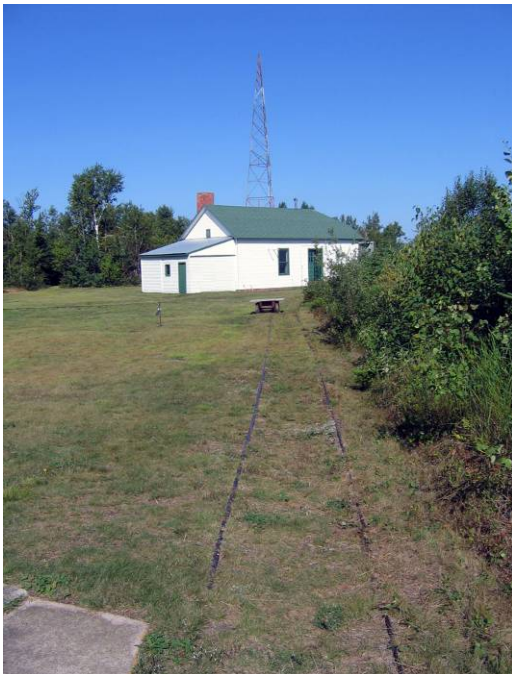
Site Image DI-33: Tram tracks near Fog Signal Building with radio beacon tower in background, 2009 (Source: MBD Devils 066.jpg)

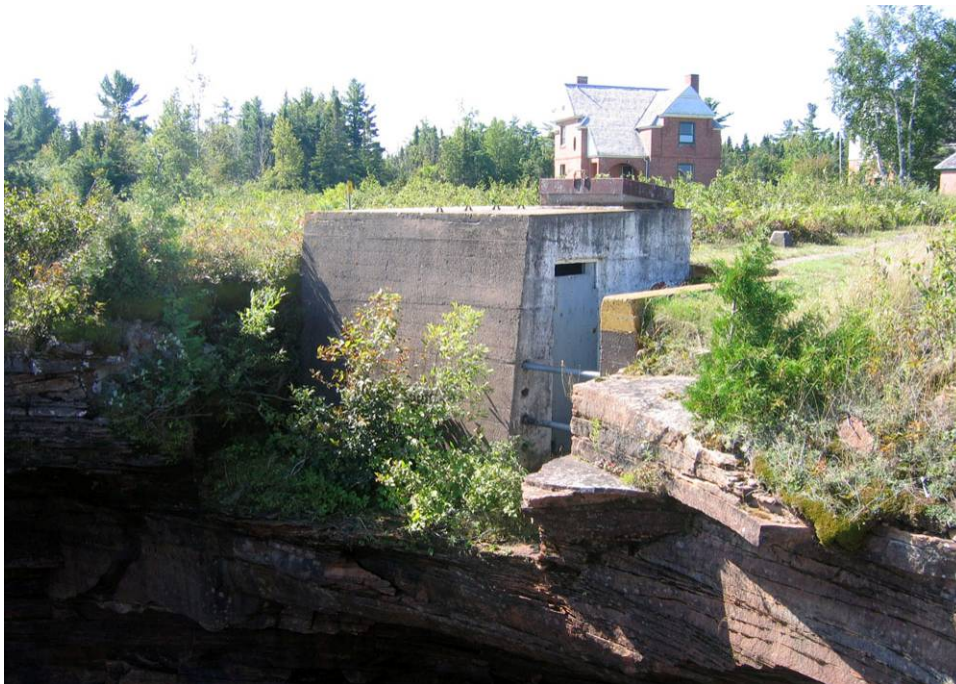
Site Image DI-34: Pump house at cliff edge, 2009 (Source: MBD Devils 085.jpg)

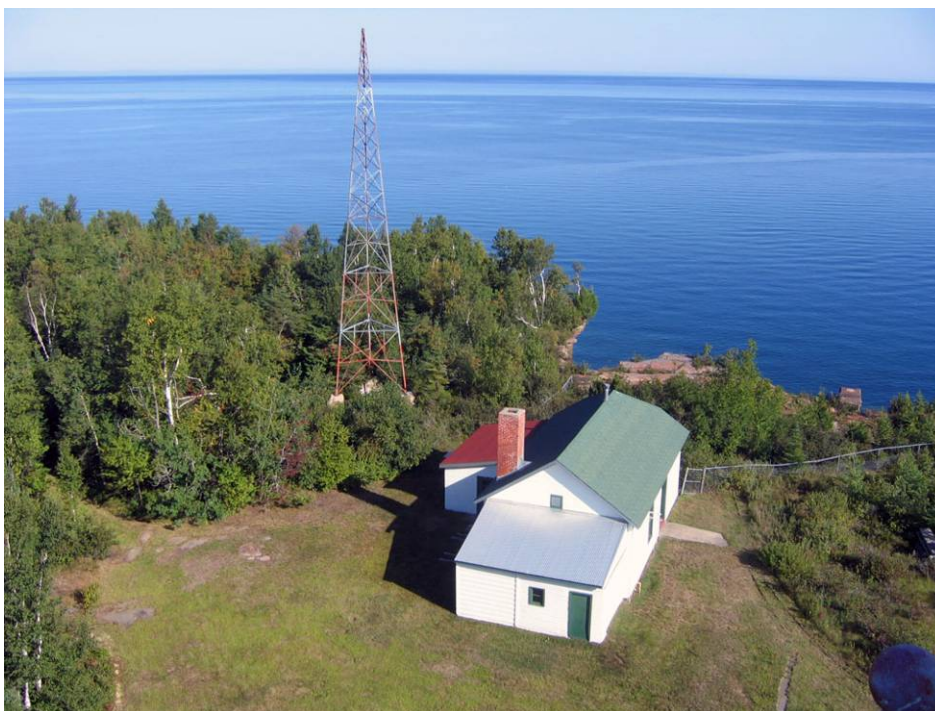
Site Image DI-35: Radio beacon tower near Fog Signal Building, 2009 (Source: MBD Devils 041.jpg)

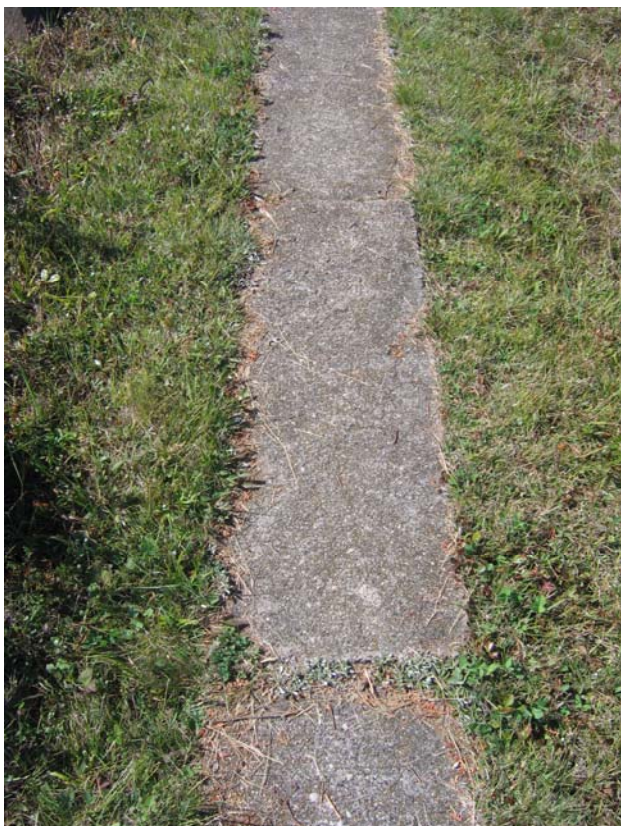
Site Image DI-39: Concrete walk to Pump House – precast slab construction, 2009 (Source: MBD Devils 088.jpg)

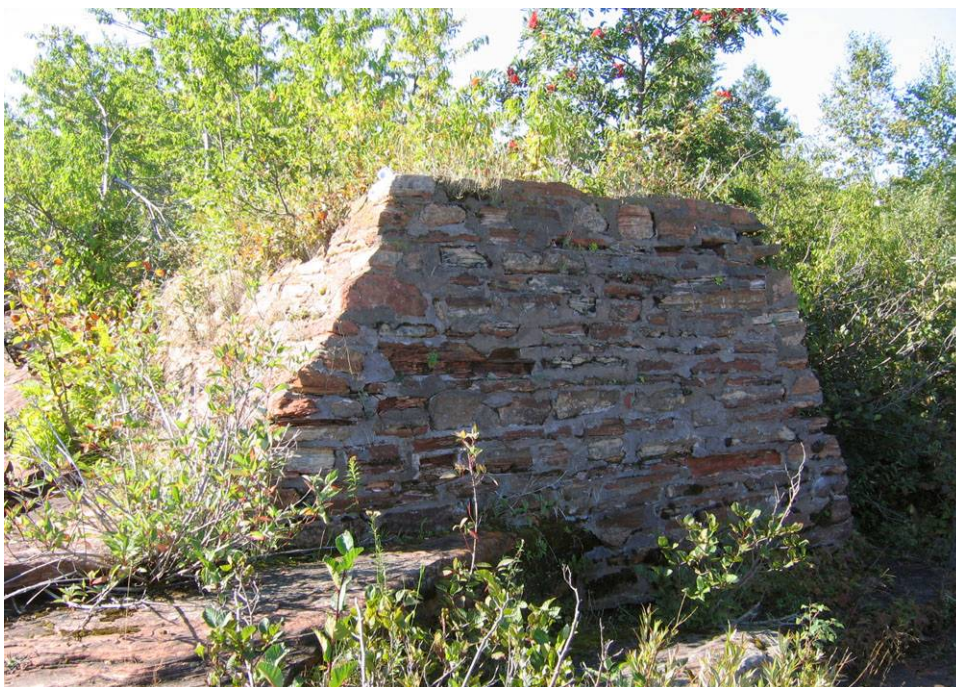
Site Image DI-40: Tram terminal, 2009 (Source: MBD Devils 050.jpg)

Repair the tram terminal near the Fog Signal Building. The intent of the treatment measures is to preserve and reveal the resource as an important feature in the cultural landscape. The feature is currently obscured by vegetation and may become damaged by root growth on top of and around the terminal. The treatment measure includes removal of vegetation (shrubs and trees) from the top of the terminal and adjacent to it; stabilization of extant tram tracks on terminal; and masonry repair (pointing) of all stone work. Replacement stone and mortar shall match existing material and craftsmanship.

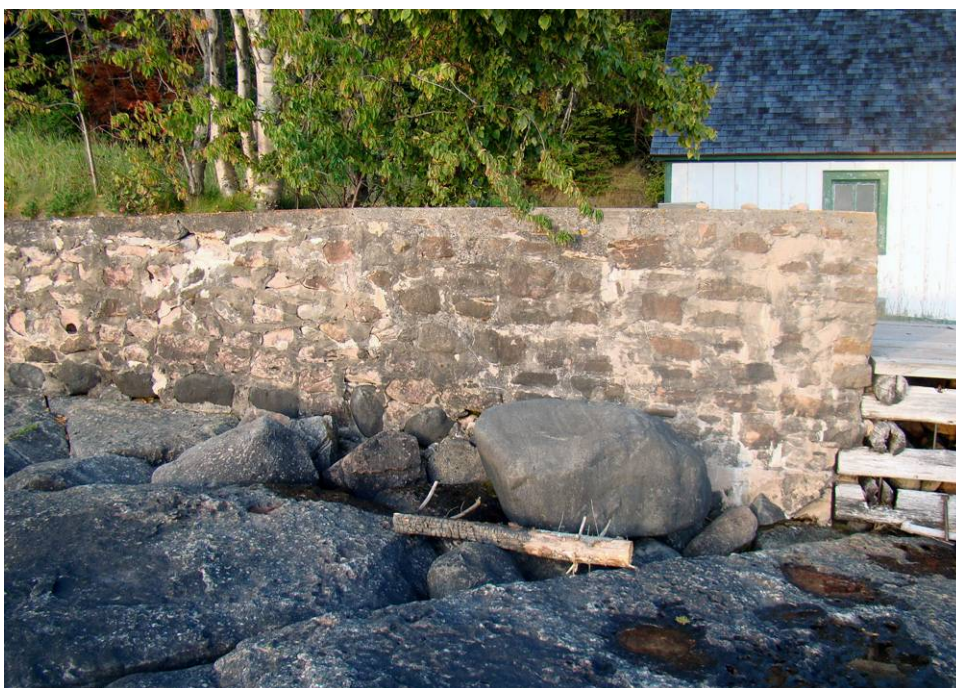
Site Image DI-42: Stone wall at Boathouse, 2009 (Source: AH DSC01075.jpg)

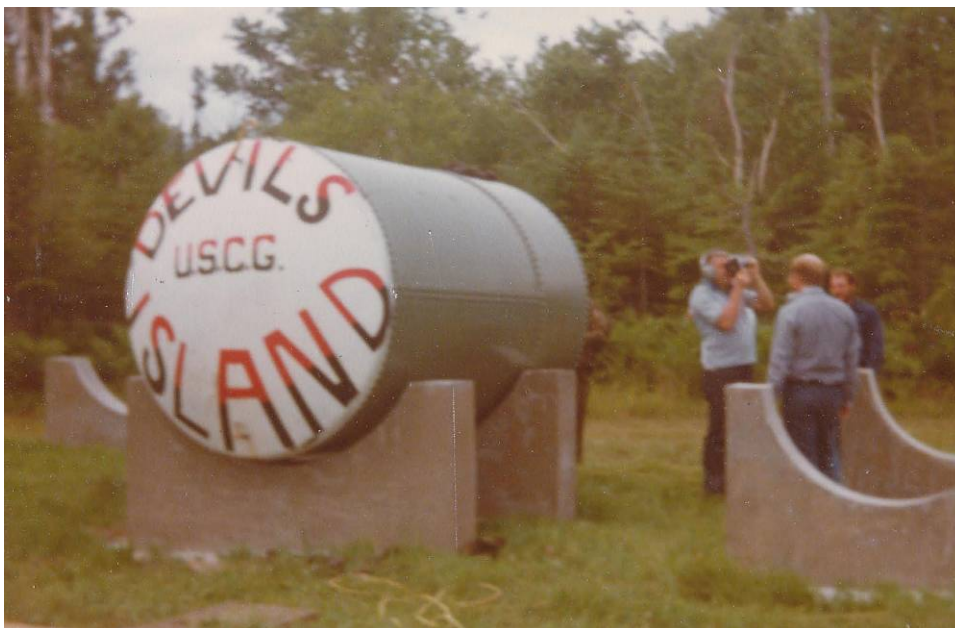
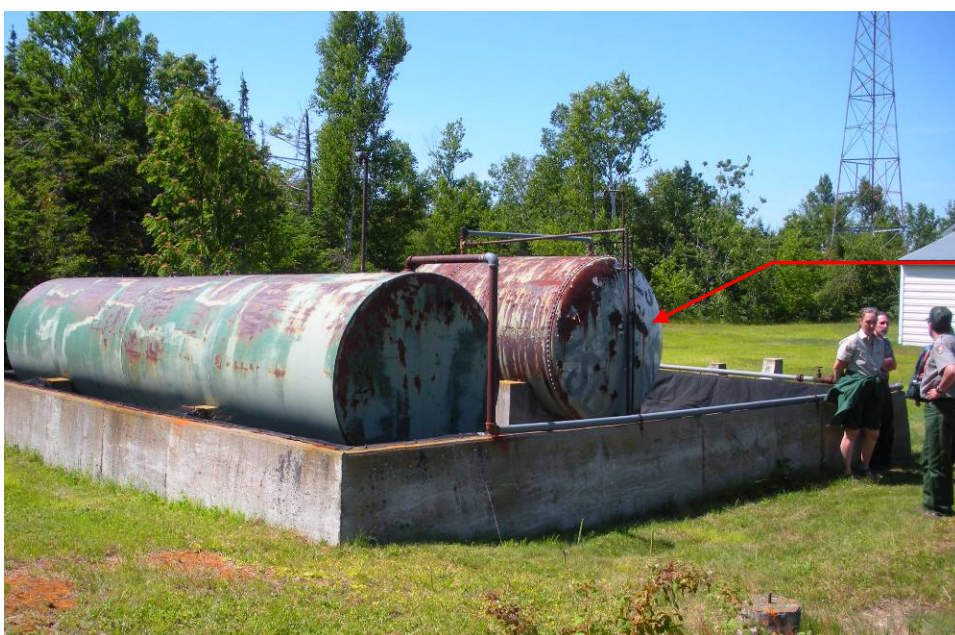
Site Image DI-51: Fuel tanks; top, (c. 1977) (Source: NPS APIS Archives); Fuel tanks with added concrete basin (constructed 1981); below (c. 2009) (Source: MBD Devils 035.jpg)

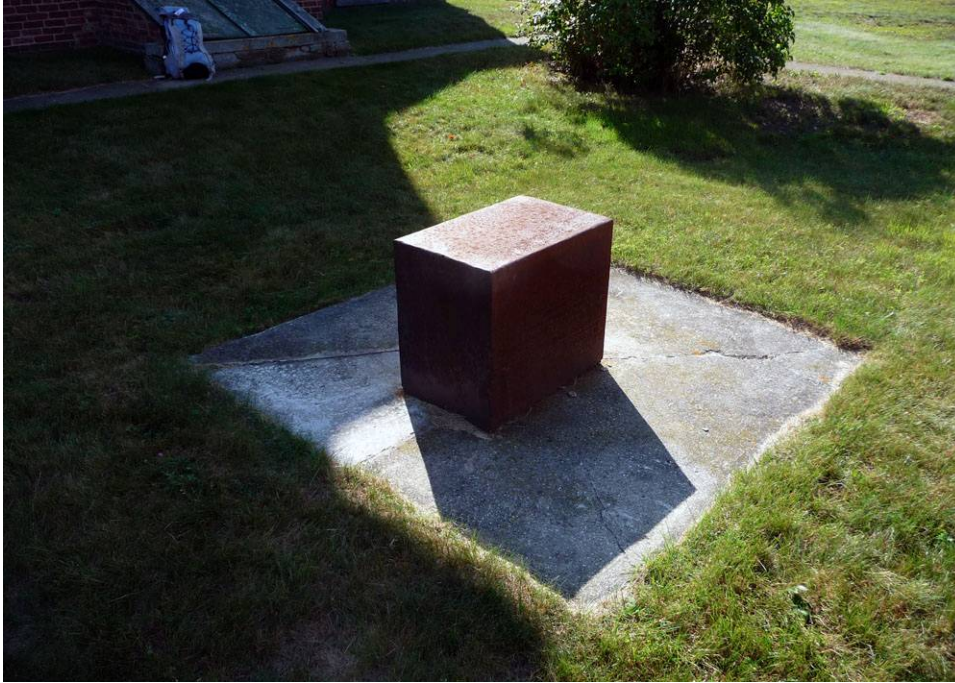
Site Image DI-53: Well head, 2009 (Source: MBD P1020100.JPG)

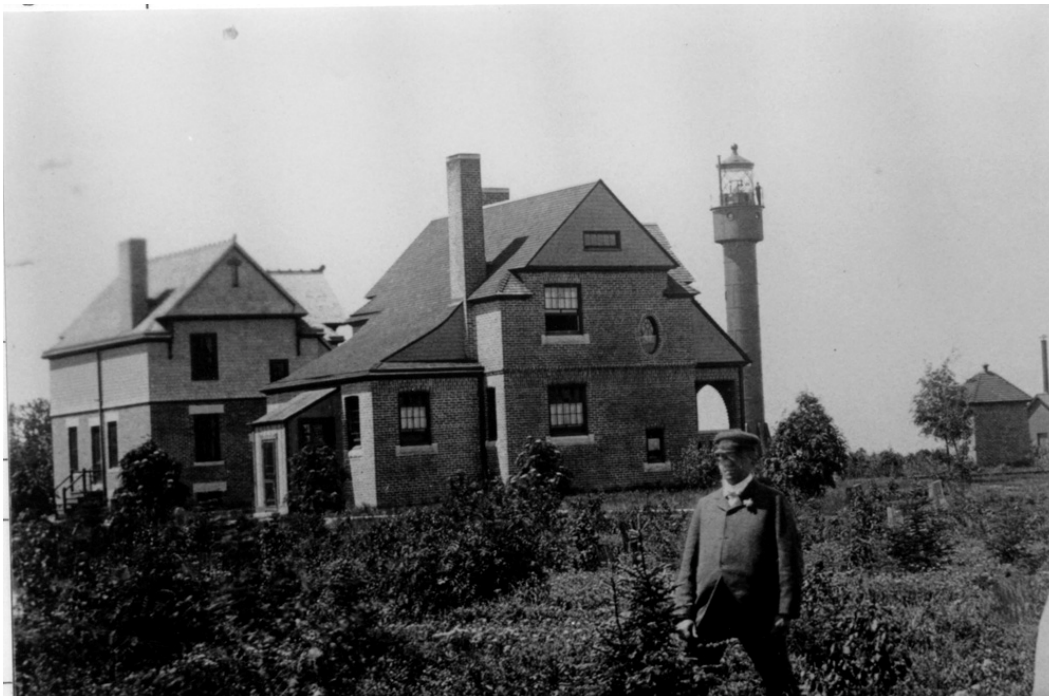
Site Image DI-69: Historic photograph of low brush condition at the Devils Island Light Station, c. 1901; (Source: NPS APIS Archives)

This treatment measure is a moderate expansion of the existing cleared lawn area. The work includes clearing of forest trees, shrubs and ground covers and establishing lawn grasses in the newly cleared area. Maintenance includes regular mowing of the lawn area to discourage forest encroachment.

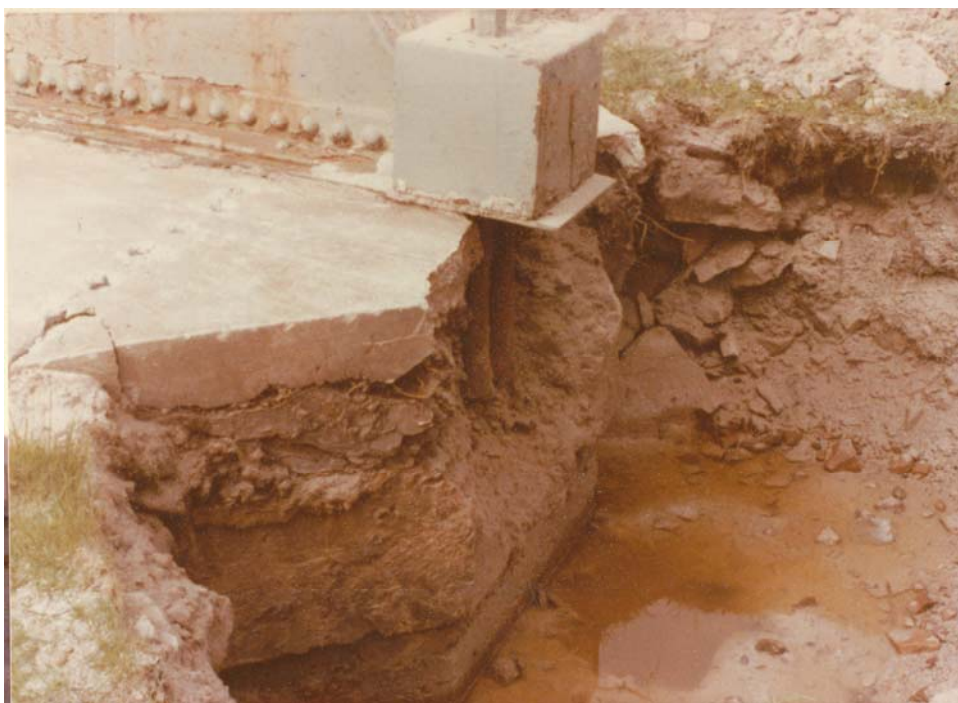
Historic Image DI-25: Devils Island Tower Foundation during repair work, 1978 (Source: NPS APIS Archives)

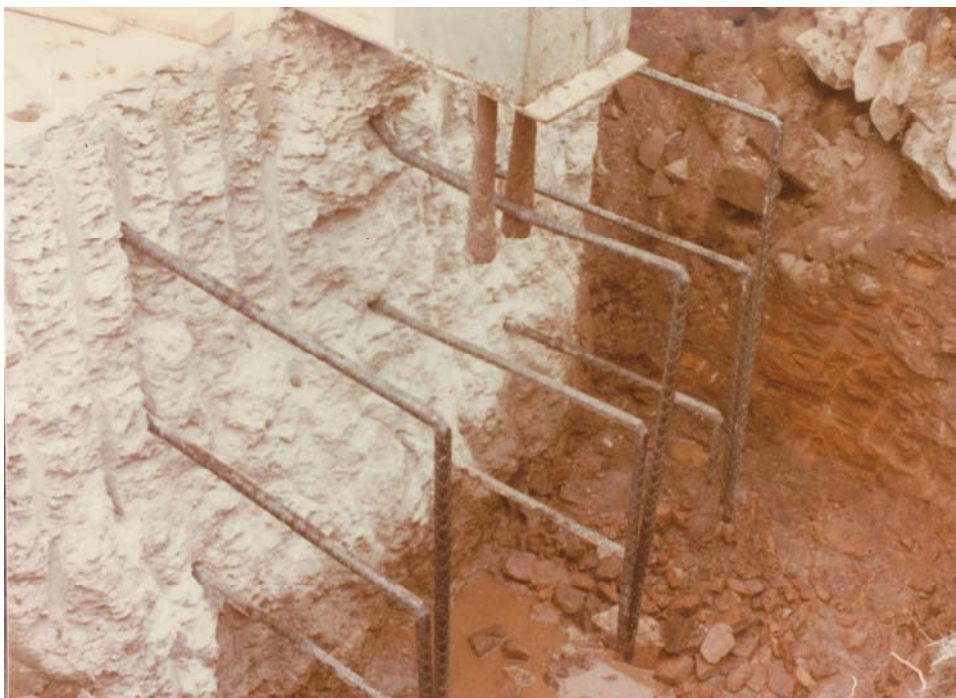
Historic Image DI-26: Devils Island Tower Foundation and Footings, 1978 (Source: NPS APIS Archives)

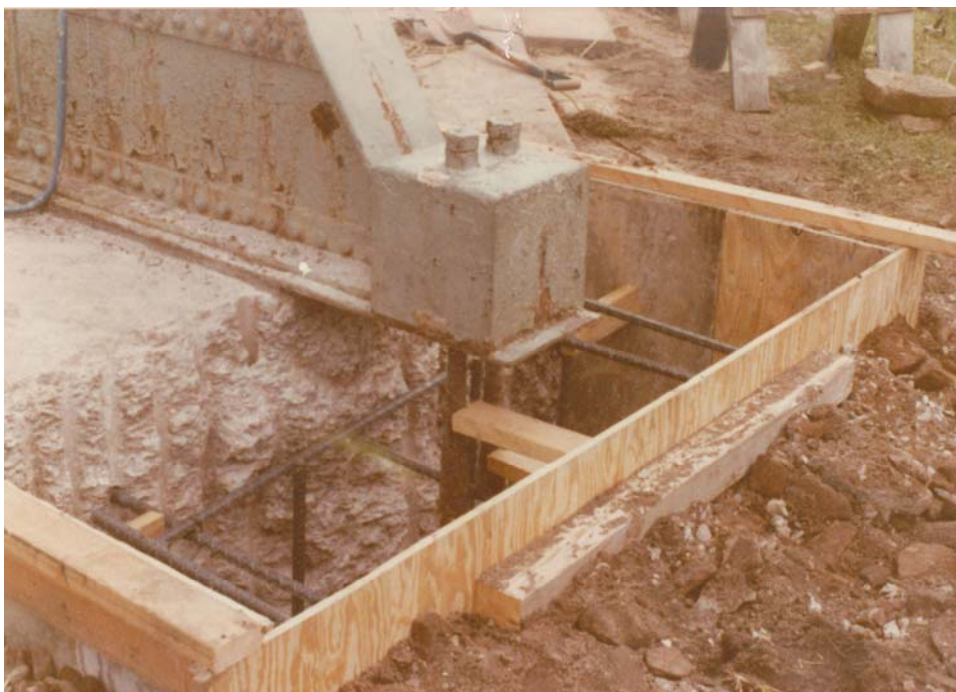
Historic Image DI-27: Devils Island Tower Foundation during repair work, 1978 (Source: NPS APIS Archives)

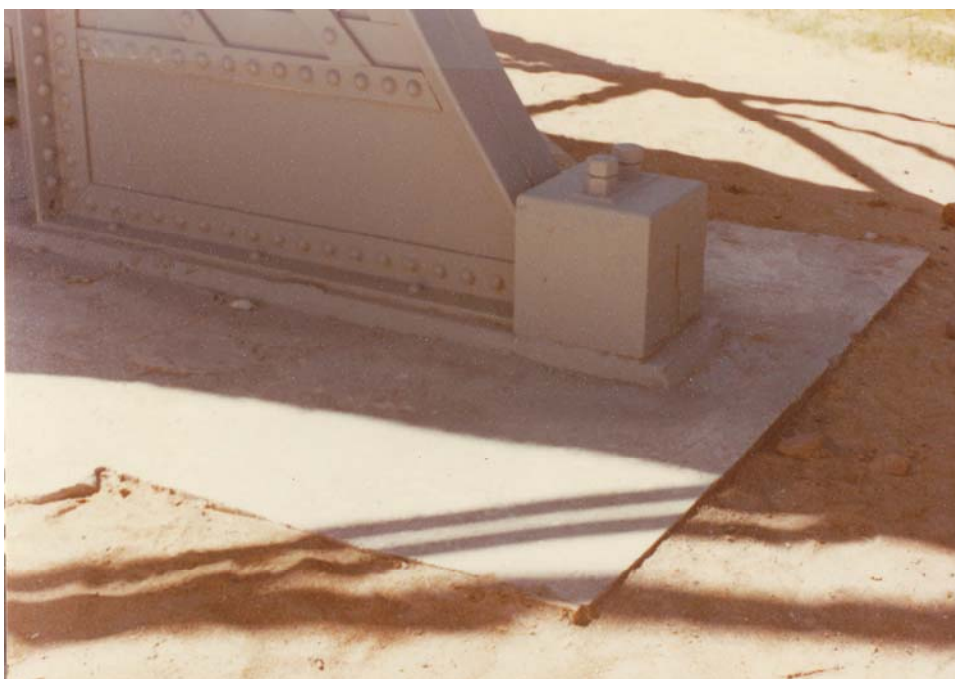
Historic Image DI-29: Devils Island Tower Foundation after repair work, 1978 (Source: NPS APIS Archives)

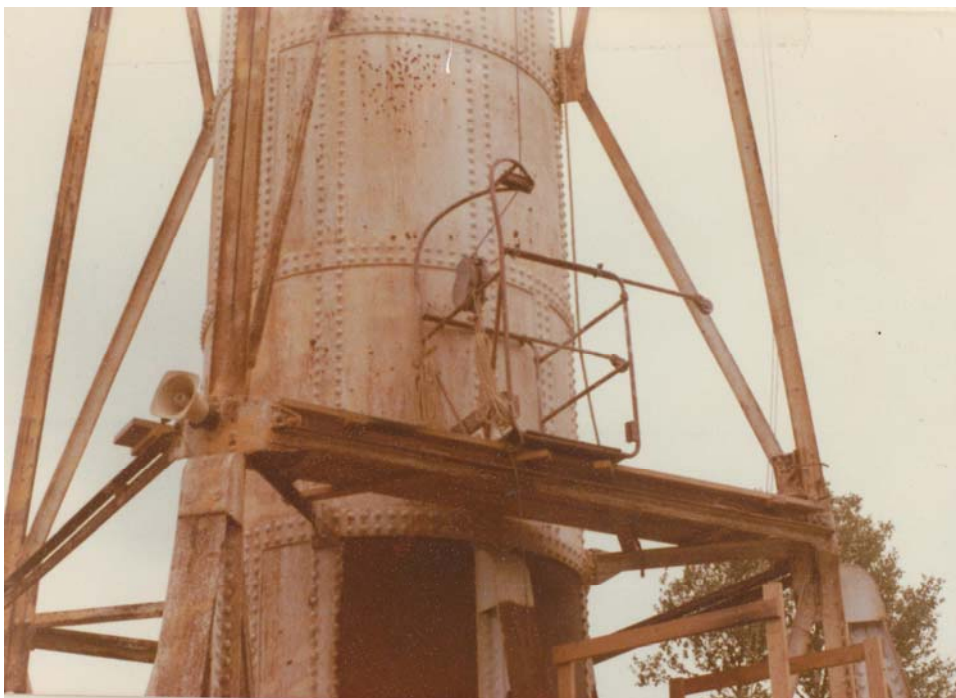
Historic Image DI-31: Devils Island Tower before painting, 1978 (Source: NPS APIS Archives)

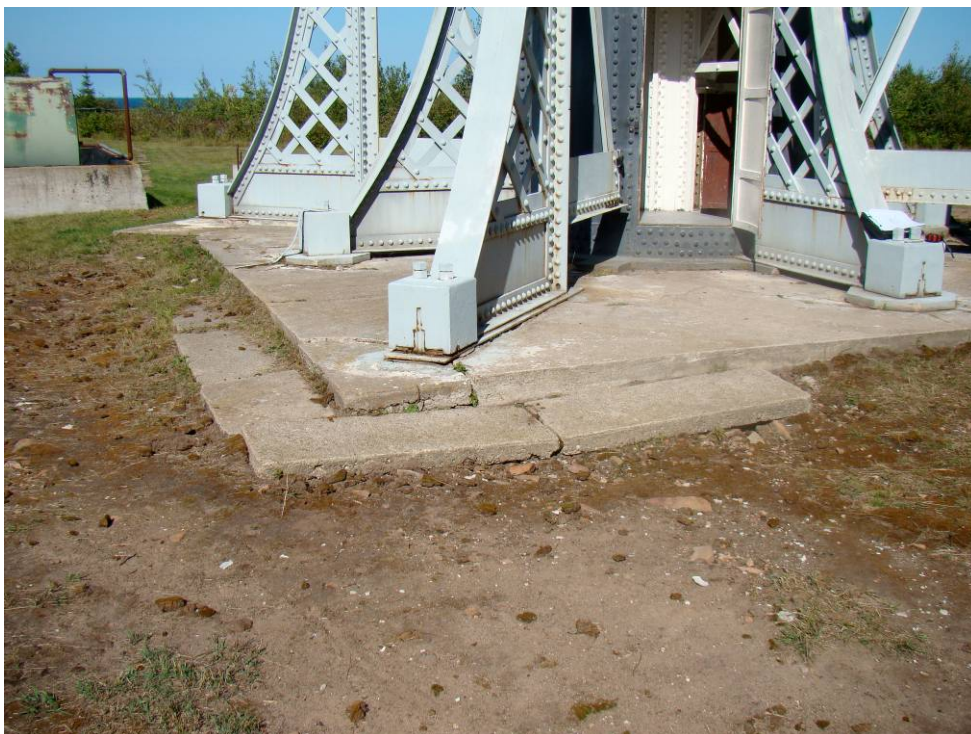
DI-LS-03: Entry and foundation (Source: AH DSC00945)

Structurally, the Light Station Tower is in fair condition. The cracked mat foundation needs further investigation to determine if the cracks and deterioration are structurally significant.

5. Foundation mitigation	Investigating and installing new foundation elements and/or reinforcing existing will disturb the original historic fabric.	Evaluate benefit of invasive foundation repair versus the risk of continued/future damage to resource.	-Repair of the foundation will help protect the resource

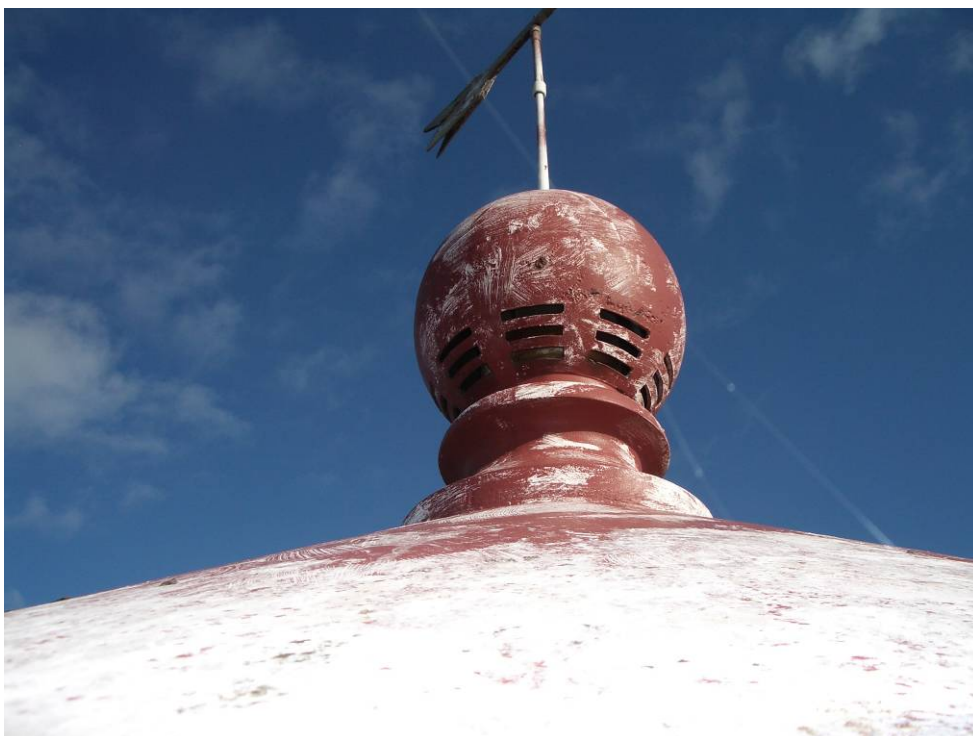
DI-LS-14: Lantern roof (Source: AH IMG2862)

The cast iron roof is in good condition with the exception of peeling paint.

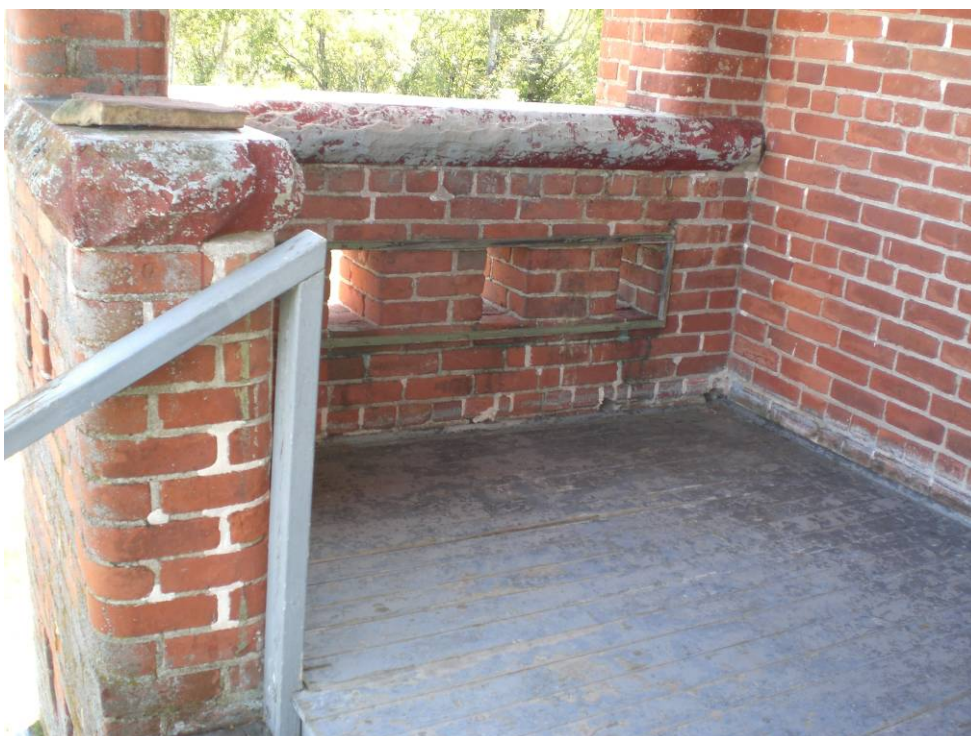
DI-KQ-12: Porch floor and walls, looking southwest (Source: AH CIMG3709)

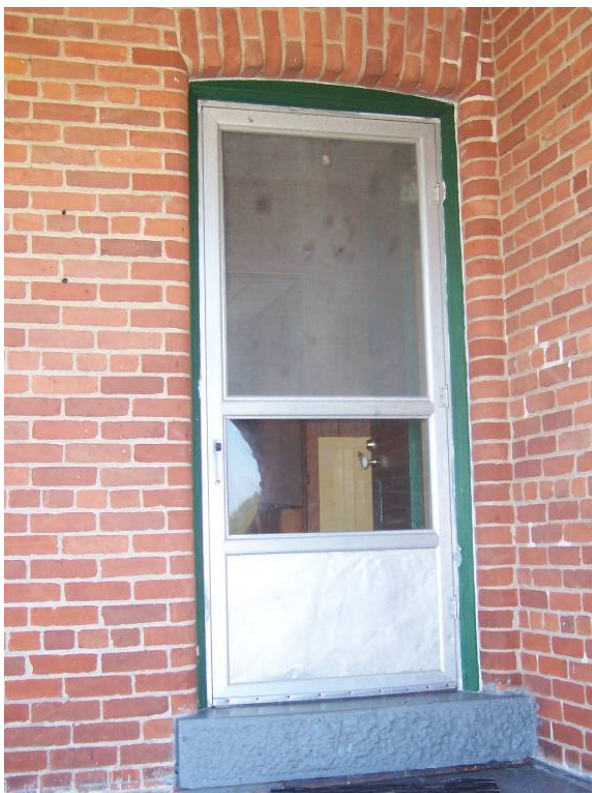
DI-KQ-13: Main entry screen door (Source: AH 100_9722)

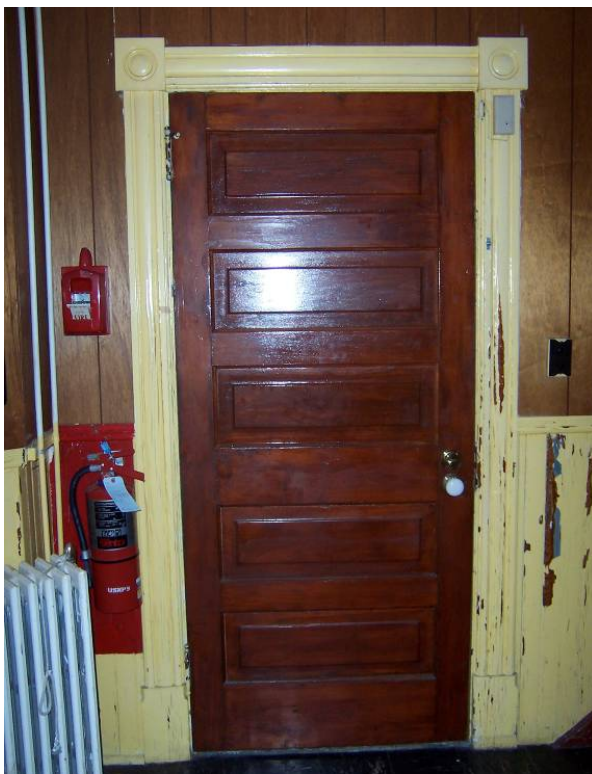
DI-KQ-14: Main entry door, interior (Source: AH 100_9723)

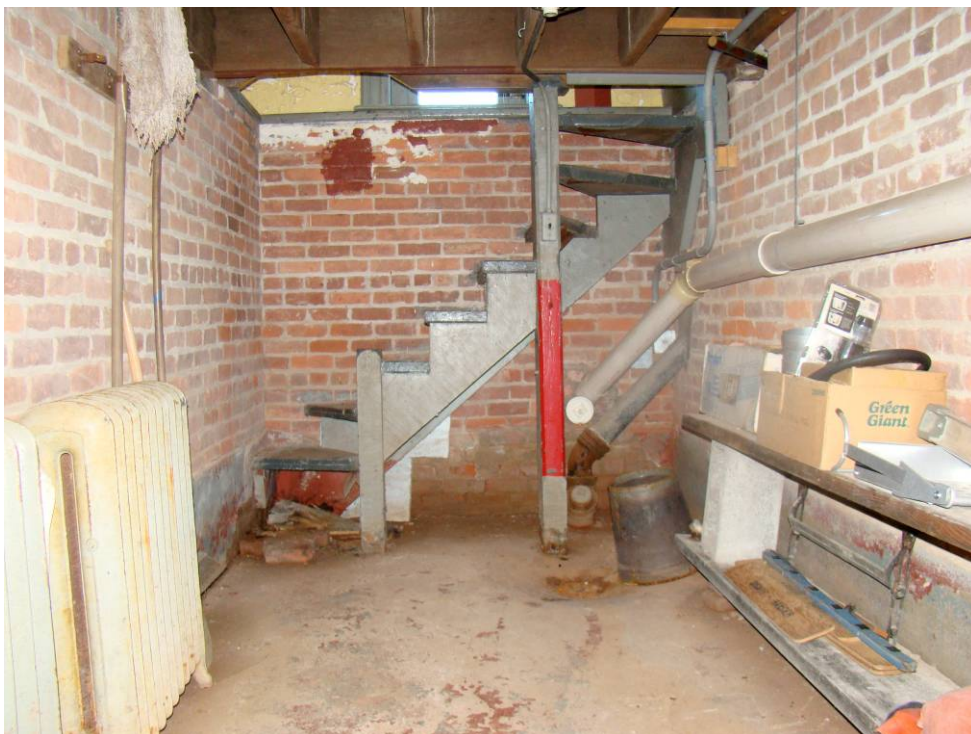
DI-KQ-15: Basement stair to first floor entry (Source: AH DSC00982)

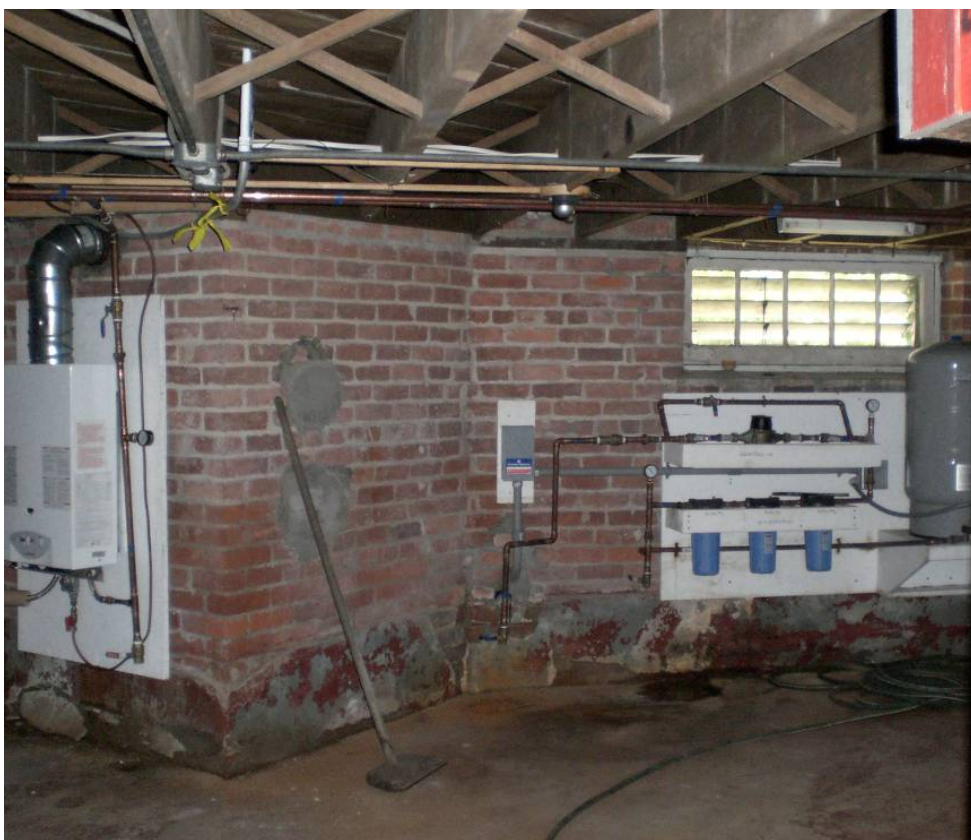
DI-KQ-16: Basement, looking west (Source: AH CIMG3830-A)

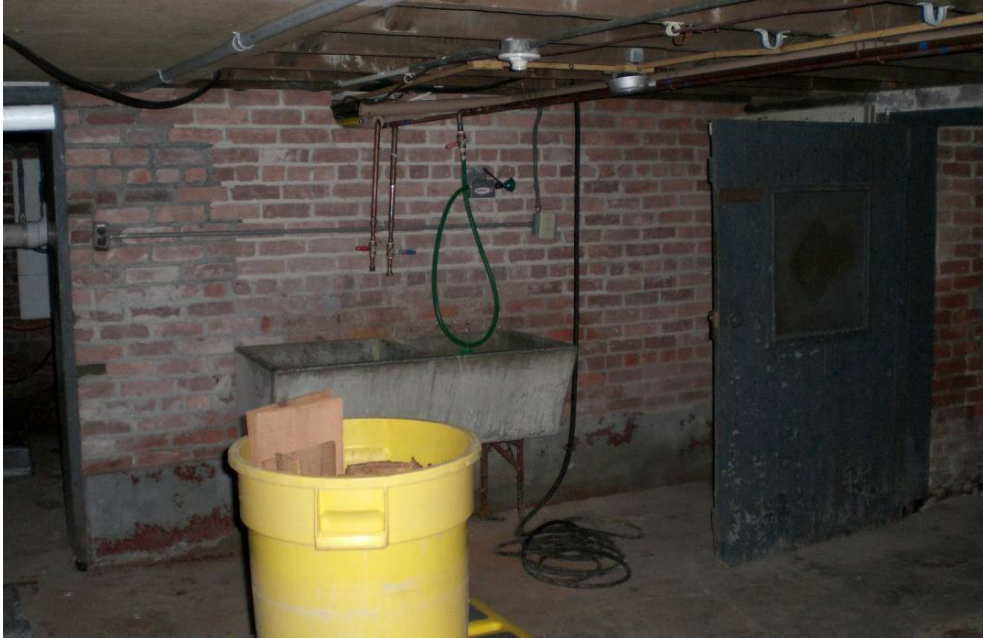
DI-KQ-17: Basement, south elevation (Source: AH CIMG3831-A)

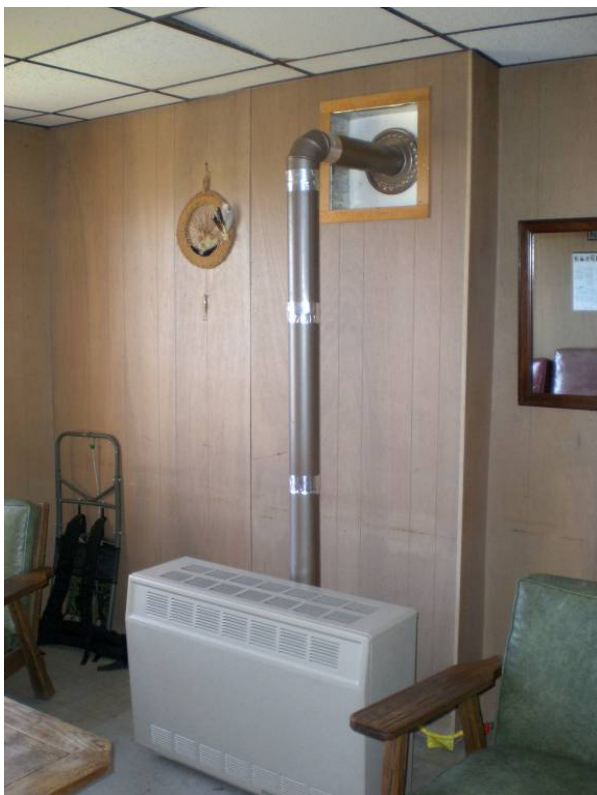
DI-KQ-19: Living room, looking southeast (Source: AH CIMG3722)

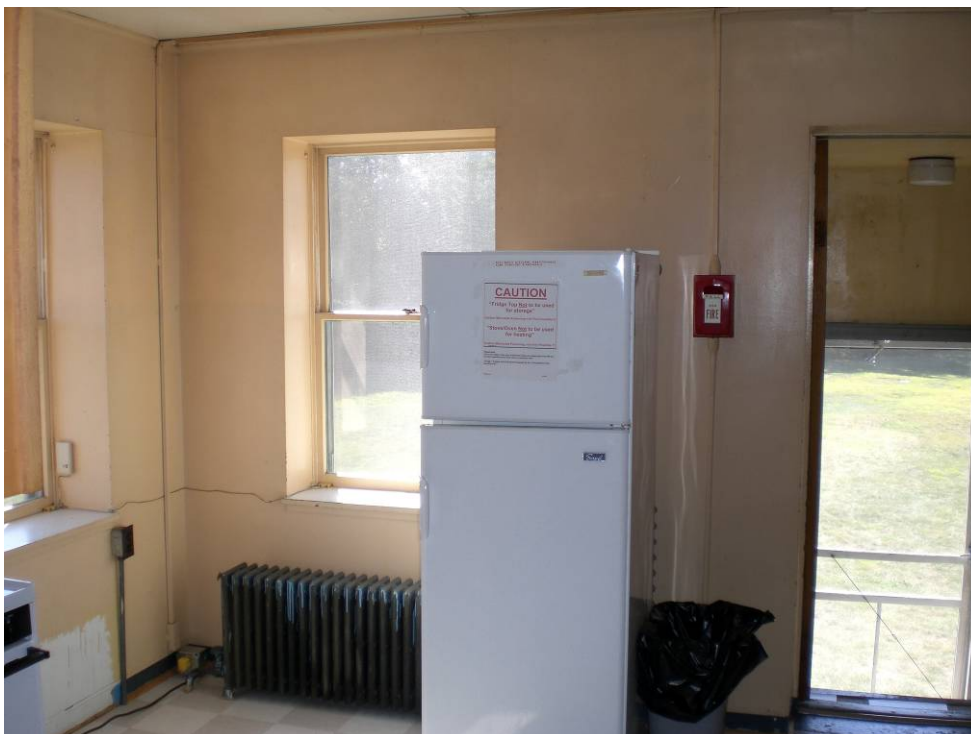
DI-KQ-20: Kitchen, looking southeast (Source: AH CIMG3730)

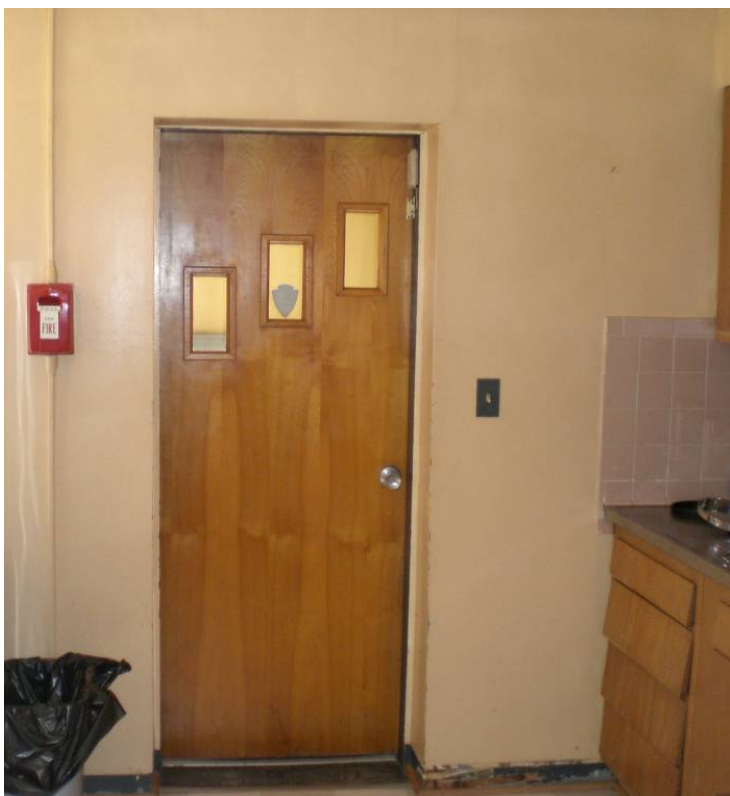
DI-KQ-22: Kitchen door, south elevation (Source: AH CIMG3735)

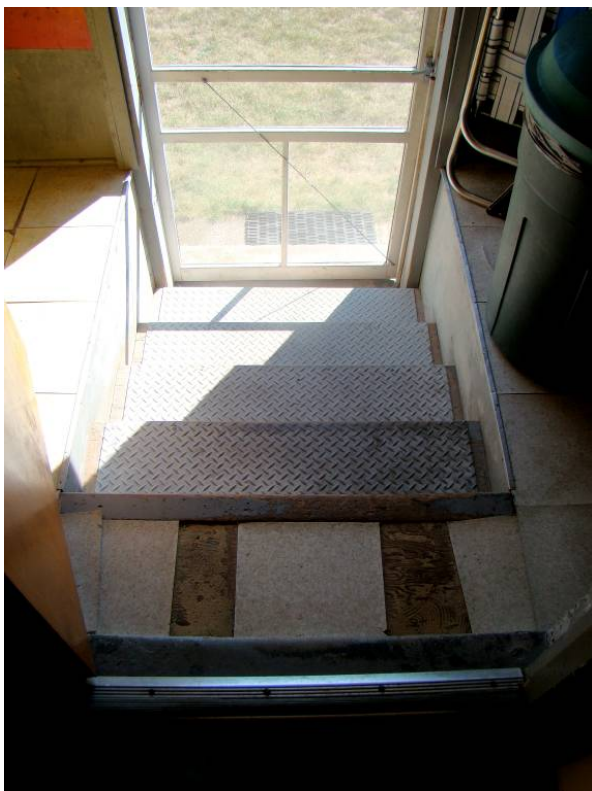
DI-KQ-23: South elevation kitchen entry stair, interior section (Source: AH CIMG3737)

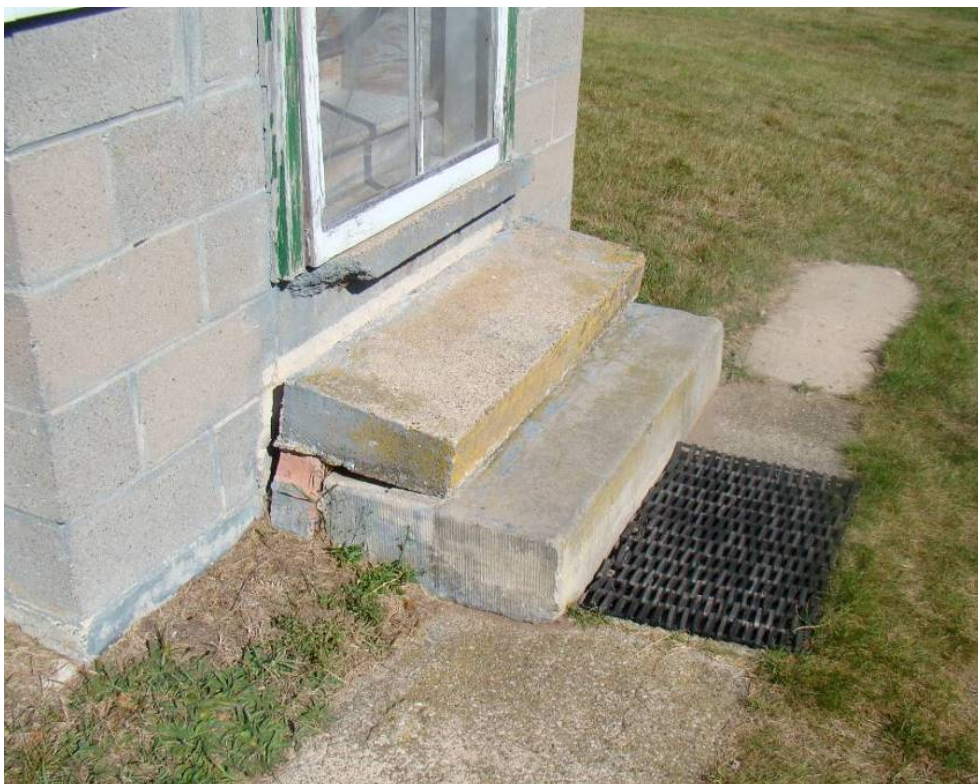
DI-KQ-24: South elevation kitchen entry stair, exterior section (Source: AH DSC00960)

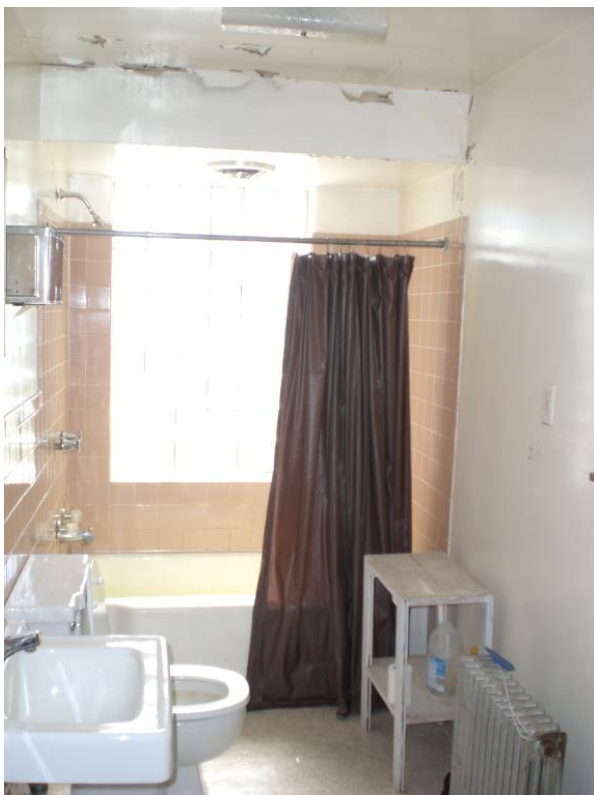
DI-KQ-25: First floor bath (Source: AH CIMG3748)

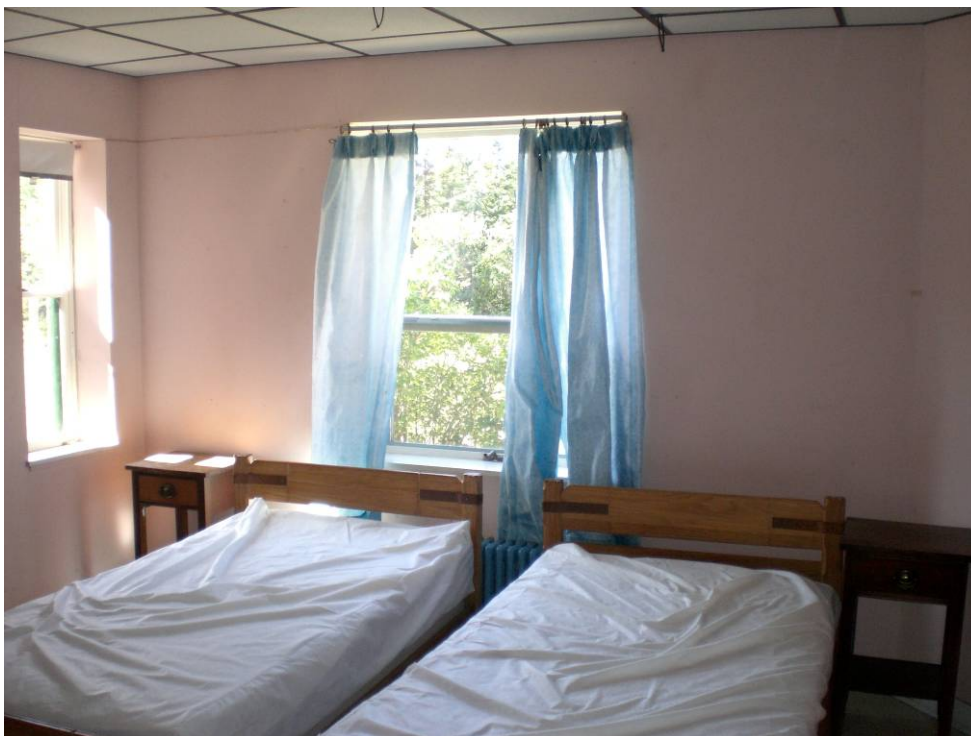
DI-KQ-26: First floor bedroom, west elevation (Source: AH CIMG3757)

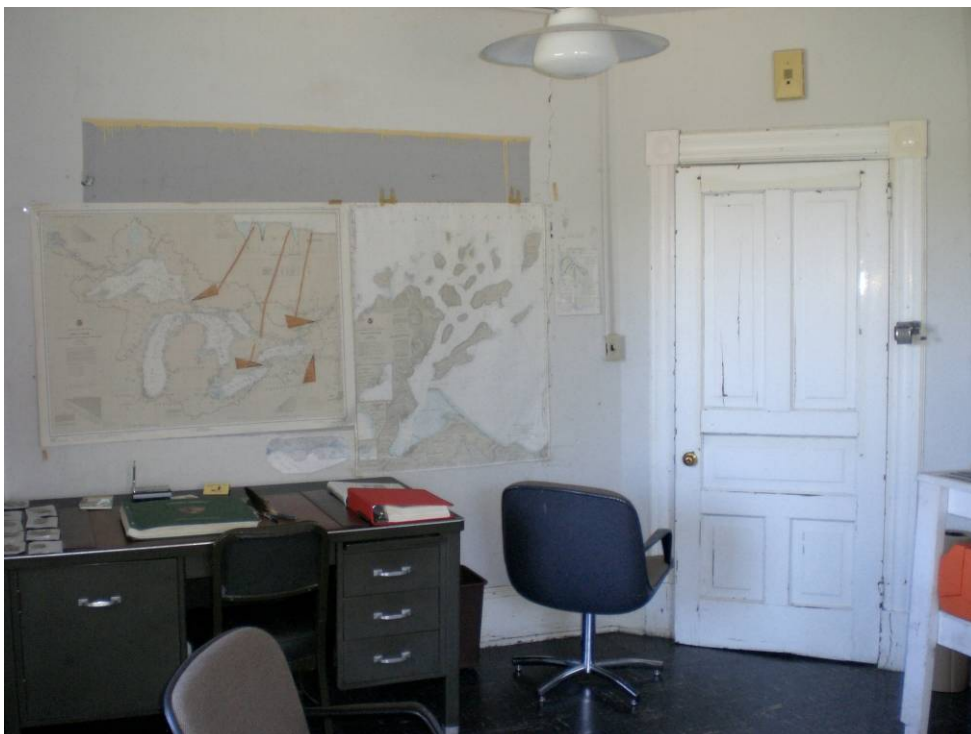
DI-KQ-27: Office, looking southeast (Source: AH CIMG3772)

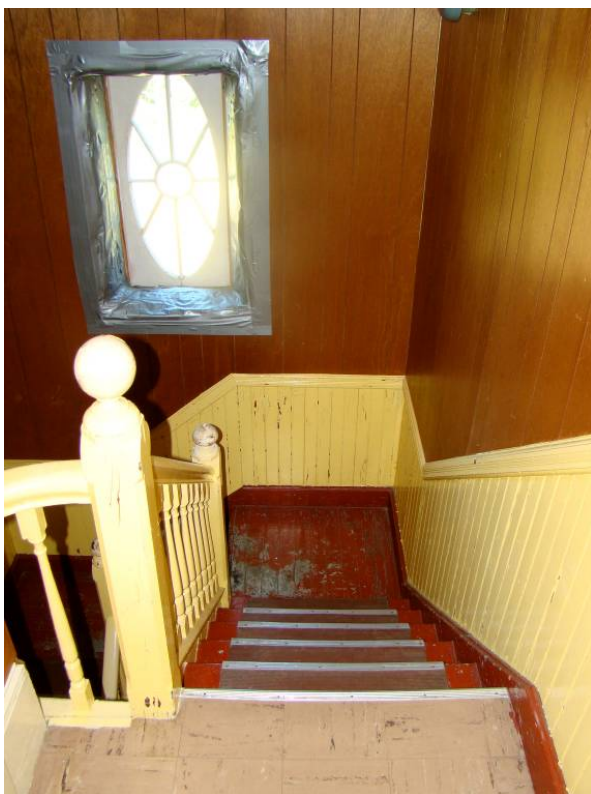
DI-KQ-28: Stairs to second floor and oval window, looking down (Source: AH DSC00974)

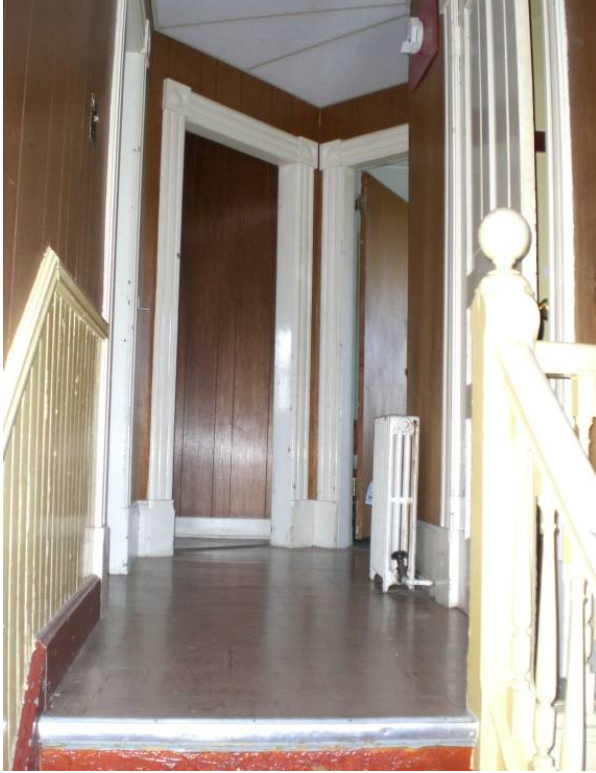
DI-KQ-29: Second floor hall, looking west (Source: AH DSC00973)

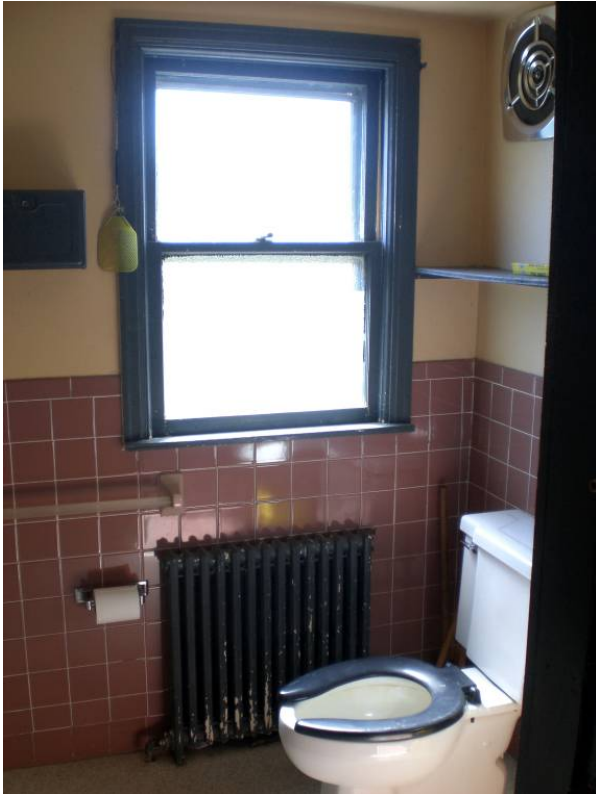
DI-KQ-30: Bath, looking southwest (Source: AH CIMG3796)

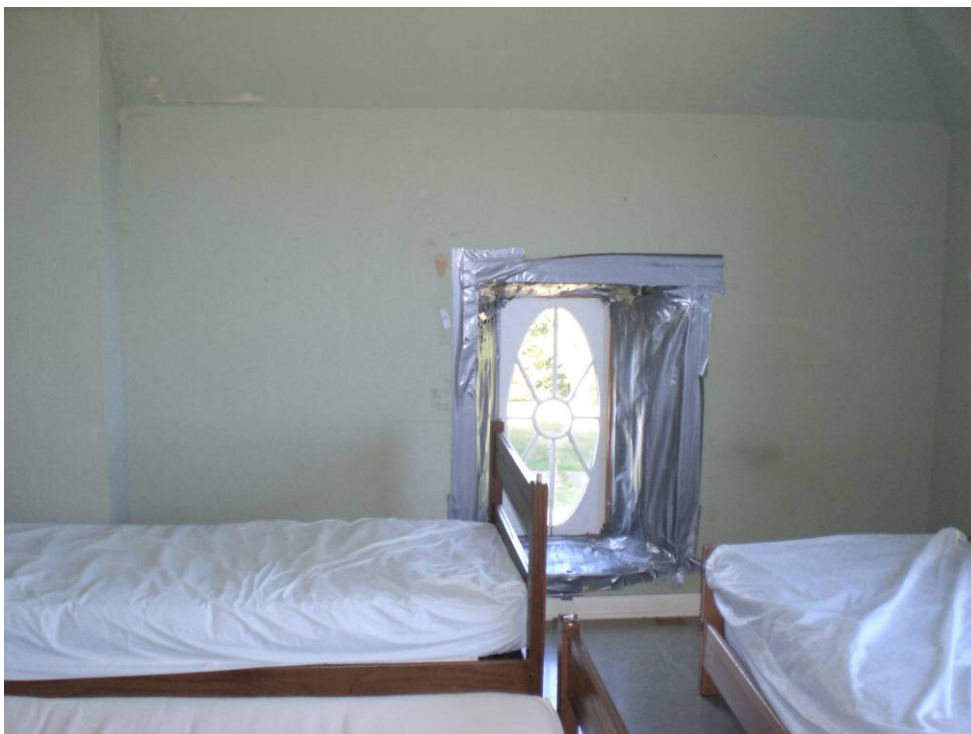
DI-KQ-31: North bedroom, west elevation (Source: AH CIMG3817)
