CULTURAL LANDSCAPE REPORT • HISTORIC STRUCTURE REPORT

VOLUME IV OF VI: DEVILS ISLAND CLR/HSR

**CULTURAL LANDSCAPE REPORT, HISTORIC STRUCTURE REPORT
AND
ENVIRONMENTAL ASSESSMENT**

prepared by
Anderson Hallas Architects, PC
Golden, Colorado

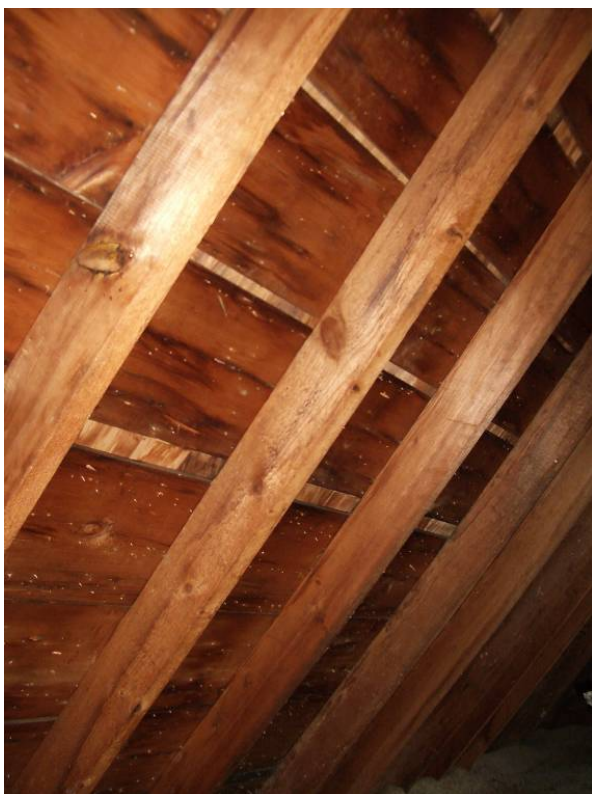
DI-KQ-32: Attic roof structure (Source: AH IMGP2886)

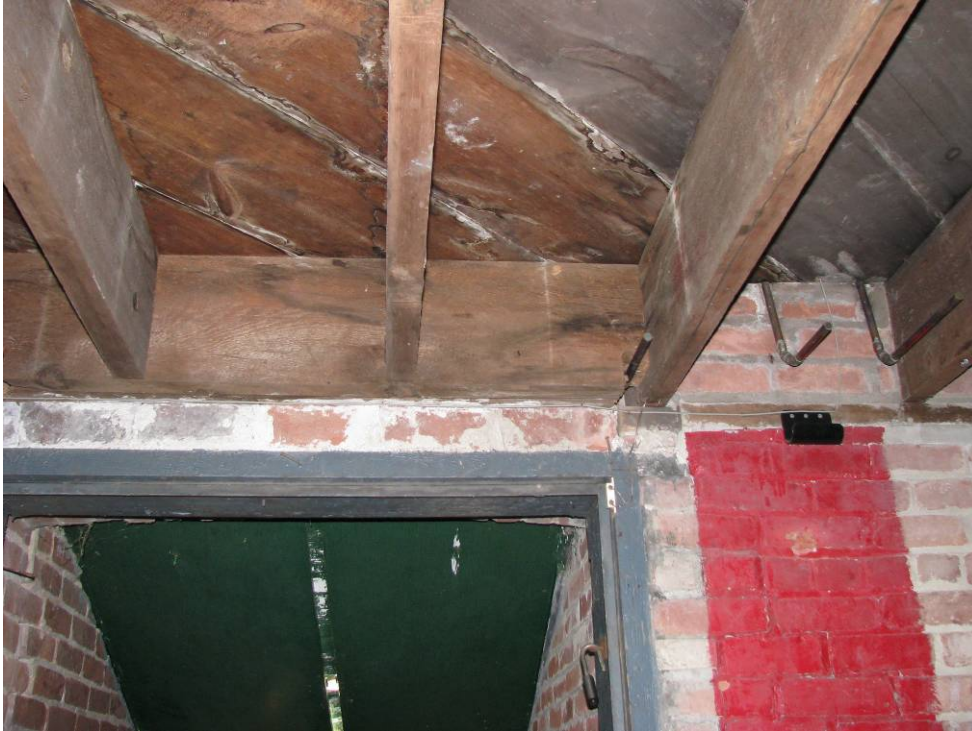
DI-KQ-33: Joist header above hatch doors (Source: Martin/Martin)

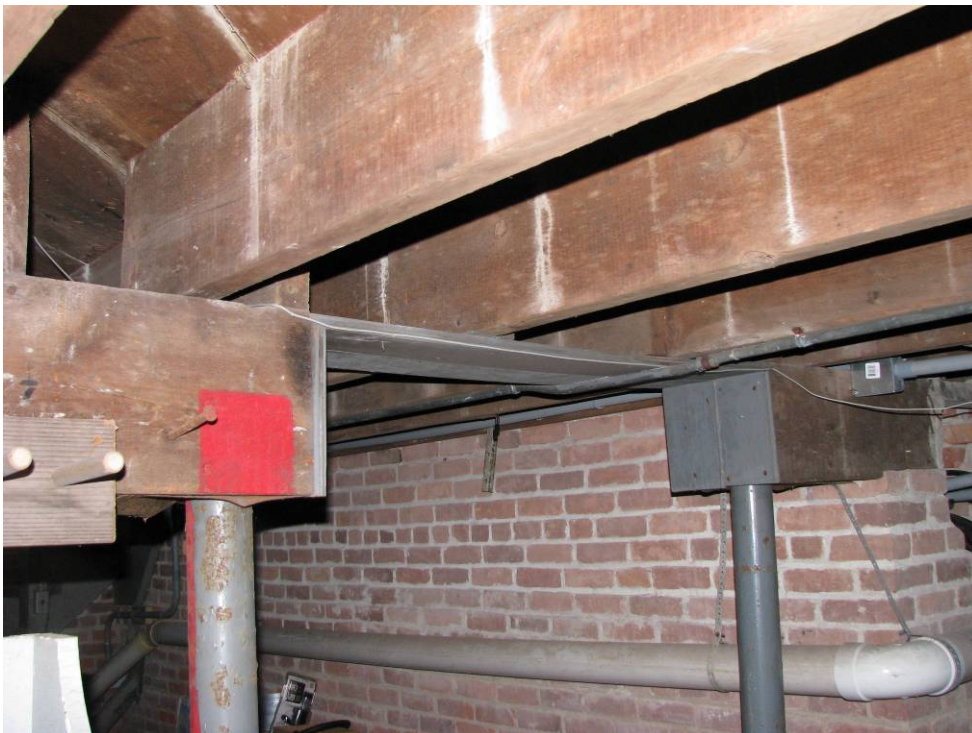
DI-KQ-34: Cut out (3) 2x10 beam (Source: Martin/Martin)

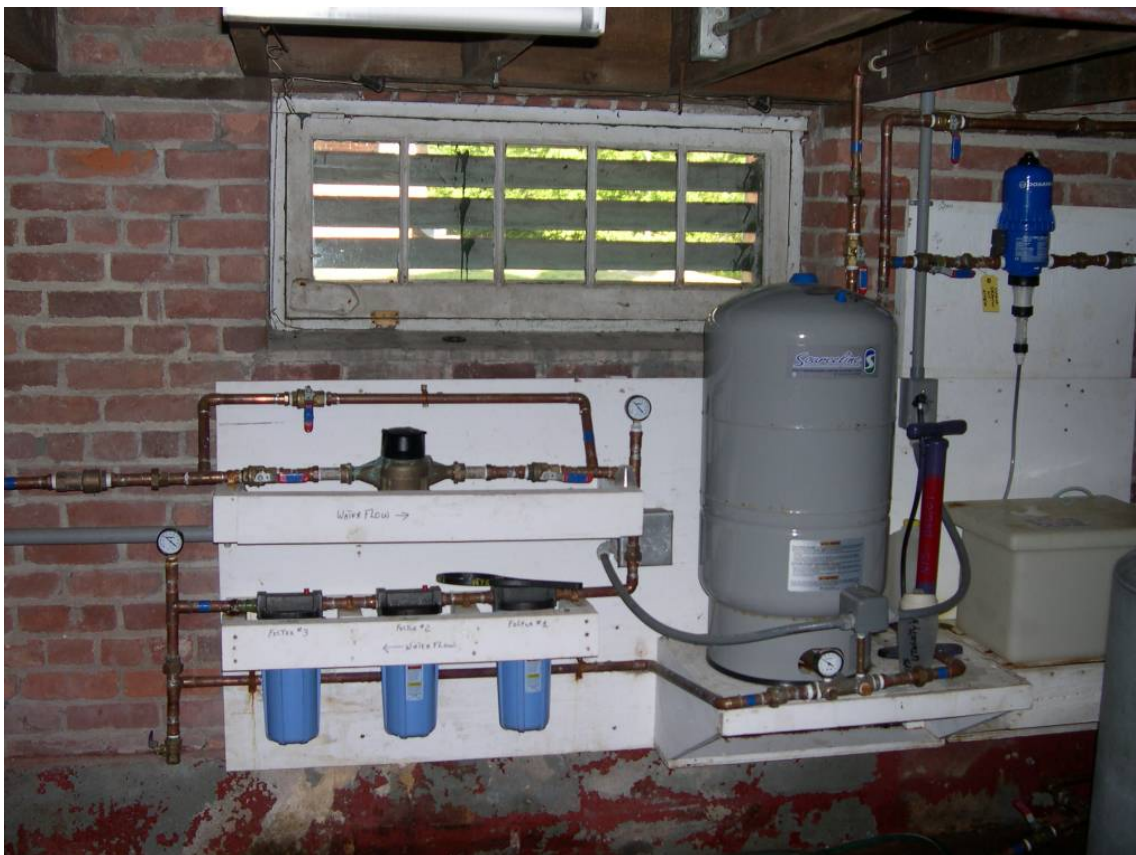
DI-KQ-39: Domestic water treatment in the basement (Source: RMH)

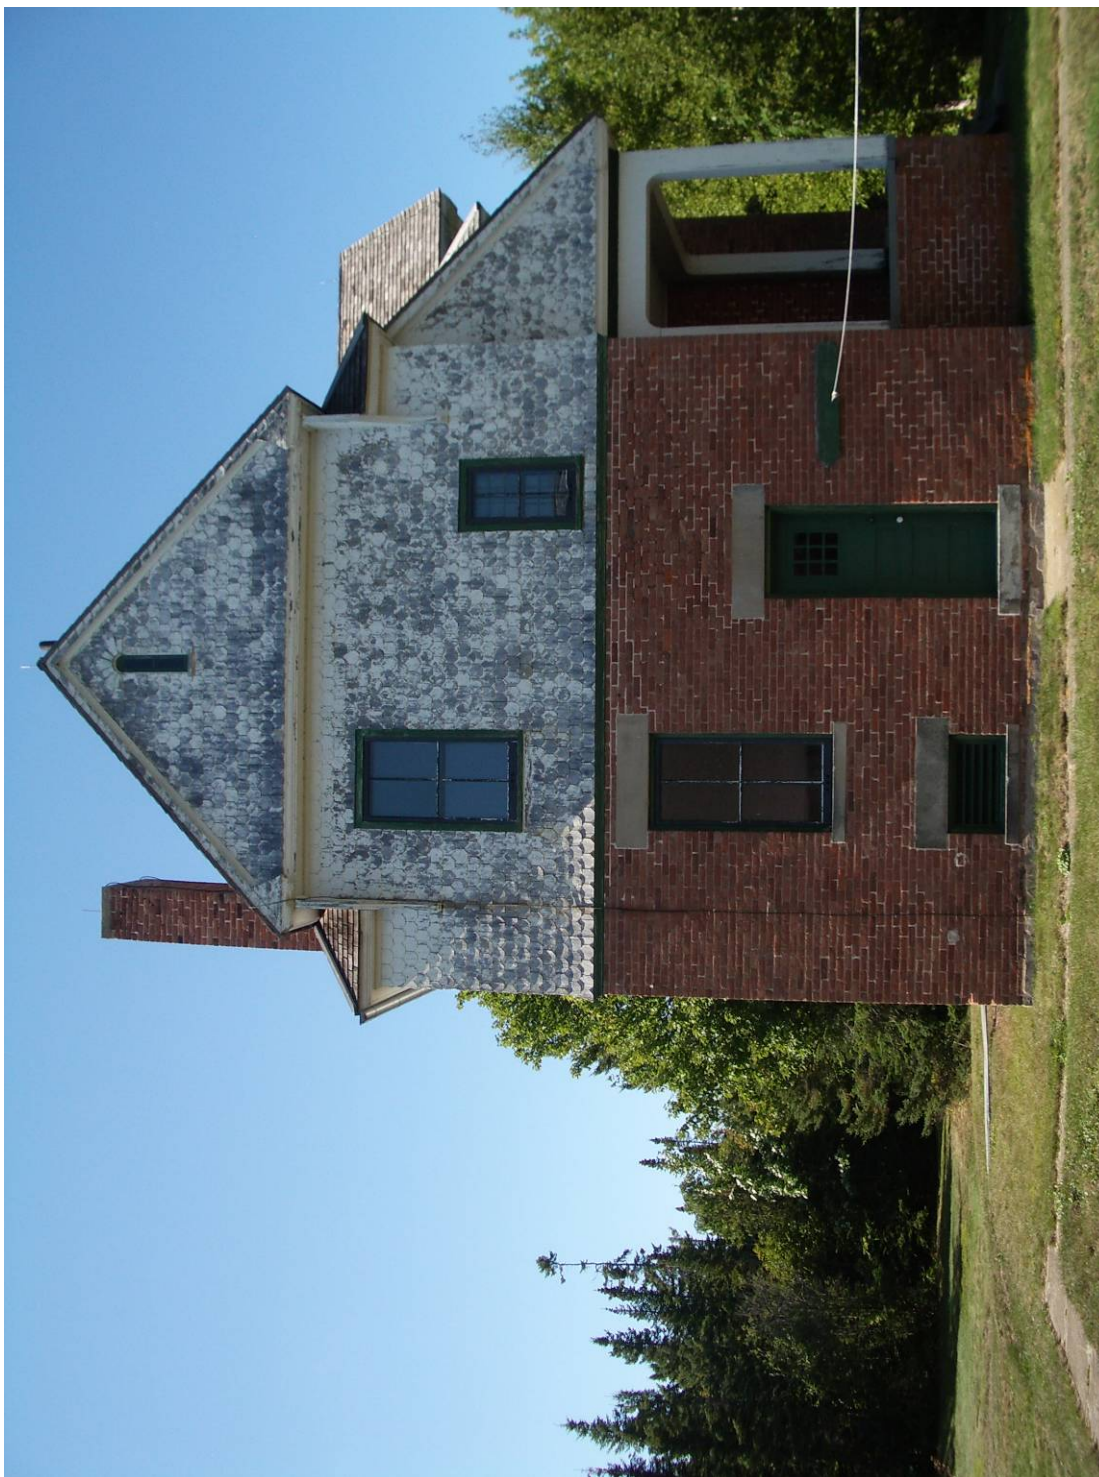
DI-AKQ-02: East elevation, 2009 (Source: AH IMG2895)

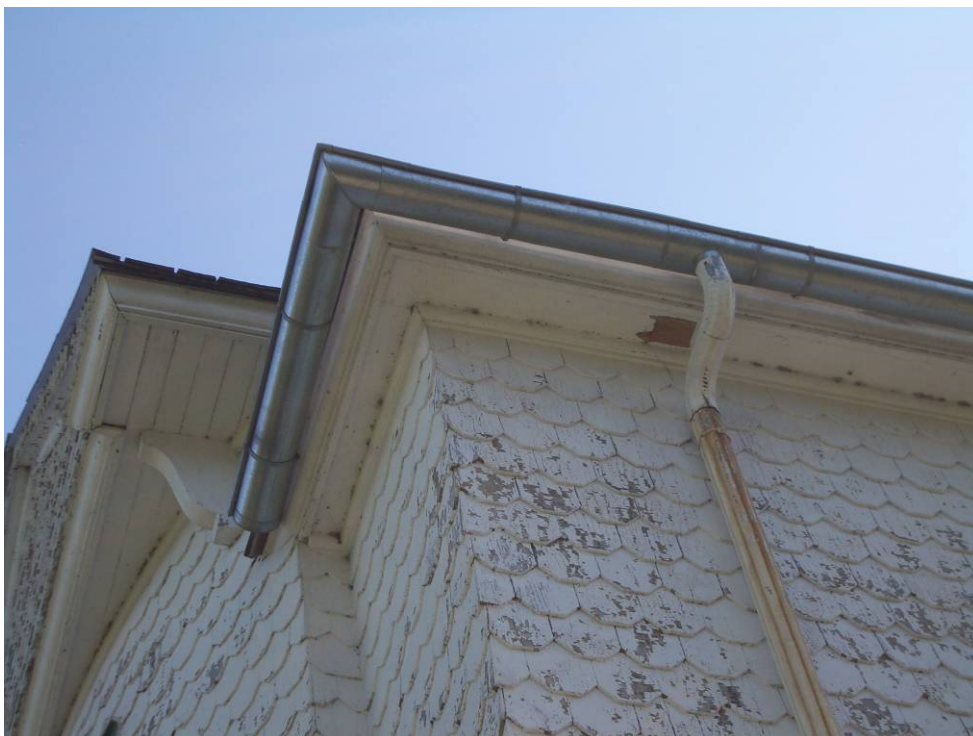
DI-AKQ-05: West elevation gutters and downspout (Source: AH IMGP2899)

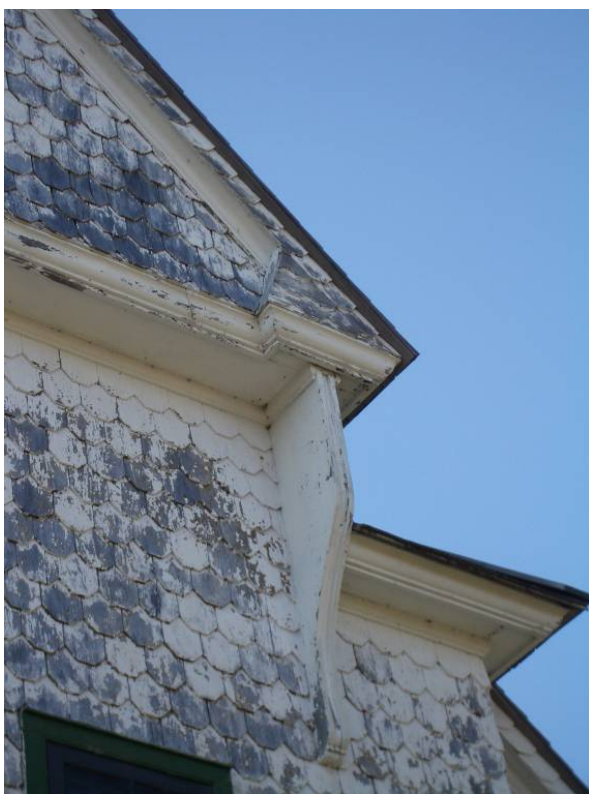
DI-AKQ-06: East elevation trim and wall shingles (Source: AH IMGP2912)

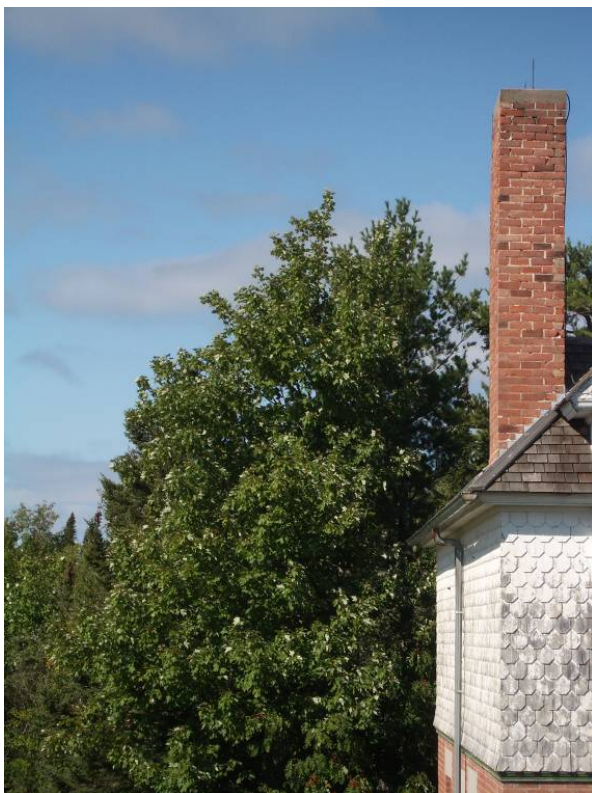
DI-AKQ-07: South chimney (Source: AH IMGP2885)

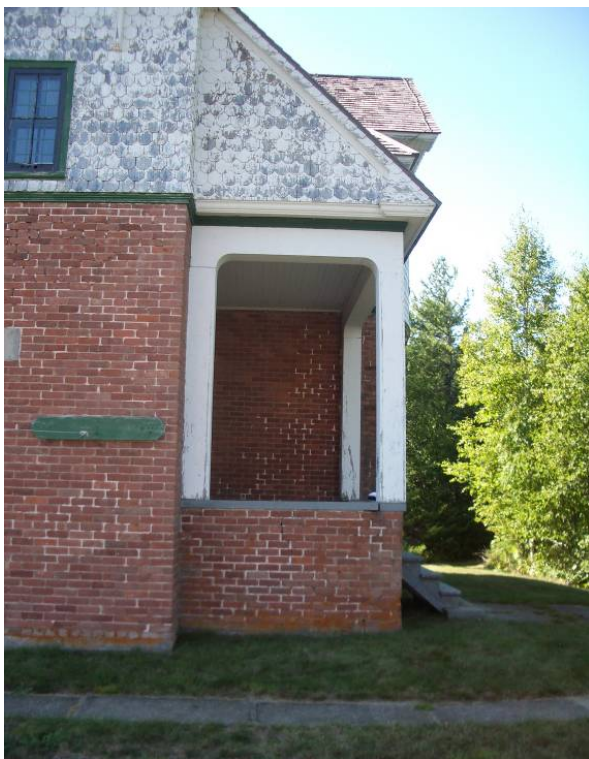
DI-AKQ-08: East elevation of entry porch and stair (Source: AH IMGP2914)

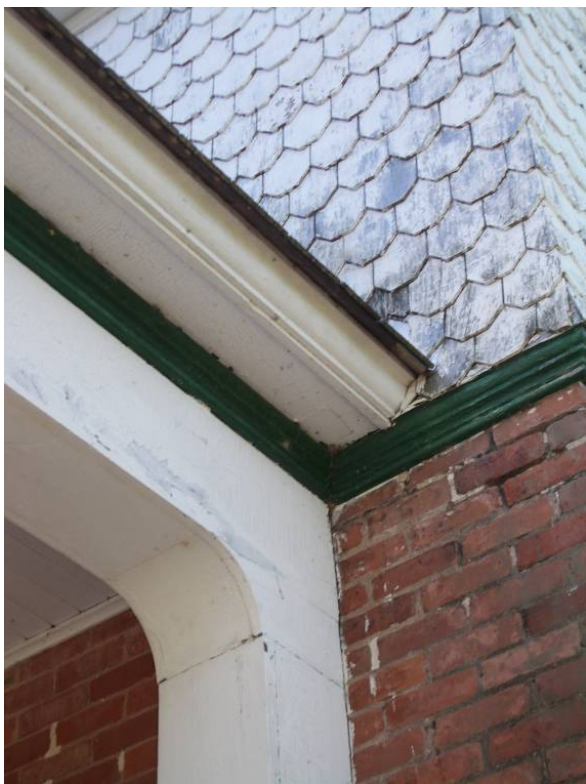
DI-AKQ-09: Entry porch eave detail (Source: AH IMGP2901)

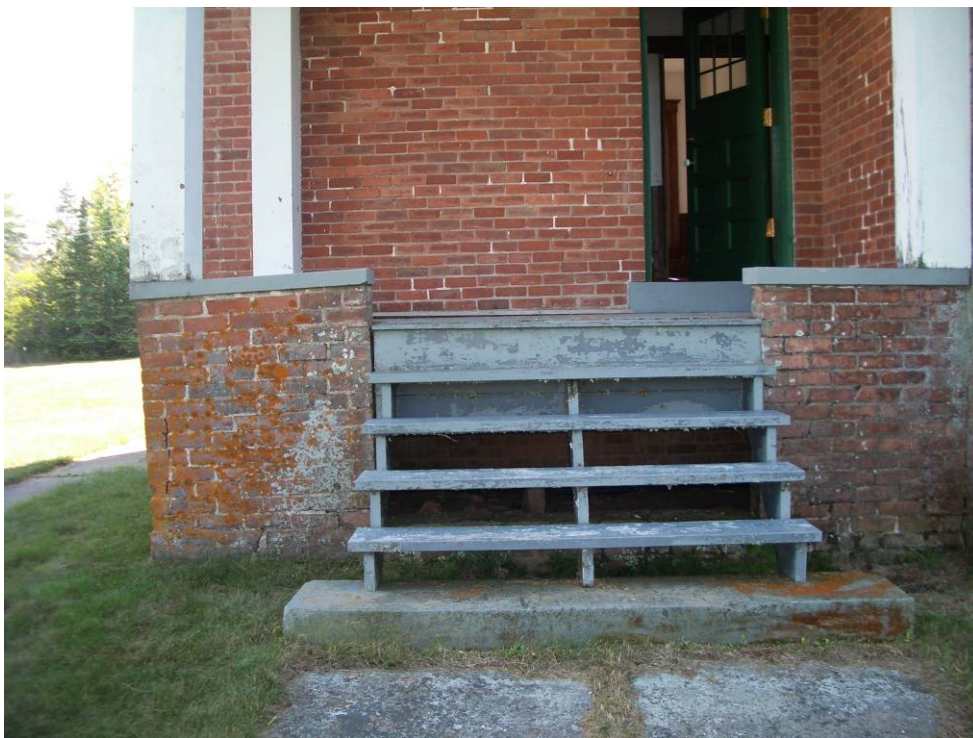
DI-AKQ-10: Entry porch and stair (Source: AH IMGP2915)

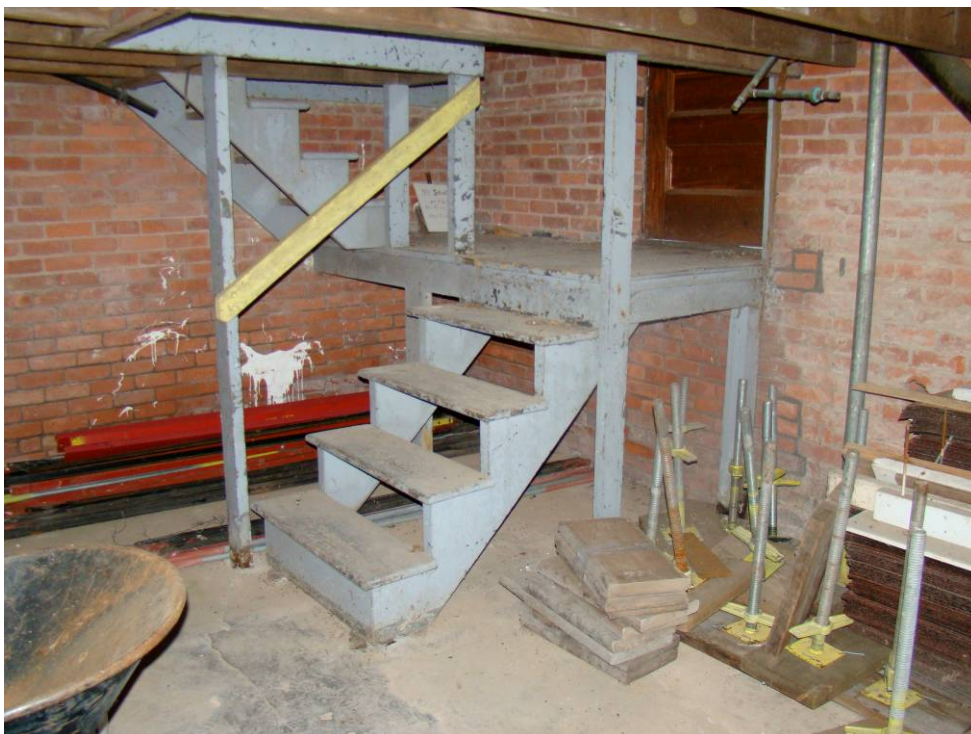
DI-AKQ-13: Basement stair to east entry door and first floor (Source: AH CIMG3910)

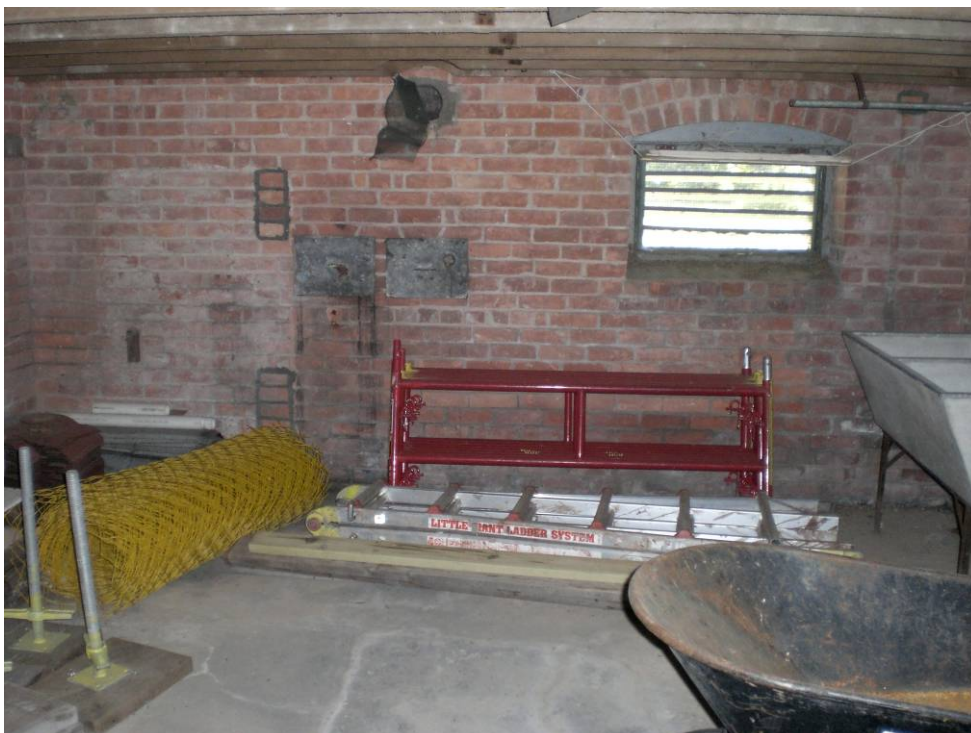
DI-AKQ-14: Basement, west elevation (Source: AH CIMG3905)

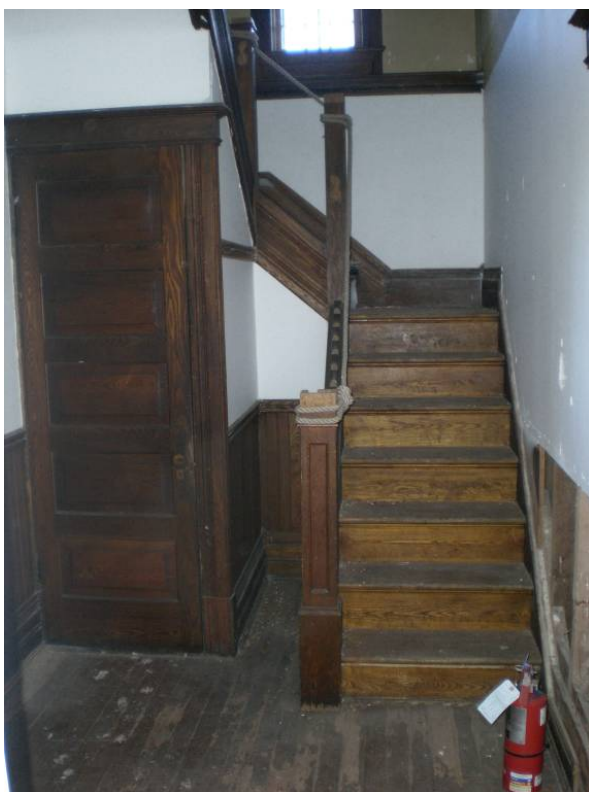
First Floor to Second Floor Stairs. These stairs are stained wood with only the newels remaining in the balustrade. A rope is acting as the handrail. There are seven risers (8" high) to a landing and then another eight risers. The treads are 10 $\frac{3}{4}$ " deep with a 1" nosing. The stairs and newels are original to the building. (DI-AKQ-16)

DI-AKQ-16: Stairs to second floor, east elevation, looking up (Source: AH CIMG3845)

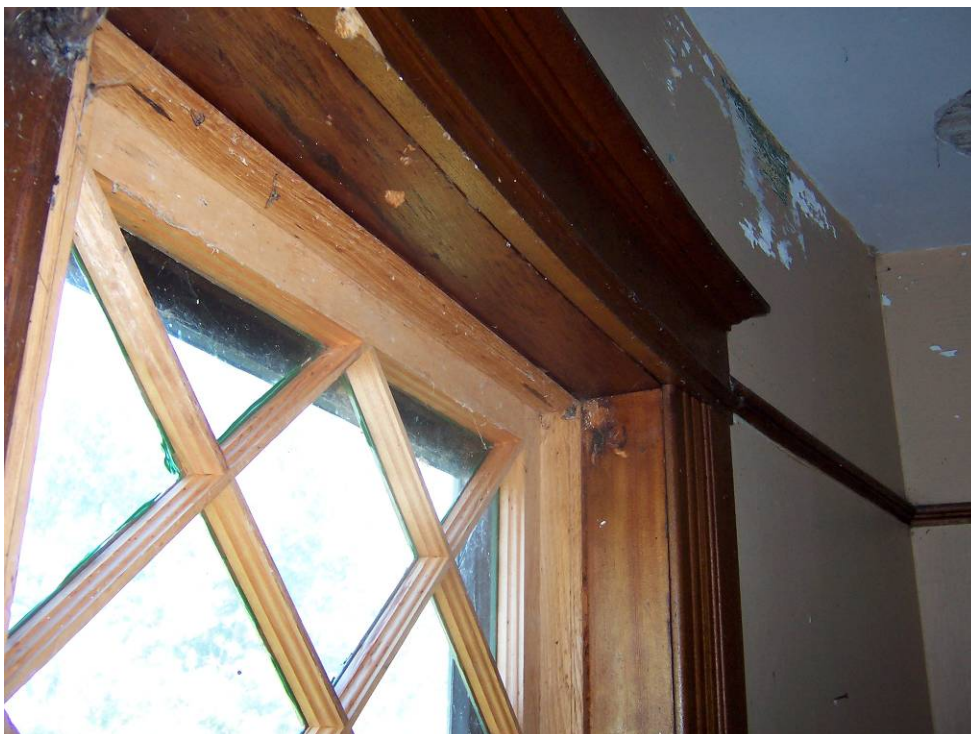
DI-AKQ-27: Second floor sitting room, bow window sash detail (Source: AH 100_9745)

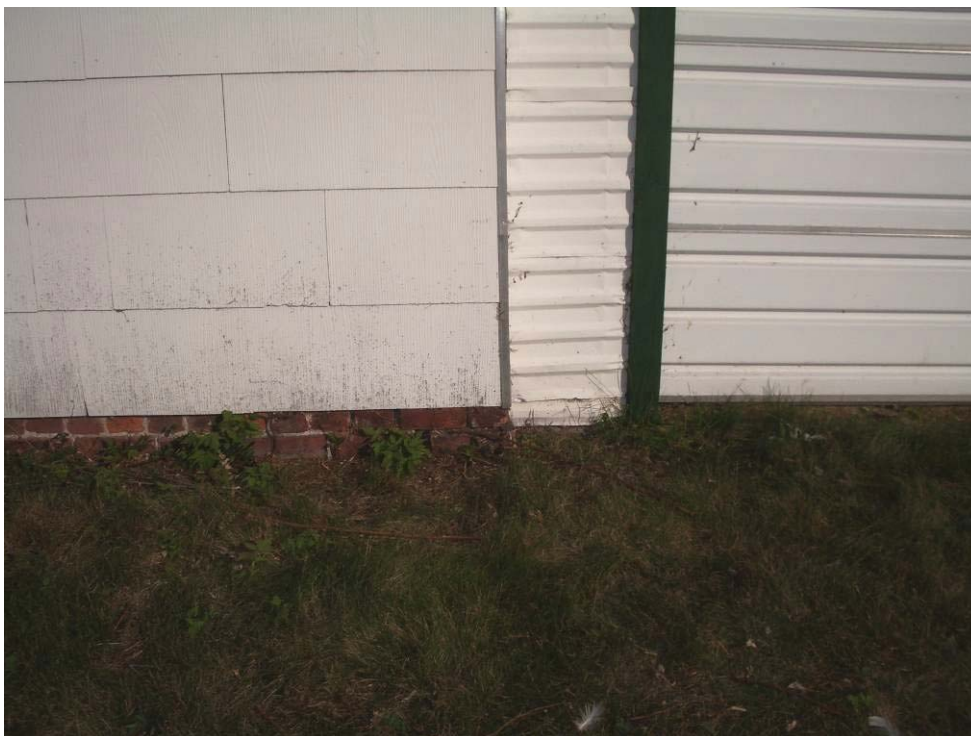
The exterior walls are of frame construction (noted as 4x4 per 1962 remodel drawings) and have asbestos shingles painted white (10” wide x 24” long) at the main portion of the building and the west shed portion. Per historic photos, the exterior walls were a corrugated sheet metal. The south shed addition consists of three types of corrugated metal panels running horizontal except at the shed’s half-gable end where it runs vertically. Wood 1x and 2x trim separates the various types of corrugated metal siding. The brick foundation is visible at the base of the walls in some areas. (DI-FSB-06)

DI-FSB-06: West elevation siding and foundation detail (Source: AH IMGP2933)

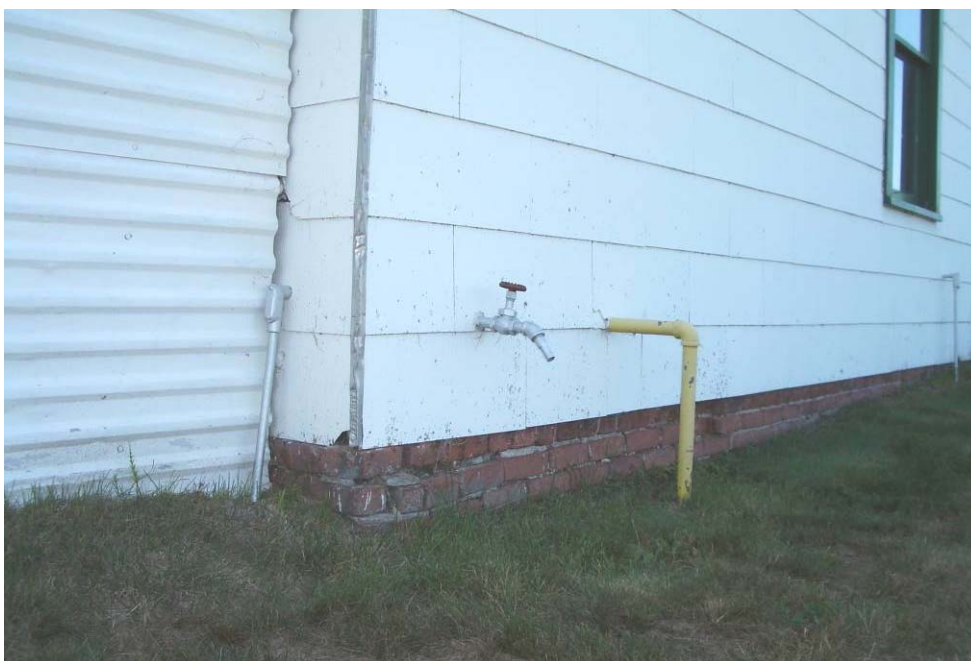
DI-FSB-07: East elevation siding and foundation detail, hose bib and piping (Source: AH IMGP2937)

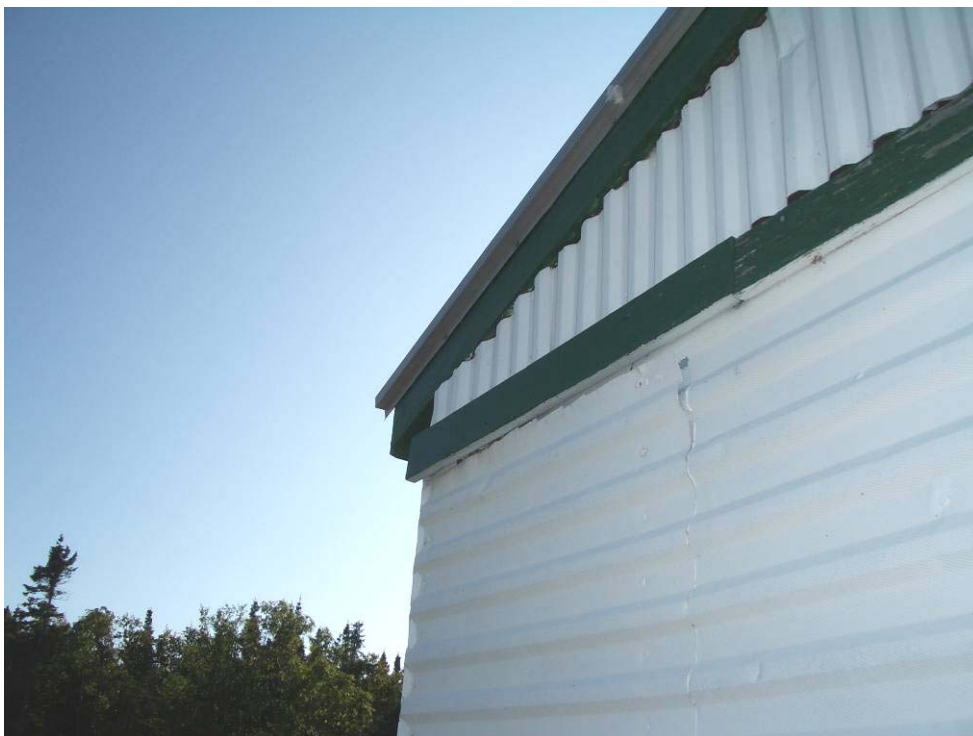
DI-FSB-08: East elevation siding and trim (Source: AH IMGP2935)

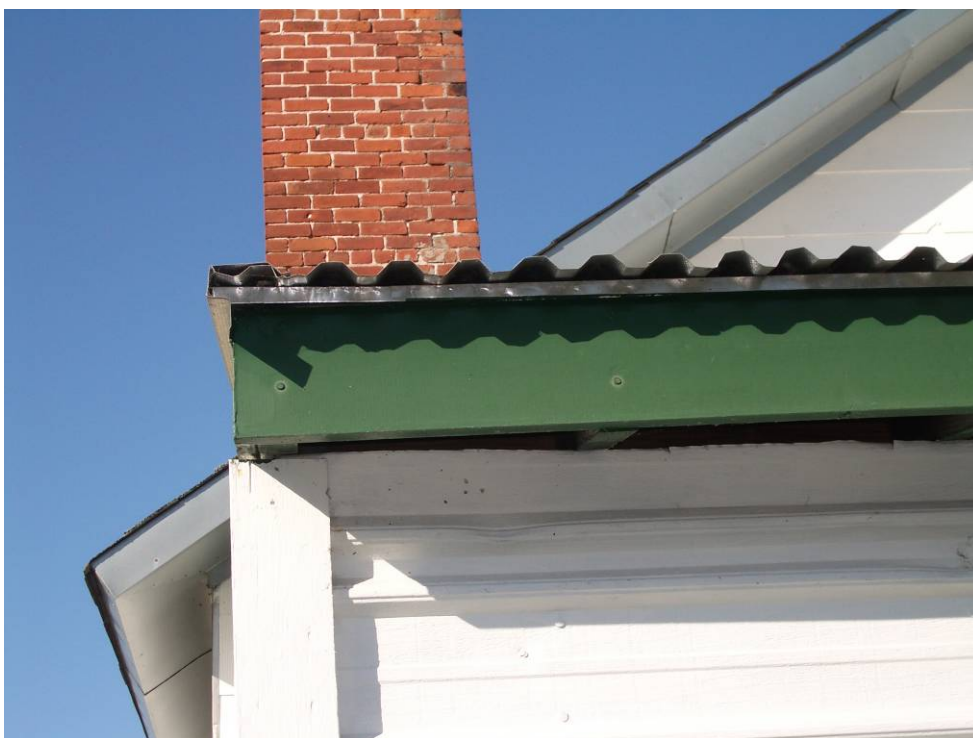
DI-FSB-09: South elevation trim, roofs and chimney (Source: AH IMGP2931)

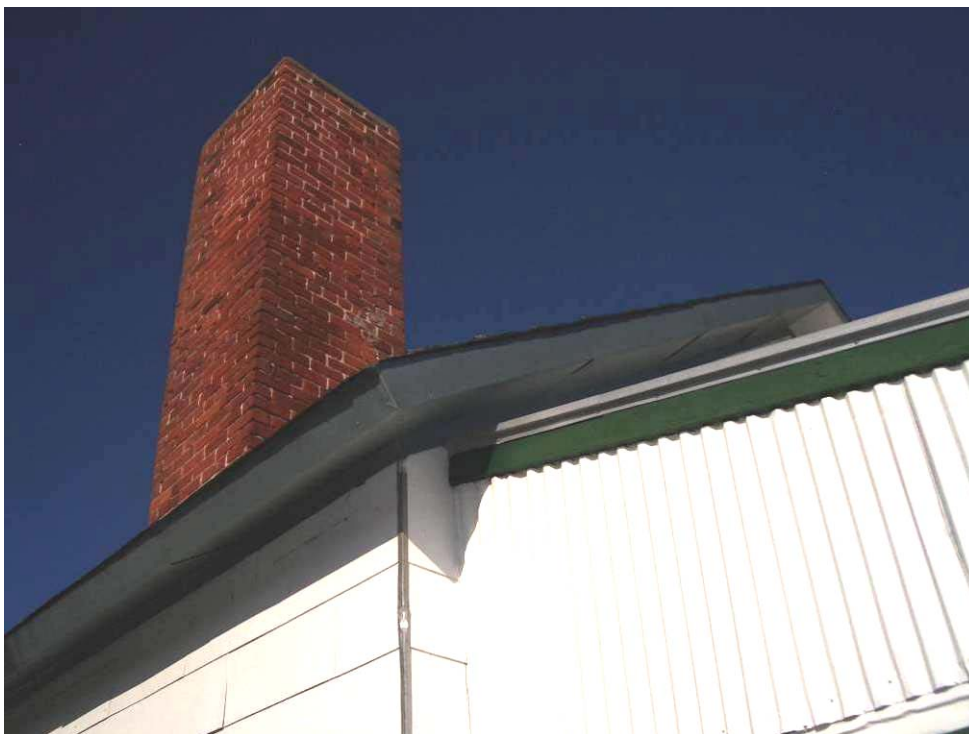
DI-FSB-10: Southwest roofing, trim, siding and chimney (Source: AH IMGP2940)

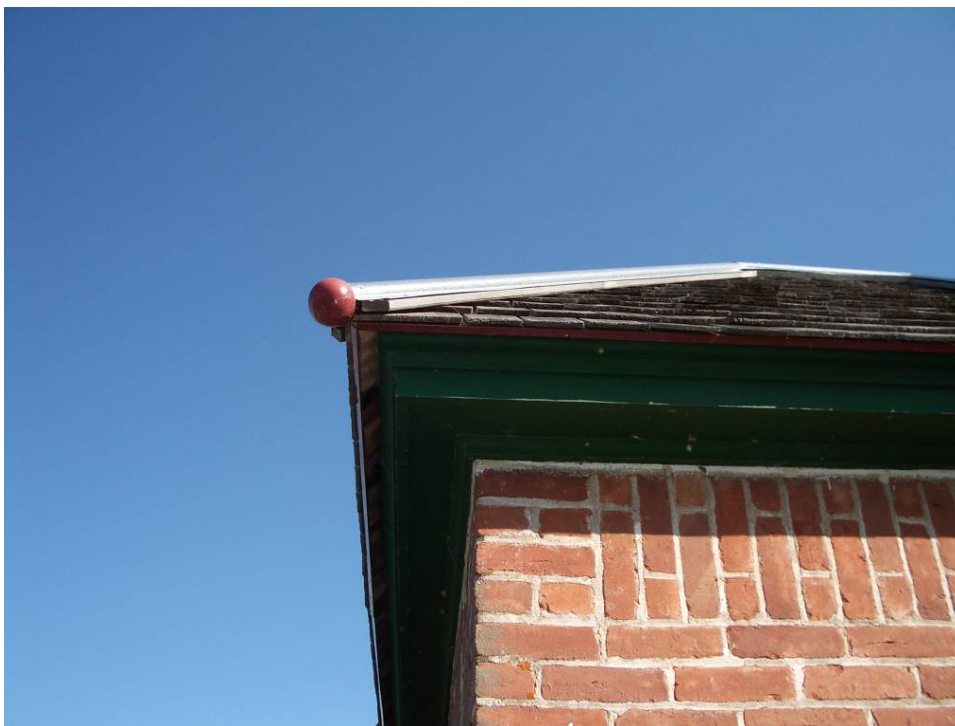
DI-OH1-05: Roof, trim and wall detail (Source: AH IMGP2919)

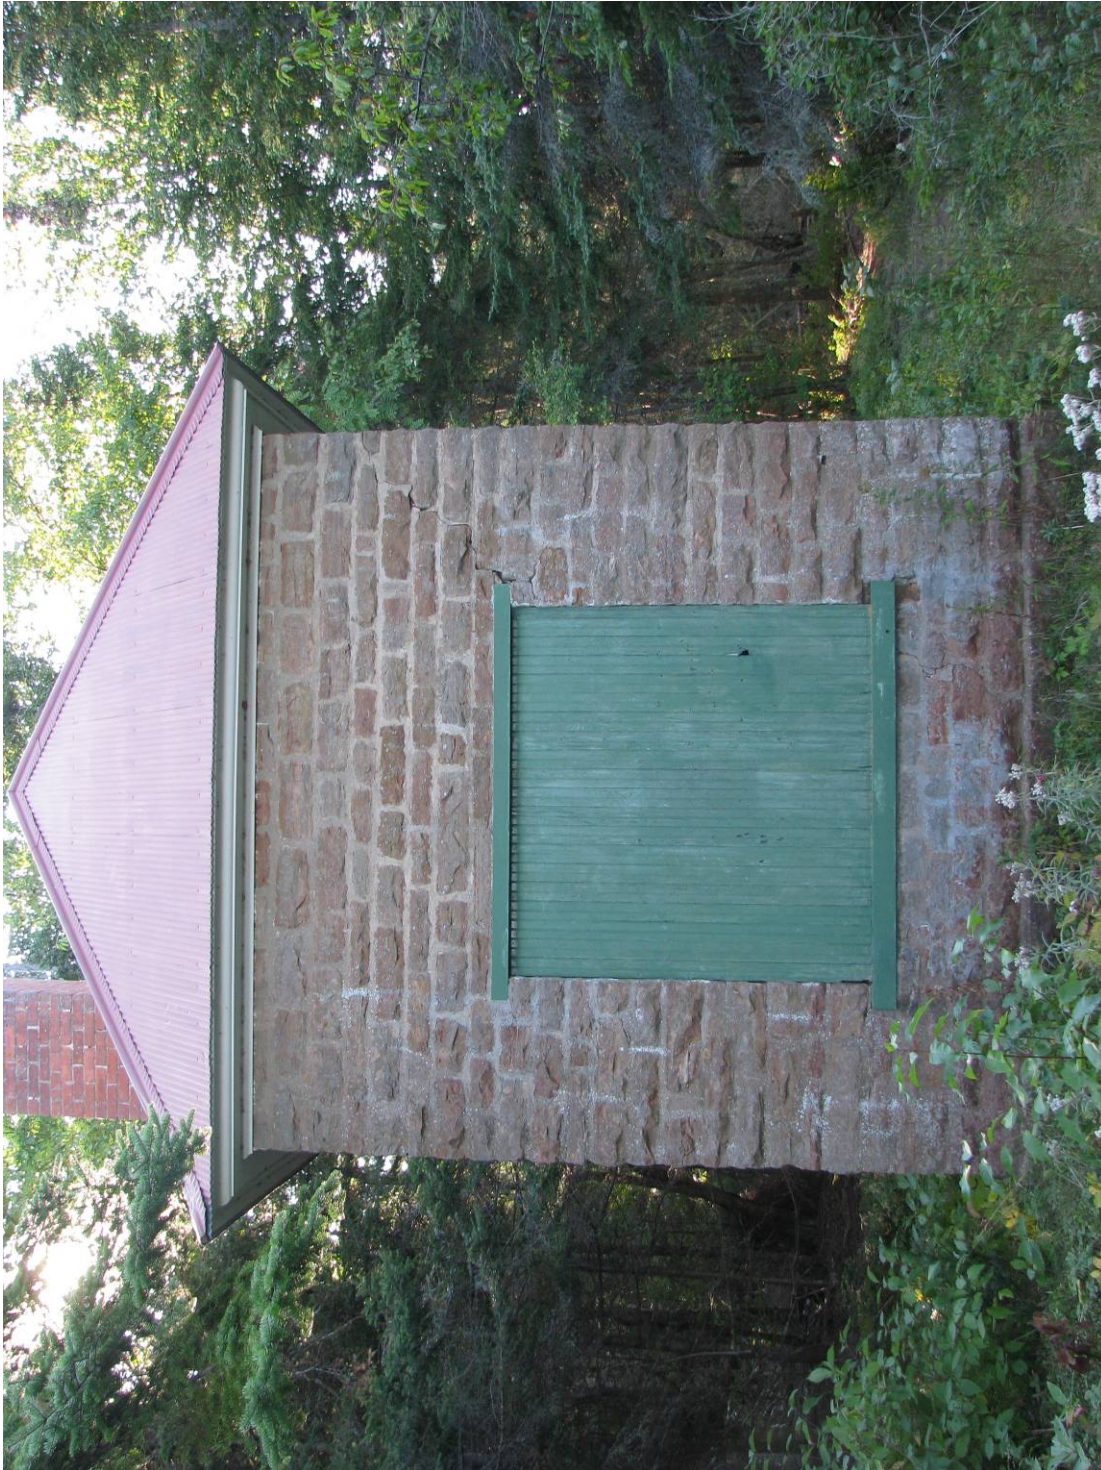
DI-TEB-01: Southeast elevation, 2009 (Source: Martin/Martin Devils Island 16 Sep 09 376.jpg)

The exterior walls are in good condition. There was one diagonal crack in the southeast façade. The crack appears to be old and stable. The crack is not a structural concern.

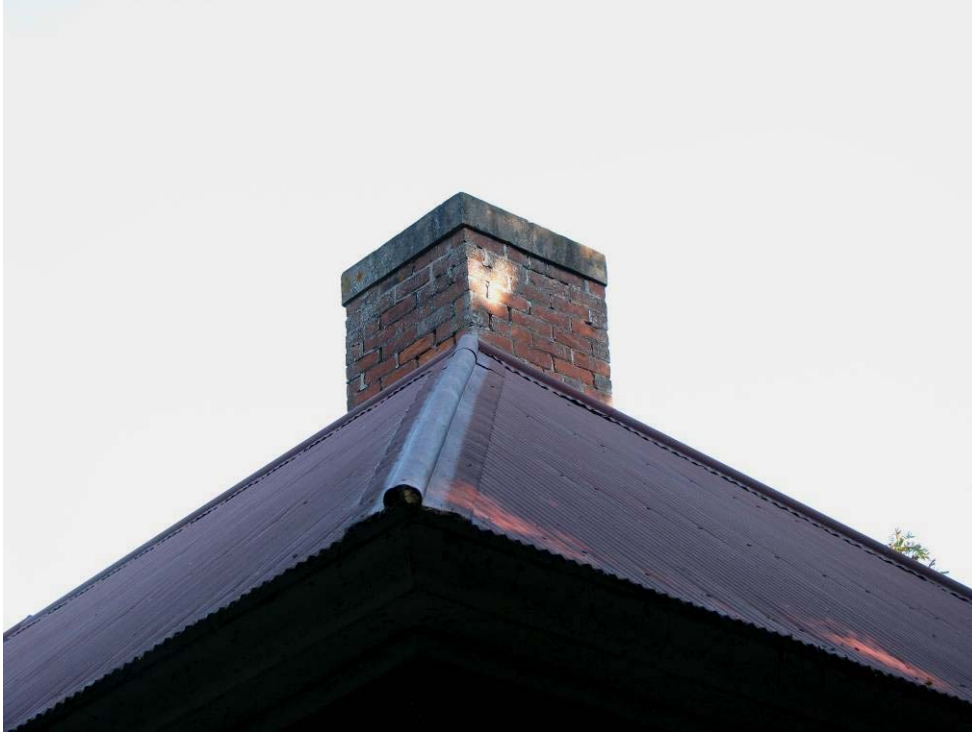
DI-TEB-05: Roof and chimney detail (Source: Martin/Martin Devils Island 16 Sep 09 375.jpg)

The chimney is in fair condition as the upper portion of the chimney is in need of repointing and there are two cracks in the concrete cap that appear to be stress fractures.

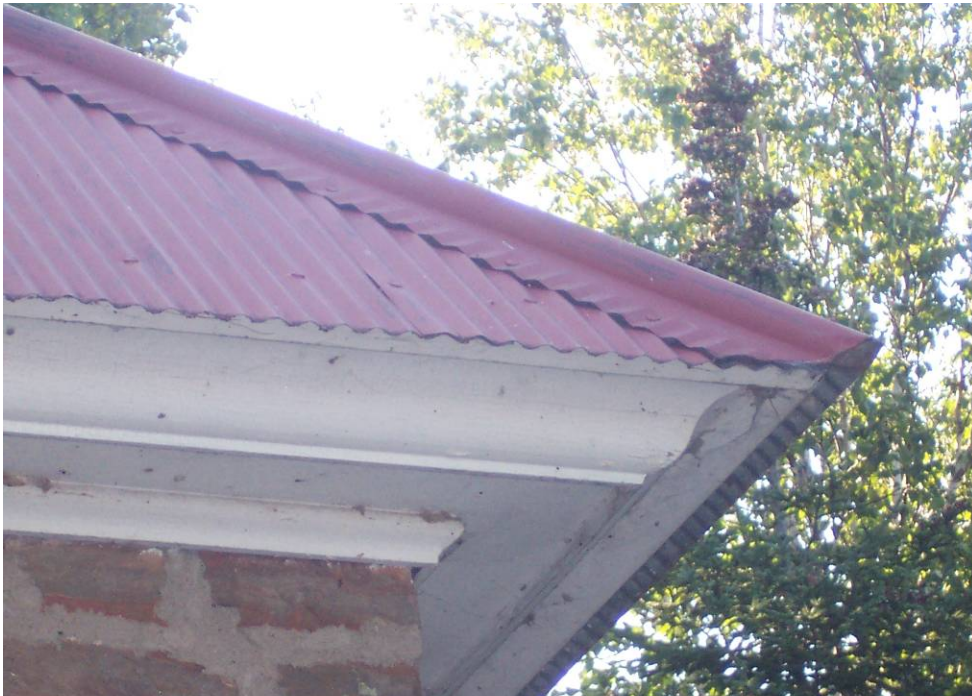
DI-TEB-06: Eave detail (Source: AH 100_9762)

The roofing is in good condition as it is well fastened. The soffits and overhangs have weathered and alligatored paint, but are overall in good condition.

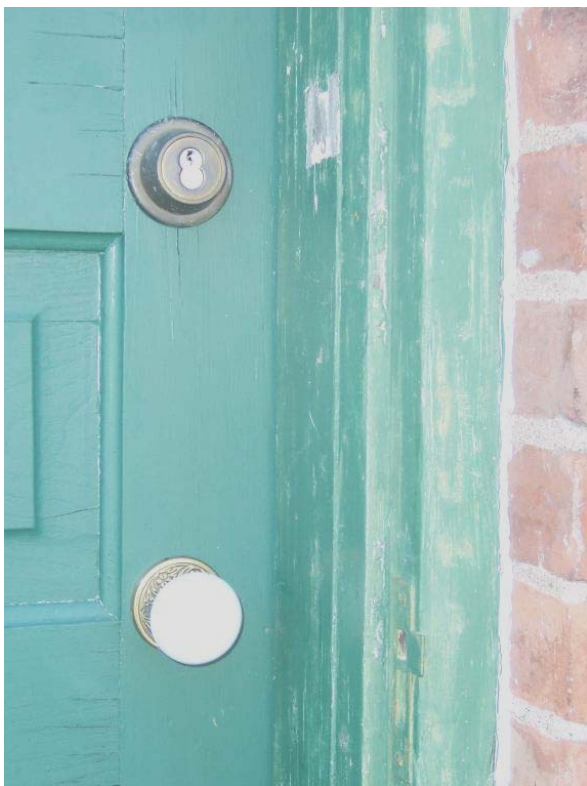
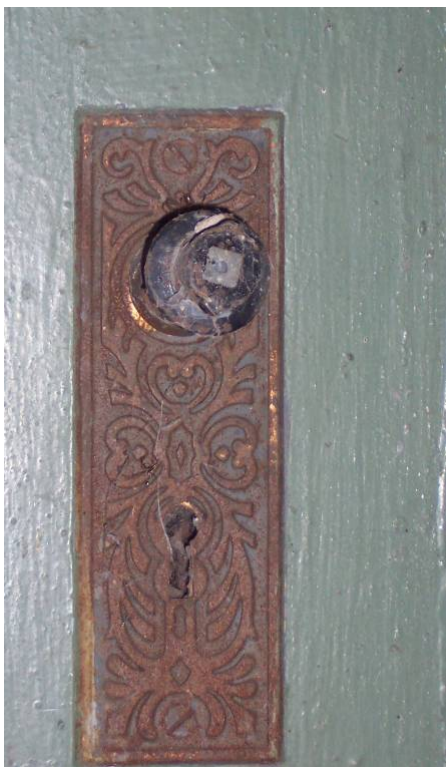
The entry door is missing its knob hardware and the interior and exterior paint is peeling.
