VOLUME V OF VI: LONG ISLAND CLR/HSR

**APOSTLE ISLANDS NATIONAL LAKESHORE
LIGHT STATIONS OF MICHIGAN ISLAND, OUTER ISLAND, DEVILS ISLAND,
LONG ISLAND AND SAND ISLAND**

**CULTURAL LANDSCAPE REPORT, HISTORIC STRUCTURE REPORT
AND
ENVIRONMENTAL ASSESSMENT**

prepared by
Anderson Hallas Architects, PC
Golden, Colorado

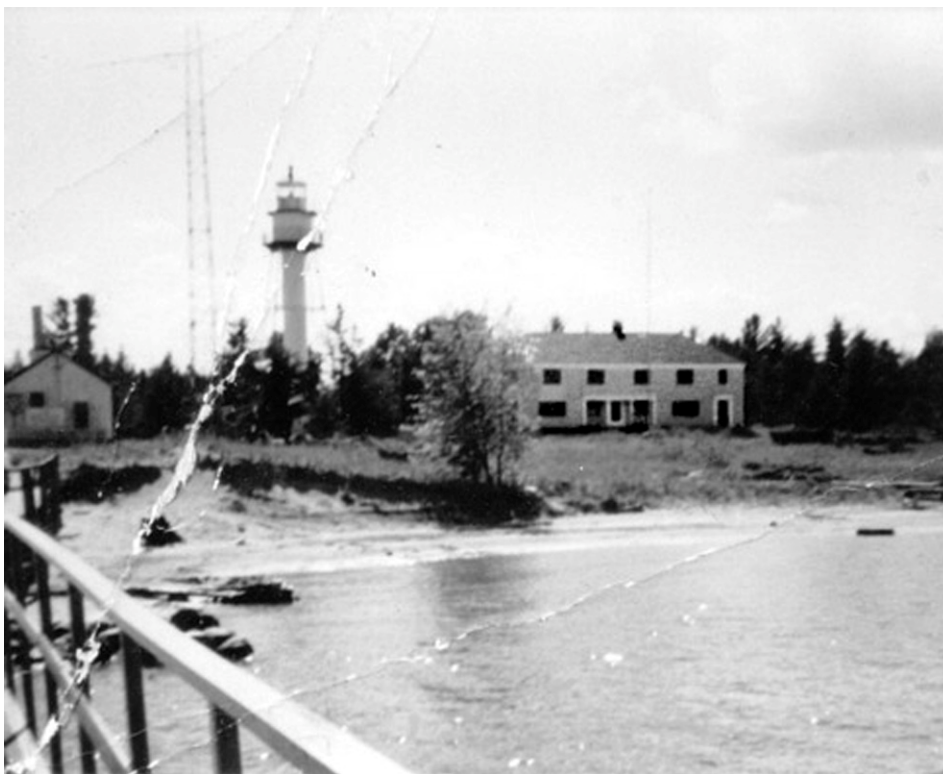
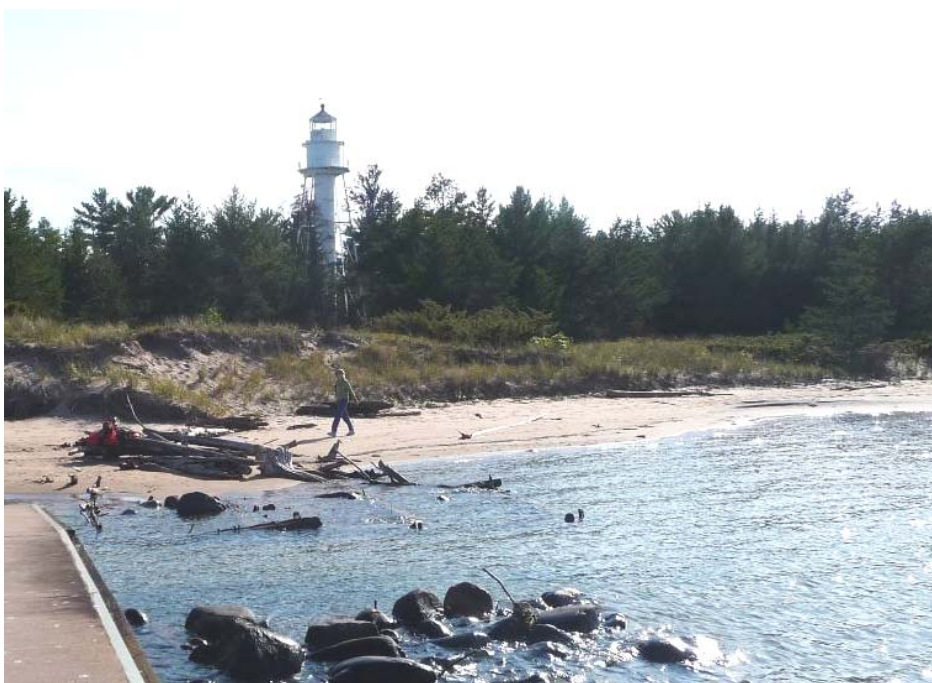
Site Image LI-24: View of LaPointe grounds from Lake Superior showing diminished spatial organization; top, c. 1969 (Source: NPS APIS Archives); below, 2009 (Source: MBD P1020369.jpg)

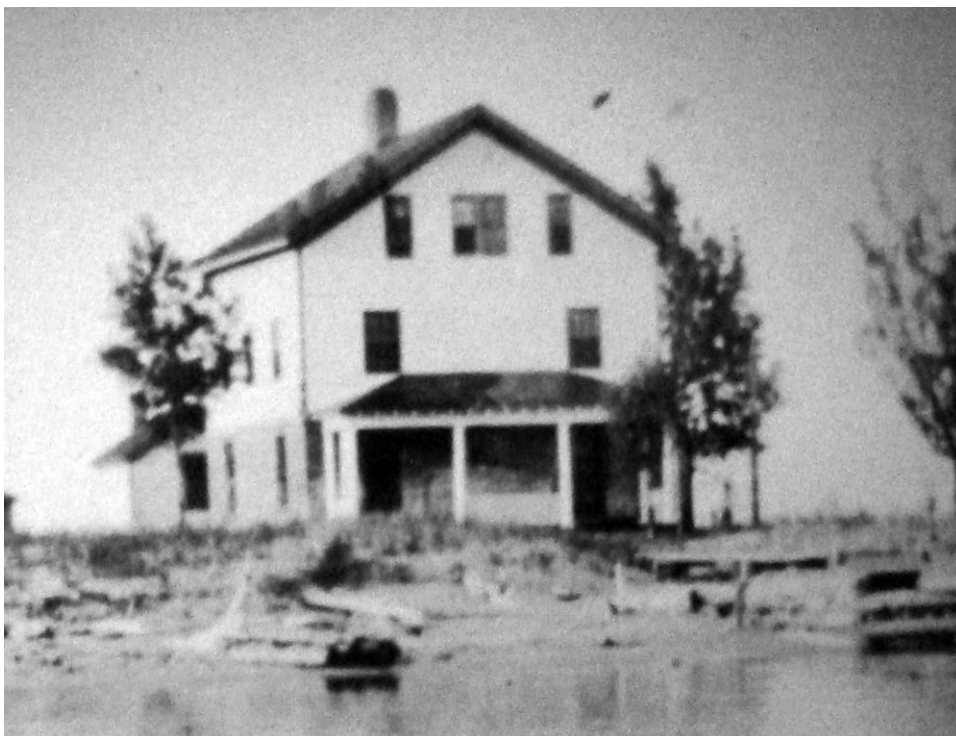
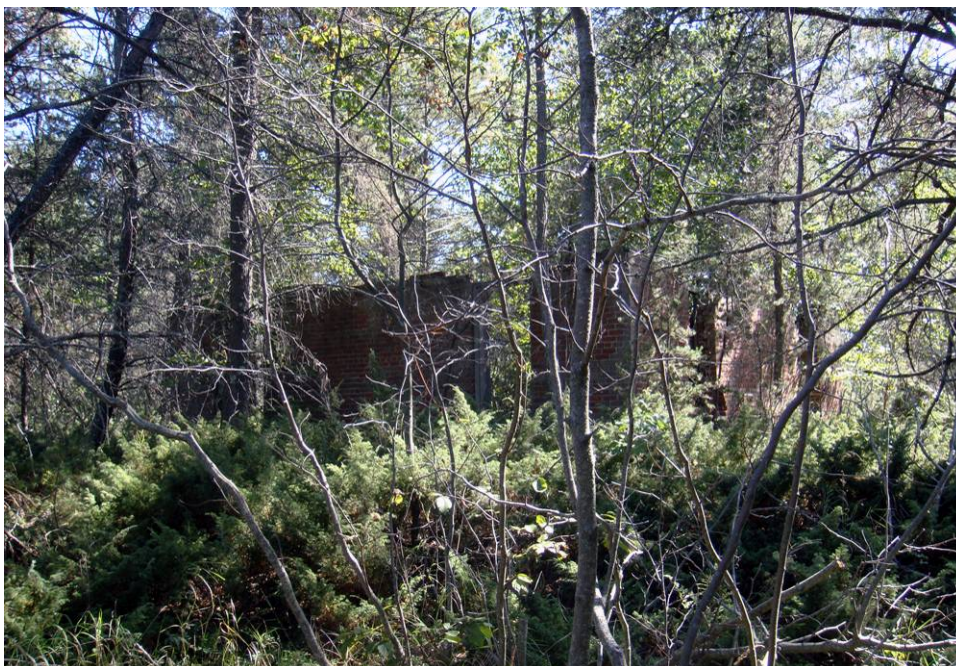
Site Image LI-25: View of Original LaPointe Lighthouse showing diminished spatial organization by encroaching vegetation; top, c. 1920 (Source: NPS APIS Archives); below, 2009 (Source: MBD DSC01285.jpg)

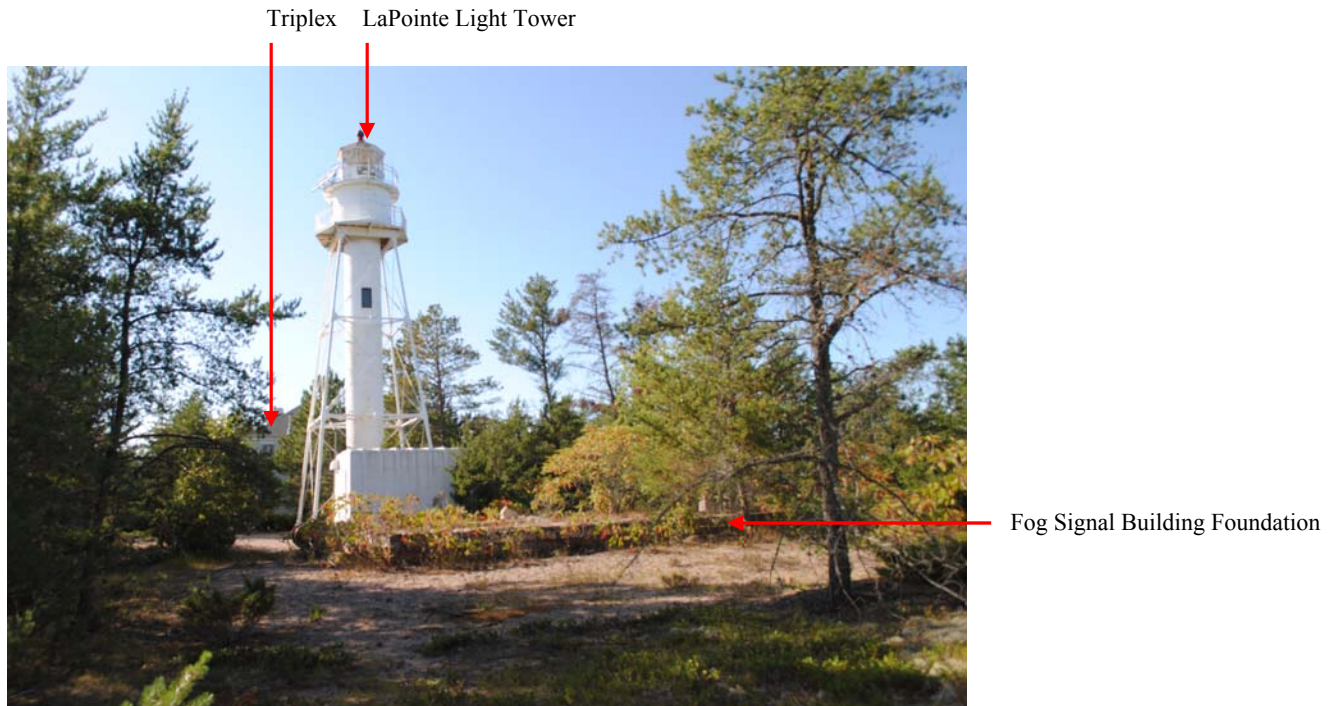
Site Image LI-26: View of LaPointe grounds from east showing diminished spatial organization by encroaching forest vegetation, 2009 (Source: MBD DSC_0180.JPG)

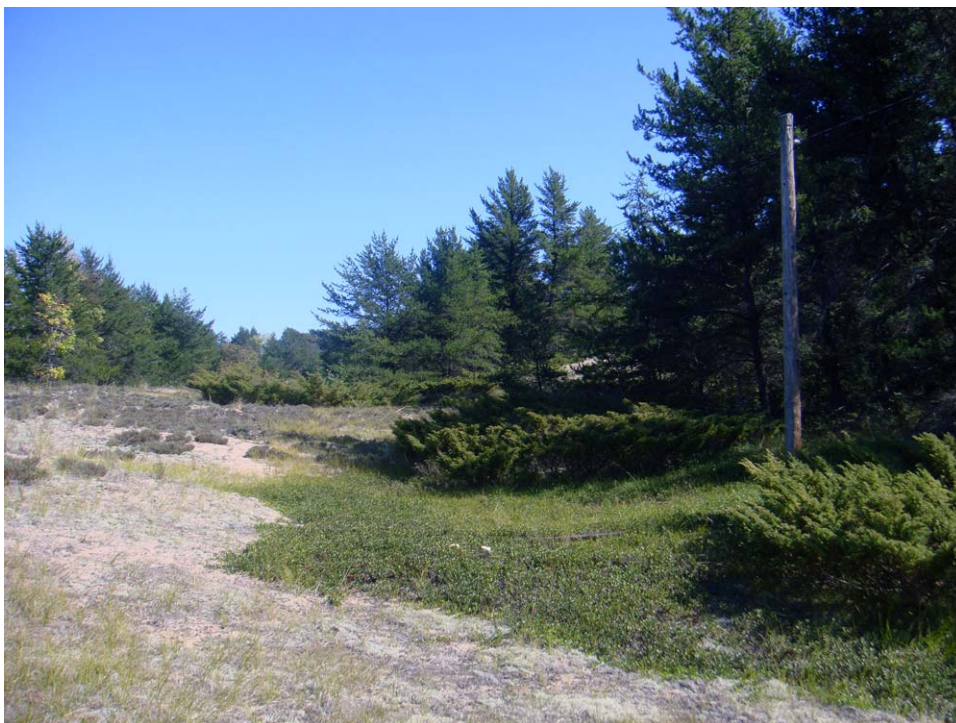
Site Image LI-31: Inland topography near the Original LaPointe Lighthouse, 2009 (Source: MBD DSC01281.JPG)

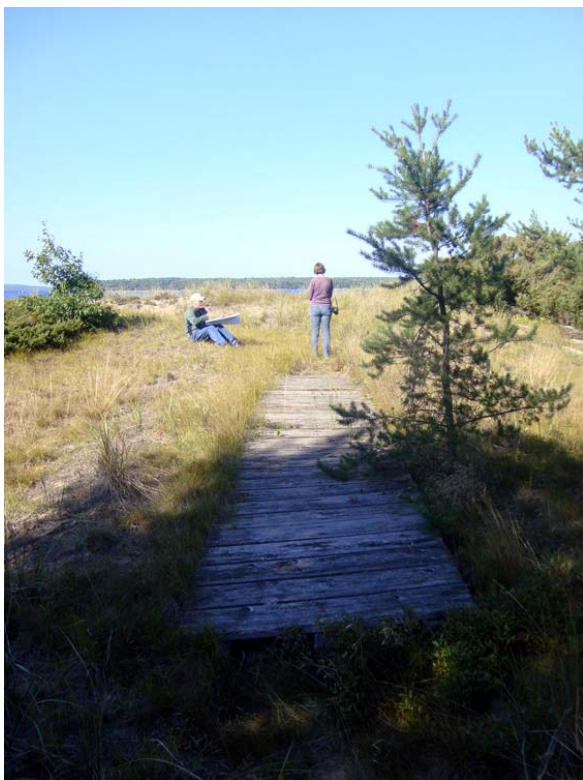
At the LaPointe site, concrete walks connected buildings and structures on the site. The concrete walks were preceded by wooden plank walks, laid on the ground surface. The remnant boardwalk indicates a pattern of circulation on the site leading from the fog signal building foundation directly north to the shoreline and former dock-landing crib location. The circulation system at the LaPointe site is the most visibly intact of the three sites and is a contributing feature.

Site Image LI-38: Extant remnants of the boardwalk at the LaPointe site leading from the Fog Signal Building foundation to the shore, 2009 (Source: MBD DSC01372.JPG)

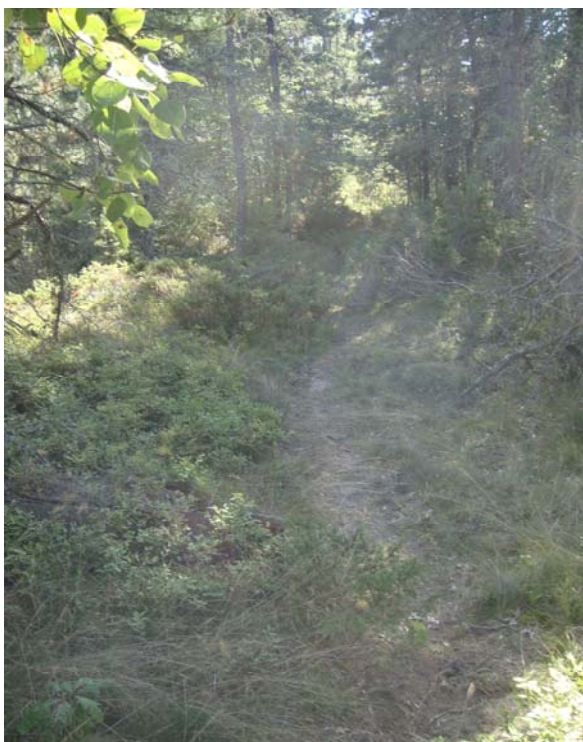
Site Image LI-39: Footpath leading south from LaPointe site to Chequamegon Bay shoreline, 2009 (Source: MBD DSC01353.JPG)

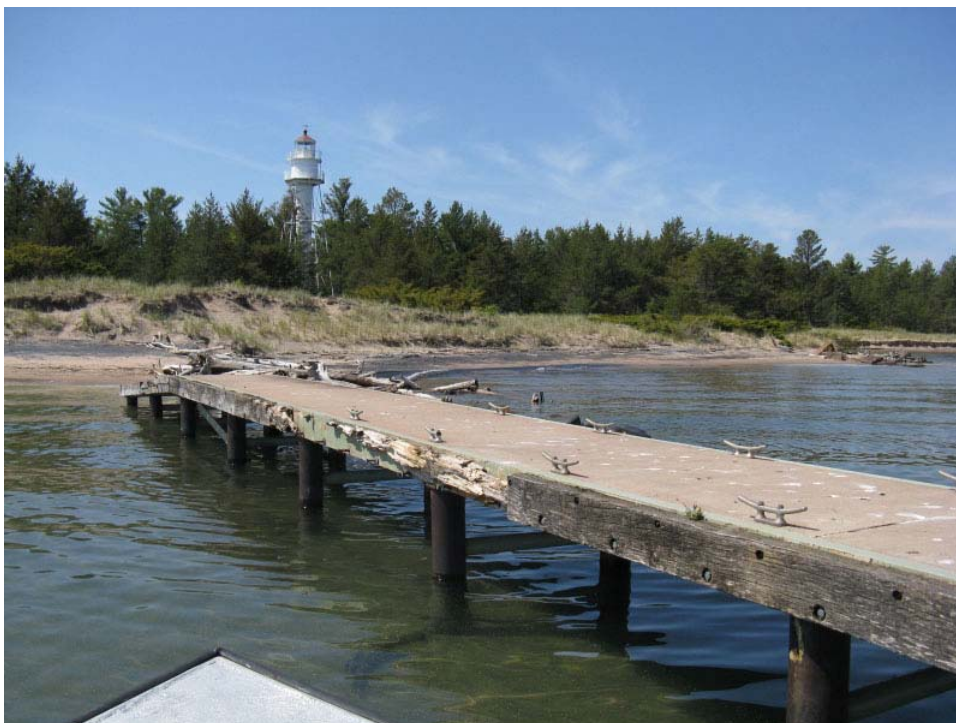
Existing Condition. A boat dock is located on the Lake Superior shoreline directly north the LaPointe Light Tower. The dock is approximately 80' long and 8' wide and is built of steel pipe framing with a concrete deck. In 2009, the south end of the dock was approximately 15' from the shoreline. Due to the nature and location of the boat dock, this dock and its predecessors have frequently been damaged or destroyed by the harsh wave and ice action of Lake Superior. The dock is used for landing small boats by visitors and park staff. The dock is in fair condition but has functionality issues related to the fluctuation of the water depth and shifting shoreline.

Site Image LI-41: Boat dock at LaPointe, 2009 (Source: APIS LaPointe Boat Dock.JPG)

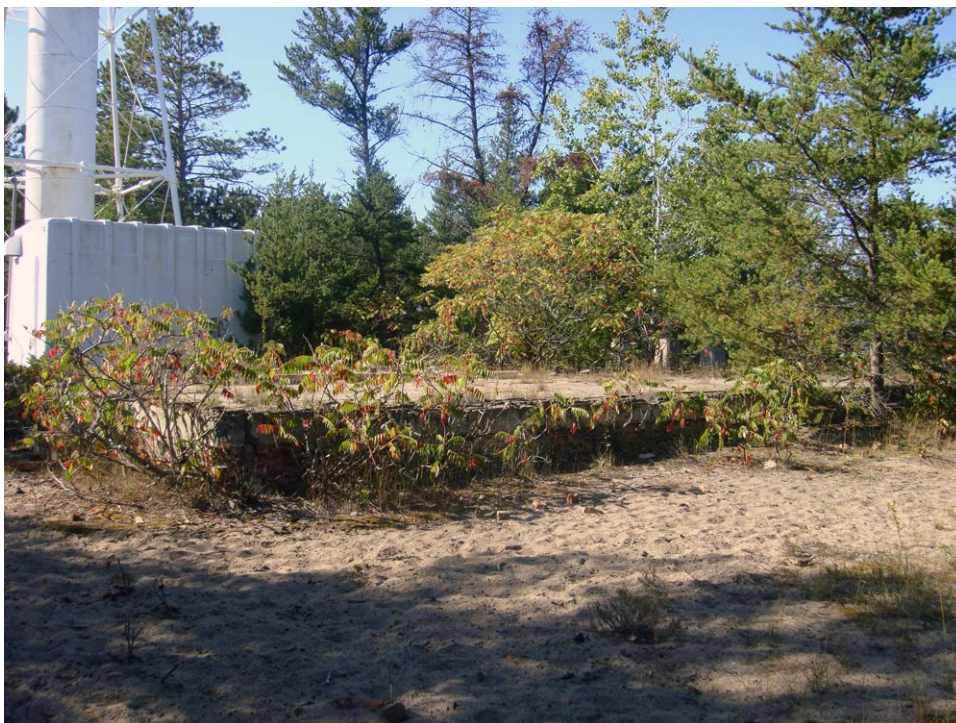
Existing Condition. The Fog Signal Building foundation is a brick and concrete foundation approximately 40' by 22' and elevated 24" above adjacent grade. The foundation includes concrete steps on the east, south, and west sides up to the finish floor elevation and remnants of the brick chimney. The foundation is in fair condition as a remnant structure.

| Feature | Site Image # | Description | Condition | Contributing? /Rationale |
|--|---|---|---|--|
| Fog Signal Building Foundation (c. 1891) | LI-42, LI-43 | see above | Fair | Contributing; See text |

Site Image LI-42: Fog Signal Building foundation, 2009 (Source: MBD DSC01356.JPG)

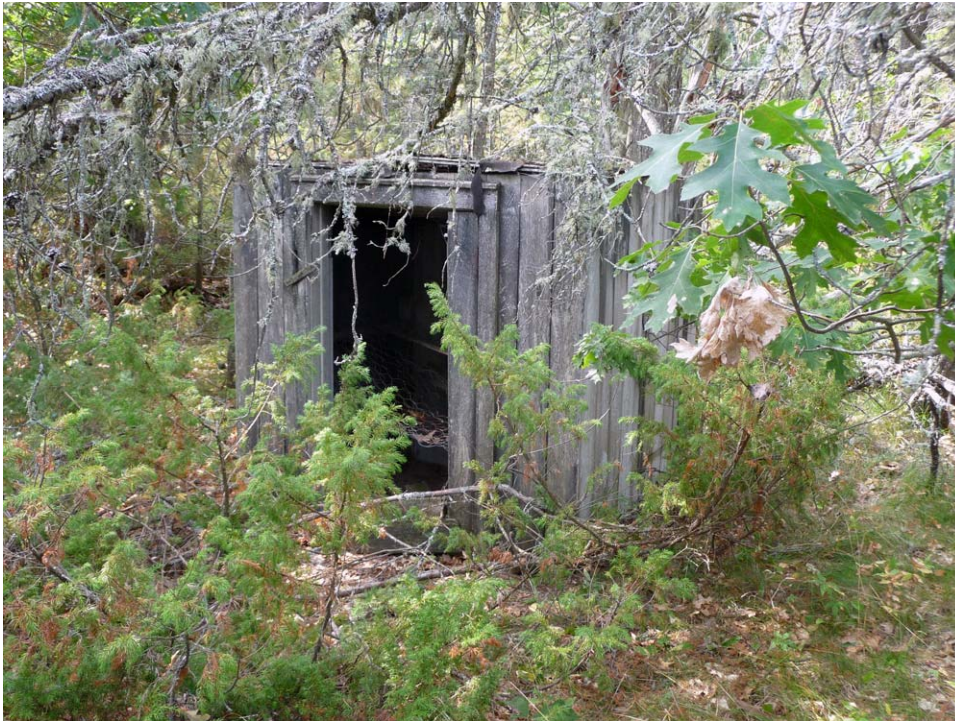
Existing Condition. A small wood framed shed is located in the forested area to the southeast of the Light Tower. The shed is approximately 10'×10' in size with wooden vertical siding and a corrugated metal roof. The shed is in poor condition.

Site Image LI-44: Wooden shed, 2009 (Source: MBD P1020349.JPG)

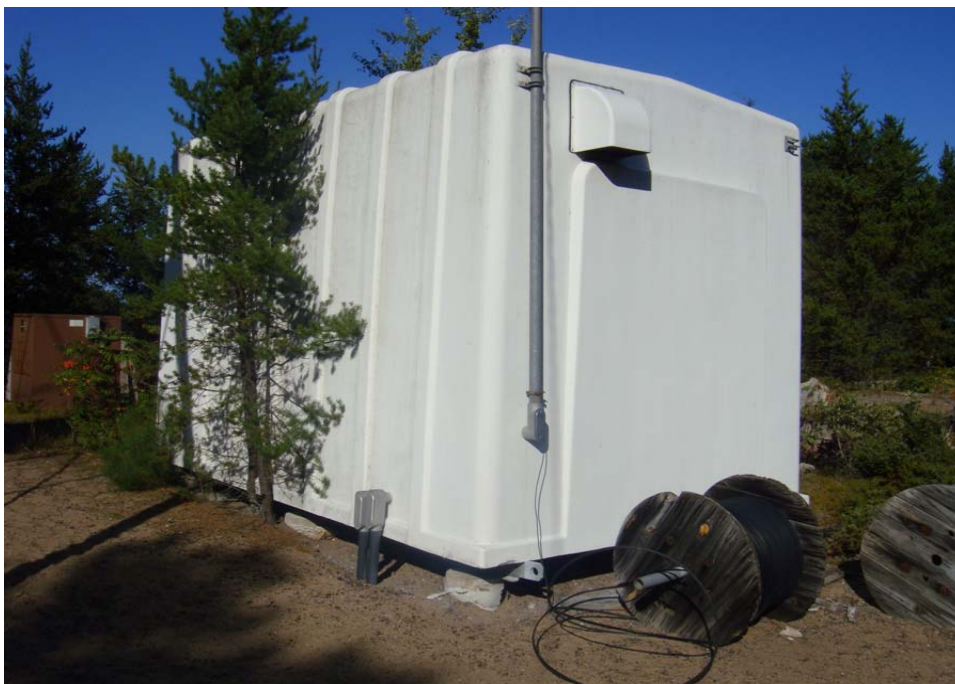
Site Image LI-45: Prefabricated utility unit, 2009 (Source: MBD DSC01416.JPG)

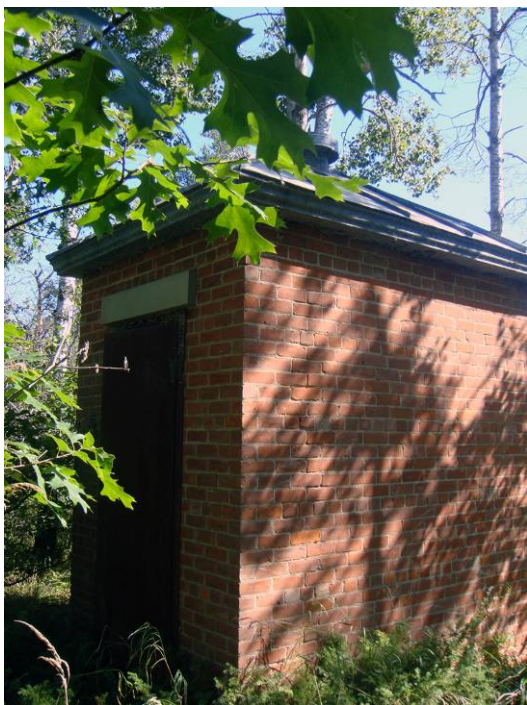
Existing Condition. The Oil Building is located approximately 80' south of the Original LaPointe Lighthouse ruin. The building is brick masonry construction, approximately 8' x 6', with a steel door (nonlocking), metal roofing and stone lintels. The exterior of the building is intact with the roofing, masonry and steel door in place. The interior of the building is in poor condition as the floor is in disrepair. In general the Oil Building is in good condition.

Site Image LI-48: Oil Building, 2009 (Source: MBD DSC01306.JPG)

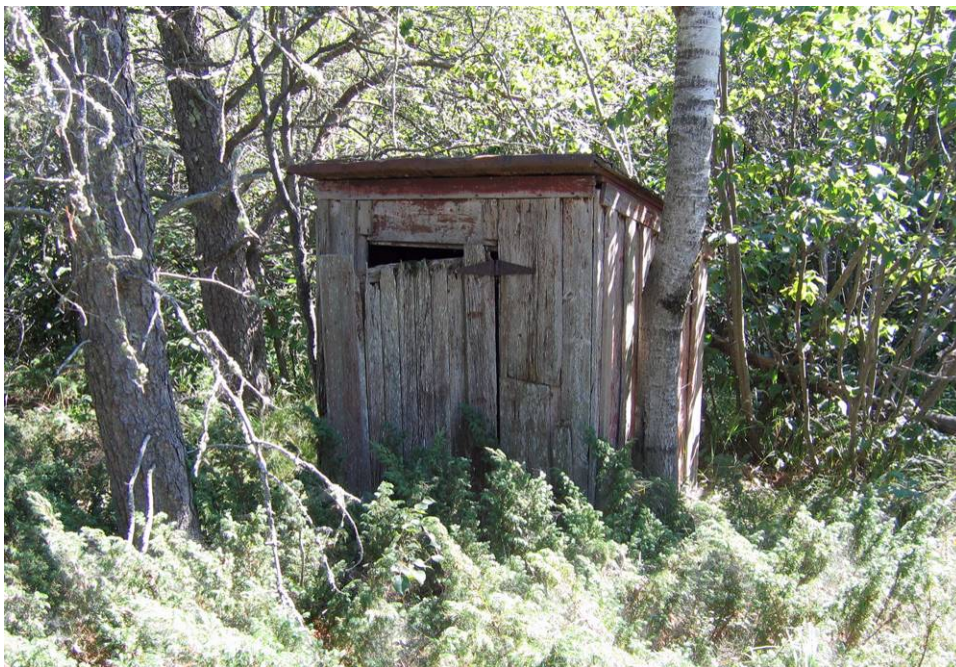
Site Image LI-49: Privy, 2009 (Source: MBD DSC01306.JPG)

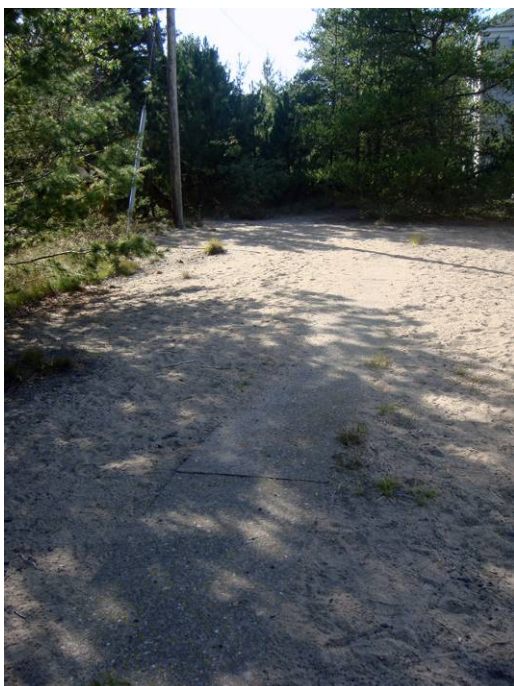
Site Image LI-51: Concrete walk south of LaPointe Light Tower, 2009 (Source: MBD DSC01349.JPG)

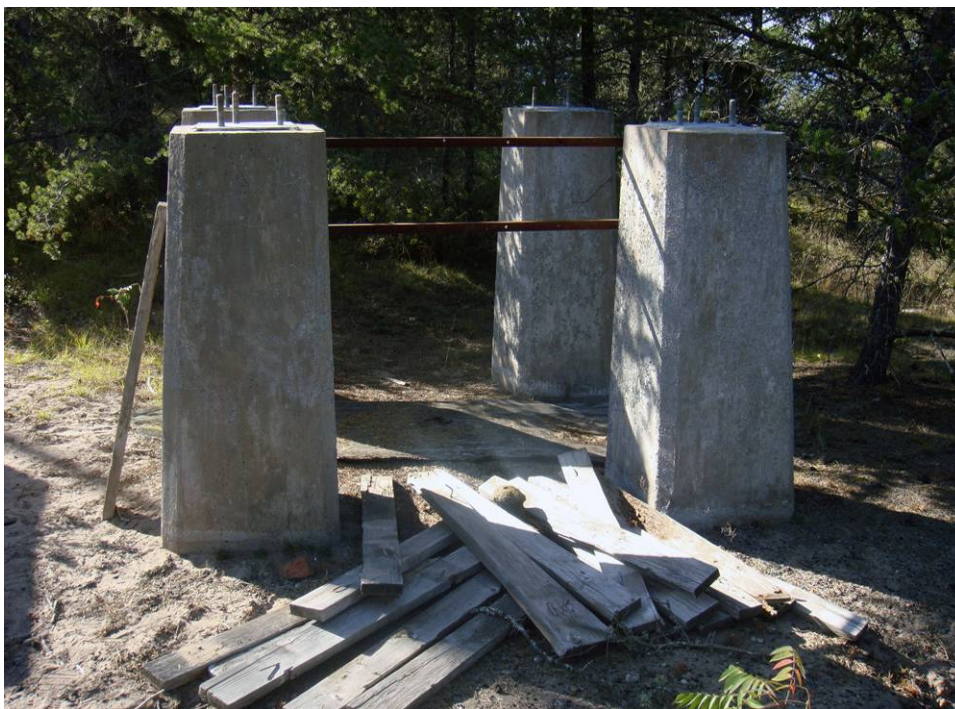
Site Image LI-53: Concrete footings (A) for nonextant steel frame radio tower northeast of LaPointe Light Tower, 2009 (Source: MBD P1020343.JPG)

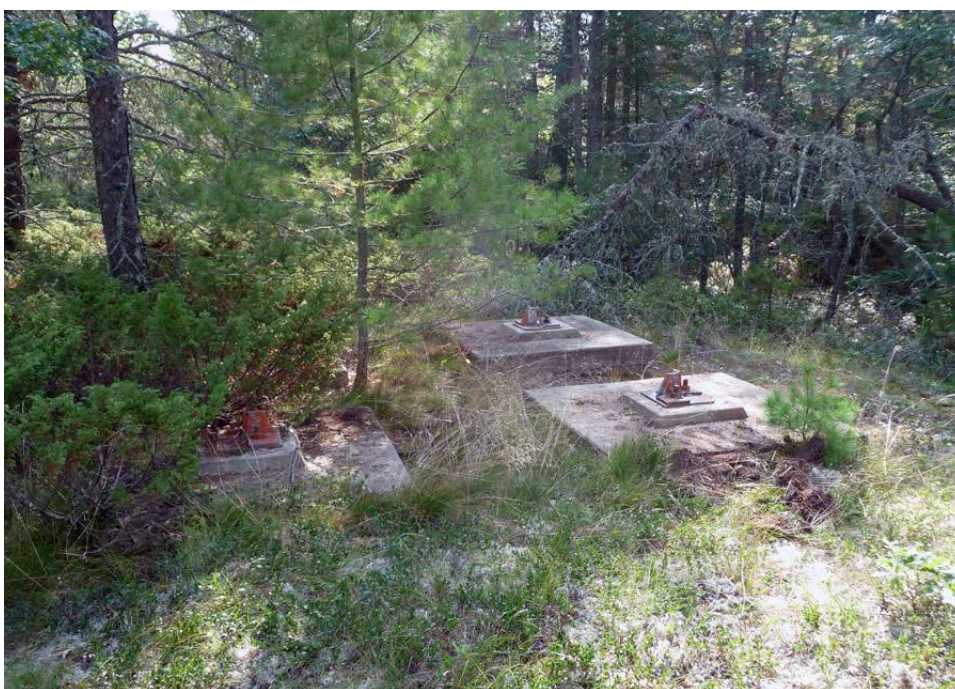
Site Image LI-54: Concrete footings (B) for nonextant radio beacon tower, 2009 (Source: MBD DSC01408.JPG)

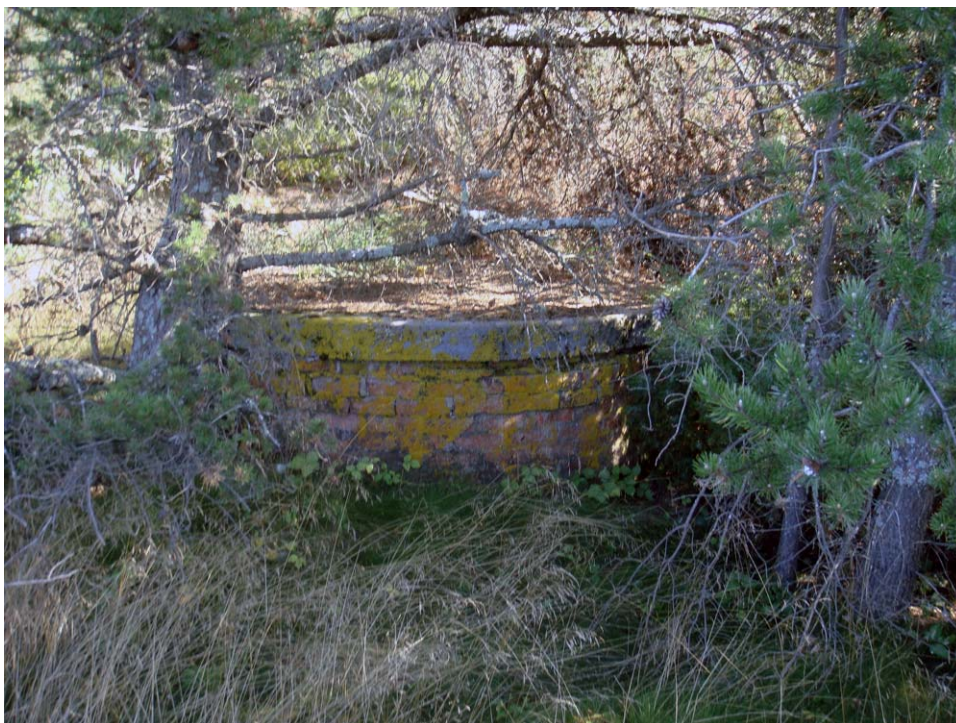
Site Image LI-55: Concrete and brick cistern, 2009 (Source: MBD DSC01401.JPG)

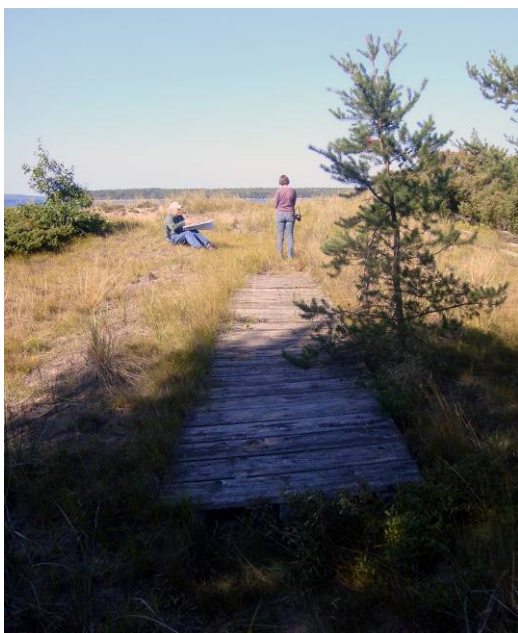
Site Image LI-56: Remnant of wooden boardwalk between Fog Signal Building foundation and water, 2009 (Source: MBD DSC01372.JPG)

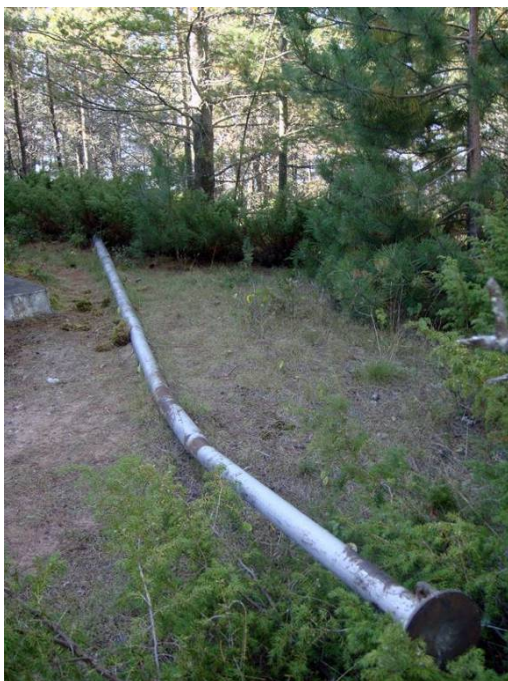
Site Image LI-57: Flagpole on north side of Triplex Building, 2009 (Source: MBD DSC01340.JPG)

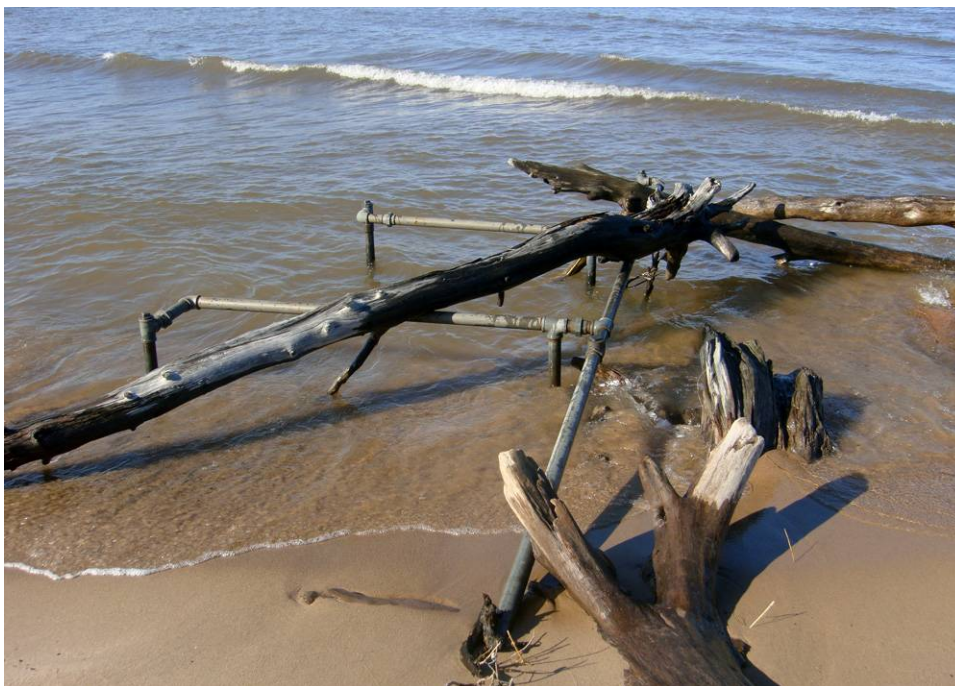
Site Image LI-59: Pipe crib at edge of water, 2009 (Source: MBD DSC01397.JPG)

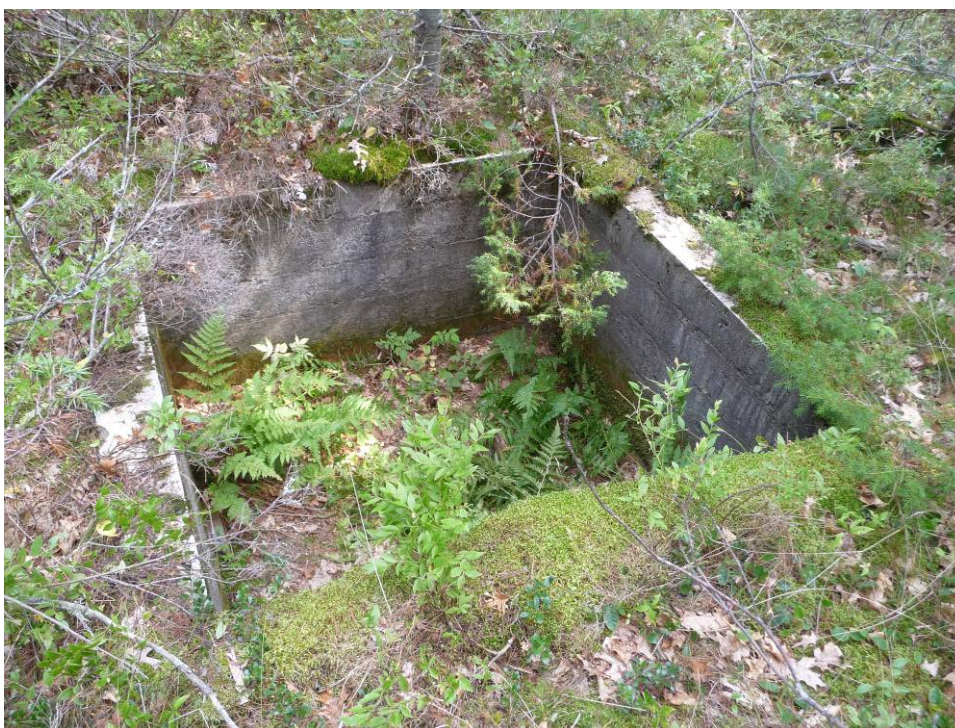
Site Image LI-60: Septic bed, 2009 (Source: MBD P1020344.JPG)

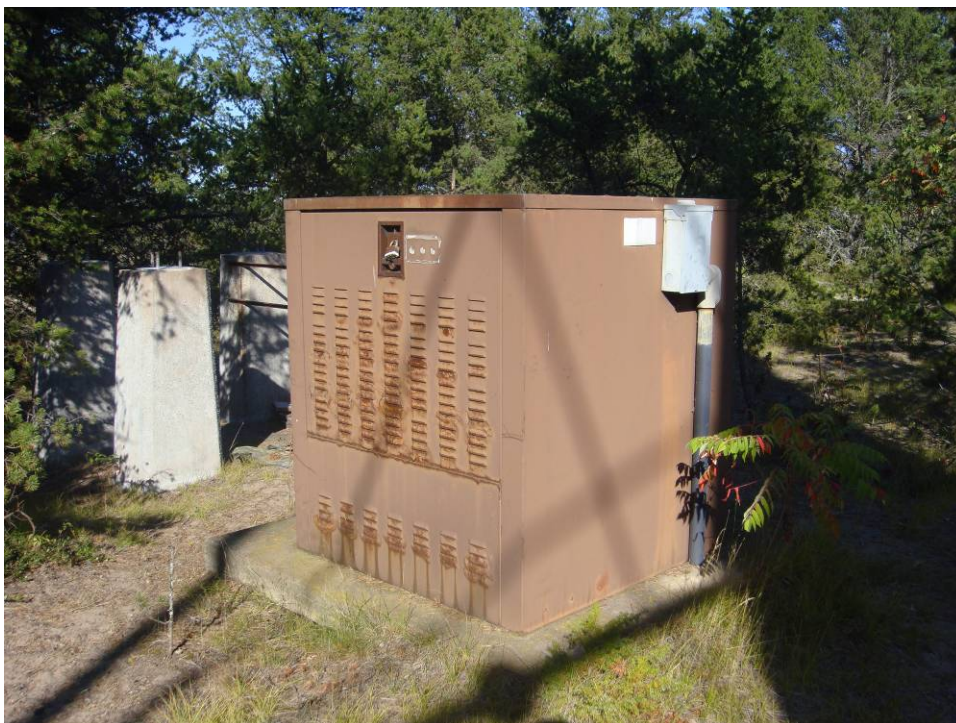
Site Image LI-61: Utility box, 2009 (Source: MBD DSC01411.JPG)

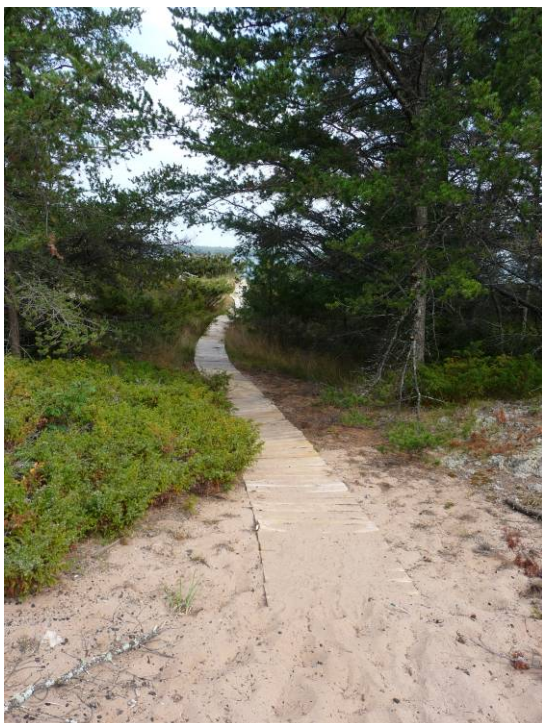
Site Image LI-62: Floating boardwalk, 2009 (Source: MBD P1020345.JPG)

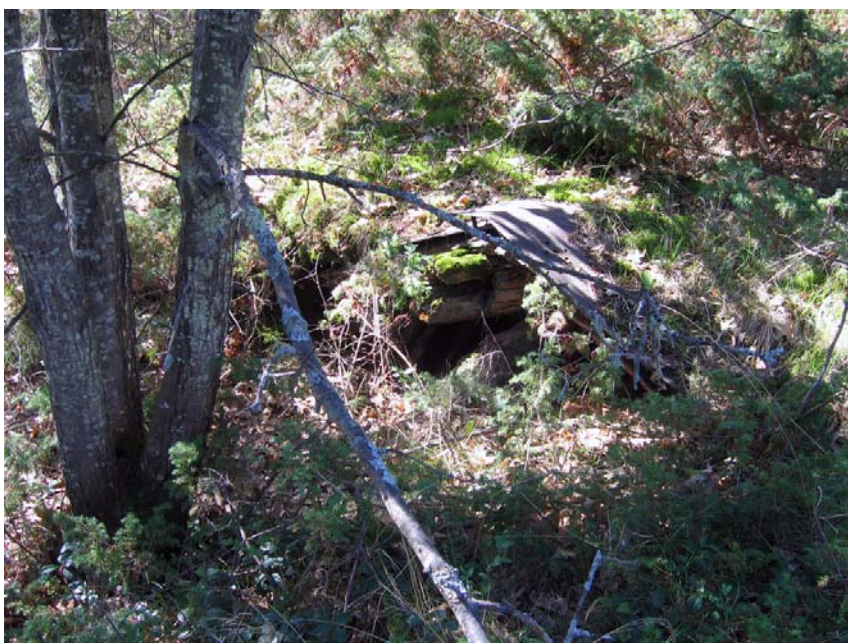
| Feature | Site Image # | Description | Condition | Contributing? /Rationale |
|---|---|---|---|---|
| Root Cellar (1891 – 1938) | LI-64 | Buried root cellar with exposed roofing and framing | Poor | Contributing; see text |

Site Image LI-64: Root cellar east of Original LaPointe Lighthouse ruin, 2009 (Source: MBD IMG_9424.JPG)

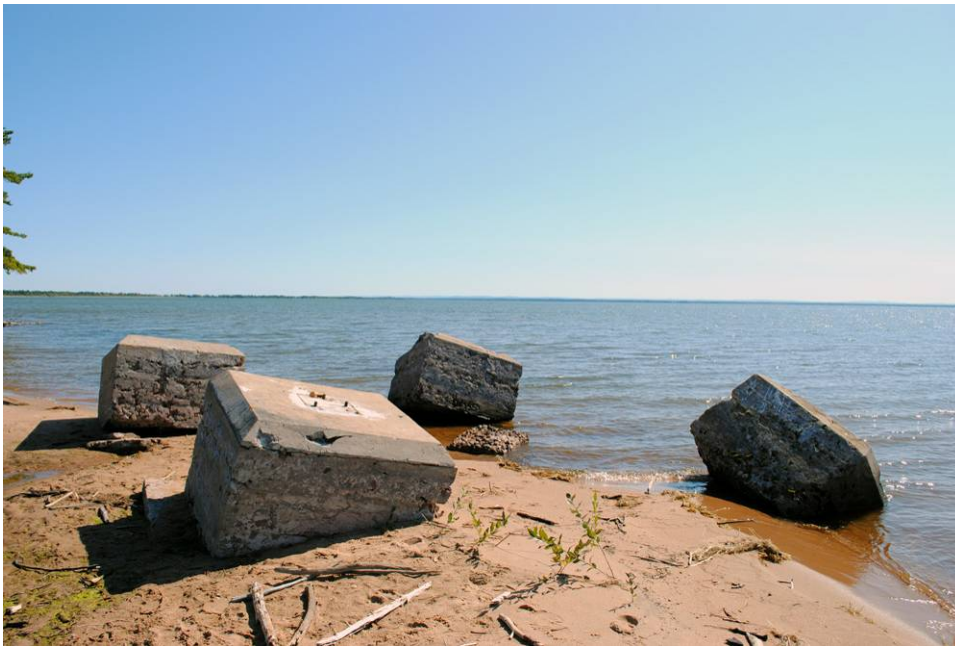
Site Image LI-66: Concrete footings remain from the former location of the Chequamegon Point Light Tower, 2009 (Source: MBD DSC_0021.JPG)

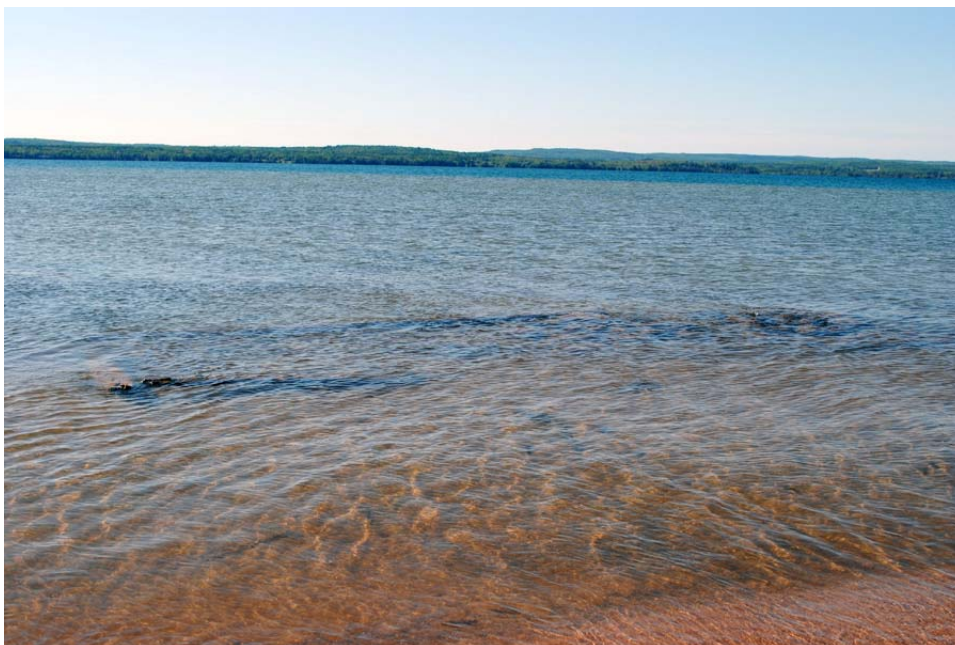
Site Image LI-67: Rubble landing crib remnants at Chequamegon Point, 2009 (Source: MBD DSC_0049.JPG)

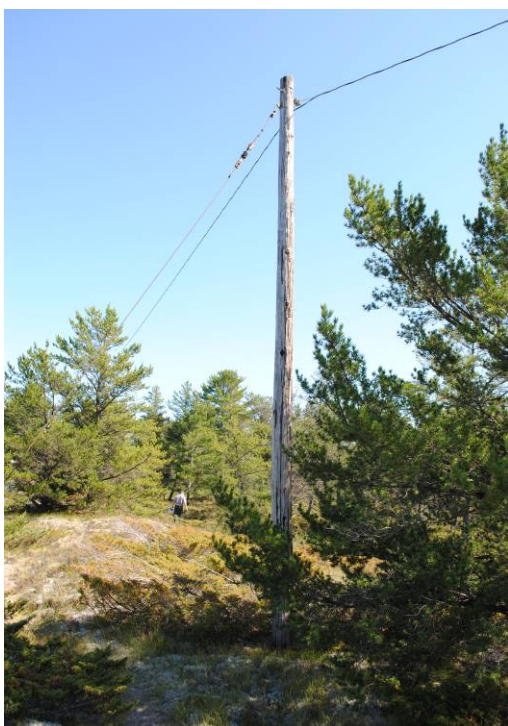
Site Image LI-68: Typical power pole for electric line, 2009 (Source: MBD DSC_0088.JPG)

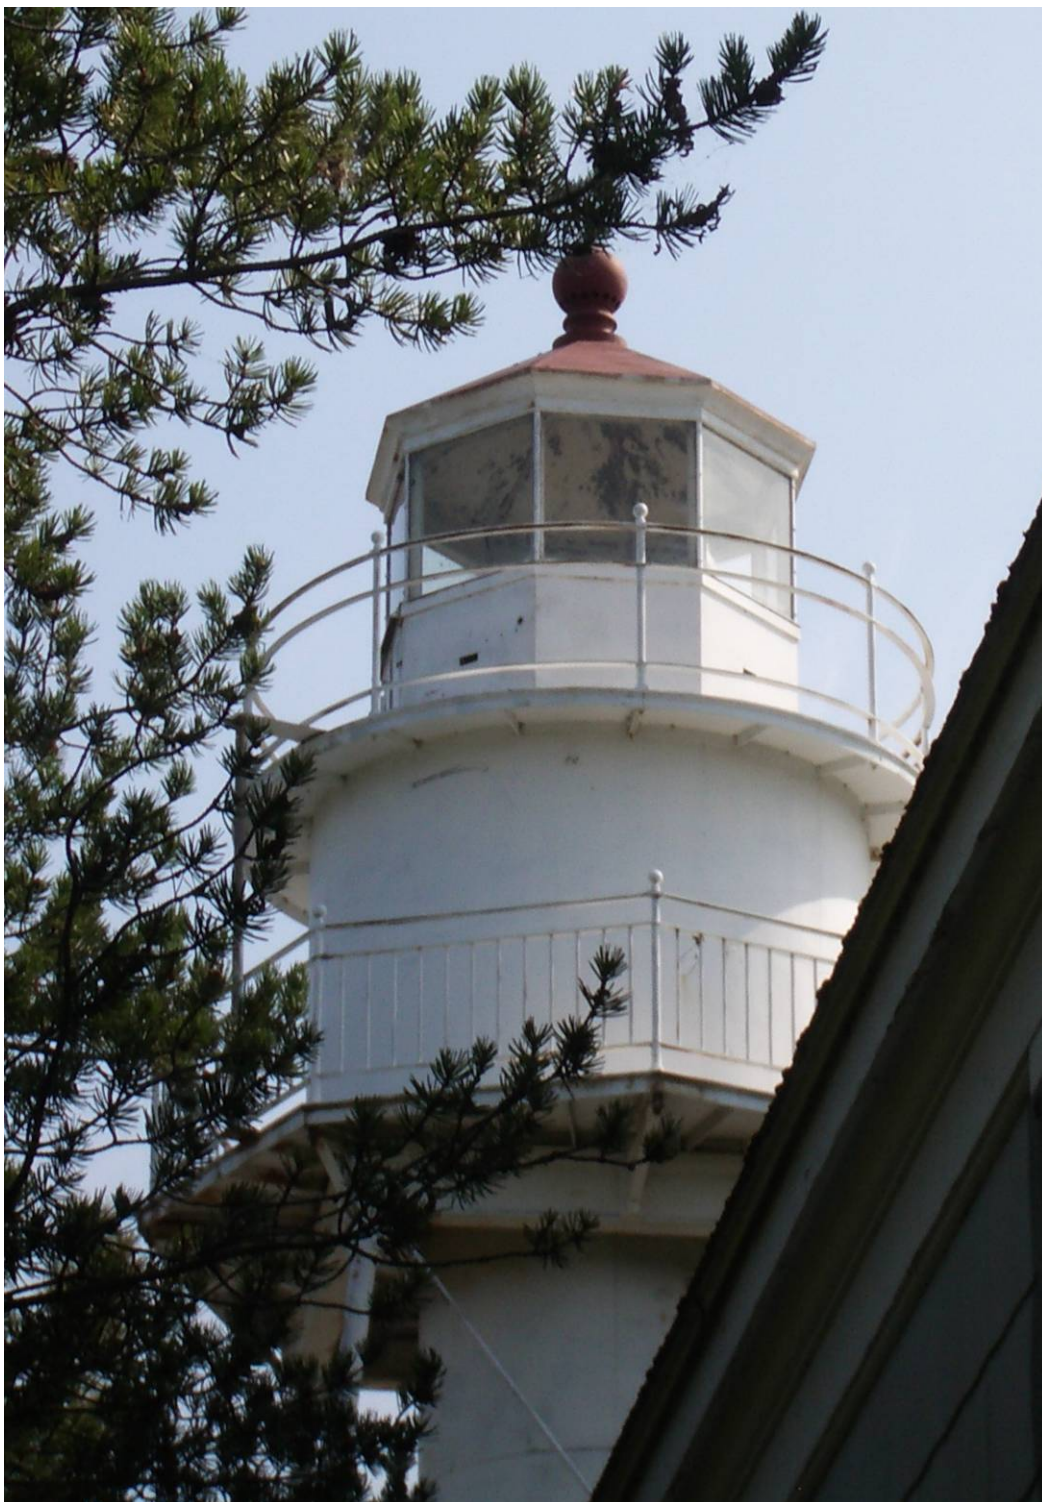
LI-LT-02: Lantern, 2009 (Source: AH IMGP3005)

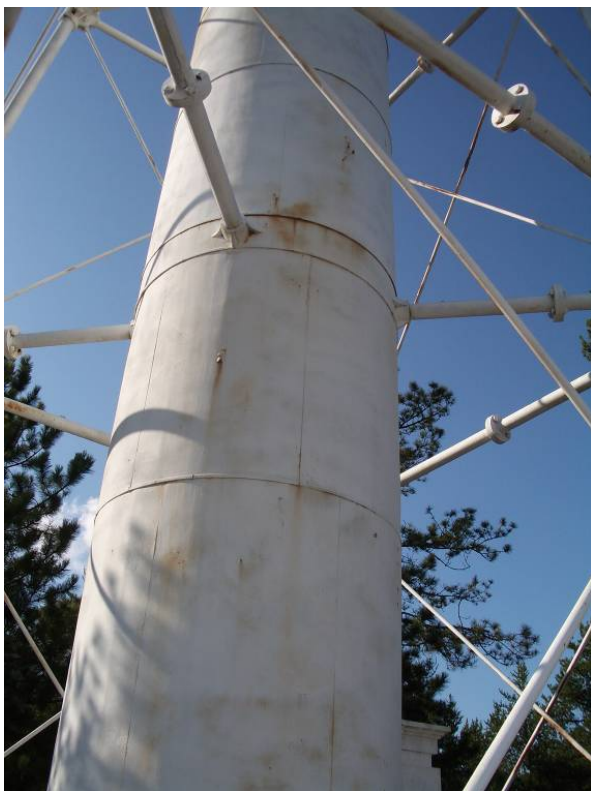
LI-LT-03: Exterior structure detail (Source: AH IMGP3026)

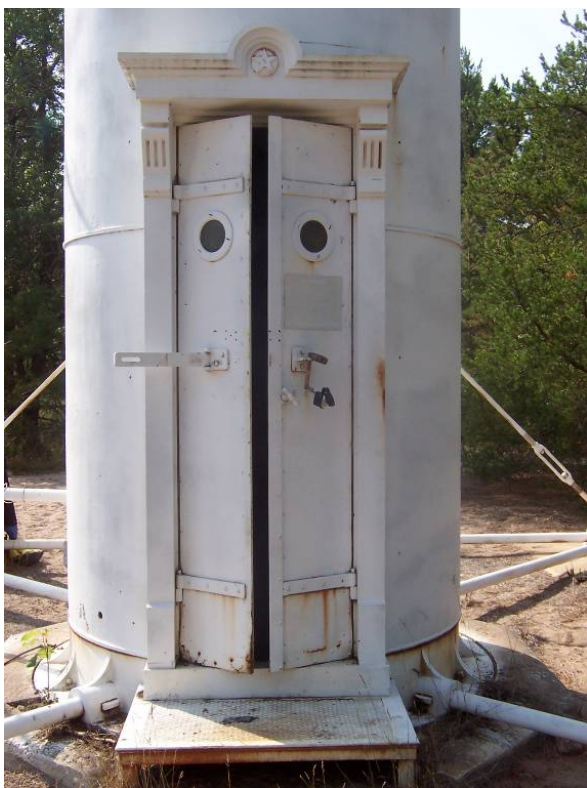
LI-LT-04: North entry door (Source: AH 100_9810)

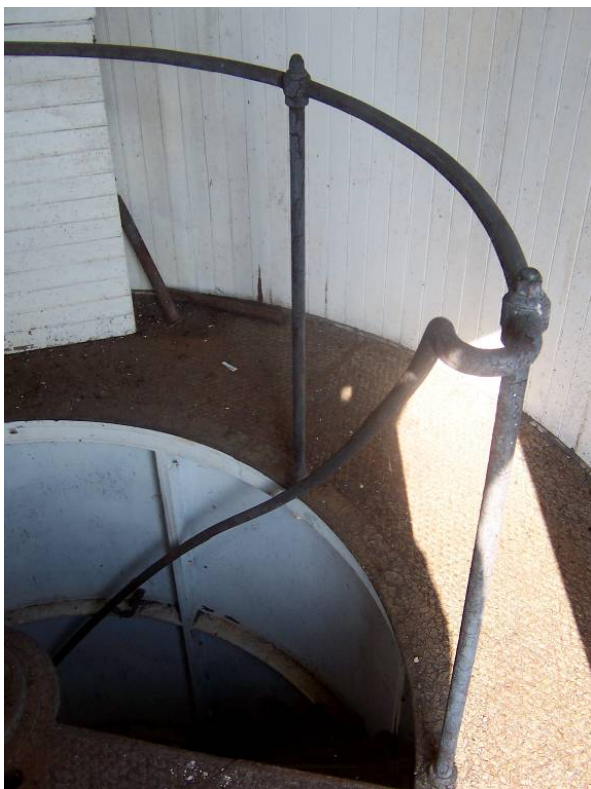
LI-LT-07: Watch room interior walkway and railing (Source: AH 100_9807)

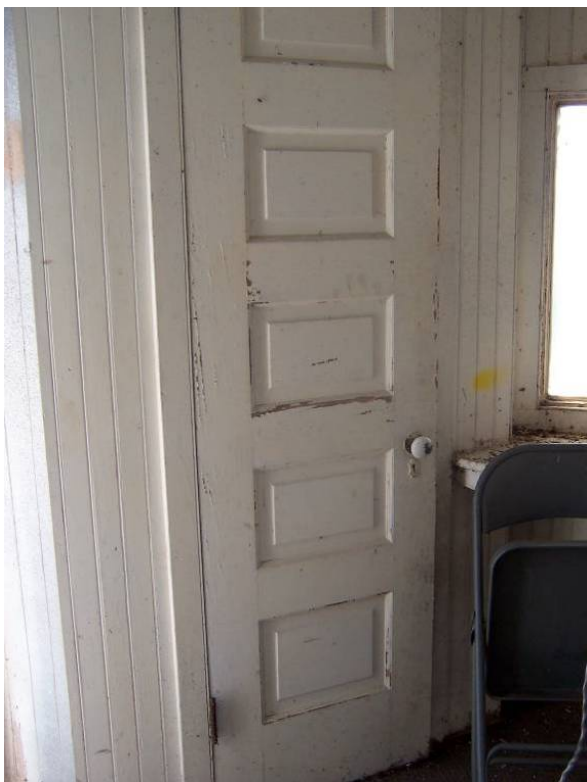
LI-LT-08: Watch room storage door (Source: AH 100_9806)

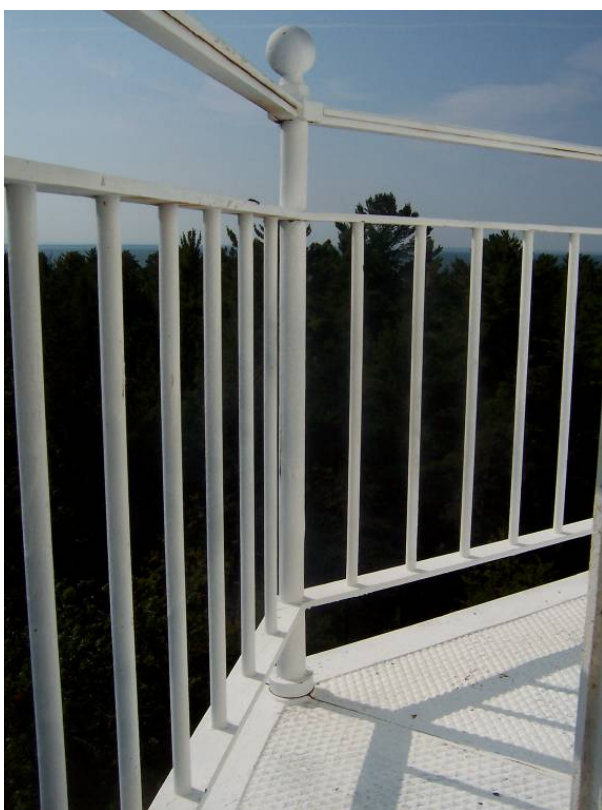
LI-LT-10: Watch walk walkway and railing (Source: AH 100_9804)

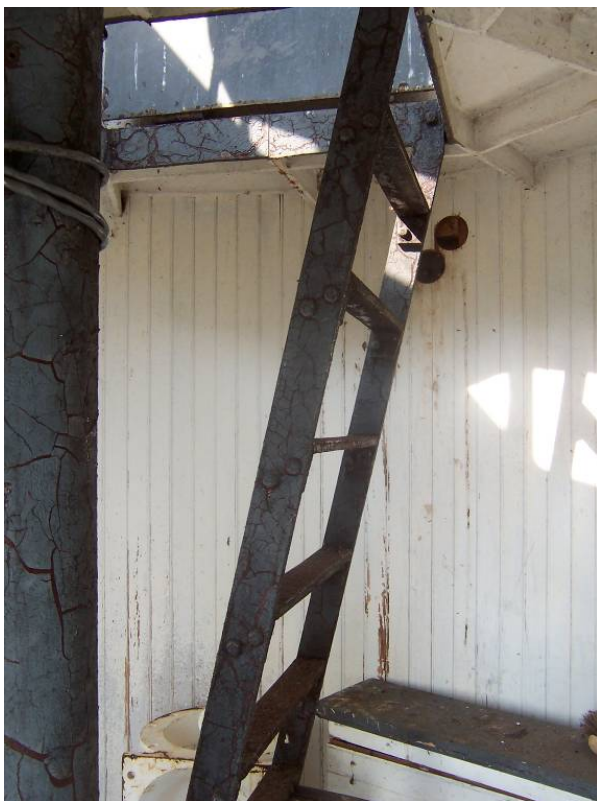
LI-LT-11: Watch room interior ladder to lantern (Source: AH 100_9805)
