VOLUME V OF VI: LONG ISLAND CLR/HSR

**APOSTLE ISLANDS NATIONAL LAKESHORE
LIGHT STATIONS OF MICHIGAN ISLAND, OUTER ISLAND, DEVILS ISLAND,
LONG ISLAND AND SAND ISLAND**

**CULTURAL LANDSCAPE REPORT, HISTORIC STRUCTURE REPORT
AND
ENVIRONMENTAL ASSESSMENT**

prepared by
Anderson Hallas Architects, PC
Golden, Colorado

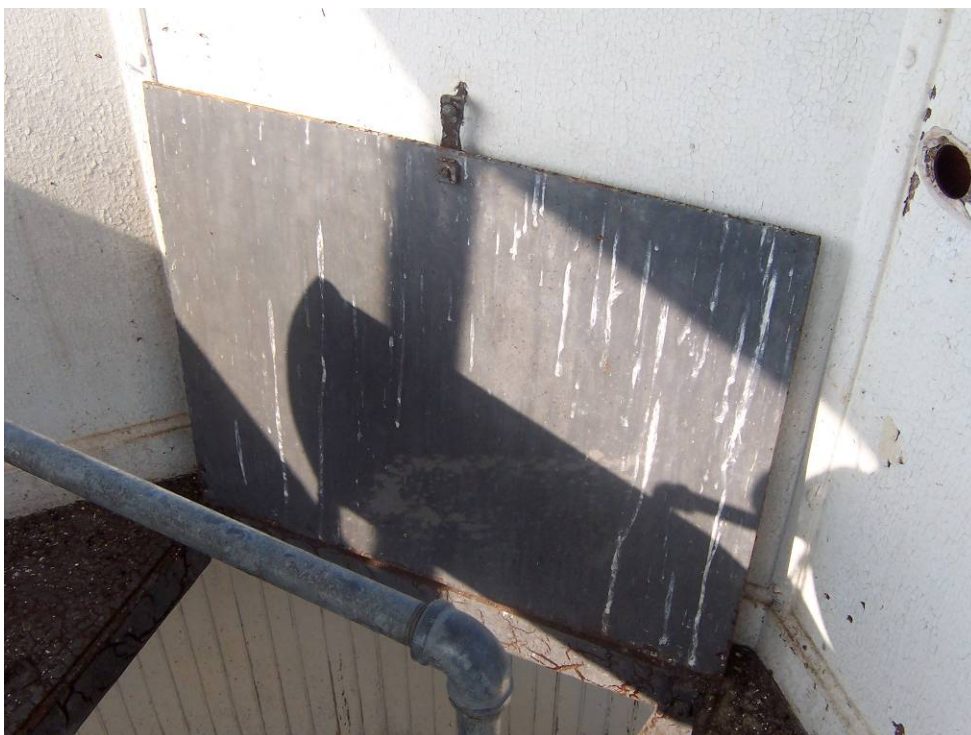
LI-LT-12: Lantern hatch (Source: AH 100_9801)

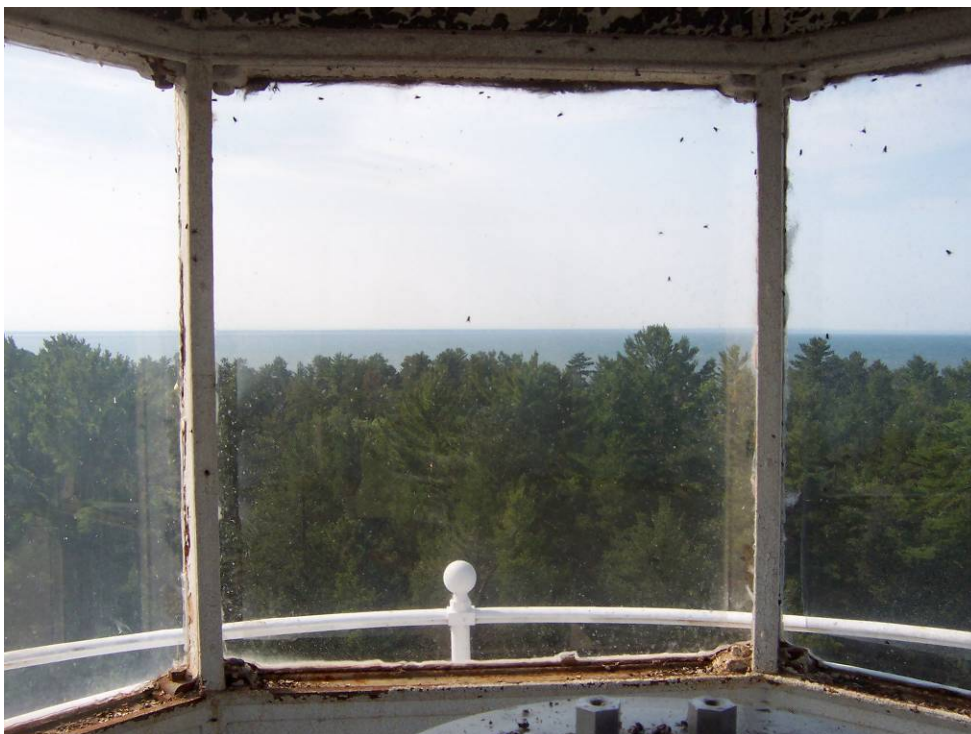
LI-LT-13: Lantern glazing (Source: AH 100_9800)

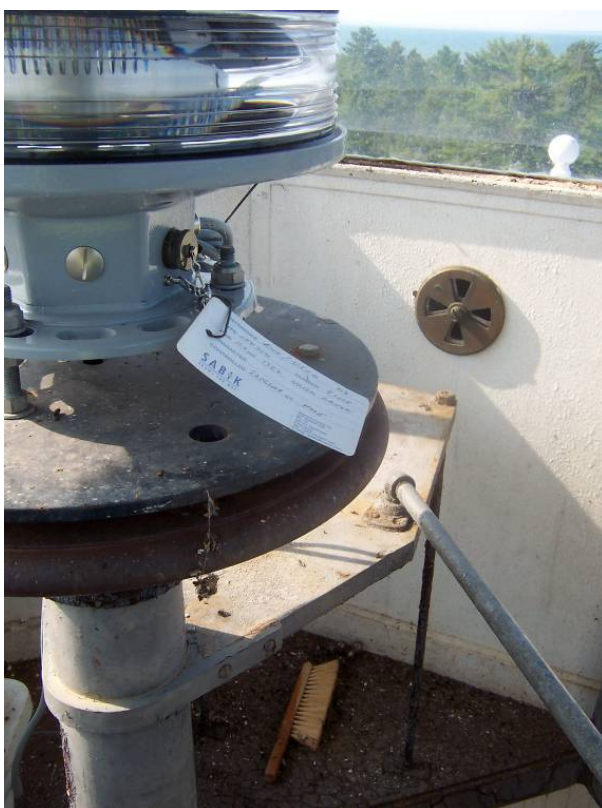
LI-LT-14: Lantern detail and vent (Source: AH 100_9799)

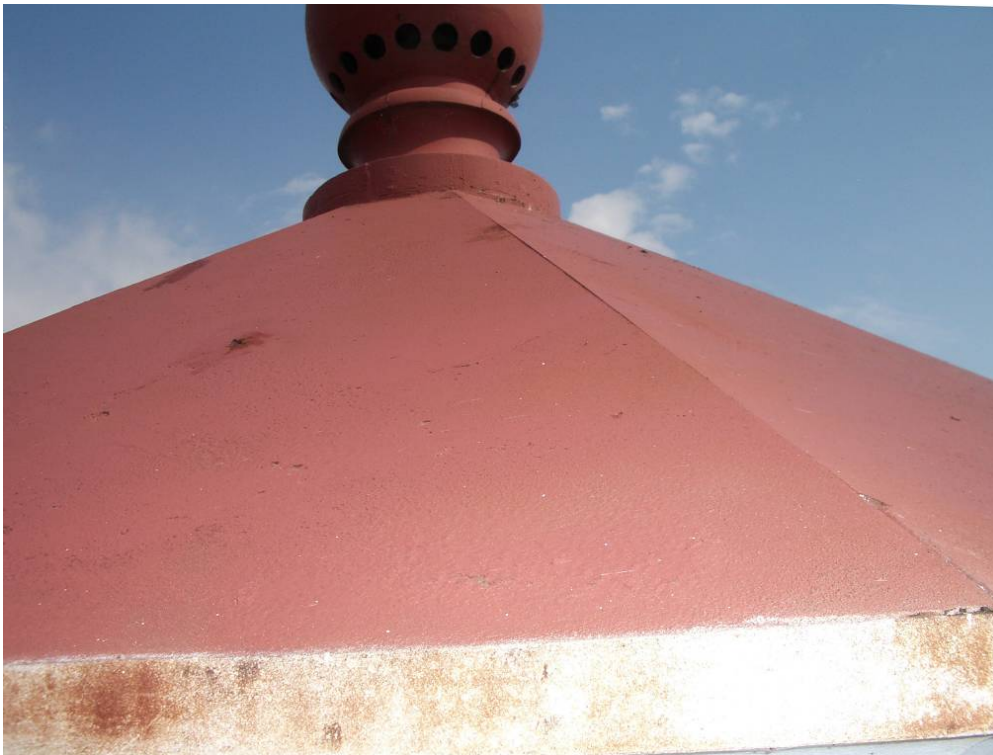
LI-LT-16: Lantern roof (Source: AH IMGP2997-A)

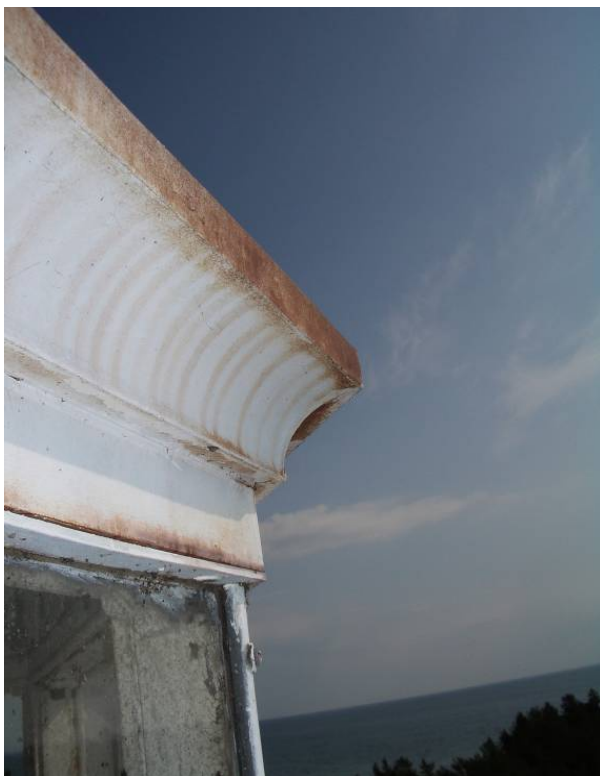
LI-LT-17: Lantern level roof trim and glazing detail (Source: AH IMGP2996)

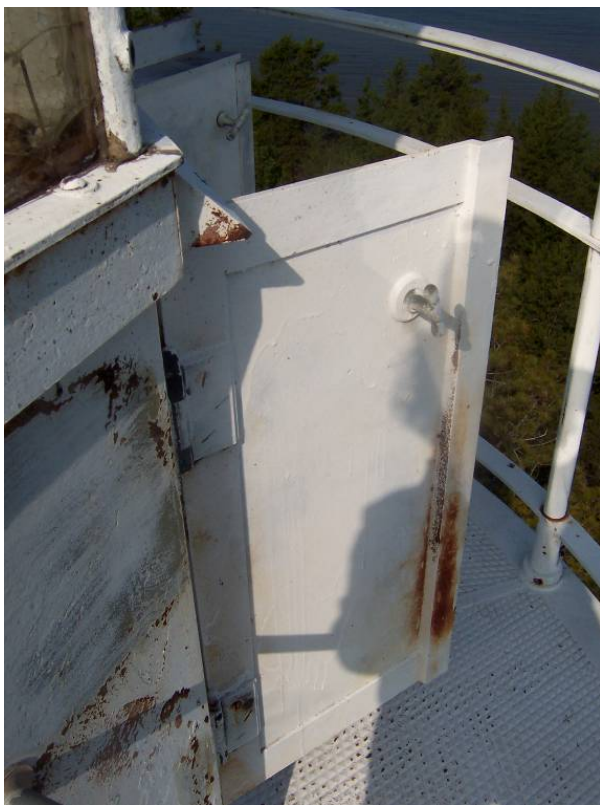
LI-LT-18: Lantern level door, walkway and railing (Source: AH 100_9796)

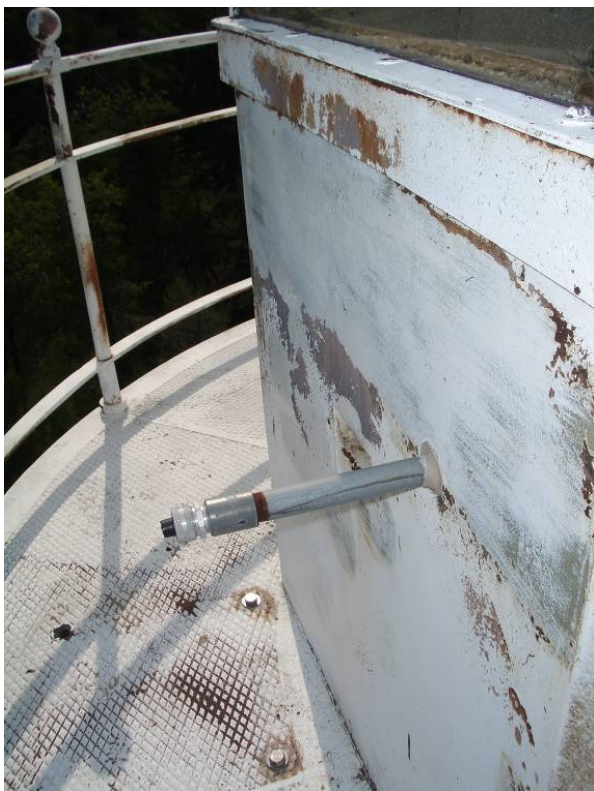
LI-LT-19: Lantern level walkway and railing (Source: AH IMGP2993)

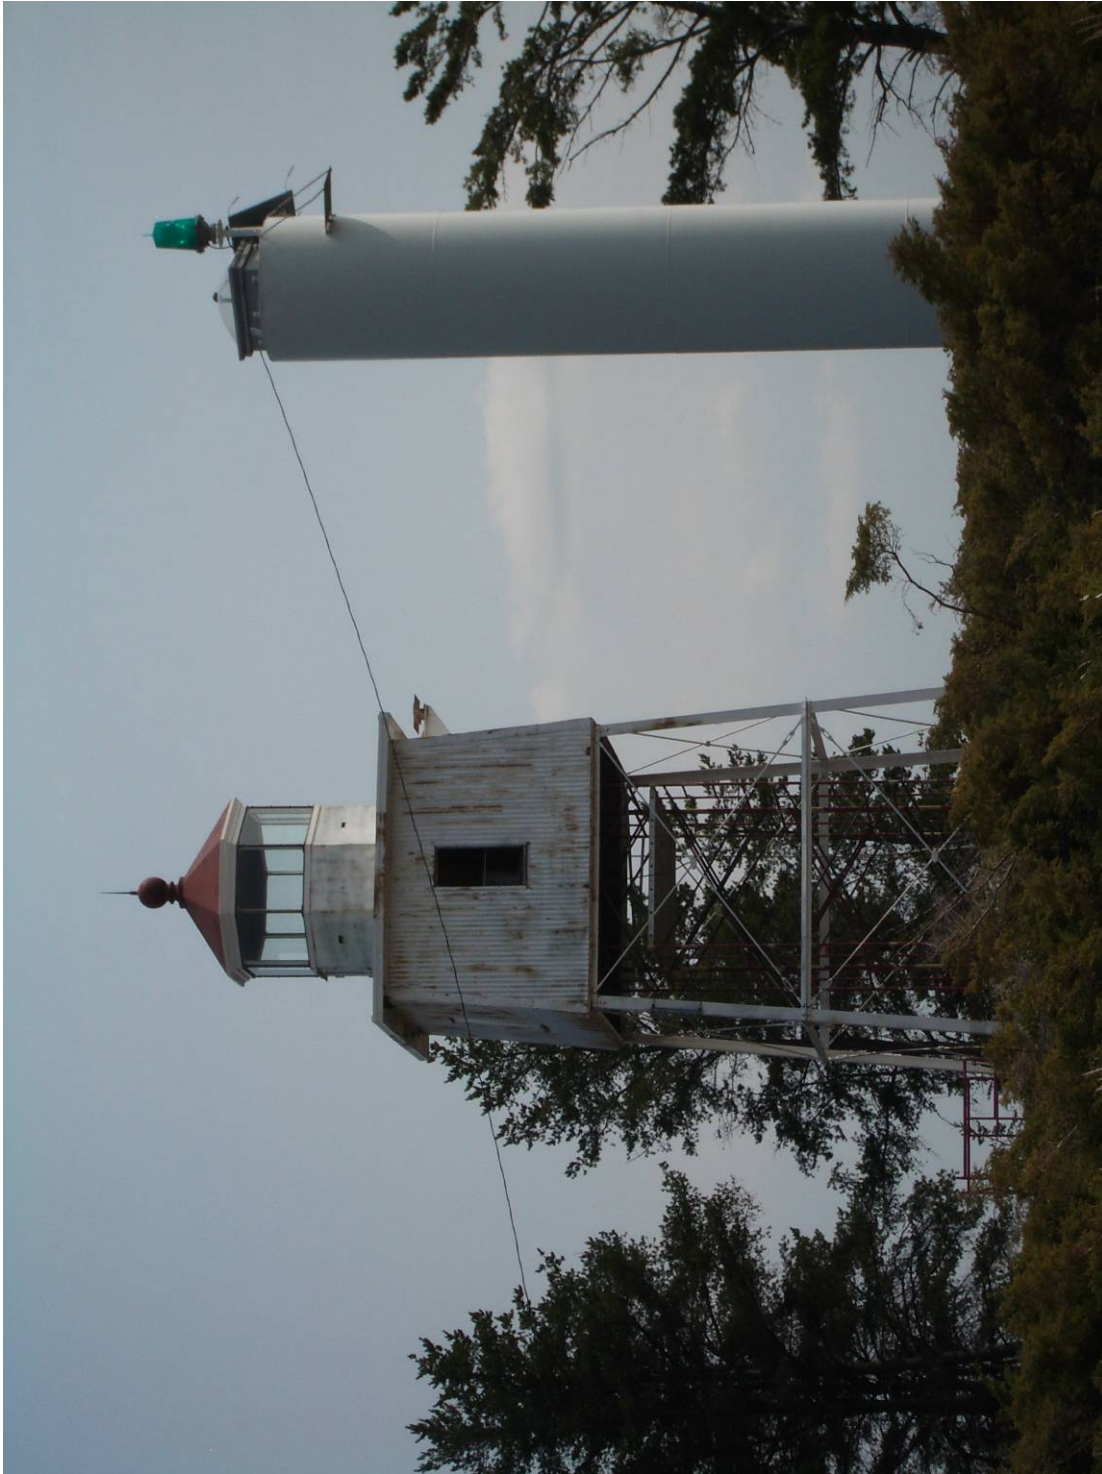
LI-CLS-01: View of Tower, 2009 (Source: AH IMG3013)

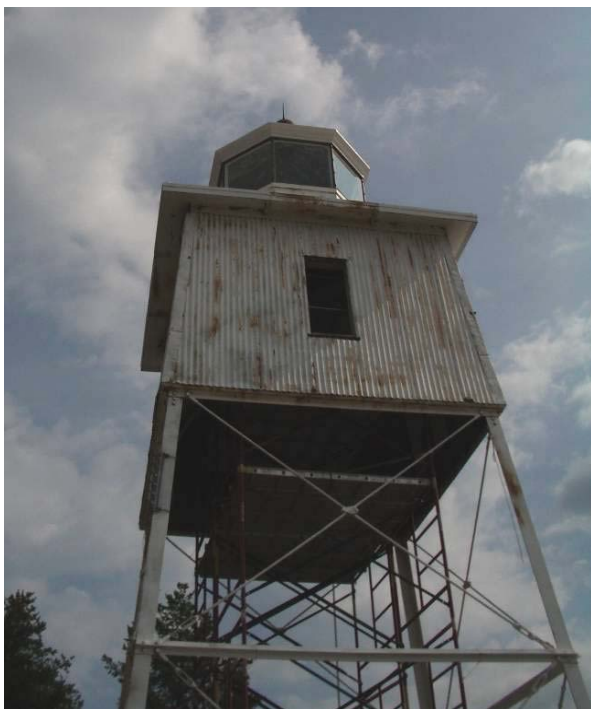
LI-CLS-02: Service level, scaffolding and lantern (Source: AH IMGP3014)

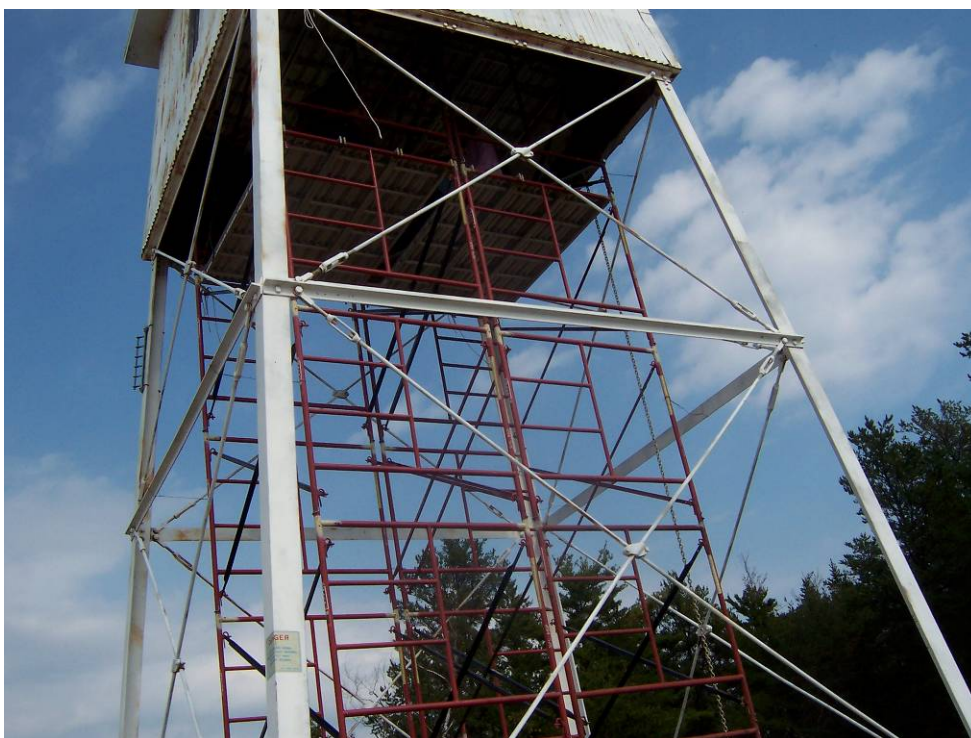
LI-CLS-03: Tower's 2009 scaffolding system (Source: AH 100_9826)

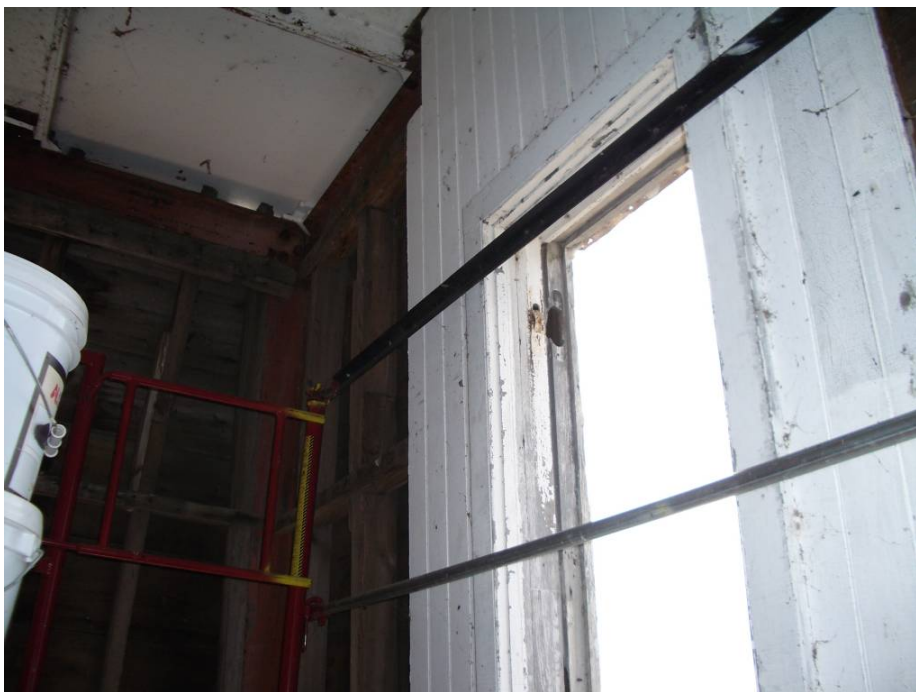
LI-CLS-04: Service level window 1 and beadboard wall finish (Source: AH IMGP3020)

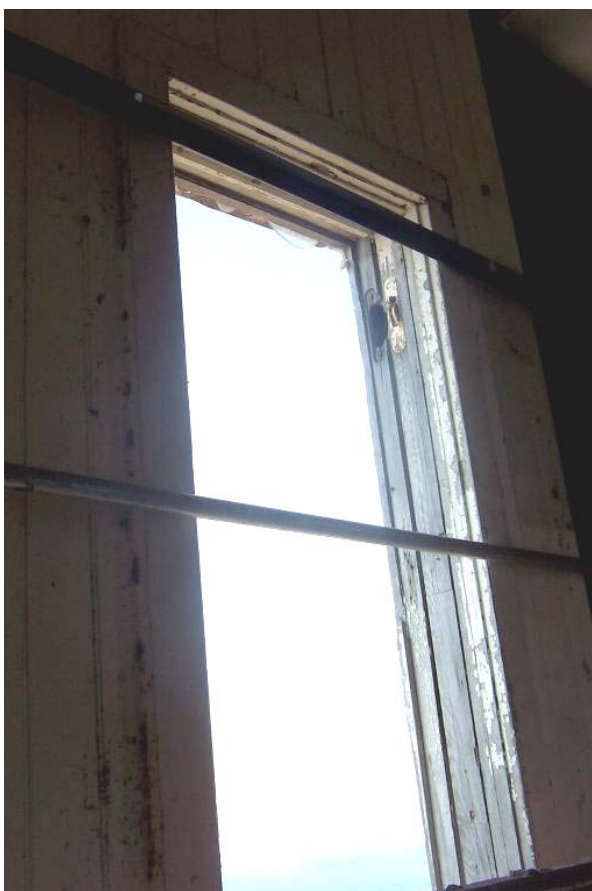
LI-CLS-05: Window 2, interior (Source: AH 100_9822)

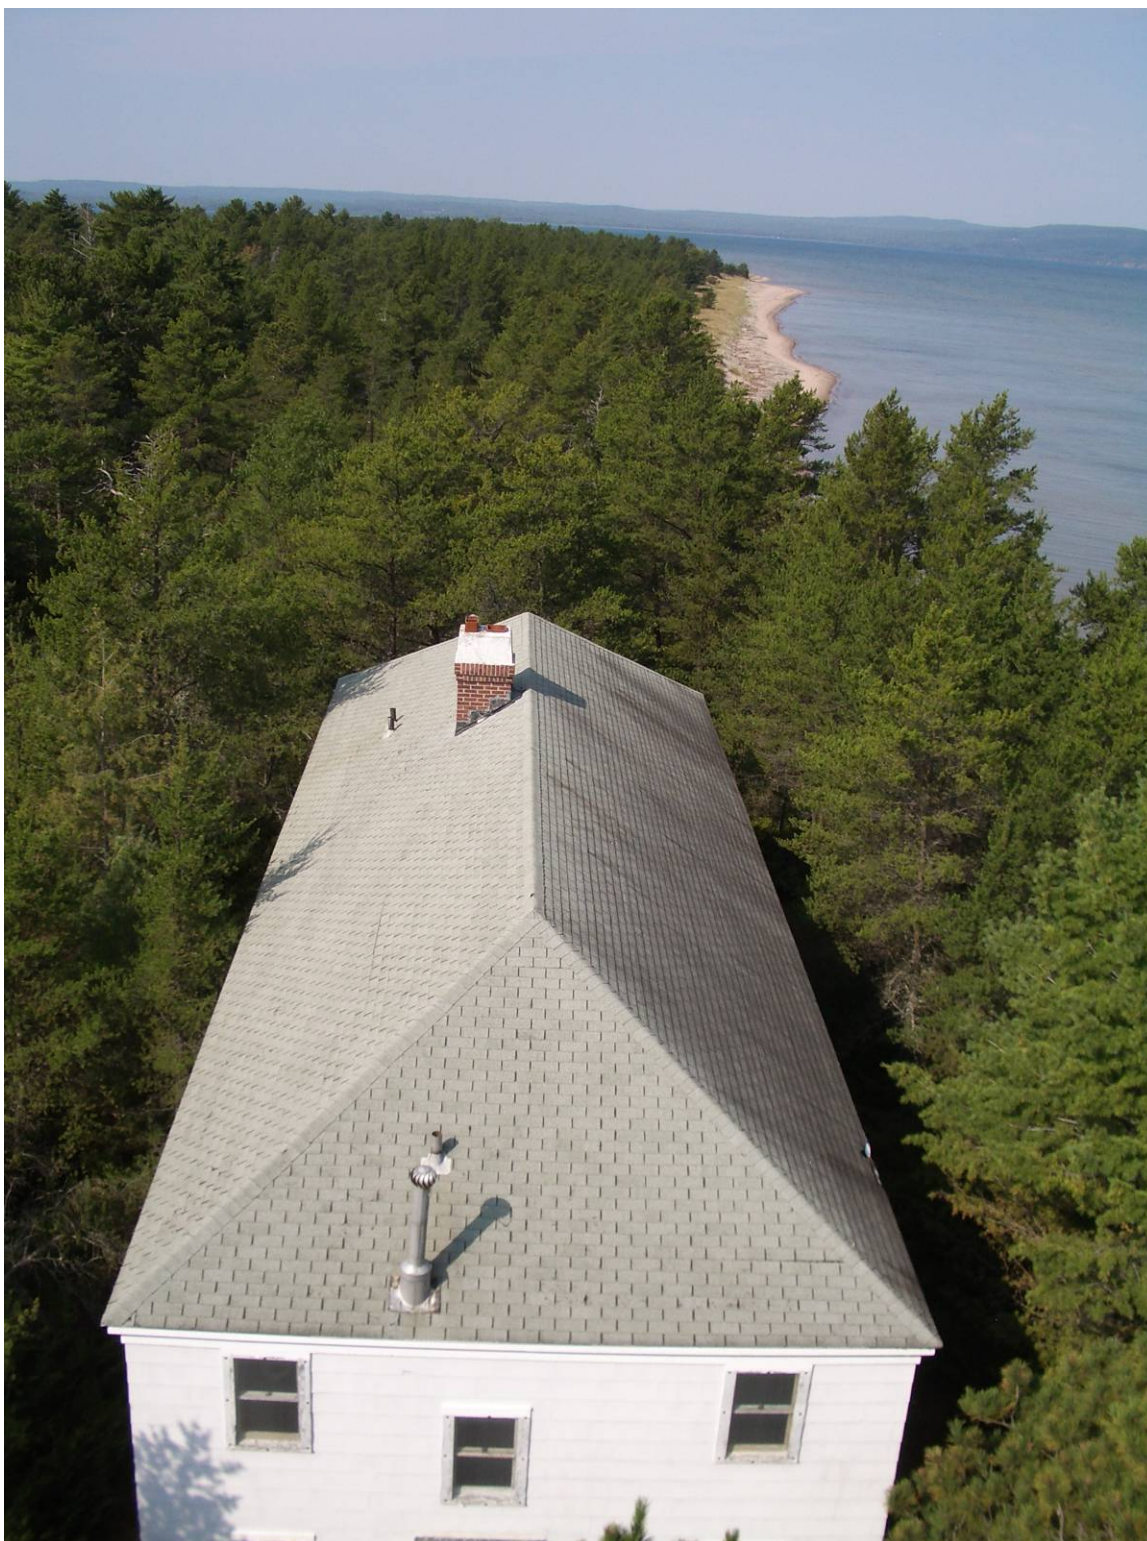
LI-TX-01: Aerial from LaPointe Tower, west view, 2009 (Source: AH IMGP2985)

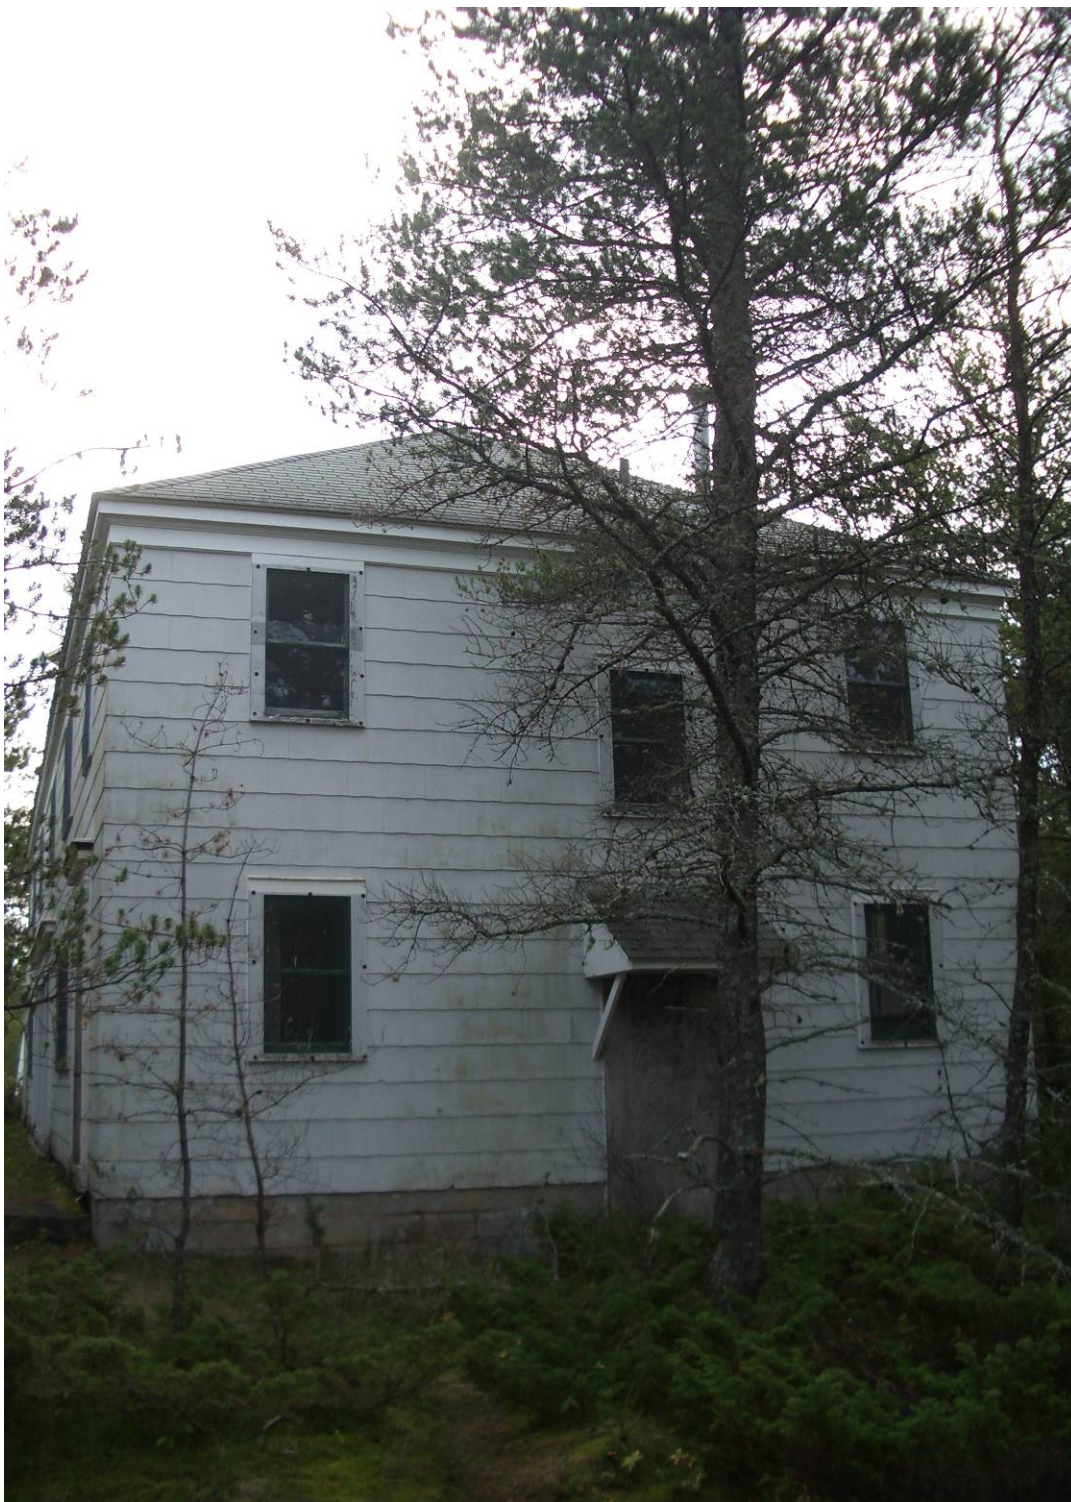
LI-TX-02: West elevation, 2009 (Source: AH IMGP2956)

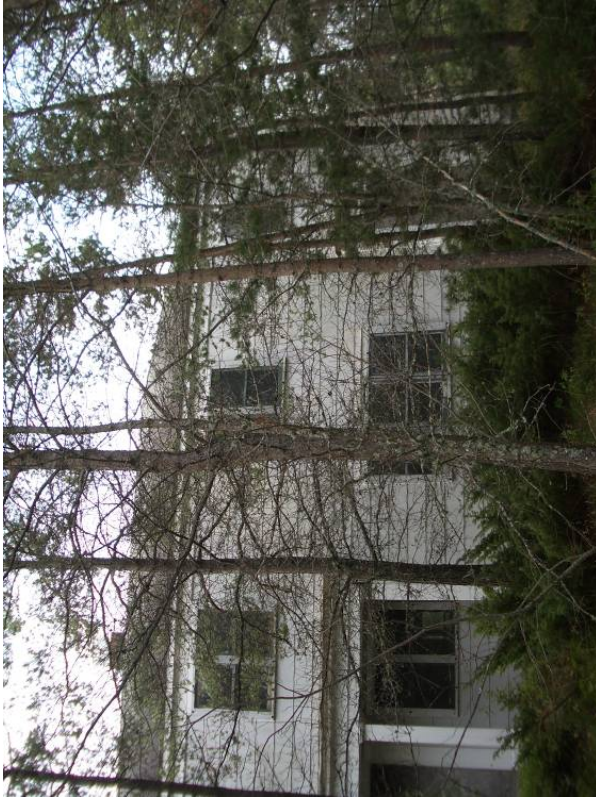
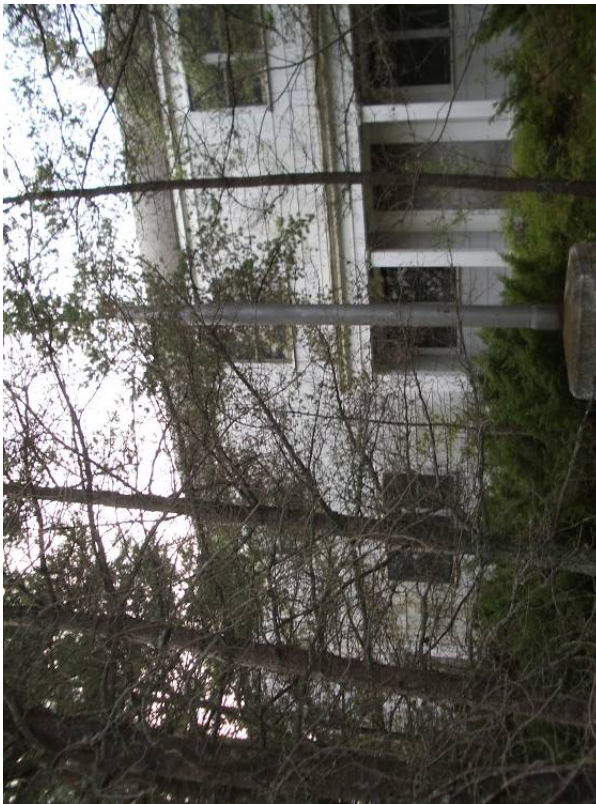
LI-TX-03 and 04: North elevation, 2009 (Source: AH IMG2959 and IMG2958)

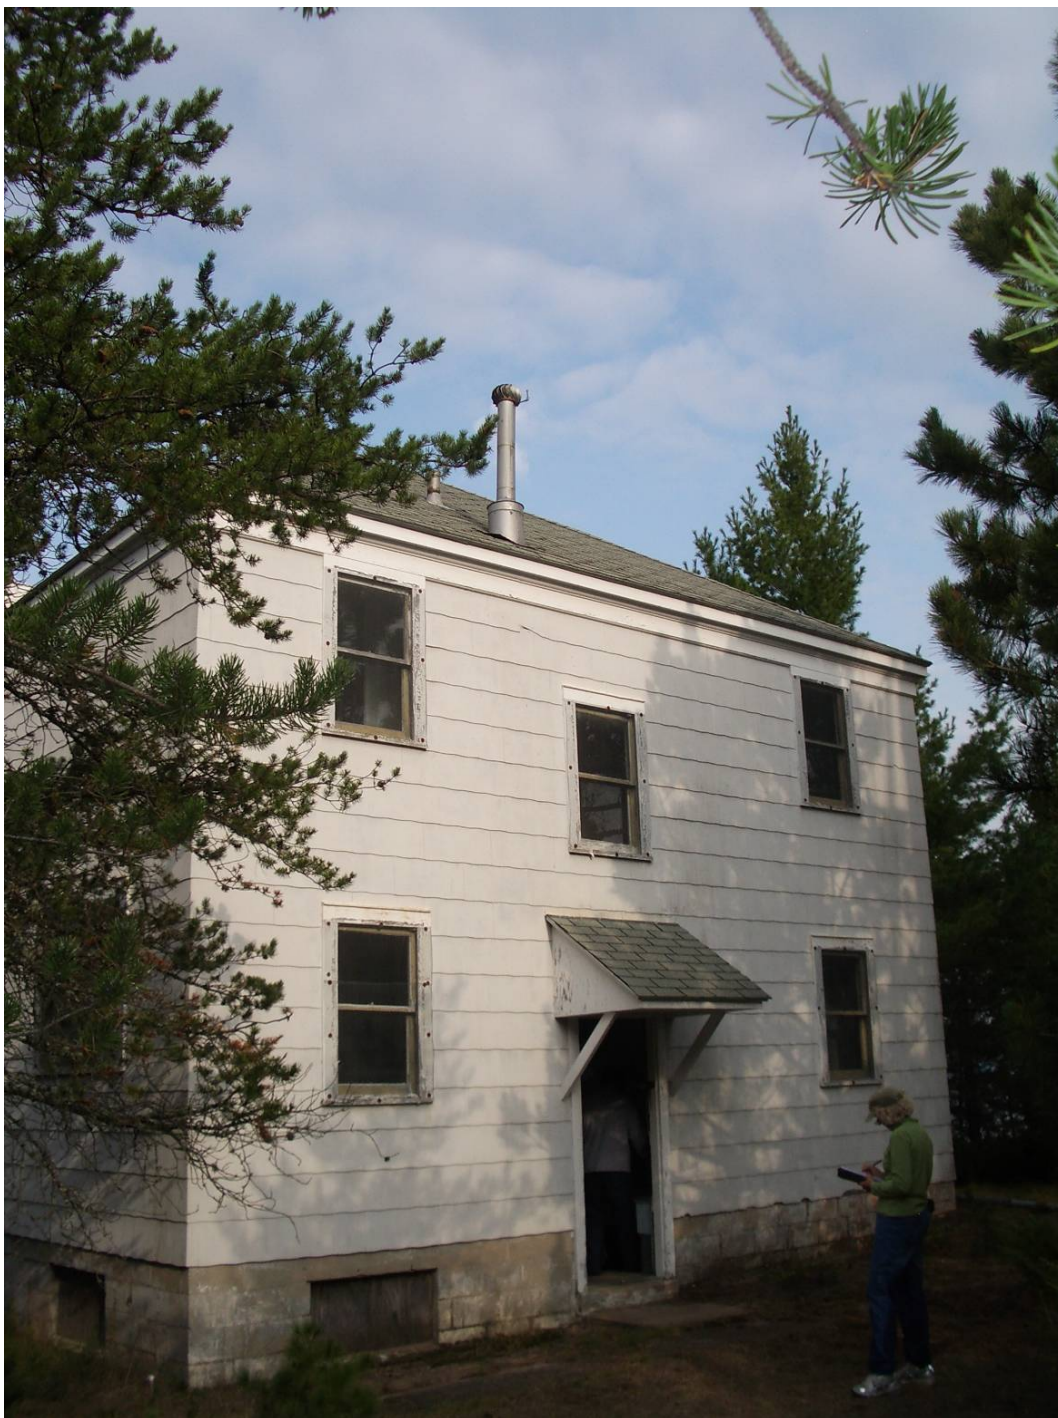
LI-TX-05: East elevation, 2009 (Source: AH IMGP2966)

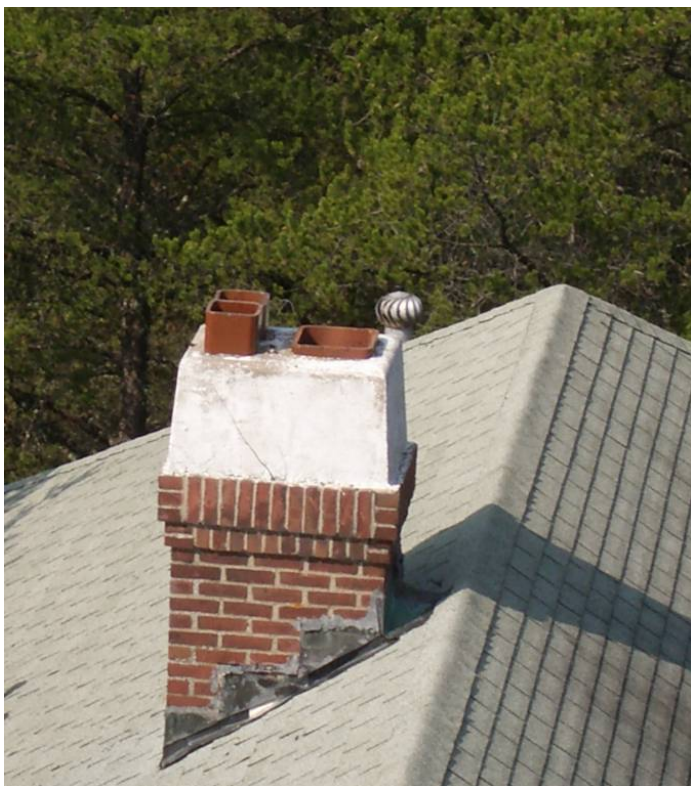
LI-TX-06: Chimney, east elevation (Source: AH IMGP2986)

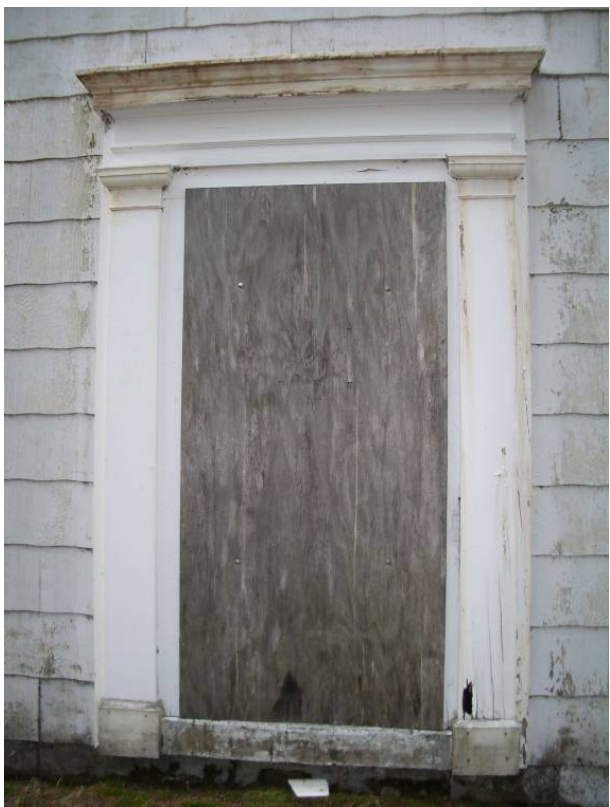
LI-TX-08: East unit's main entry door (Source: AH IMGP2976)

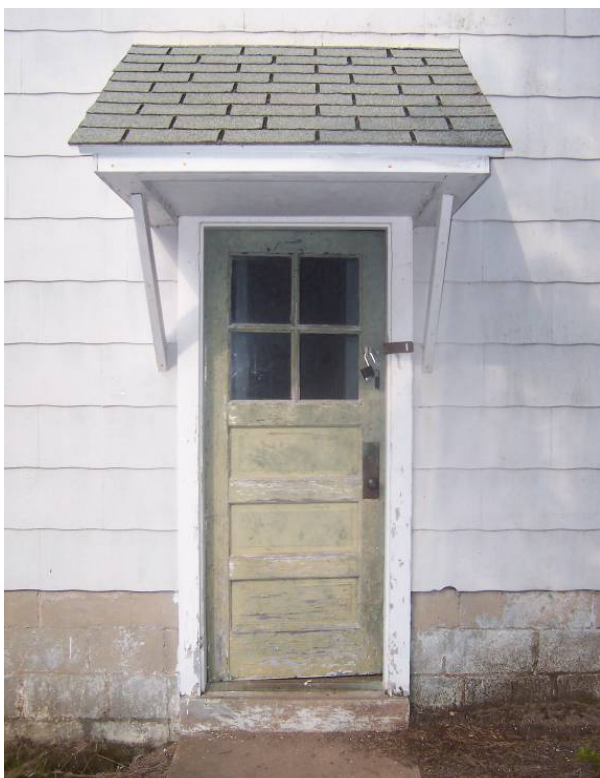
LI-TX-09: East unit's kitchen entry door and overhang (Source: AH 100_9784)

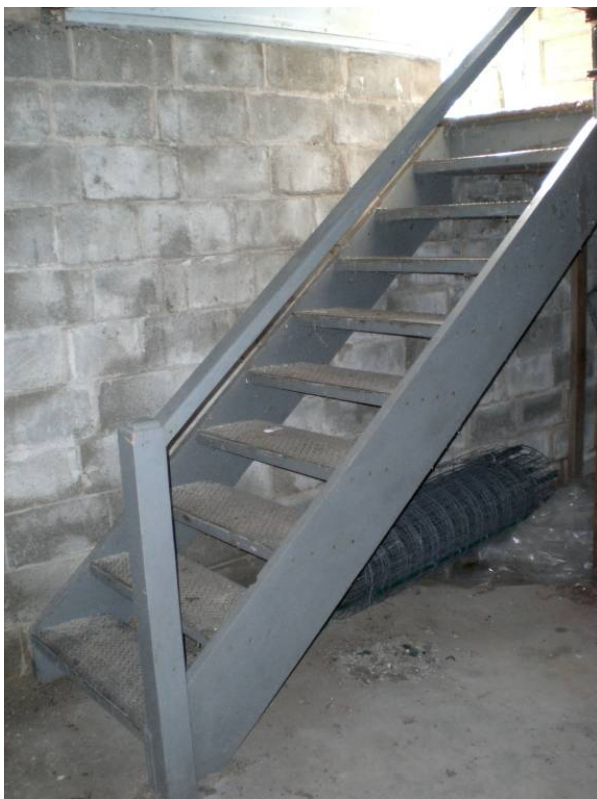
LI-TX-10: East unit's basement stair (Source: AH CIMG4073)

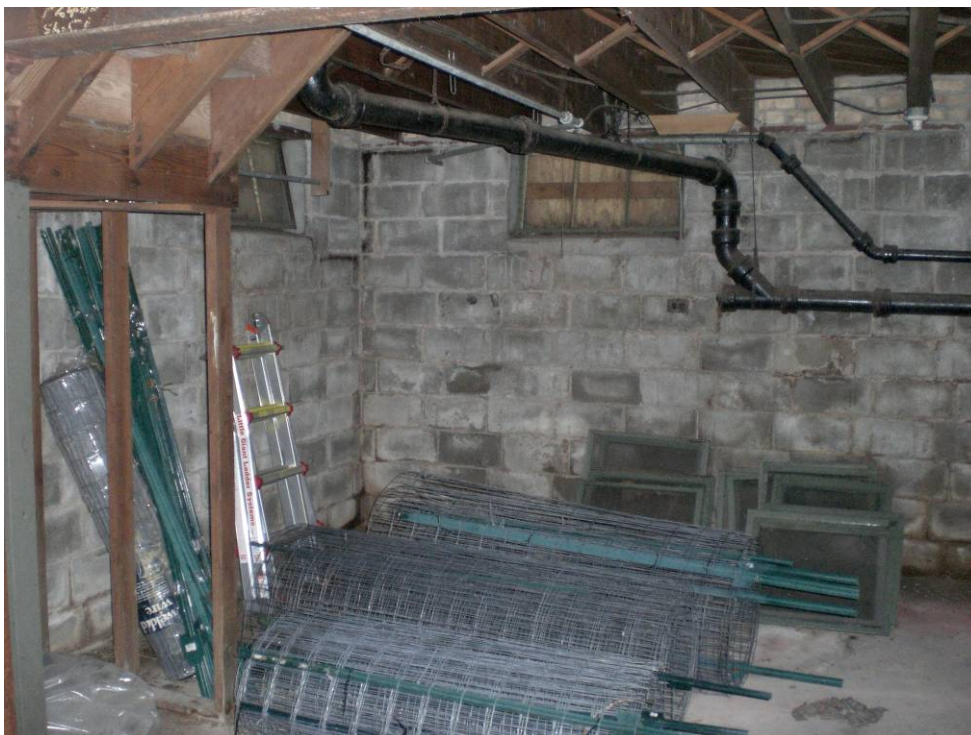
LI-TX-11: East unit's basement, north elevation (Source: AH CIMG4074)

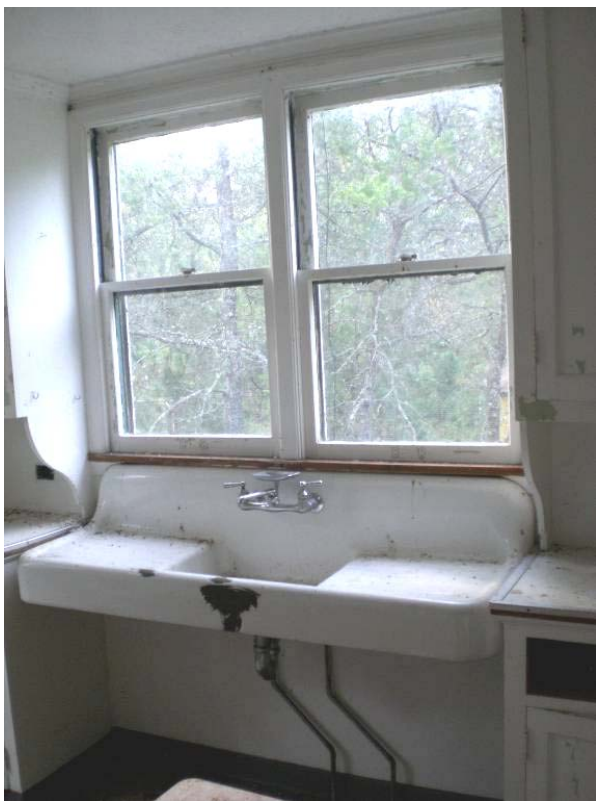
LI-TX-12: East unit's kitchen, north elevation (Source: AH CIMG3962)

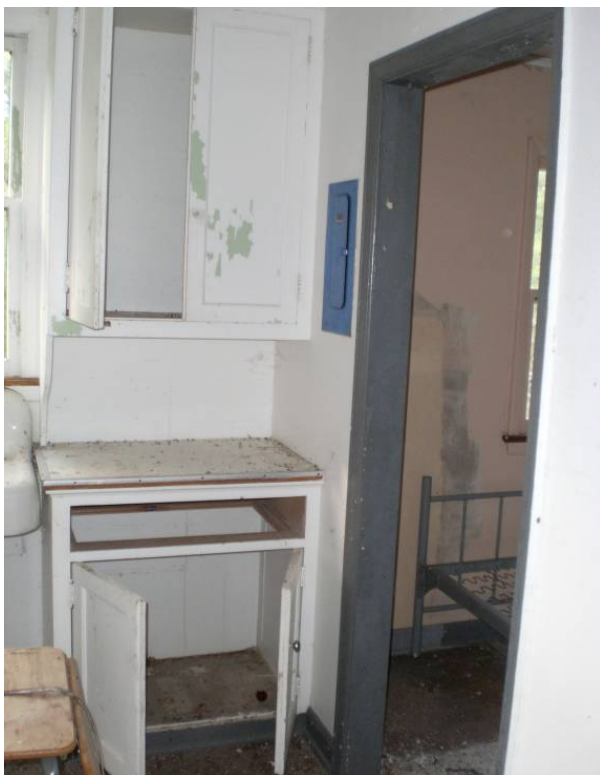
LI-TX-13: East unit's kitchen cabinetry, looking northwest (Source: AH CIMG3972)

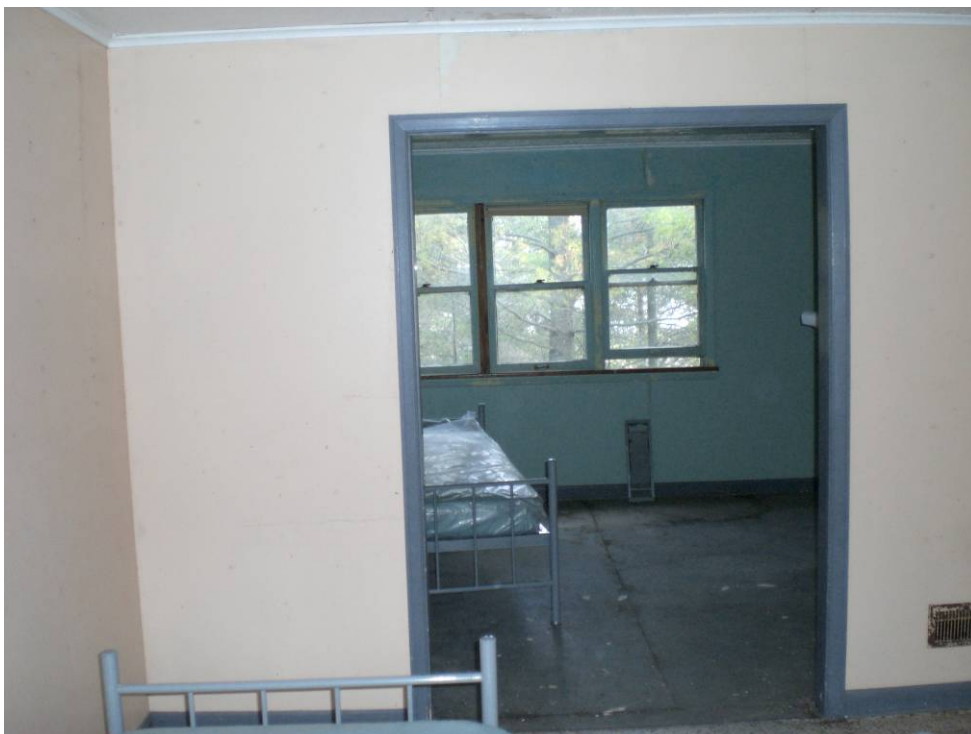
LI-TX-14: East unit's parlor, looking south into entry (Source: AH CIMG3977)

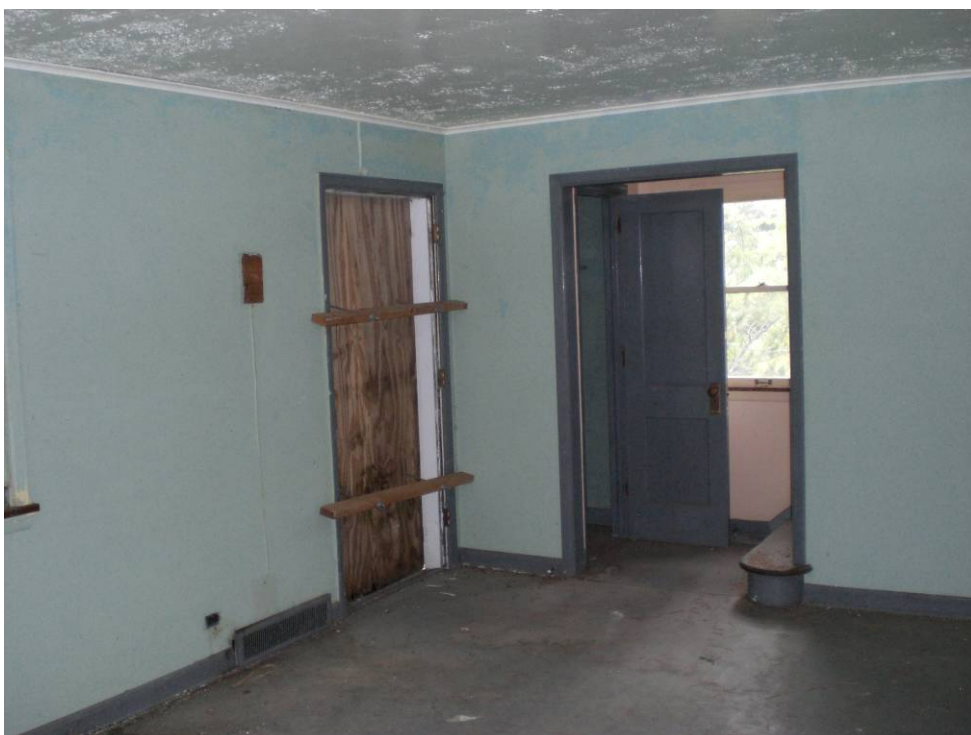
LI-TX-15: East unit's entry and stair, looking southeast (Source: AH CIMG3938)

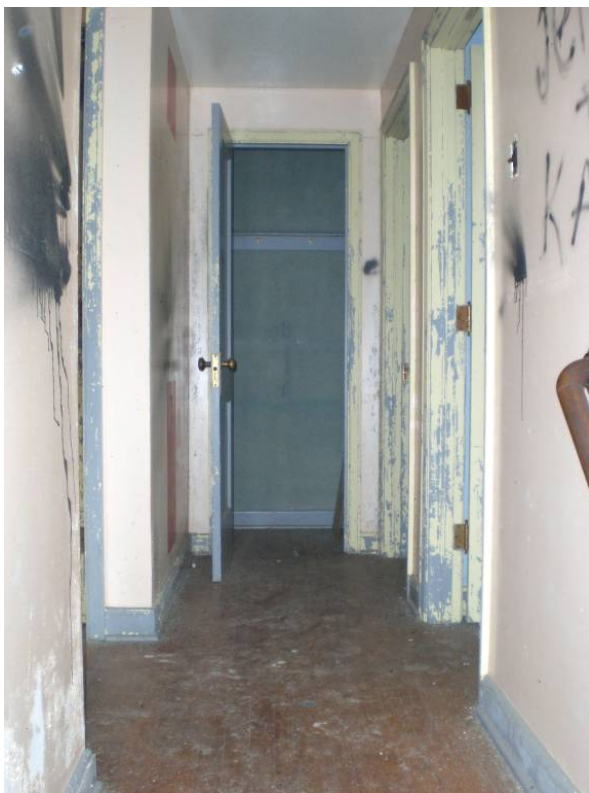
LI-TX-16: East unit's second floor hall, looking north (Source: AH CIMG3987)

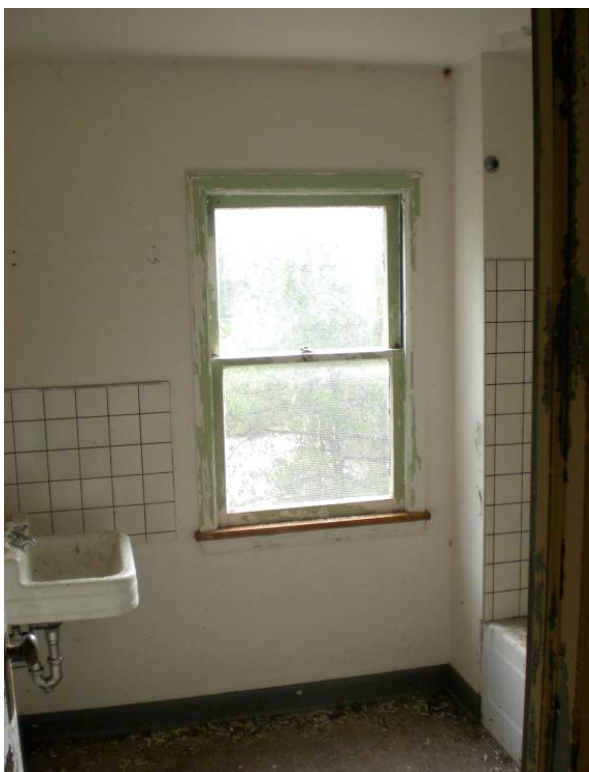
LI-TX-17: East unit's bath, looking east (Source: AH CIMG3998)

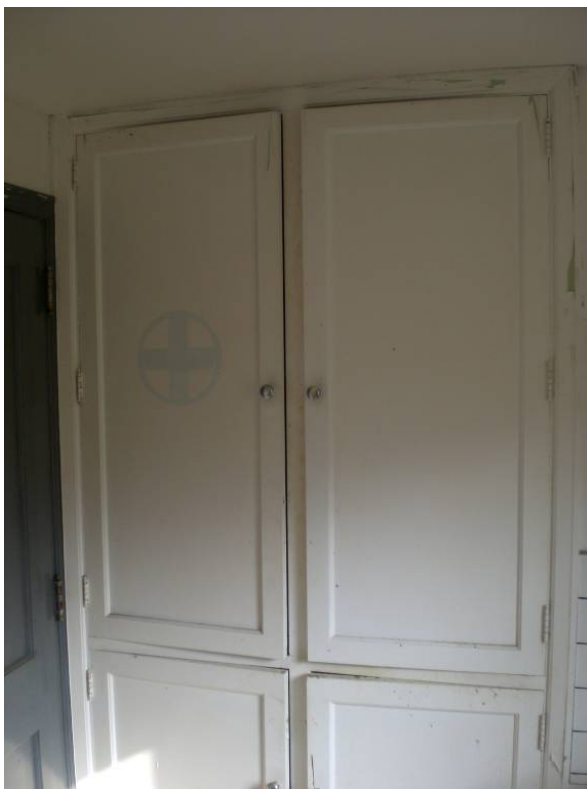
LI-TX-18: East unit's bath, looking northwest (Source: AH CIMG4003)

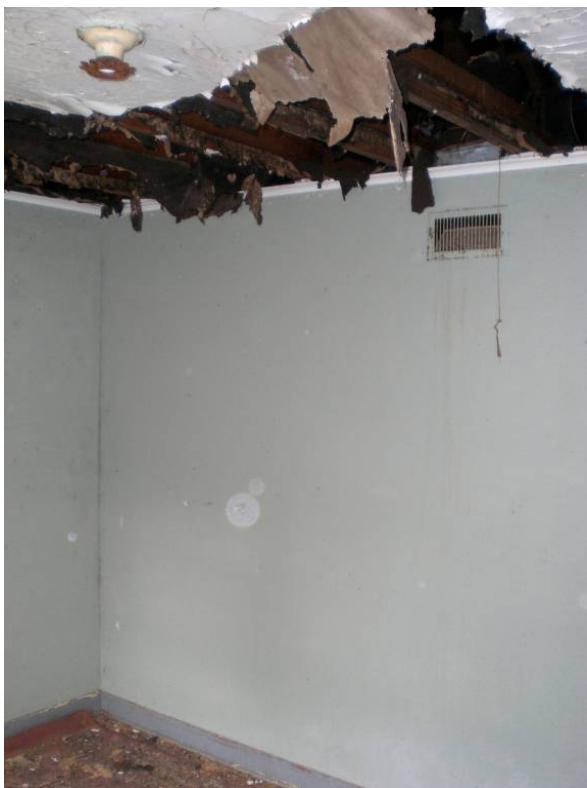
LI-TX-19: East unit's northeast bedroom, looking southeast (Source: AH CIMG4018)

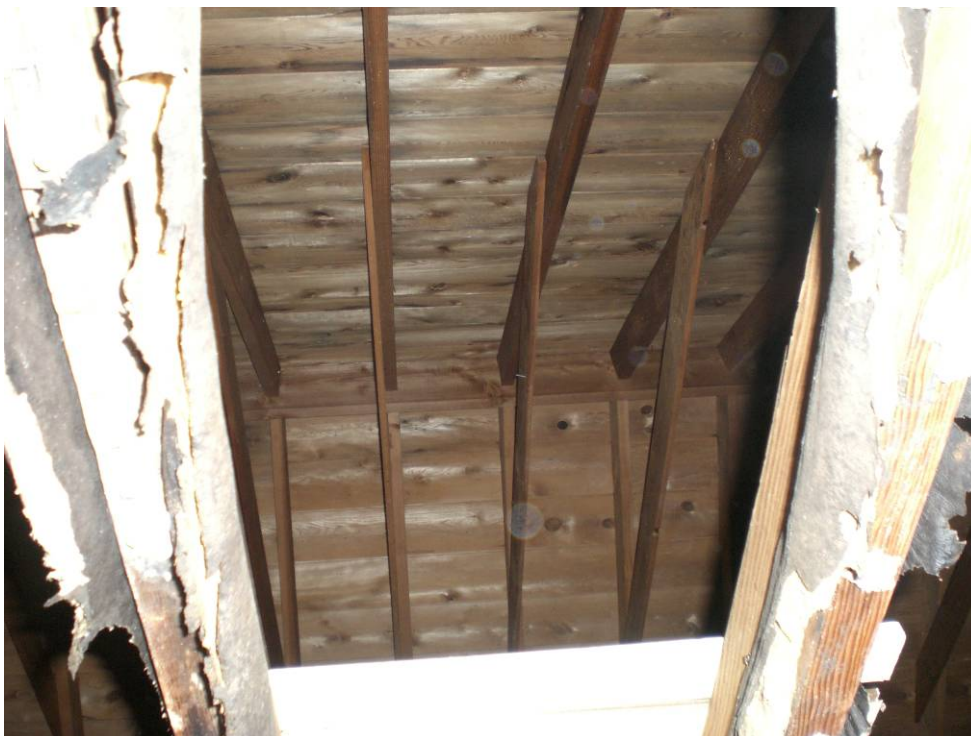
LI-TX-20: East unit's northeast bedroom, attic view through fallen ceiling (Source: AH CIMG4022)

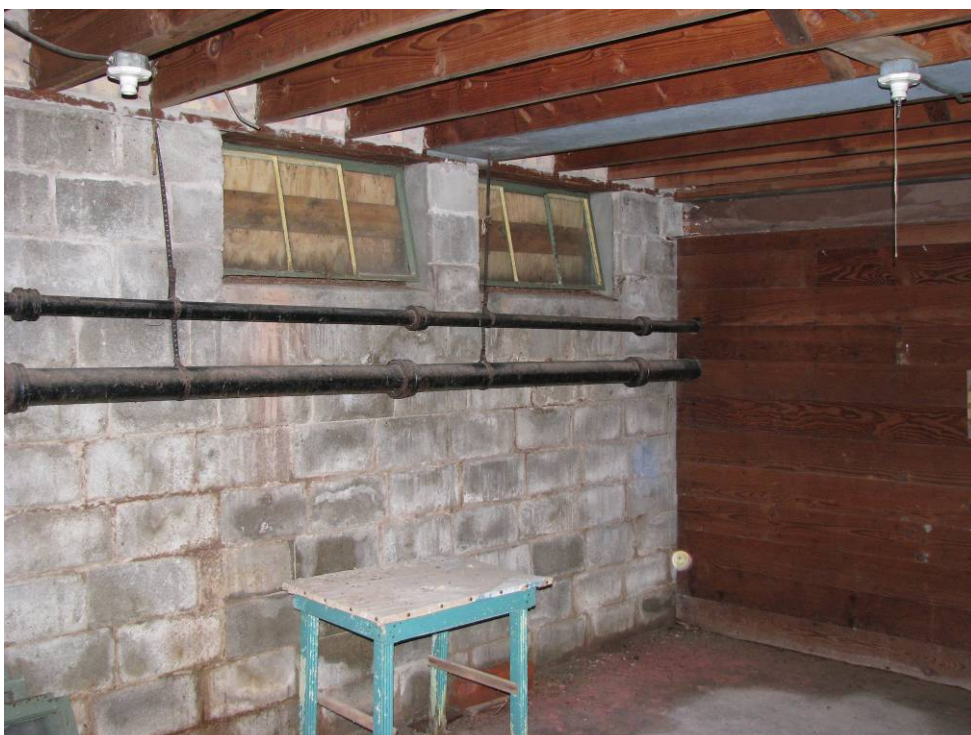
LI-TX-46: Joist header above window (Source: Martin/Martin)
