VOLUME V OF VI: LONG ISLAND CLR/HSR

**APOSTLE ISLANDS NATIONAL LAKESHORE
LIGHT STATIONS OF MICHIGAN ISLAND, OUTER ISLAND, DEVILS ISLAND,
LONG ISLAND AND SAND ISLAND**

**CULTURAL LANDSCAPE REPORT, HISTORIC STRUCTURE REPORT
AND
ENVIRONMENTAL ASSESSMENT**

prepared by
Anderson Hallas Architects, PC
Golden, Colorado

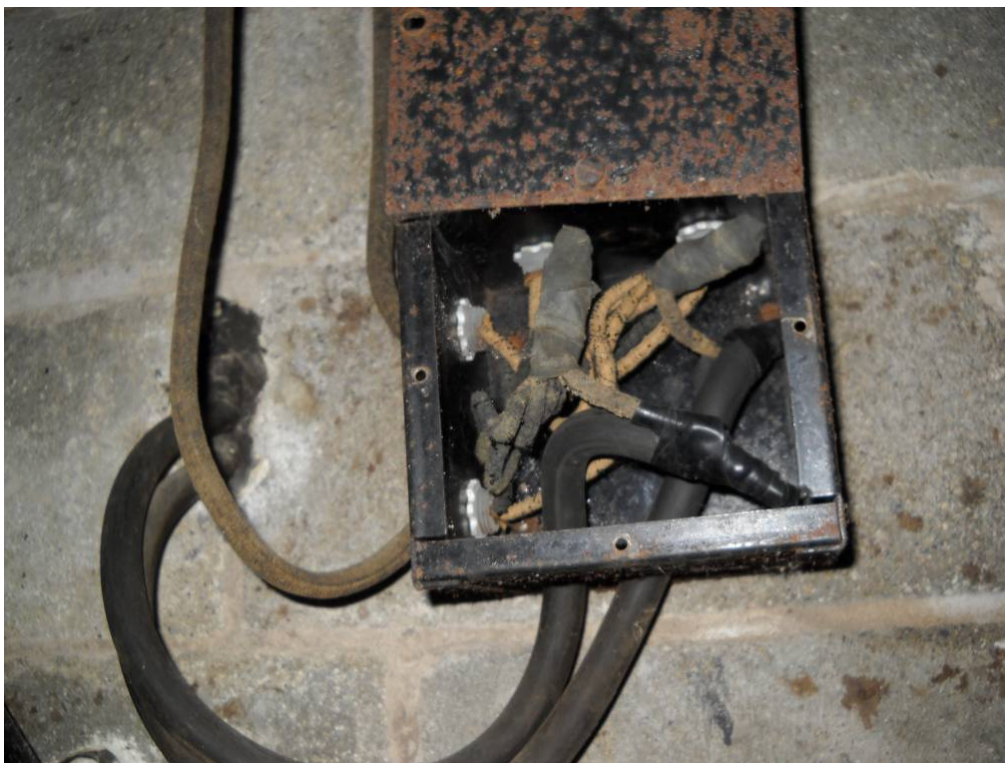
LI-TX-49: Service entrance, power for all three units connected through small (approx. #6AWG) conductors (Source: RMH)

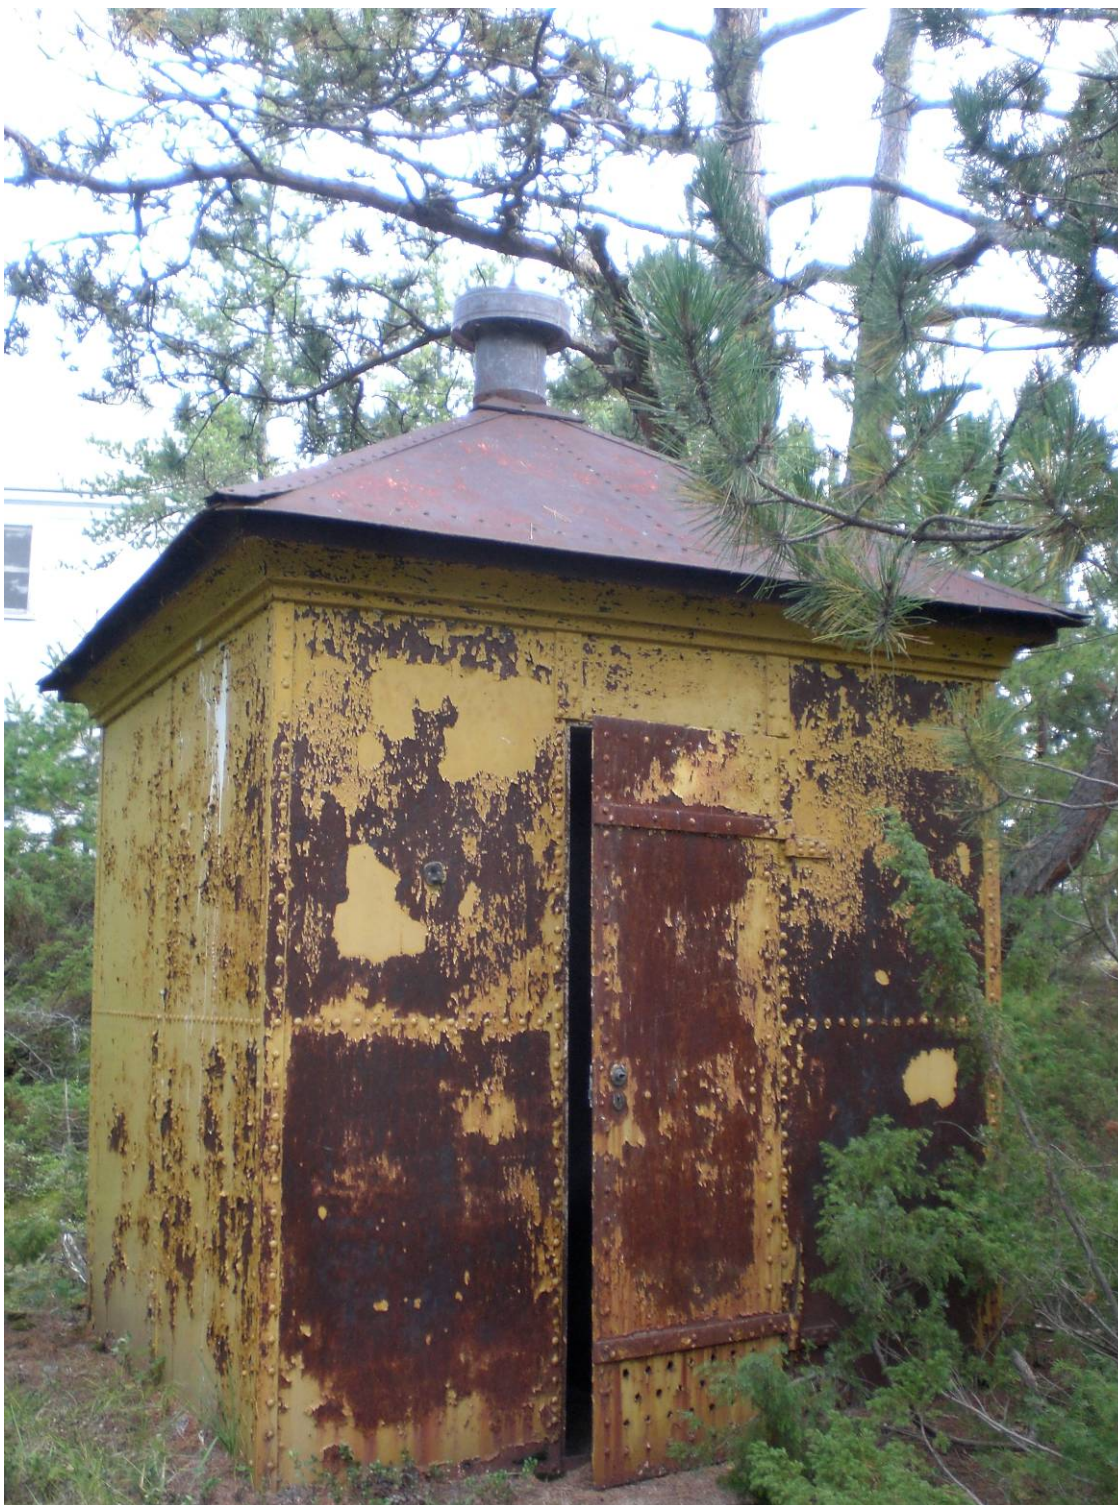
LI-OB-01: South elevation, 2009 (Source: AH CIMG3930)

The sheet metal is in fair condition as the yellow paint is peeling and a large amount of surface rust is visible.

The door is badly rusted on the surface, is missing one hinge pin, no longer has its original hardware, and has badly peeling paint.

| Recommended Treatment | Potential Effects | Mitigating Measures | Beneficial Effects |
|--|--|--|--|
| 2. Replace missing hardware to secure building | Adding new (modern) hardware elements may be visually disruptive and may require removal of historic hardware to allow proper door and hardware operation. | Attempt to match finish of existing hardware elements. | -Provides secure storage for NPS - Proper security will prevent possible future damage due to vandalism |

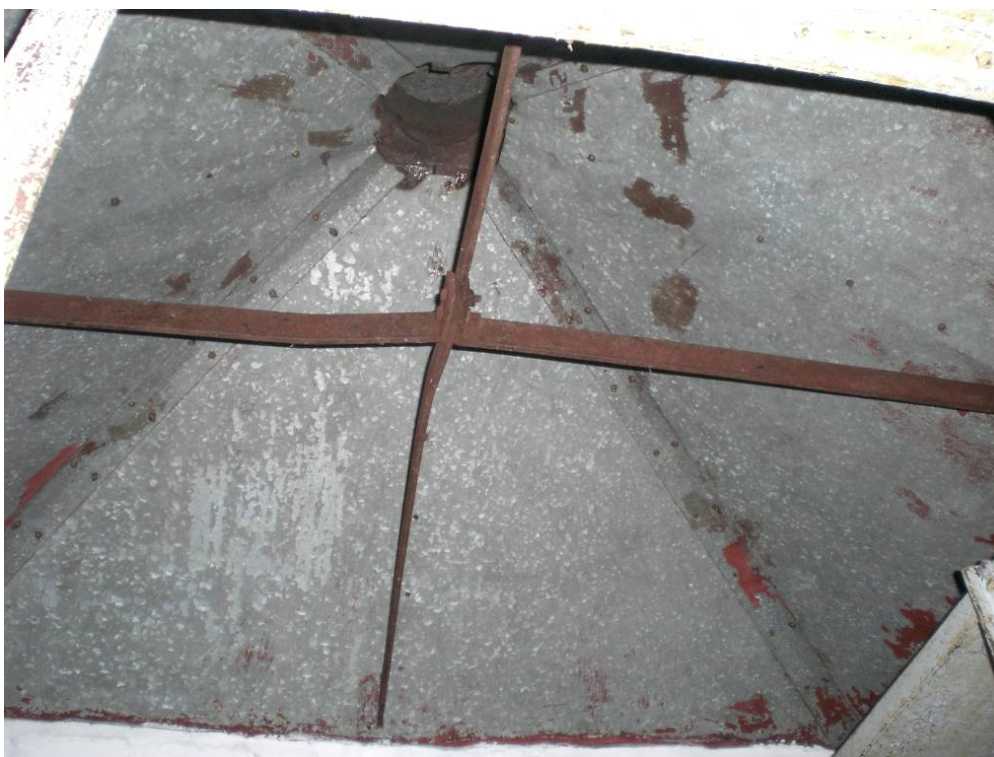
The sheet metal roof is in good condition but the cross-bracing is rusting.

LI-OB-06: Sheet metal ceiling (Source: AH IMG3002)

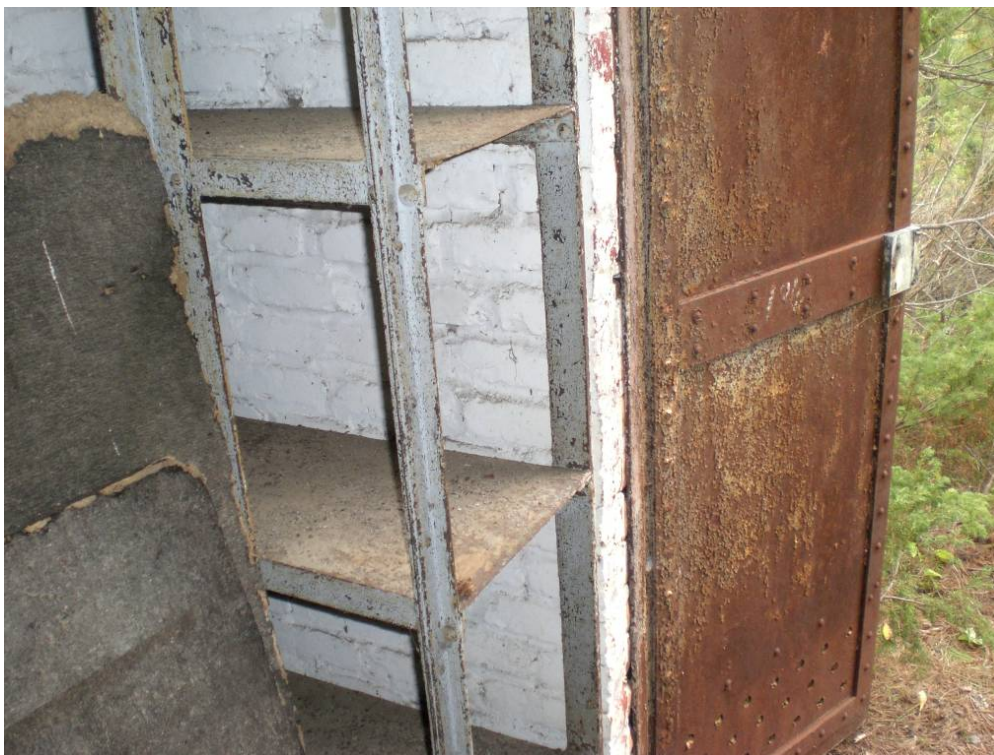
The painted brick is in good condition, but there is some spalling at the floor level, which indicates moisture may be trapped between the masonry and the sheet metal siding.

LI-OB-07: Door and brick interior walls, looking south (Source: AH CIMG3923)
