VOLUME VI OF VI: SAND ISLAND CLR/HSR

APOSTLE ISLANDS NATIONAL LAKESHORE
LIGHT STATIONS OF MICHIGAN ISLAND, OUTER ISLAND, DEVILS ISLAND,
LONG ISLAND AND SAND ISLAND

JULY 2011

**CULTURAL LANDSCAPE REPORT, HISTORIC STRUCTURE REPORT
AND
ENVIRONMENTAL ASSESSMENT**

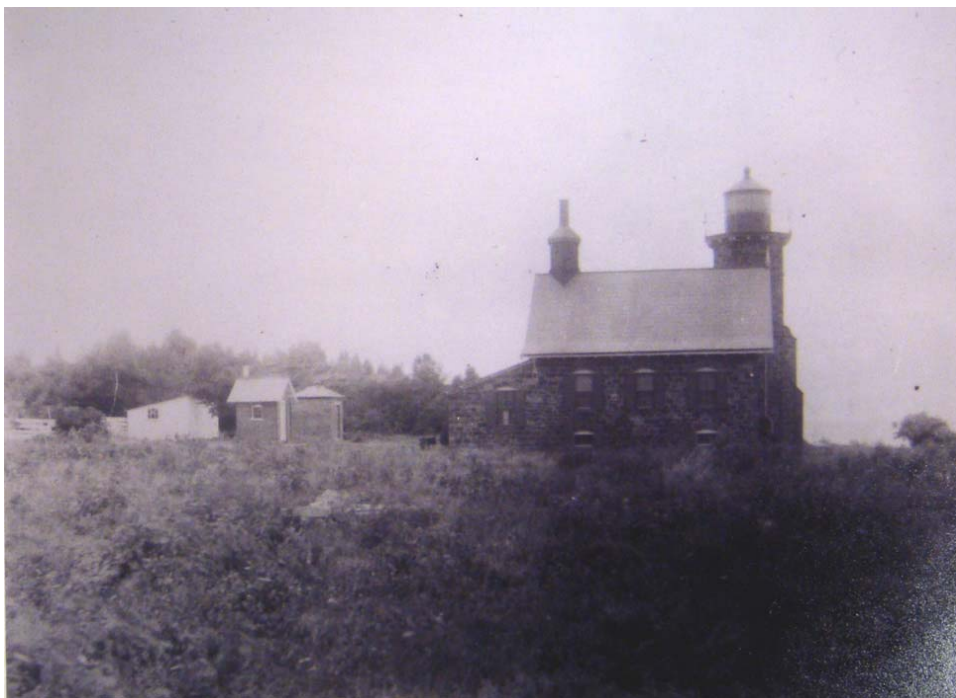
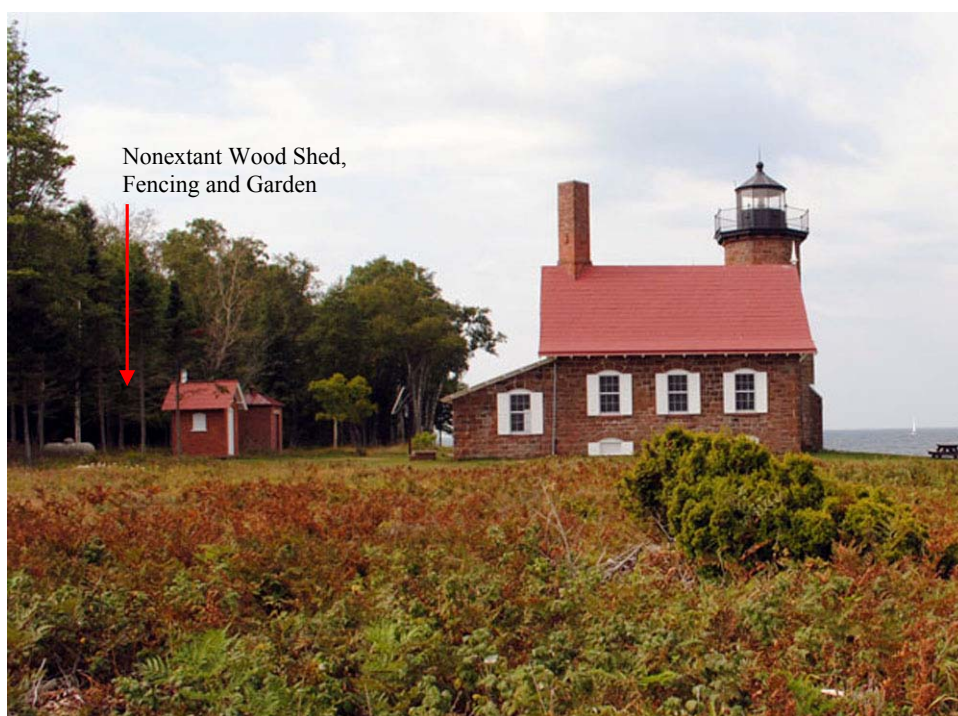
Site Image SI-26: View of Light Station from the east – note reduction in cleared area to left and growth of forest; top, c. 1913 (Source: NPS APIS Archives); below, 2009 (Source: MBD DSC_0250.JPG)

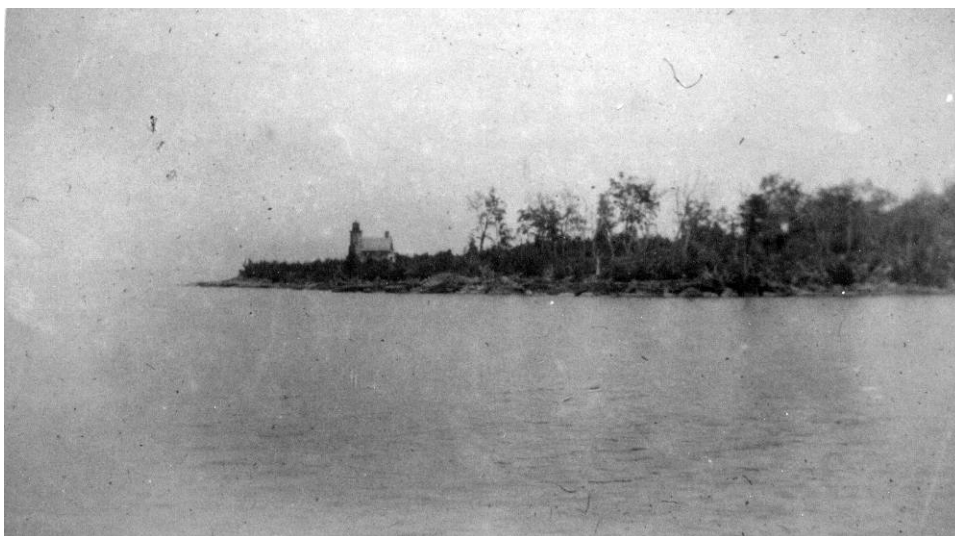
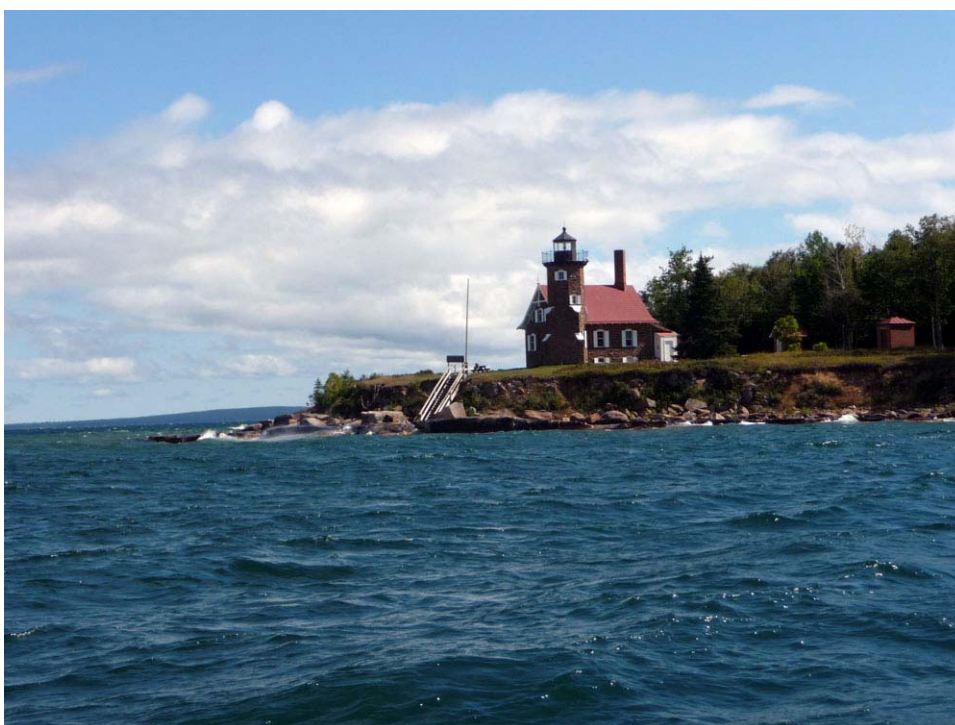
Site Image SI-30: View of Light Station Quarters from Lake Superior; top, c. 1891 (Source: NPS APIS Archives); below, 2009 (Source: MBD P1020458.JPG)

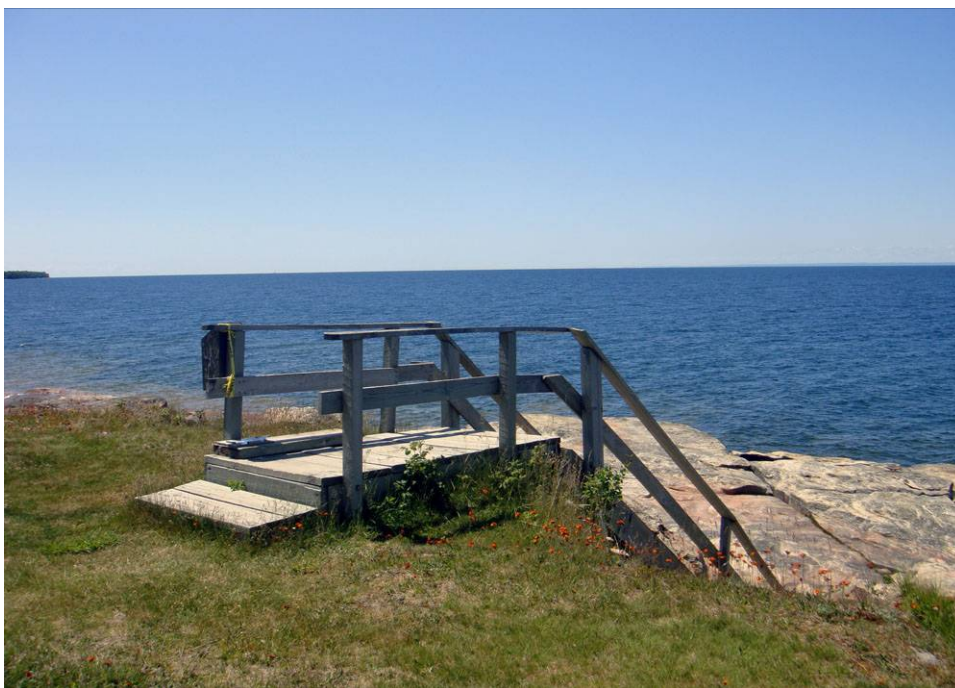
Existing Condition. A wooden staircase connects the light station grounds to a natural rock outcrop (approximately 18' high) used as a boat landing. The staircase is built of dimension lumber, is 4' wide with railing on both sides, and approximately 3' high. There is a 1' x 4' step on the light station grounds leading up to a 6' x 4' landing. There are 22 steps leading from the landing to the rocky ledge. The alignment of the staircase is offset from the historic concrete walks above by approximately 20'. The staircase is showing signs of disrepair and is in poor condition. A 30"x48" precast concrete slab, from the walk above, has been placed at the bottom of the staircase.

Site Image SI-39: View of the wooden stairway at the North Landing, 2009 (Source: MBD DSC00711.JPG)

Repair the wooden staircase leading down the rock outcrop north of the Light Station Quarters. Alter the staircase to meet current ABAAS standards.

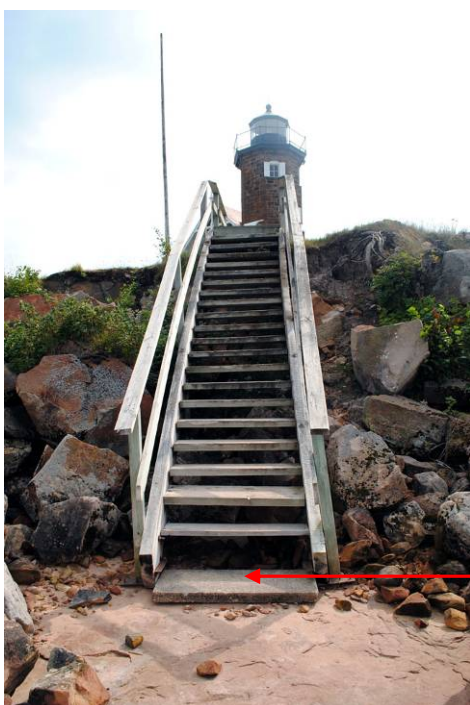
Site Image SI-40: View of the staircase from the North Landing, 2009 (Source: MBD DSC_0274.JPG)

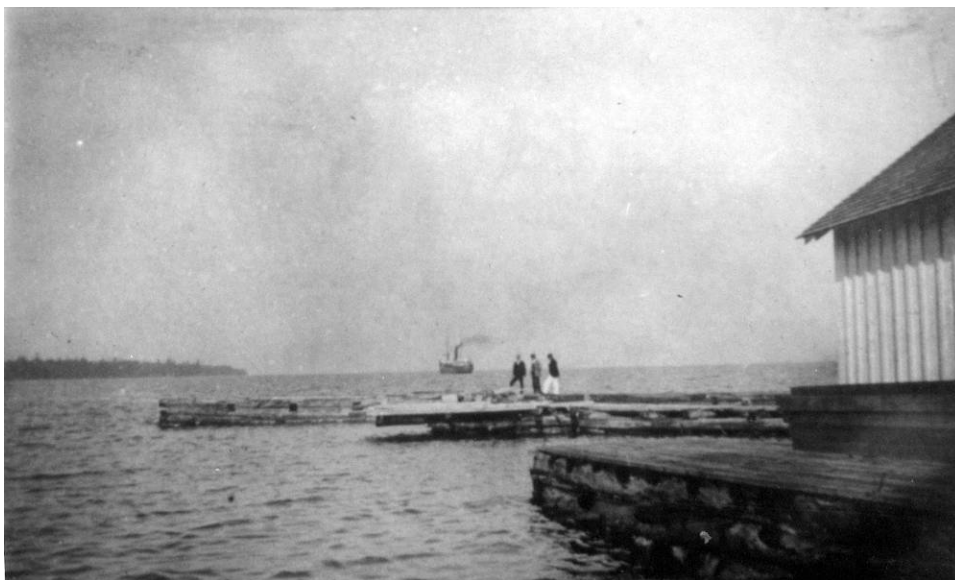
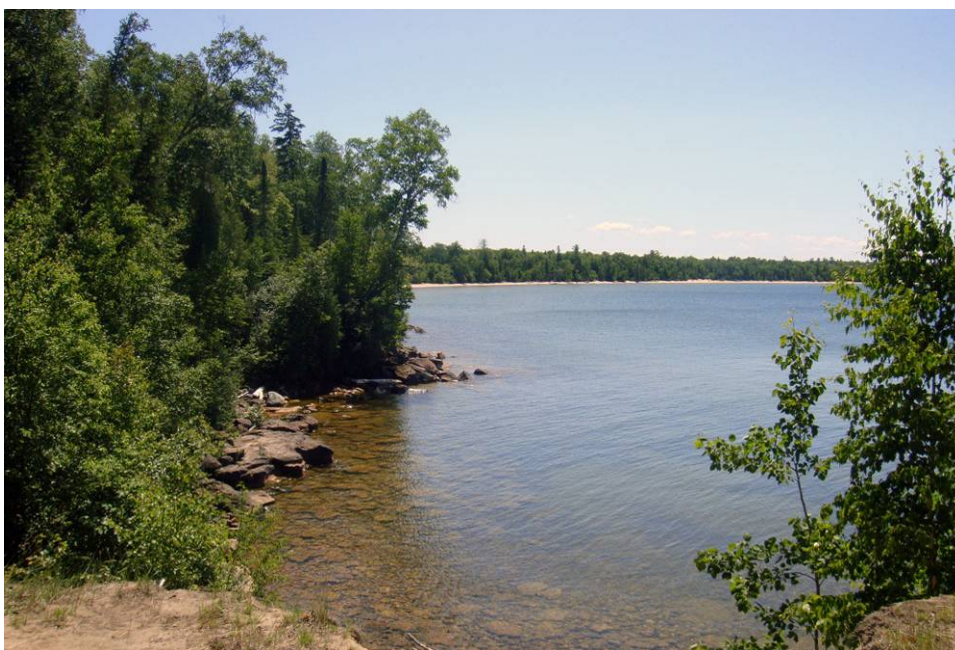
Existing Condition. No readily visible features of the Boathouse exist. Remnant materials from the landing cribs exist under the water.

Site Image SI-41: Former Boathouse area; top (c. 1904) (Source: NPS APIS Archives); below (2009) (Source: MBD DSC00705.JPG)

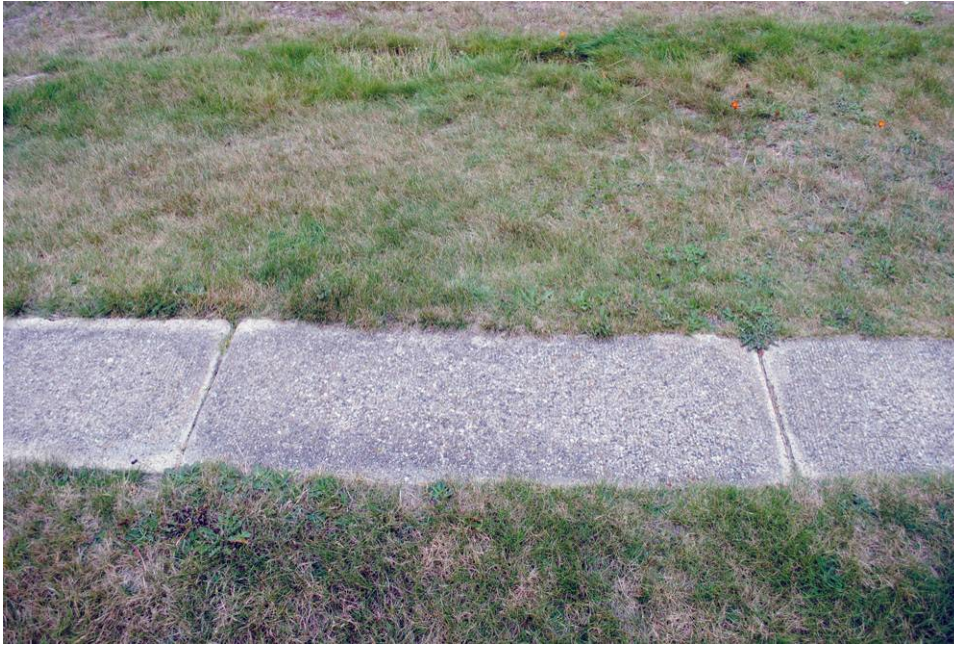
Existing Condition. The concrete walks were installed during the period of significance, many of them following the earlier alignment of wood planks as was typical of the Apostle Islands. Common to several Apostle Islands light stations, the walks are composed of individual 4' thick precast units. The slabs are of two sizes, 30" x 48" and 18" x 48". The units have a fine aggregate finish and tooled edges (Site Image SI-42). Historic photographs indicate that the concrete units were installed on top of the ground surface without excavation. Small portions of the concrete walks appear to have been poured in place to fill odd shapes and address building edges. Overall the concrete walks are in good condition with only one area that appears to require replacement of broken concrete.

Site Image SI-42: Typical concrete walk of precast slabs, 2009 (Source: MBD DSC_0290.JPG)

A detailed description of treatment measures for concrete walks can be found in small scale features.

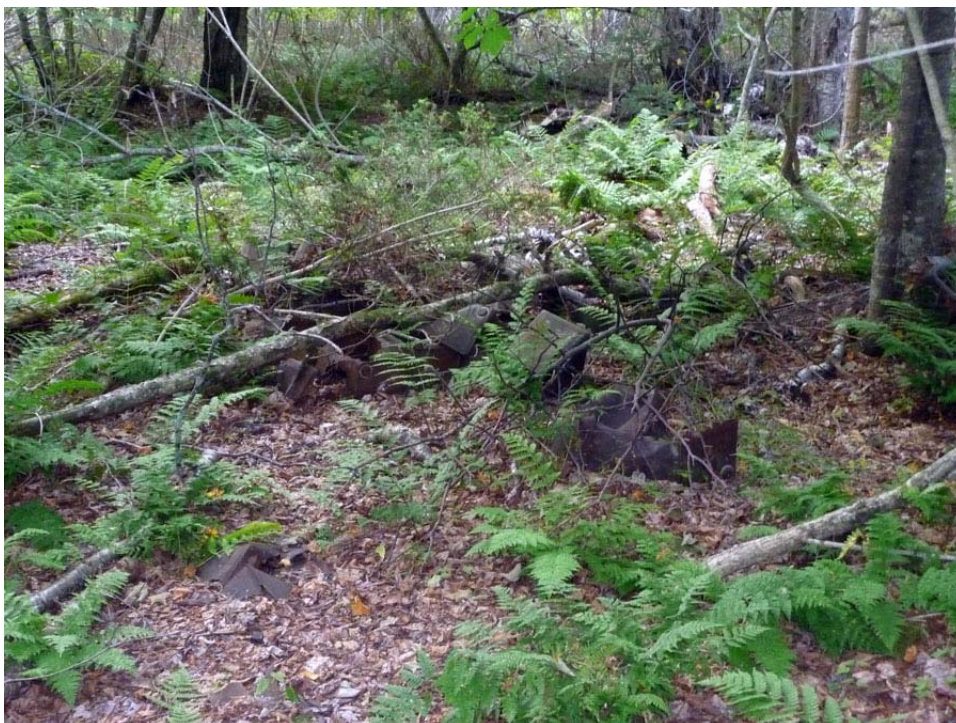
Existing Condition. Three dump sites and a site containing brick rubble exist in the forest vegetation in the area surrounding the Sand Island Light Station. The sites were located at varying distances from the light station, one at 60 feet away and another at 220 feet. The sites contain various materials Dump Site 1 is primarily glass bottles and soda cans, Dump Site 2 consists of what appears to be fuel containers, and Dump Site 3 has remnant wood panels and other materials, possibly remnants of a building interior.

Site Image SI-46: Dump site No. 2, 2009 (Source: MBD P1020387.JPG)

Complete an archeological survey for all known resources in the light station (including dump sites described earlier in this section) using non-destructive investigations to document the extent of buried or non-visible cultural resources that exist across the island. Consider using ground penetrating radar and other non-invasive measures to assist in locating resources. If a comprehensive survey for the entire Island is not possible, complete archeological investigations for proposed projects in advance of any other work on the project, including demolition. In compliance with the National Historic Preservation Act, and in consultation with the NPS Midwest Archeological Center, undertake archeological investigations for all projects, as appropriate to their scale, impacts, and extent of ground disturbance.

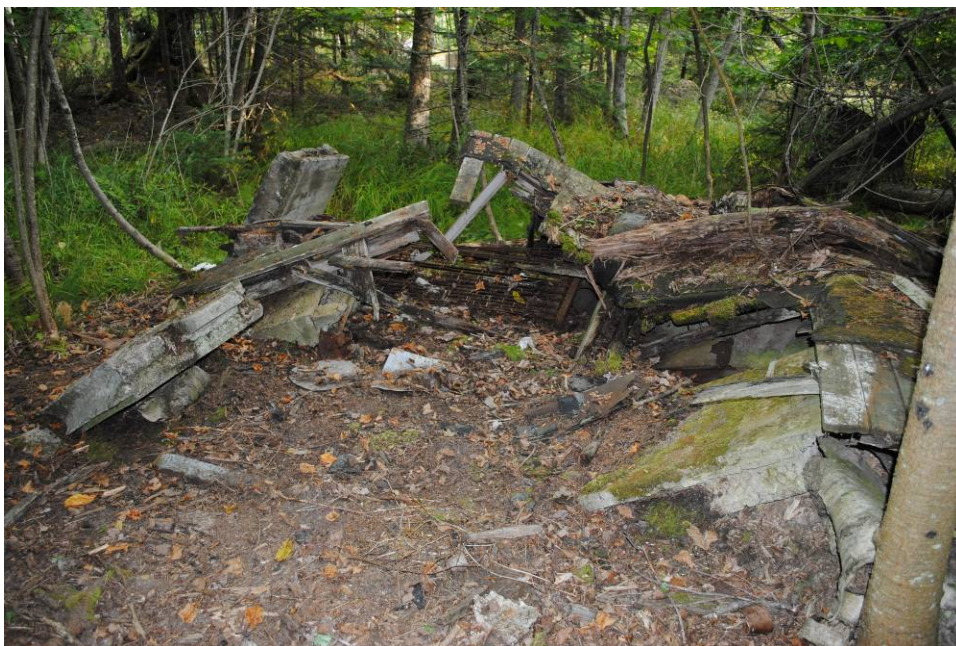
Site Image SI-47: Dump site No. 3, 2009 (Source: MBD DSC_0227.JPG)

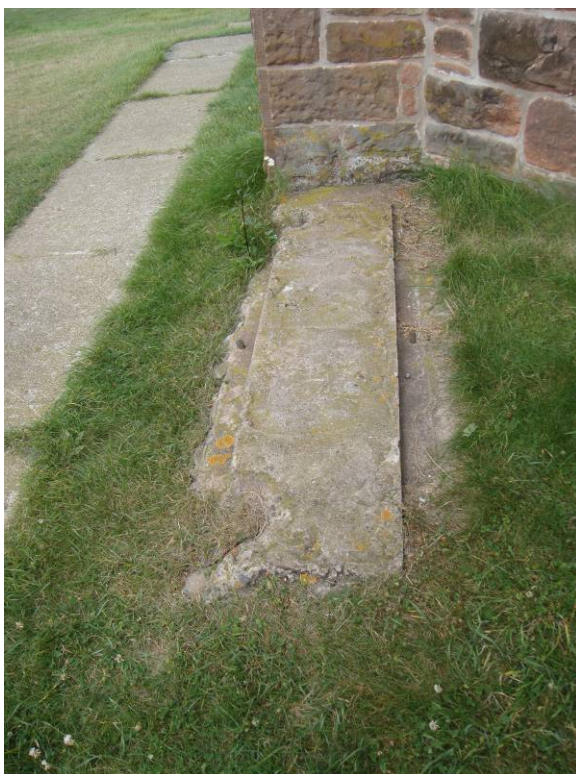
Tank House Foundation, 1931	SI-49	Concrete foundation, immediately south of Light Tower at Light Station Quarters. Approximately 30" x 6'. Foundation for nonexistent Tank House installed in 1931	Fair	Noncontributing; Compatible
Sign (1970 – 2009)	SI-50	NPS wooden interpretive sign	Fair	Noncontributing – contemporary; Compatible
Trail Sign (1970 – 2009)		NPS trail sign	Good	Noncontributing – contemporary Compatible
Fire Pit (1970 – 2009)	SI-51	Steel fire pit – located away from Light Station Quarters	Good	Noncontributing – contemporary; Compatible
Flagpole (1970 – 2009)	SI-52	Wooden flagpole similar in design to flagpoles at Michigan and Outer. As it is not pictured in any of the historic photographs, it appears that it is an NPS addition.	Good	Noncontributing – contemporary; Compatible
Bench	SI-54	Wooden, rough cut log bench	Fair	Noncontributing – contemporary; Compatible
Wood Headwall (c. 1980)	SI-55	Wood headwall for drain outlet. Part of 1980s drainage system from the basement from the Light Station Quarters.	Good	Noncontributing – contemporary; Noncompatible

Site Image SI-49: Concrete Foundation south of Light Tower at Light Station Quarters, 2009 (Source: MBD DSC01439.jpg)

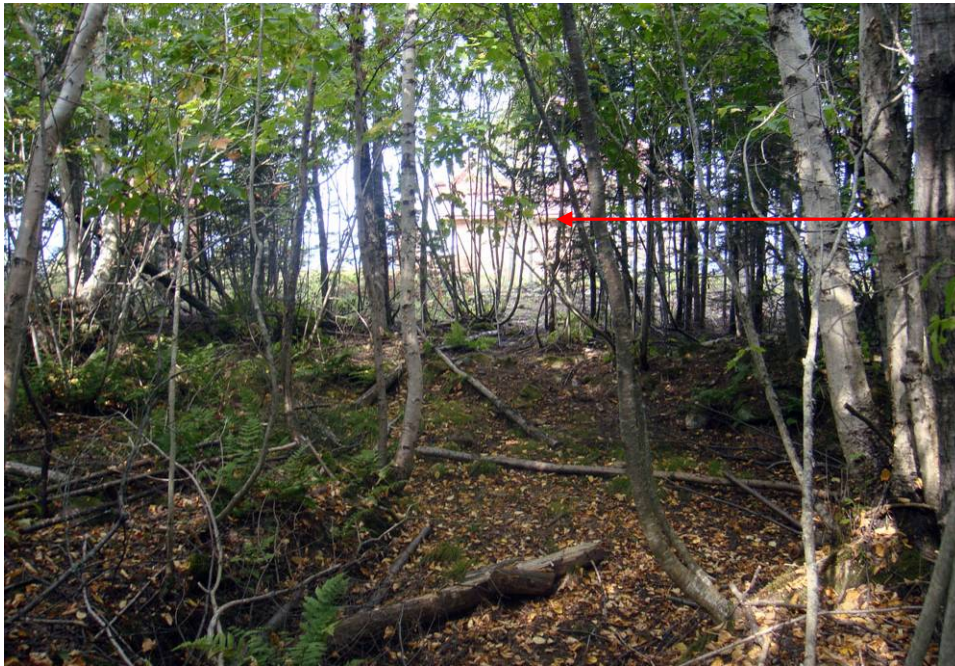
The condition of the vegetation on the light station grounds is fair. The historically cleared area of the light station is in poor condition.

Site Image SI-62: Forest encroachment into former garden area, 2009 (Source: MBD DSC01436.JPG)

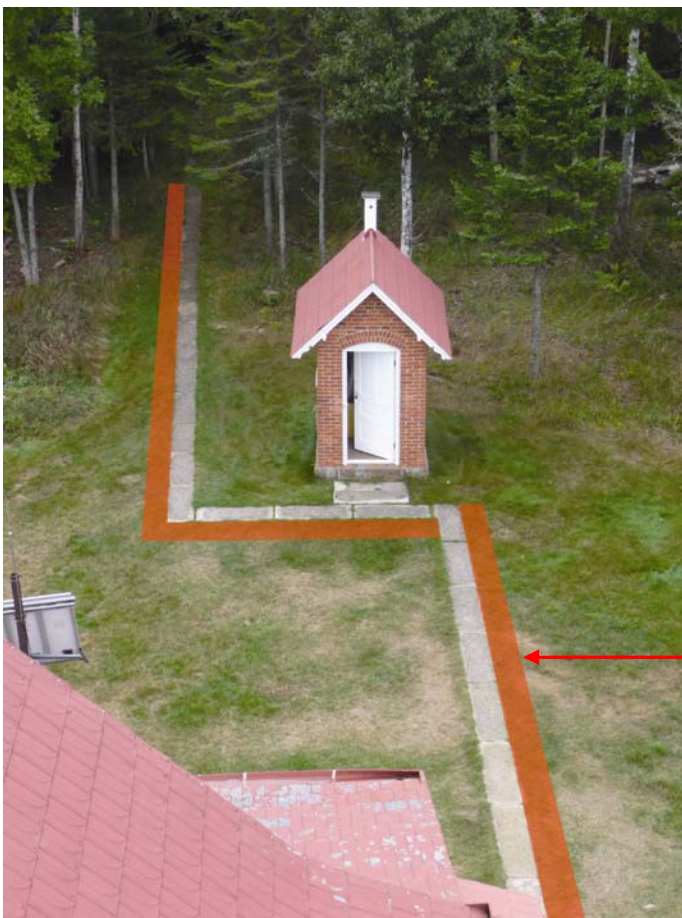
Site Image SI-67: ABAAS Option - Widen walks by retaining existing historic walks in place and installing new precast concrete material to achieve an accessible width. (Source: MBD P1020420_annotated.JPG)

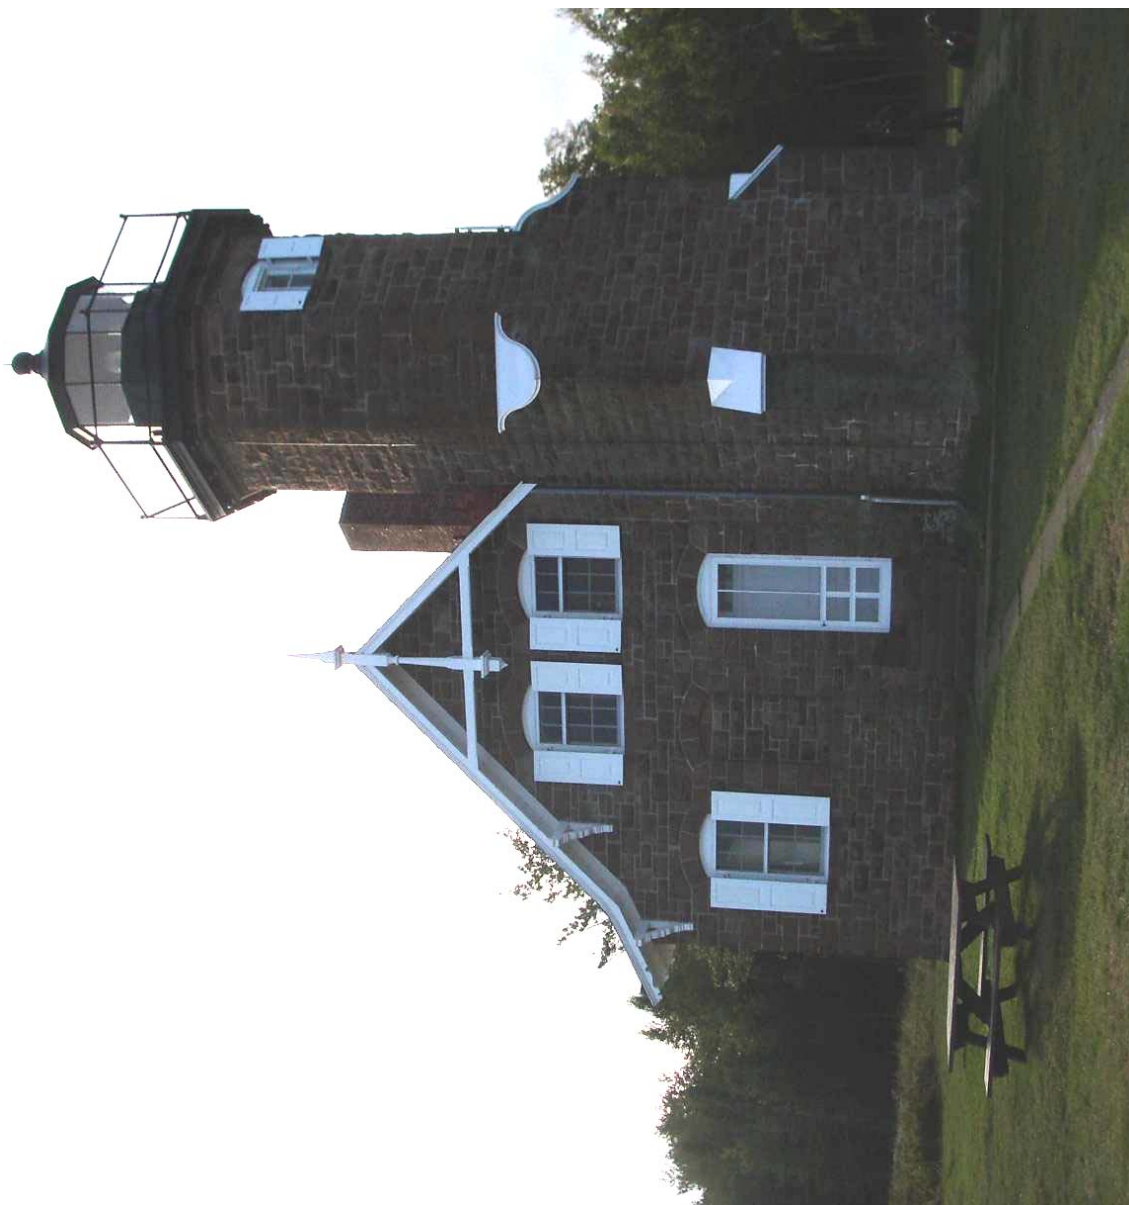
SI-LSQ-01: North elevation, 2009 (Source: AH DSC01353)

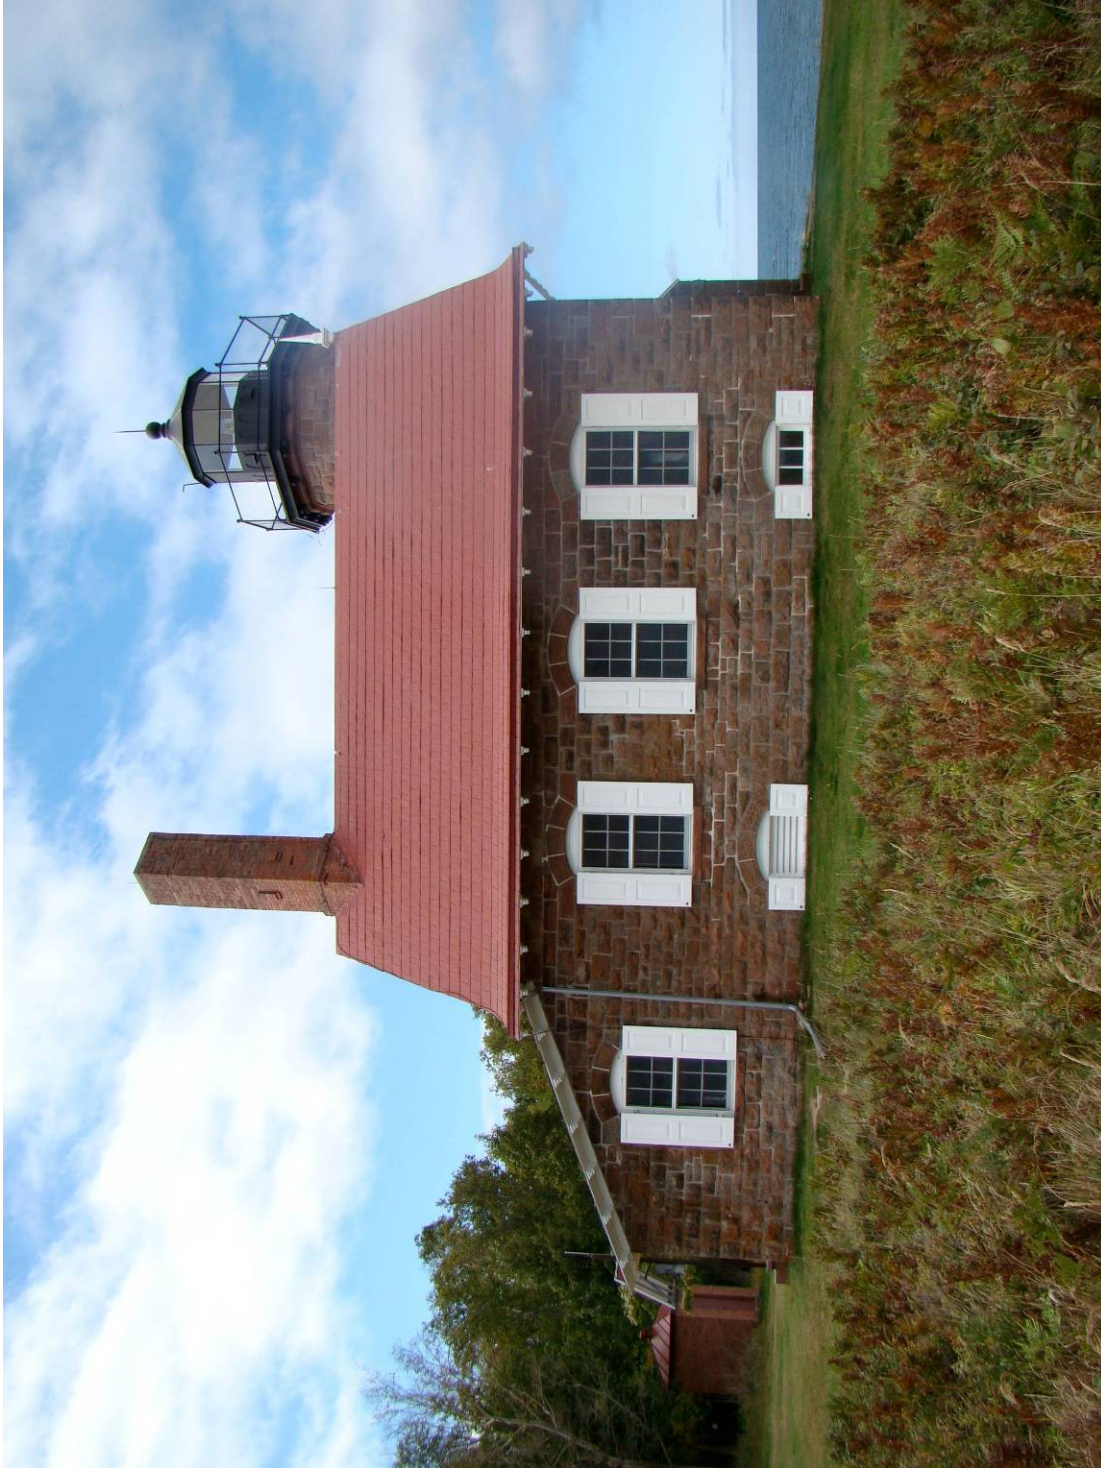
SI-LSQ-02: East elevation, 2009 (Source: AH DSC01342)

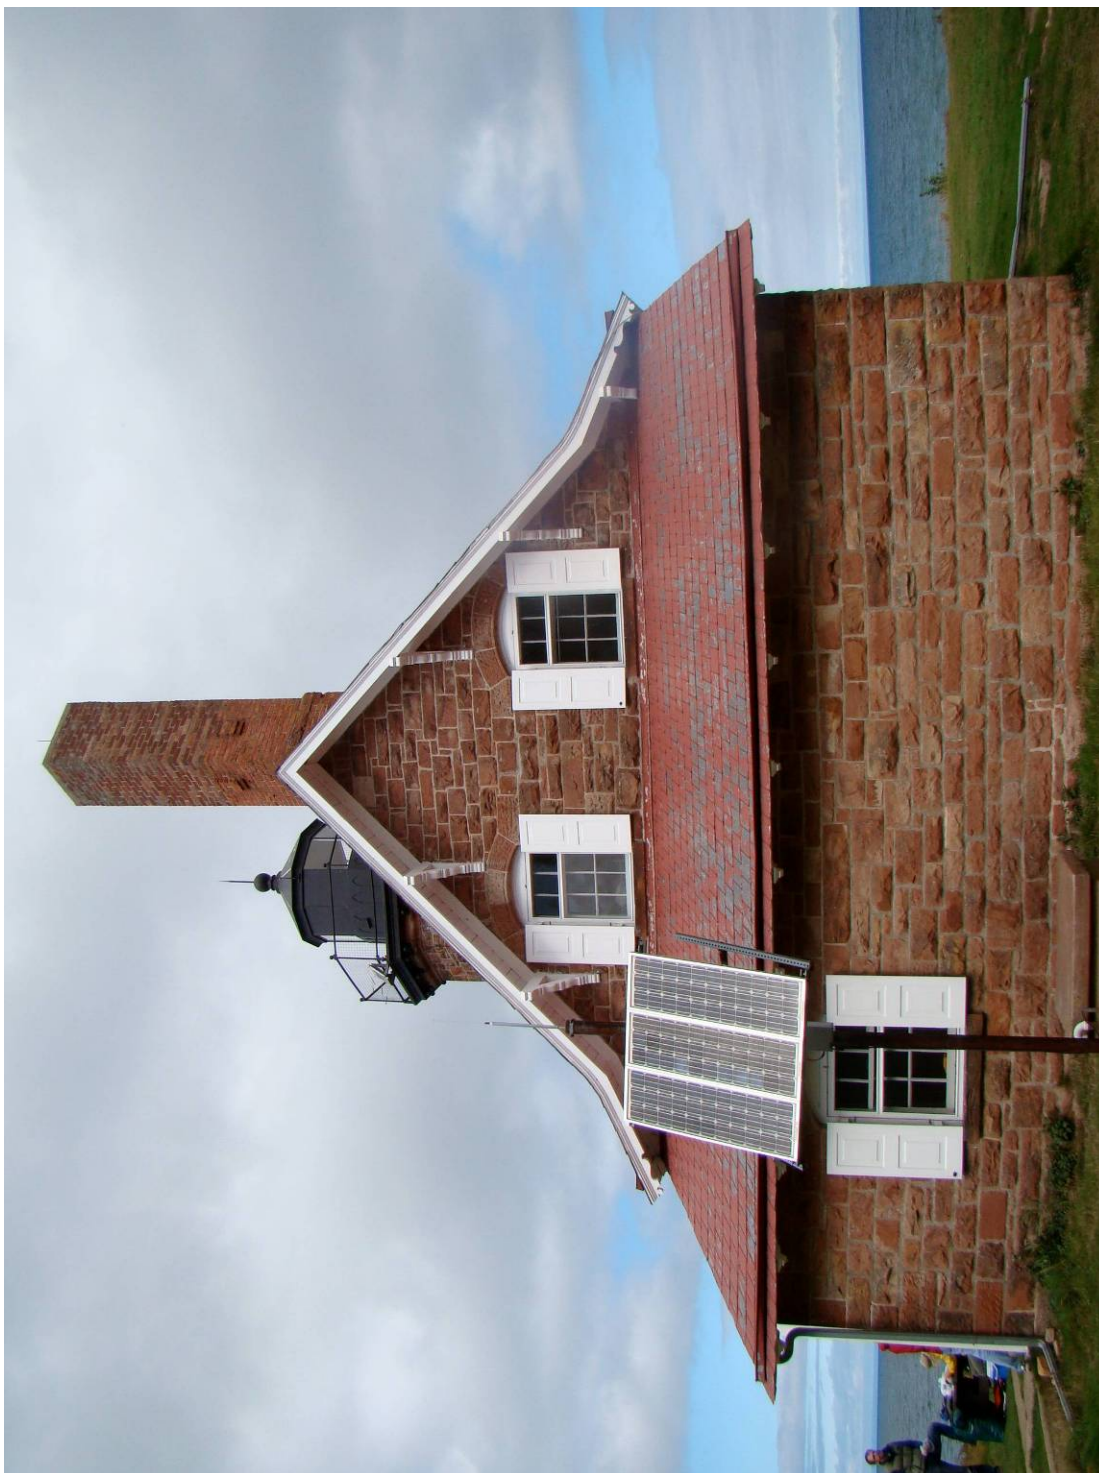
SI-LSQ-03: South elevation, 2009 (Source: AH DSC01343)

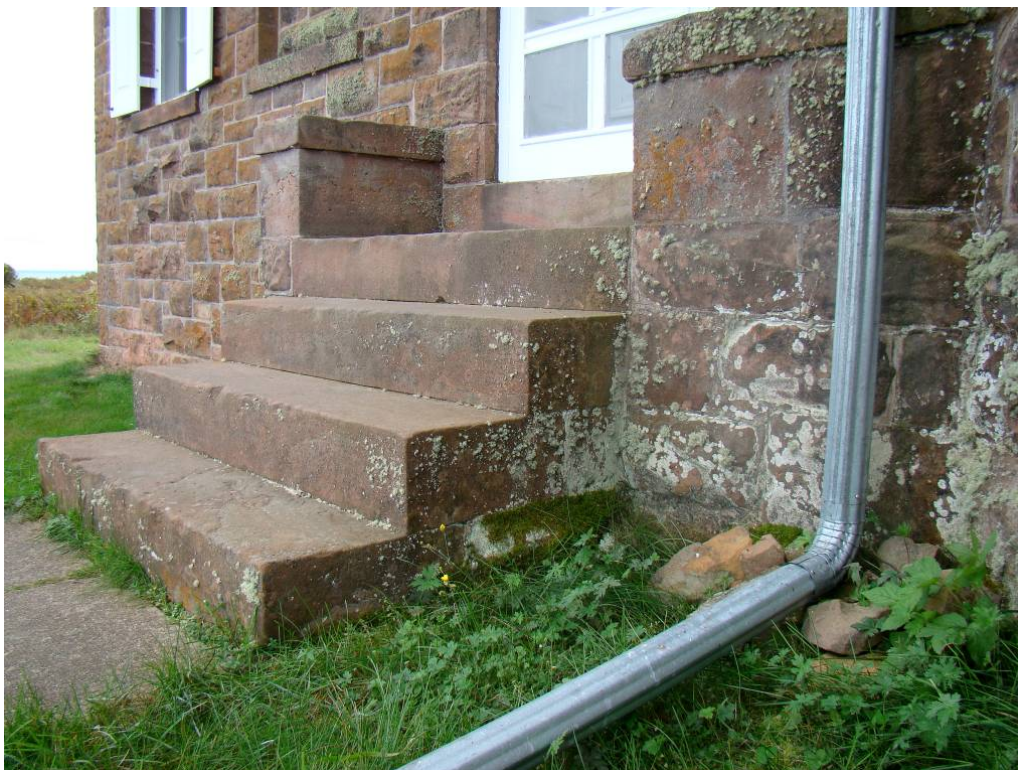
The downspouts (located on the east and west) originally drained into an interior cast iron fill system for the cistern under the kitchen. Later, a split drain was installed to 3" diameter fluted downspouts located on the exterior. Currently, the downspouts only drain to the exterior – not the cistern, though it does have standing water. The downspouts utilize both older pieces and have been supplemented by a newer, galvanized fluted downspout to match. An older downspout is also found at the north elevation at the roof to Tower intersection. Historic photos show this as early as 1890. (SI-LSQ-11) Historic photos do not show the exterior downspouts at the east and west, only the cistern inlet at the wall. Historic photos do show a downspout on the south shed's west side that appears to drain to grade as early as c. 1915.

SI-LSQ-11: Entry stairs and downspout, north elevation (Source: AH DSC01301)

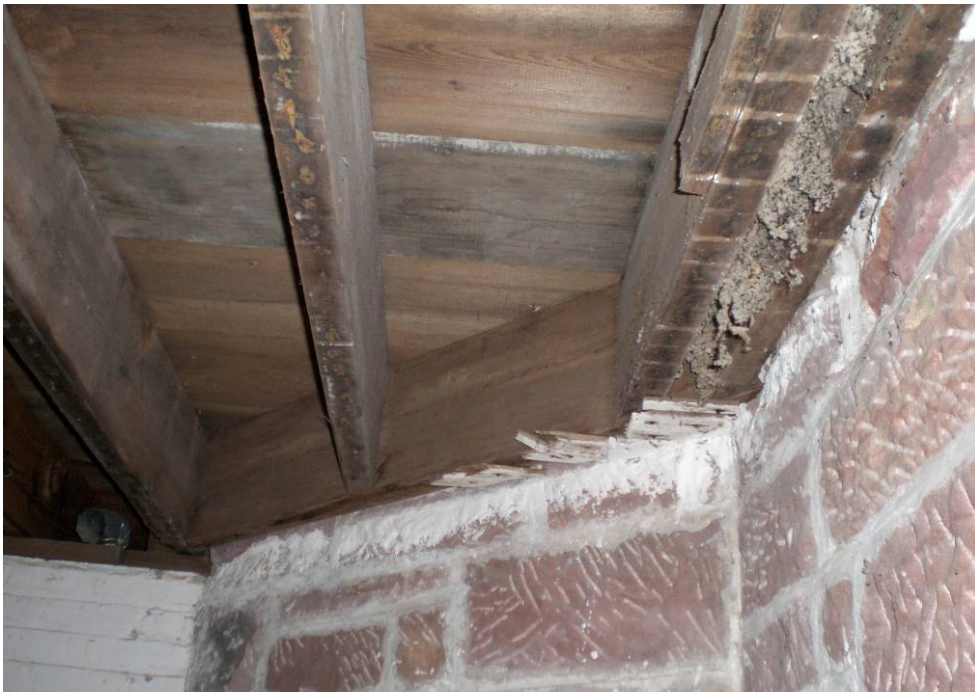
SI-LSQ-16: Basement cellar ceiling and remnants of lath and plaster, looking east (Source: AH CIMG4320)

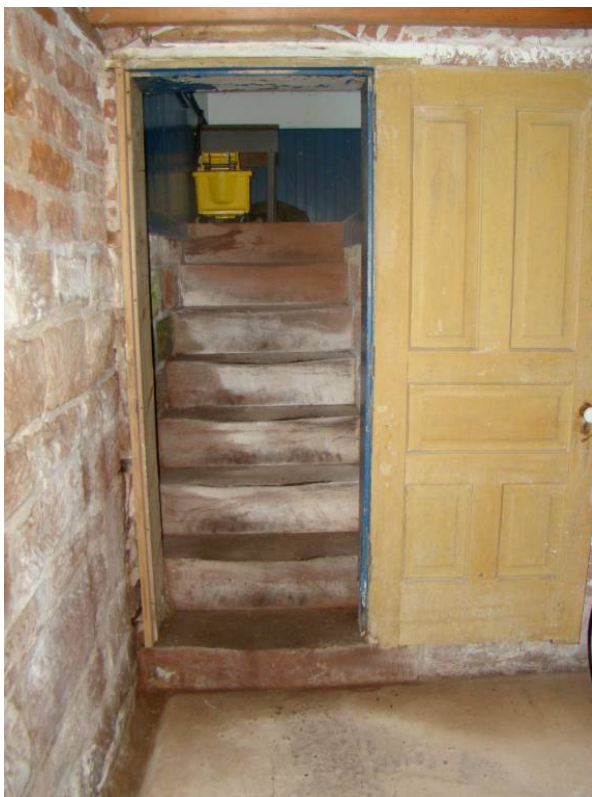
Basement Stairs. These stairs are stone, have eight risers at 9" high, and have treads that are 10" deep and 2'-11 ½" wide. The stairs do not have a handrail and are heavily worn from foot traffic, as evidenced by the bowl-shaped center of the treads. (SI-LSQ-17)

SI-LSQ-17: Basement stairs to summer kitchen (Source: AH CIMG4293)

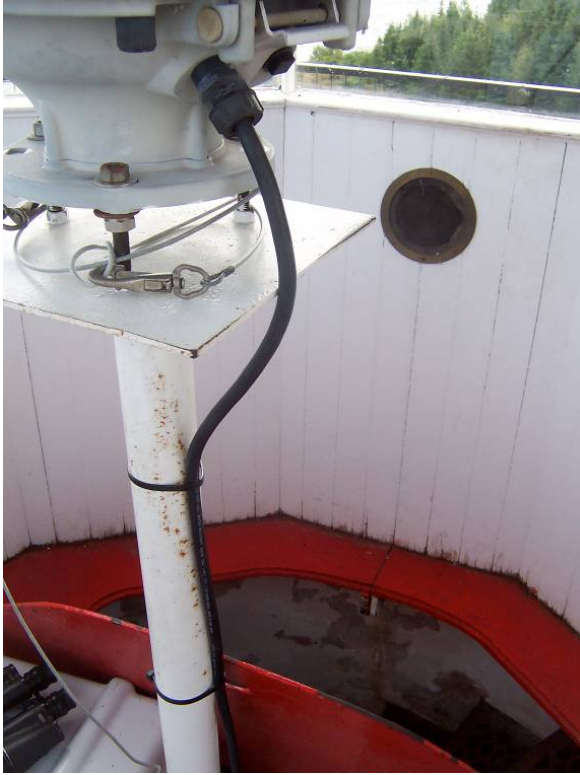
SI-LSQ-31: Lantern interior and floor hatch to stairs (Source: AH 100_9840)

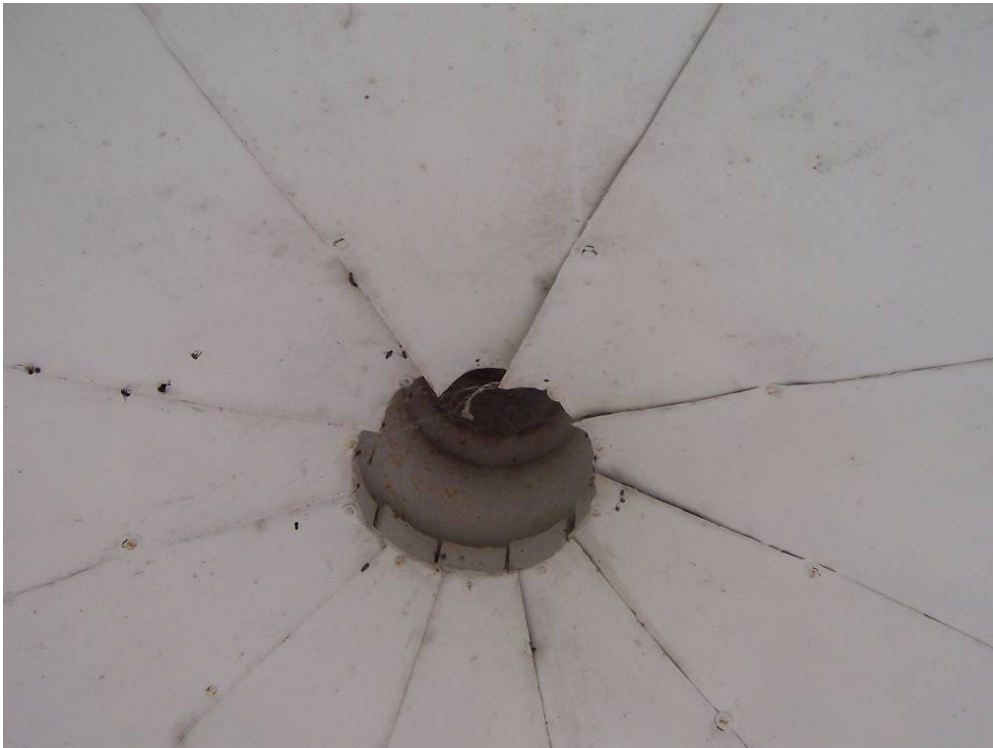
SI-LSQ-32: Lantern ceiling vent (Source: AH 100_9839)

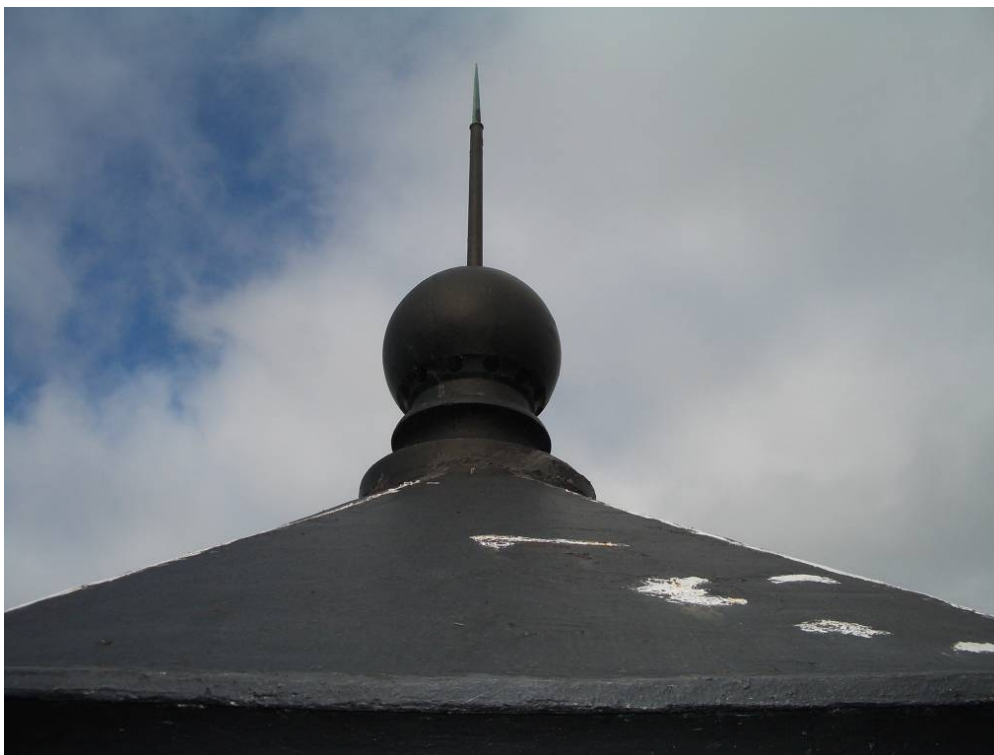
SI-LSQ-33: Lantern roof and lightning rod (Source: AH IMGP3055)

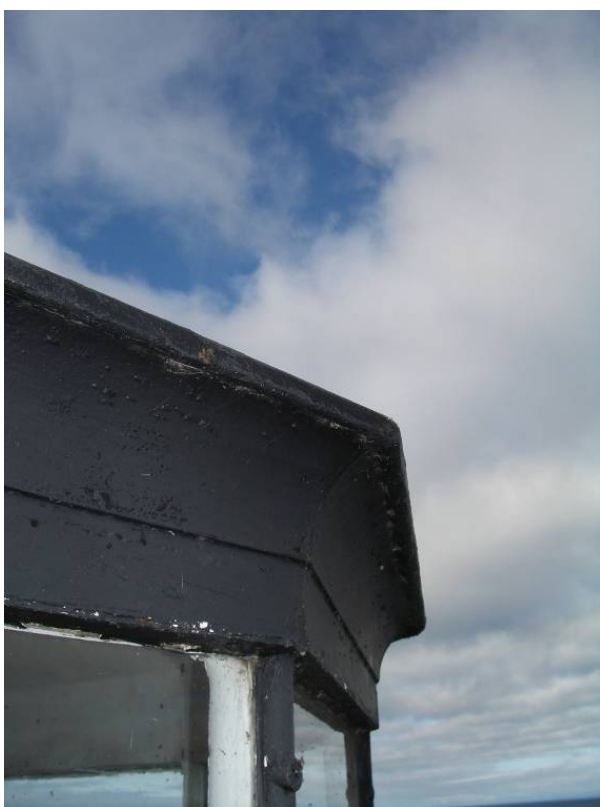
SI-LSQ-34: Lantern trim and glazing detail (Source: AH IMGP3053)

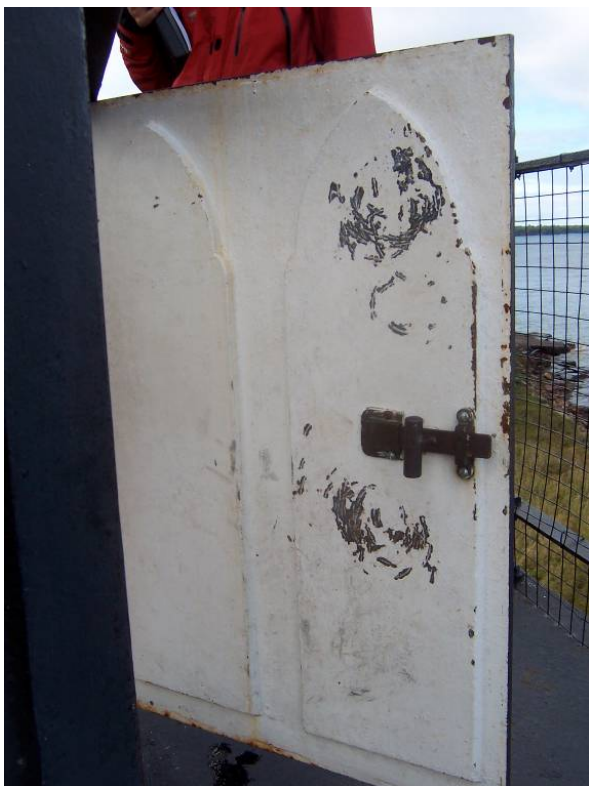
SI-LSQ-35: Lantern door to walkway with circular imprints (Source: AH 100_9836)

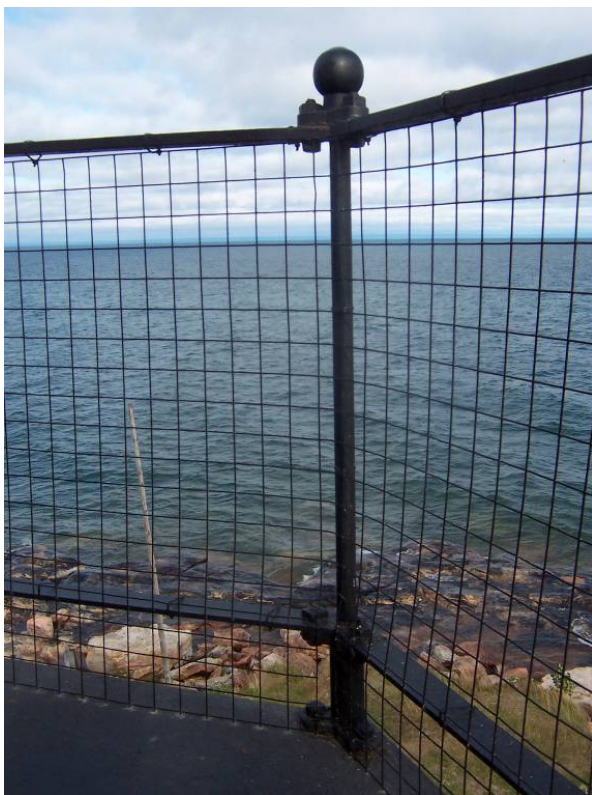
SI-LSQ-36: Lantern walkway and railing (Source: AH 100_9835)

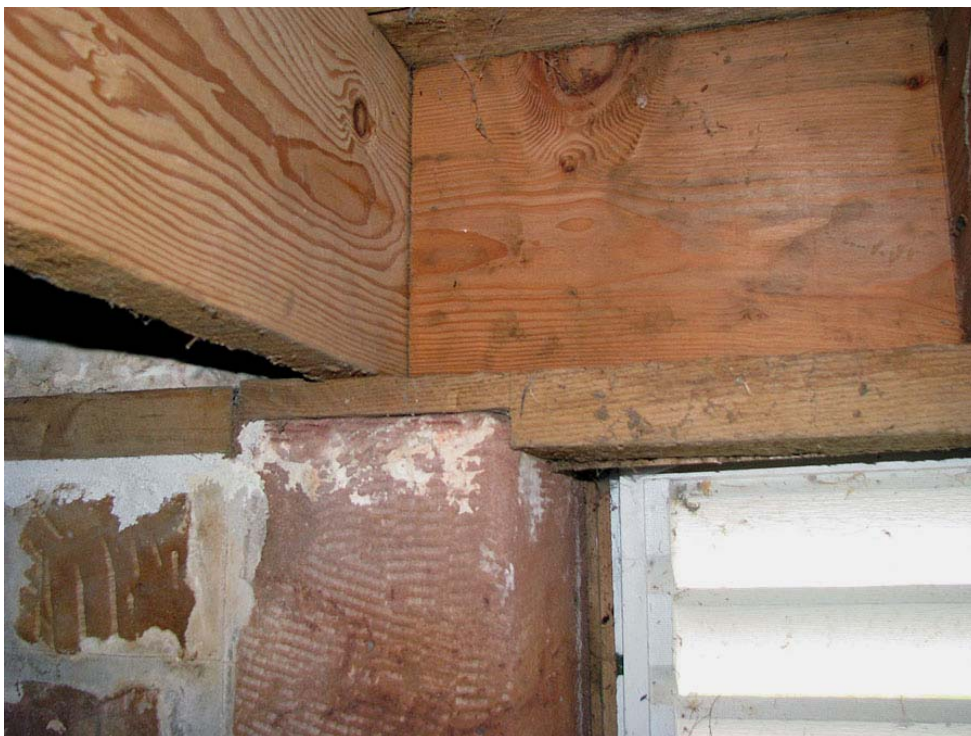
SI-LSQ-37: Joist header above window at basement (Source: Martin/Martin)

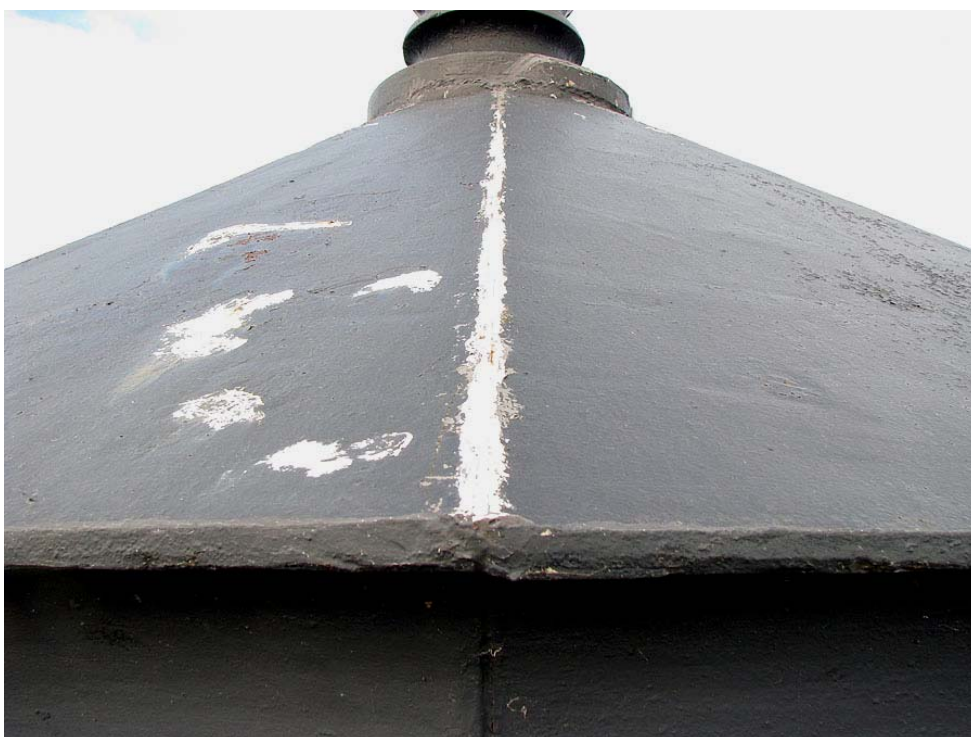
SI-LSQ-38: Sealed joints in roof (Source: Martin/Martin)

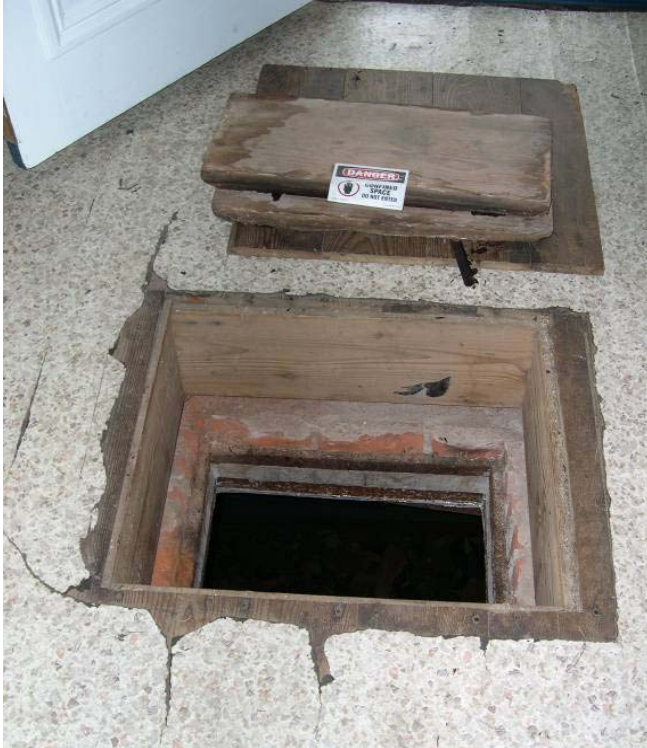
SI-LSQ-39: Cistern opening in summer kitchen floor (Source: Martin/Martin)

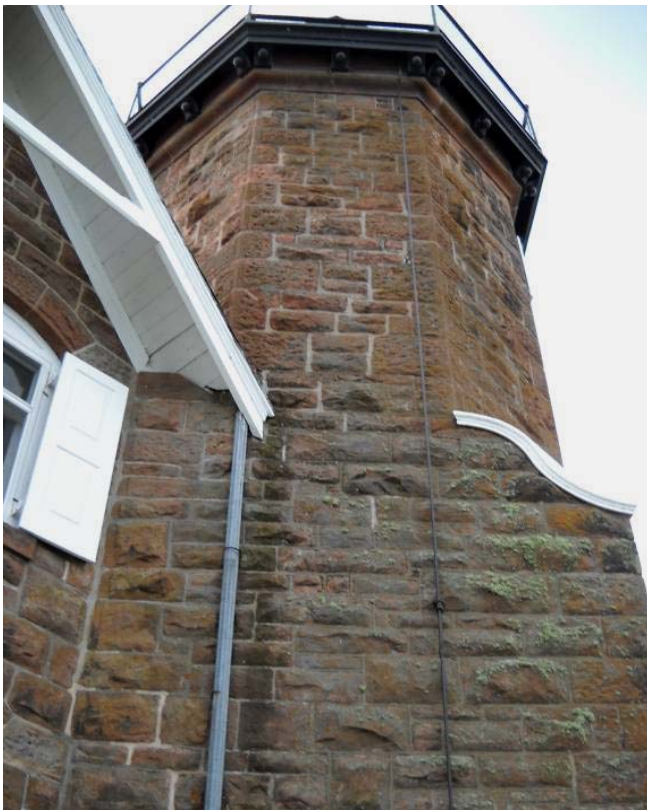
SI-LSQ-40: Lightning protection, historic grounding conductor with insulator (Source: RMH)
