VOLUME VI OF VI: SAND ISLAND CLR/HSR

APOSTLE ISLANDS NATIONAL LAKESHORE
LIGHT STATIONS OF MICHIGAN ISLAND, OUTER ISLAND, DEVILS ISLAND,
LONG ISLAND AND SAND ISLAND

JULY 2011

**CULTURAL LANDSCAPE REPORT, HISTORIC STRUCTURE REPORT
AND
ENVIRONMENTAL ASSESSMENT**

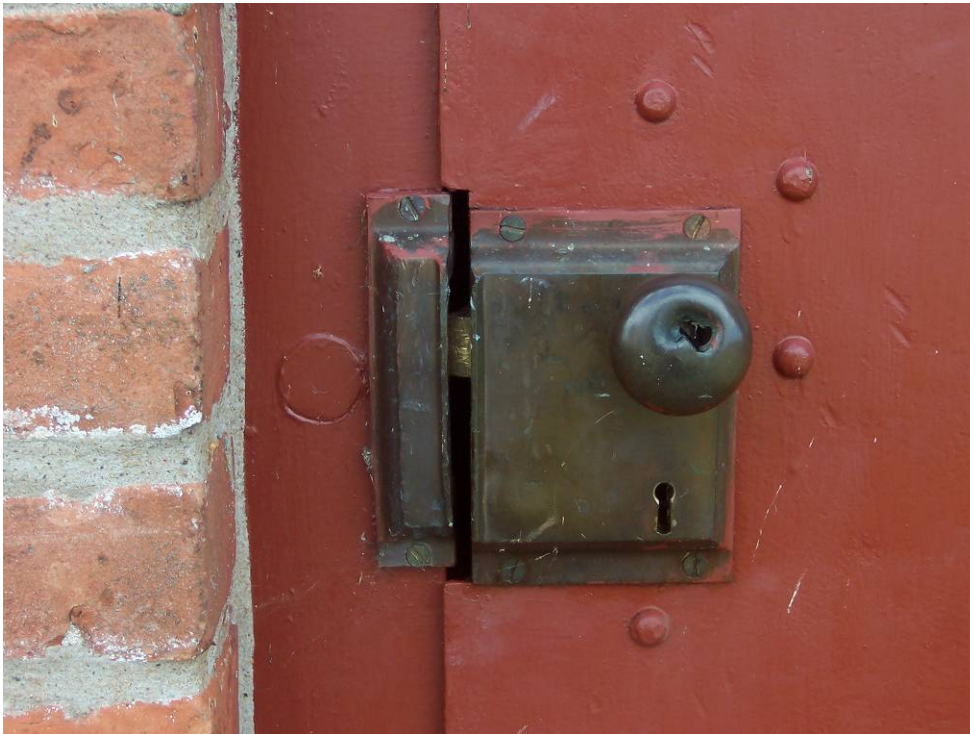
The door knob is damaged and does not function.

SI-OB-06: Entry door hardware detail (Source: AH 100_9880)

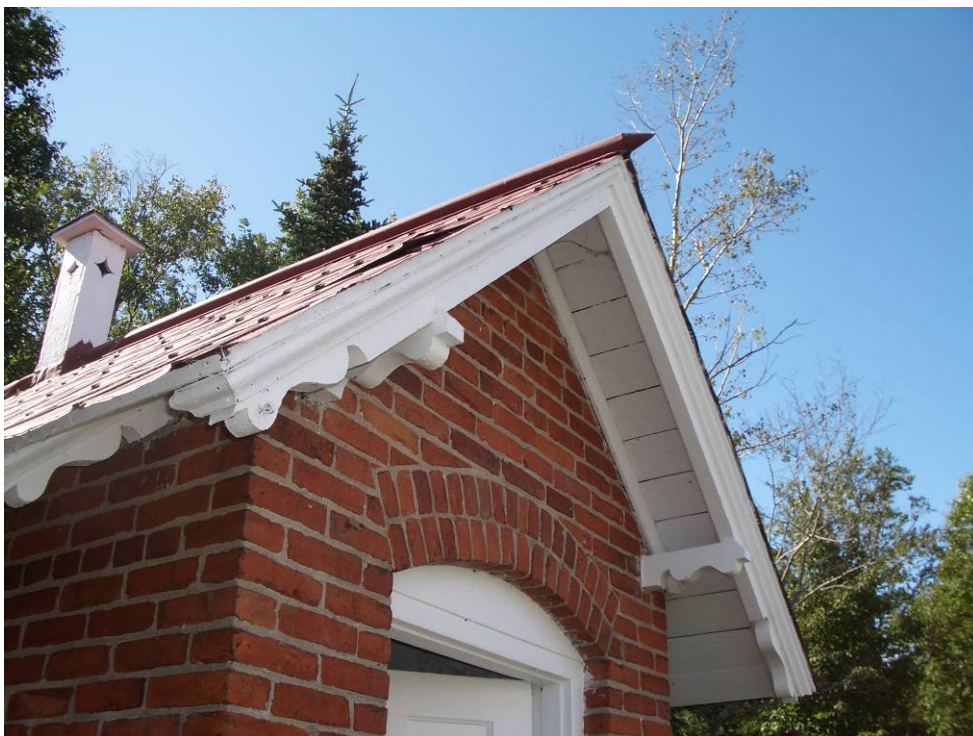
SI-P-06: East wall and window (Source: AH 100_9873)

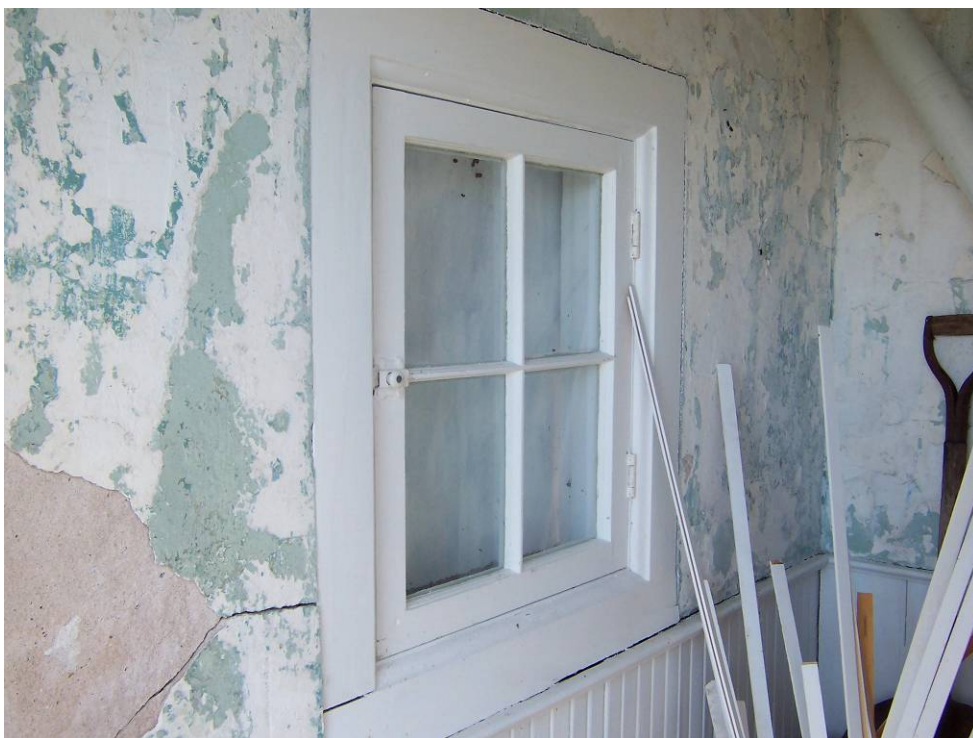
SI-P-07: Window hardware (Source: AH 100_9874)
