# Historic Structure Report

**The Blackwell School Alliance Board**

**UTSA** College of Architecture,  
Construction and Planning

Date : 04.24.19

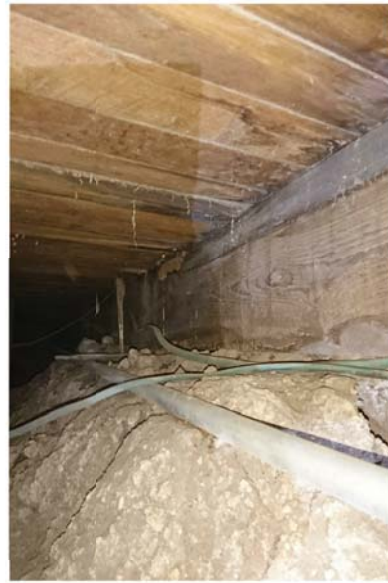
**2** Rubble wall foundation has been modified and partially removed in this location for installation of indoor restrooms.

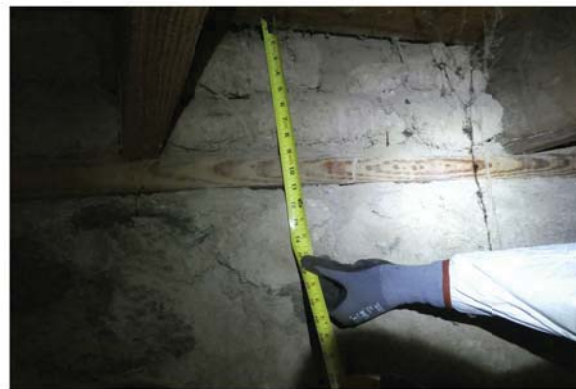
**5** Adobe wall assembly stops approximately 1'-0" below the finished floor above and is supported on stone wall footing.

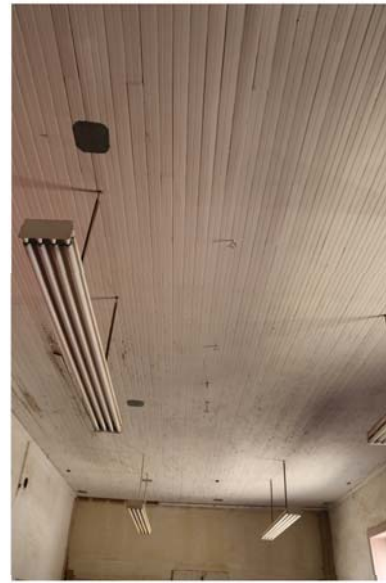
**3** Various holes and patches appear in the ceiling. Retain all existing light fixtures in the museum room and blue room.

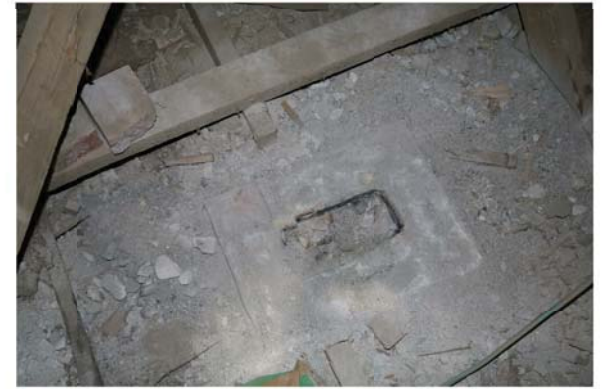
**5** Embedded into the top of the adobe wall is the remains of an old brick chimney that has been removed.

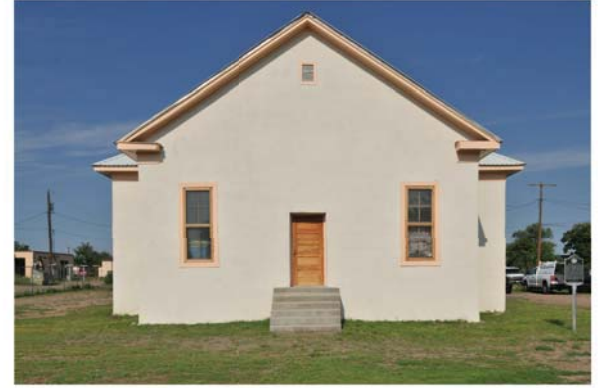
**5** East elevation has been modified from original arch entry.

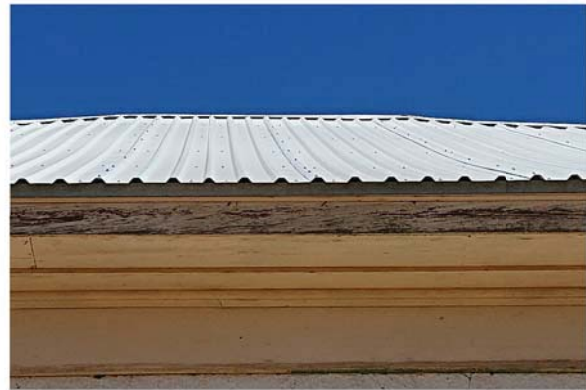
**1** Ridge is out of true and sloped plane bows downward.

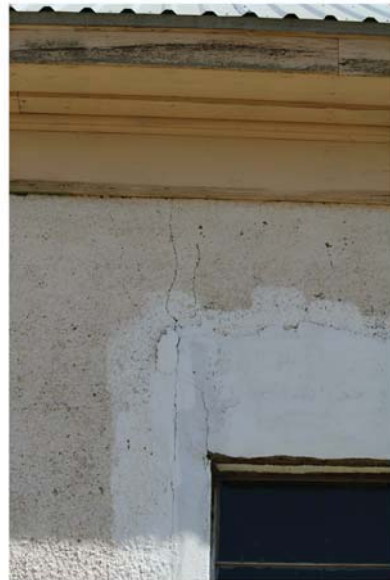
**4** Modifications to the original window openings are visible at the stucco patching.

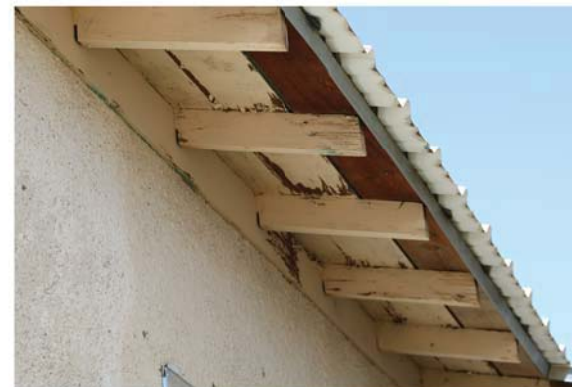
**1** Rafter tails are deteriorated and exposed roof deck boards have been replaced.

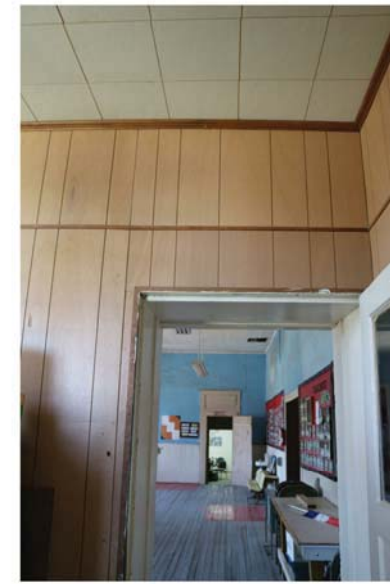
**5** Wood veneer paneling covers original transom which is still intact and can be seen from other side.

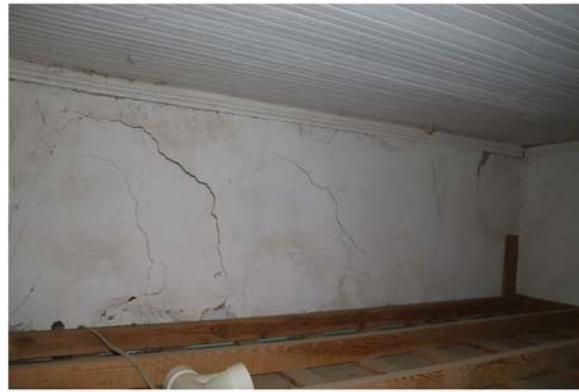
**1** South wall above dropped ceiling at office area. Wall shows numerous cracks not seen below the ceiling due to the installation of paneling on lower portion of wall.

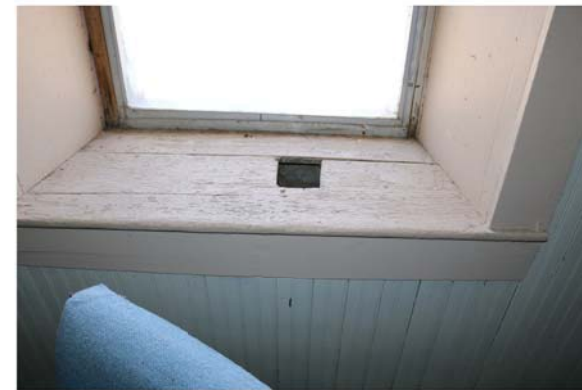
**5** The deep window sill, or stool, is rounded and sits above the window apron. The stool has been cut for an unknown reason.

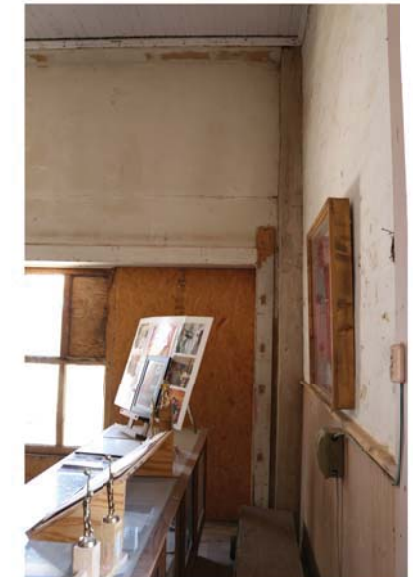
**6** Concrete columns support the roof structure above, but do not bond with the adobe construction.

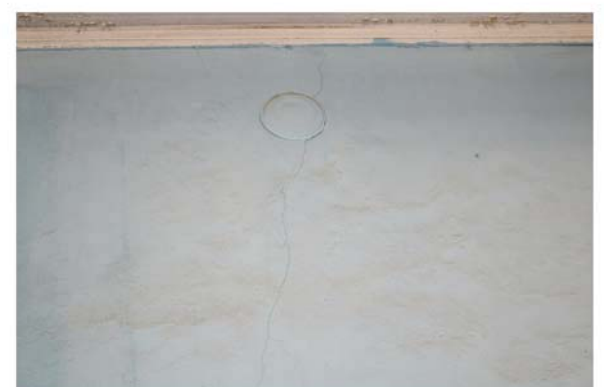
**7** Metal plate caps opening for flue.

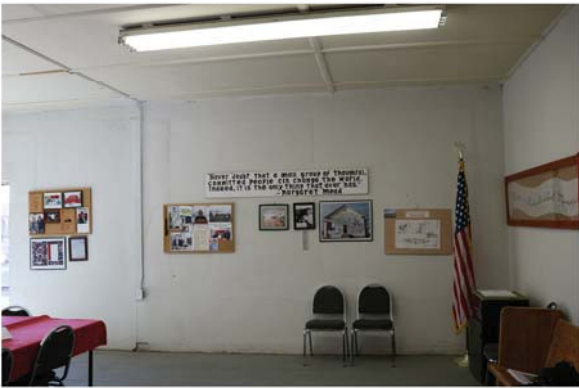
**4** Five windows were previously blocked. The ghost of the openings is visible.
