HISTORIC STRUCTURES REPORT

FORT HANCOCK QUARTERMASTER STRUCTURES, 1900-1918

SANDY HOOK UNIT, GATEWAY NATIONAL RECREATION AREA

April 1979

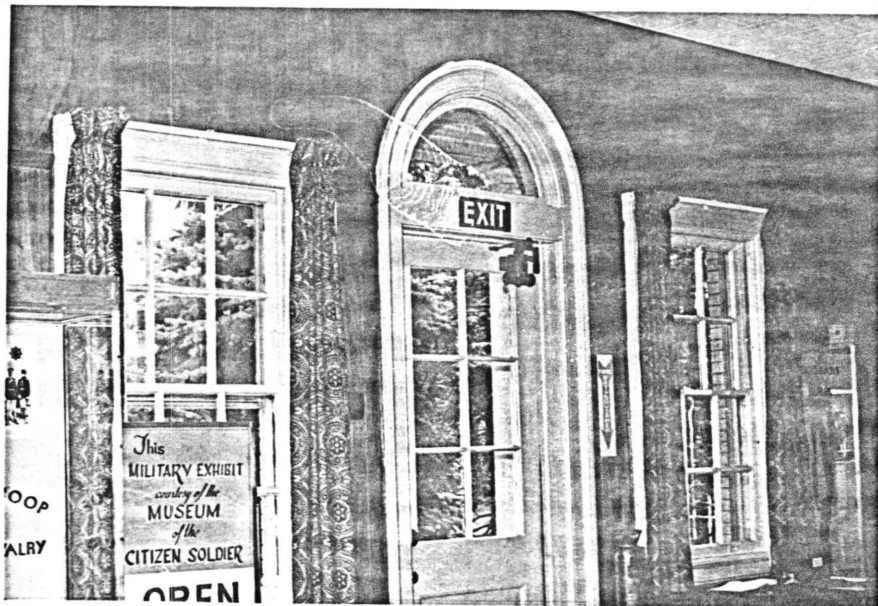
Building 40, Y.M.C.A., interior. Front door.  
S-2 15A

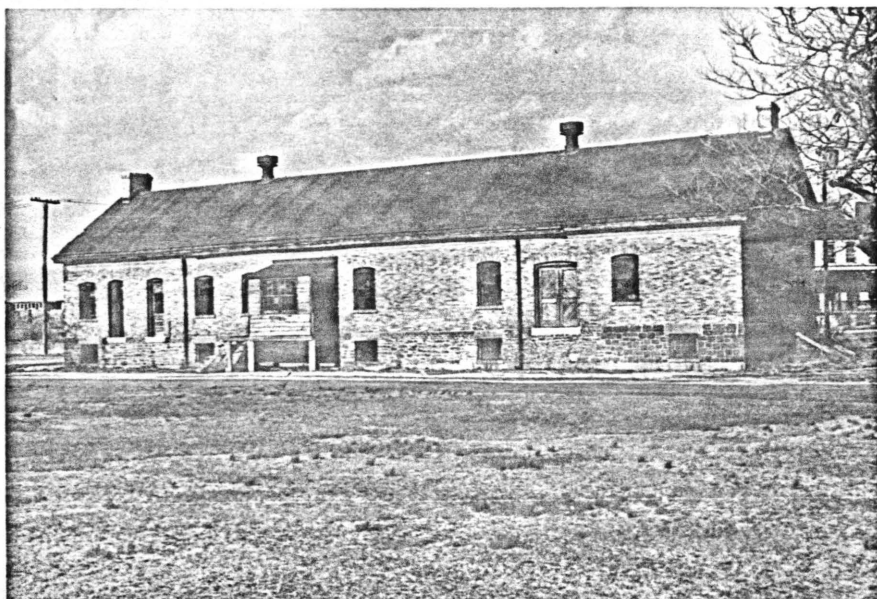
DW 11/79 FH3

The condition of the exterior walls and foundation has seriously deteriorated. There are areas of masonry damage in particular where the loading docks have been removed which are allowing moisture penetration. Unique to this building is the wholesale discoloration which has occurred to the face brick. Possibly the brick used in constructing this building was inferior to other brick used on post. The entire wall surface is darkened to some extent, with individual bricks having darker discoloration than others, resulting in a mottled appearance. Mortar joints are not

Ironwork at the windows has rusted severely in the corrosive atmosphere, and staining of the brickwork has resulted. Window sash are deteriorated and many windows have been vandalized. The original slate roof remains but has areas of damaged shingles. Sections of the ridge cap are missing entirely. Serious damage to the cornice and built-in gutters is evident. Roof ventilators are rusting badly. Doors are unpainted and rotting. On the west side, the middle loading doors have been enclosed by a frame vestibule, which is rotting and coming apart.

Building 47, Subsistence Storehouse, west side.

1. Remove vegetation from the east facade and perimeter of the building.
2. Remove west wood porch addition and provide simple, temporary wood stairs. When money becomes available, build platform to match original plans.
3. Repair/replace damaged slate shingles and ridge roll.
4. Repair/replace gutters and leaders.
5. Rebuild/repair cornice assembly.
6. Repair/replace roof ventilators.
7. Replace damaged flashing.
8. Replace missing face bricks and repoint exterior masonry, including chimneys. Clean masonry with brushes and light detergent solution.
9. Repair window sash to sound operable condition, reglazing as necessary.
10. Prepare and paint exterior wood and metalwork, paying particular attention to iron bars at window openings.
11. Provide wood screens and wood storm windows (on interior, due to iron-bars).

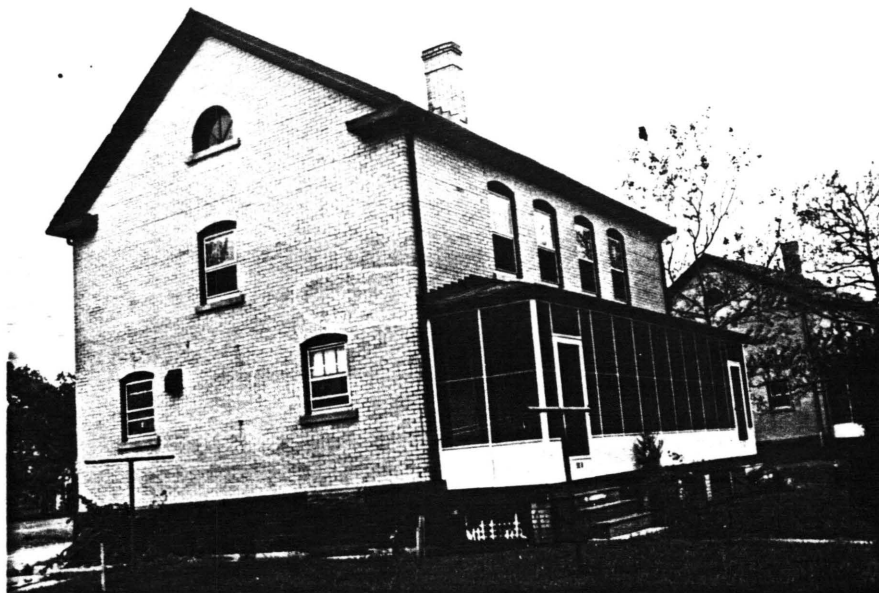
Building 52, N.C.O. Qtrs., Northwest view, showing  
aluminum porch enclosures. FH 9/78 B-2 24

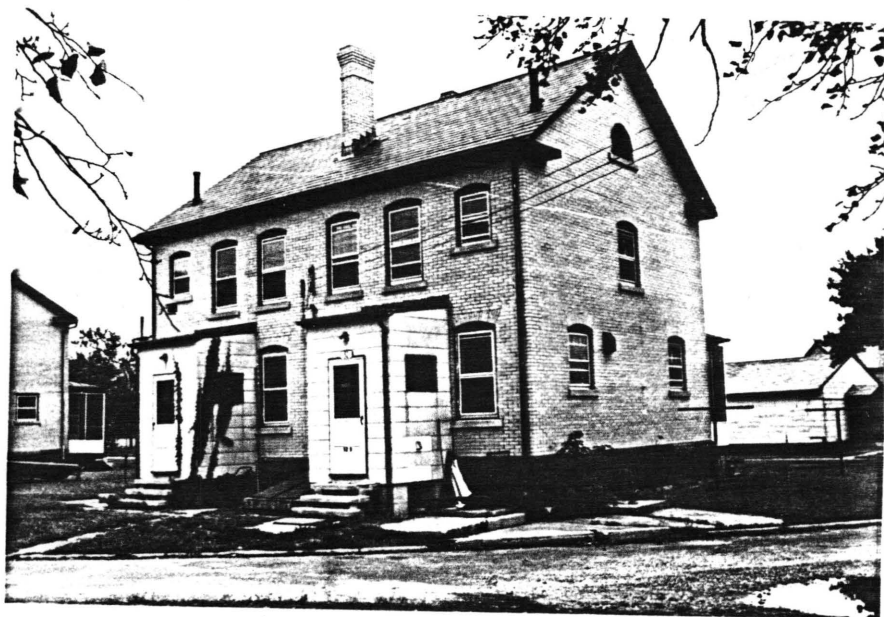
Rear elevation, showing basement areaway and enclosed  
rear entries. FH 9/78 B-2 22

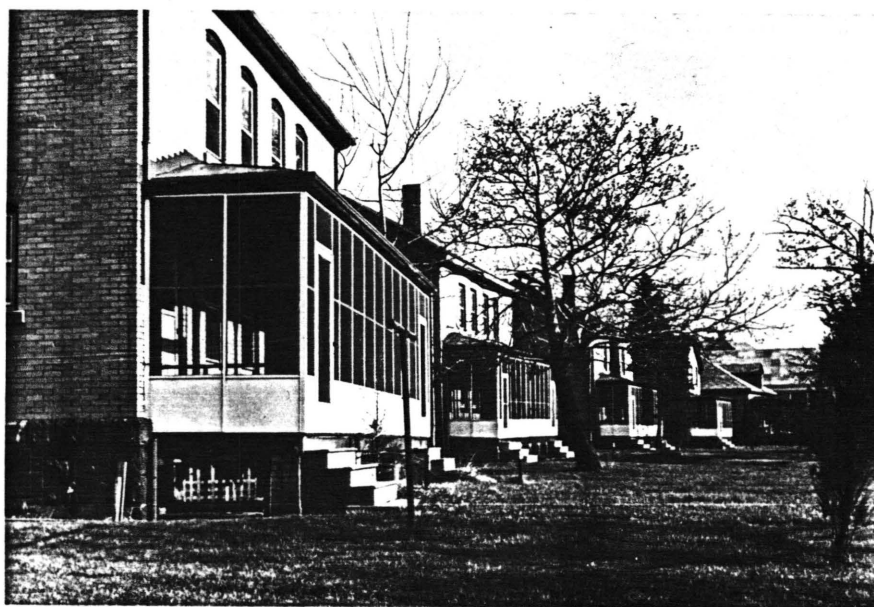
L to R: Buildings 52, 30, 29, 64, 28, 40. View along  
Kearney Road looking south. 4/79 FH

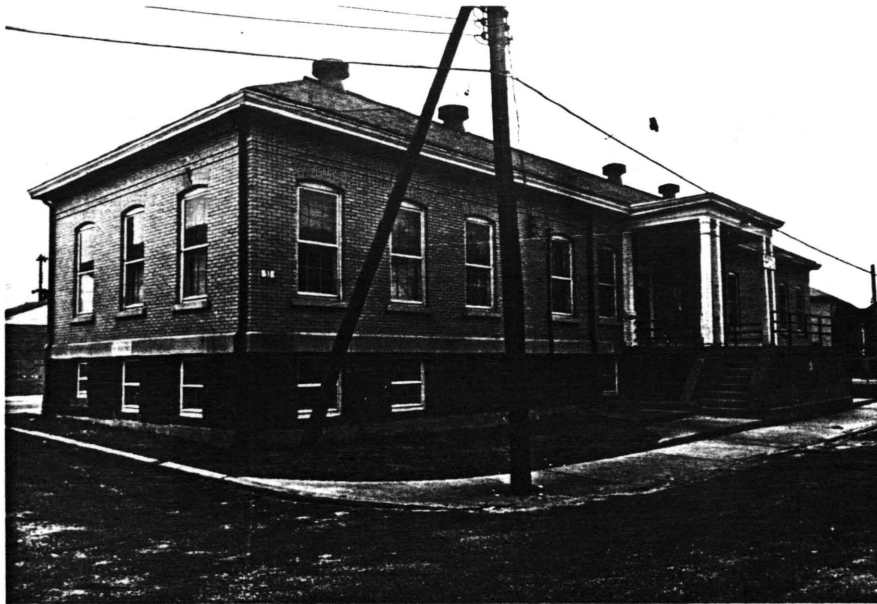
Building 53, Post Exchange, northwest view. DW 4/79 FH1

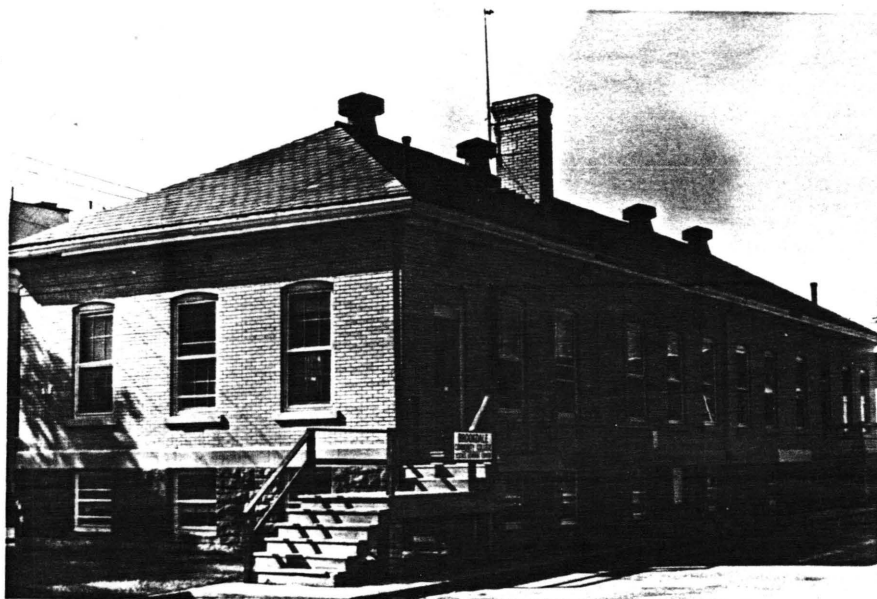
Southeast view. FH 9/78 B6 15.

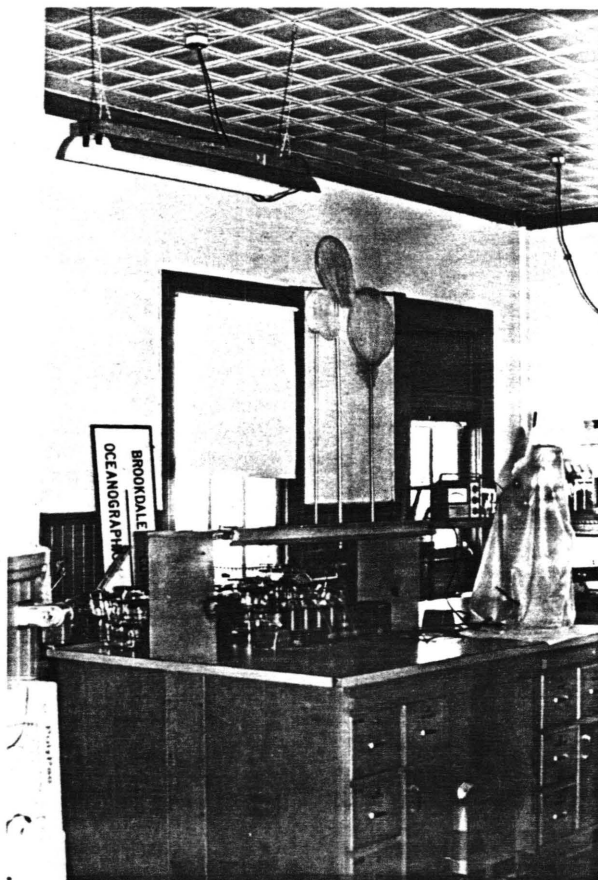
FH 9/78 B-6 7

Interior view, laboratory.

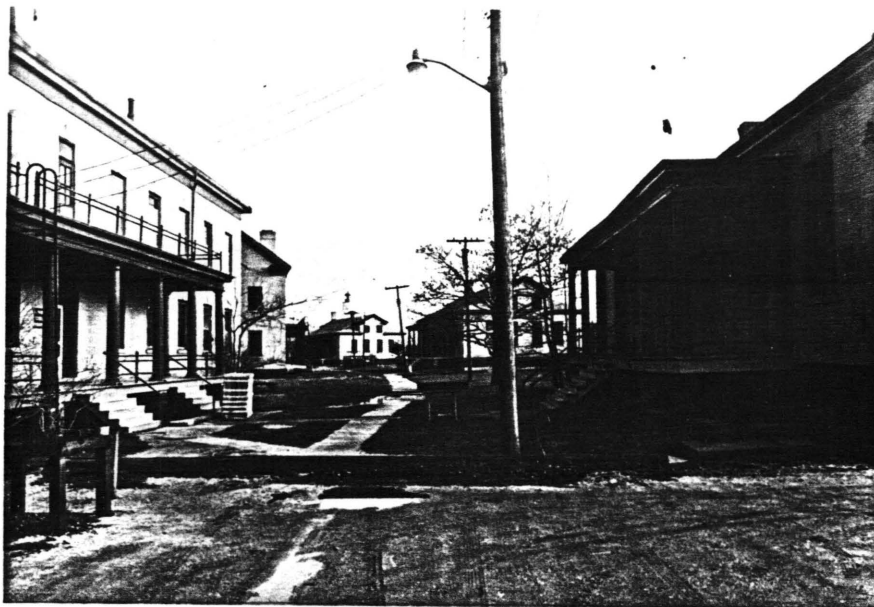
View northward. Barracks 22 on left, mess hall 55 on right.  
4/79 FH6

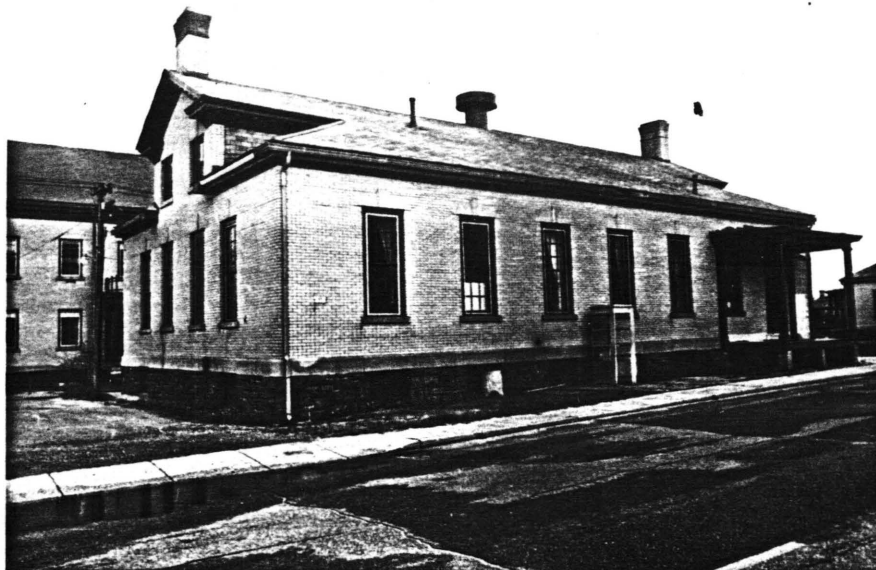
Building 55, Mess Hall, southeast elevation. 4/79 FH6

Much of the original cornice has been replaced with plain metal flashing and gutters are in poor condition. Erosion of mortar joints, particularly in the water table and foundation, has been severe. There are large settlement cracks in the wall around windows on the east, and there is some brick displacement on the south wall. The rear porch has been removed entirely and replaced by wood stairs leading directly to the kitchen door. Patching of brickwork where original porch joined the building includes some red brick infill. The south chimney is missing entirely.

1. When present roofing deteriorates reroof with slate grey asphalt shingles.
2. Repair/replace gutters and downspouts.
3. Repoint eroded masonry. Rebuild south chimney.
4. Repair/replace flashing.
5. Patch, prepare, and paint west porch deck.
6. Rebuild east porch to match existing on other mess halls.
7. Replace rusting steel lintels.
8. Provide wood storm windows. Provide wood screens - repair existing where possible.
9. Provide (new or repair existing) frame and sash for basement windows.

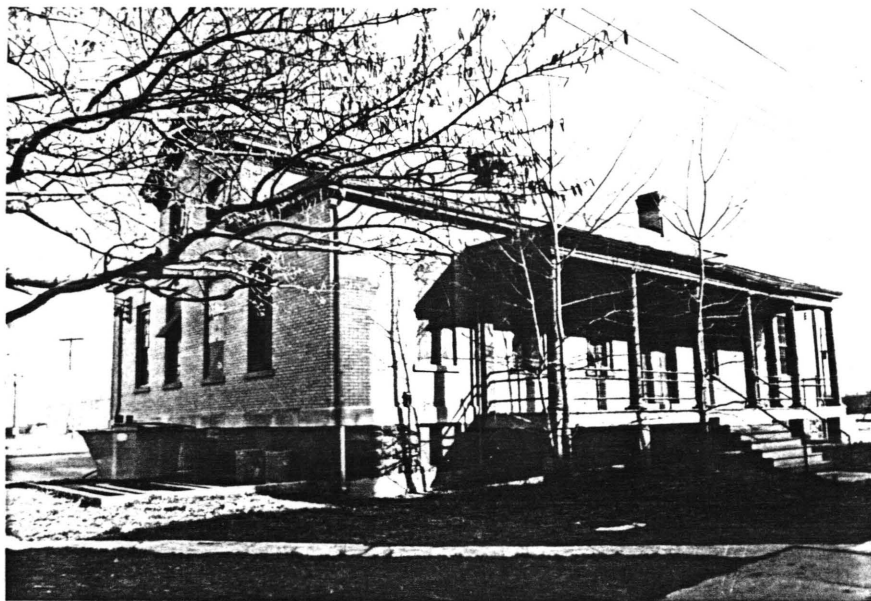
Northwest elevation.

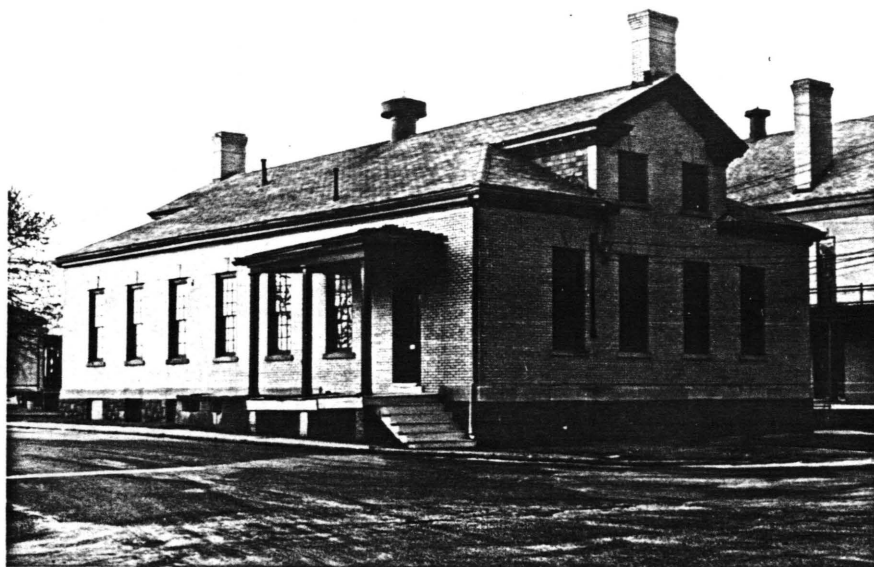
Building 58, Mess Hall, northeast view. Building is right on curb of Magruder and Hudson Roads. 4/79 FH6

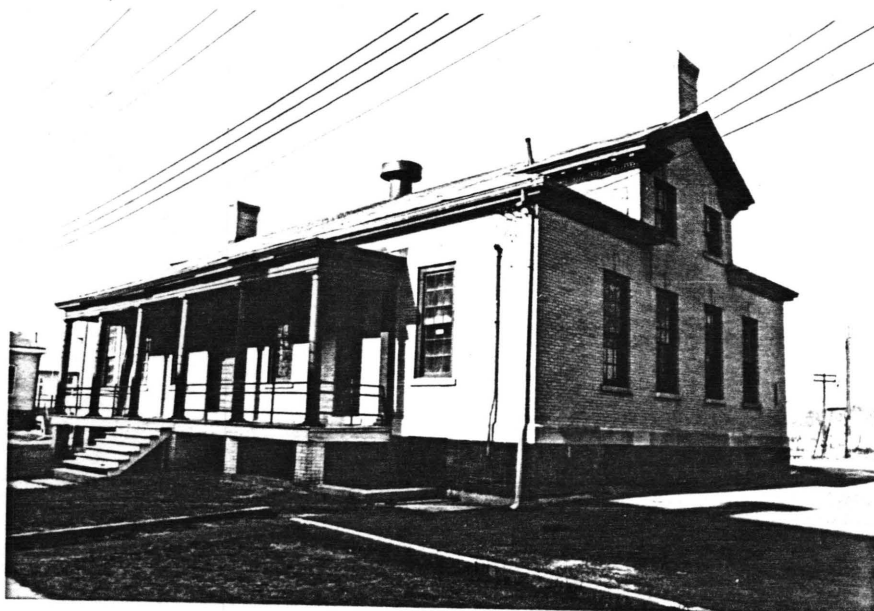
Southwest view. Note two separate electric service entries for these buildings. 4/79 FH 3

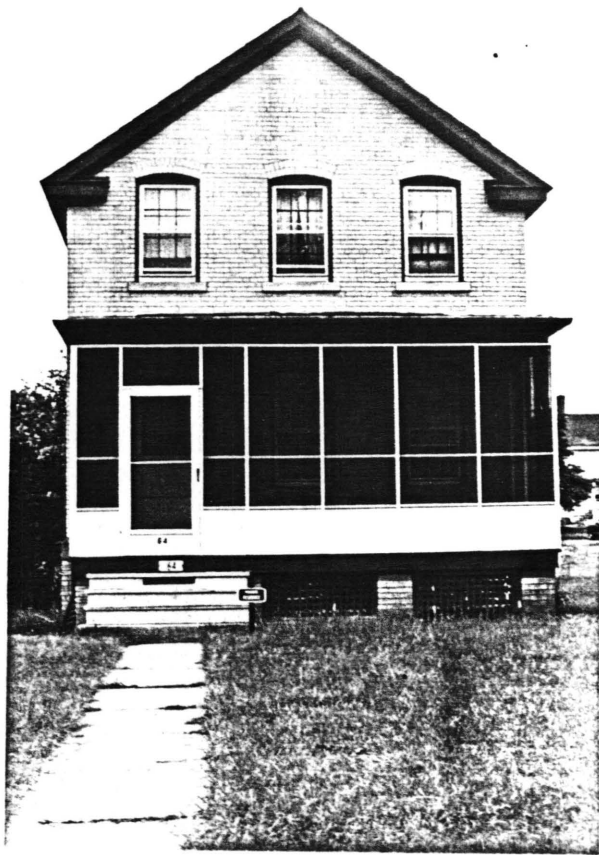
Bldg. 64, N.C.O. Qtrs.,  
Front (west) elevation.  
S-1 20  
Southeast view. S-2 31A

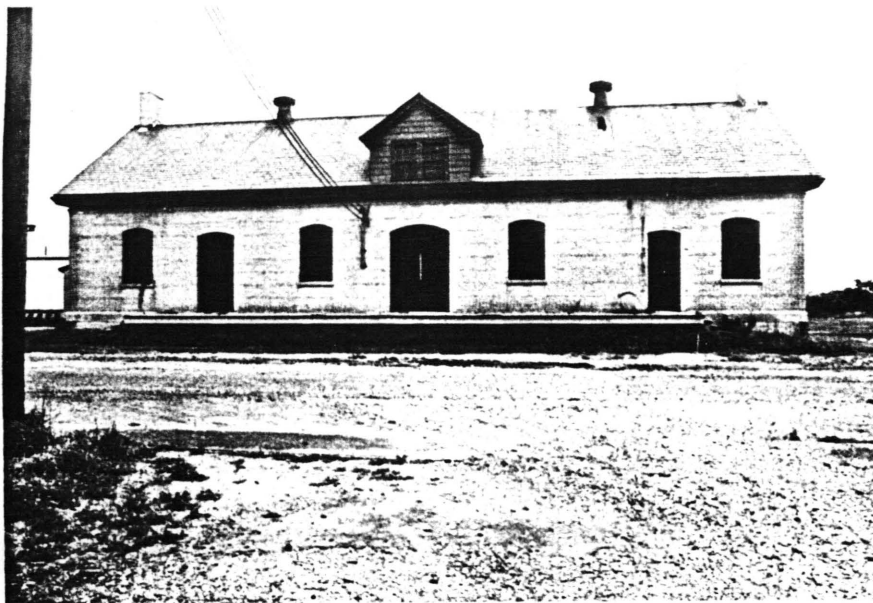
Building 65, Ordnance Storehouse, west elevation.

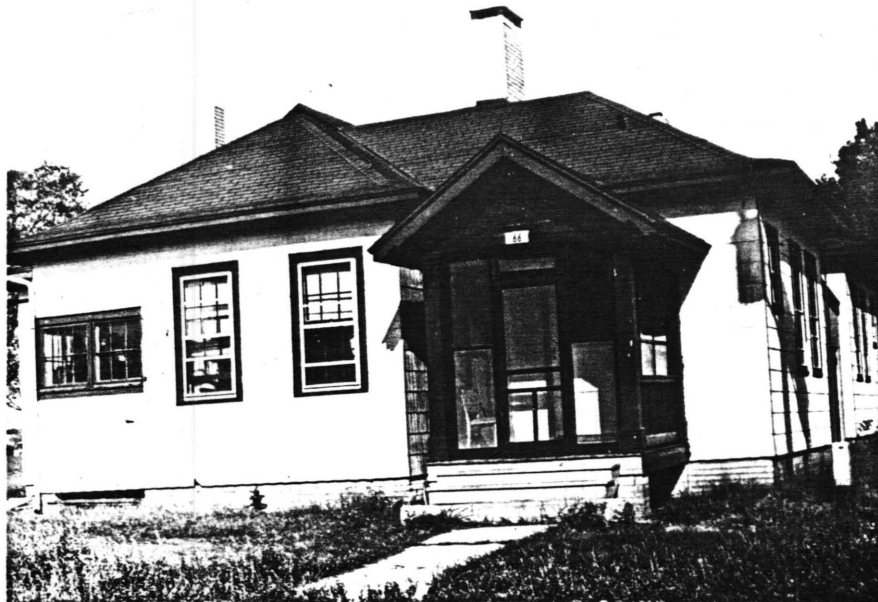
FH 9/78 B-8 3

Building 66, Civilian Quarters, southwest view.

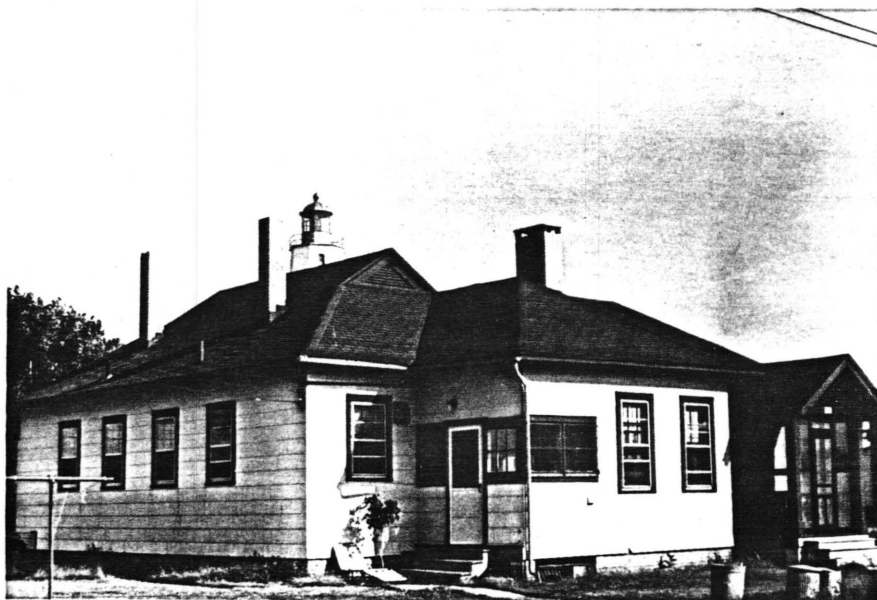
FH 9/78 B-8 5

Northwest view.

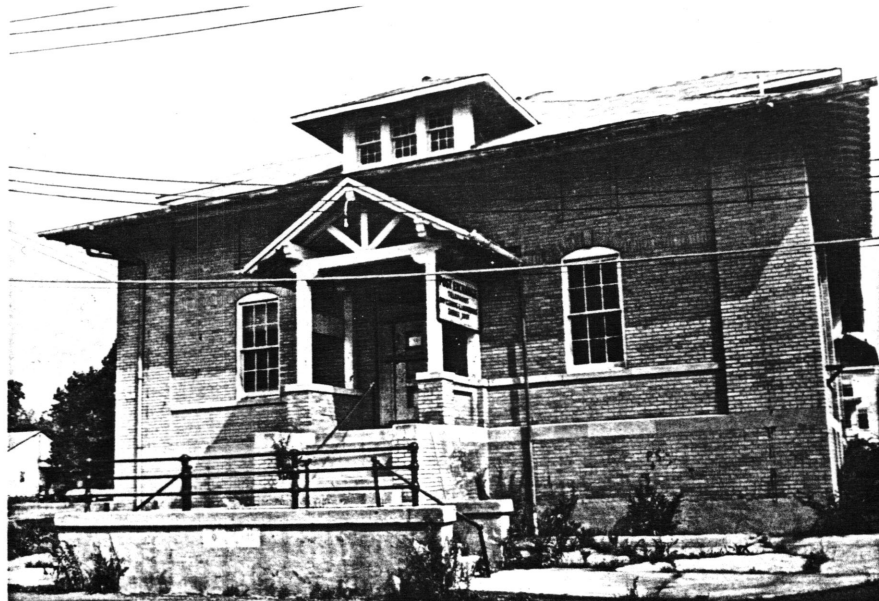
Building 70, Gymnasium and Bowling Alley,  
front (west) elevation. S-8 1

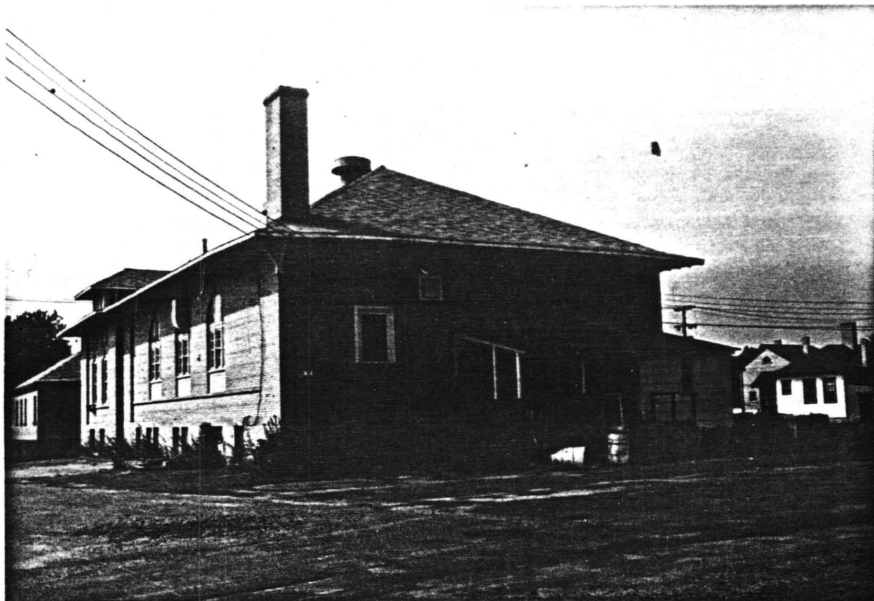
Building 70, Gymnasium and Bowling Alley,  
southeast view. S-8 7

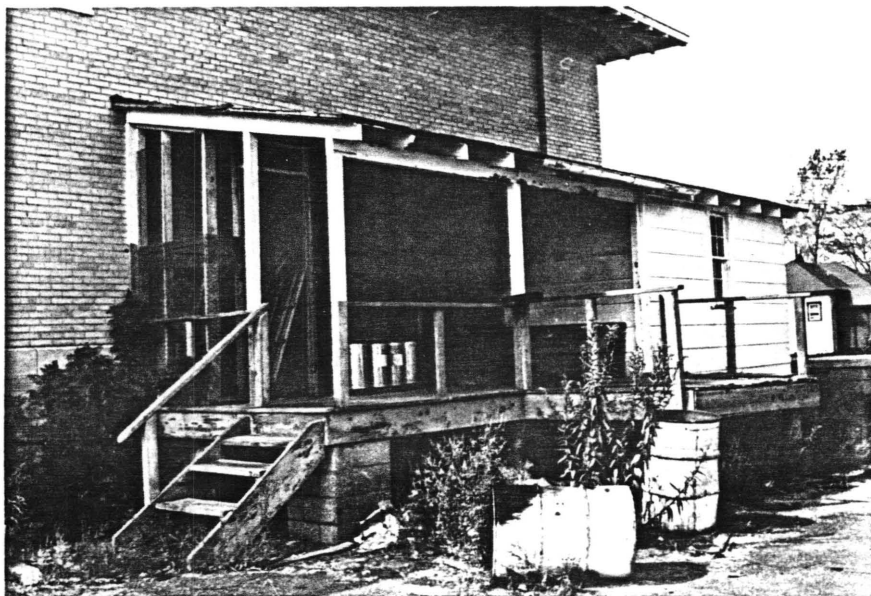
Detail, shed roof rear addition. S-8 8

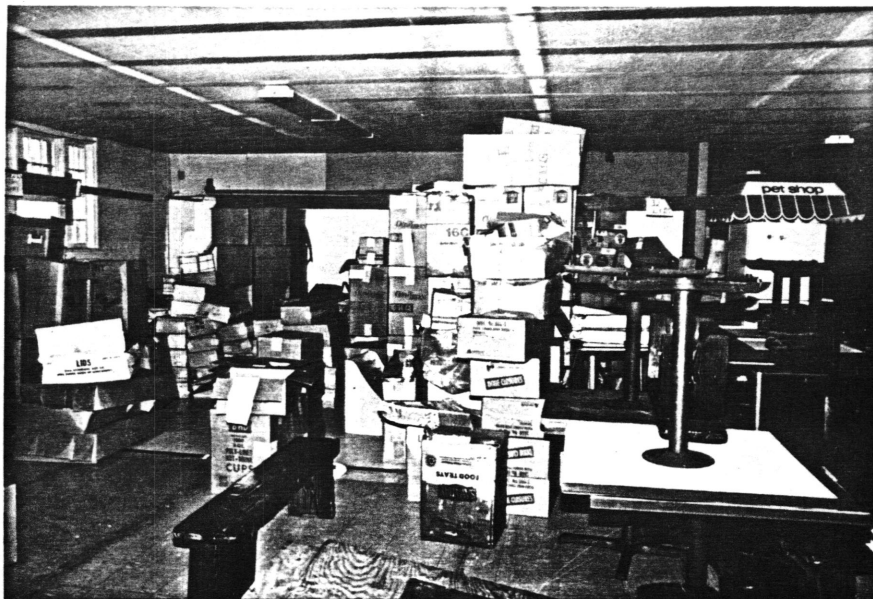
Building 70, Gymnasium and Bowling Alley,  
Gym interior, with dropped ceiling and asphalt  
tile floor. Current use: Concessionaire storage  
4/79 FH6

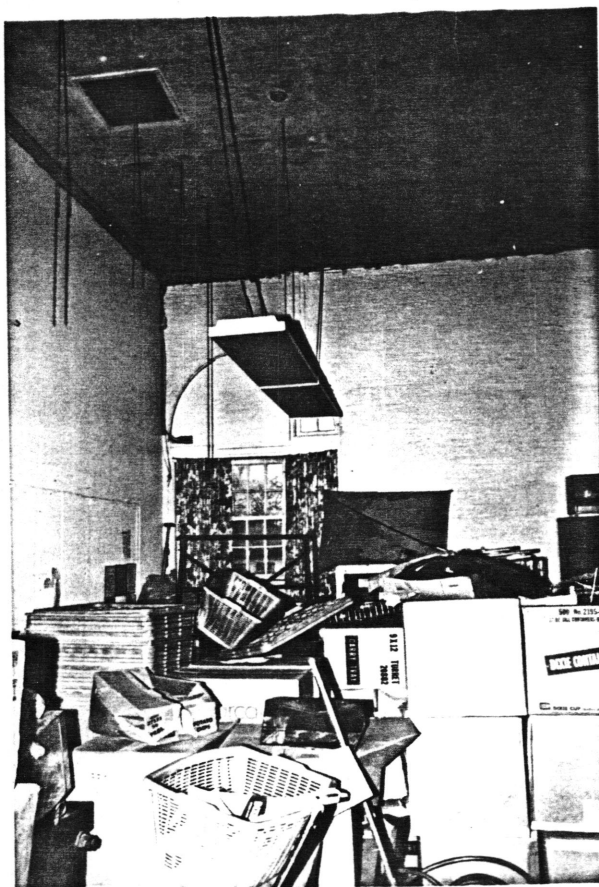
Northeast corner of  
gym, room partitioned  
off from main space,  
with full-height  
ceiling.  
4/79 FH6

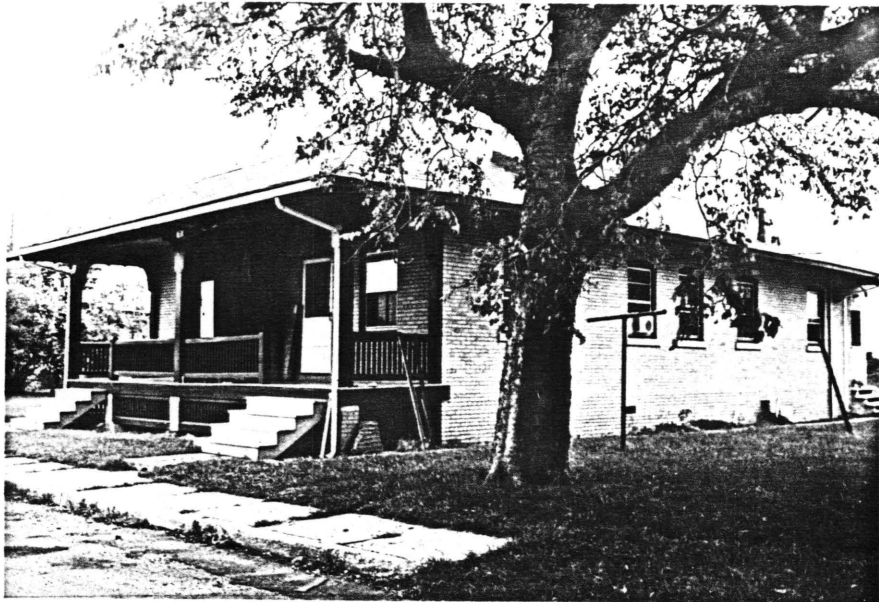
FH 9/78 B-2 15

Building 71, Firemen's Quarters, southwest view.

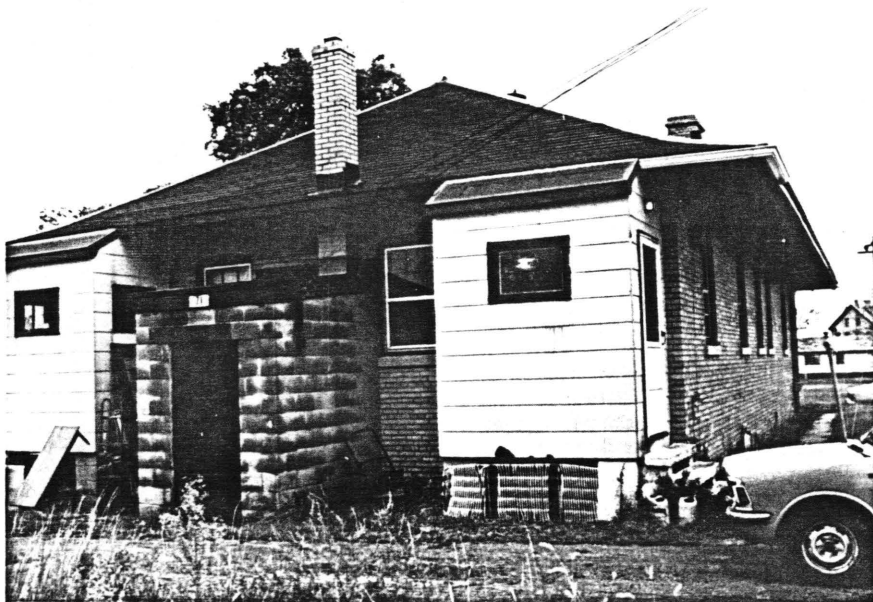
FH 9/78 B-2 9

Rear of duplex, showing furnace room addition at center.

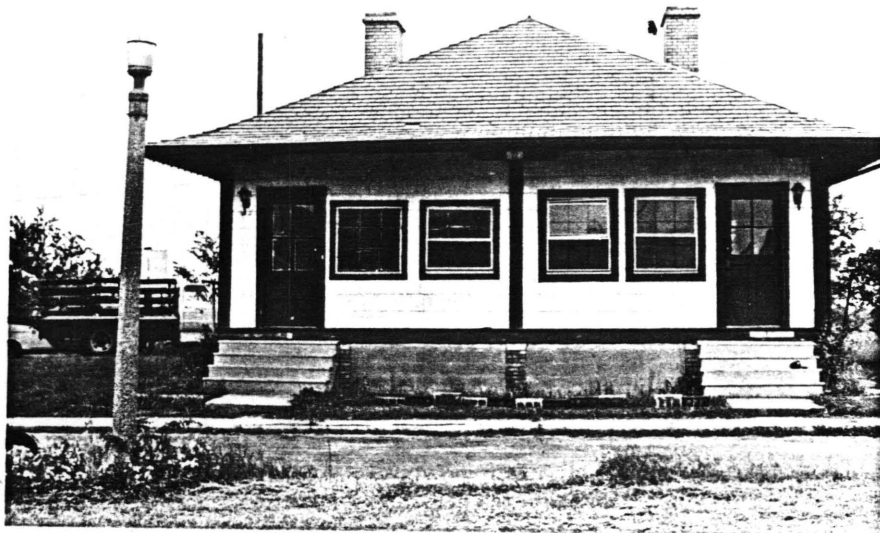
Building 72, N.C.O. Duplex Quarters, front elevation.  
S-1 23

The historic appearance of this building remains intact, the only intrusion being the asbestos-sided walls added to enclose the rear porch. Mortar has greatly deteriorated, especially at the water table. The slate roof is in fairly good condition with some slates missing on the east slope.

1. Repair slate roof.
2. Repoint eroded masonry.
3. Reflash where necessary.
4. Repair window sash to sound operable condition.
5. Provide wood screens and wood storm windows.
6. Remove vegetation from building perimeter.

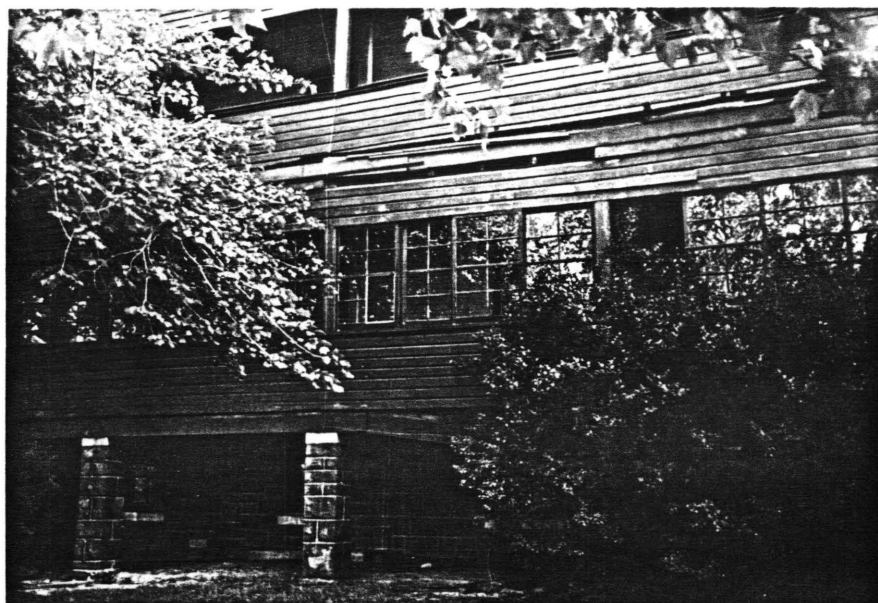
Building 74, Two-Company Barrack, detail, front (west) porch. Siding and sash date from 1940. S-3 8A

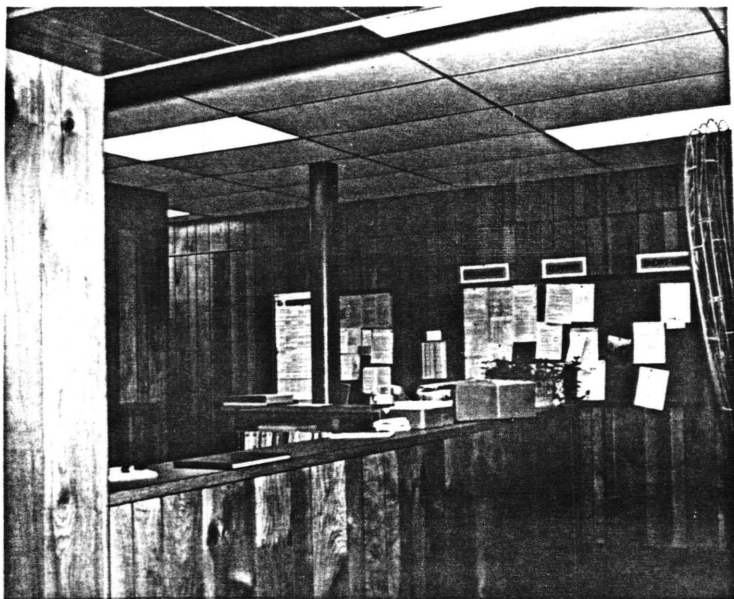
Detail of remodeled interior, with dropped ceiling  
and veneer paneling hiding original room finishes.  
S-3 24A

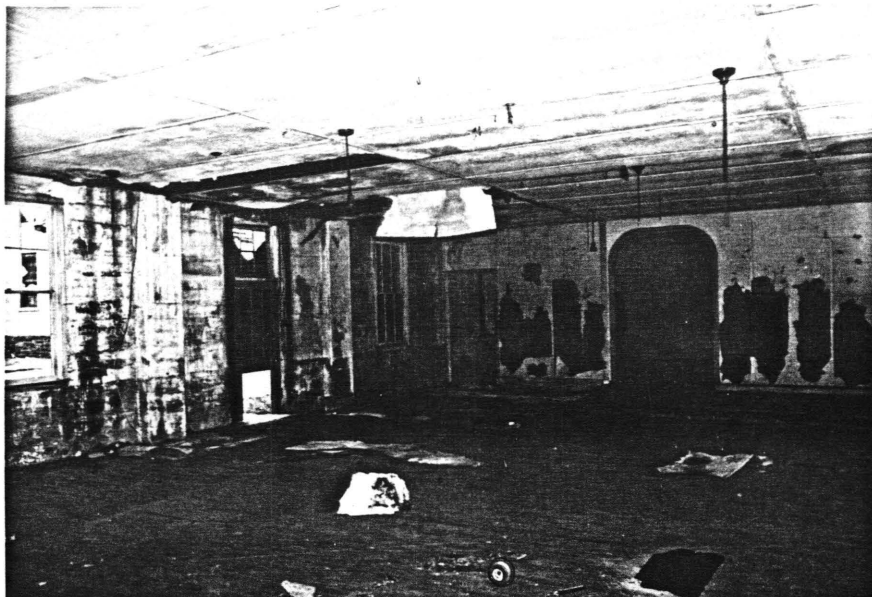
from fire, but intact. The main room, originally a laundry and later a garage, has been altered by the addition of a wood floor built on sleepers, a new east-west partition, and furred walls. The original plaster wall surface remains underneath the new wall, and has a gray painted wainscot with a pinkish cream wall color above. The wood flooring is missing entirely in sections. In the north end of the building the rooms retain their wall finishes, but all have suffered from weather. Several steam radiators remain in the building. On the east side of the structure are boiler rooms and a large garage.

Building 77, PX Laundry, major room. Partition  
with arched opening is not original to building.  
4/79 FH1

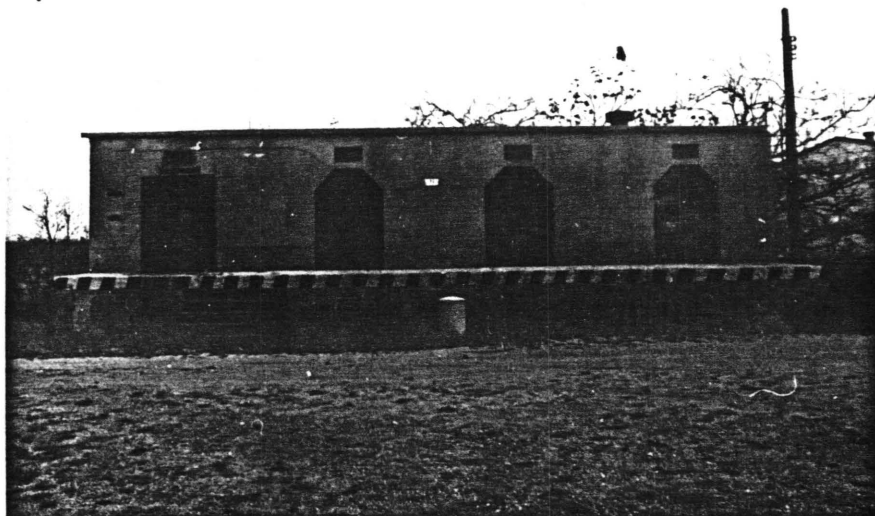
Some deterioration has occurred as well as minor changes. The northernmost door was framed down to fit a standard single door with 4 lights and 3 panels, and lights above the doors have been sealed with plywood. Concrete is spalling off along the short overhang of the roof and three of the roof ventilators are missing. Walls and foundation at the east and west have some long cracks and deteriorating sections. From an earlier photograph the ~~porch~~ <sup>PLATFORM</sup> appears to be wood frame with wood stairs at the south end. The present ~~porch~~ <sup>PLATFORM</sup> is reinforced concrete with sound wooden stairs located in front of the northern of the entry doors.

Building 79, Oil and Paint Storehouse.  
West elevation. S FH3

1. Remove damaged concrete from the roof structure. Wire brush any exposed reinforcing, and patch.
2. Replace roof ventilators to match historic.
3. Reglaze lights above doors.
4. Clean and patch cracking and spalling concrete at walls and foundations.
5. Remove vegetation from walls and building perimeter.

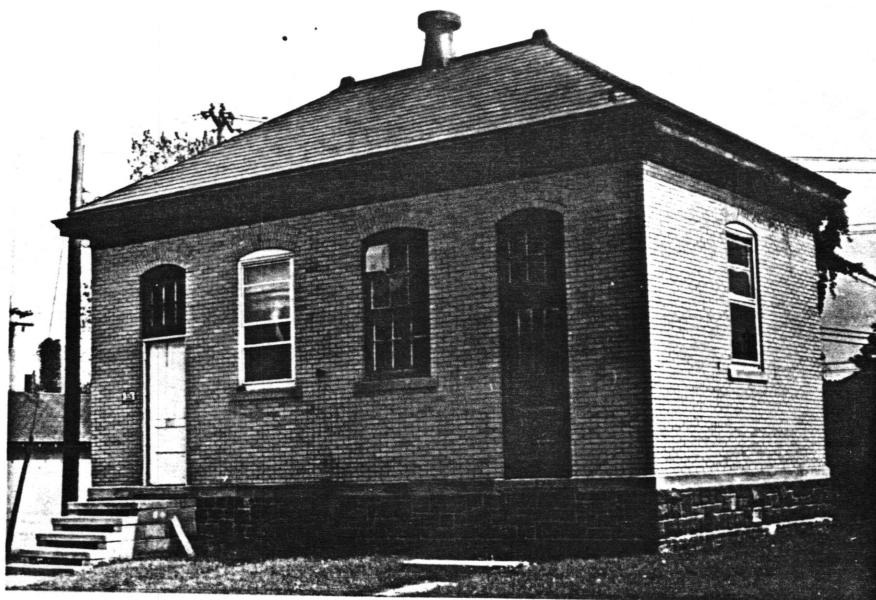
remains and is in acceptable condition. <sup>The</sup> Metal gutter-cornice assembly is severely rusted and leaders are broken or missing. (Mortar for foundation water table and walls <sup>is eroding</sup> ~~are receding~~ in spots, or missing <sup>entirely.</sup> Some separation between bricks occurs near the arch of one of the rear windows. Wood of windows and doors has suffered from the weather and is exposed and cracking in places. The western of the entry stairs <sup>has</sup> ~~have~~ been removed.

Building 326, Morgue, southwest view. FH 9/78 B-13 3

1. Gutters should be repaired and rain water leaders repaired or replaced. Rust should be removed from cornice gutter assembly and protective paint applied.
2. Doors and windows should be scraped and given a protective coat of paint.
3. REPOINT EXTERIOR WALLS.

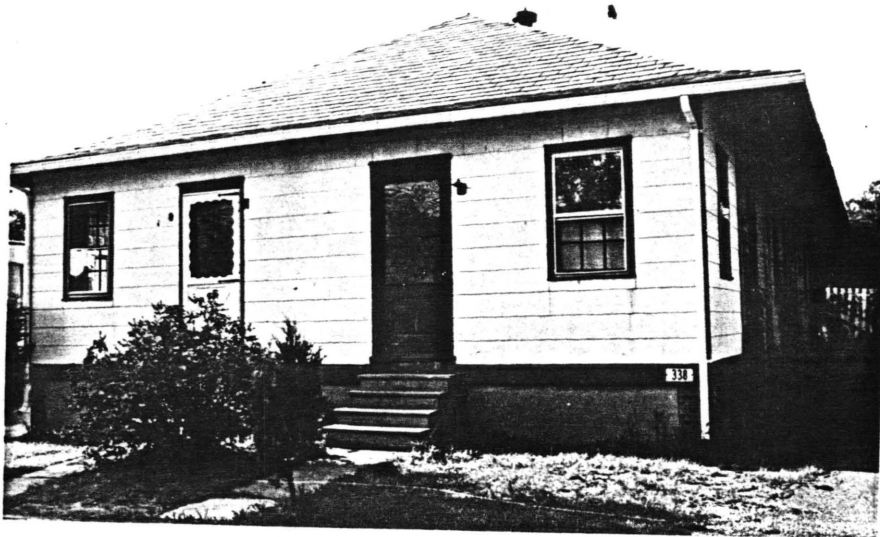
Some deterioration is visible in this building. Brick walls are solid but mortar is receding. The roof is still covered with slate. Gutters are missing at the main roof. Several windows are broken and some are boarded over.

Building 338, Duplex Firemen's Quarters,  
front (south) elevation S-4 26

1. Repair existing slate roof.
2. Repoint eroded masonry.
3. Restore front porch to original appearance by removing walls and replacing railings, posts, and decking as necessary.
4. Prepare and paint exterior wood and metalwork.
5. Provide wood screens, wood storm windows, and wood storm doors.
6. Replace/repair gutters
7. Repair damaged and deteriorated windows

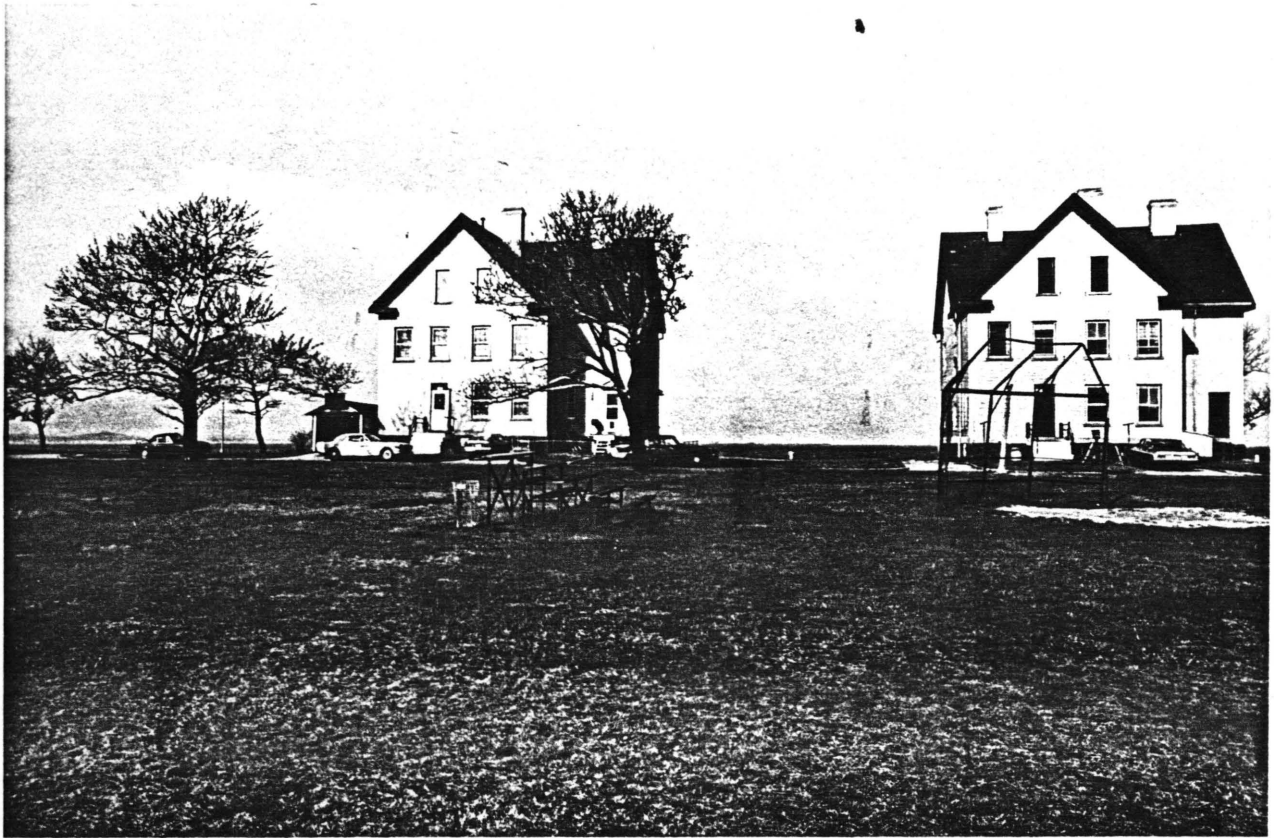
Lieutenants' Quarters 18(L) and 17(R)  
from Parade Ground, April 1979 4/79 FH6

In the foreground are the semi-fixed seating and backstop set up for baseball. The historic playing field was not on the main parade ground, but on the north parade, opposite Building 47. Building 18 has been used as housing by the Department of Commerce, and serves as a pilot for adaptive use problems and procedures. It is broken up into separate living units, the occupancy is high, and each occupant has an automobile. If the building were used as office space, the occupancy, visitation, and the resultant parking problem would be even acute. Although these buildings are well suited for adaptive use, anything other than single family residential use will turn the western edge of the parade ground into a parking lot. It is human nature to want to get as close to one's destination as possible, particularly in cold or wet weather. Parking lots 1/4 mile away will simply not work.
