# Grand Canyon Park Headquarters

## Historic Structure Report

National Park • Arizona

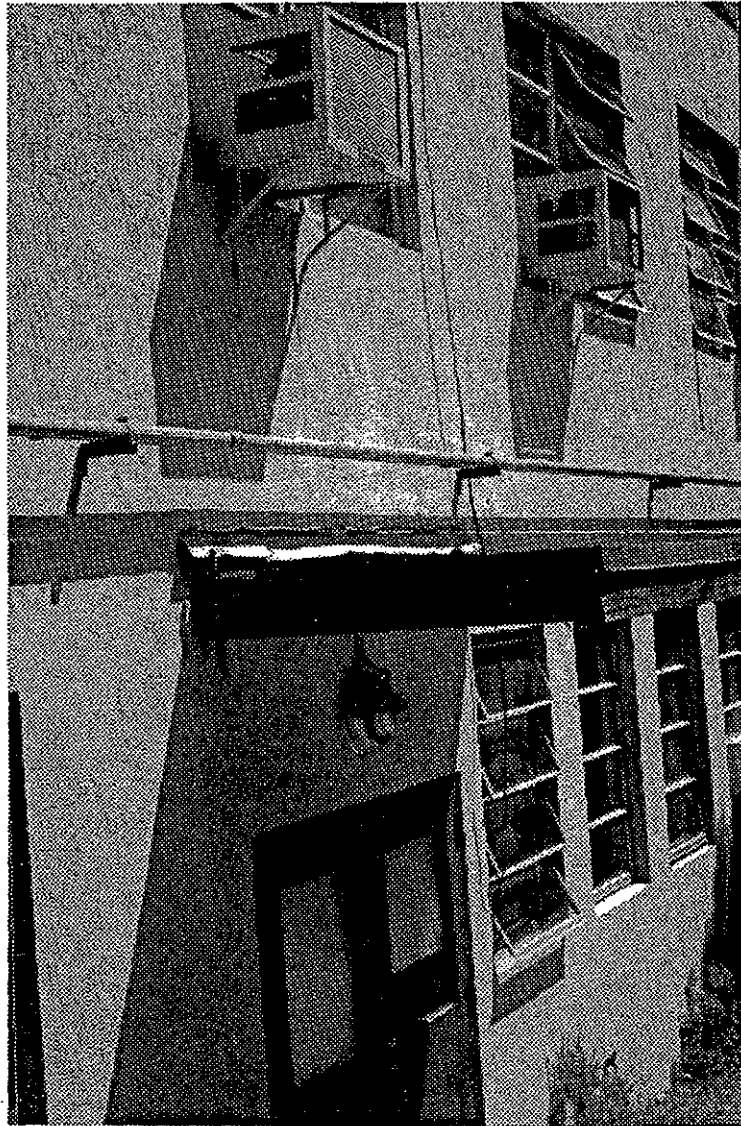
*Figure 8. Rear elevation. Door and overhang are original to the 1957 works.  
ARG Photo, dated May, 2000.*
