HISTORIC STRUCTURES REPORT
HOT SPRINGS NATIONAL PARK

PREPARED FOR THE
NATIONAL PARK SERVICE
U.S. DEPARTMENT OF THE INTERIOR

CROMWELL, NEYLAND, TRUEMPER, MILLETT & GATCHELL, INC.
ARCHITECT - ENGINEER
LITTLE ROCK, ARKANSAS

NOVEMBER, 1973

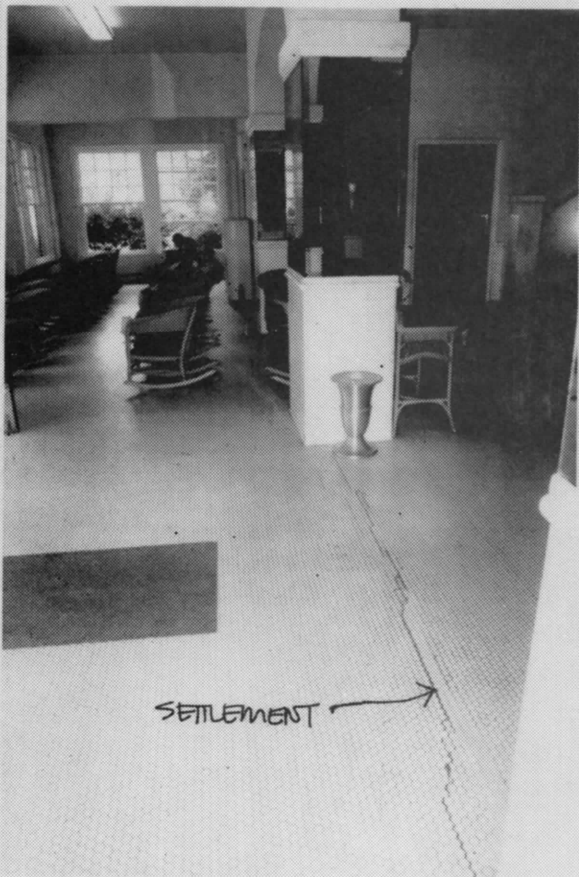
100 LOBBY

SETTLEMENT →

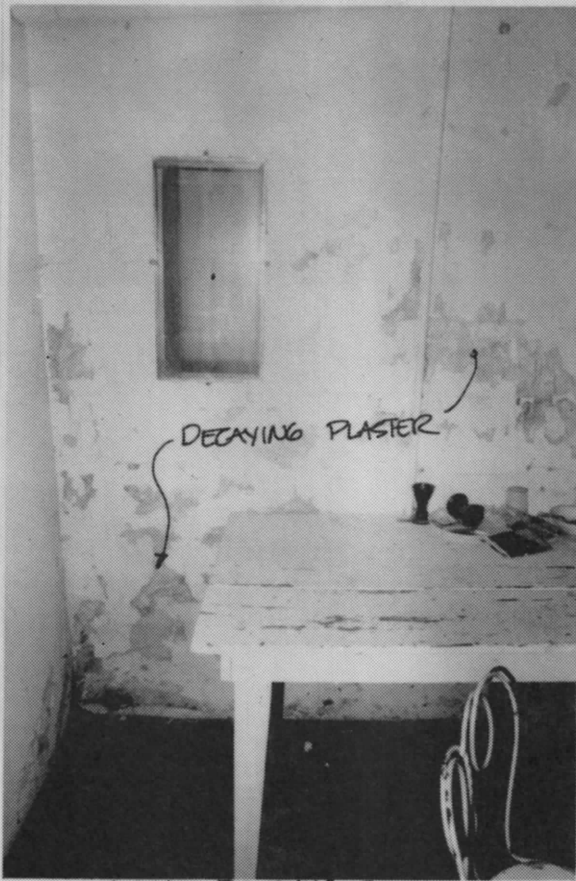
B112 EMPLOYEE DRESSING ROOM -
EXTERIOR WALL NEEDS WATERPROOFING

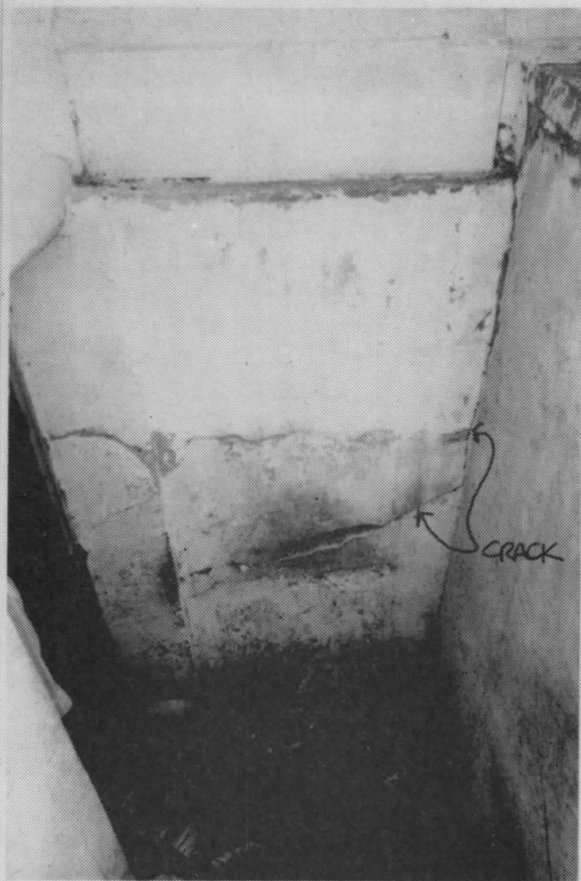
EXTERIOR STAIR TO BASEMENT -
EVIDENCE OF SETTLEMENT

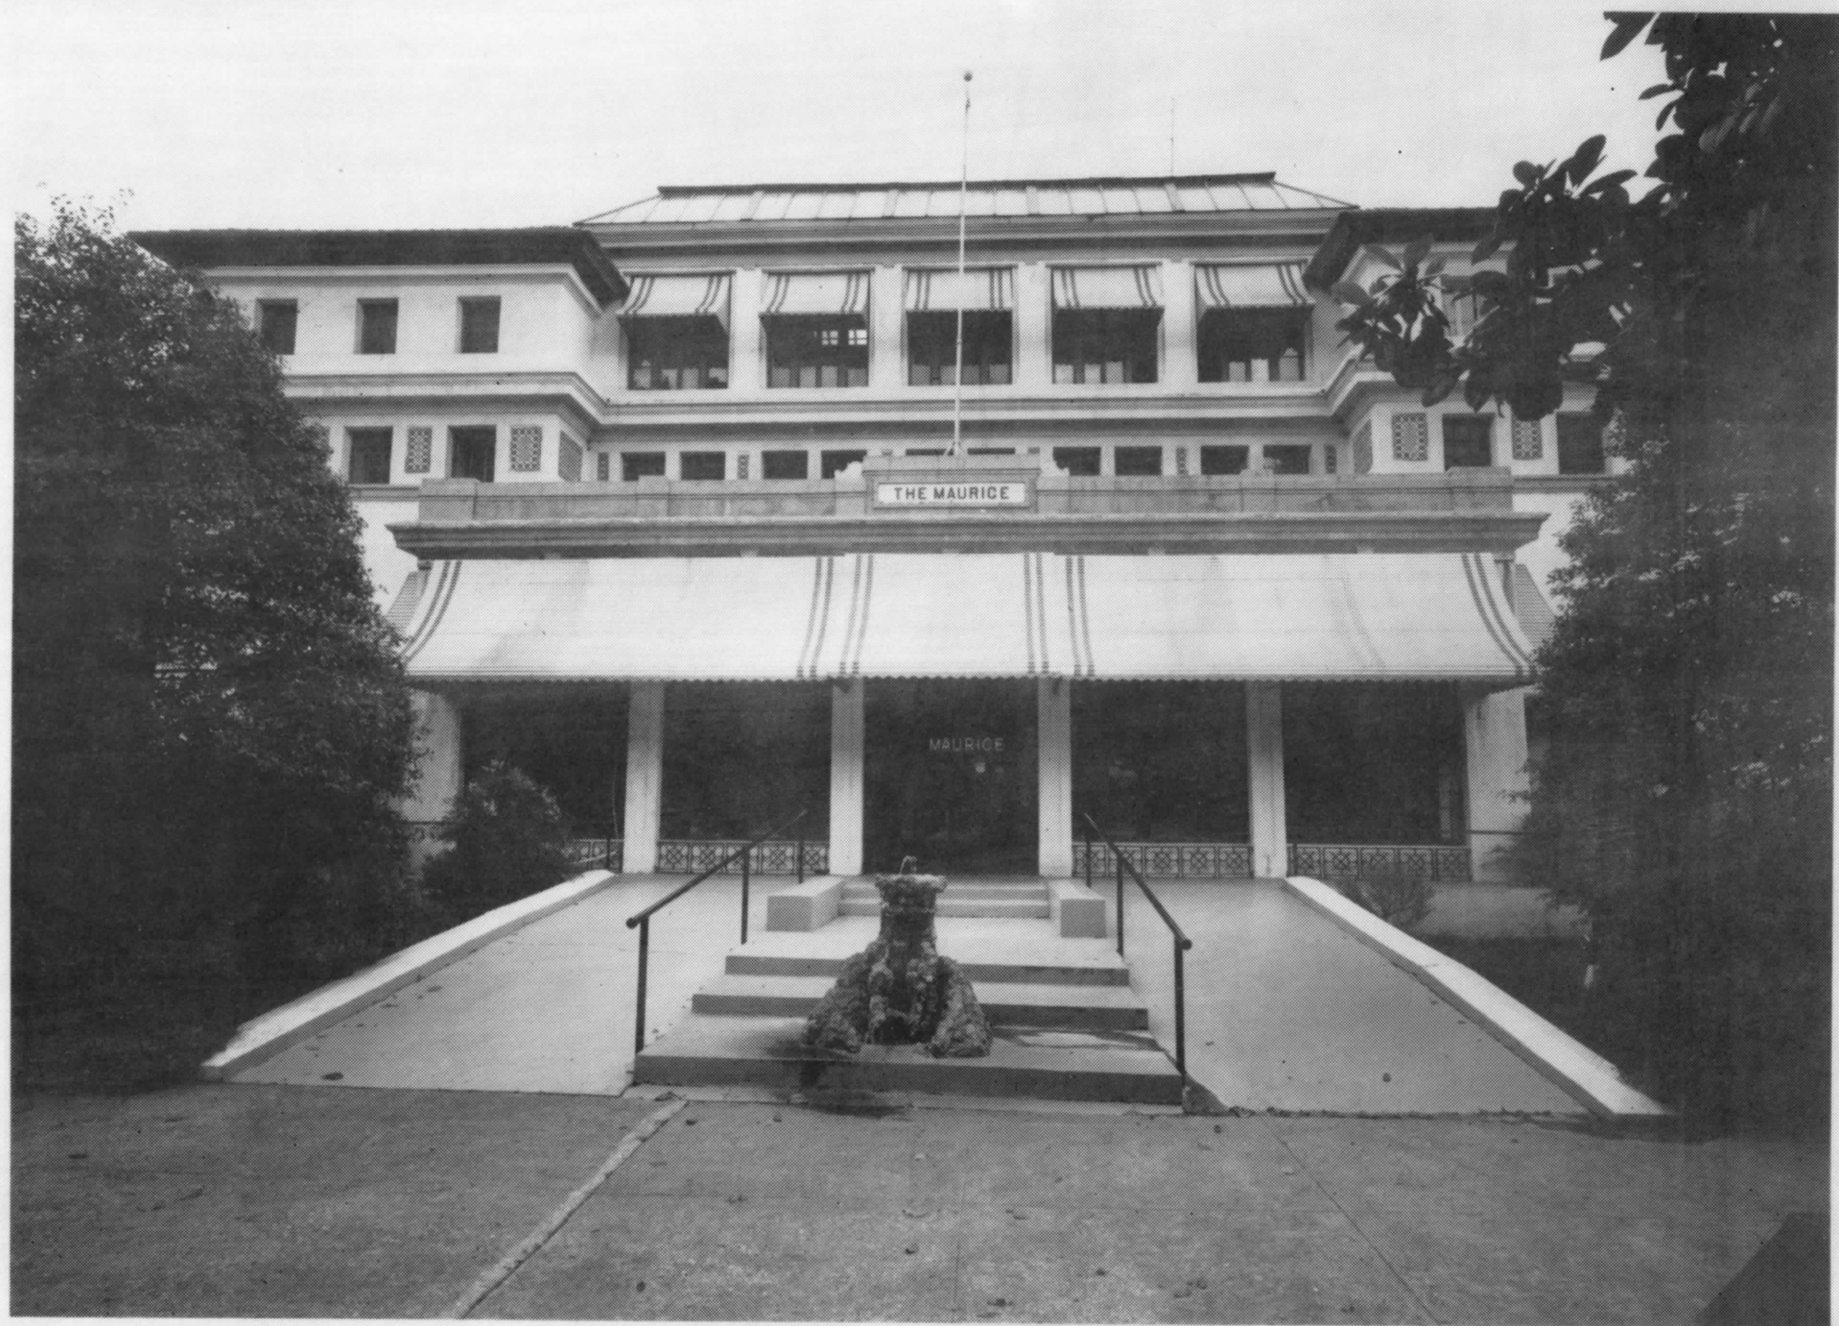
SETTLEMENT
CRACK

north side

SURFACE CRACK IN STUCCO

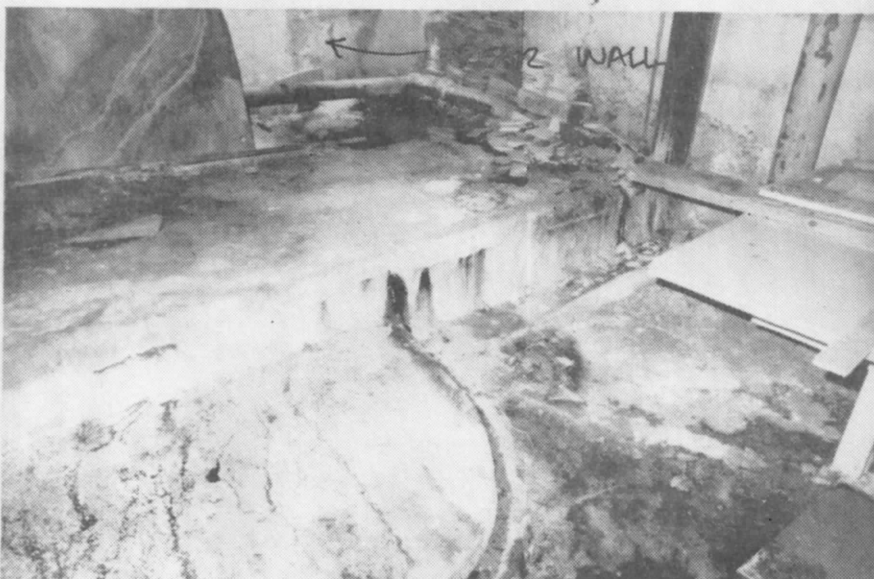
B109 BASEMENT FLOOR / MINERAL WATER IN FILTRATION

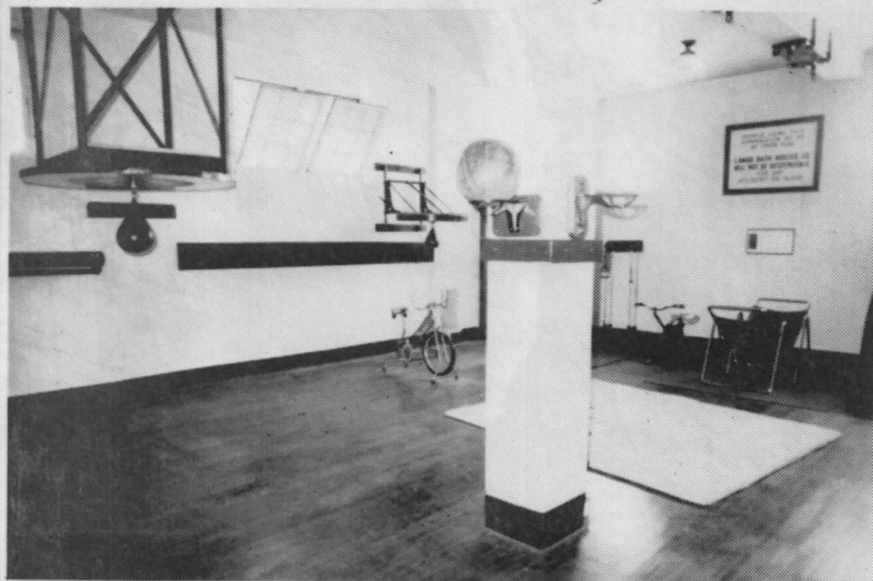
MENS DRESSING RM. CEILING, 2ND FL. / ROOF LEAKS

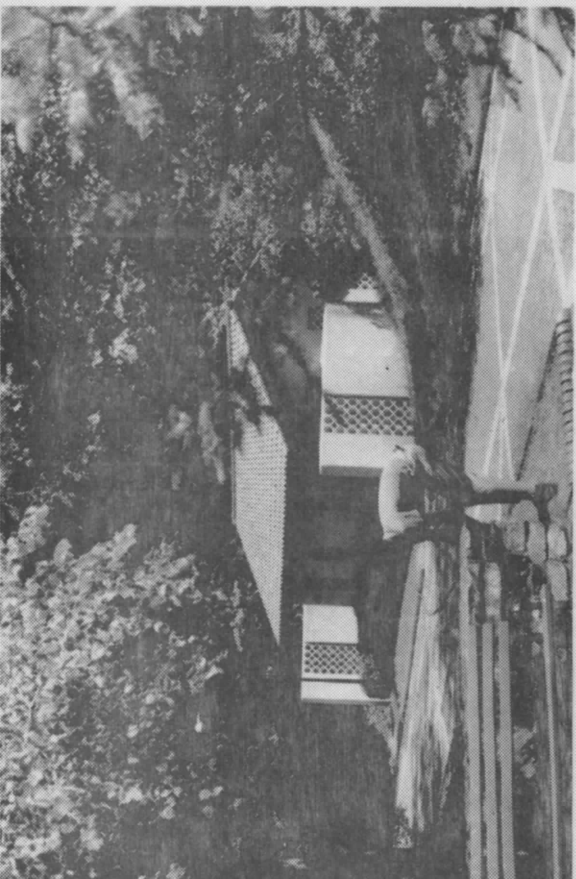
⑤ ← COMFORT STATION - 2 @ UPPER PROMENADE

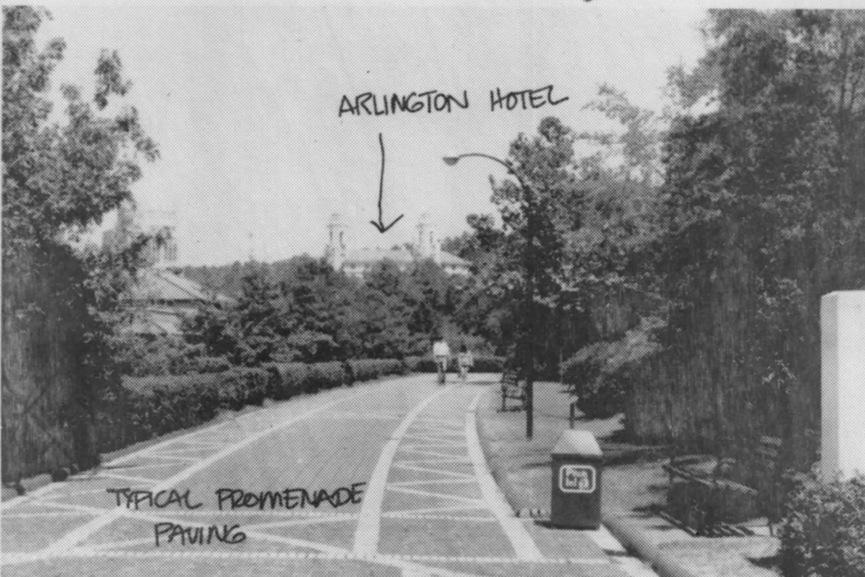
③ ↑ TYPICAL PROMENADE VIEW - LOOK'G NORTH

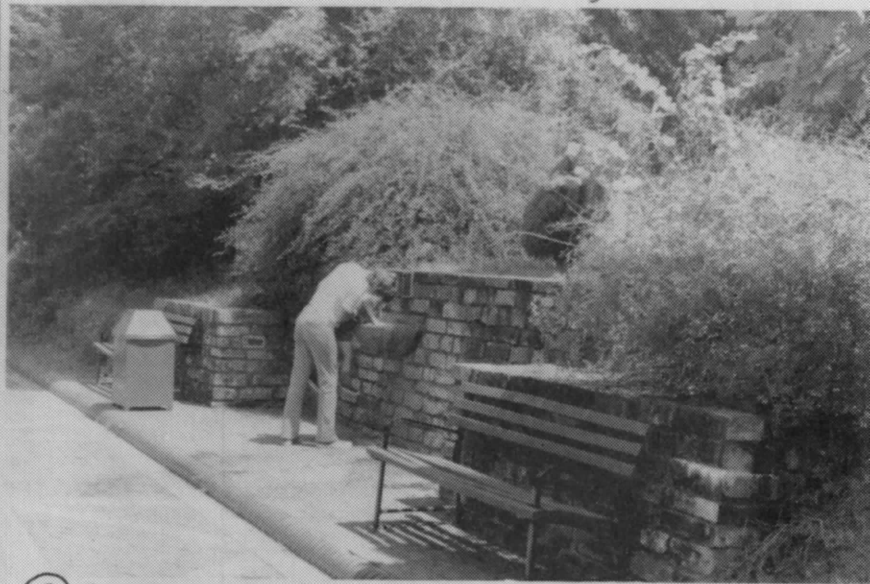
⑥ ↑ DRINKING FOUNTAIN @ PROMENADE

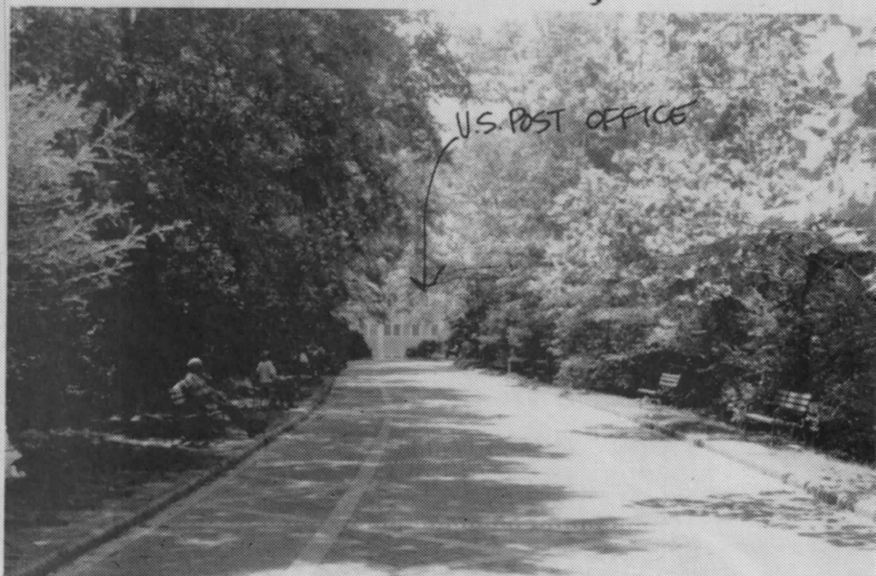
⑦ ↑ SOUTH END OF PROMENADE, LOOK'G SOUTH

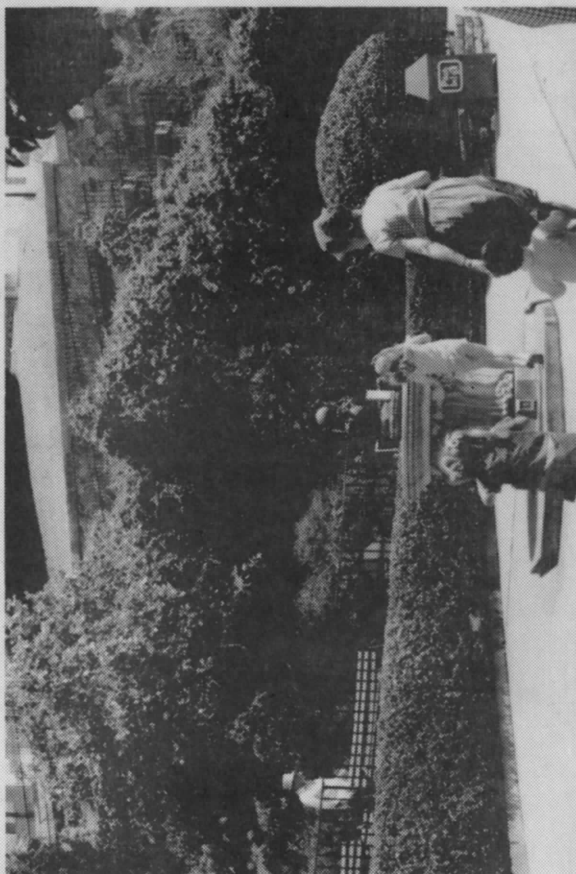
⑩ ← FOUNTAIN @ SO. END OF PROMENADE

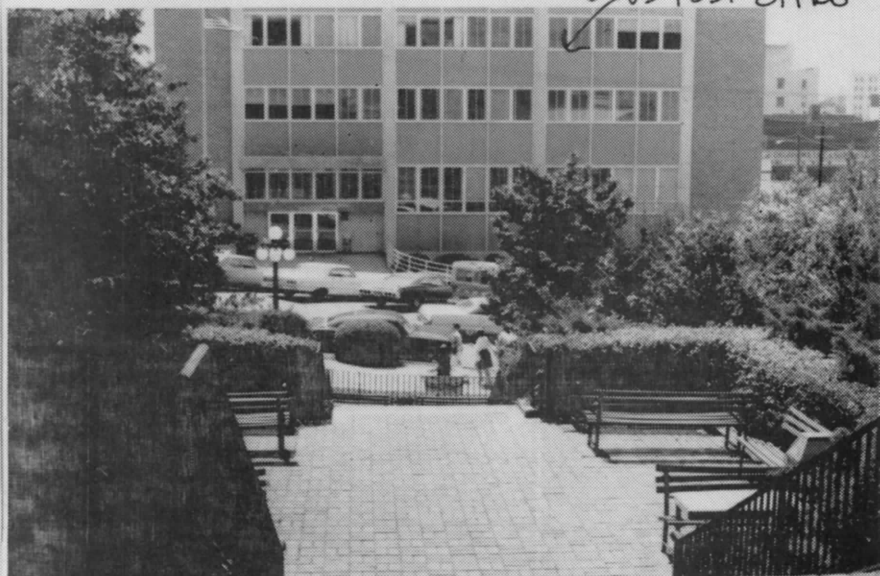
⑧ ↑ SOUTH TERMINUS OF PROMENADE

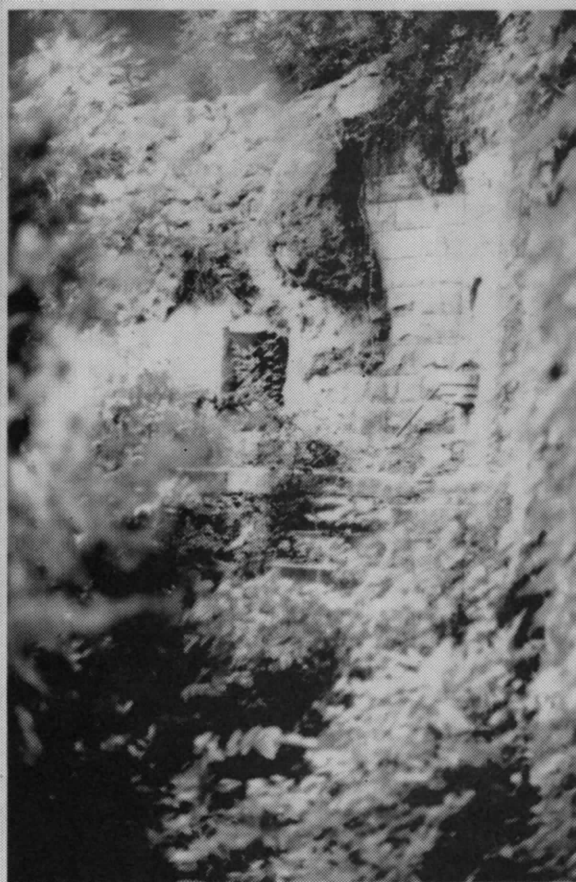
(19) ↑ OLD SPRING DISPLAY

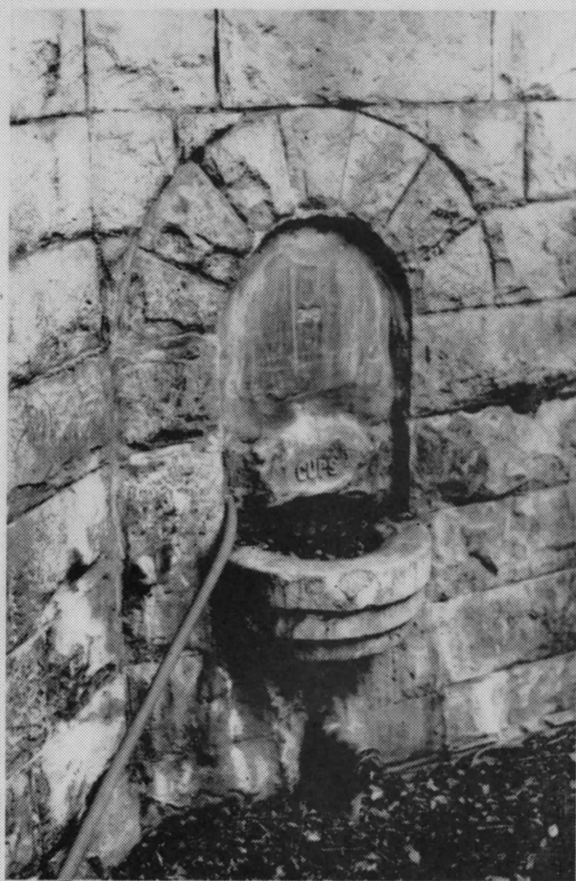
(20) ↑ OLD SPRING DISPLAY

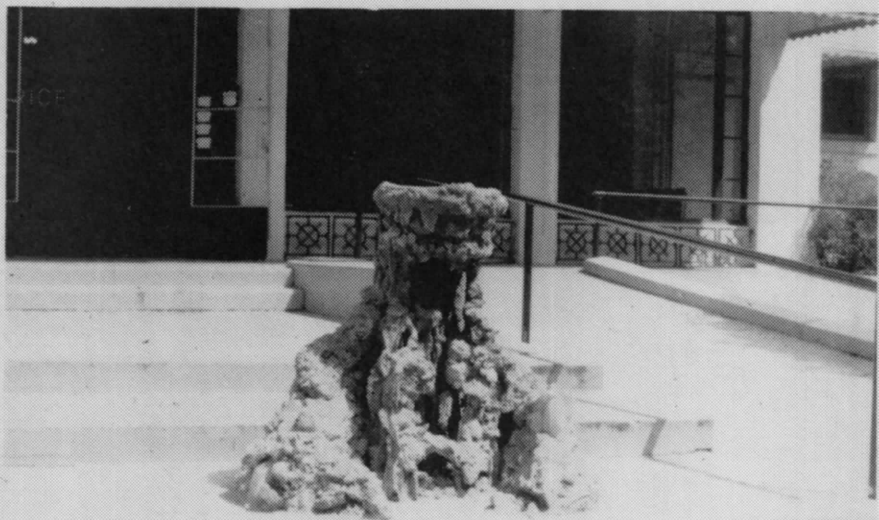
(17) ↑ FOUNTAIN @ MAURICE
