**WILLIAM JOHNSON HOUSE  
NATCHEZ NATIONAL HISTORICAL PARK**

**NATCHEZ, MISSISSIPPI**

**HISTORIC STRUCTURE REPORT**

ANN BEHA ASSOCIATES

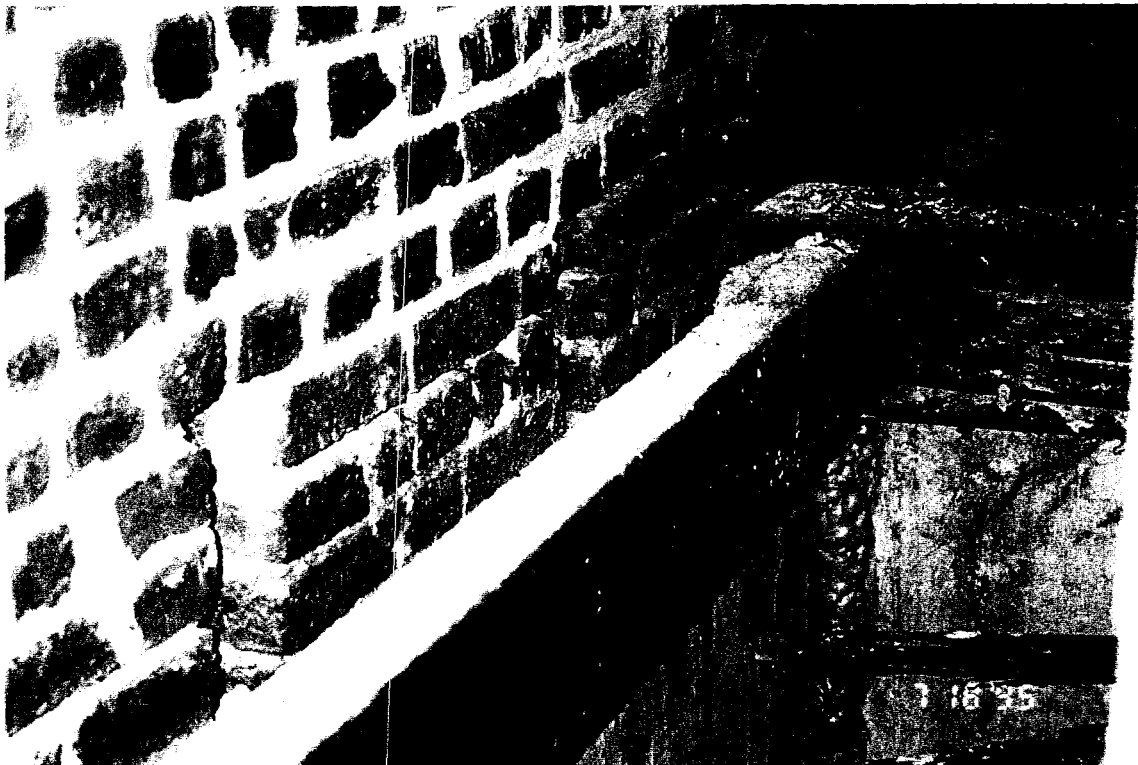
- 22-A Gap in wall injected with foam at southeast corner of second floor. (ABA)
- 23-A Deteriorated mortar on east wall in attic. (ABA)
- 24-A Mortar cracks on south elevation. (ABA)

22-A Main House - Gap in wall injected with foam at southeast corner of second floor.

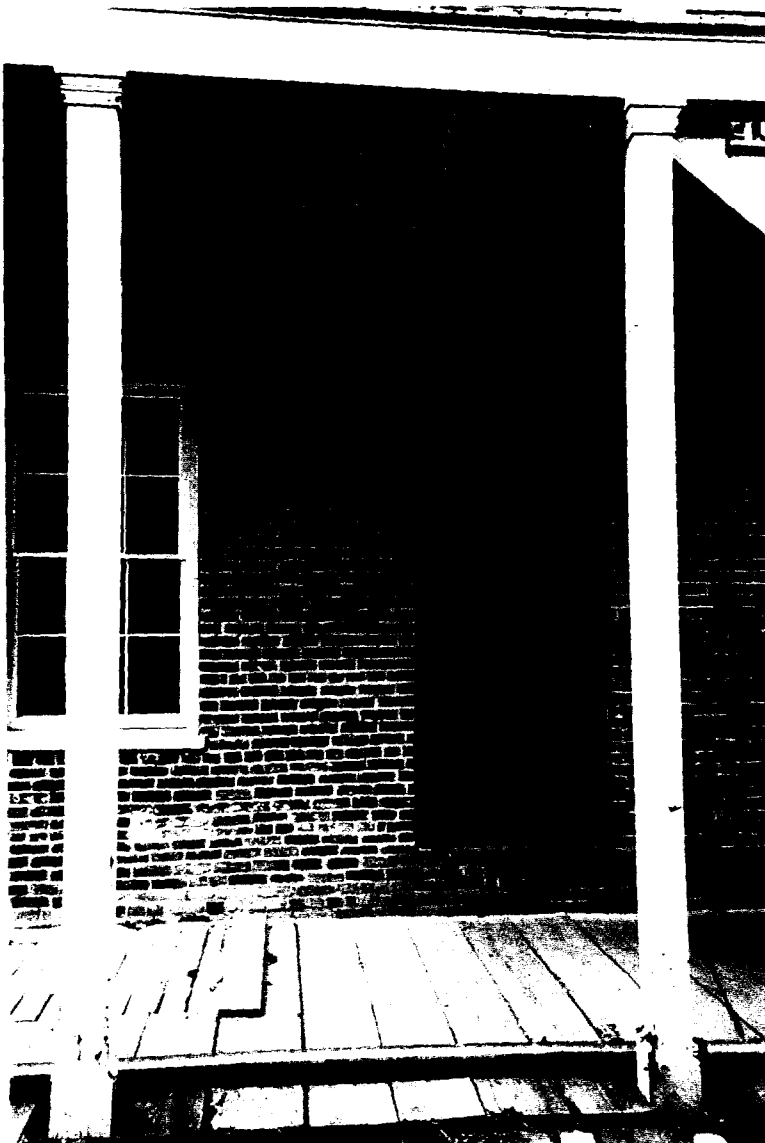
25-A Main House - Gaps between porch floorboards, opened joints at column bases, and mildewed ceiling.

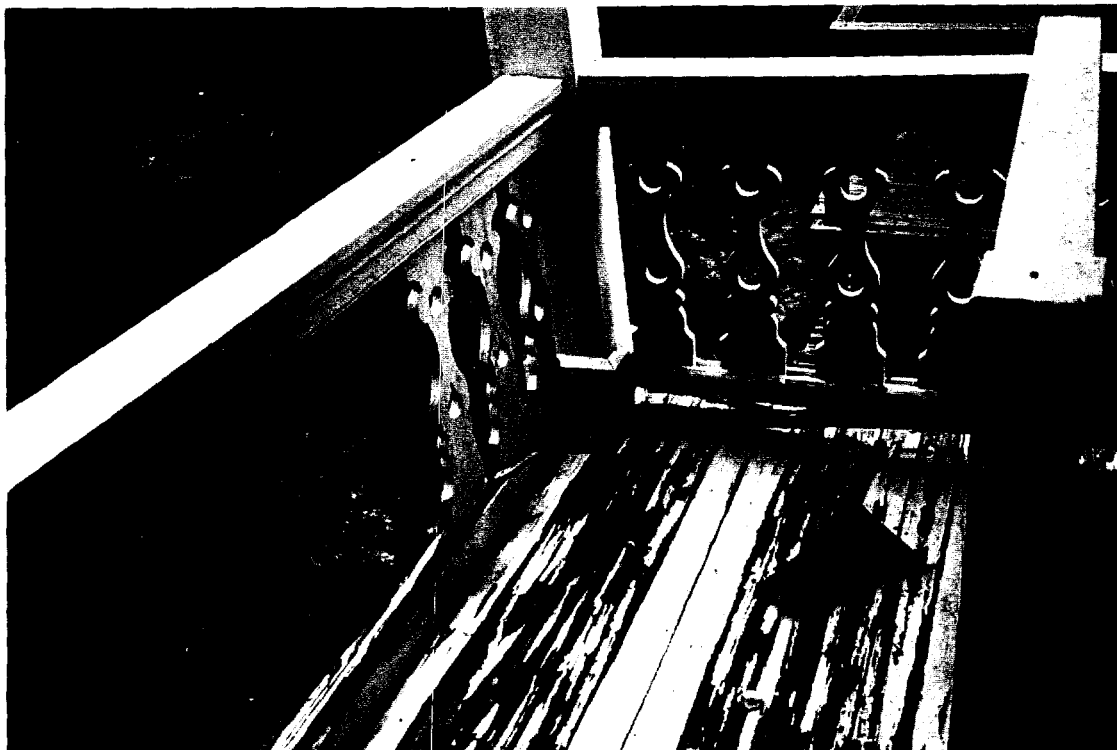
27-A Main House -  
Peeling  
paint on  
porch,  
and rotted  
balustrade.

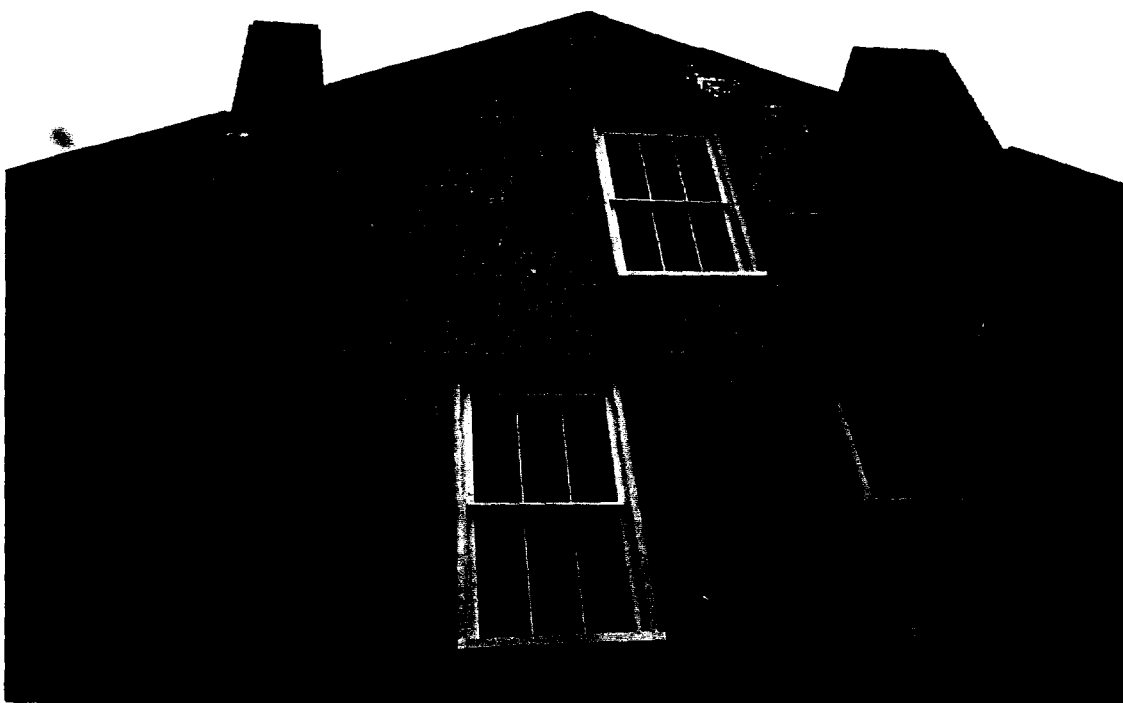
28-A Main House - Peeling paint on north facade window frames.

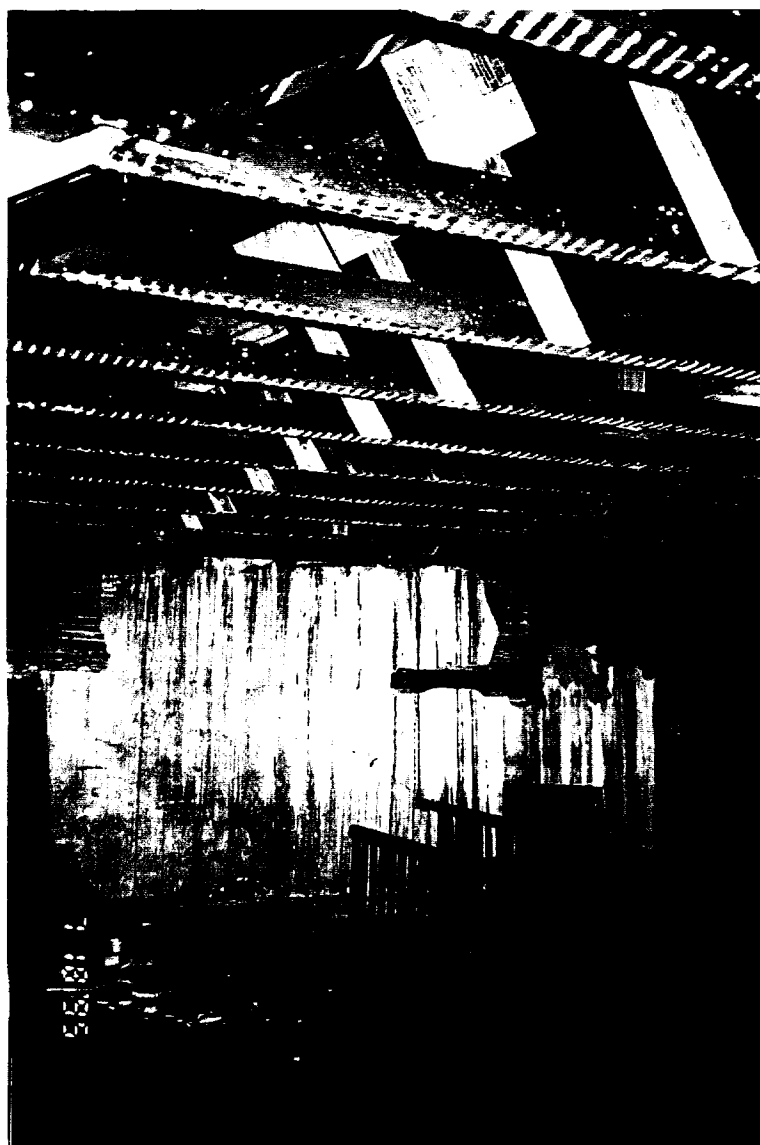
40-A Main House - Missing third-floor plaster.

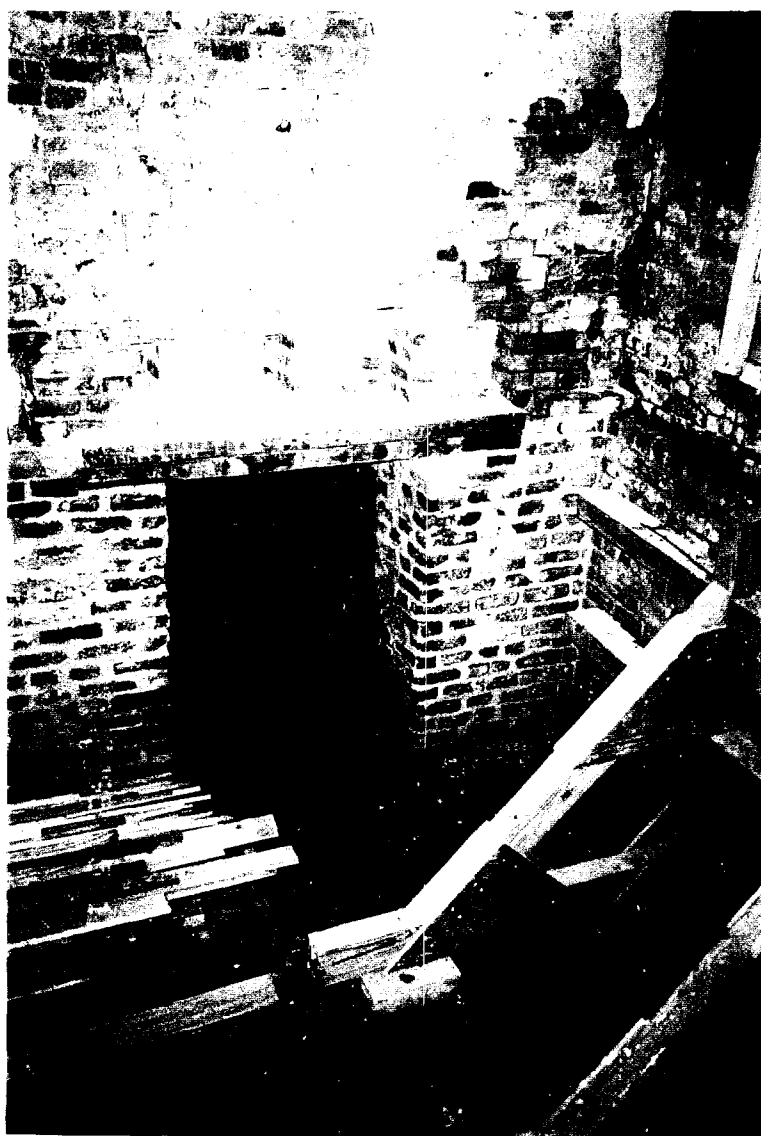
42-S Main House - View of rotted wood below south porch ground floor.

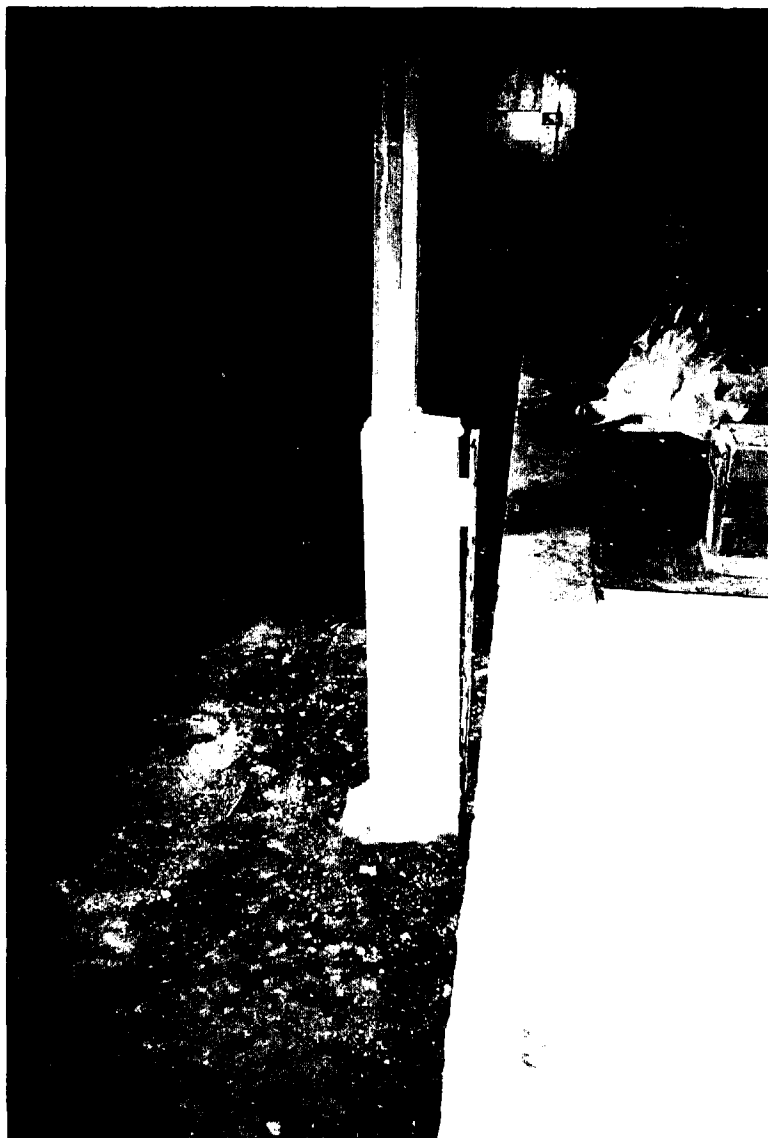
43-S Main House - View of northwest corner of basement.

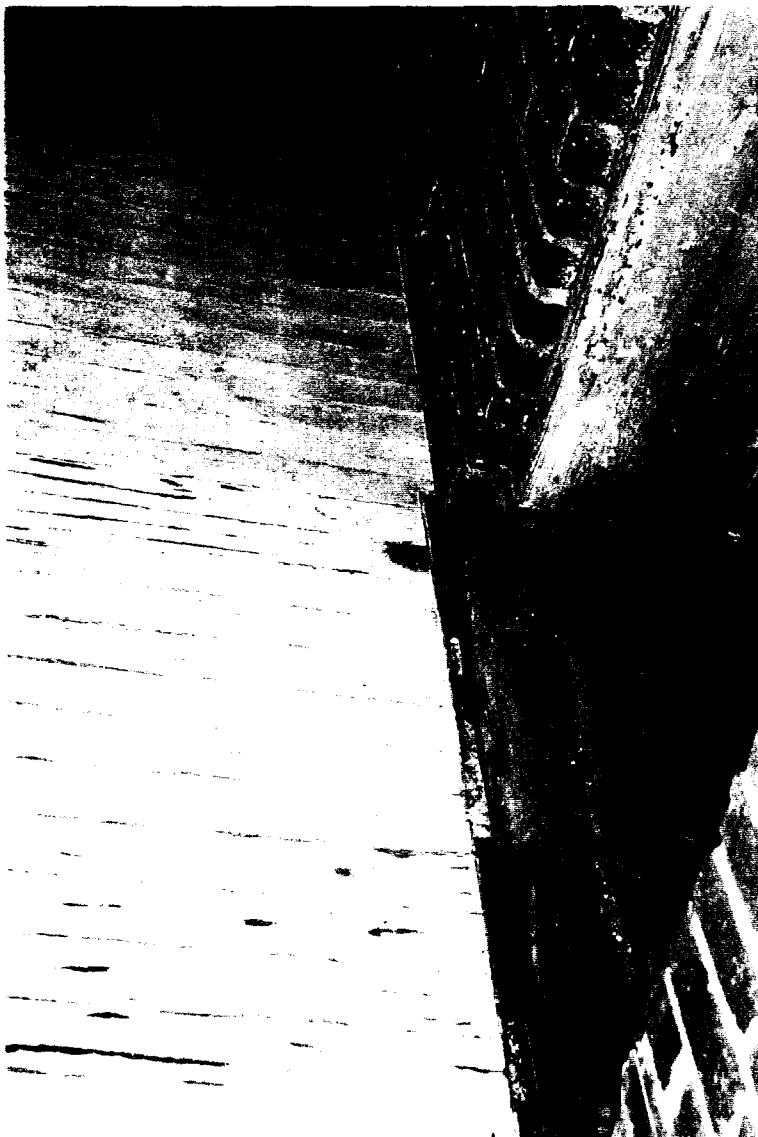
48-S Main House - View of underside of attic-floor framing.

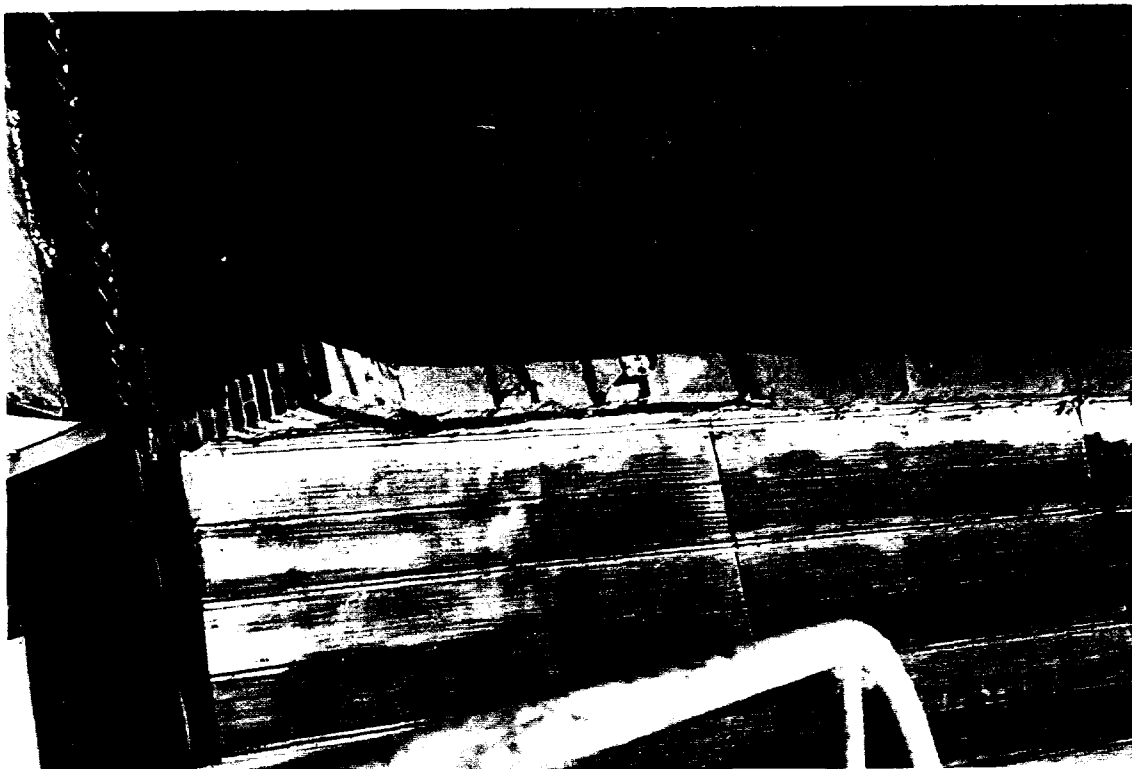
55-S Main House - View of the south porch roof.

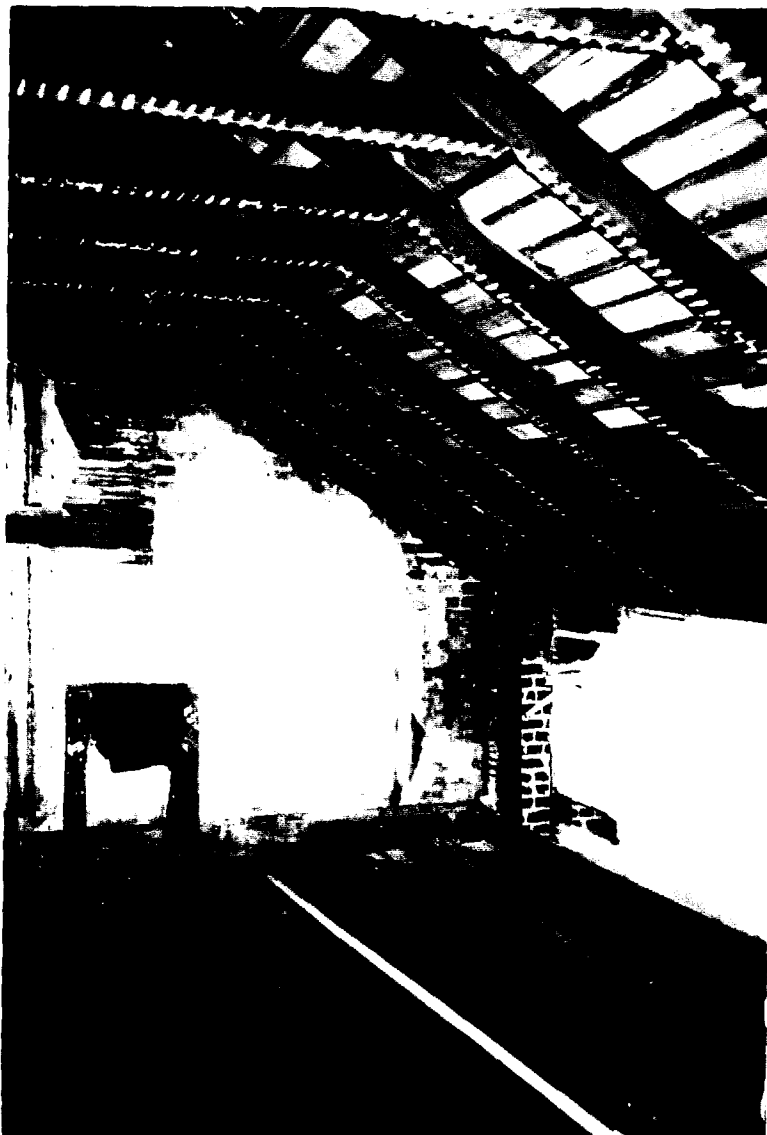
60-S Area of probe made into the south elevation of the McCallum House and William Johnson House.

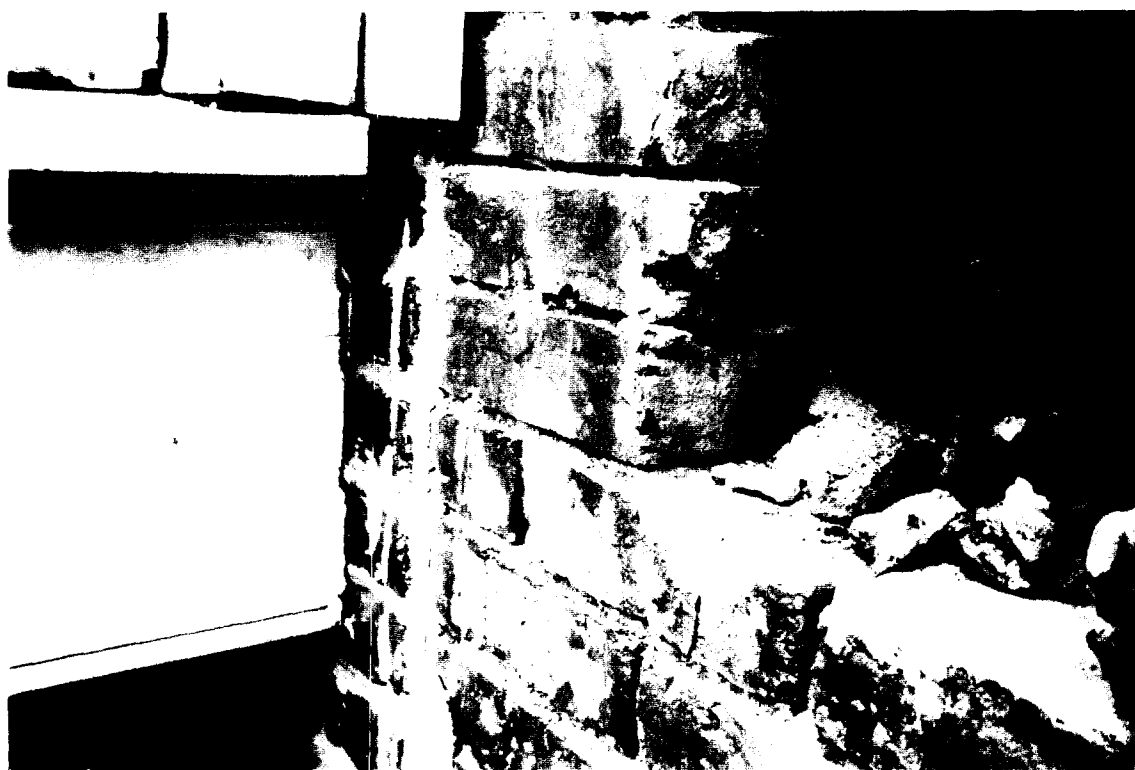
- 62-S View looking into probe in the south elevation. (See photograph 60-S for general view). (RSA)
- 63-S View looking west into probe in the south elevation. South porch framing is at left. (RSA)

62-S Main House - View looking into probe in the south elevation.  
(See photograph 60-S for general view).

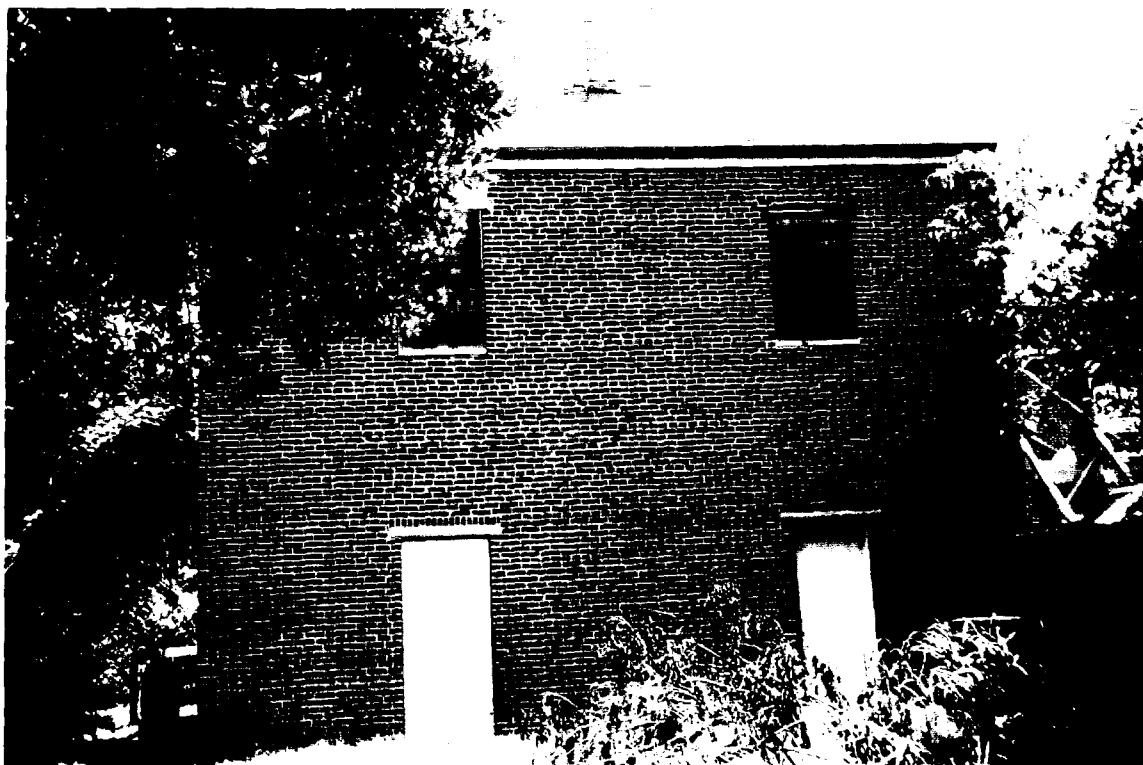
*Existing Conditions.* On the north facade there are four four-panel doors, with transoms above and four six-over-six double-hung sash windows. The doors and windows appear solid, however there are some gaps between the masonry and wood frames, sills, and lintels that need to be caulked (66-A). The frames and lintels are bare wood and need some minor consolidation. The doors only have a primer coat of paint applied to them. The shutter hardware remains, but the shutters have been removed.

66-A Dependency - Caulk gaps at window frames on north facade.

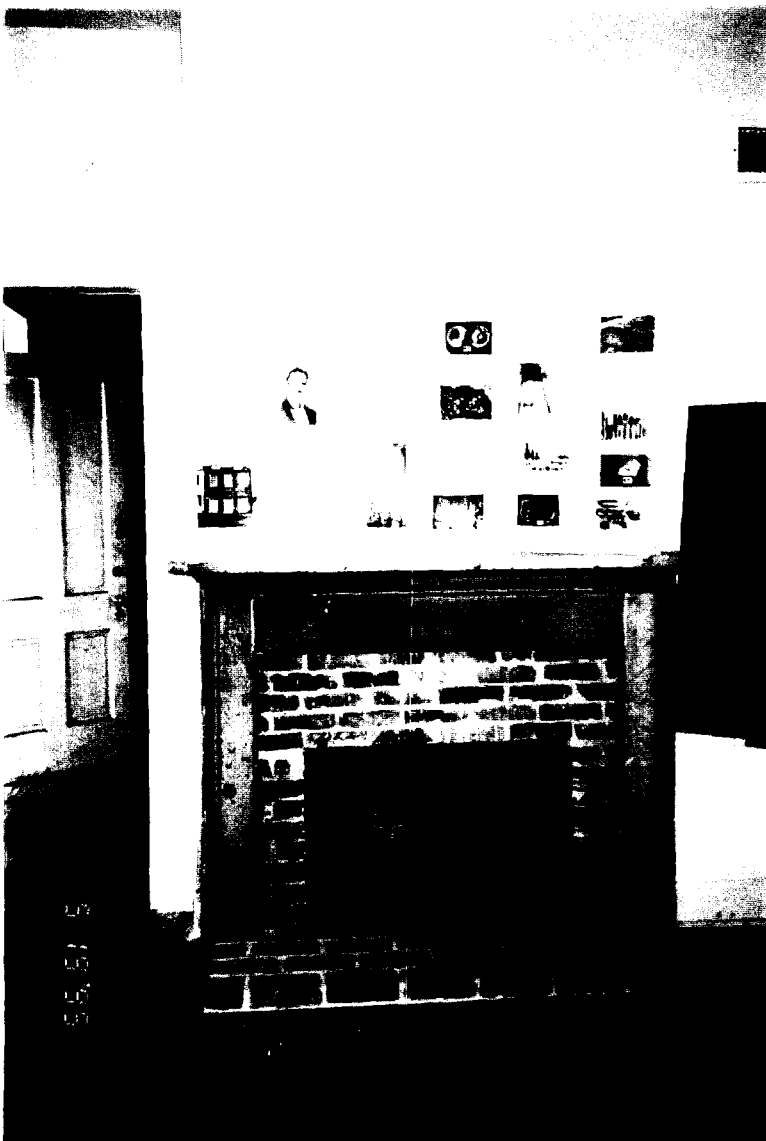
**Existing Conditions.** The interior is in good condition. The walls are newly re-plastered and all need to be painted except the first floor, West Room 101 (68-A). The flooring has been replaced throughout.

68-A Dependency - Second-floor walls replastered, unpainted.
