# Burdick House

NEW PHILADELPHIA NATIONAL HISTORIC SITE  
BARRY, ILLINOIS  
PMIS 343880

## Condition Assessment and Treatment Report

JUNE 2026

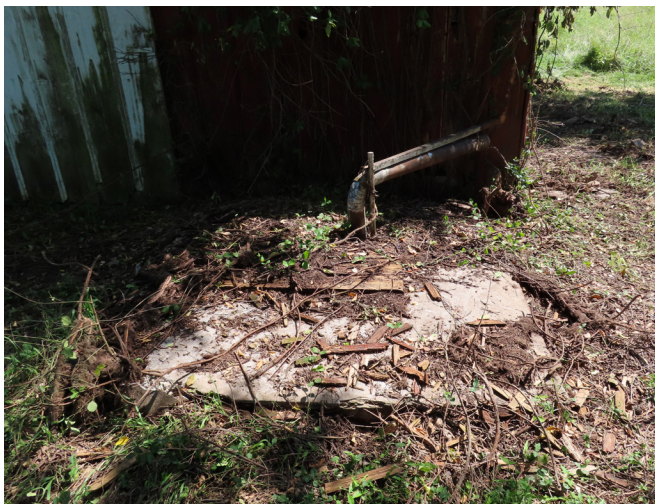
The largest cistern is adjacent to the barn along the north wall. (Figure 15) Piping connecting the cistern to the barn is present. This likely diverted rainwater from the roof of the barn to the cistern. The cistern was capped with deteriorated wood planks and was inundated with vegetation. Another cistern is located several yards from the southeast corner of the house. The base of this cistern was constructed with brick masonry and a concrete cap was present. (Figure 16)

Figure 15. Large cistern near barn. (source:RRJ, 2025)

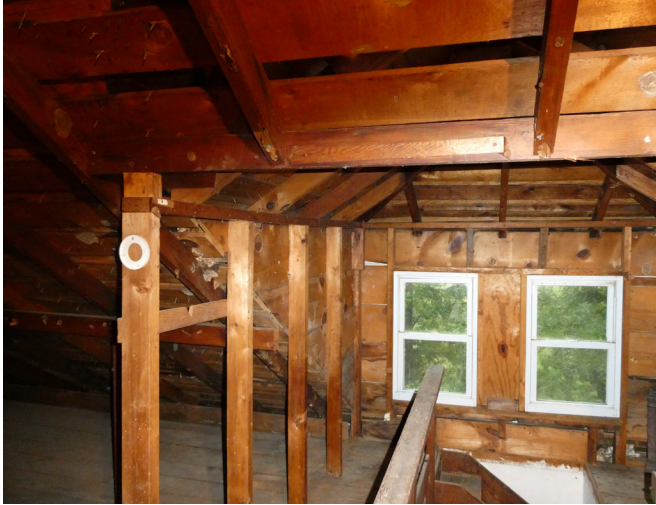
Figure 52. East dormer with appropriate roof framing. (source: RRJ, 2025)

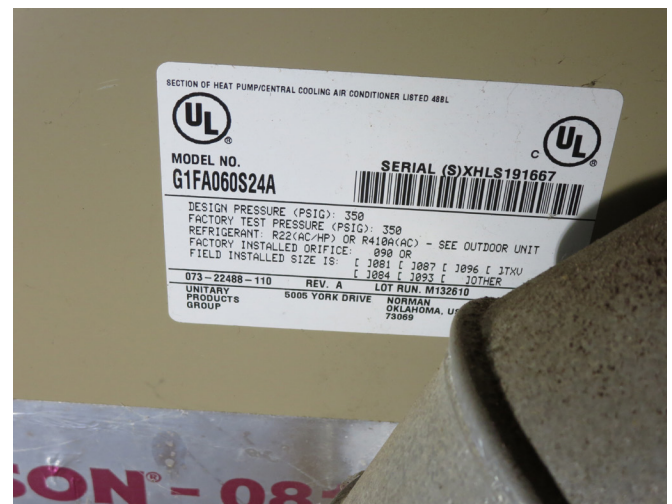
The furnace in the basement is currently provided with an A-frame refrigerant coil with a capacity of 5-tons (60,000 BTU/h) of cooling. The coil is a York, model G1FA060S24A, serial number (S) XHLS191667, which would have operated on R-22 refrigerant (Figure 94). The cooling coil is assumed to never have been connected to an exterior air-cooled condensing unit based on no piping at the coil observed. It is assumed the house has never had mechanical cooling (Figure 90). The age of the coil is 35-years old based on the "X" in the serial number, which corresponds to a manufacture date in 1990. While the coil has never been used for cooling, putting it back into service is not recommended as this coil was designed and built to use R-22 refrigerant which was phased out and illegal to produce or import for new systems after January 1, 2020. It would be best to replace the coil and the rest of the system to use a modern, ozone-safe refrigerant like R-32. Replacing the system with one with the new refrigerants will allow operation utilizing a higher efficiency and performance.
