**Vanderbilt Mansion National Historic Site  
Conservation of Interior Stonework  
May-June 2005**

## Conservation of Interior Stonework 2005

### Conservation Assessment and Treatment Reports

# **Vanderbilt Mansion National Historic Site Interior Architectural Stone Conservation Needs Assessment**

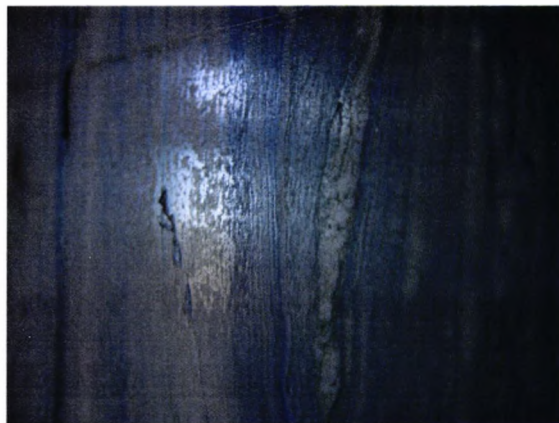
**Matte and shiny appearance of surface in raking light.**

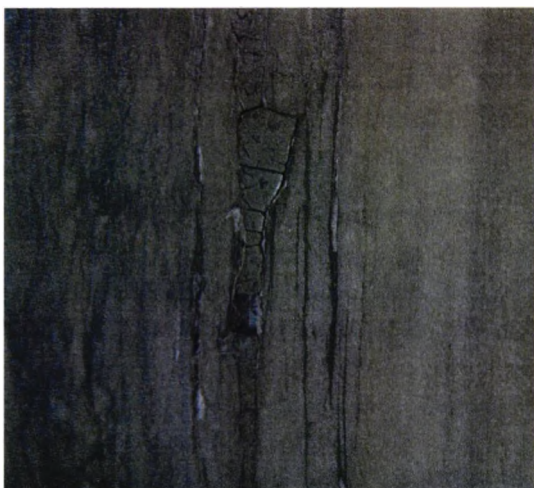
**Detail of painted fill, and green pigment in recesses and veins.**

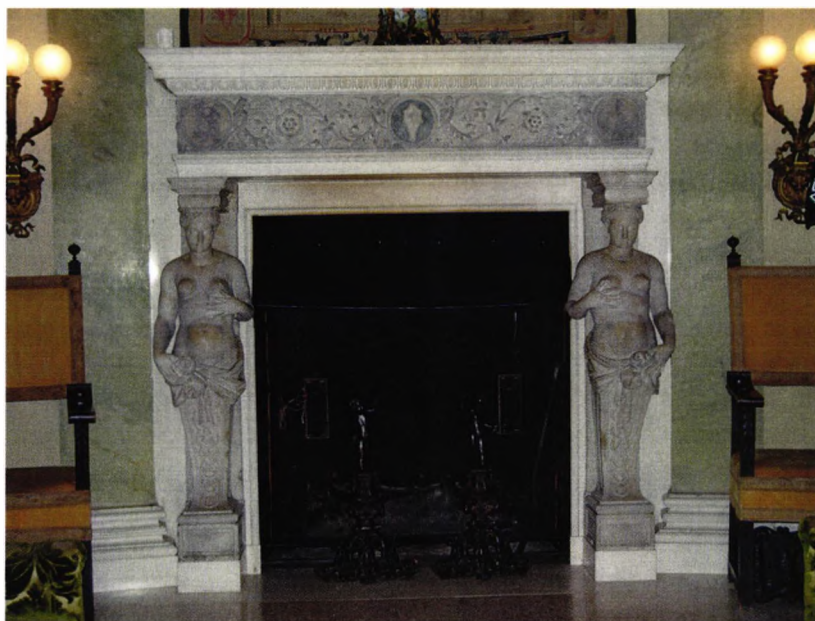
**Caryatid Fireplace Mantel.**

The Caryatids appear to be composites, created from several different pieces, some possibly antique and some contemporary to the creation of the piece. There are fills on each one, especially the proper right caryatid. This caryatid has several fills on the neck and right arm at the upper arm to below the hand with some plaster and toning throughout. The proper left caryatid has obvious joins at the nose tip, nipples, and hands. Both caryatids are a dark grey color, possessing heavy soot deposits. The remaining areas of the mantel are also covered with a layer of grey soot, especially on the upper planes. The frieze element appears much darker grey than the rest of the entablature, perhaps due to the natural color of the stone and an intentional design consideration.

Cleaning tests were conducted on the caryatids and various areas of the entablature. A vinyl eraser did little to remove soot deposits, as did pure spring water, acetone, and ethanol. Saliva removed some soot, but a 3% ammonium citrate/water solution was most successful, exposing white marble below, especially as dwell time was increased. Ultra Violet light examination exposed areas of infills, toning, and joins on the caryatids.

The time estimate for the cleaning of the mantel and aesthetic integration of previous repairs/joins of caryatids is 80 hours or 10 conservation days.

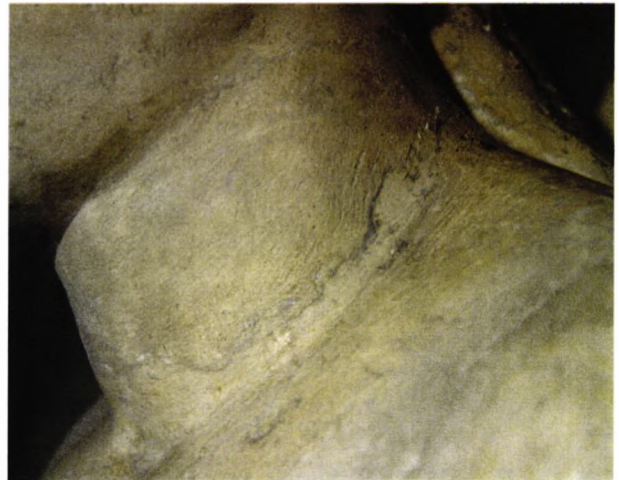
**Detail neck infill and join on proper right caryatid.**

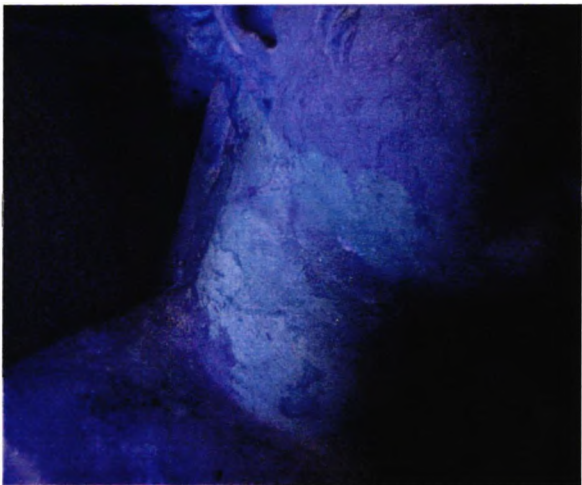
**Detail of inpainting on neck (yellow area) of proper right caryatid under ultraviolet light examination.**

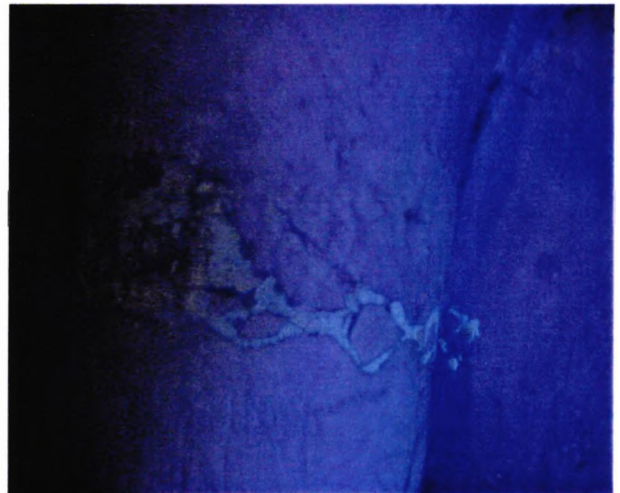
**Join and fill at upper arm.**

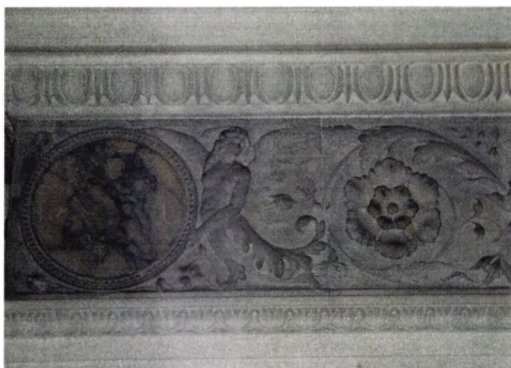
**Detail of frieze that is darker grey than surrounding white marble of entablature of fireplace mantel.**

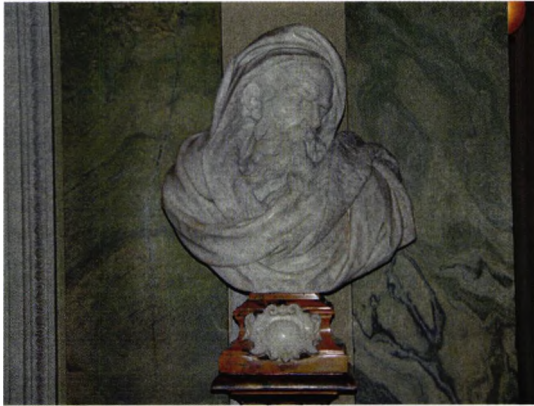
Two marble busts placed on yellow and red marble bases adorn the west side of the Reception Hall. They are now disfigured with dirt and soot.

**Marble bust. of a hooded man.**

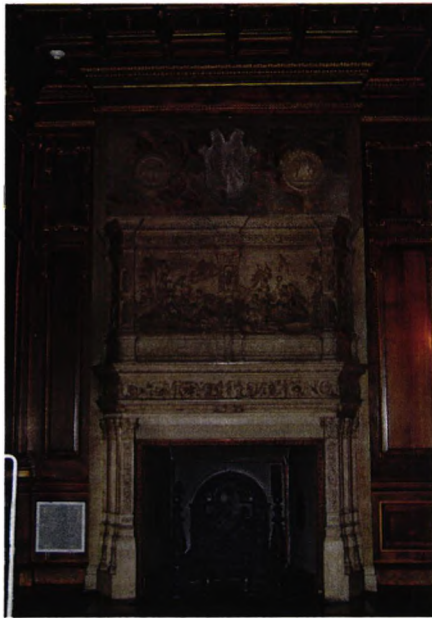
West Mantel

*West Mantel:* Consists of a beige/grey marble with some orange veining. This mantel does not appear to have any previous test cleaning patches. There is heavy overall surface soot, especially on the upper planes. There is a plaster fill on the front, decorative molding of the fireplace surround with what appears to be gold paint.

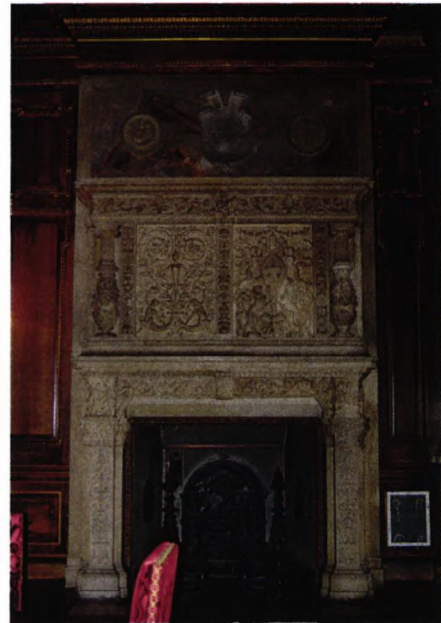
East Mantel

*East Mantel:* Largely consists of relatively dense beige/grey marble, with some orange veining. After visual and ultraviolet examination of the two central panels, it was determined that these areas consist of molded plaster, toned to match the surrounding marble. Close examination of the previously cleaned, proper left Griffin shows some remaining grey/brown toning in recesses of the Griffin's hair and legs.

There are heavy overall soot deposits on all surfaces, especially the horizontal planes and areas near the vent. There are dark, paint-like streaks on the far proper left wall panel directly beside the vent. This streak-like stain does not fluoresce under ultraviolet light

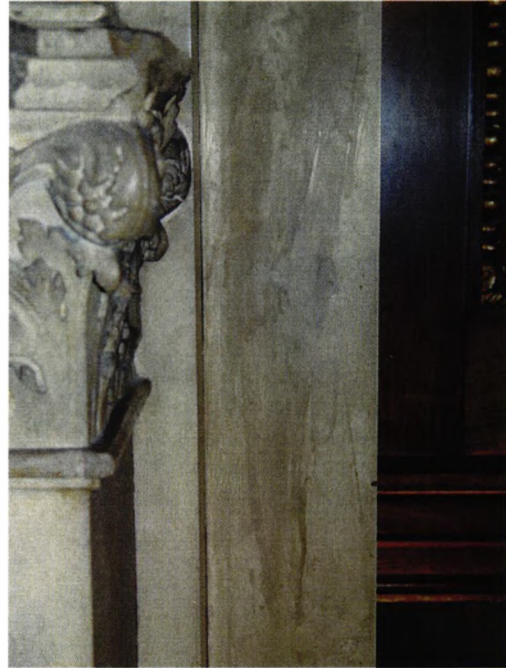
**Proper left side of mantel showing dark, paint-like streak pattern.**

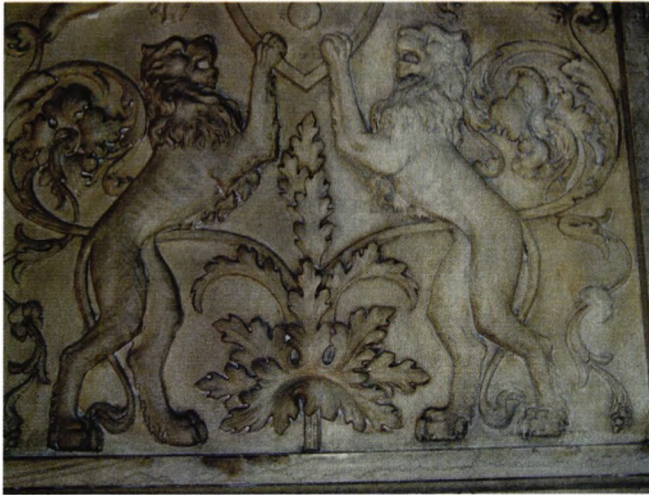
**Proper left side of plaster panel showing previous cleaning of Griffin, and NMSC cleaning tests on half of central leaf.**

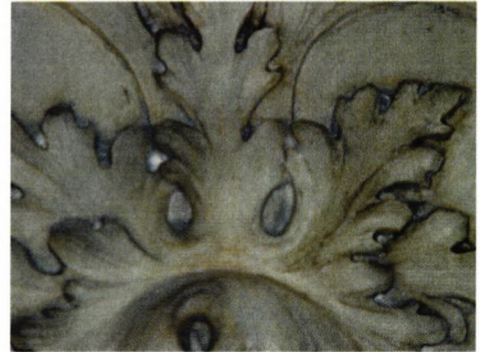
**Detail of central leaf showing dirt and clean, toned surface.**

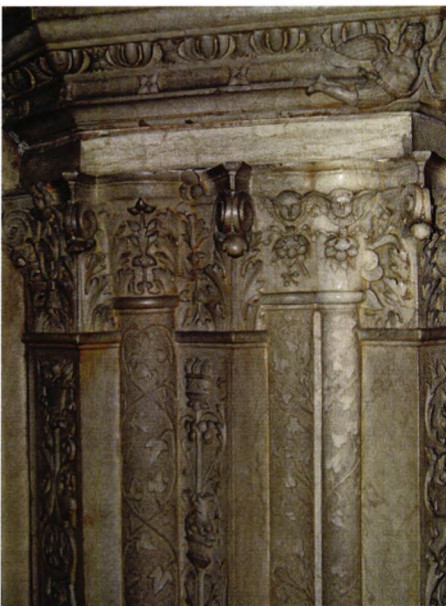
**Proper right side of mantel showing areas cleaning using an ammonium citrate/water solution.**

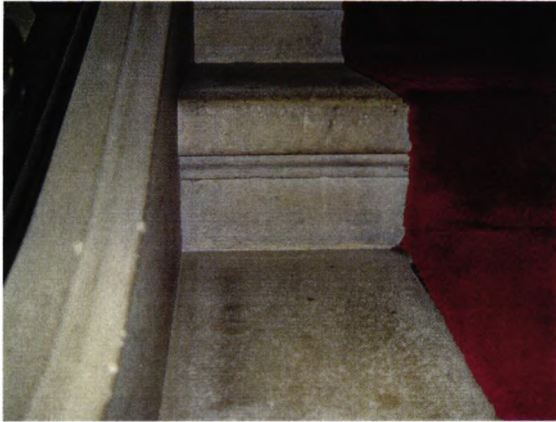
Underneath the red carpeting, especially on the landings, the marble flooring and limestone stairs appear much cleaner than the exposed areas. There is also tape residue

**Limestone stair showing surface soiling.**

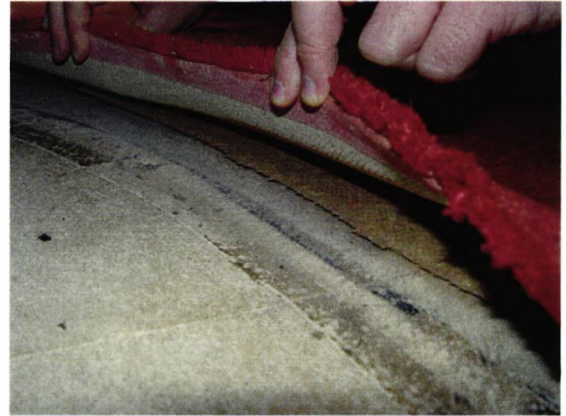
from attempts to secure the carpet. The Park has expressed a desire to remove the red carpeting, therefore requiring both the tape residue and soiling to be removed. A dense, decorative marble urn is set below the stair on the first floor.

**Tape residue below red carpet.**

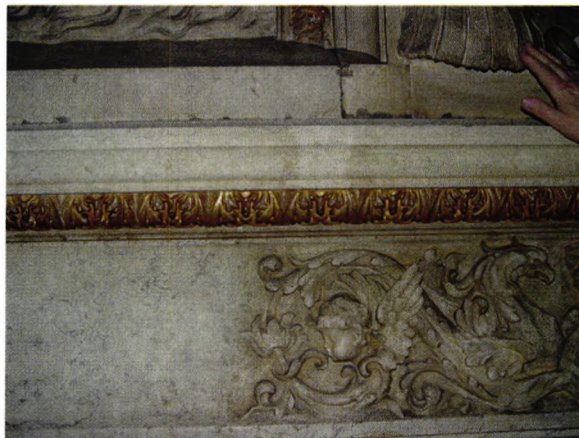
Areas of previous cleaning tests are visible on the proper left side of the mantel in Mr. Vanderbilt's bedroom. The mantel is disfigured with soot overall and past breaks and old fill repairs are visible on the proper left side where a section of metal armature is exposed. Orange/brown toning is visible in the recesses of the egg and dart molding although the toning does not fluoresce under ultraviolet light examination, suggesting little or no binders are present.

**Gilded decorative elements and previous cleaning tests are apparent.**

The mantel is very dirty and should be cleaned by an NMSC Conservator using the lowest effective percentage of an ammonium citrate (<3%) / water solution, wiped onto the surface using cotton pads and cleared with spring water. Exposed and corroded armature iron should be stabilized and previous failed and disfigured repairs removed and redone with improved toning for visual integration with surrounding marble.

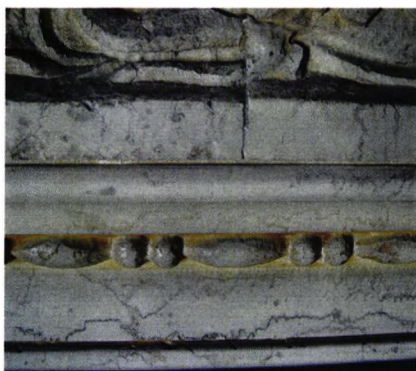
**Detail showing water soluble toning on egg and dart pattern.**

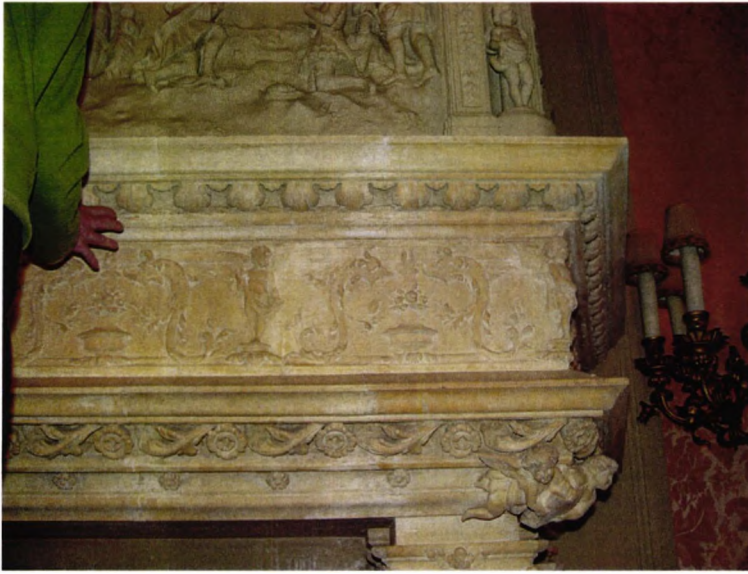
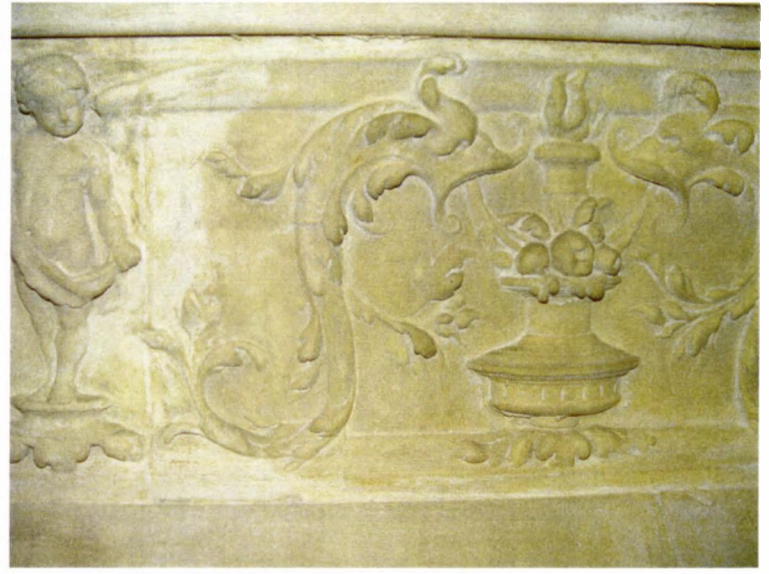
**Figures 3 a,b,c. Details of the original toned plaster surface of the Rosecliff fireplace surround.**

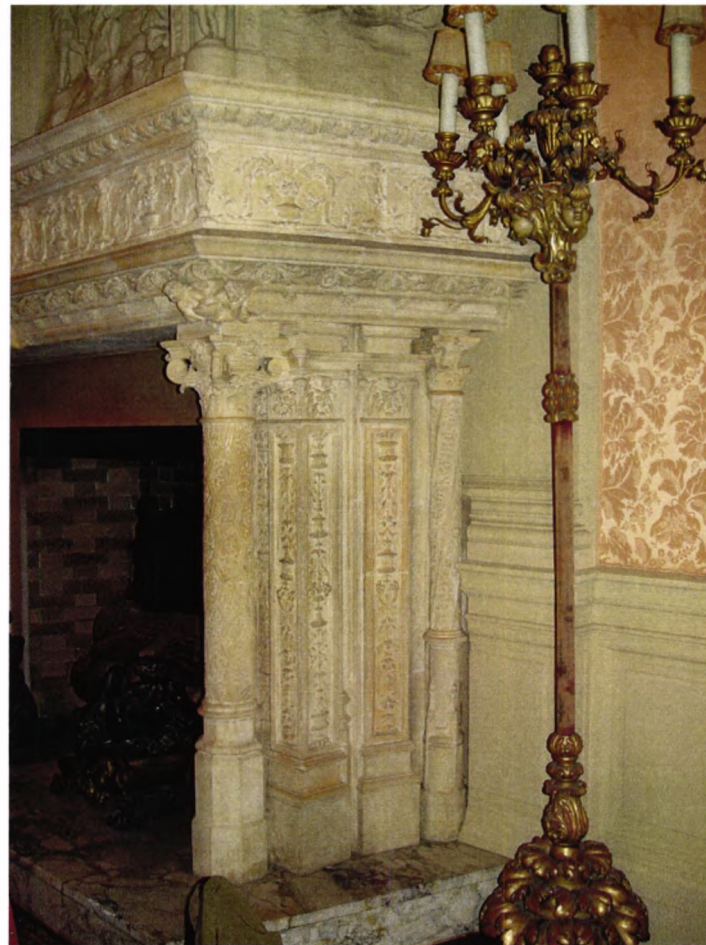
**Figure 4. Details of a toned mantelpiece in the Marble House.**

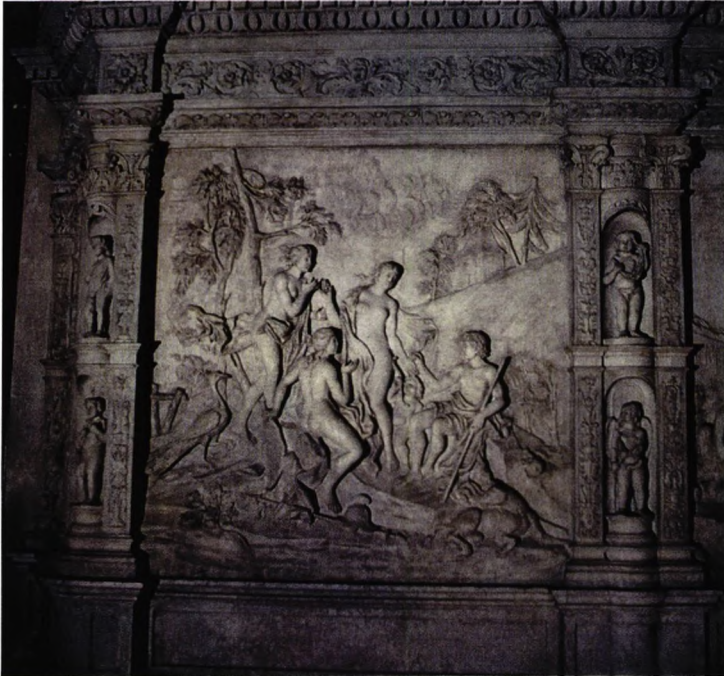
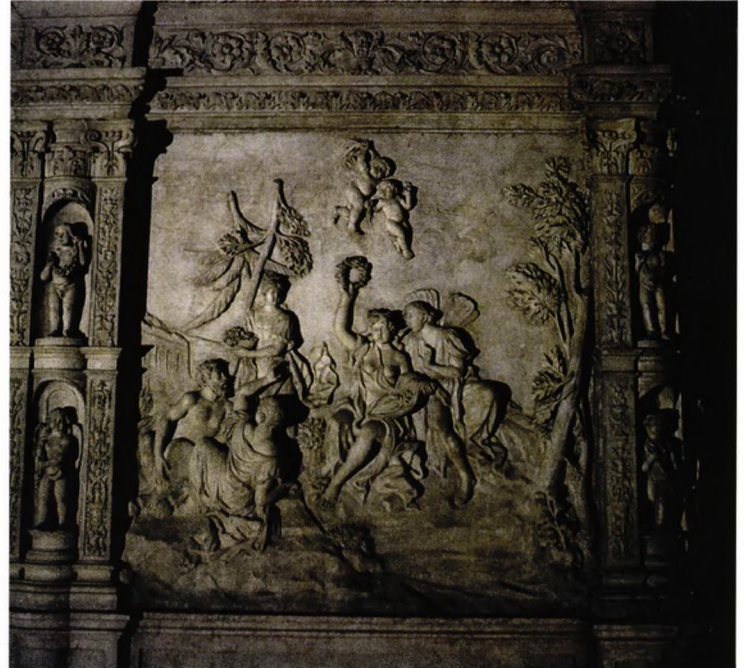
**Figure 2 a & b. The front frieze panels after treatment. The proper right scene appears to depict a courtship scene while the proper left shows a wedding scene.**

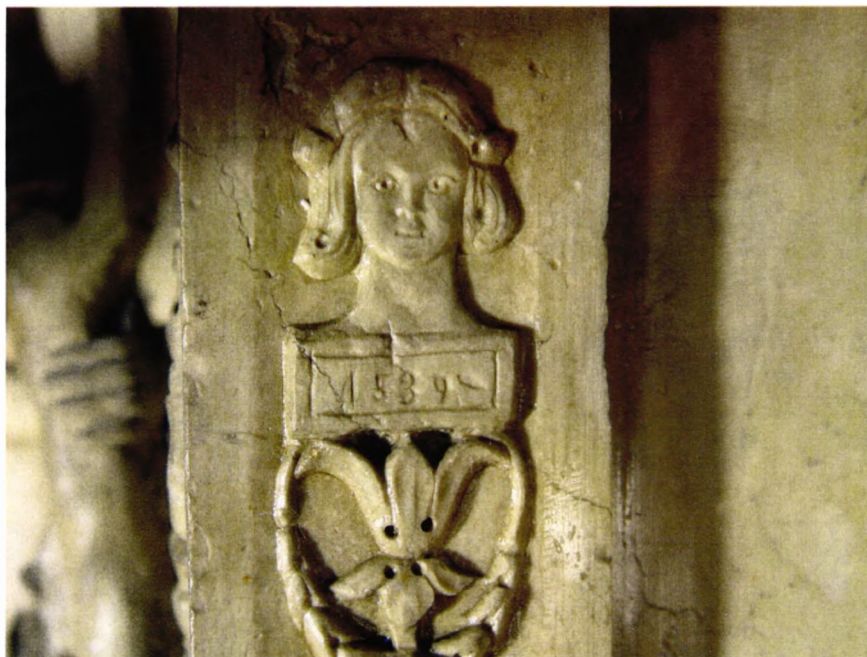
**Figure 3. Date carved into side of frieze panel.**

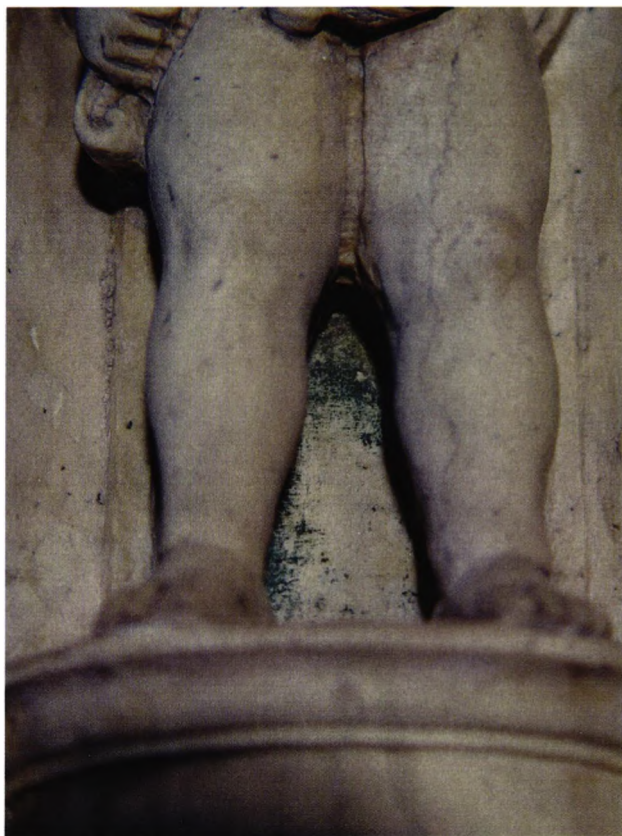
**Figure 8. Brown colored oil residue is also apparent in the drapery and tree recesses of the frieze panel.**

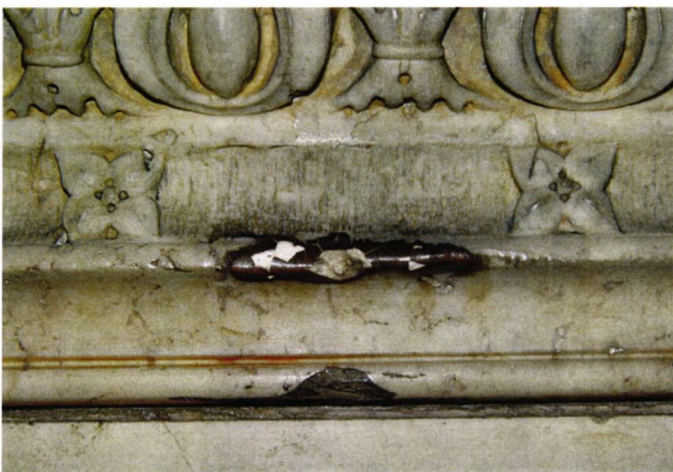
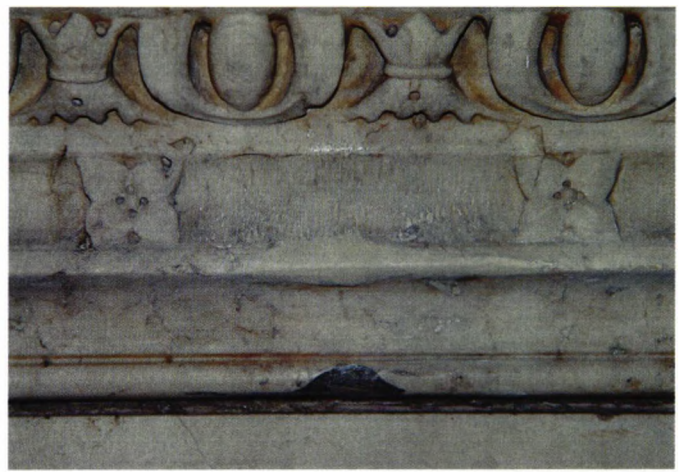
**Fireplace Surround:** The proper right side of the surround has heavy, oily soot accumulation, while the proper left side has somewhat less. Various chips and cracks are present, especially near the floor. There is a plaster fill on the front, rounded edge molding of the fireplace surround coated with what appears to be bronze paint (Figures 9 a & b).

**Figures 9 a & b. Gold painted fill before and after treatment with new plaster fill toned using acrylic paints.**

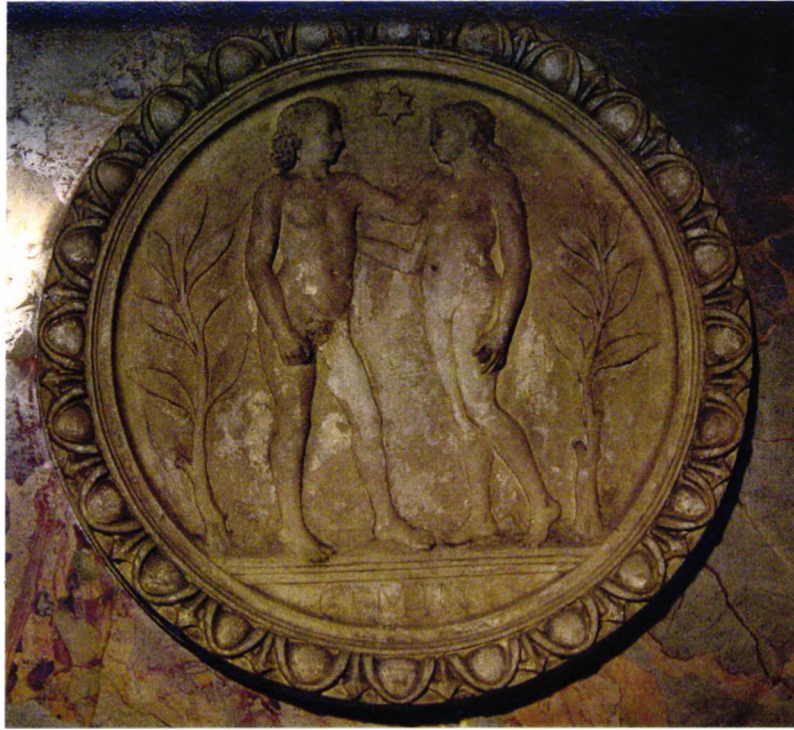
**Figure 10 a & b. Spotty appearance of Gemini medallion due to surface coating loss before treatment and after cleaning and toning with acrylic paints.**

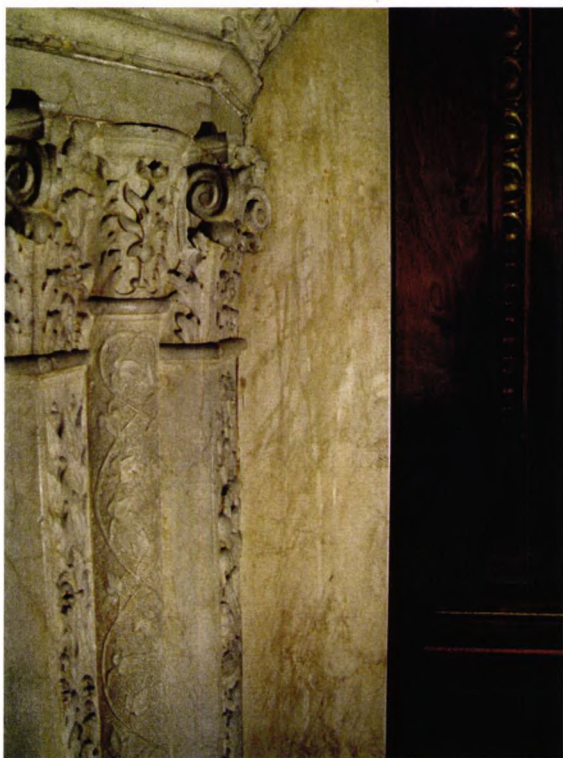
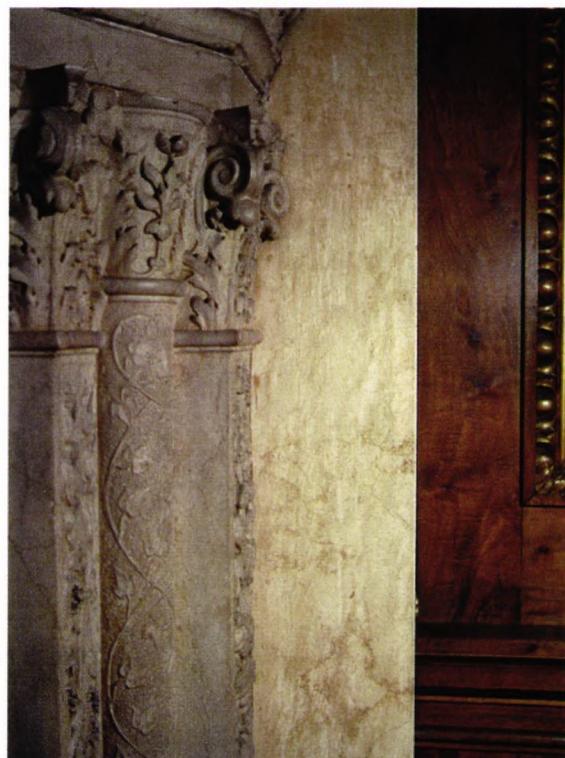
**Figures 13 a & b. Streaky/drippy areas were reduced using 1% ammonium citrate and water on cotton swabs.**

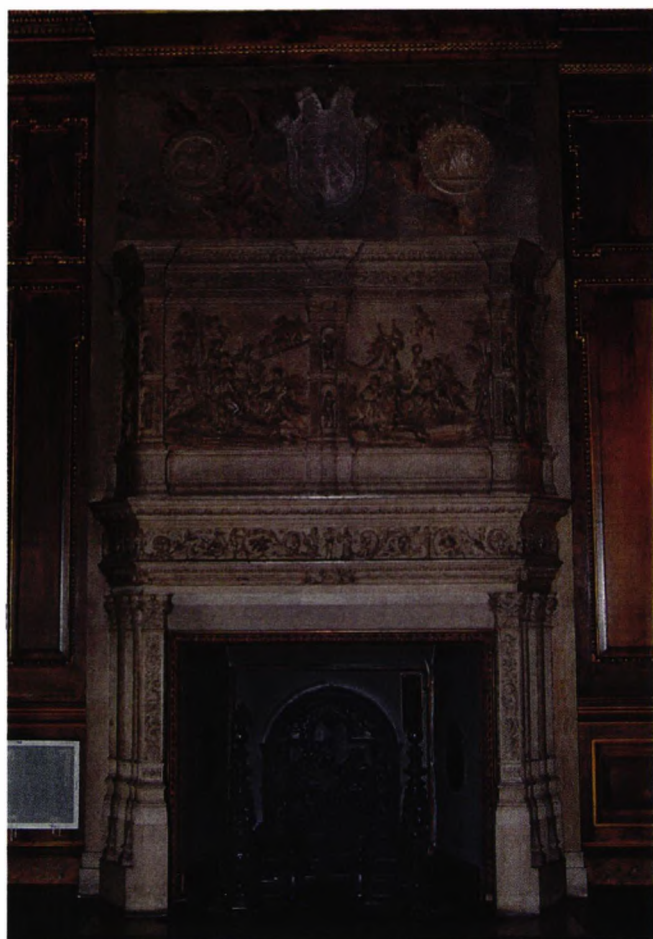
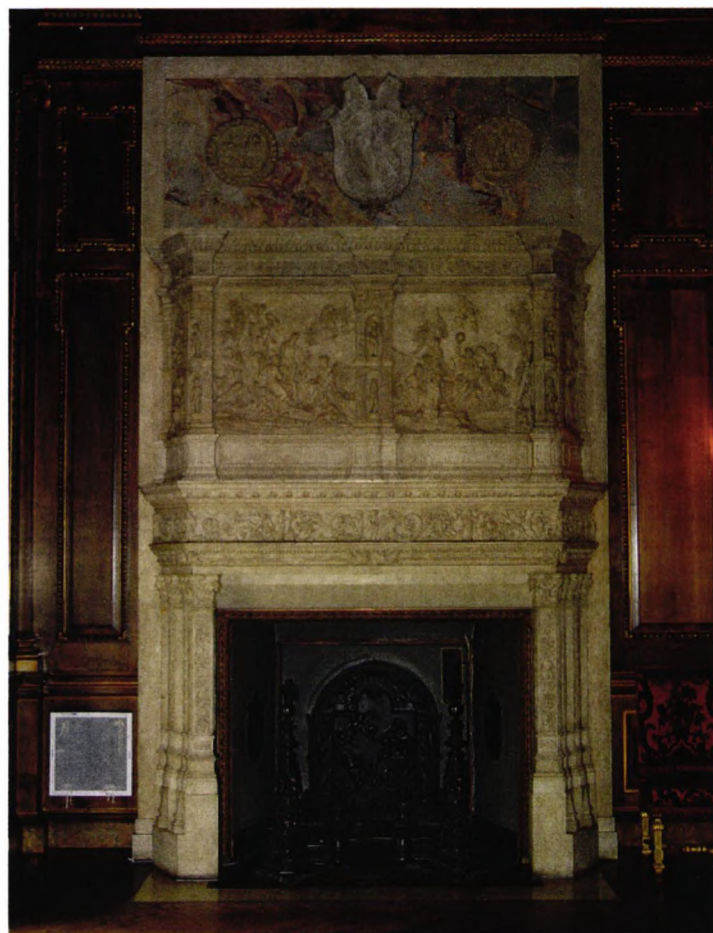
**The West Fireplace Mantel before and after treatment.**

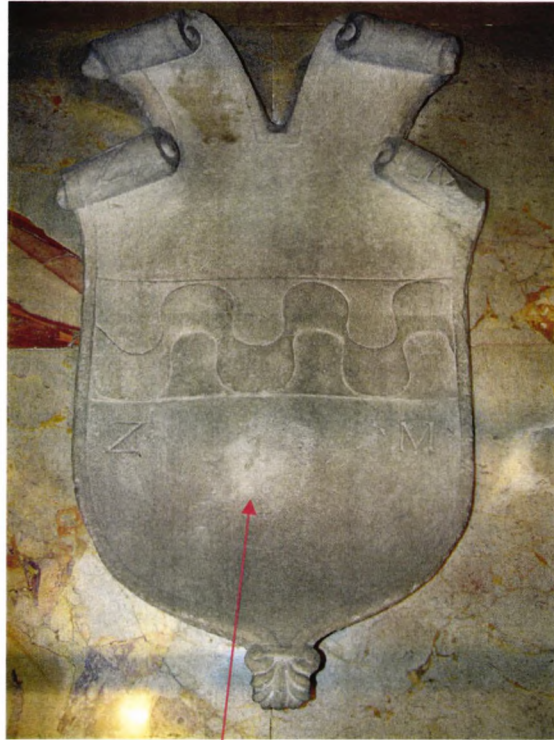
deposition, especially the ram figure, resulting in a spotty white/grey appearance in many areas. The central shield has a regular, overall tone, and has the letters "Z" and "M" on either side below the meander and on the lower scrolls (Figure 6). There is evidence of letters that were ground down near the center between the "Z" and "M" (Figure 7).

**Figure 6. Detail of shield before cleaning showing central meander and the letters “Z” and “M”.**

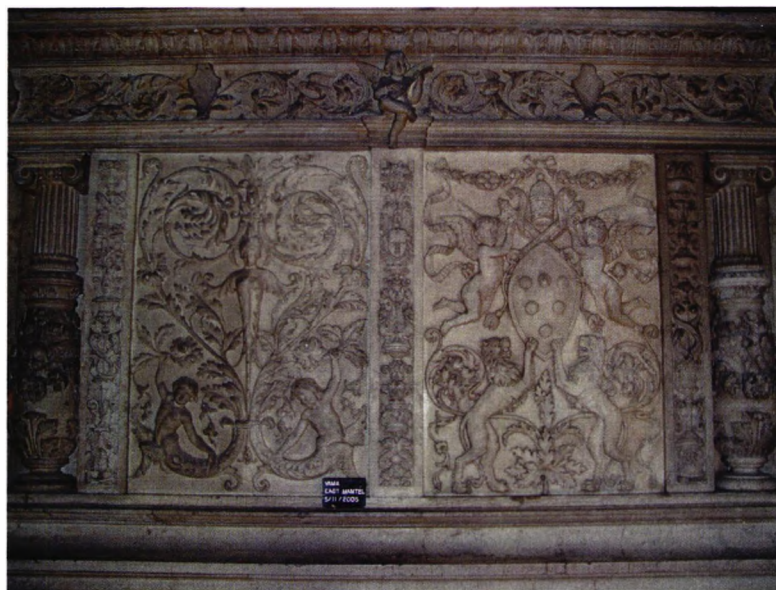
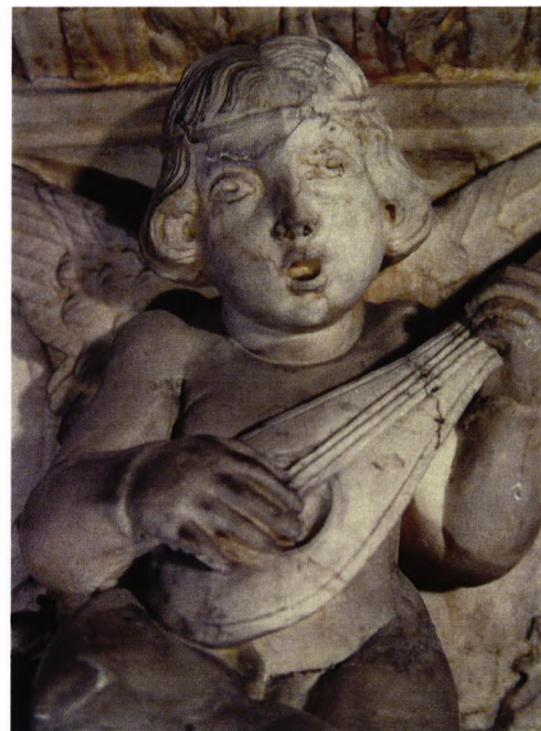
**Frieze Panel:** The frieze panel has heavy soot accumulation, especially on the proud horizontal planes (Figures 9 a & b). The proper left panel has previous cleaning attempts on the proper left putto and griffin resulting in a light, raw plaster appearance (Figures 10 a & b).

**Figures 9 a & b. Details of the frieze panels and putto during cleaning.**

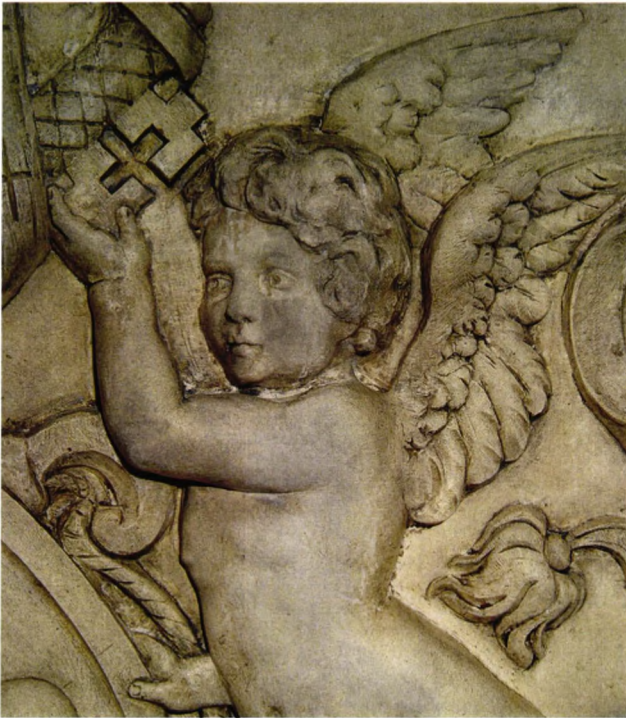
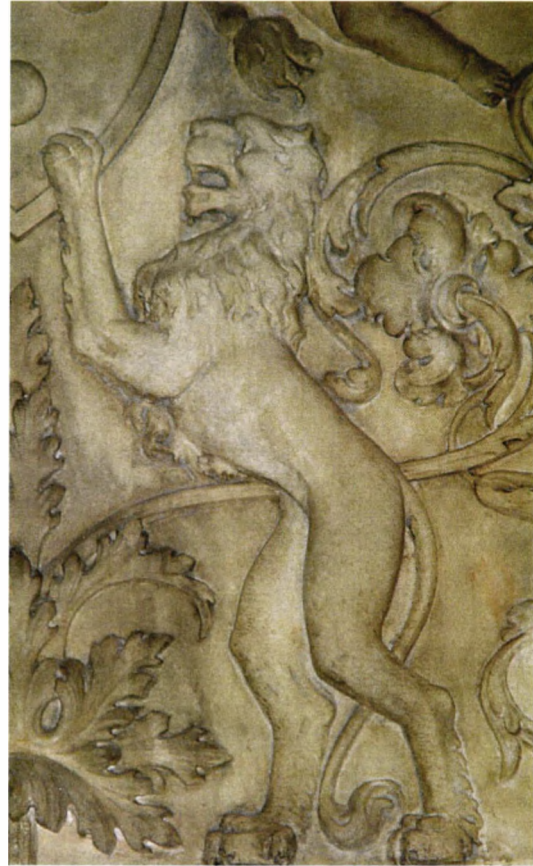
**Figures 10 a & b. Previous cleaning attempts to the proper left putto and griffin resulted in a light, raw plaster appearance.**

coat of 3% Acryloid B-72 in acetone was applied to the proper left putto and griffin which were then toned to better integrate with the original toned plaster appearance (Figure 16).

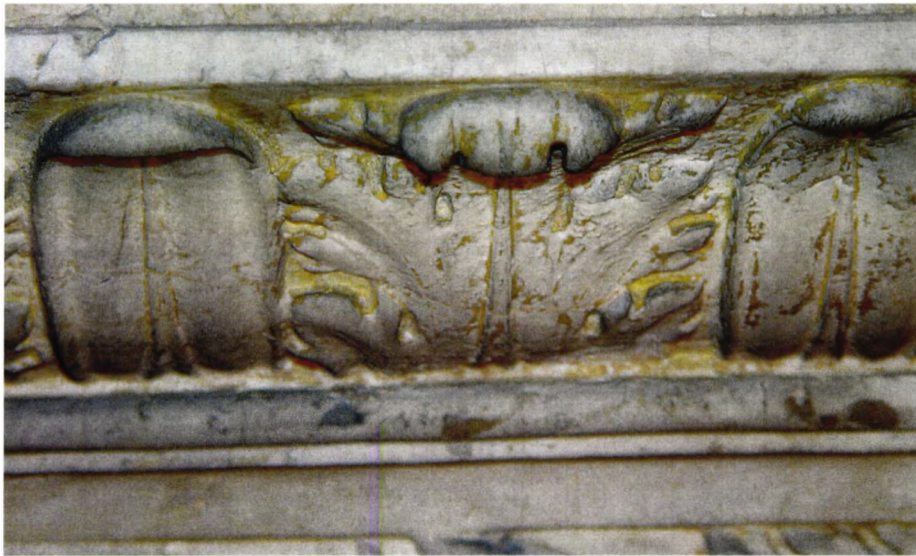
**Frieze Panel:** The acanthus leaf molding and frieze were cleaned using spring water on cotton pads and swabs. Most marble areas were further cleaned using 1% ammonium citrate and spring water on cotton swabs, followed by rinsing with spring water. In the recesses of the carved acanthus leaf molding is a yellow-orange paint/coating residue. This area appears very rough and worn, similar to a surface that has been severely pitted. It is possible that this area was once gilded (Figure 15). The deeply carved putto was cleaned with both 1% ammonium citrate and spring water and saliva on cotton swabs. Cleaning revealed that there were several repairs to the putto. There were at least two, if not three pieces (big toe, etc.) that appeared to have been previously readhered.

**Figure 15. Yellow paint/coating residue in recesses of abraded acanthus leaf molding.**

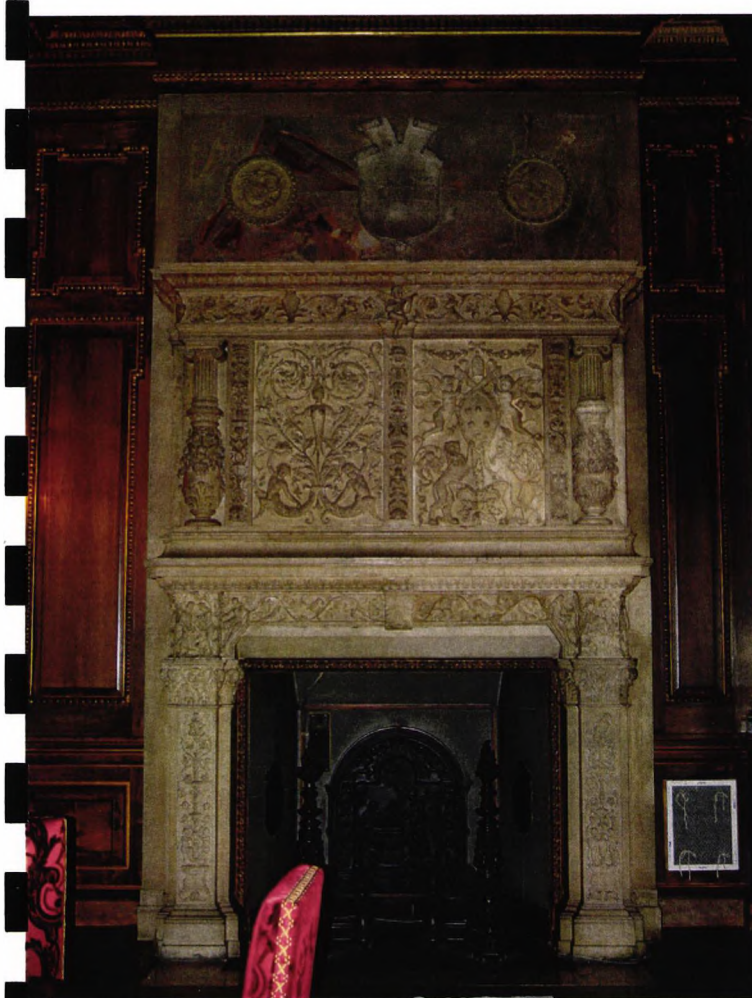
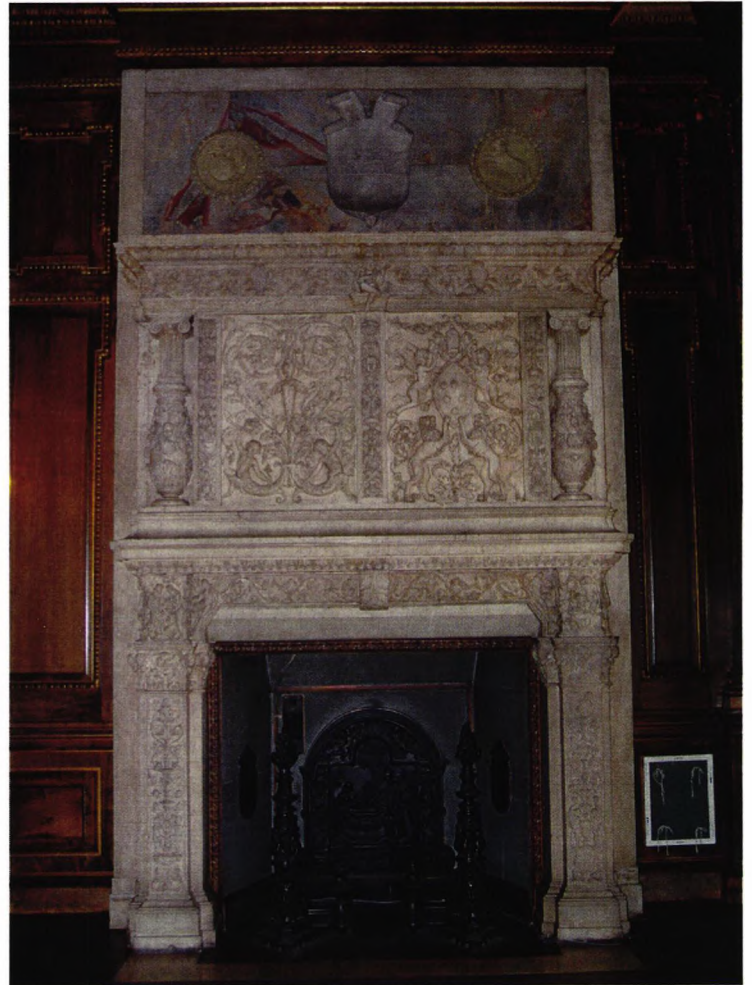
**The East Mantel before and after treatment.**

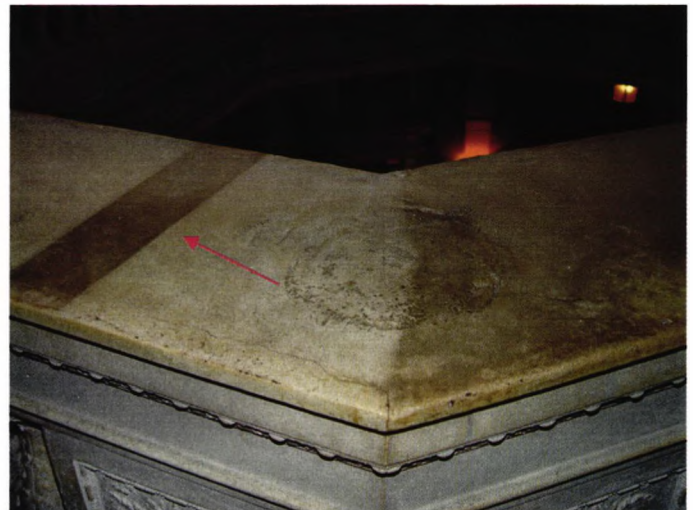
**One narrow strip was left during cleaning for visitor interpretation.**

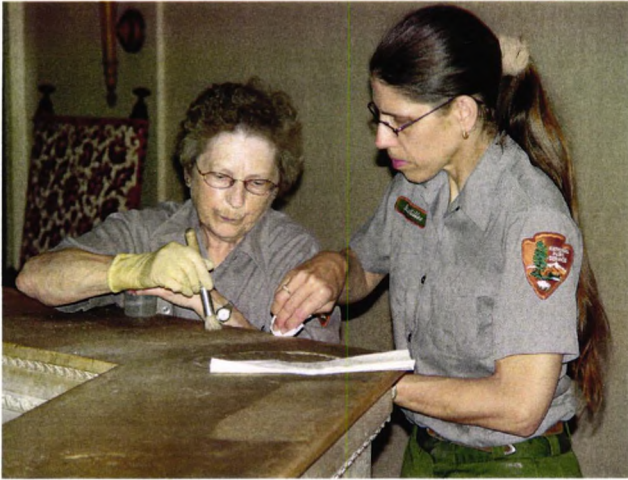
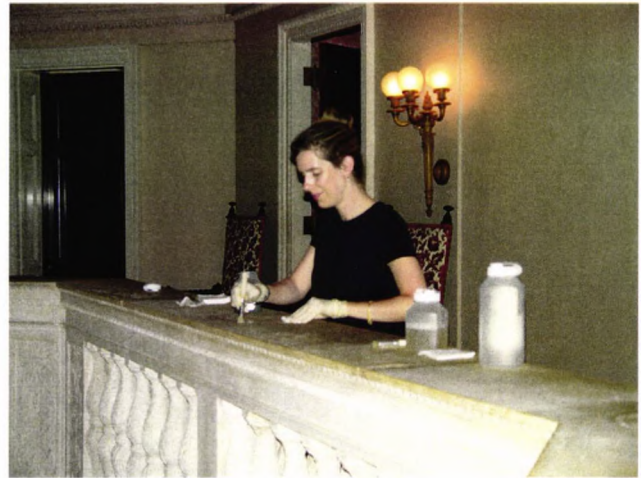
**Park staff Deborah Miller and Lucille Momme and Contract Conservator Rachael Perkins Arenstein cleaning the balustrade.**

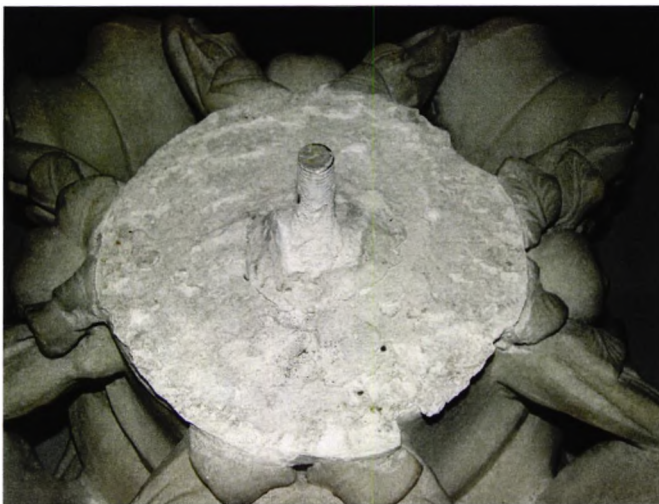
The capital was detached from the column. The capital had originally fallen off of the capital during transportation of the column to the Nassau County Museum of Art. Jerry Jiritano of Fine Art Conservation, Inc, repaired the column by placing a stainless steel pin in the capital that fits into a hole in the column. The pin was secured to the capital using an acrylic grout, and the capital was readhered to the column using the same acrylic grout (See Fine Art Conservation Treatment Report, 1999). During transportation back to the Park in February, 1999, the capital detached from the column once again, the repair failing at the same location.

**The capital and column before treatment showing acrylic grout residue.**

- Old acrylic grout was removed from both the capital and the column surfaces using a scalpel, chisel and rubber mallet. The grout surrounding the stainless steel pin was not removed as it held the pin in place.
- 3% Acryloid B-72 (ethyl methacrylate, ethyl acrylate copolymer) in acetone was used as a barrier coat on both the cleaned column surface and the capital.
- "Premixed Tile Grout" (limestone, acrylic copolymer, and water by Custom Building Products, 800-272-8786), was placed into the hole and approximately 1 inch from the edge of the column and the capital was placed back on top of the column.

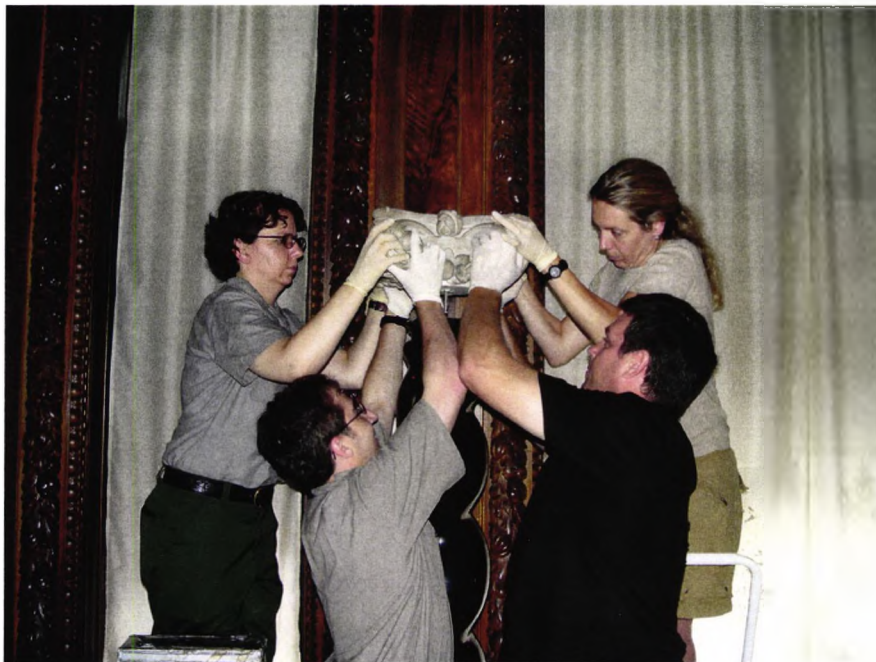
**Park staff and CCB conservator raising capital on top of column.**

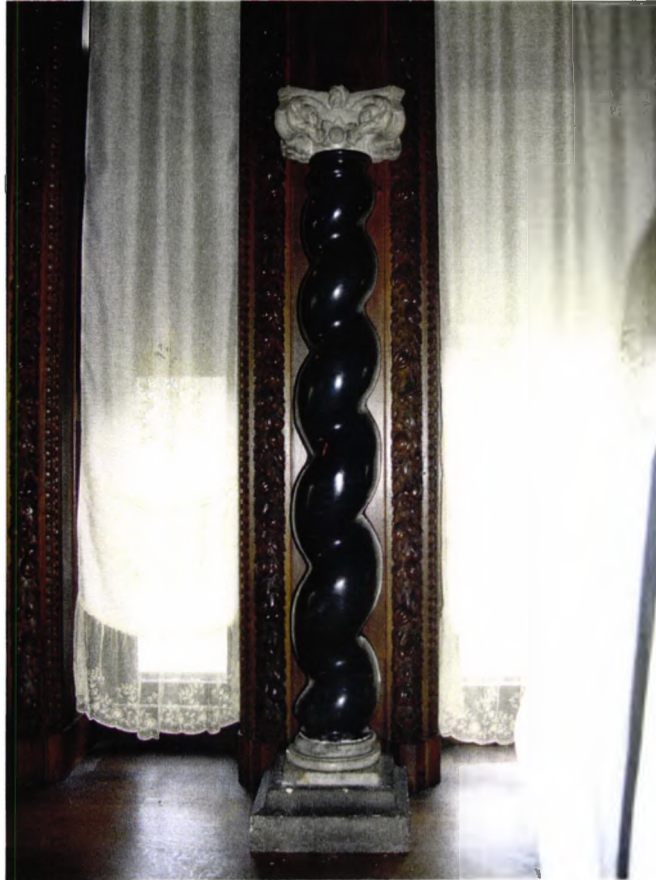
**The column and capital after treatment.**

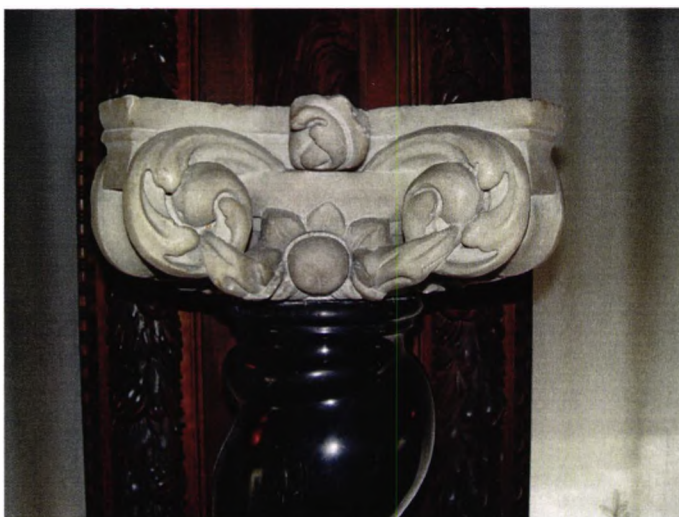
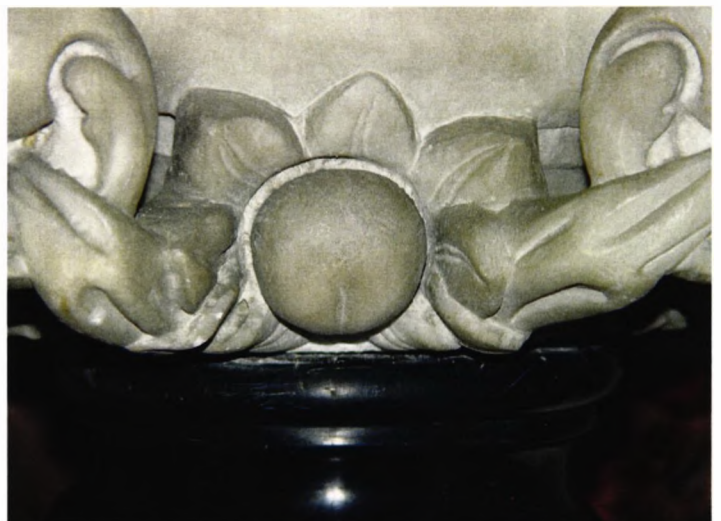
**Detail of newly placed capital on top of column.**

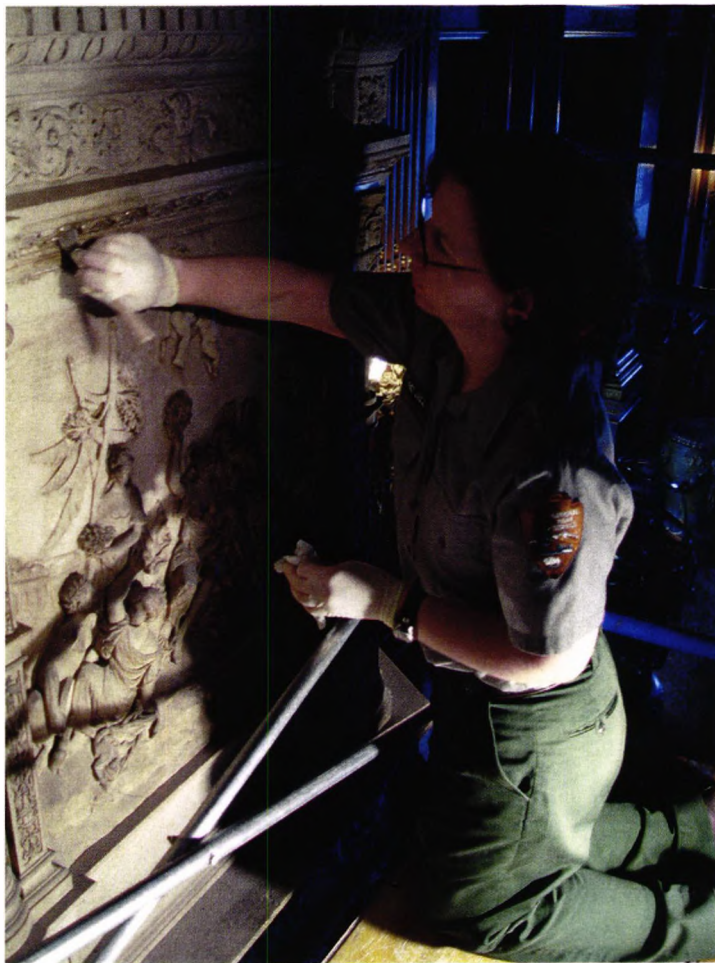
**Park staff member Tara McGill cleaning sections of the West Mantelpiece.**
