**Vanderbilt Mansion National Historic Site  
Conservation of Interior Stonework  
May-June 2005**

## Conservation of Interior Stonework 2005

### Conservation Assessment and Treatment Reports

# **Vanderbilt Mansion National Historic Site Interior Architectural Stone Conservation Needs Assessment**

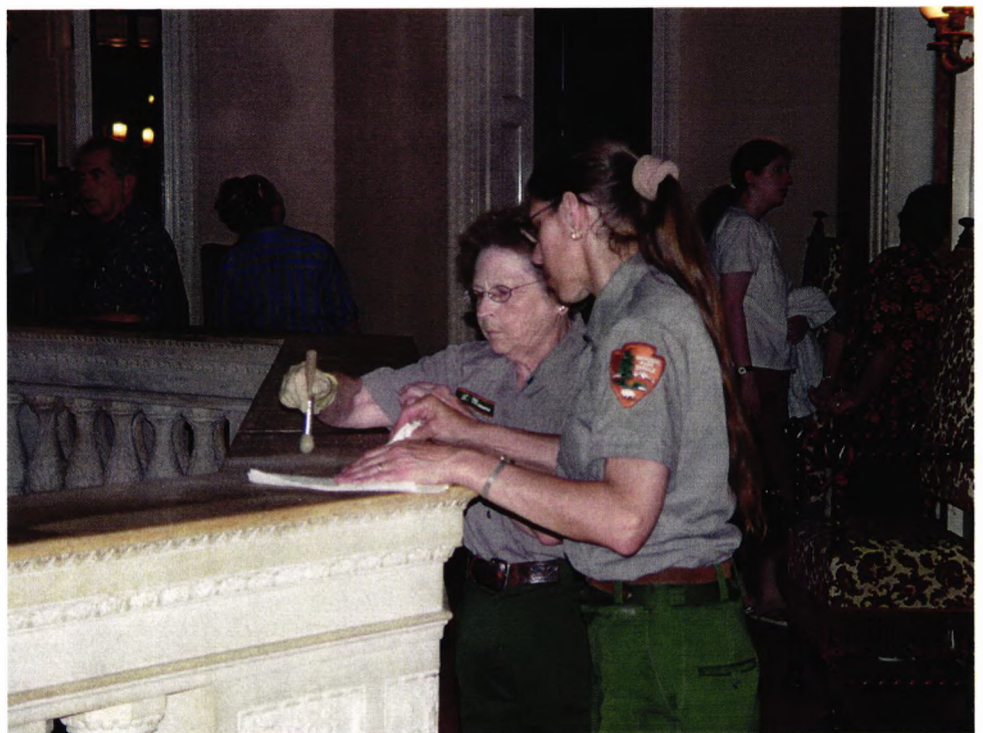
The balustrade has accumulated dirt/lipids and water staining due to use. In previous years, the Park placed potted plants on the railing which has left water ring stains. Visitors frequently lean on the railing leaving dirt and lipids from hands and arms.

**Deborah Miller and Lucille Momme cleaning the balustrade while visitors tour the Mansion.**
